# NATIONAL TRANSPORTATION SAFETY BOARD

## MATERIALS LABORATORY FACTUAL REPORT

Report No. 17-056

Place : Boise, Idaho  
Date : September 21, 2015  
Vehicle : Aero Commander 680E, N222JS  
NTSB No. : WPR15LA265  
Investigator : Samantha Link, AS-WPR

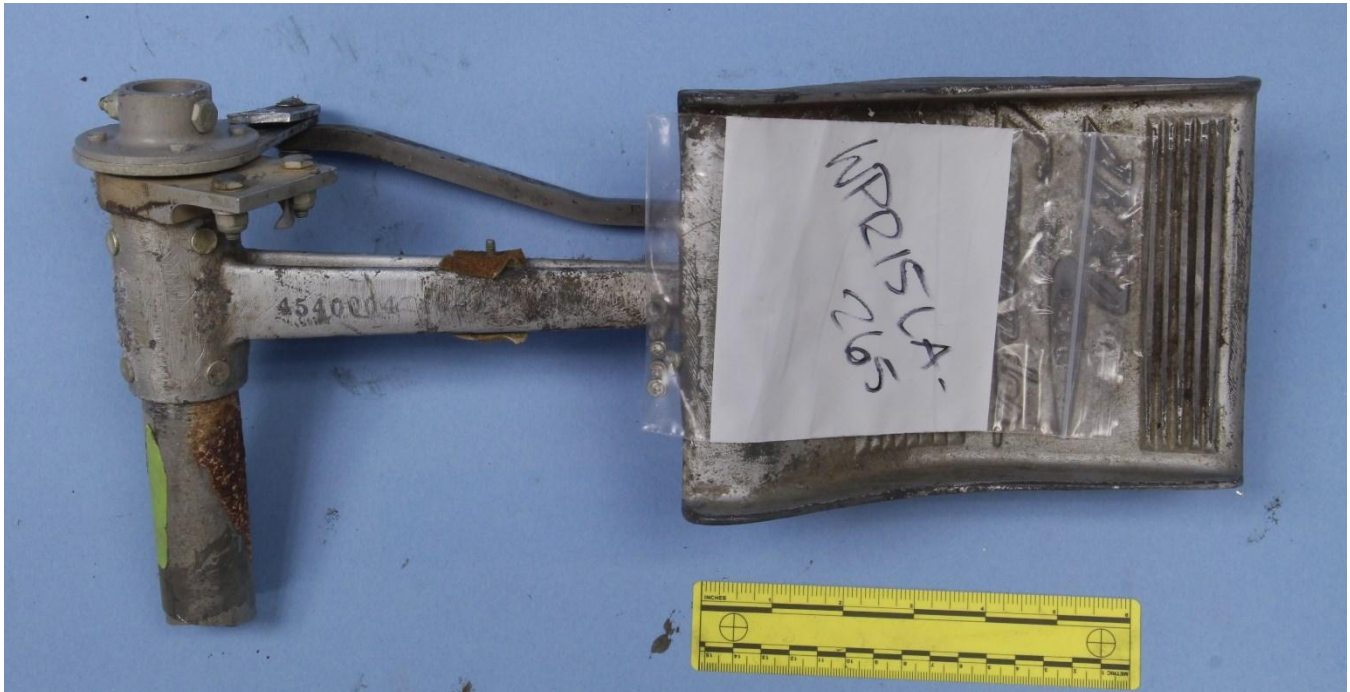
Figure 1 shows parts from the left rudder pedal, as received. Attached to the pedal was a plastic bag containing six fragments of fractured rivets. The pieces were all from the upset ends (tails) of the rivets. The fracture surfaces of these rivets are shown in Figures 2 and 3. The rivets were arbitrarily labeled 1 through 6 for the purposes of this report.

Figure 1 – The rudder control pedal and bagged rivet tails, as received.

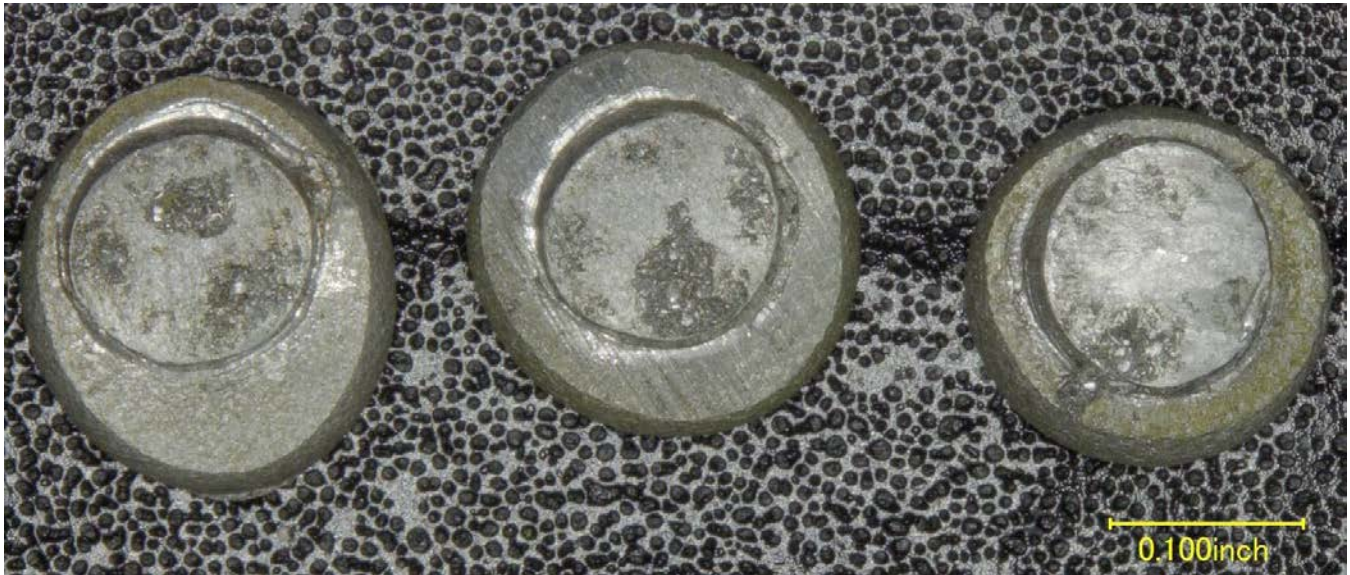
As shown in Figures 2 and 3, the rivet tail fractures were generally flat, exhibiting visual linear marks consistent with smearing across the fracture face. The side adjacent to each rivet fracture surface exhibited bulging deformation away from the center of the rivet shank. On the diametrically opposite sides, the rivets exhibited deformation patterns inward toward the rivet. These features were consistent with overstress shearing toward the bulged sides.

Figure 2 – The fracture surfaces of tails of rivets 1 through 3, as received.

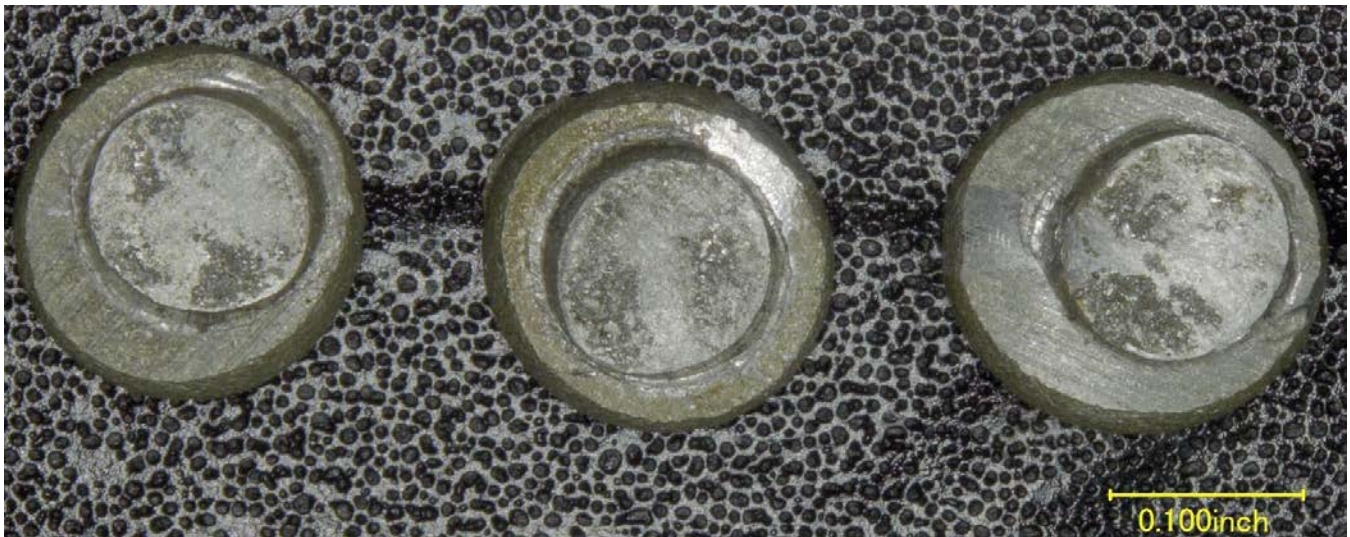
Figure 3 – The fracture surfaces of tails of rivets 4 through 6, as received.

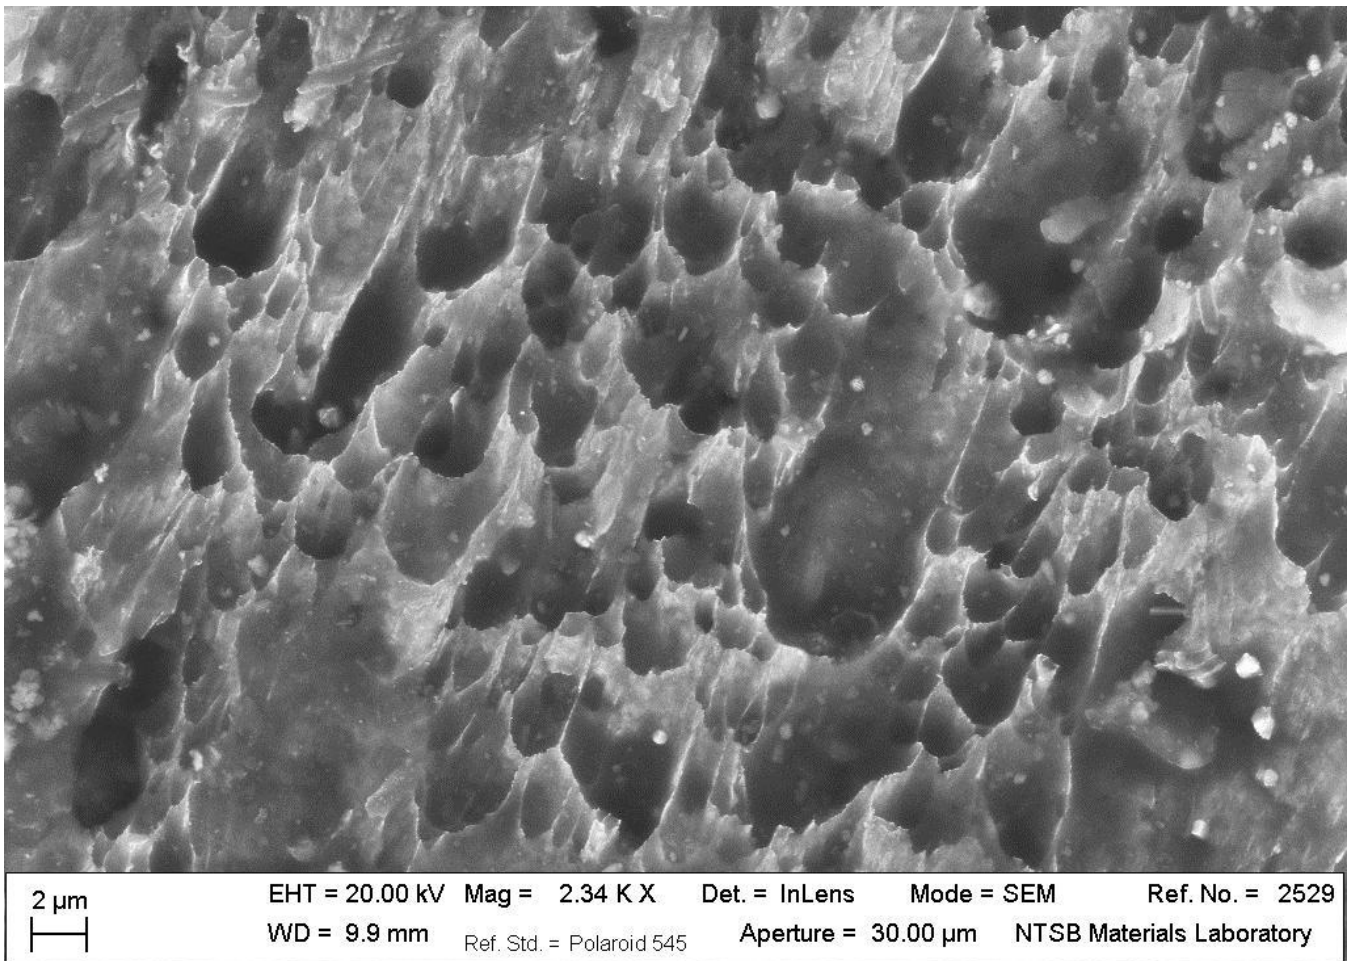
The rivet fracture surfaces were examined using a scanning electron microscope. Approximately half of each rivet fracture surface exhibited smearing features consistent with post-fracture damage. The undamaged regions of the rivet fracture surfaces exhibited ductile dimple rupture, as typified in Figure 4. The dimple rupture features were oriented in along the direction of the smearing. These features were consistent with shearing overstress.

Figure 4 – Secondary electron micrograph of a typical portion of the fracture surface of rivet 4, showing slanted ductile dimple rupture.
