## **NATIONAL TRANSPORTATION SAFETY BOARD**

# **AIRFRAME AND ENGINE EXAMINATION**

**WPR16FA014**

Location: Morongo Valley, California  
Date: October 17, 2015  
Aircraft: Piper PA28R-180, Registration Number: N4972J, Serial #: 28R-30723  
NTSB IIC: Elliott Simpson

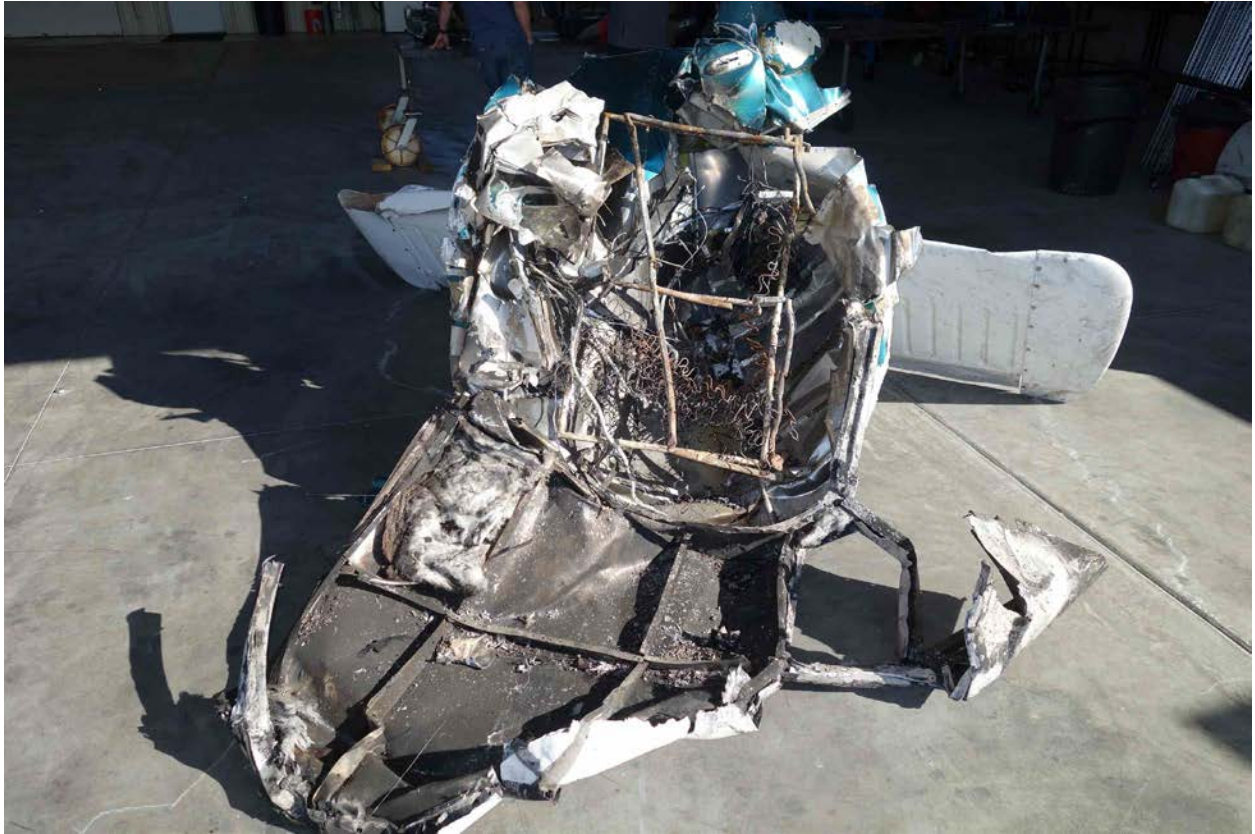
Photo 1 - Aft Cabin

The airframe sustained extensive thermal damage consuming the entire cabin through to the tail section (Photo 1). The firewall was crushed and detached from the airframe, and the steel remnants of the seat frames, flight control columns, cables, and bellcranks exhibited fragmentation and bending damage with fire consuming all of their ancillary components (Photo 2).

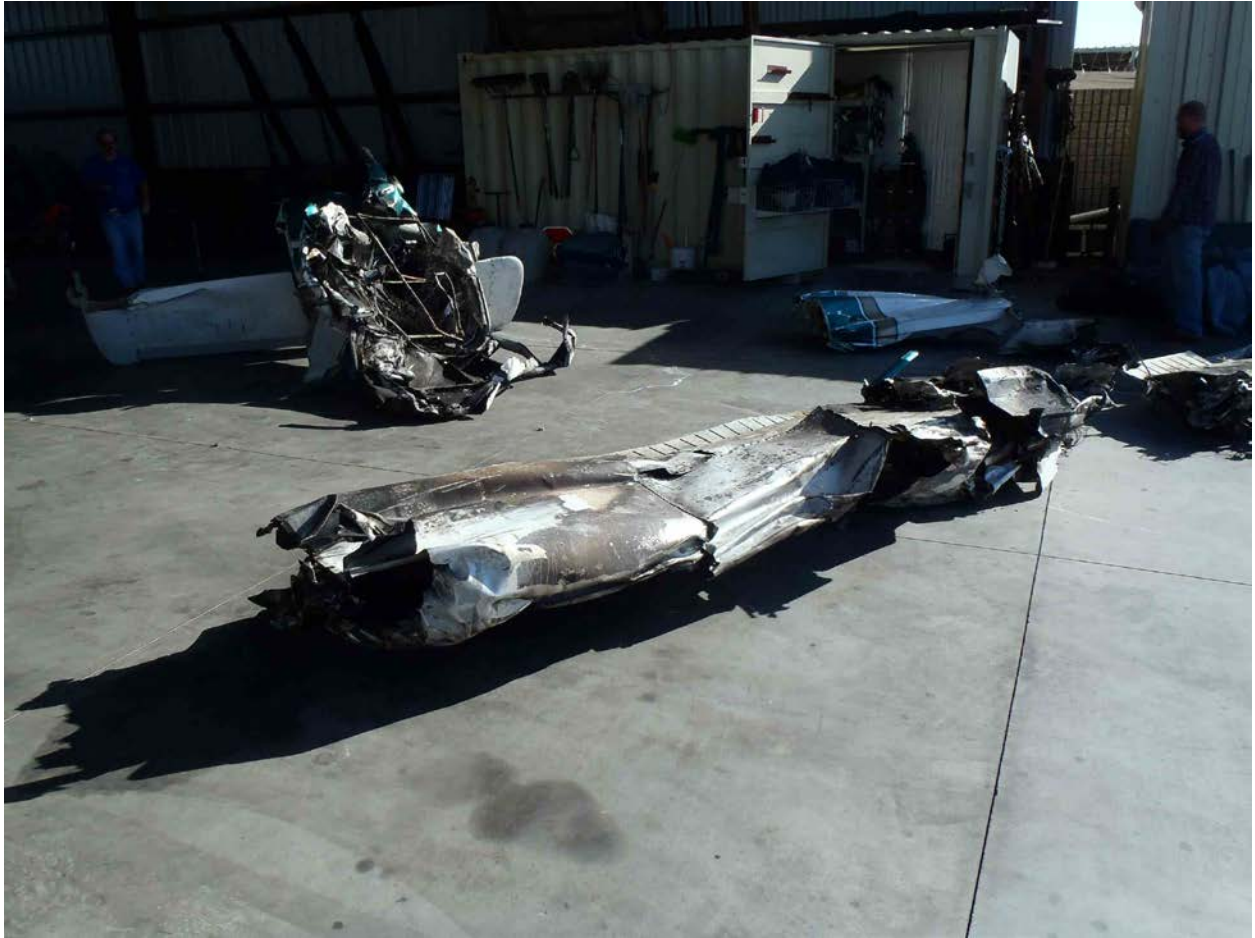
Photo 3 - Right Wing

The right wing sustained leading edge crush damage through to main spar along its entire length, along with thermal damage to all surfaces (Photo 3). The fuel tank was breached, and the fuel cap was in place at the filler neck. Both the flap and aileron remained attached (Photo 4). The wing tip had separated. The outboard bellcrank remained connected to its wing rib, and the push-pull tube remained connected to the aileron (Photo 5). The landing gear was retracted within the wheel well, and exhibited bending damage around the well frame consistent with the wheel being retracted at impact (Photo 6).

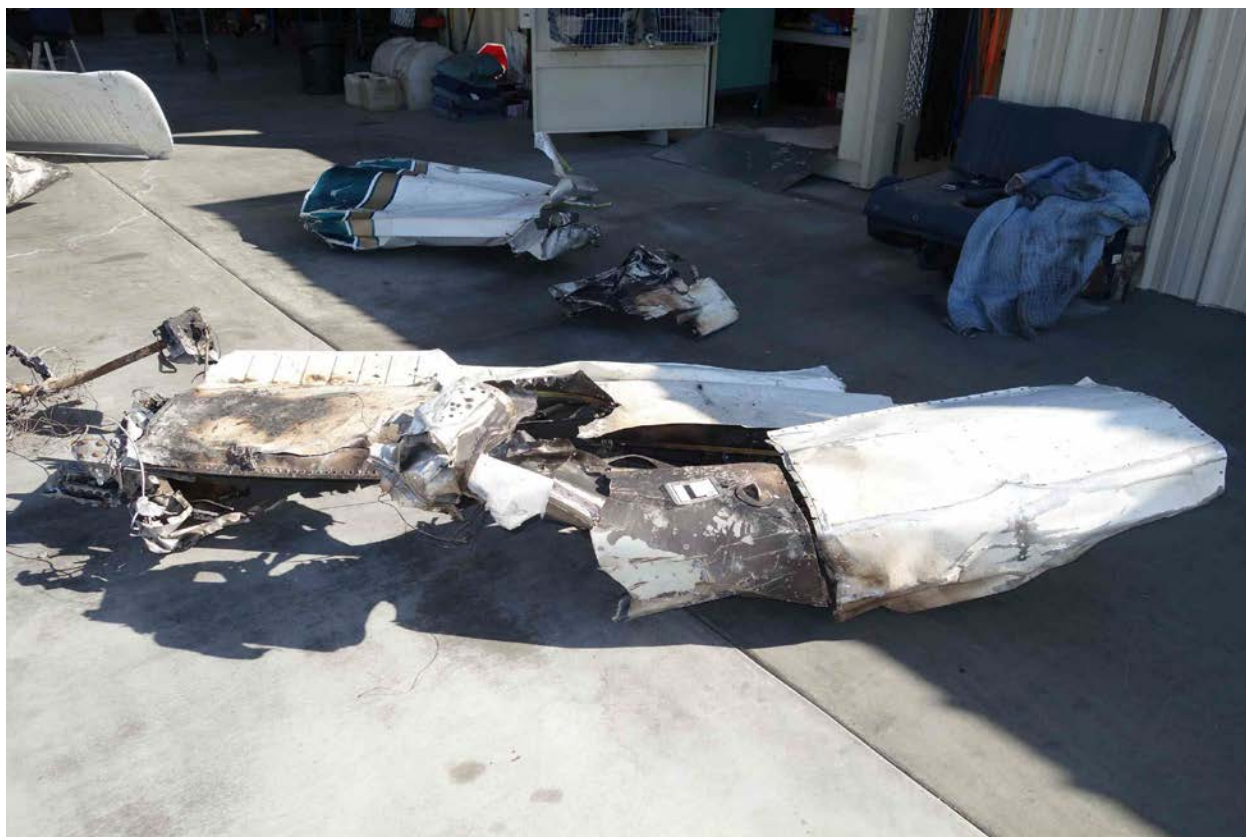
Photo 7 - Left Wing

The left wing sustained leading edge crush damage through to main spar along its entire length, along with fire damage to all surfaces (Photo 7). The fuel tank was breached, and the fuel cap was in place at the filler neck. The outboard wing section had separated adjacent to the flap and aileron interface (Photo 8). The flap remained connected at its inboard hinge. The aileron bellcrank was still attached to its wing rib and control cables, but the aileron push-pull tube had separated at the eyebolt, where it exhibited bending signatures consistent impact. The landing gear had separated from the spar, and the wheel had separated from landing gear arm (Photo 9). According to recovery personnel, the left aileron had been misplaced during recovery (it was observed and documented by the NTSB investigator-in-charge at the accident site (Photo 10)).

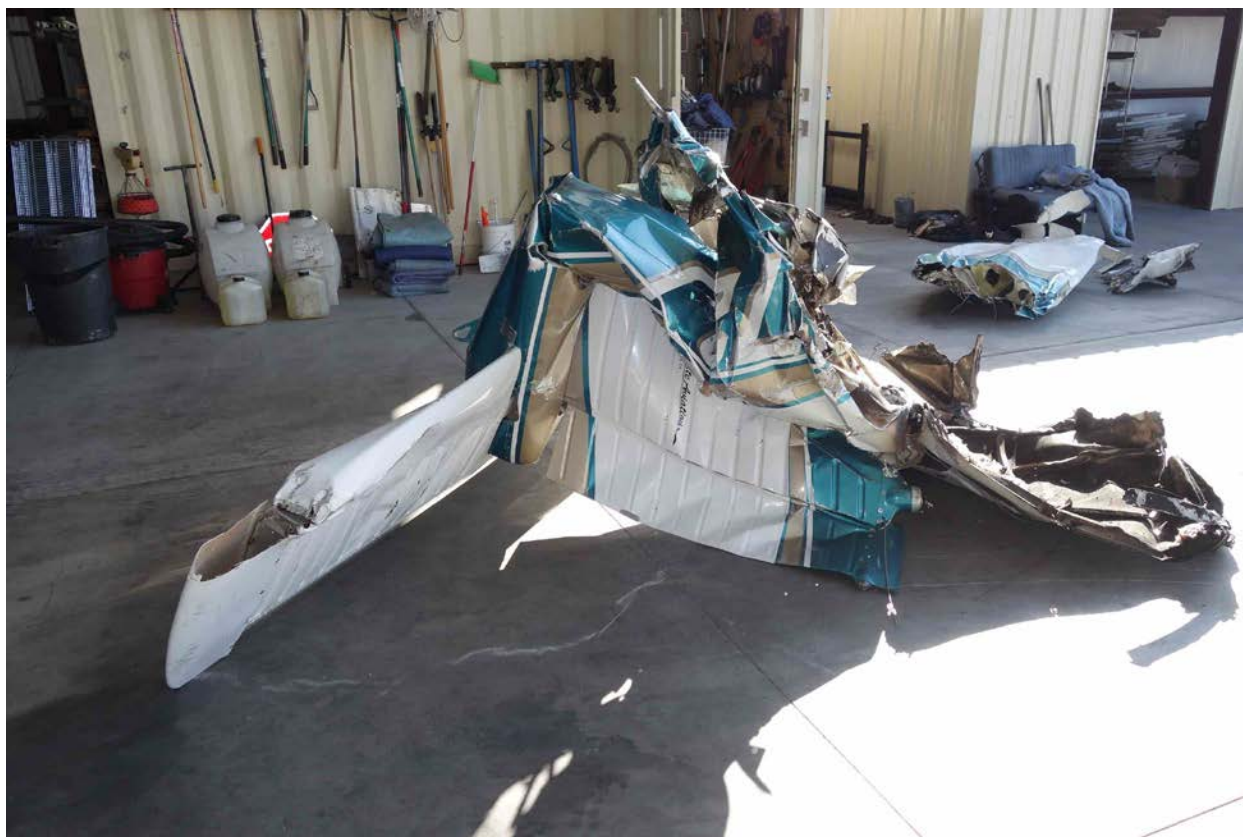
Photo 11 - Empennage

The tailcone had become crushed forward against the remnants of the aft cabin (Photo 11). The vertical stabilizer and stabilator remained attached to each other and the tailcone. The vertical stabilizer sustained crush damage and the rudder remained attached at its hinges. Both control cables were still attached to the rudder (Photo 12) and were continuous to the cabin where they had been cut by recovery personnel. Forward of the cut, the cables were continuous to the remnants of the rudder foot pedals.

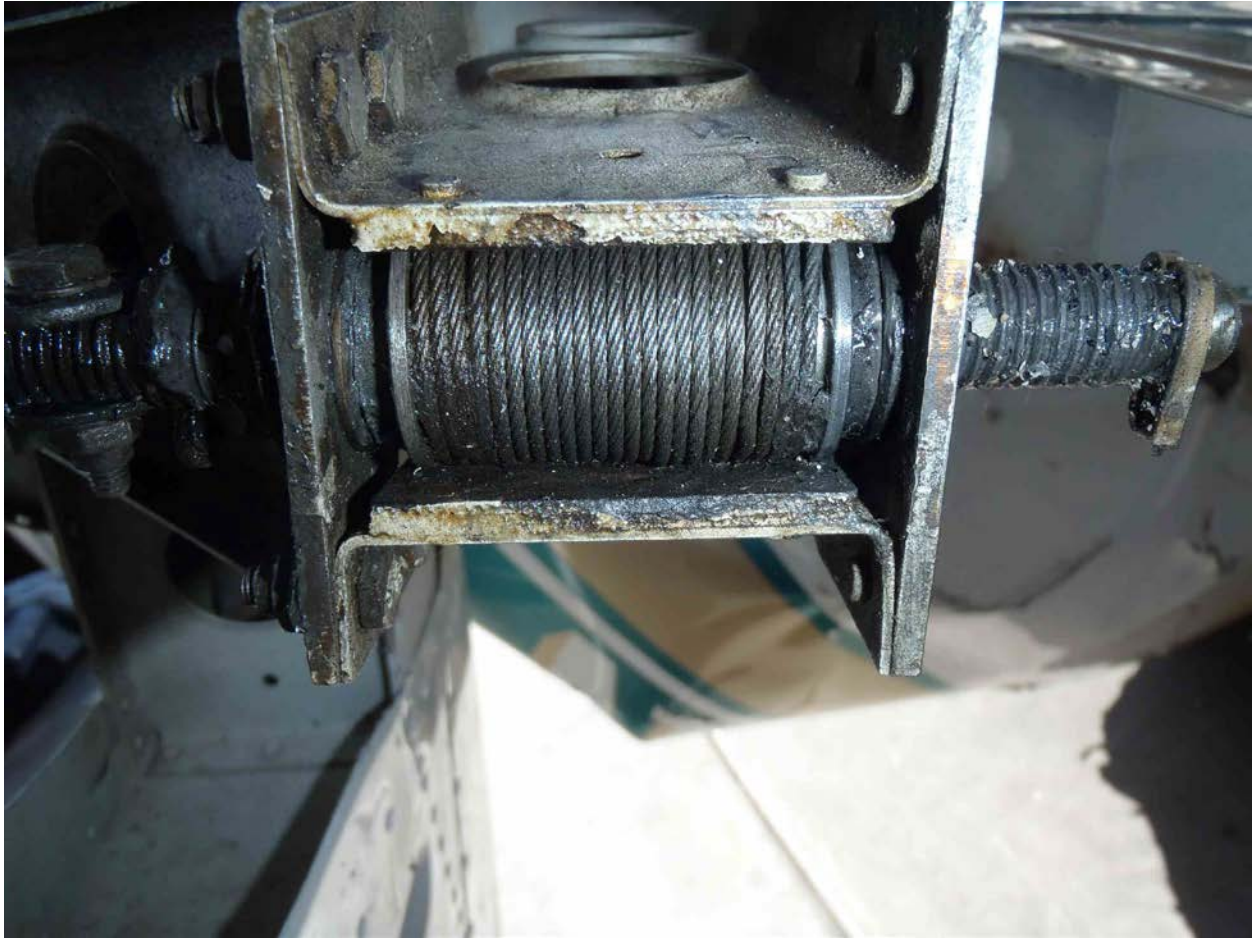
Photo 13 - Stabilator Trim Actuator

The stabilator and trim tab were intact. Twelve threads were visible on the upper jack of the trim actuator (Photo 13), and the stabilator control cables were continuous to the cabin where they had been cut by recovery personnel. Forward of the cut, the cables were continuous to the remnants of the control column.

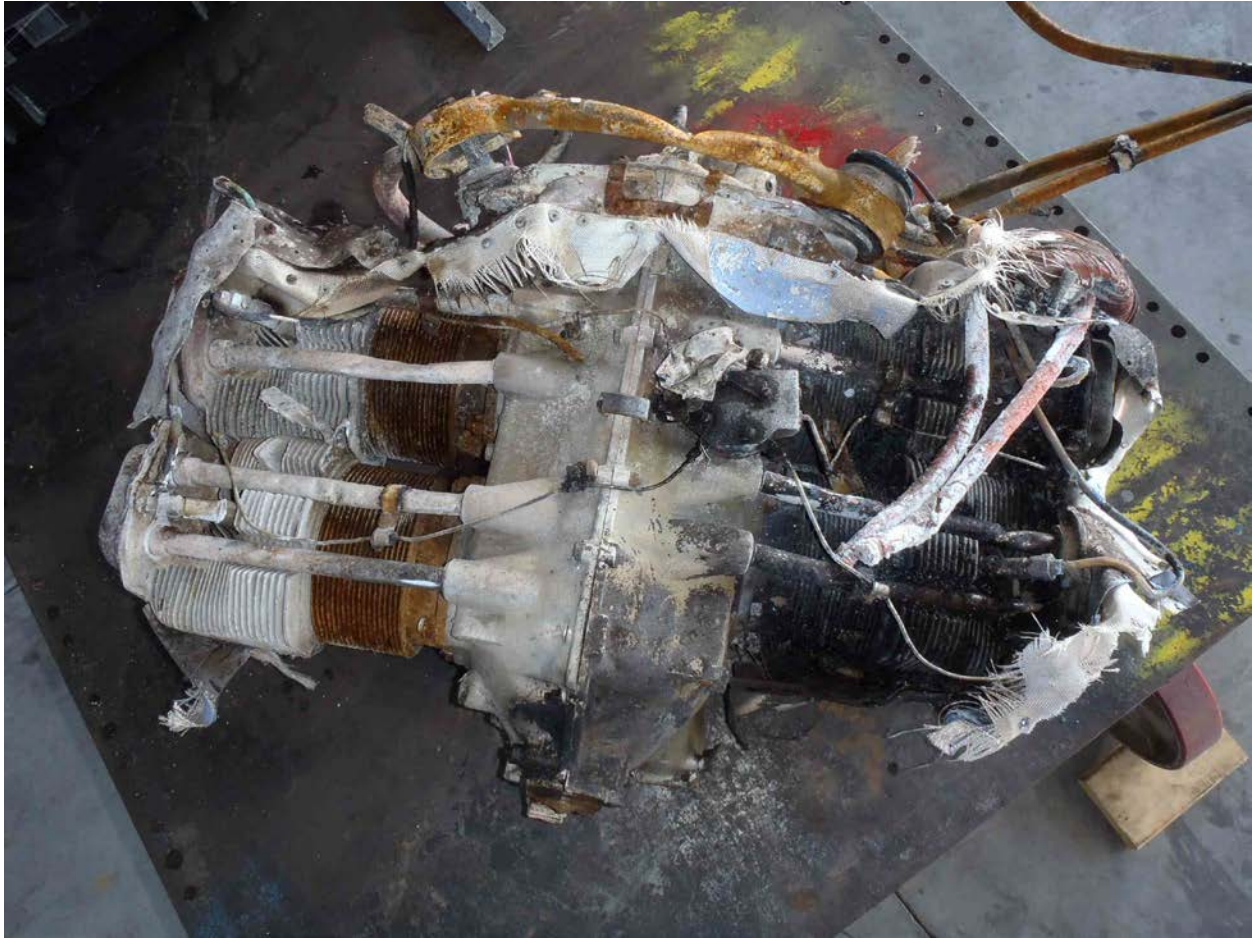
Photo 14 - Engine

The engine remained partially attached to its mount, which had detached from the firewall (Photo 14). The engine was thermally discolored and covered in soot, and the forward crankcase had sustained cracks around the area of the forward crankcase bearing (Photo 15). The forward fins of cylinder number 1 were bent, along with all of the pushrod cover tubes.

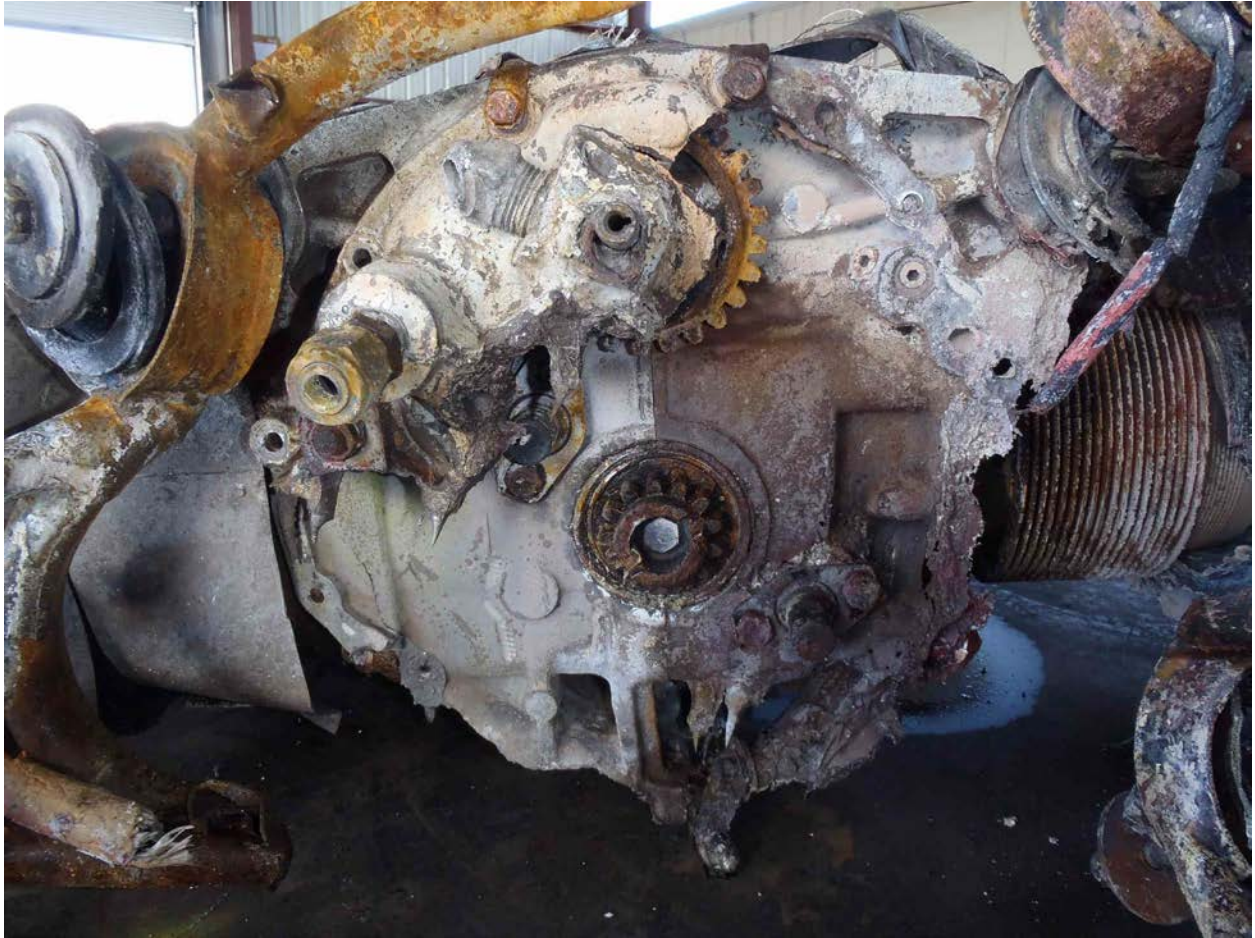
Photo 16 - Aft Engine Section

The accessory case was consumed by fire along with both magnetos, the vacuum pump, the oil sump and induction tubes. The drive train area was exposed, with only the crankshaft and camshaft drive gears remaining (Photo 16). Both idler gears were located separately and had been incased in molten aluminum. The engine driven fuel pump, along with the fuel servo sustained extensive thermal damage, exposing their internal components (Photo 17, 18). The crankshaft gear, bolt, locking device and dowel remained secure and intact.

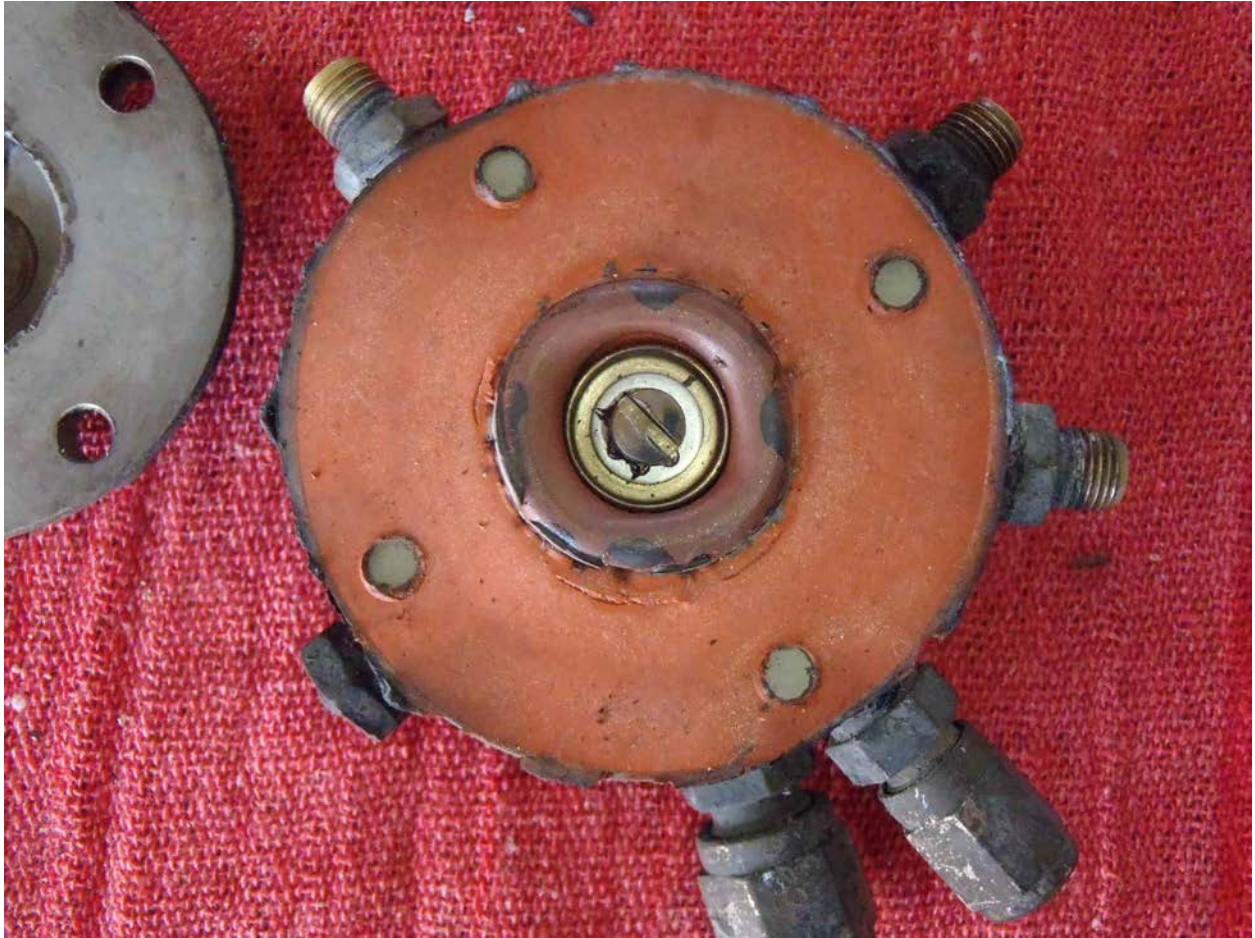
Photo 19 - Fuel Flow Divider Diaphragm

The fuel flow divider remained intact, with all fuel lines connected to their respective fuel injector nozzles with the exception of line three which was crushed and separated at the flow divider outlet. The flow divider was disassembled and the diaphragm appeared thermally damaged (Photo 19). The fuel injector nozzles were free of obstruction.

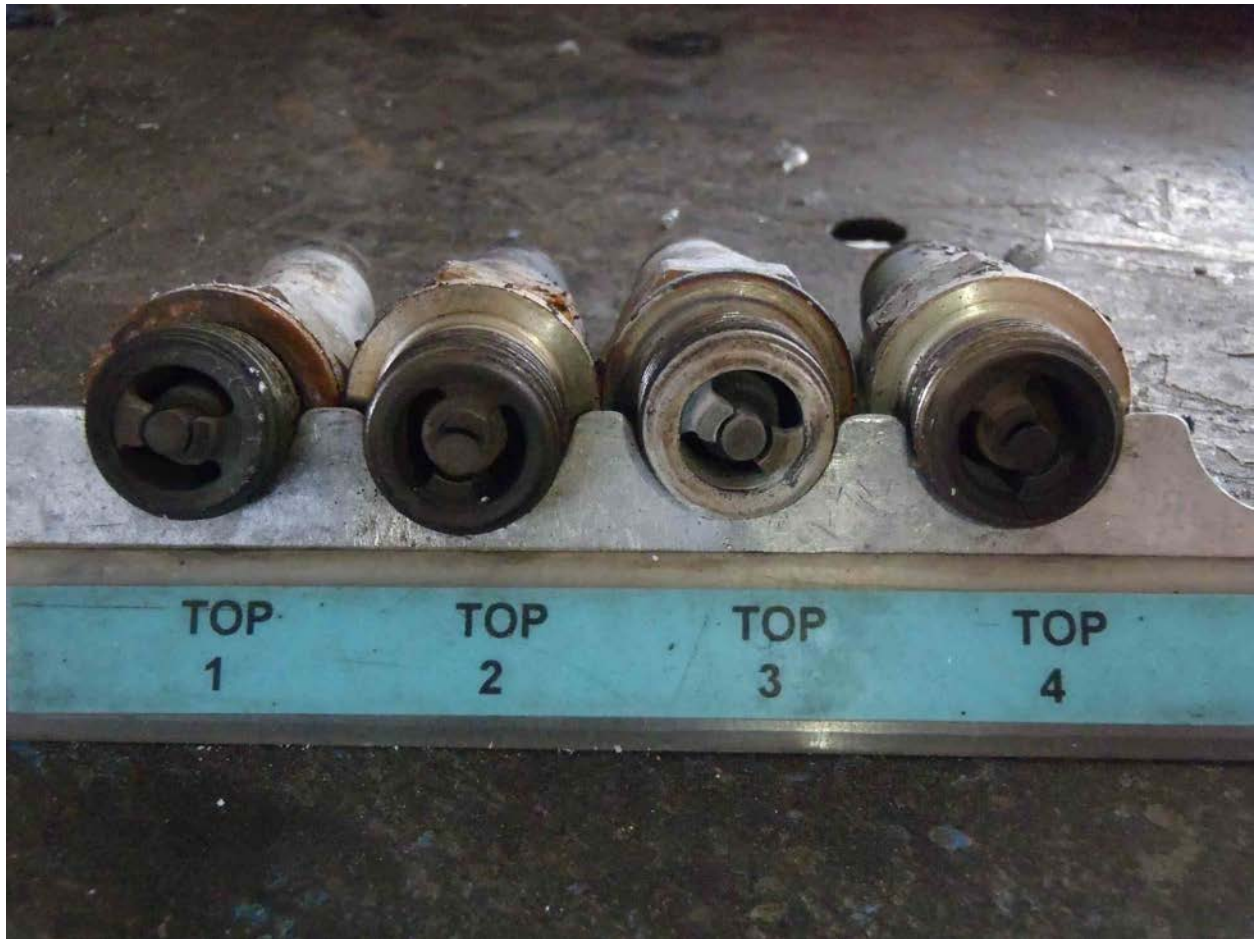
Photo 20 - Top Spark Plugs

The top spark plugs were removed and examined. The spark plugs were of the massive electrode type, and cylinder number 1, 2 and 4 were dark in color with plug 3 exhibiting a lighter grey coloration. The varying coloration was attributed to being exposed to the thermal effects of the post impact ground fire. According to the Champion Aviation Check-A-Plug AV-27 Chart, the electrodes exhibited wear signatures consistent a short service life (Photo 20).

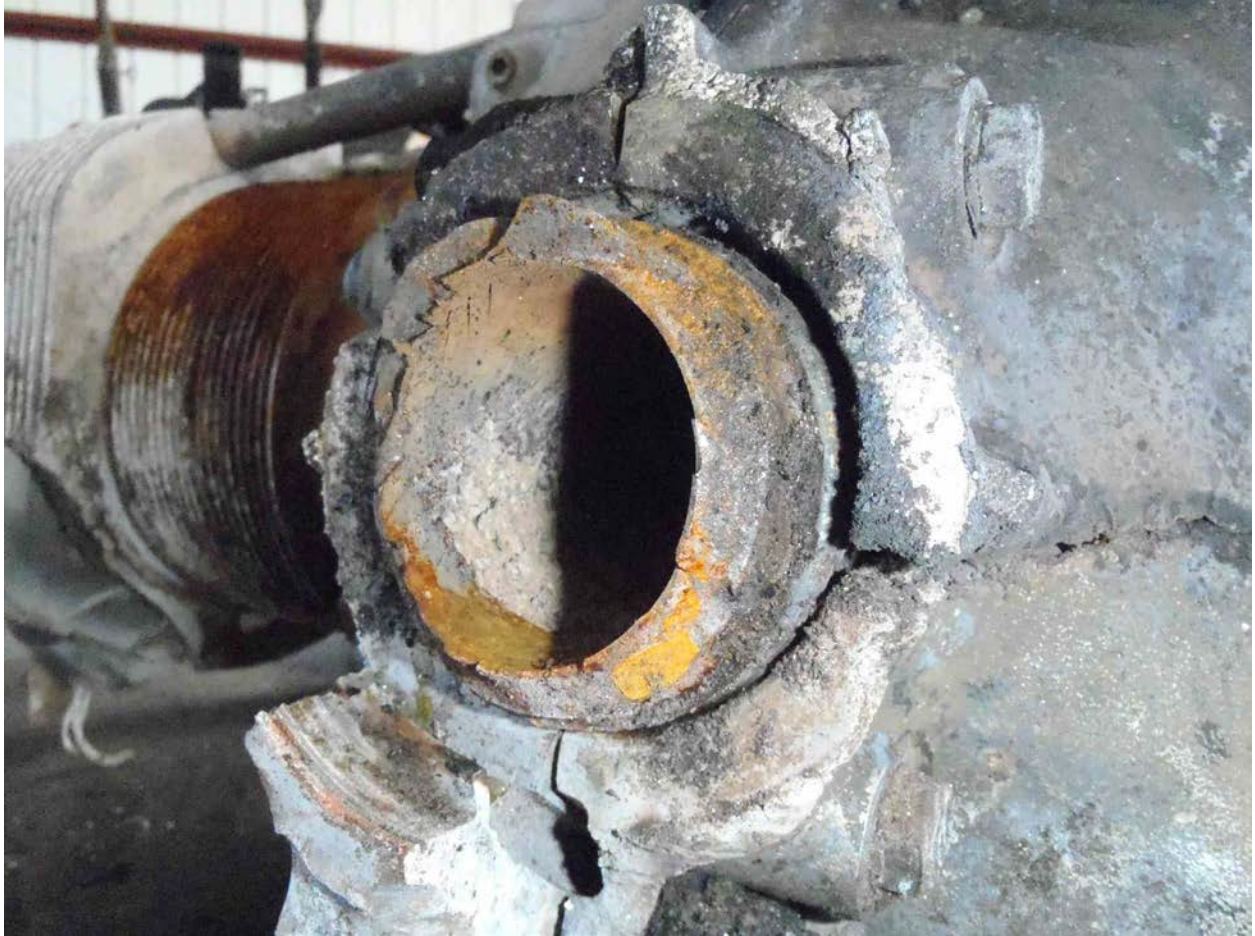
Photo 21 - Crankshaft at Prop Hub

The propeller hub had separated from the crankshaft. The separation features on the crankshaft were conical in appearance with a 45 degree shear lip around the entire radius of the break (Photo 21). Both propeller blades had separated about 10 inches from their tips (Photo 22). Both inboard blade sections exhibited similar chordwise scratches, tip twist, and leading edge nicks (Photo 23, 24). One of the blades tips was located and, exhibited similar damage signatures (Photo 25). The second tip was not located and presumed destroyed by fire; however its separation surfaces were similar to the other blade.
