**NATIONAL TRANSPORTATION SAFETY BOARD  
Office of Research and Engineering  
Vehicle Recorder Division  
Washington, D.C. 20594**

# **GROUP CHAIRMAN'S FACTUAL REPORT OF INVESTIGATION**

**WPR16FA029**

**Specialist's Factual Report**  
**By Sean Payne**

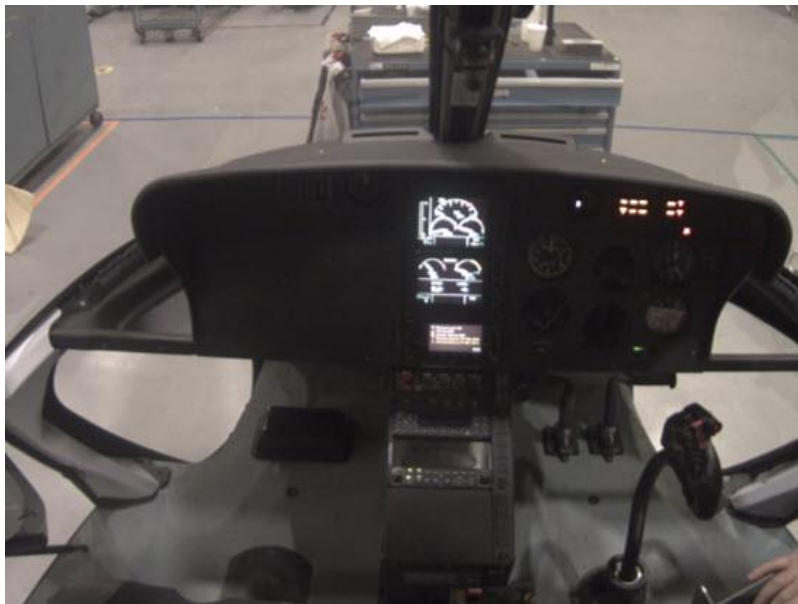
**Figure 1. The Appareo Vision 1000's field of view as mounted on the accident rotorcraft during the accident flight.**

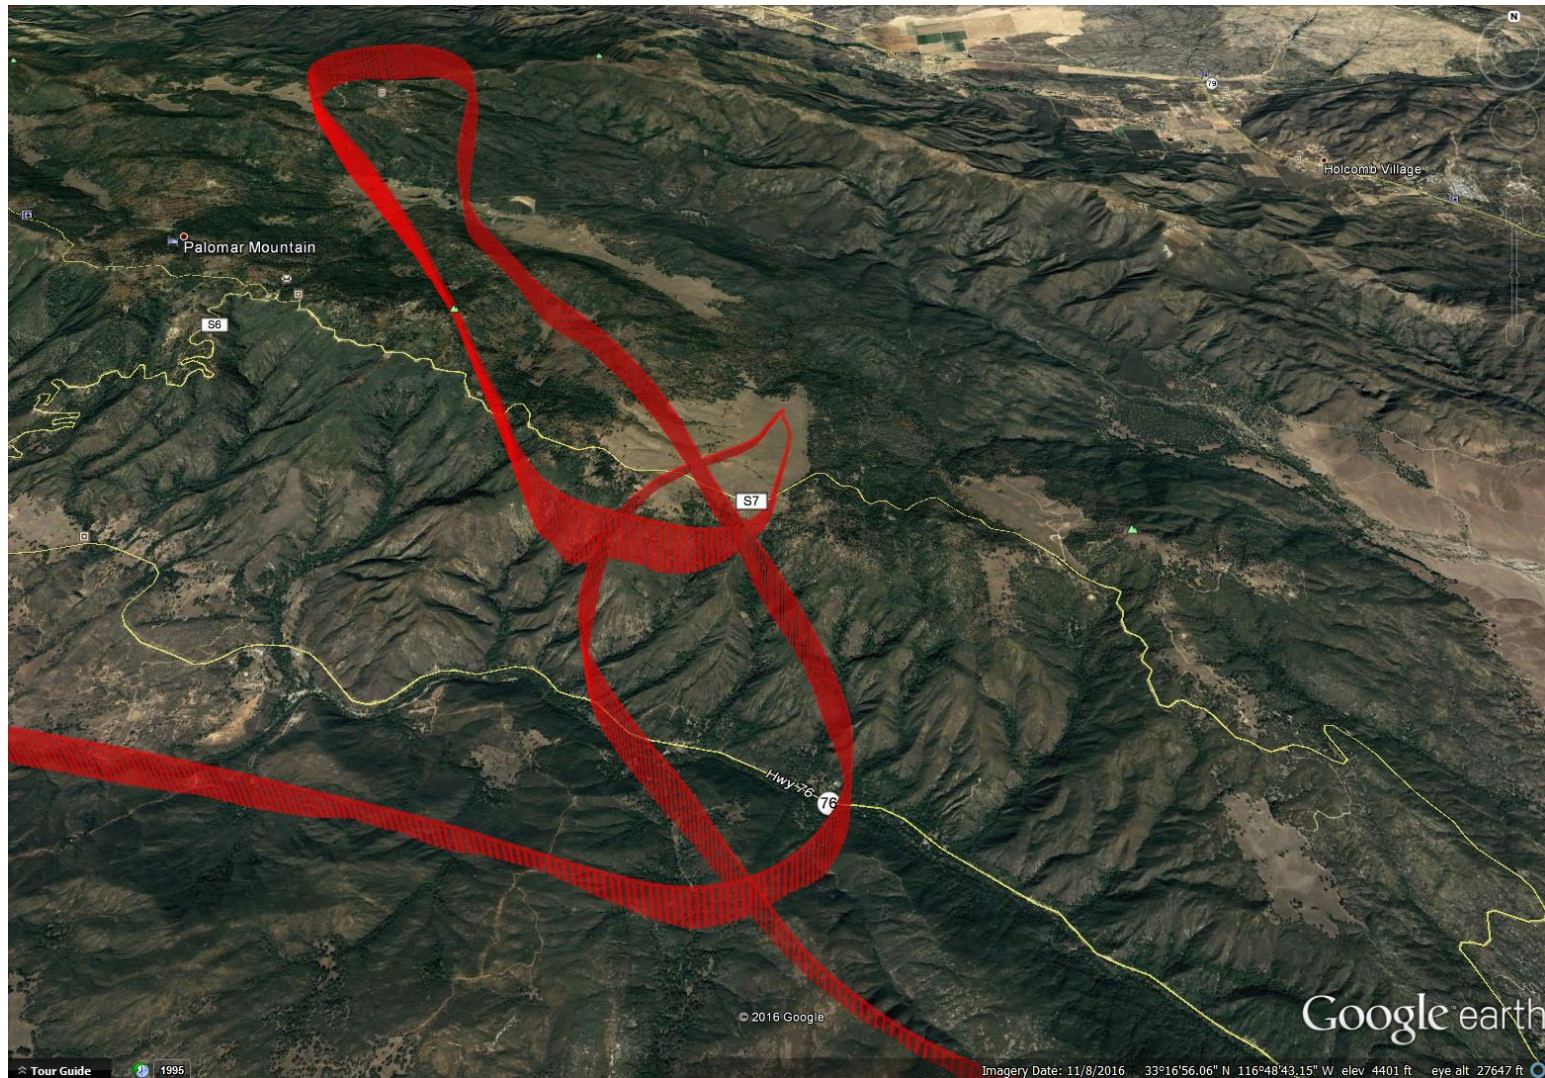
At 14:41:04, the pilot landed the rotorcraft after making a long, low approach to an open area of land (reference figure 3). The landing was uneventful.

**Figure 3. The rotorcraft's maneuvers during the accident flight in the vicinity of Palomar Mountain, San Diego County, California.**

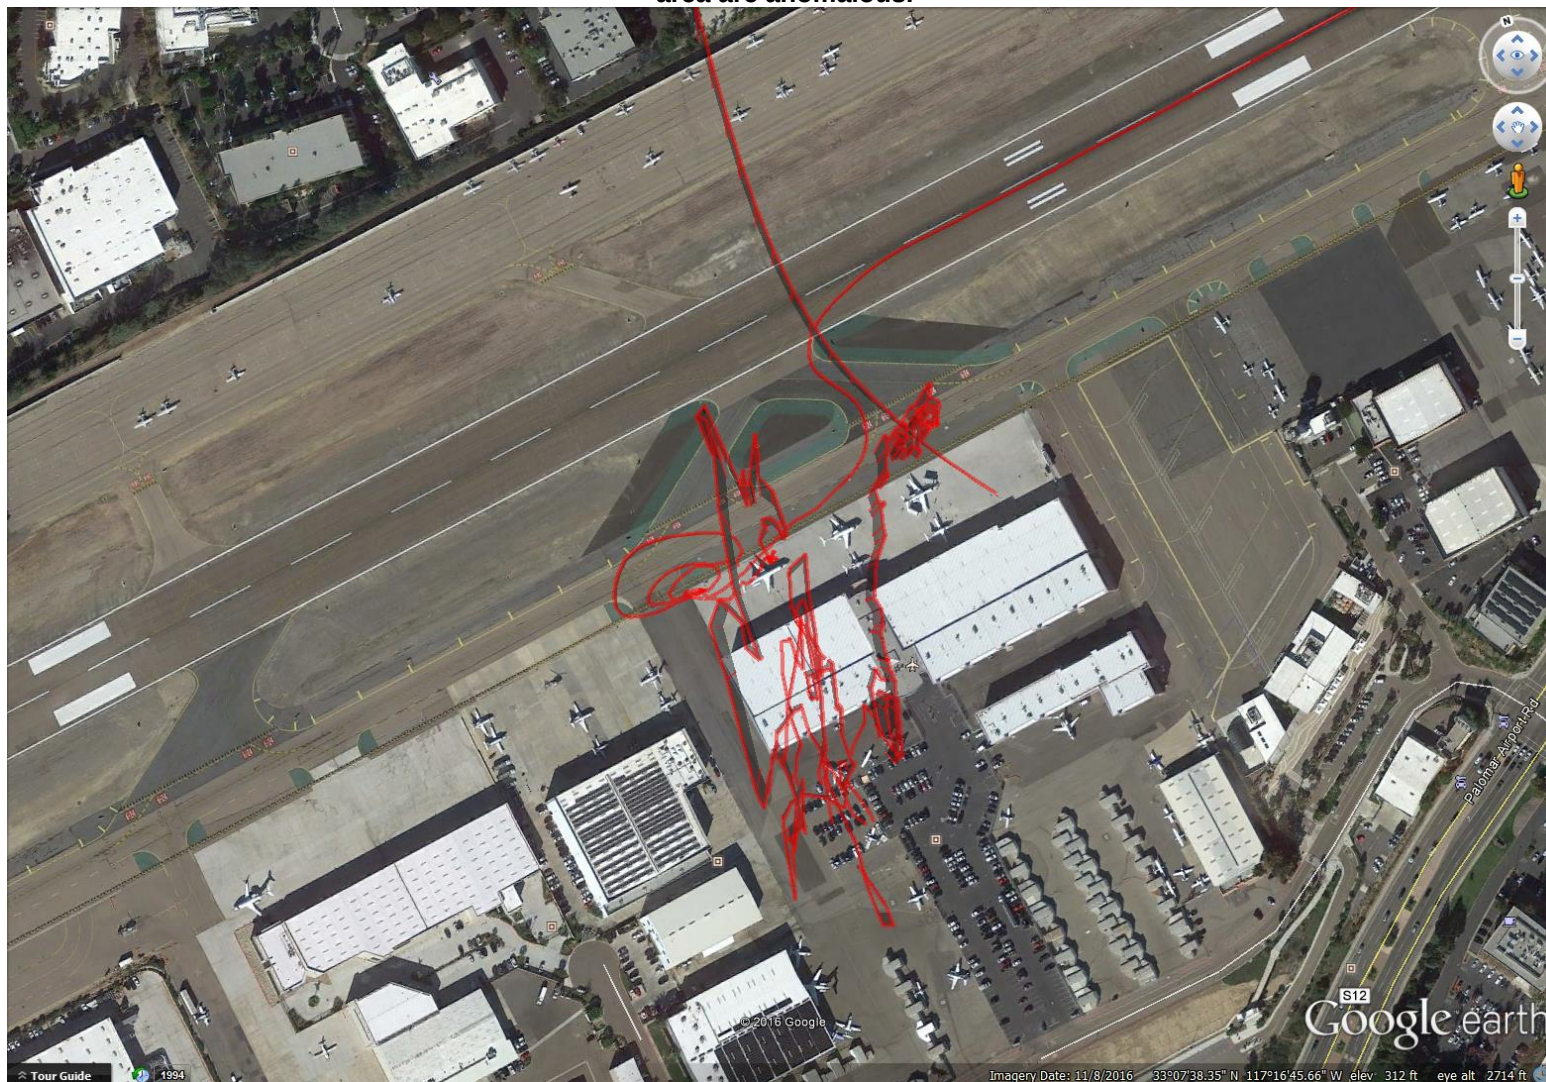
At 16:13:38, the dolly area came into sight of the camera. The sun washed out most of the camera's view of the dolly. Figure 4 is a Google Earth overlay showing the rotorcraft's maneuvers in the vicinity of the accident site. Note that some of the GPS tracks recorded were anomalous during the time the rotorcraft was spinning on the ramp area.

**Figure 4. The rotorcraft's maneuvers in the immediate vicinity of the wreckage location. Note that many of GPS tracks recorded in this area are anomalous.**

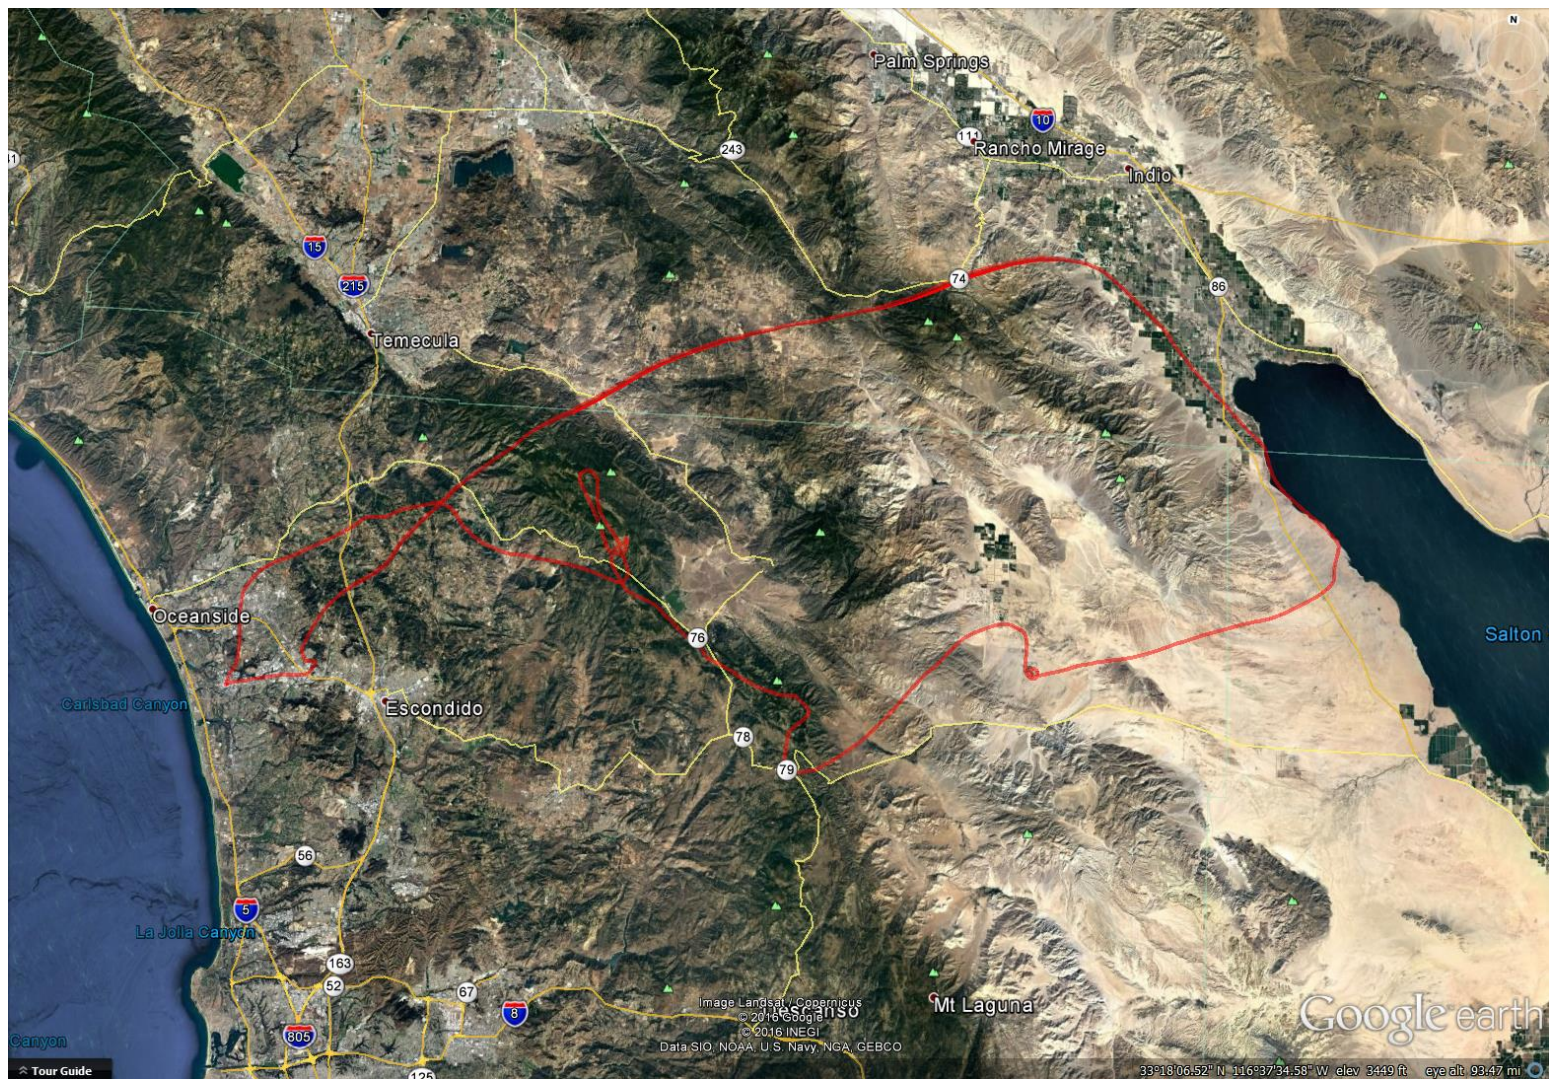
Figure 5 is a north-up overview of the tracklogs from the Appareo device of the entire recording.

Figure 5. A tracklog generated from the Appareo Vision 1000 device during the entire accident flight.
