## **NATIONAL TRANSPORTATION SAFETY BOARD**

# **AIRFRAME EXAMINATION**

**WPR16FA041**

Location: Bakersfield, California  
Date: December 19, 2015  
Aircraft: Piper PA-32RT-300T, Registration Number: N36402  
NTSB IIC: Elliott Simpson

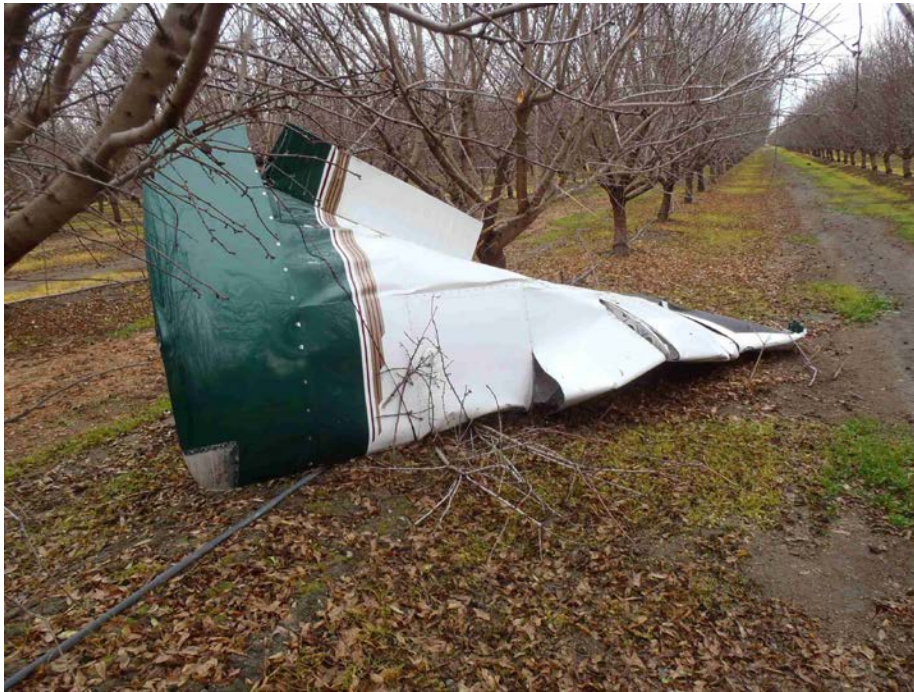
Photo 1 – Right Wing at Accident Site

The right wing was completely separated from the airplane at its root, and came to rest largely intact at the accident site with the wingtip twisted approximately 90 degrees leading edge down with respect to the root (Photo 1). The wing twist was less pronounced during the exam since the wing had been flattened for transport. The aileron and flap remained attached at their respective hinge points (Photo 2), and the aileron balance weight was attached. The flap was free to move

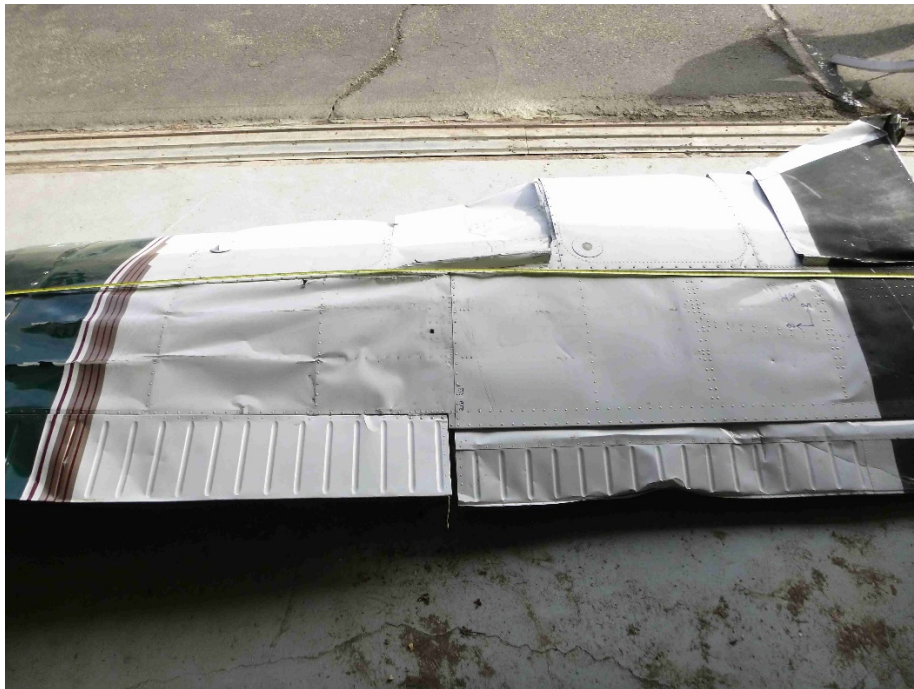
Photo 2 – Right Wing Trailing Edge

about the hinges and the aileron was jammed in place. The outboard aft corner of the aileron was deformed up. The trailing edge of the flap was deformed near wing station (WS) 178. The wing leading edge between the wing root (WS 23) and WS 49 was deformed up, with the upper skin exhibiting a compression buckle forward of the main spar. The inboard 12 inches of leading edge exhibited green paint transfer consistent with fuselage contact (Photo 3). The inboard forward corner of the leading edge was crushed up and outboard. The leading edge rivet line at WS 49 was popped along both the upper and lower surface. The leading edge rivet line at WS 89 was popped along the upper surface but the lower surface rivet line was intact. The forward half of the leading edge rivet line at WS 116 was popped along the upper surface and the entire lower surface rivet line was popped. The leading edge between WS 116 and WS 147 exhibited an impact impression. The main spar was fractured at approximately WS 108 in the area of the main spar splice joint and was buckled and deformed between WS 101 and WS 116. The aft spar was fractured near WS 118. The upper and lower wing skins exhibited diagonal wrinkling between WS 106 and WS 171 and between the main and aft spars. There was pillowing of the upper skin between the wing root and WS 49 and between the main and aft spars. The forward wing attach point was intact and the fuselage fitting was pulled from the fuselage (Photo 4). The main spar upper and lower caps were fractured near WS22 (Photo 5,6). The upper spar cap exhibited upward deformation at the fracture locations and the upper horizontal leg of the T-shaped spar cap was separated from the vertical leg (Photo 5). The lower spar cap exhibited slight upward deformation (Photo 6). The upper tang of the forward spar web was fractured through some rivet holes in an upward and outboard direction and the upper tang of the aft spar web was intact. The lower tangs on the forward and aft spar webs were fractured about 1 inch inboard of the spar cap fracture. The center spar web was intact. The fractures exhibited a dull, grainy appearance consistent with overload separation. The aft wing attach lug on the wing was fractured in an inboard direction with evidence of hole elongation in the inboard direction (Photo 7). The right main landing gear was in the extended position at the impact site and the strut was fractured in the aft direction.

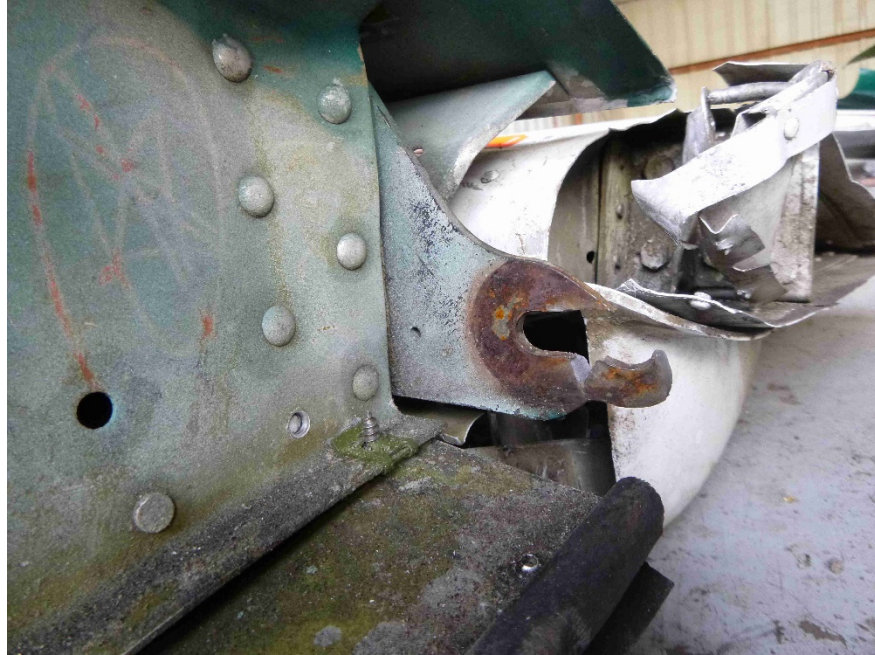
Photo 7 – Right Wing Aft Spar Attach Lug

The aileron cable pass-throughs at the root rib exhibited cable tears in an upward direction. The aileron control and balance cables were attached to the right bellcrank. The aileron cables were broken about WS 32, with the ends exhibiting a splayed, broomstrawed appearance consistent with tension overload separation. The upper aileron control horn bracket was pulled from the upper skin. There was a single impact impression on the forward aileron stop, with no evidence of repeated impact on the forward and aft stops.

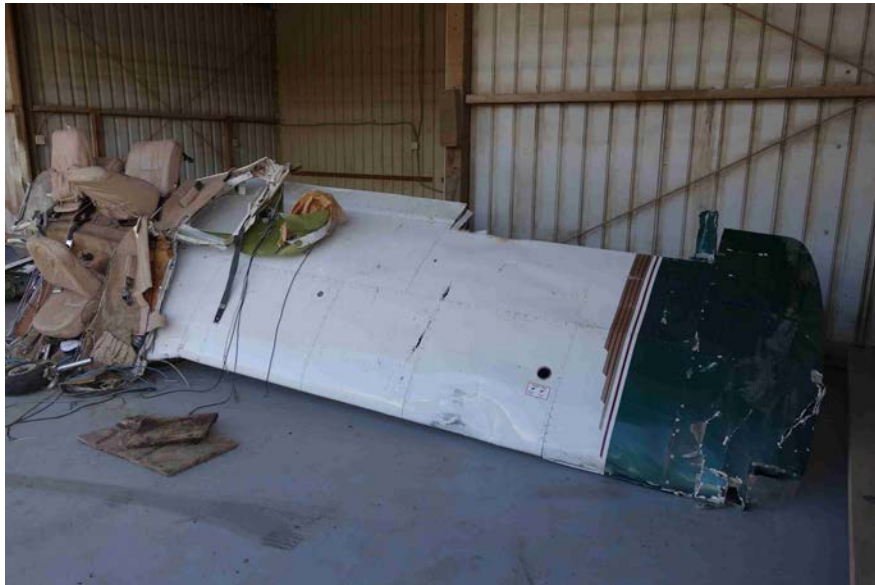
Photo 8 – Left Wing

The left wing remained attached to the center fuselage section and was mostly intact (Photo 8). The flap was attached, jammed in the retracted position, and relatively undamaged. The majority of the left aileron was separated. The inboard and outboard aileron hinges were intact and remained attached to the wing, with small pieces of skin and the end ribs attached (Photo 9). The outboard half of the aileron skin was recovered in two pieces; the remainder of the aileron was not recovered. The recovered portion of the aileron skin was splayed open along the trailing edge. The aileron spar between the hinges was not recovered. The left aileron balance weight had pulled from the outboard end rib and not recovered. The left main landing gear was down and locked. The leading edge of the wing between WS 116 and WS 147 exhibited an impact

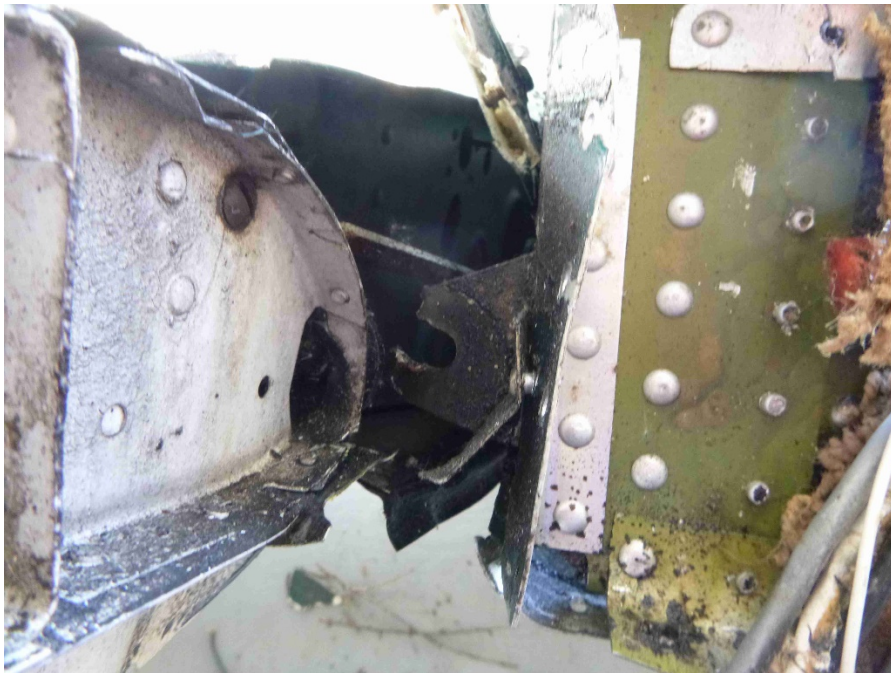
Photo 10 – Left Wing Aft Spar Attach Lug

impression. There was no obvious deformation of the main or aft wing spars along their lengths. The forward and main wing attach points were intact. The aft wing attach lug on the fuselage was fractured in an outboard direction, with evidence of hole elongation in the outboard direction (Photo 10). The bolt remained attached to the wing lug. The lower wing skin was buckled near WS 107 beneath the main spar. There was buckling of the lower wing skin forward of the main spar, between WS 23 and WS 51. The aileron control and balance cables were intact from the center section to the control horn in the left wing. The aileron push-pull tube was intact between the control horn and the inboard aileron hinge. The cable ends exhibiting a splayed, broomstrawed appearance consistent with tension overload separation.

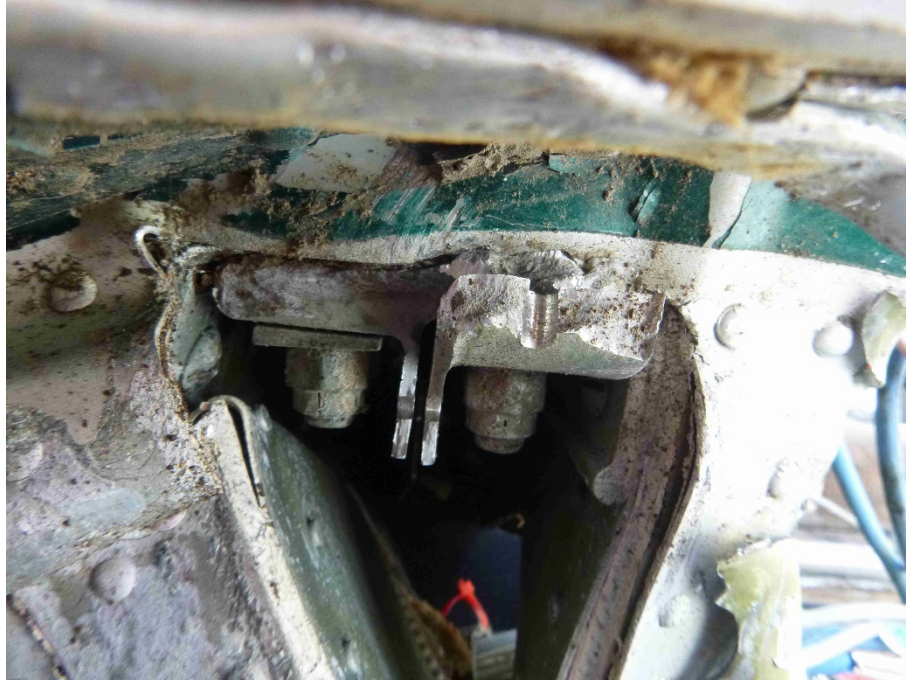
Photo 11 – Right Wing Main Spar Upper Web

The wing center section and lower fuselage was intact between the wing roots from fuselage station (STA) 72 to STA 128. The left side fuselage skin above the center section was attached and a portion of the right-side fuselage skin remained attached. The lower fuselage skin along the airplane centerline between the main and rear spars exhibited tear about 20 inches in length below the location of the rudder and stabilator flight control cables. The inner surface of the fuselage skin had parallel scrapes in the paint along the length of the tear consistent with a cable tear. The right wing upper spar cap was deformed upward (Photo 11). There was no obvious deformation of the right wing lower spar cap (Photo 12). The center section main spar fractures on the right side matched those observed on the right wing. The aft wing attach lug was intact and the bolt was installed (Photo 13). The flap handle was in the retracted/stowed position.

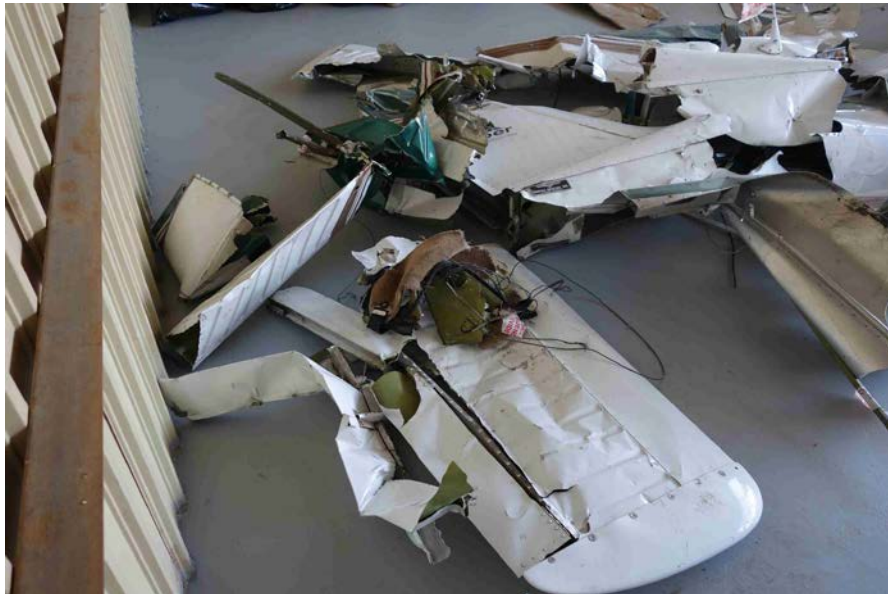
Photo 14 - Empennage

The empennage was fragmented into multiple pieces (Photo 14). The vertical stabilizer remained attached to a portion of the upper fuselage. The lower half of the vertical stabilizer was undamaged. The upper half of the vertical stabilizer displayed damage and buckling consistent with torsion to the left (Photo 15). The stabilator fitting was torn from the upper end of the vertical stabilizer. The stabilator hinges remained intact and attached to the fitting. The stabilator stops exhibited no evidence of repeated contact. The stabilator balance weight remained attached in the tip of the vertical stabilizer. The upper 16 inches of the stabilator push-pull tube was attached to the fitting (Photo 15). The center 35 inches was separated, and the lower 8 inches remained attached to the separated bellcrank. The fracture locations in the push-pull tube were consistent with the damage to the rest of the vertical stabilizer and empennage.

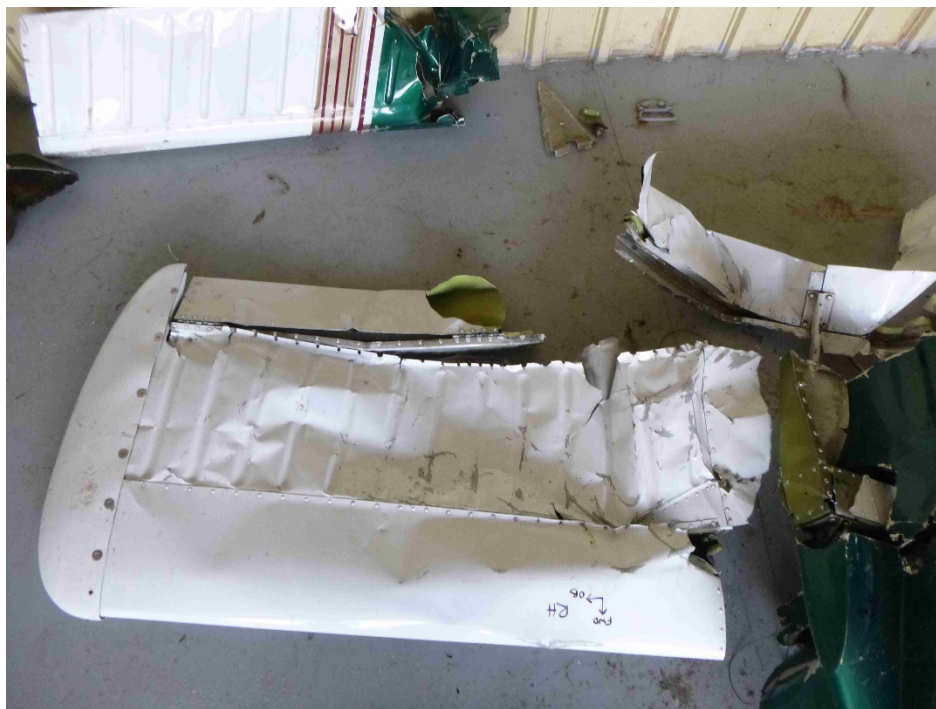
Photo 16 – Right Stabilator

The right stabilator main spar was fractured near the root rib at stabilator station (SS) 7 (Photo 16). The upper skin on the right stabilator and inboard face of the leading edge root rib exhibited green paint transfer (Photo 17). The inboard 10 inches of the forward spar was deformed aft. The right upper stabilator skin was separated from the rear spar, with the exception of the outboard 5 inches. The outboard trim tab hinge was intact at the outboard end of the rear spar. The right lower stabilator skin was separated from the rear spar, with the exception of the outboard 20 inches. About 32 inches of the rear spar remained attached to the right stabilator. About 29 inches of the right trim tab remained attached to the rear spar at the outboard and center hinges. No evidence of paint transfer was observed on the lower skin of the right stabilator. The right stabilator upper and lower skins exhibited significant damage and deformation.

The stabilator spar fractures exhibited a dull, grainy appearance consistent with overload separation.

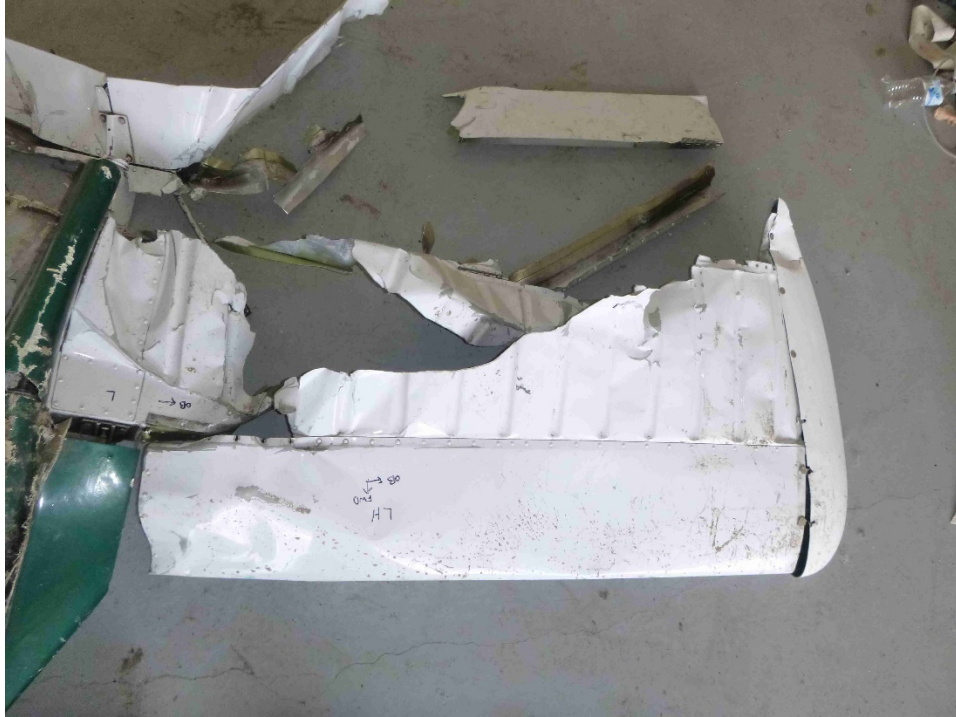
Photo 18 – Left Stabilator

The left stabilator main spar was fractured near SS 17. The entire left stabilator rear spar was separated (Photo 18). There was green paint transfer on the left stabilator upper leading edge skin (Photo 19). A section of the rear spar about 30 inches in length, with the center tab hinge and a portion of left upper stabilator skin attached was separated from the stabilator. The inboard half of the left lower stabilator skin was separated and not recovered. The outboard 25 inches of left trim tab was separated from the stabilator.

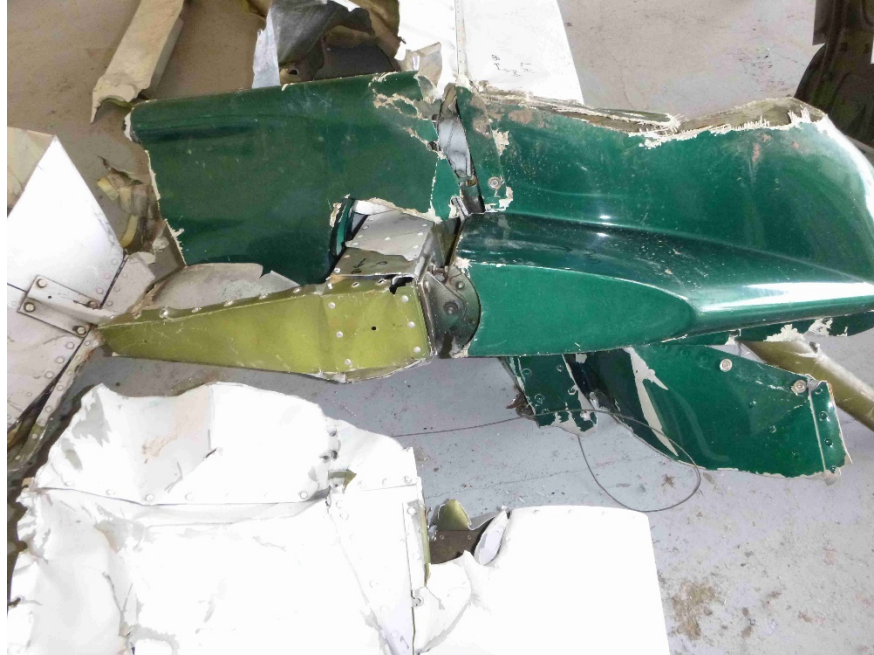
Photo 20 – Rudder Upper Hinge

The rudder remained attached to its fitting at the upper hinge point (Photo 20). The rudder torque tube was separated from the rudder along the rivet line. The upper 12 inches of rudder exhibited significant crushing and deformation. The lower 32 inches of rudder was mostly undamaged. The rudder counterweight remained attached to the leading edge. The aft vertical fin fairing was separated. The trailing edge of the fairing exhibited scraping damage consistent with the location of the inboard edges of the right and left stabilators.

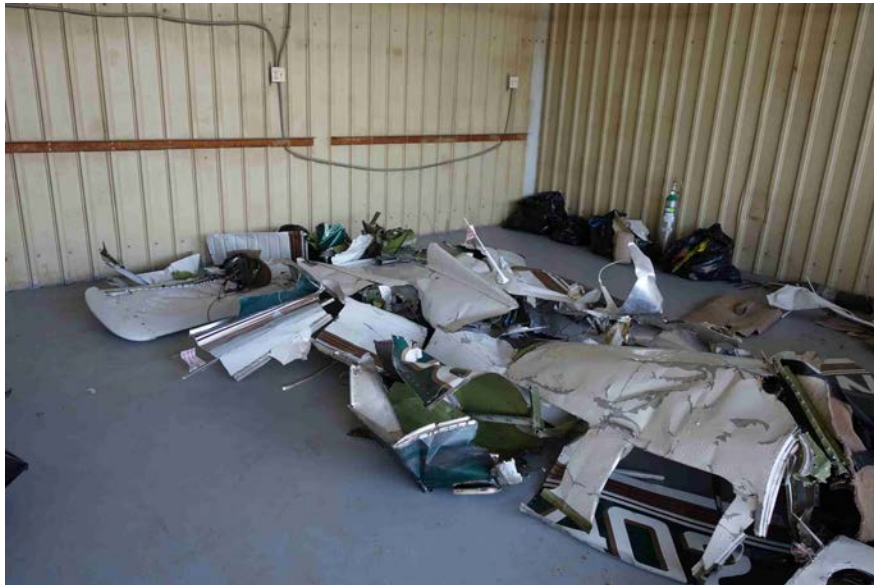
Photo 21 – Fuselage Structure

The fuselage structure was highly fragmented and recovered in many pieces (Photo 21). The individual pieces were laid out and there was no obvious evidence of impact noted. The right forward cabin door was intact but separated with the hinges pulled from the fuselage structure. The right forward cargo door remained attached to the forward fuselage. The left cabin door was separated and fractured into several pieces. The left cargo door was intact and remained attached to a portion of the fuselage structure. The forward fuselage between the firewall at STA 33 to the forward edge of the wing at STA 73 was mostly intact but extensively crushed. The upper cockpit roof and center windshield post were separated. The nose landing gear trunnion remained attached to the forward fuselage but the wheel and oleo were separated.

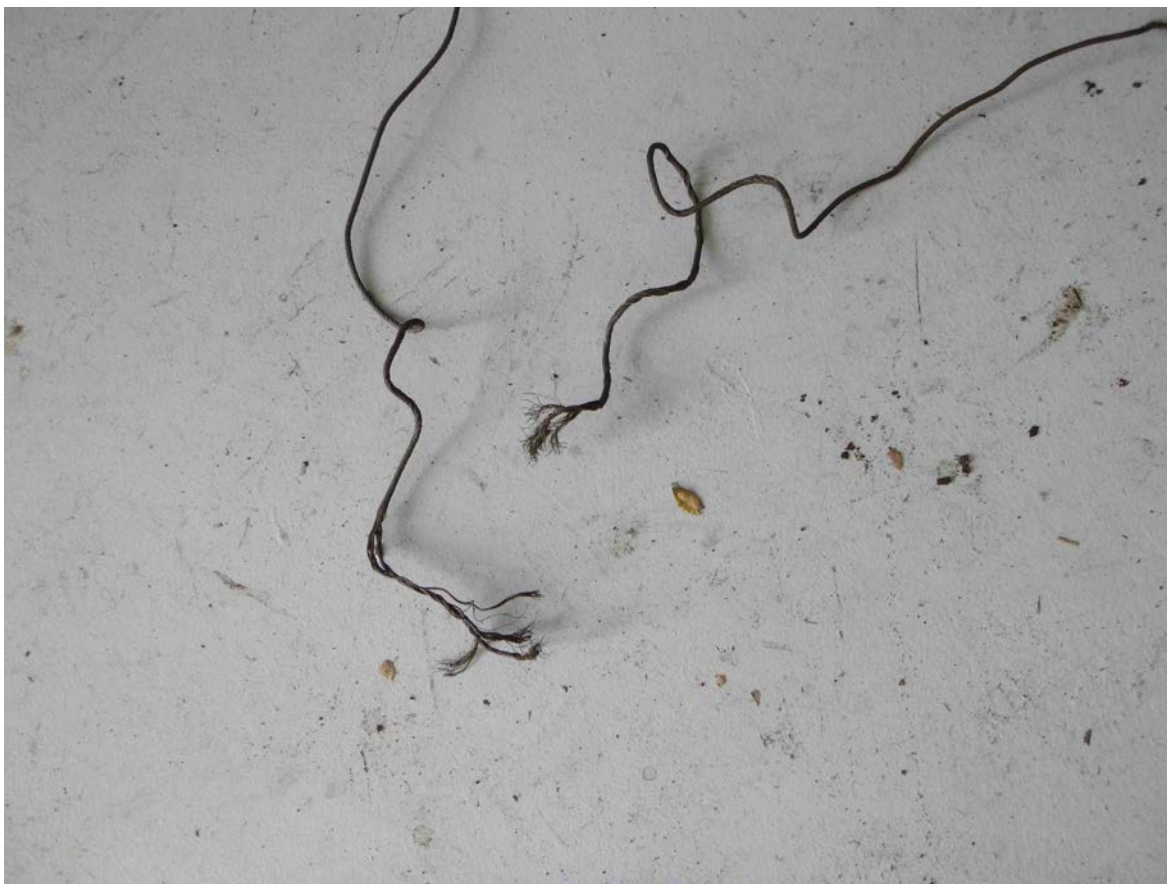
Photo 22 – Typical Cable Separation

The primary flight control cables were traced from the cockpit to their respective flight control surfaces. All cables were broken at varying locations consistent with the breaks in the structure. About 10 feet of one of the rudder cables was not recovered. All the cable ends had a splayed, broomstrawed appearance consistent with tension overload separation (Photo 22).
