## **NATIONAL TRANSPORTATION SAFETY BOARD**

# **ENGINE EXAMINATION**

**WPR16FA041**

Location: Bakersfield, California  
Date: December 19, 2015  
Aircraft: Piper PA-32RT-300T, Registration Number: N36402  
NTSB IIC: Elliott Simpson

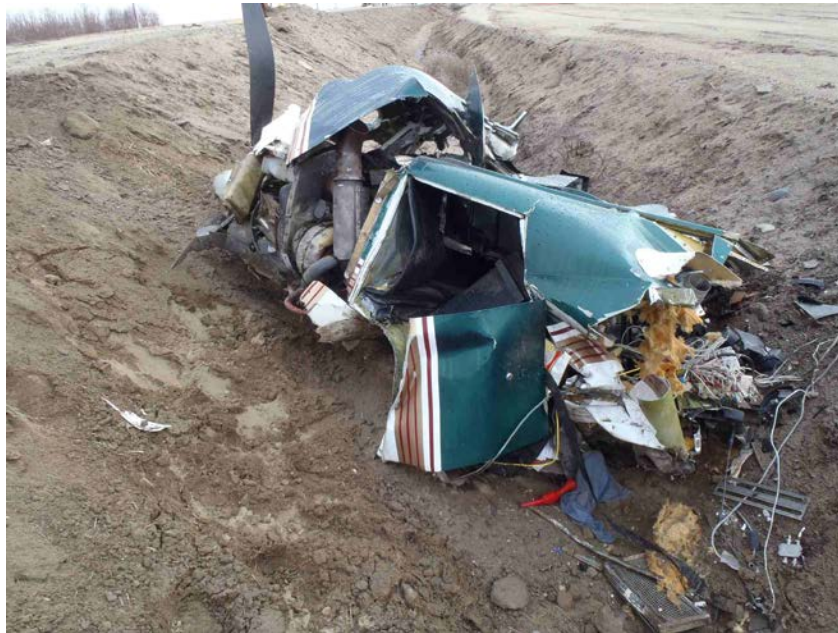
The engine remained partially attached to its mount, with all but the upper left mounting lugs separated from the crankcase. The engine mount was attached to the forward cabin which included the flight instruments and controls, along and forward baggage hold (Photo 1). The upper side of the engine sustained crush damage, flattening the pushrods and exhaust manifolds around the cylinder heads, and severing all spark plug leads at the spark plugs (Photo 2). The governor had broken away from the upper bolts at its mounting pad, and the upper side of the crankcase exhibited multiple lateral cracks. The flywheel, along with the propeller and hub remained attached to the crankshaft; the flywheel was bent, and the starter motor and alternator had fragmented and separated from their respective pads. The six engine cylinders remained attached to the crankcase, and the oil dipstick was in place at the filler neck, which was crushed.

Photo 1 – Engine and Instrument Panel at Accident Site

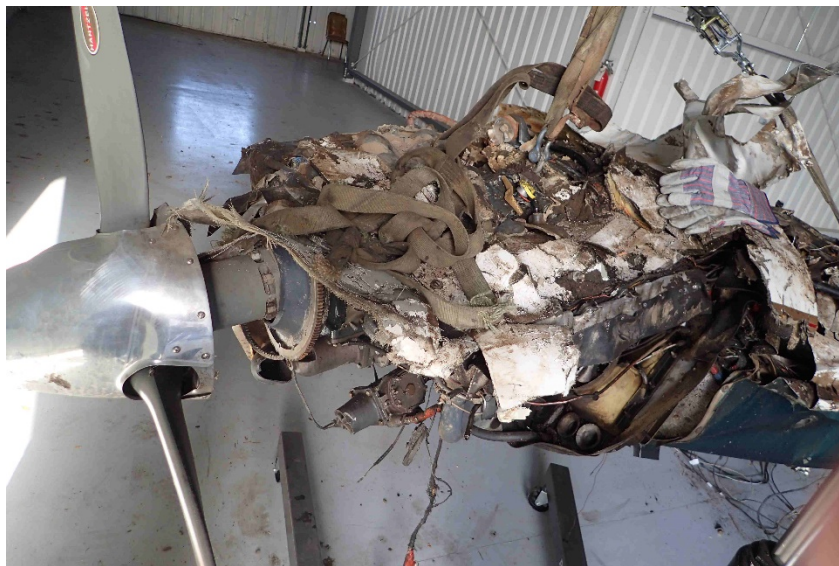
Photo 2 – Engine

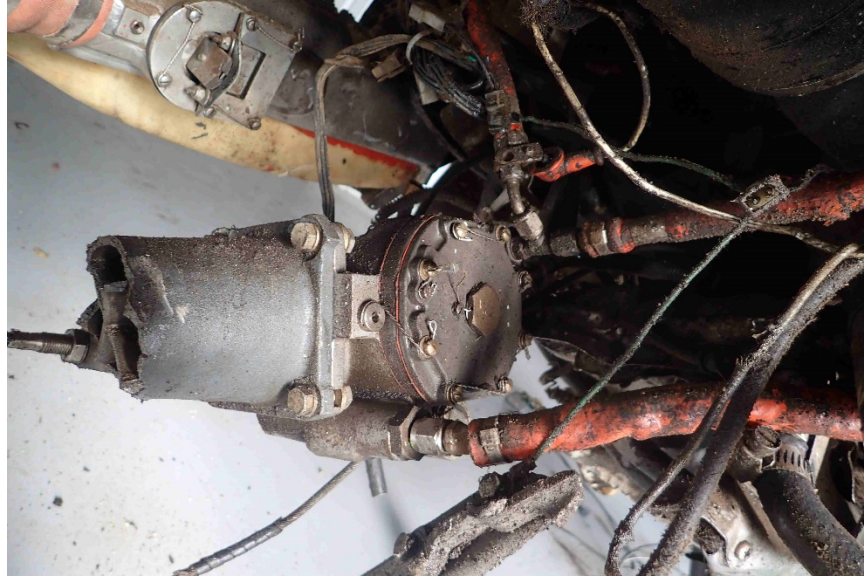
The oil sump had fragmented, revealing the inside of the crankcase lower chamber, along with the bent oil dipstick. The inlet manifolds, and servo throttle body (Photo 3), had been crushed

Photo 3 – Throttle Body

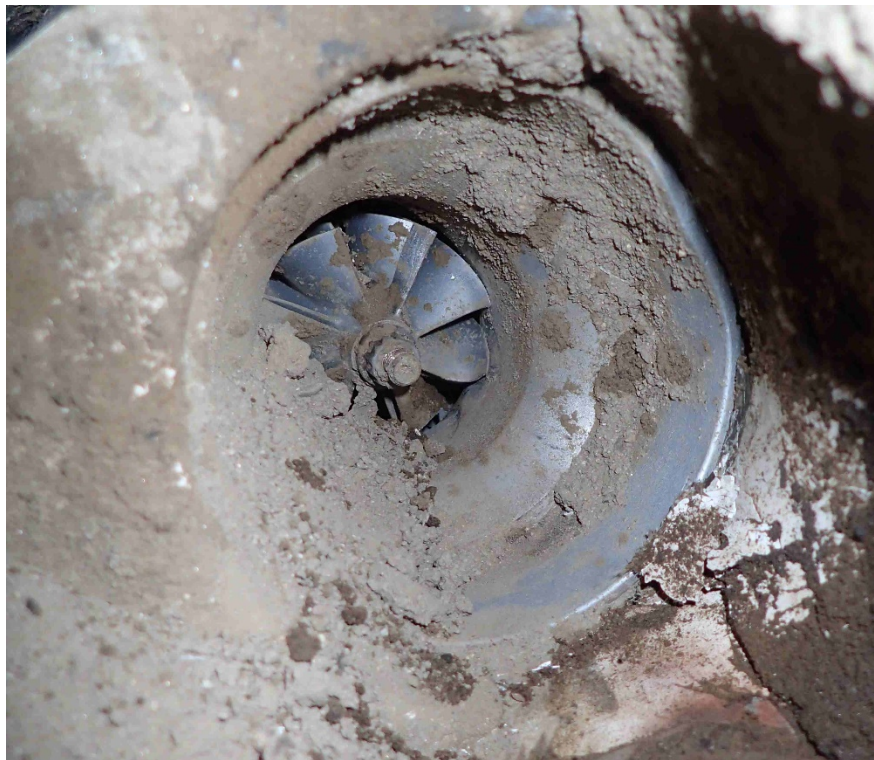
and fragmented. The turbocharger and all exhaust pipes remained attached; the turbocharger inlet shroud was clogged with mud, crushed, and impinged against the compressor wheel (Photo 4). The compressor wheel was intact, with two blades bent at the point of contact with the shroud. The turbine wheel was intact, and coated, along with the inner surface of all exhaust pipe, with light colored tan deposits (Photo 5).

Photo 4 – Turbocharger Inlet

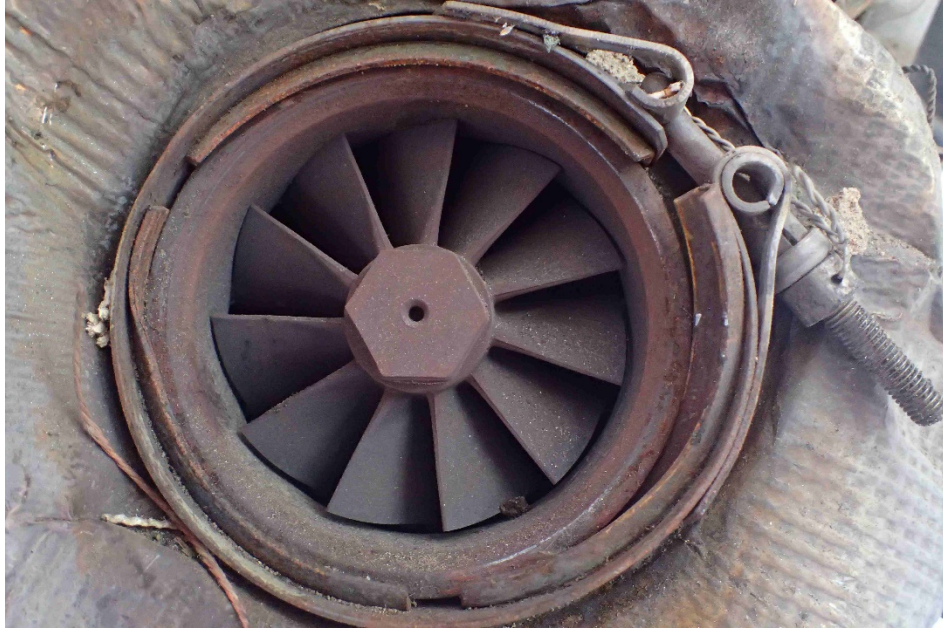
Photo 5 – Turbo Charger Turbine Wheel

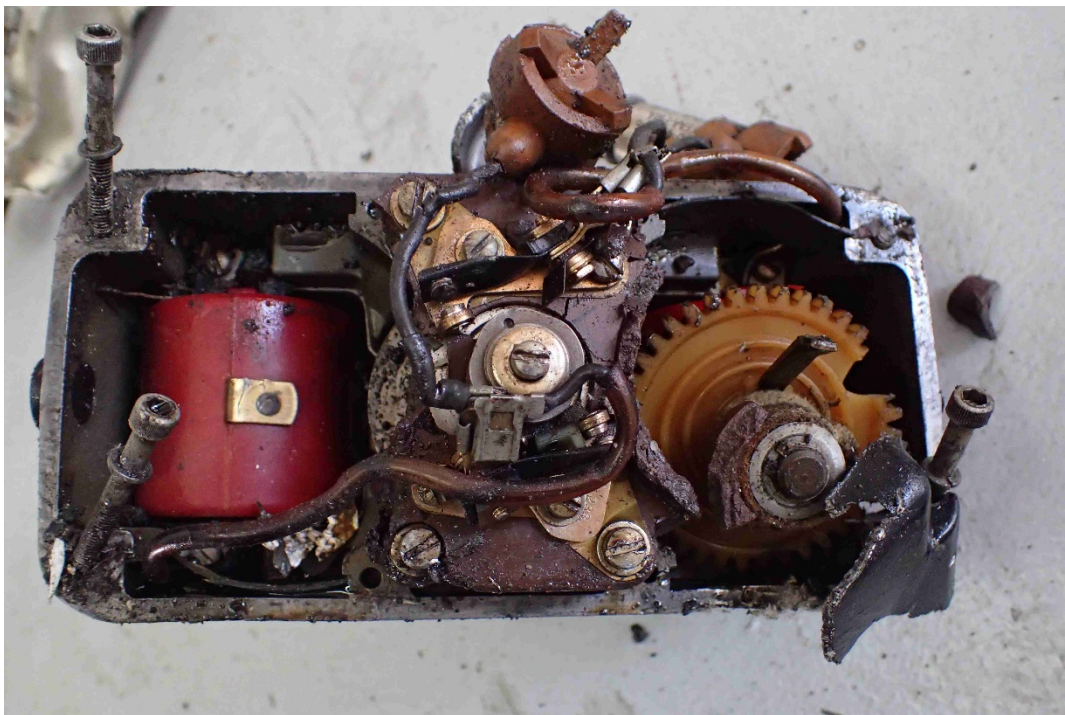
The dual magneto case had shattered, separating the spark plug leads, and resulting in the crushing, and expulsion of the magneto's internal components (Photo 6).

Photo 6 – Dual Magneto

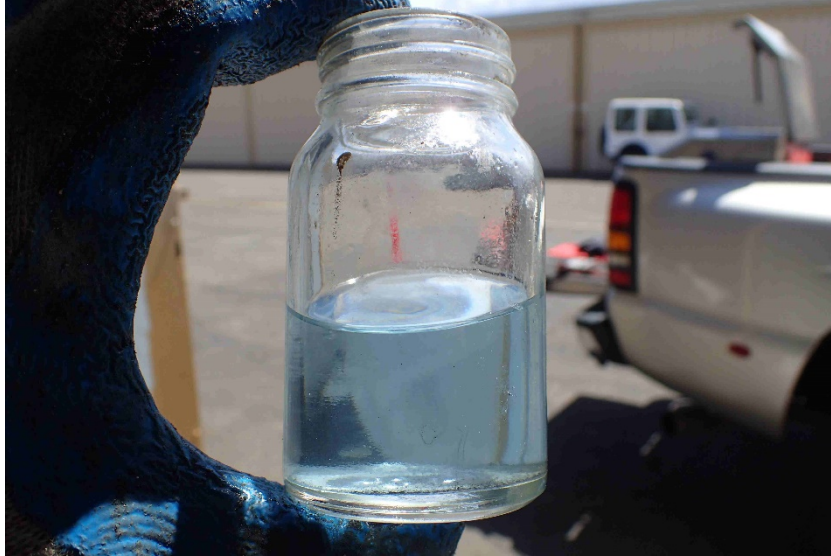
The fuel selector valve was disassembled and contained 3 ounces of clear, blue-colored fuel (Photo 7).

Photo 7 – Fuel From Fuel Selector Valve

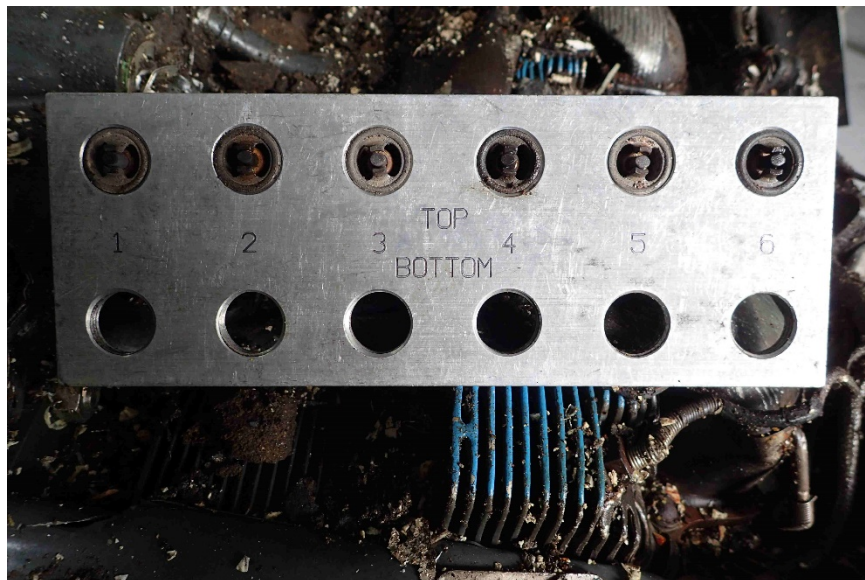
The top spark plugs exhibited crush damage to their insulating sleeves. Removal revealed that the plugs for cylinder number two, four, and six were wet with oil, with one, three and five exhibiting grey and tan deposits. When compared to the Champion Aviation Check-A-Plug chart, the plugs exhibited worn out – normal signatures (Photo 8).

Photo 8 – Top Spark Plugs

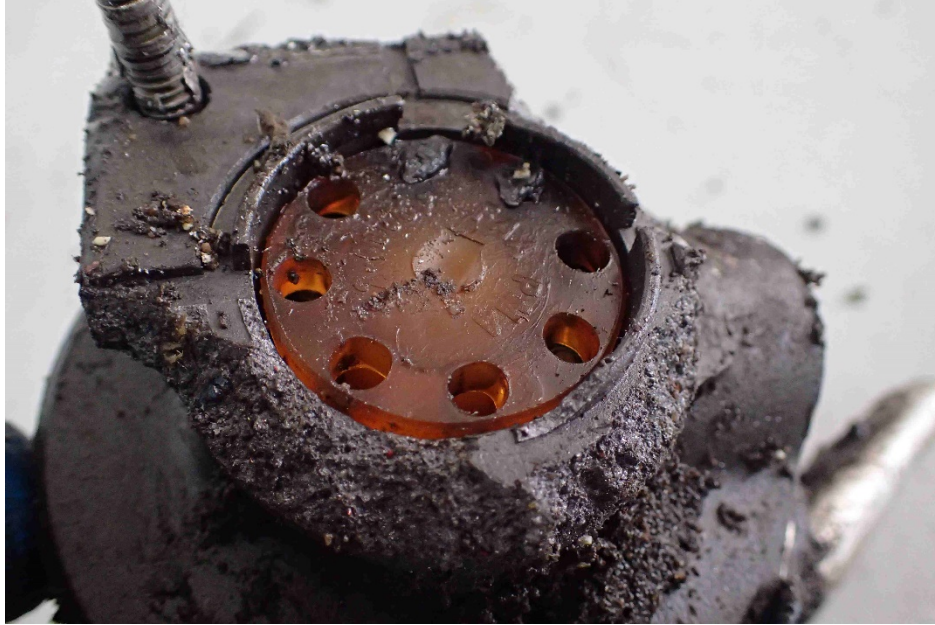
The primary vacuum pump had broken away from its pad, exposing the plastic coupling which was intact. Two of the coupling pins (Photo 9) had broken away and remained within the coupling; no smearing was present on the coupling surfaces. The pump was disassembled, all vanes were intact, and the rotor had cracked in the center. (Photo 10). The electrically driven backup vacuum pump assembly was intact at the firewall (Photo 11), disassembly revealed that the plastic coupling (Photo 12) along with the rotor and all vanes (Photo 13) were intact and undamaged. The vacuum filter was clear.

Photo 9 – Primary Vacuum Pump Drive Coupling

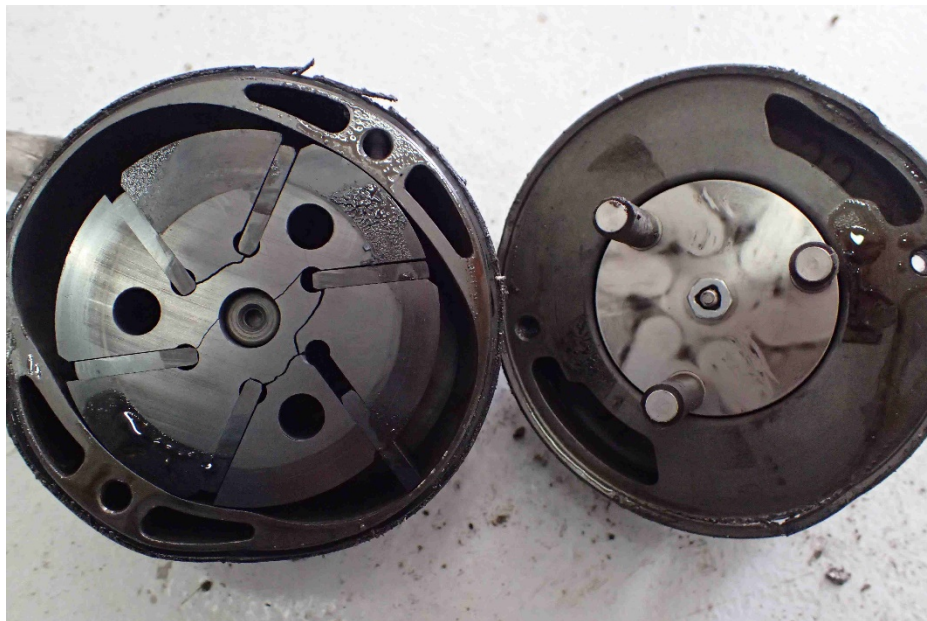
Photo 10 – Vacuum Pump Internal Components

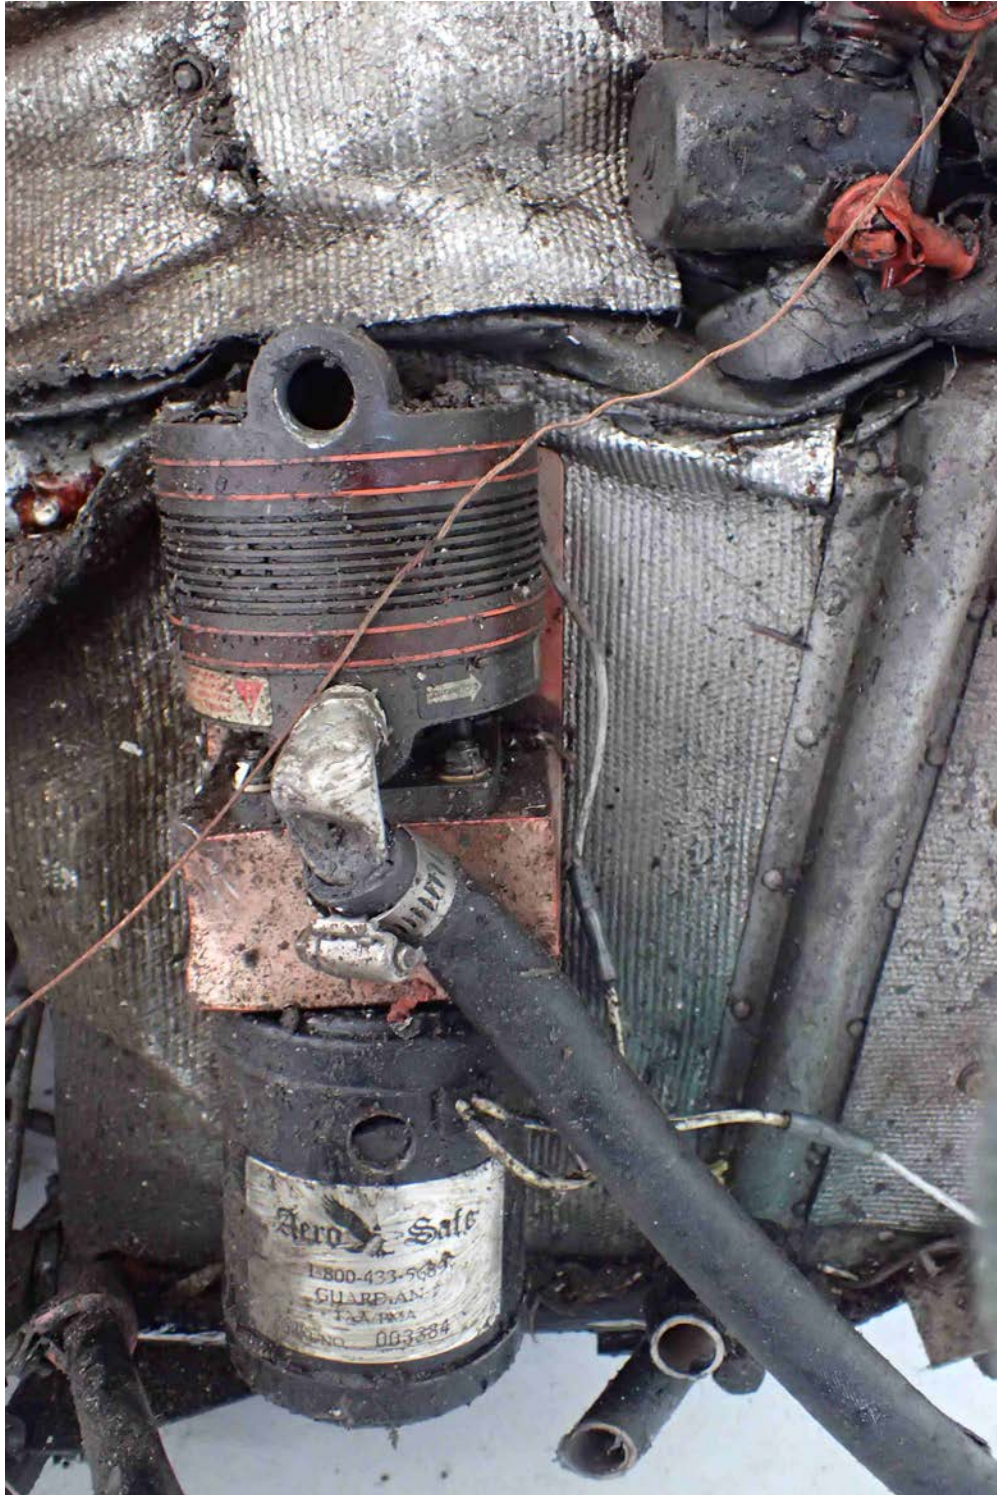
Photo 11 – Secondary Vacuum Pump

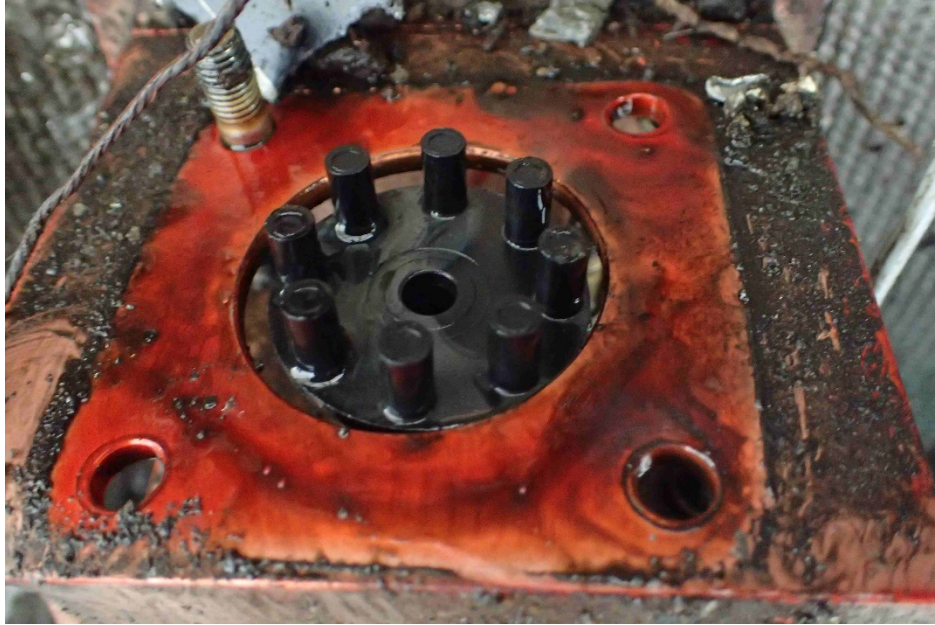
Photo 12 – Secondary Vacuum Pump Drive Pins

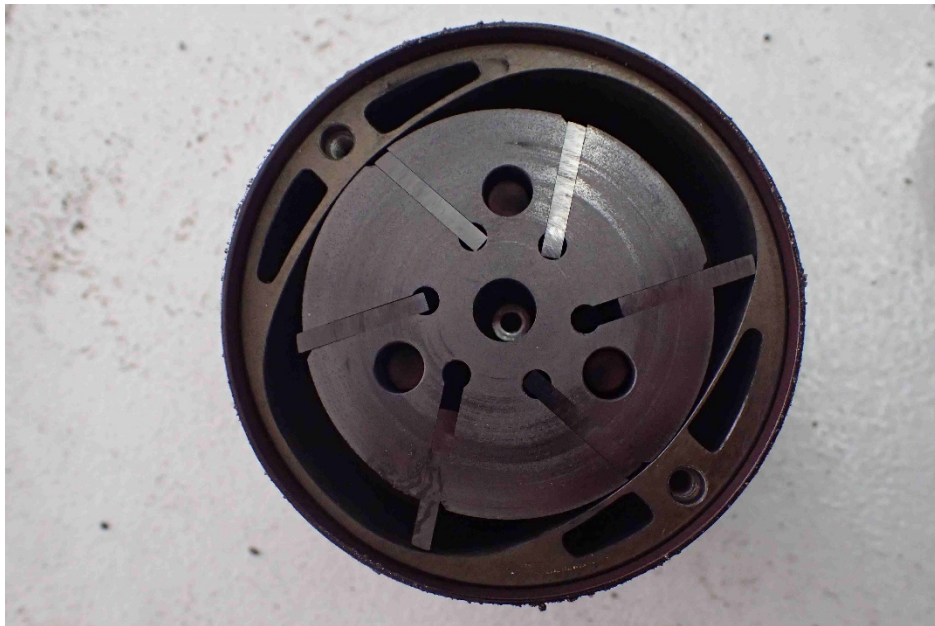
Photo 13 - Secondary Vacuum Pump Vanes and Rotor

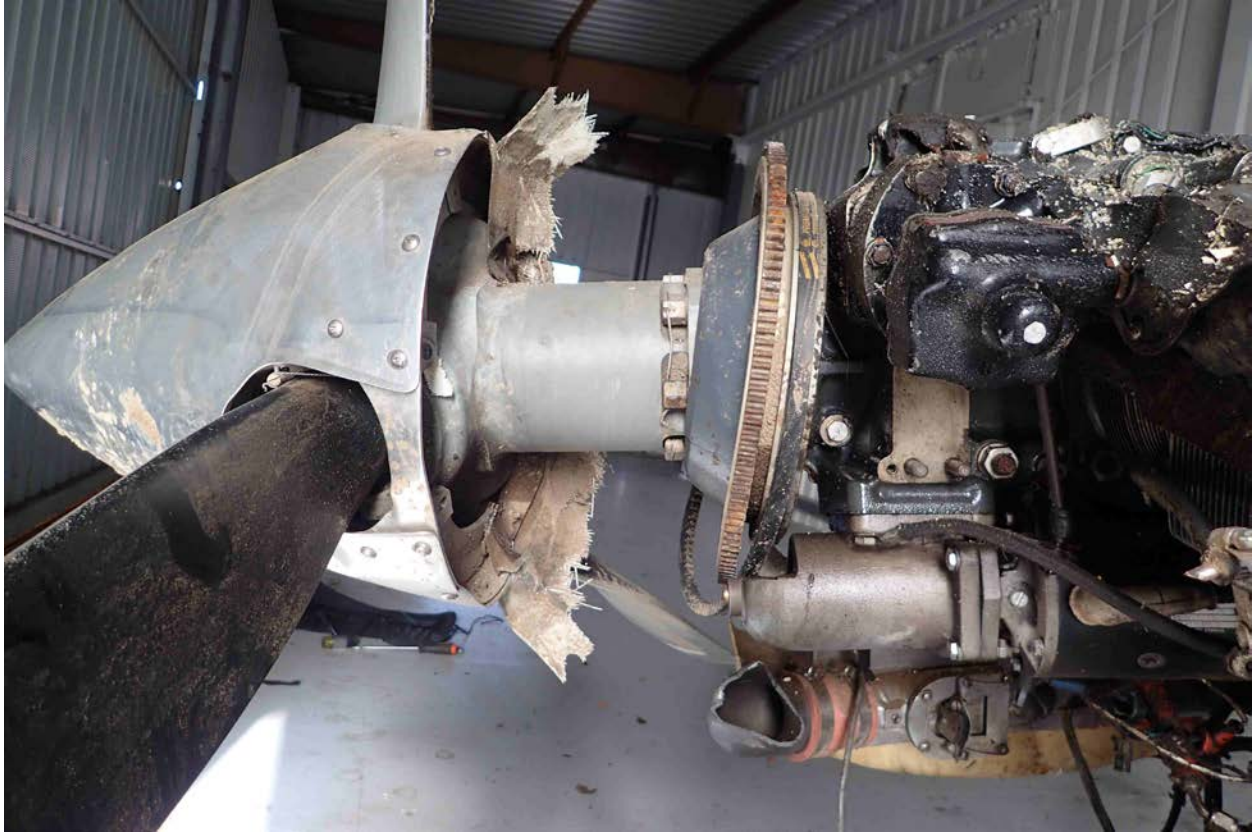
The propeller blades attached to the hub (Photo 14), One blade was intact, the second exhibited a 15 degrees forward bend midspan, the third blade was bent 5 degrees aft at hub. All blades were free of leading edge nicks.

Photo 14 – Propeller and Hub
