## **NATIONAL TRANSPORTATION SAFETY BOARD**

### **ON SITE EXAM REPORT**

WPR16FA046

Location: Alpine, Wyoming  
Date: January 4, 2016  
Aircraft: Aerostar SA YAK52, Registration Number: N912EB, Serial #: 832912  
NTSB IIC: Howard Plagens

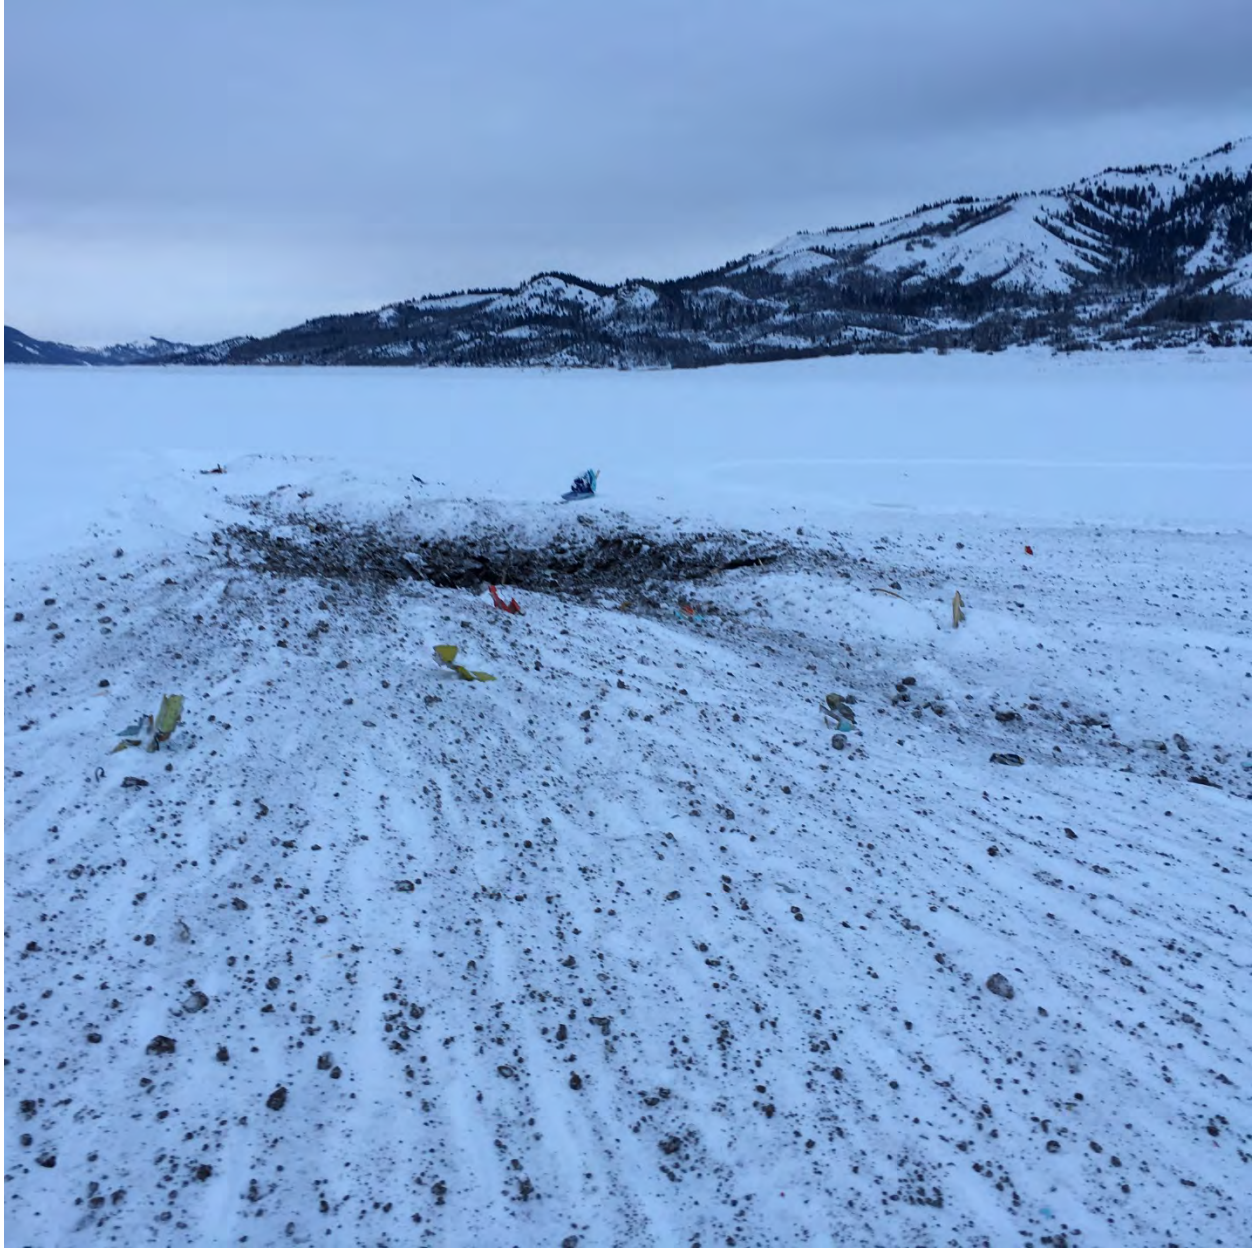
*Figure 1. First Identified Point of Contact*

The airplane highly fragmented along a debris path of 122°. The first identified airplane parts were a piece of the left wing tip and the pitot tube from the outboard left wing. The pitot tube was about 2 ft long, and half of it was buried in the soft dirt. These pieces were on the left side of the principle impact crater (PIC), which was about 6 ft across, 2 ft deep, and 15 ft long.

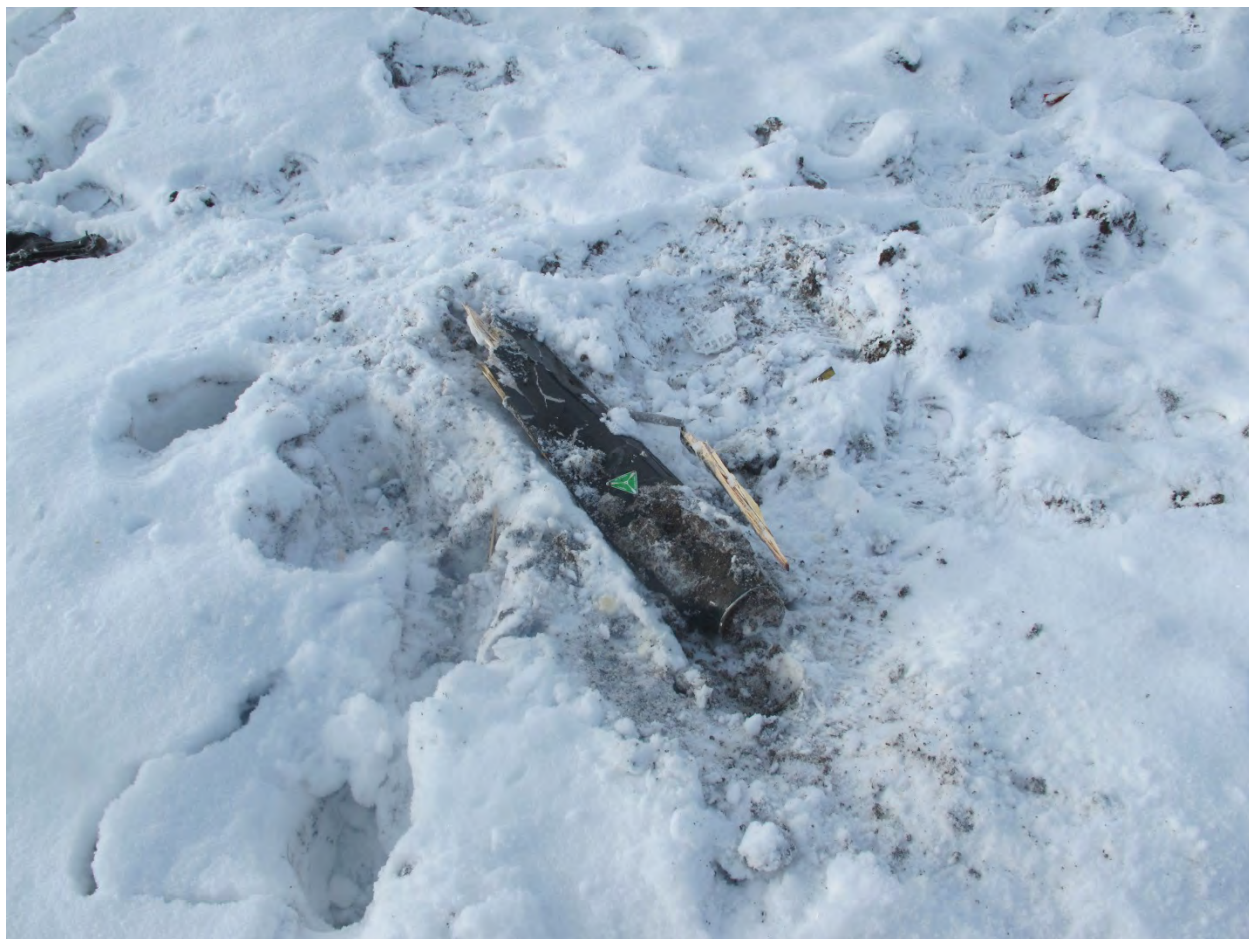
*Figure 3. Piece of Propeller Blade*

At the end of the PIC was a separated propeller blade.

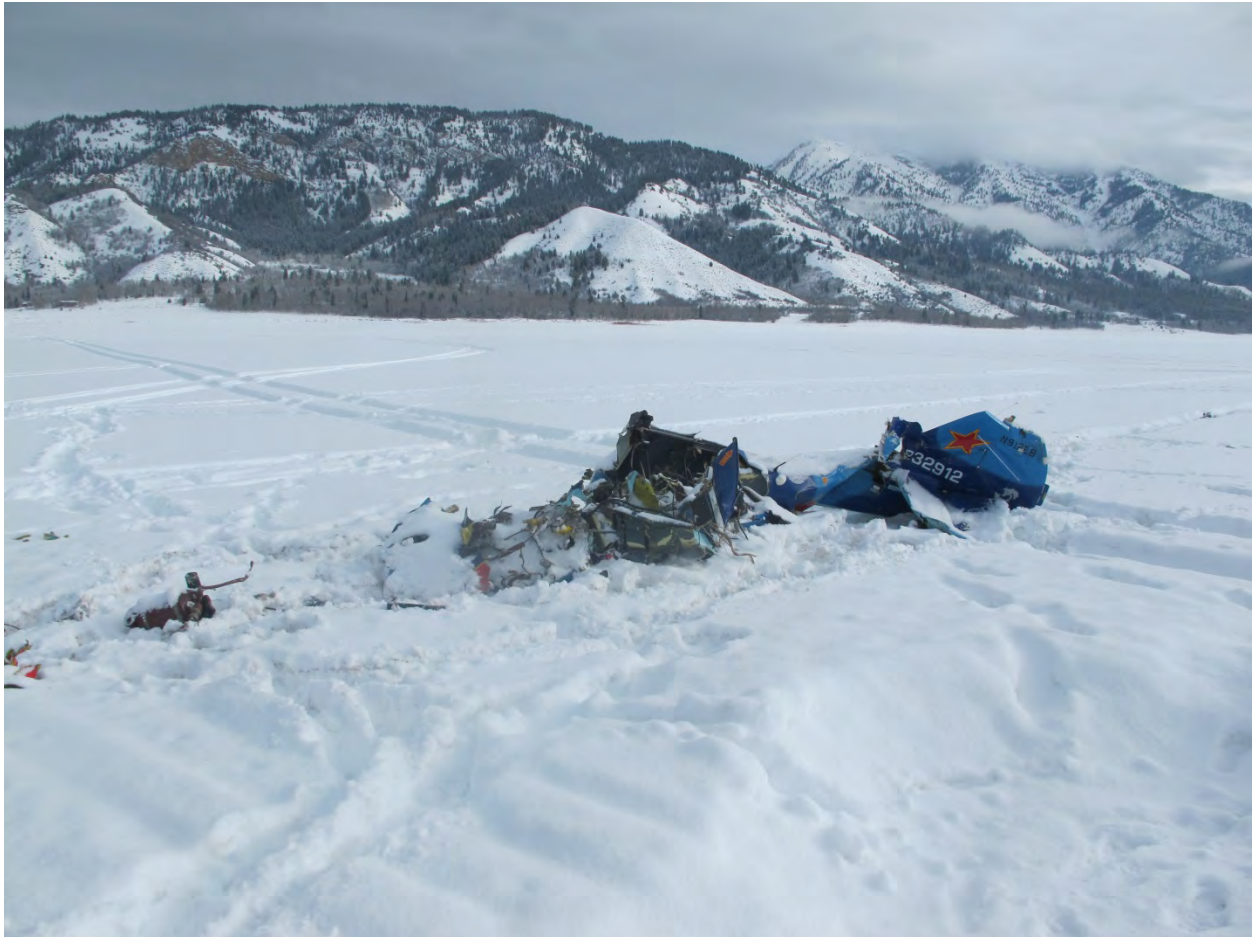
*Figure 6. Main Wreckage*

The main wreckage consisted of the fuselage and empennage.

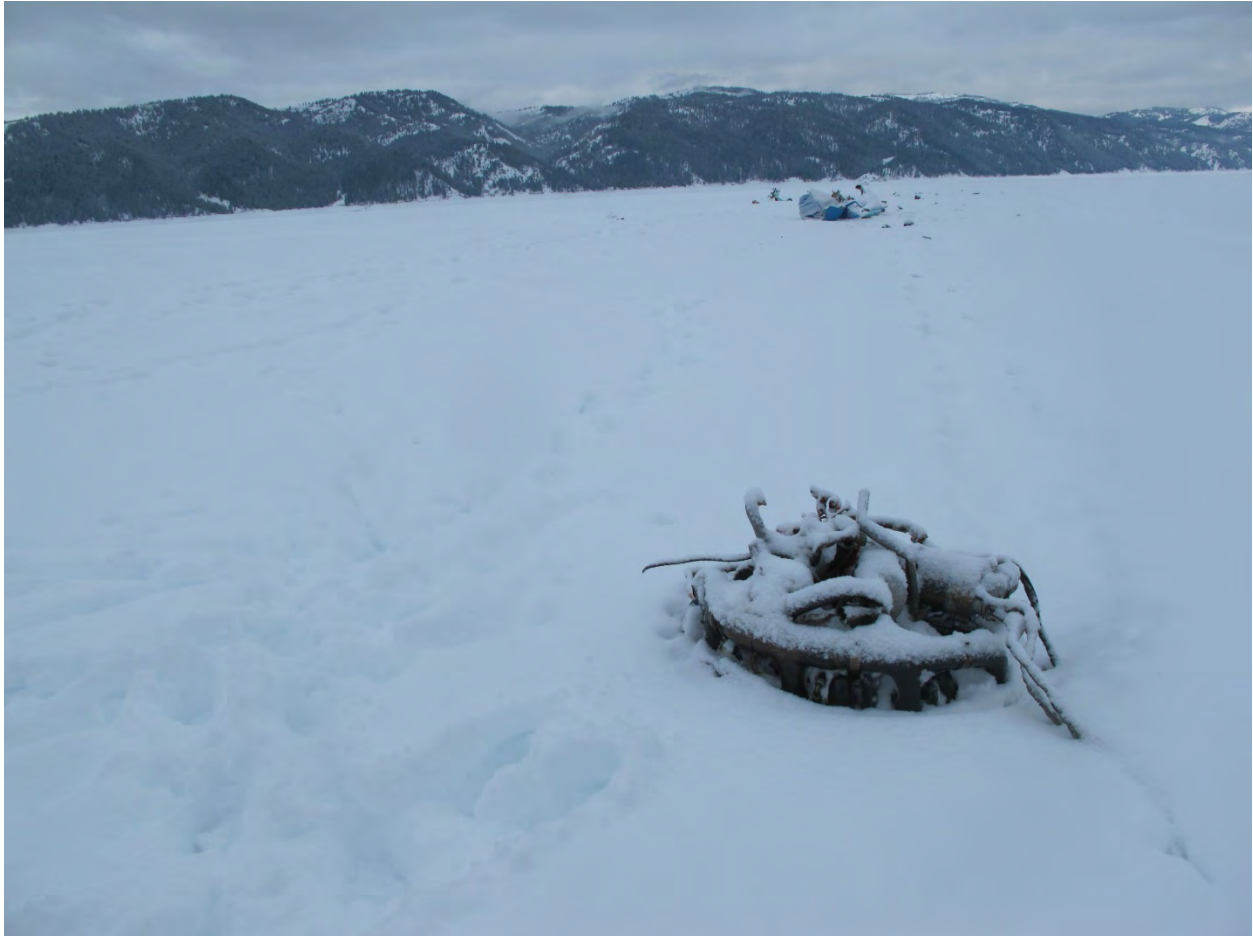
*Figure 7. Engine*

The engine separated, and was the most distant piece of wreckage identified at 578 ft.

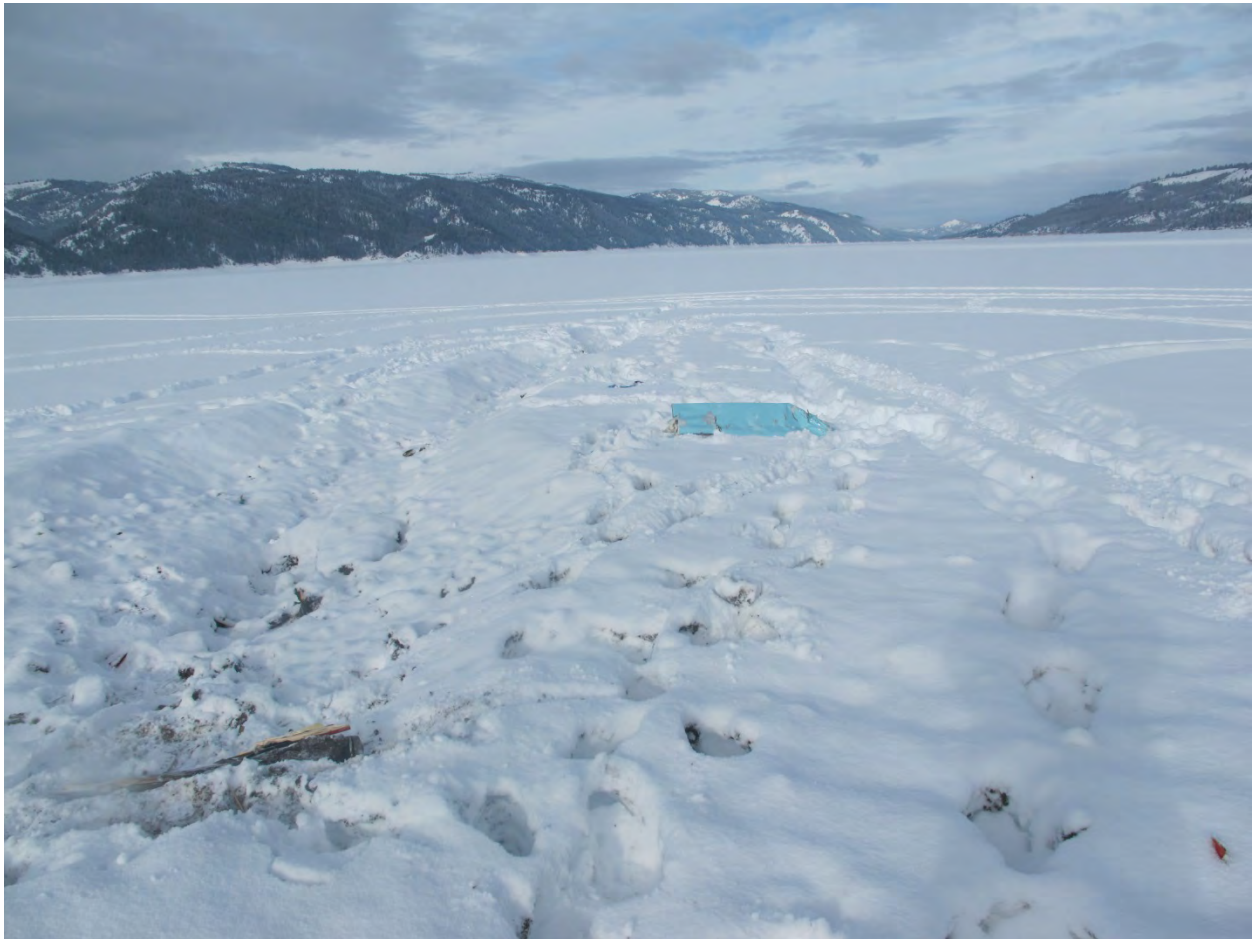
*Figure 8. Left Wing Fragments*

The left wing fragmented.

Both wings separated from the fuselage. Most left wing pieces were in the first half of the debris field.

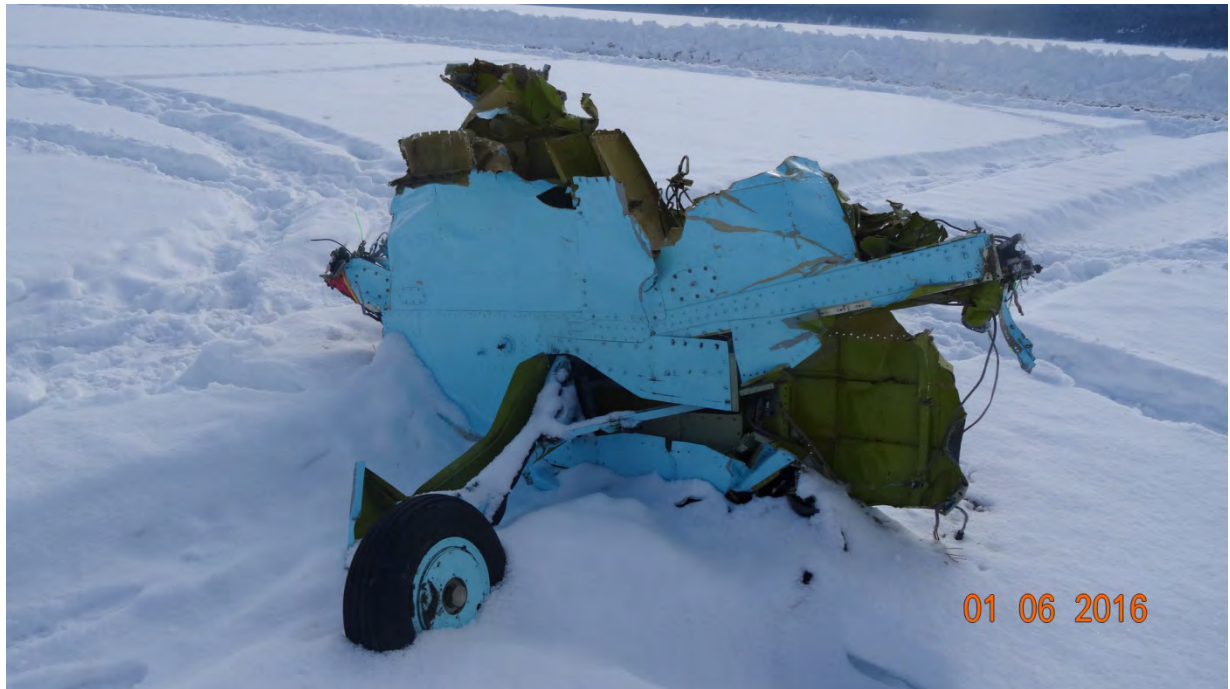
*Figure 9. Left Wing Fragment Containing a Main Landing Gear*

The inboard portion of the left wing with the left main landing gear attached was midway into the debris field; that landing gear was down.

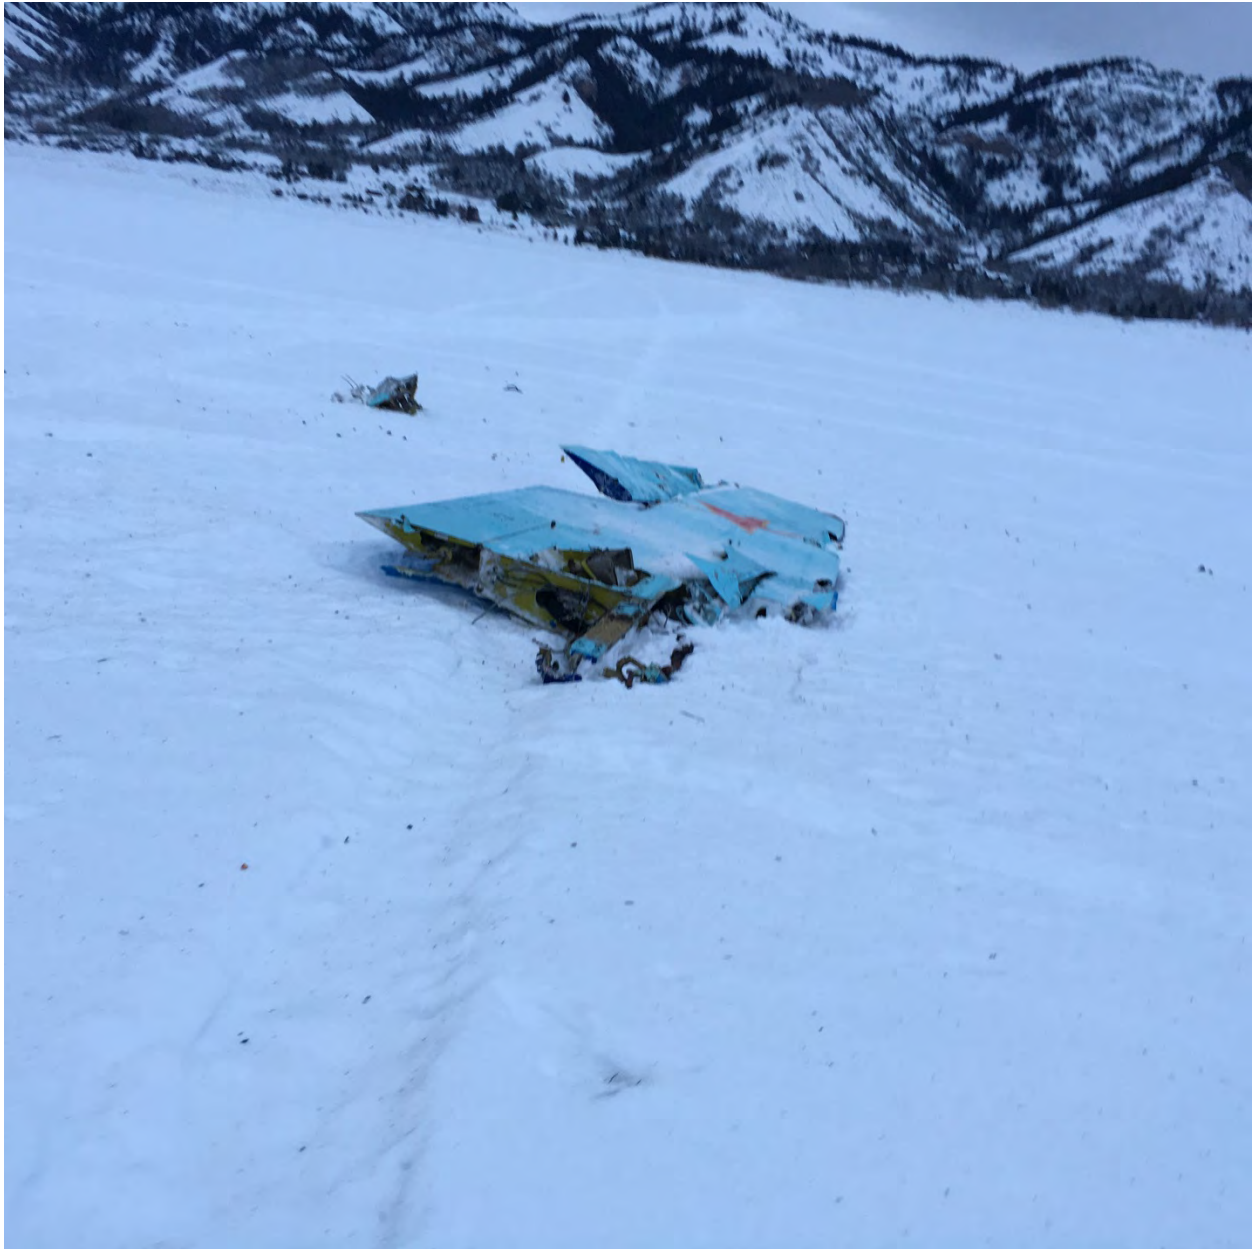
*Figure 10. Inverted Right Wing*

The inverted right wing was 400 feet into the debris field, and had the carry through spar attached to it.

The right wing exhibited aft leading edge crush damage. The right aileron separated at the inboard and outboard hinges.

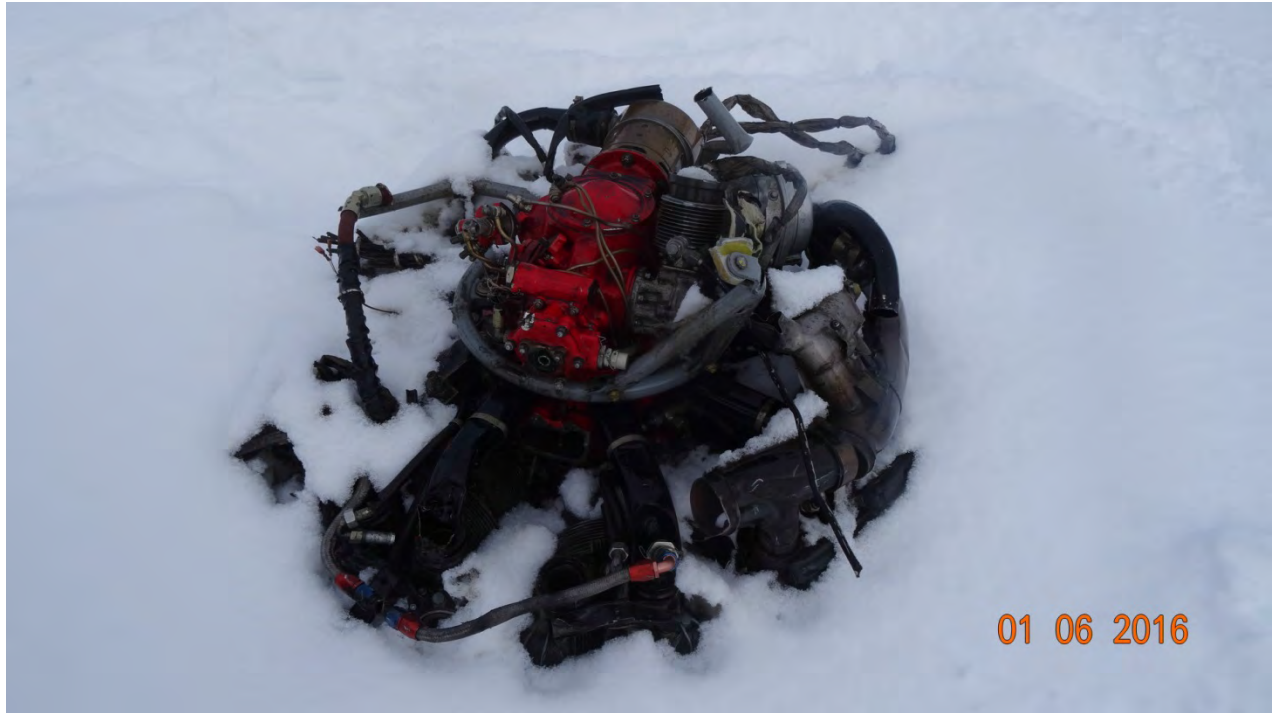
*Figure 11. Engine*

The front of the engine case separated
