## **NATIONAL TRANSPORTATION SAFETY BOARD**

### **AIRFRAME AND ENGINE EXAM REPORT**

WPR16FA046

Location: Alpine, Wyoming  
Date: January 4, 2016  
Aircraft: Aerostar SA YAK-52, Registration Number: N912EB, Serial #: 832912  
NTSB IIC: Howard Plagens

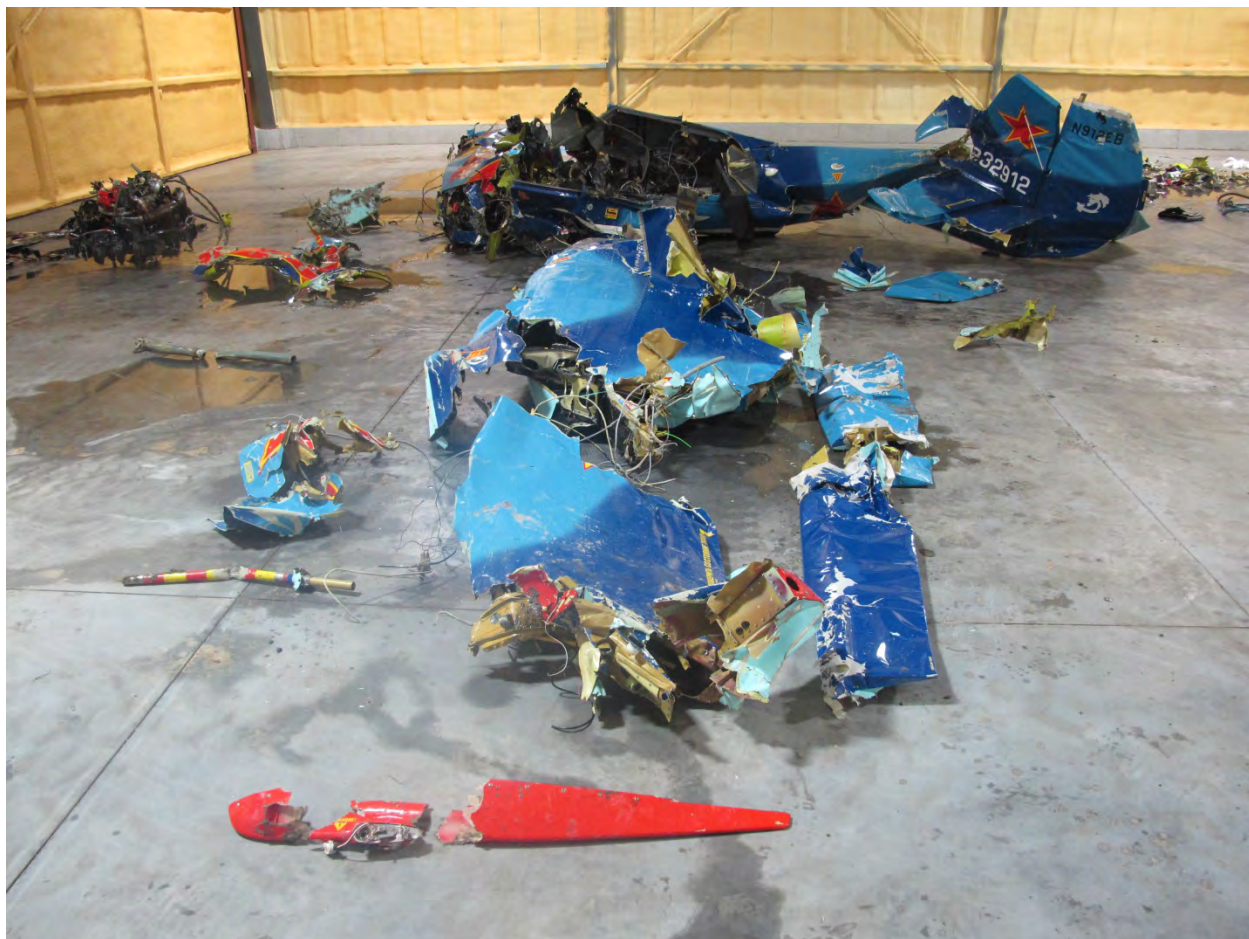
*Figure 1. Left Side of Wreckage*

The airframe was highly fragmented, but all major components and flight control surfaces were identified. All fracture surfaces were angular and jagged.

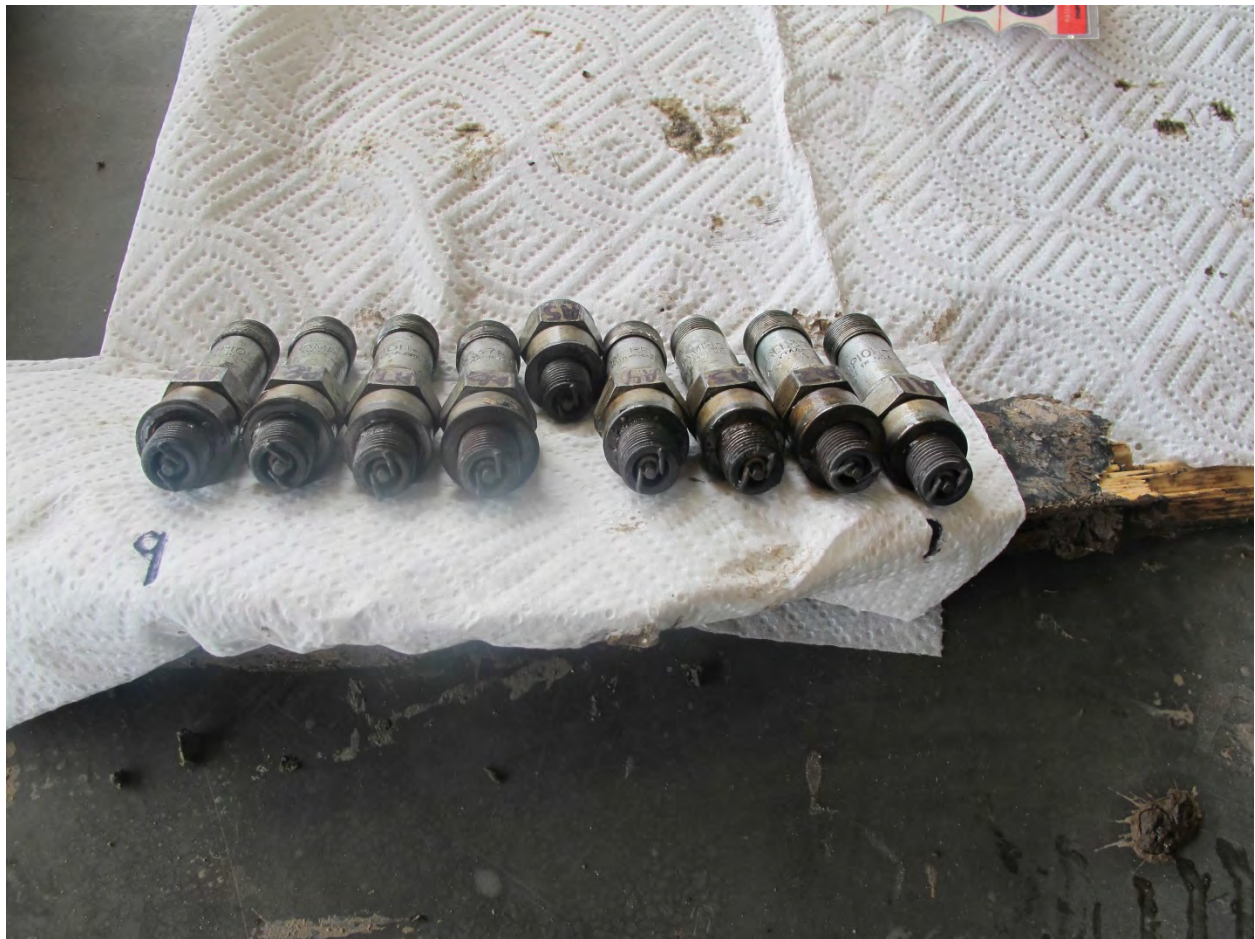
*Figure 9. Spark Plugs*

The spark plugs were clean with no mechanical deformation of the electrodes. The spark plug electrodes were gray, which corresponded to normal operation according to the Champion Aviation Check-A-Plug AV-27 Chart.

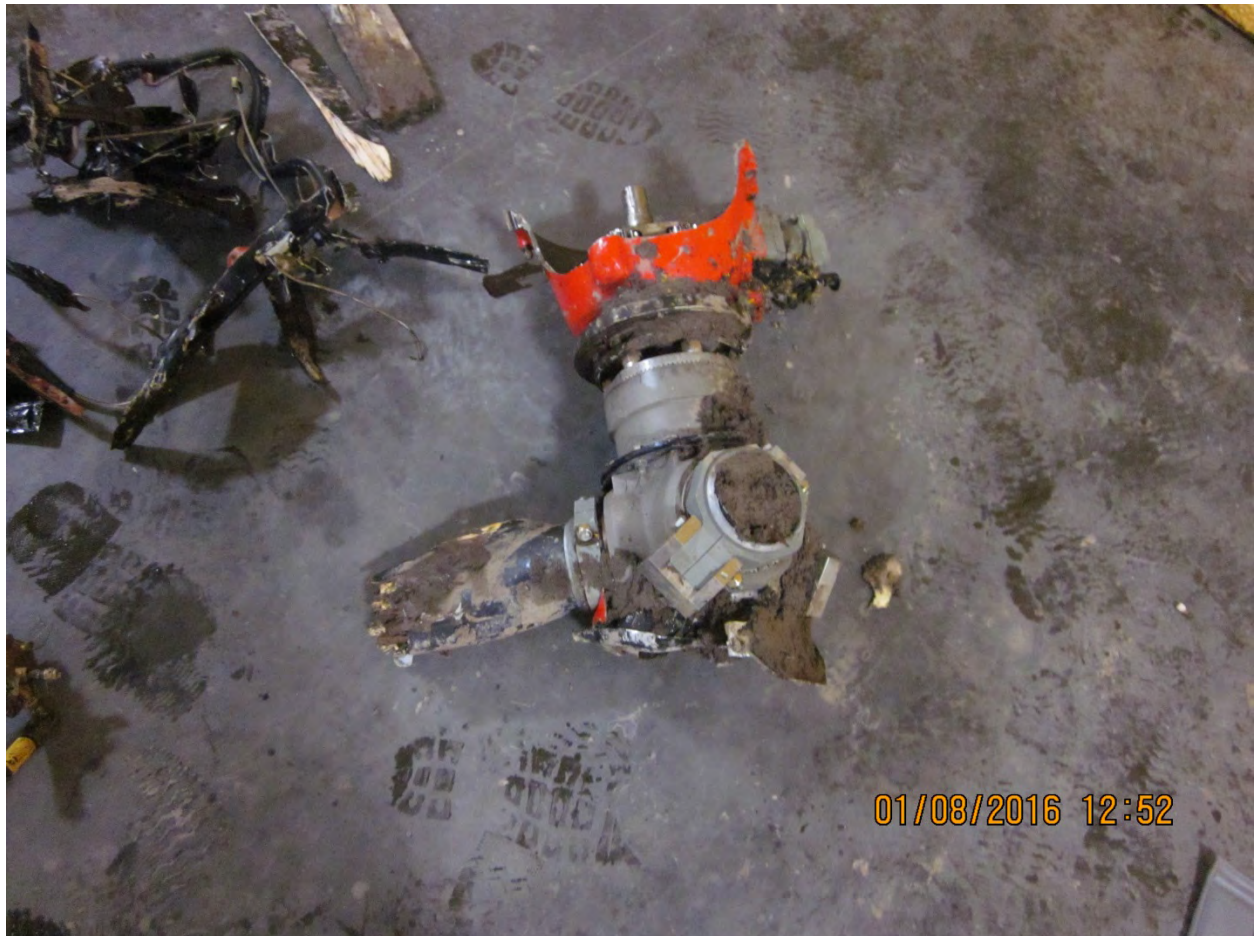
*Figure 10. Propeller Hub*

All of the propeller blades shattered and fragmented.
