**GROUP CHAIRMAN'S FACTUAL REPORT OF  
INVESTIGATION**

**WPR16FA055**

| Aircraft: | Airbus Helicopters EC130T2, N11VQ |
| NTSB Number: | WPR16FA055 |

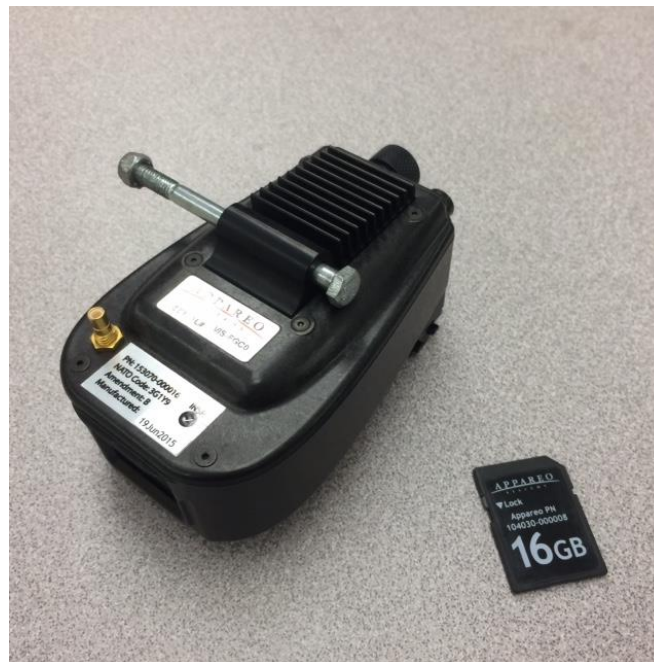
Upon arrival at the NTSB Vehicle Recorder Division, it was evident that the Appareo Vision 1000 had not sustained any heat, water or structural damage and the device's records were extracted from the unit normally, without difficulty. Figure 1 is an image of the Appareo Vision 1000 as received.

**Figure 1. The Appareo Vision 1000 and SD card.**

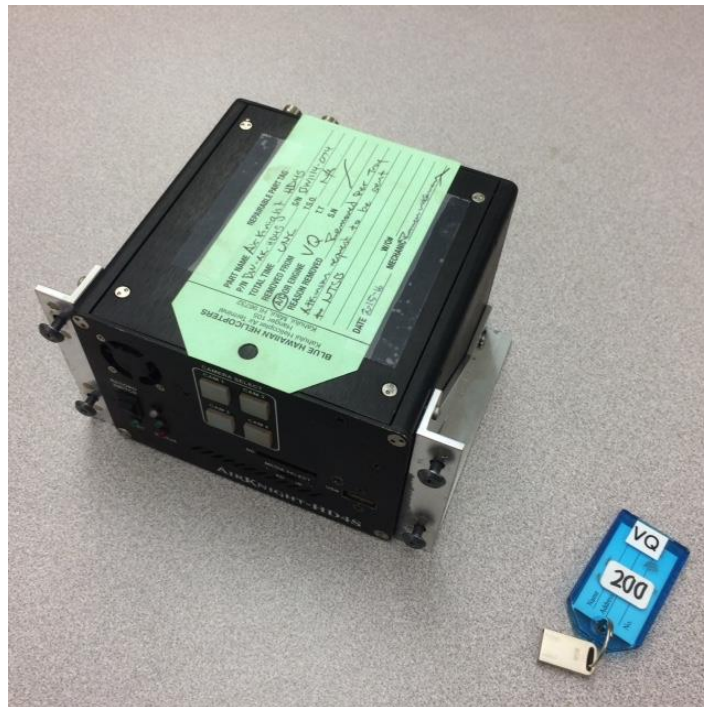
damage. The USB drive was examined for image and audio files. Figure 14 is an image of the Datatoys AirKnight HD4s and the associated USB flash drive that contained video data.

Figure 14. The Datatoys AirKnight HD4s.

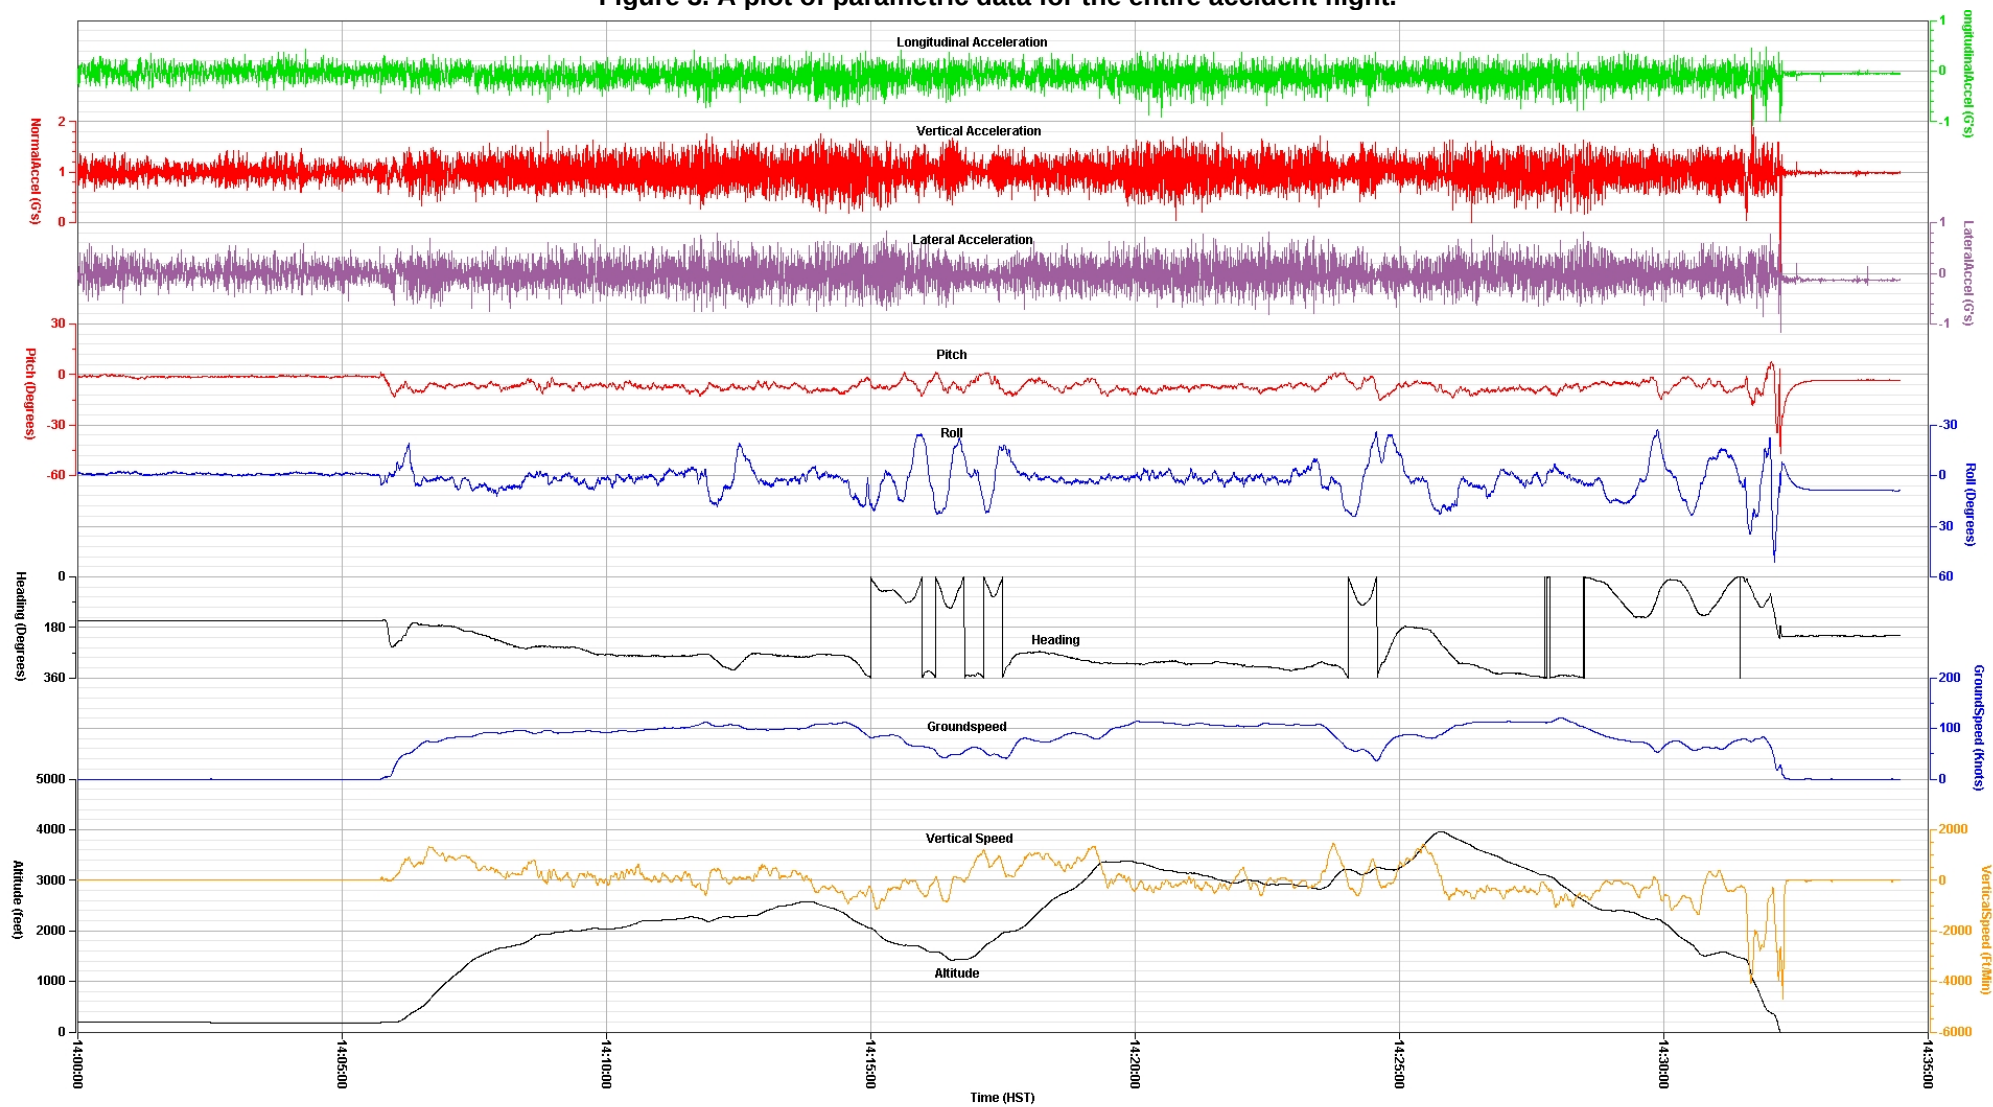
Figure 3 is a plot of the relevant parameters for the entire accident flight. The plotted time interval is from 14:00 HST to 14:35 HST. The data shows takeoff occurred about 14:05:44 HST. The flight continued normally for the next 26 minutes. About 14:31:31 HST, the rotorcraft began to yaw to the right of its course of around 360 degrees. The altitude at this time was approximately 1,450 feet MSL. Around the same moment, vertical speed began spiking to local minima of around -4,000 feet per minute. The aircraft experienced a roll to the right of around 30 degrees and a nose down pitch of about 20 degrees as its heading changed to about 108 degrees. Around 14:31:54 HST, the rotorcraft's heading began changing again to the left, the rotorcraft's roll became around 20 degrees left and, as it reached a heading of around 065, the rotorcraft's pitch had become slightly positive. During this time, recorded vertical speed ranged from about -285 feet per minute to -4,000 feet per minute. Around 14:32:03 HST, the rotorcraft began to roll right. During this time, data showed the aircraft at approximately 374 feet MSL. During this period of maneuvers, the rotorcraft's groundspeed was between approximately 70 and 80 knots. By 14:32:06 HST, the rotorcraft's roll was about 51 degrees right, pitch increased to about 35 degrees nose down, and vertical speed approached -4,000 feet per minute. The rotorcraft came to a heading of about 220 degrees as its roll component began to level out around 14:32:11 HST. At this time, groundspeed decreased to around 20 knots. Impact with the ground occurred around 14:32:12 when the value for normal acceleration showed a spike in G force. The recorder's sample rate of 4Hz was not enough to quantify the force of the impact. The recording ended at 14:34:17.50 HST.

Figure 3. A plot of parametric data for the entire accident flight.

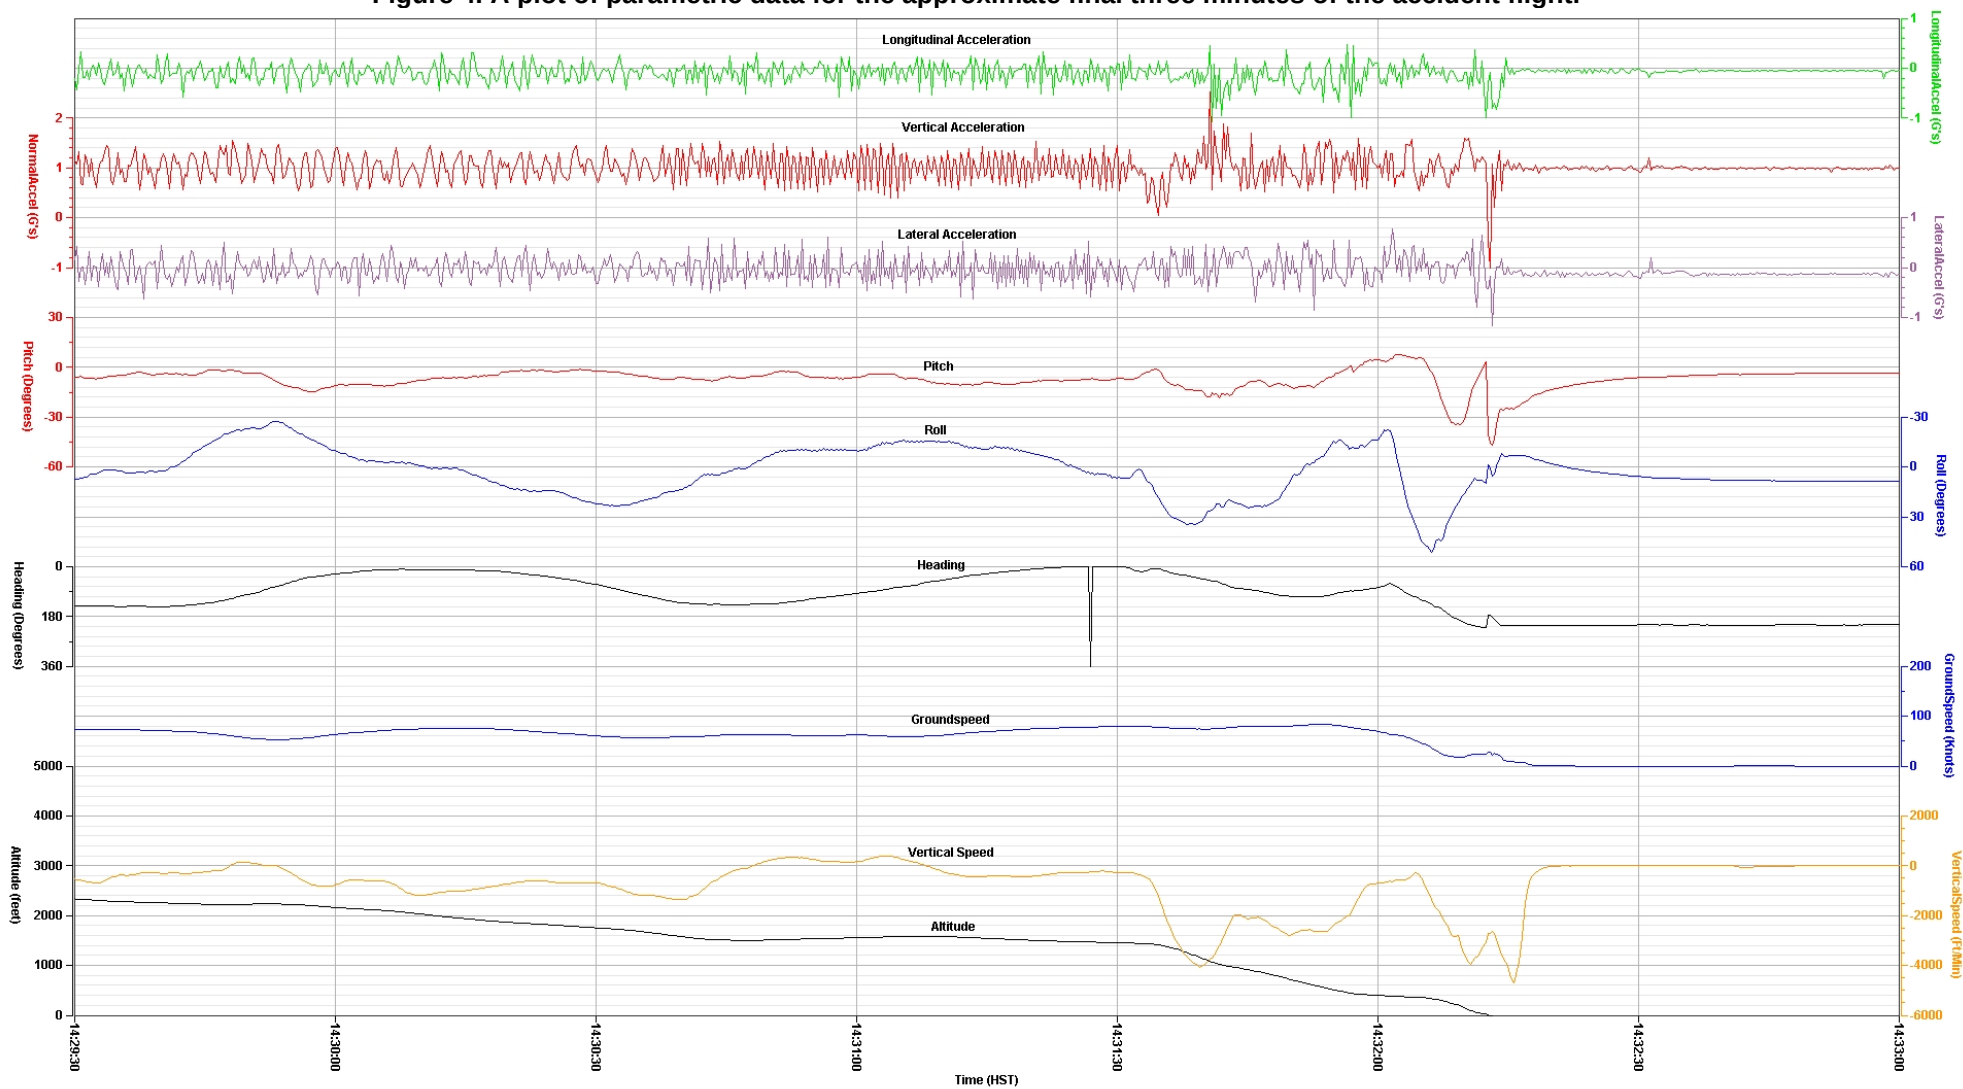
Figure 4 shows the approximate final three minutes of flight. The plotted time interval starts at 14:29:30 and ends at 14:33:00.

Figure 4. A plot of parametric data for the approximate final three minutes of the accident flight.

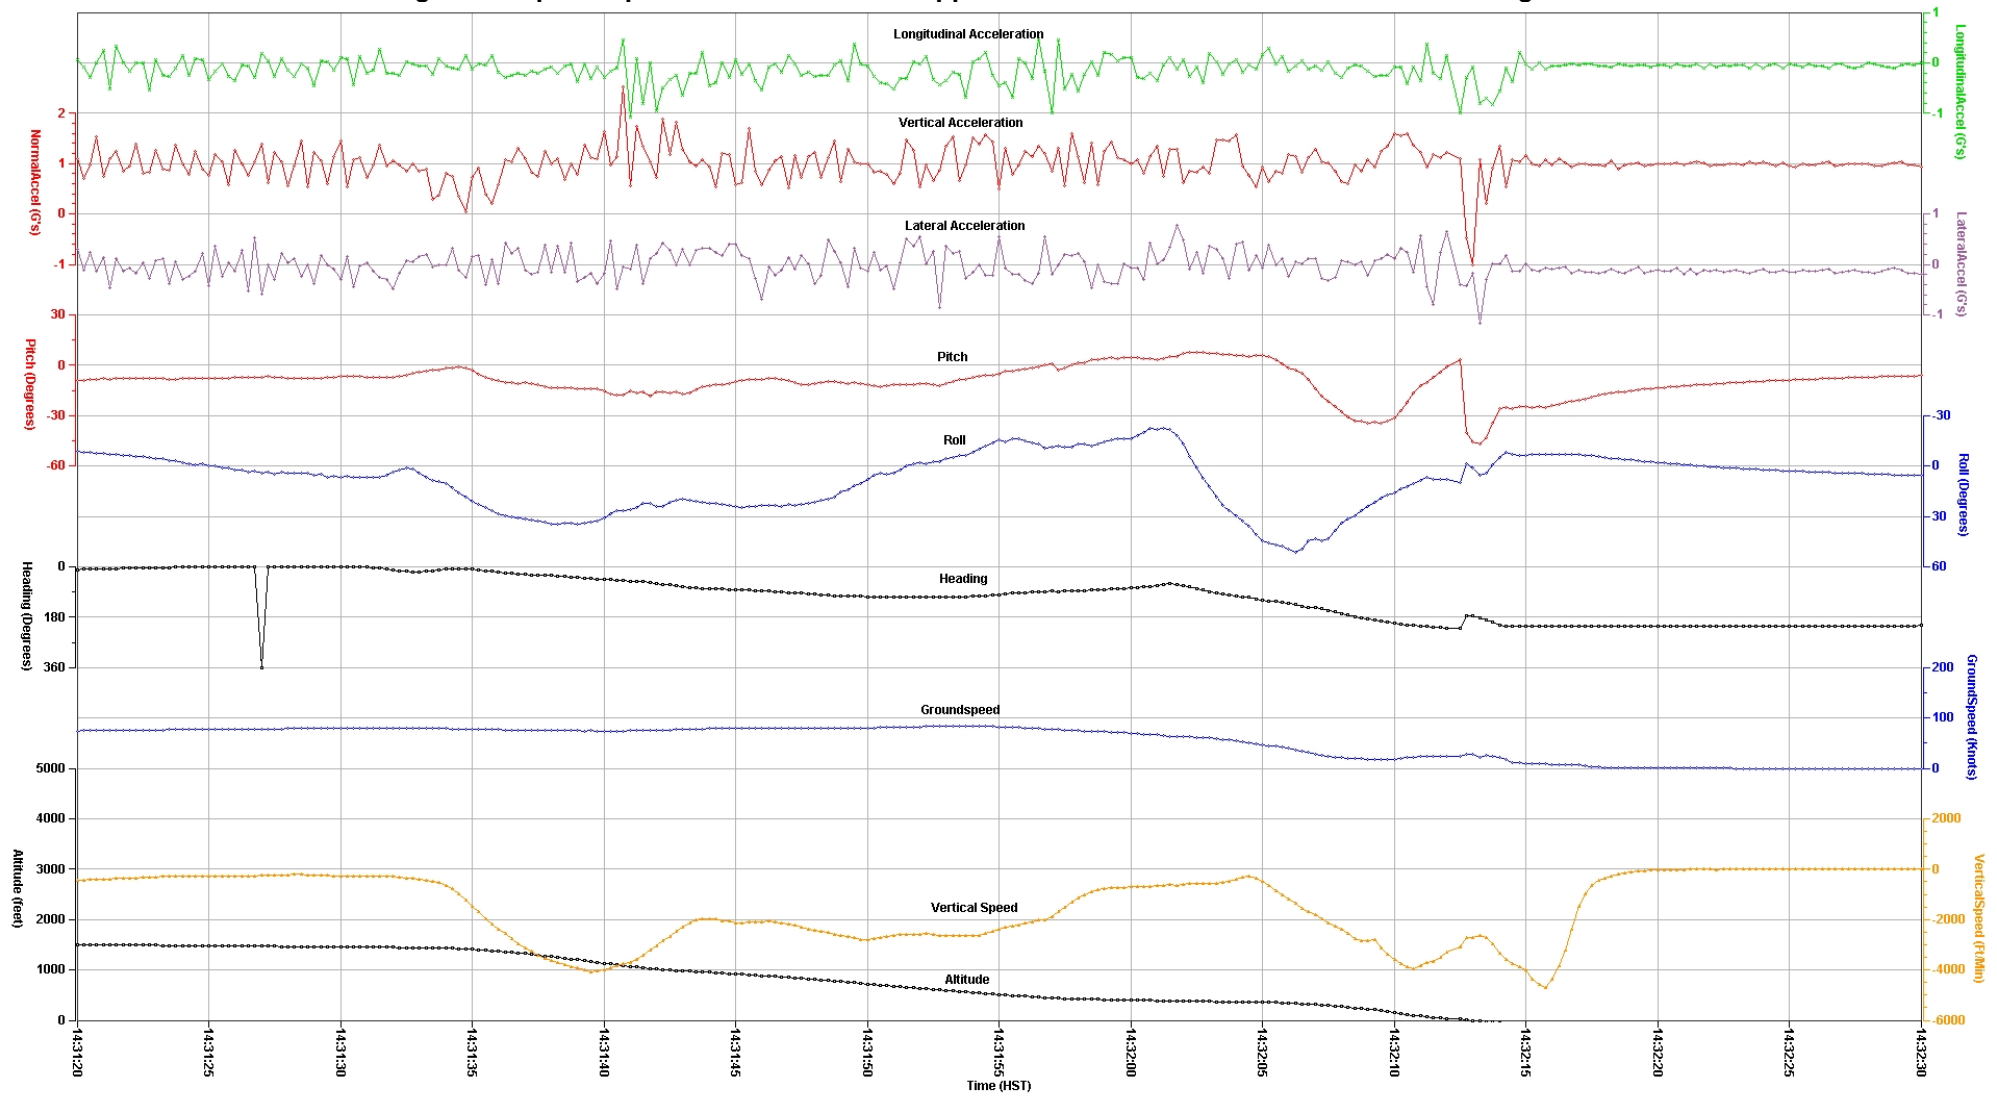
Figure 5 shows the approximate final one minute of flight. The plotted time interval starts at 14:31:20 and ends at 14:32:30.

Figure 5. A plot of parametric data for the approximate final one minute of the accident flight.
