**Equipment: STARTER GENERATOR**  
**AIRBUS P/N: 704A46101011**  
**THALES AES P/N: 524-031 AMENDMENT J**  
**Title: EC130T2 –N11VQ NTSB Investigation- Thales Submission**  
**Doc. Ref. THALES TAES-20\_048\_DIN\_PMA**

| <b>THALES</b><br>AVIONICS ELECTRICAL SYSTEMS | <b>AIRBUS HELICOPTER<br/>EC130 – STARTER<br/>GENERATOR</b><br><br><b>EC130T2 –N11VQ NTSB<br/>Investigation- Thales Submission</b> | <b>20_048_DIN_PMA</b> | |

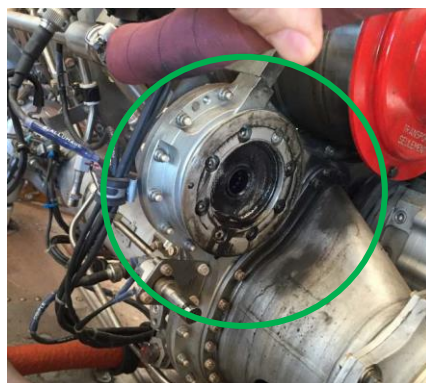
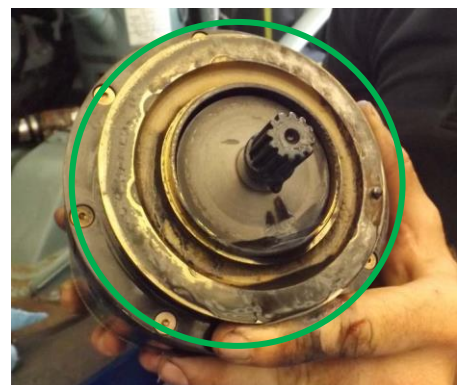
- A significant presence of greasy/oil material at the engine/starter-generator interface as shown hereafter

Nevertheless, this testing revealed that during the visual inspection, it has been observed a presence of greasy/oil material; play was also observable with a hand movement on the starter-generator torque shaft. The starter-generator was cleaned before this testing on the Exemplar EC130T2 helicopter

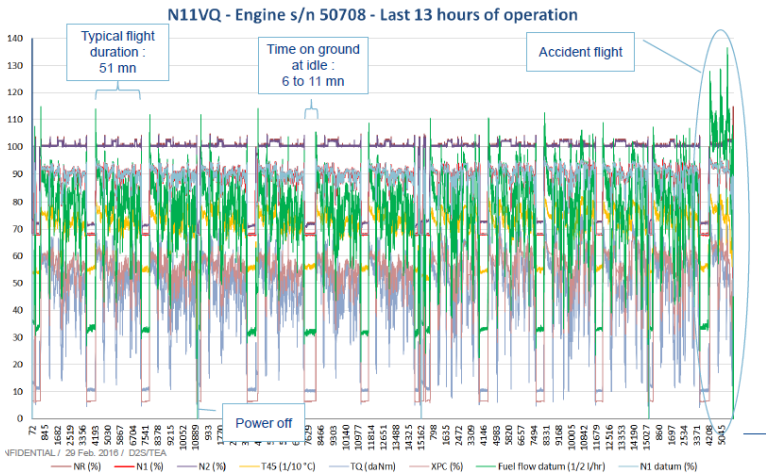
EDR Data extract (AIRBUS Helicopters report)

Typically, it appears on this recording that during the last 13 hours of operations the helicopter performed a succession of four 50 minutes (approx..) flights, thereafter remaining on the ground for approximately 10 minutes with the engine maintained at Ground Idle. Then, after the fourth flight, the engine was shut down. As further Engine manufacturer testing is shown, Vibration levels appeared to be higher when the engine was being operated at ground idle (see Engine Testing chapter).

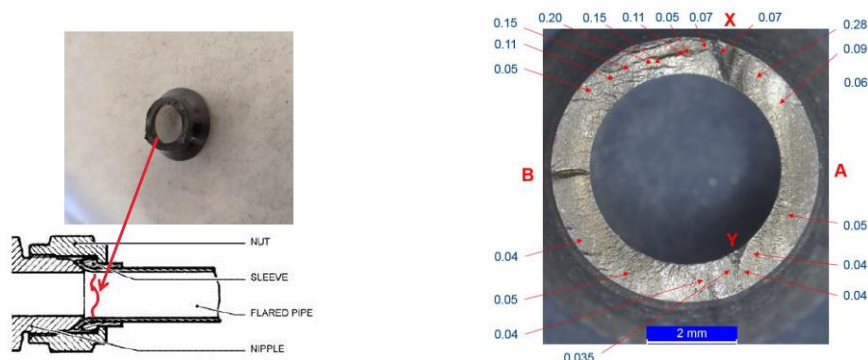
Additional to the NTSB examination, Engine Manufacturer under BEA supervision, performed additional and detailed physical analysis using binocular and Scanning Electron Microscope (FEG-SEM). This analysis was thoroughly reviewed by the BEA, Airbus Helicopter and Thales.

The BEA System group (BEA, AH, Engine Manufacturer, Thales) concluded that the rupture of the pipe was mainly due to fatigue phenomenon.

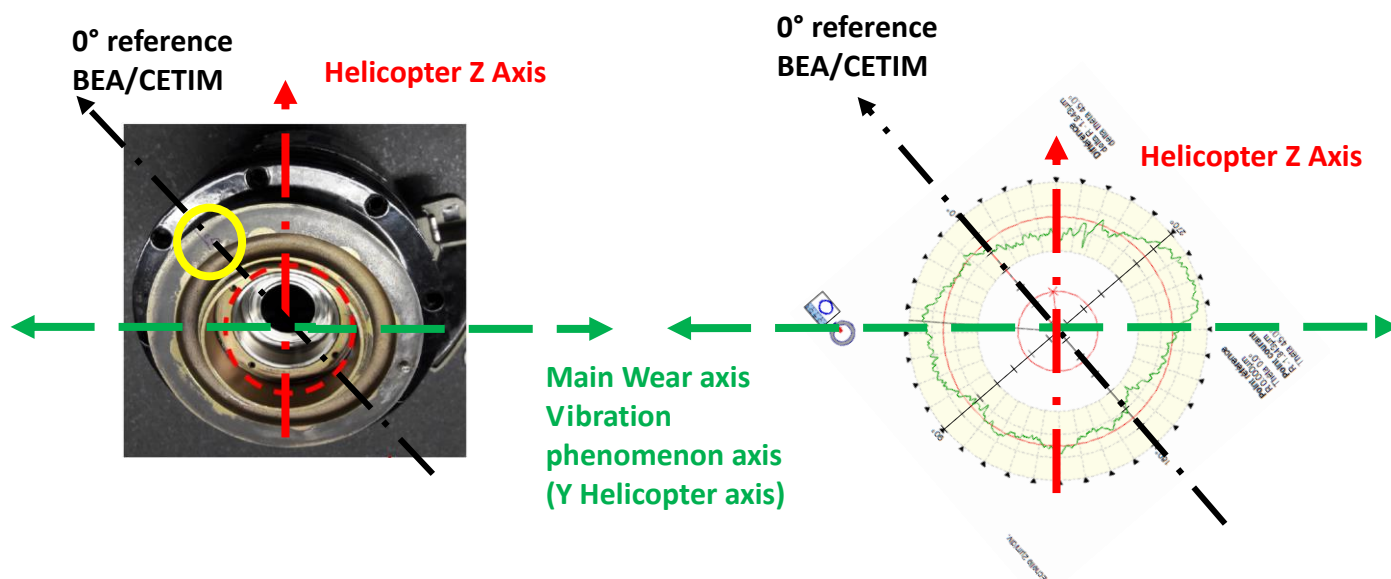
The front bearing cage shows wear with “rugby balloon” shape. This wear is out of acceptable tolerance and measured by the BEA and the CETIM independent laboratory with a difference around 0.650 with a maximum of 0.680 mm between a local diameter and the nominal diameter.

This “rugby balloon” shape on this longer dimension axis is along the Y axis of the helicopter as shown hereafter.

This observation, in which the wear is not uniform around the bearing cage and appears to be under on one axis, taking into account that no other discrepancy was noted, indicates that the starter generator may have been subjected to an external vibration phenomenon or force on that preferred axis of degradation.

The measurements made by Airbus Helicopter and Thales, confirm that finding that the vibration of the starter-generator occurs along the Helicopter Y axis.

In early 2018 (March 12th, 2018) Airbus Helicopter issued a Recommended Service Bulletin SB EC130-24-008 that asks to check on time the starter-generator for radial play (0.05 mm radial play criteria) of the front bearing before reaching 450 Flight hours as well as for any oil slippage at the starter-generator – engine interface. Additionally, the Service Bulletin requests that operators report all measurements and observations to Airbus. Of course, the SB also requests that appropriate measures are taken if any discrepancies are observed.

At the end of 2018 (December 24th, 2018) Airbus Helicopters issued Service Bulletin (N°EC130-05-030) that strongly recommend to modify the starter-generator maintenance intervals and required inspections every 300 Flight hours, the equipment for radial play and potential oil slippage at the starter-generator – engine interface. The service bulletin also requires to take appropriate measures if discrepancies are noted during the Service Bulletin required inspections. This service bulletin is based on the Thales Service bulletin n° 524-03X-80-011 that gives the appropriate radial play measurement method.
