# NATIONAL TRANSPORTATION SAFETY BOARD

## MATERIALS LABORATORY FACTUAL REPORT

Report No. 16-023

Place : Hanalei, HI  
Date : January 17, 2016  
Vehicle : Airbus Helicopter EC130T2, N11VQ  
NTSB No. : WPR16FA055  
Investigator : Van McKenny, AS-WPR

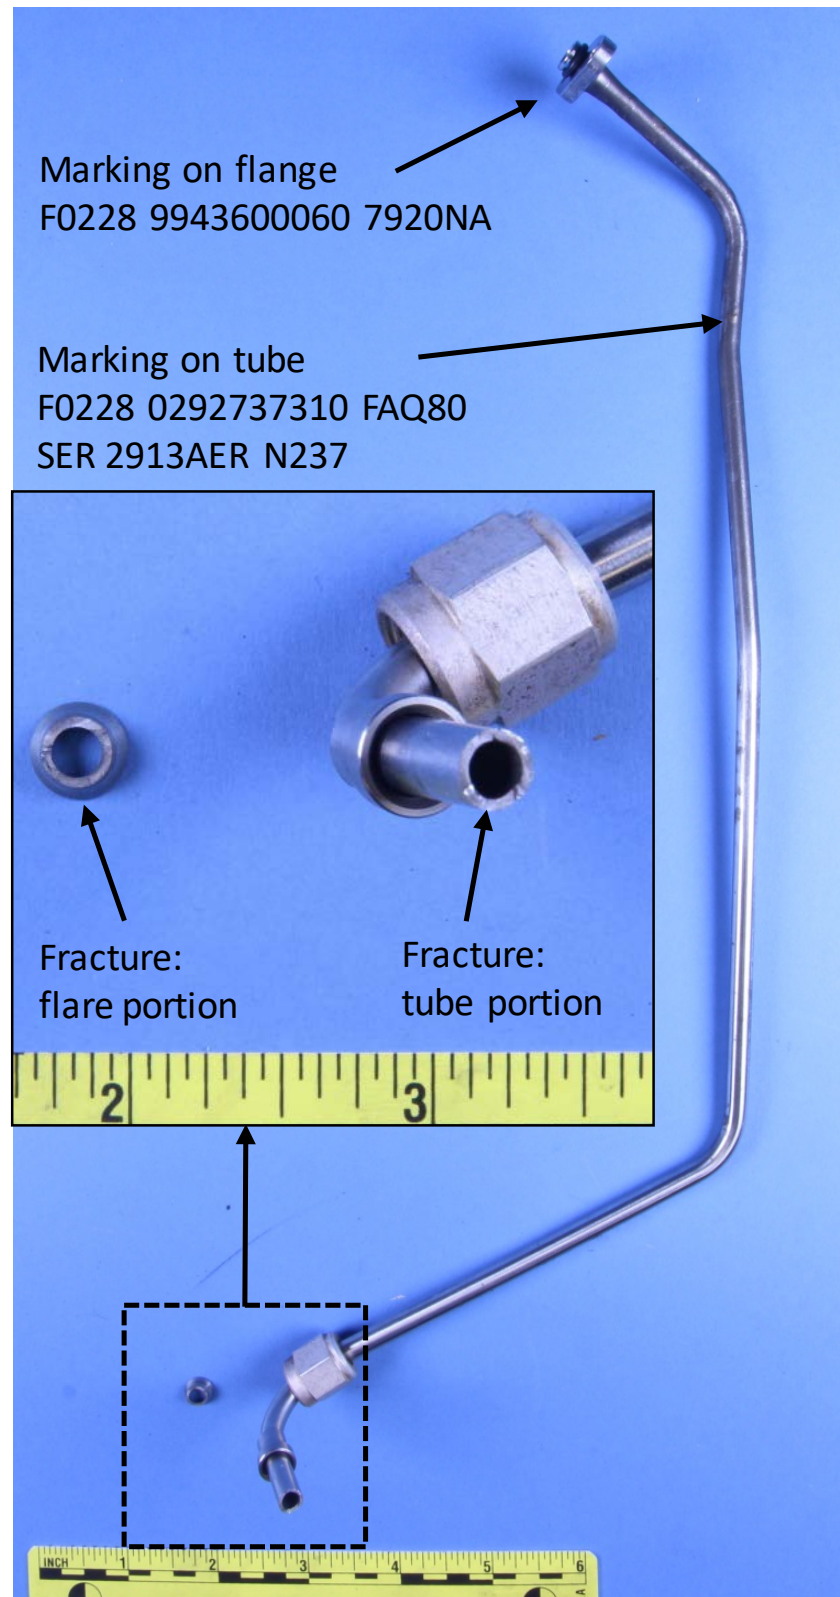
The as-received fuel line pieces are shown in Figure 1 with manufacturer markings on the tubing and flange indicated. As identified in Figures 1 and 2, the tube fractured at the flared end. A closer view of the fracture surface on the tube portion is shown in Figure 3. Using a digital microscope, fractographic features such as ratchet marks and crack arrest marks were observed. Such marks are consistent with reverse bending fatigue fracture initiation on the outside surface of the tube in the regions identified in Figure 4. Oblique angle views of the crack initiation regions are shown in Figures 4b and 4c.

Figure 1 Images of the as-received fuel line pieces.

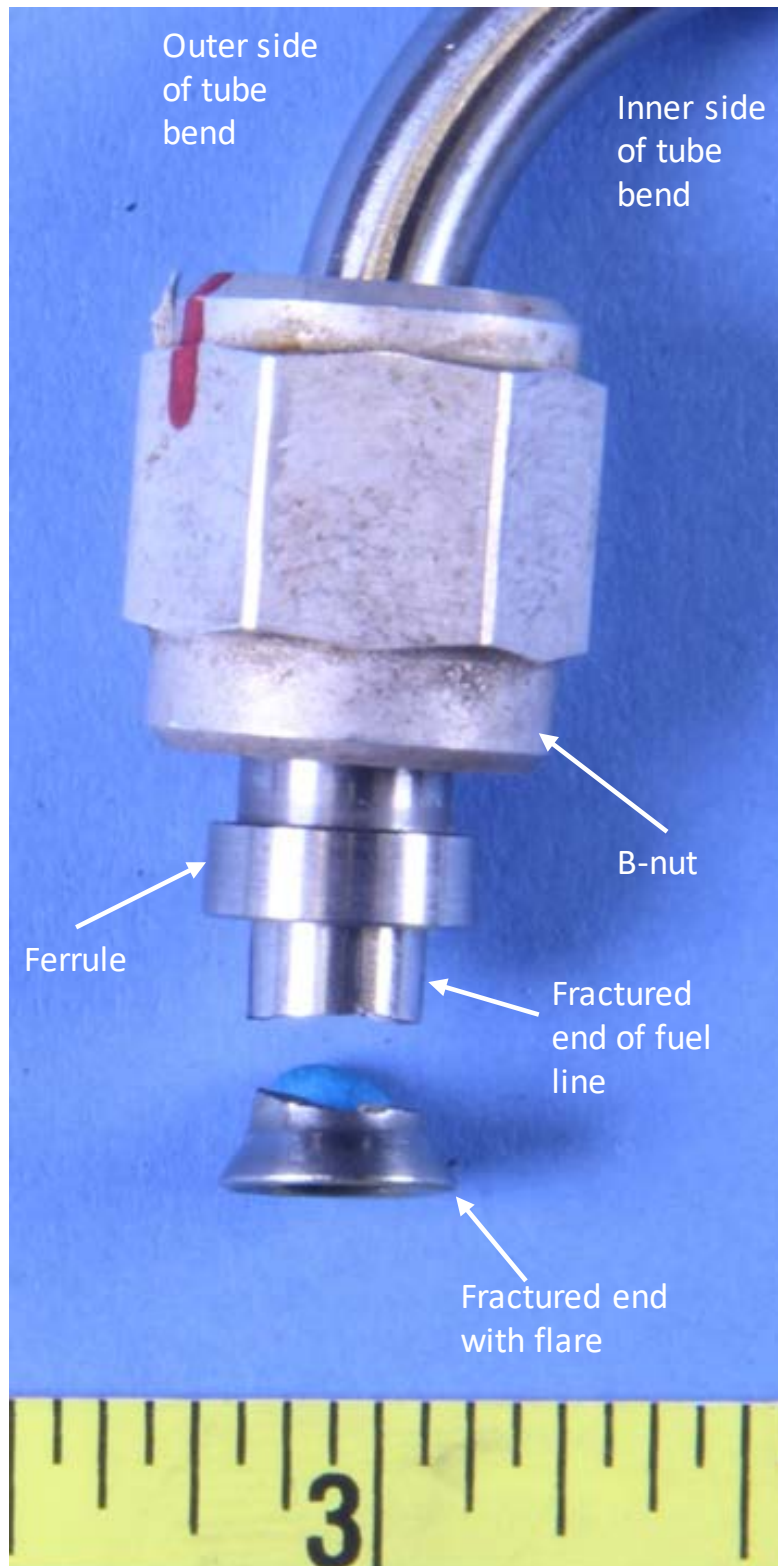
Figure 2 Image showing a close view of the b-nut ferrule assembly at the fractured flare end of the fuel line.

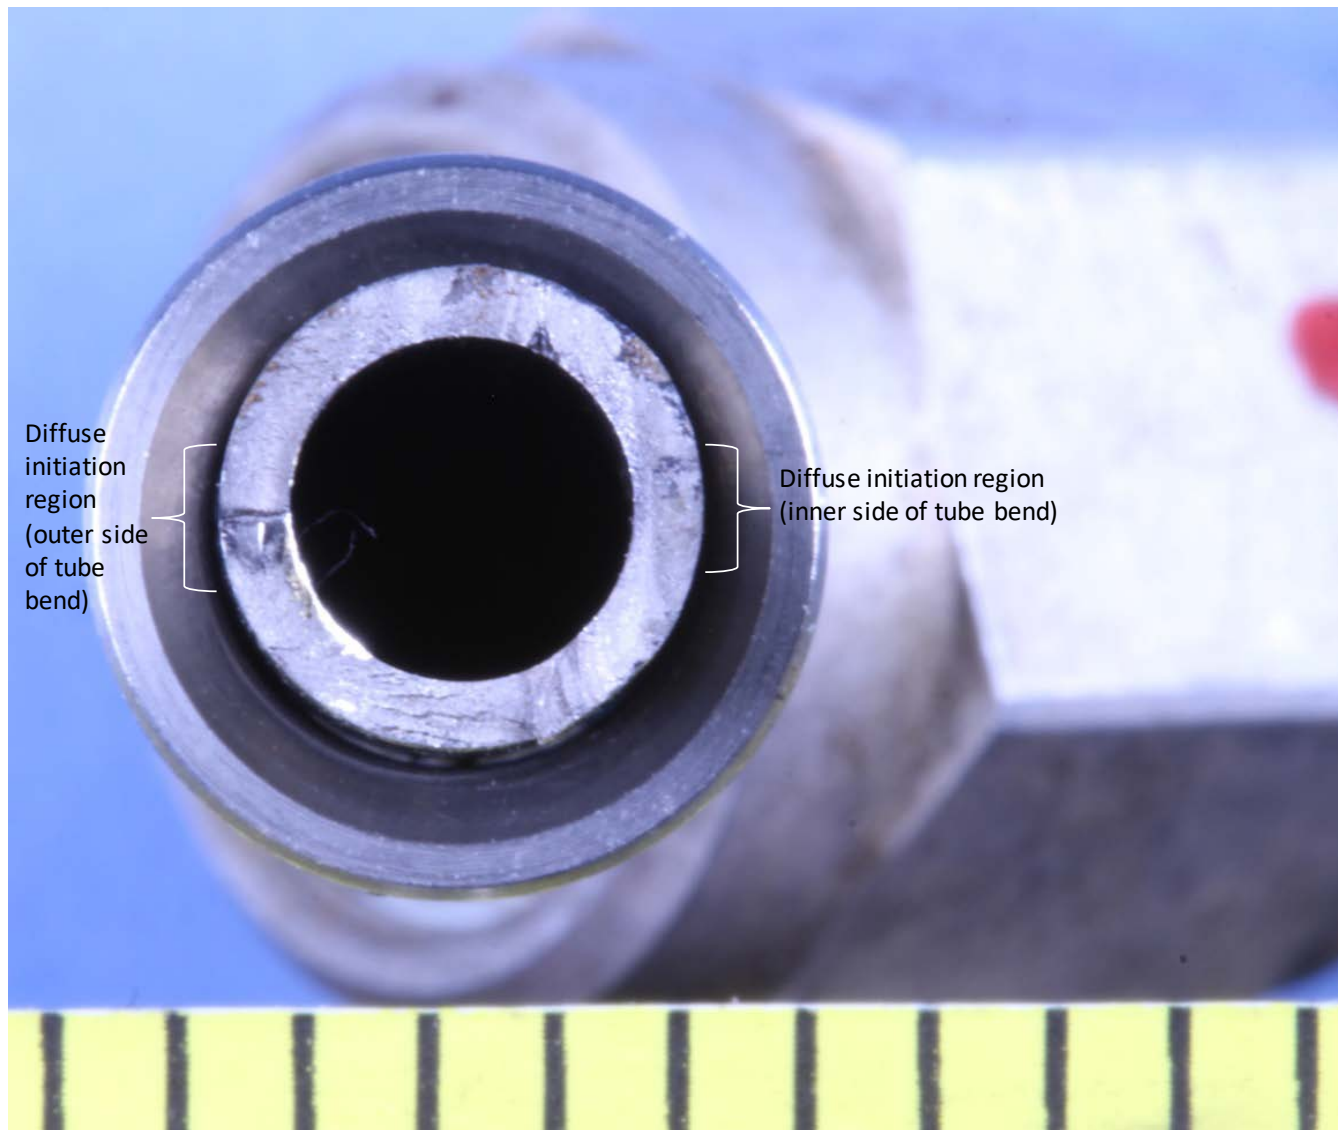
Figure 3 Close view of the fractured end of the fuel line tube with the fracture initiation regions identified.

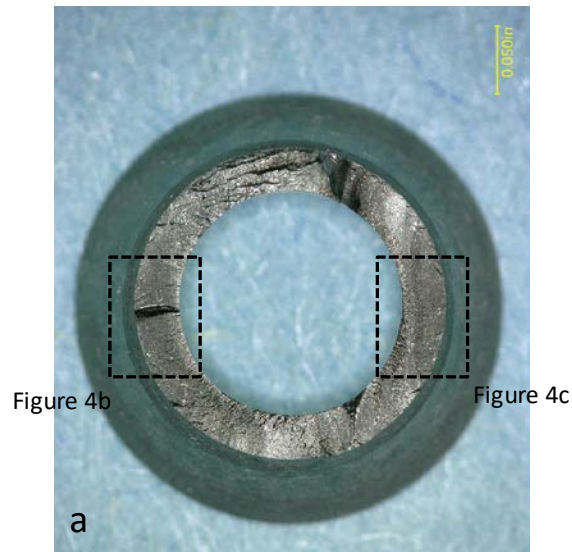
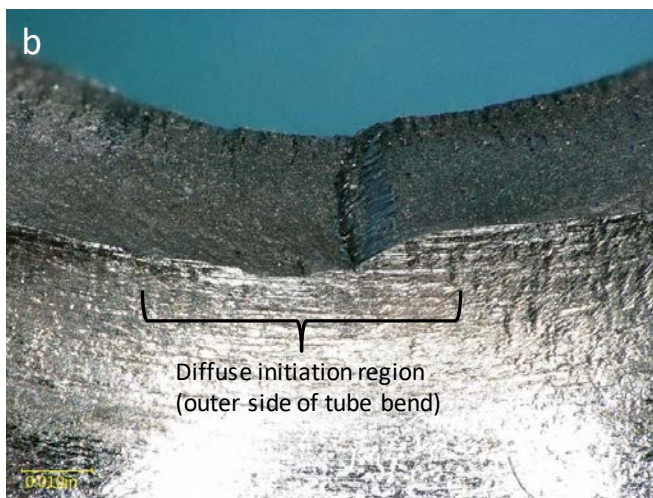
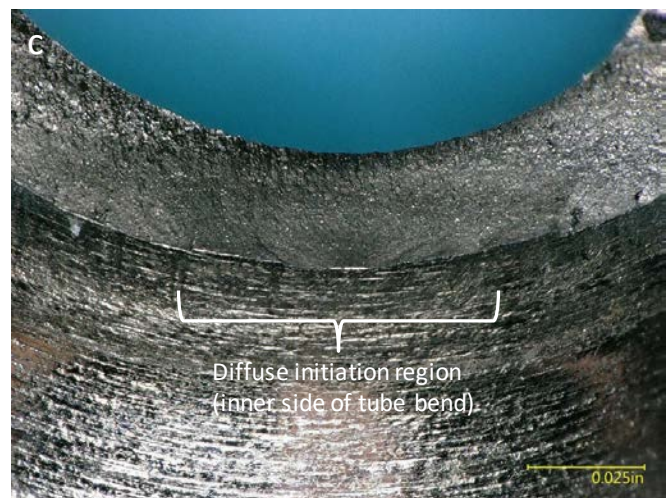
Figure 4 Digital microscope images of the fractured flare portion of the fuel line. View a is an overall view of the fracture surface. View b is a closer image of the initiation region at the outer side of the tube bend. View c is a closer image of the initiation region at the inner side of the tube bend.

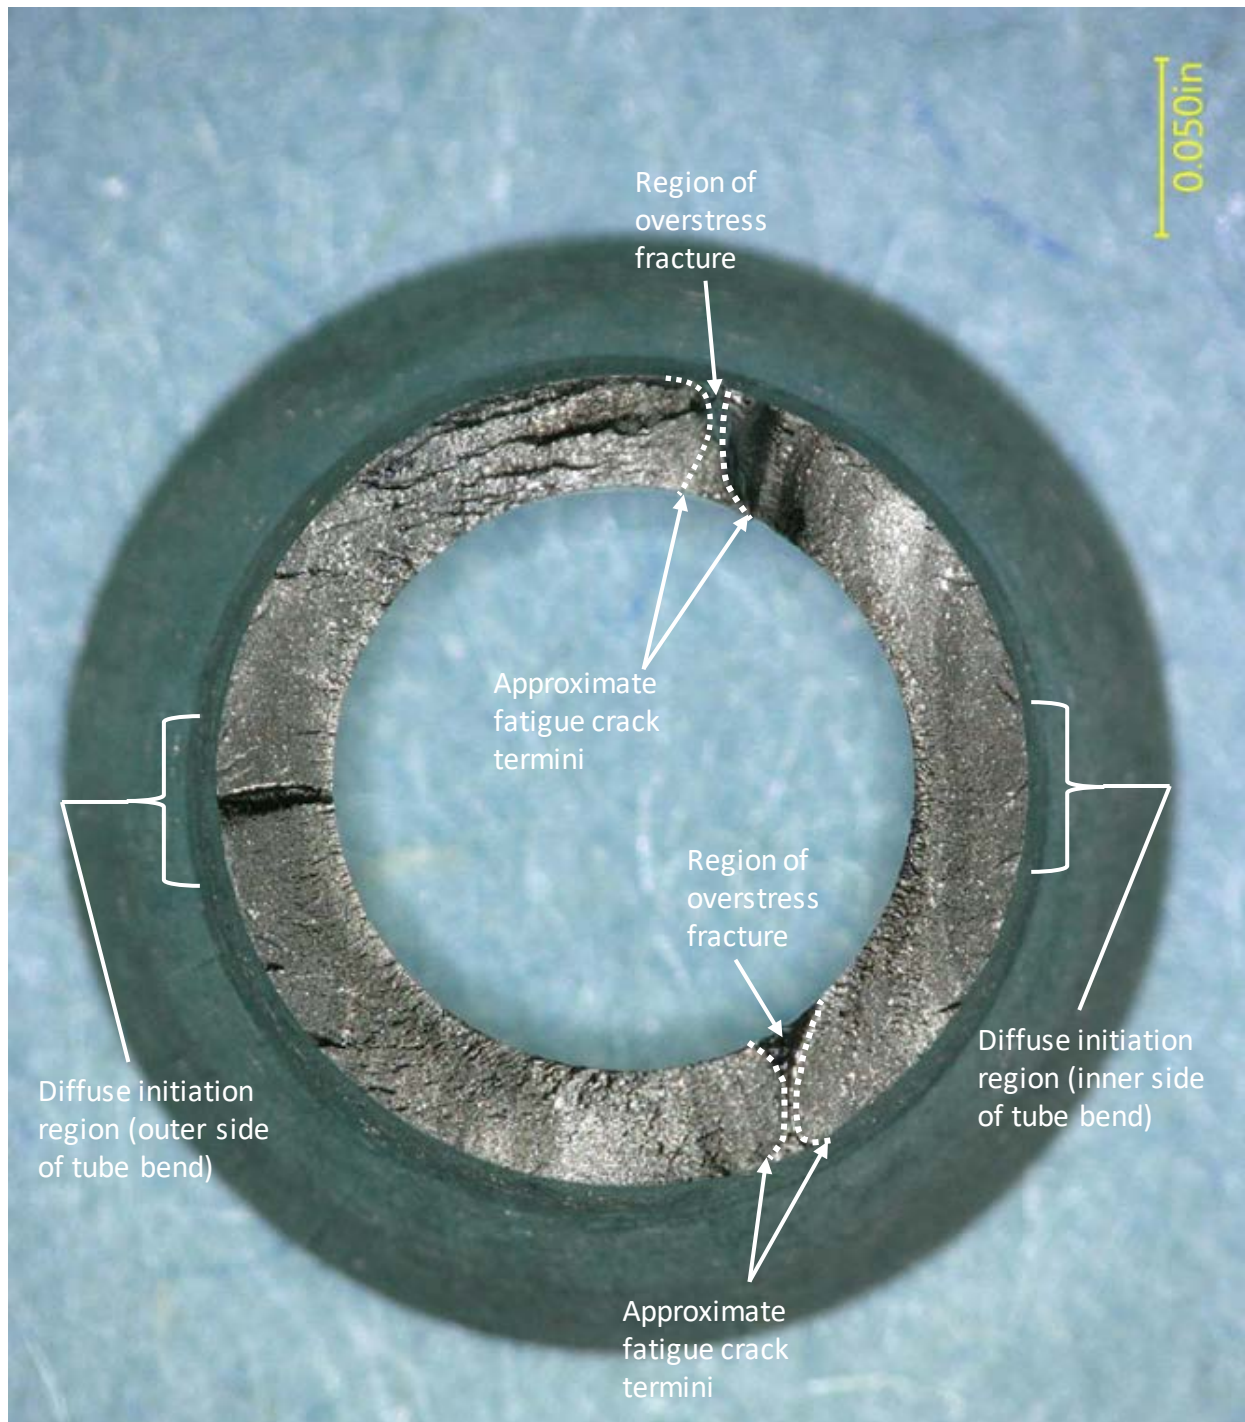
Figure 5 shows the locations of two diffuse-origin fatigue cracks that initiated on the outside surface of the tube about 180 degrees from each other. These cracks propagated through the thickness of the tube wall and circumferentially around the tube. Regions of final overstress fracture are identified in Figure 5.

Figure 5 Digital microscope image of the fractured flare portion of the fuel line with annotations to identify the fatigue crack initiation regions and the regions of final overstress fracture.

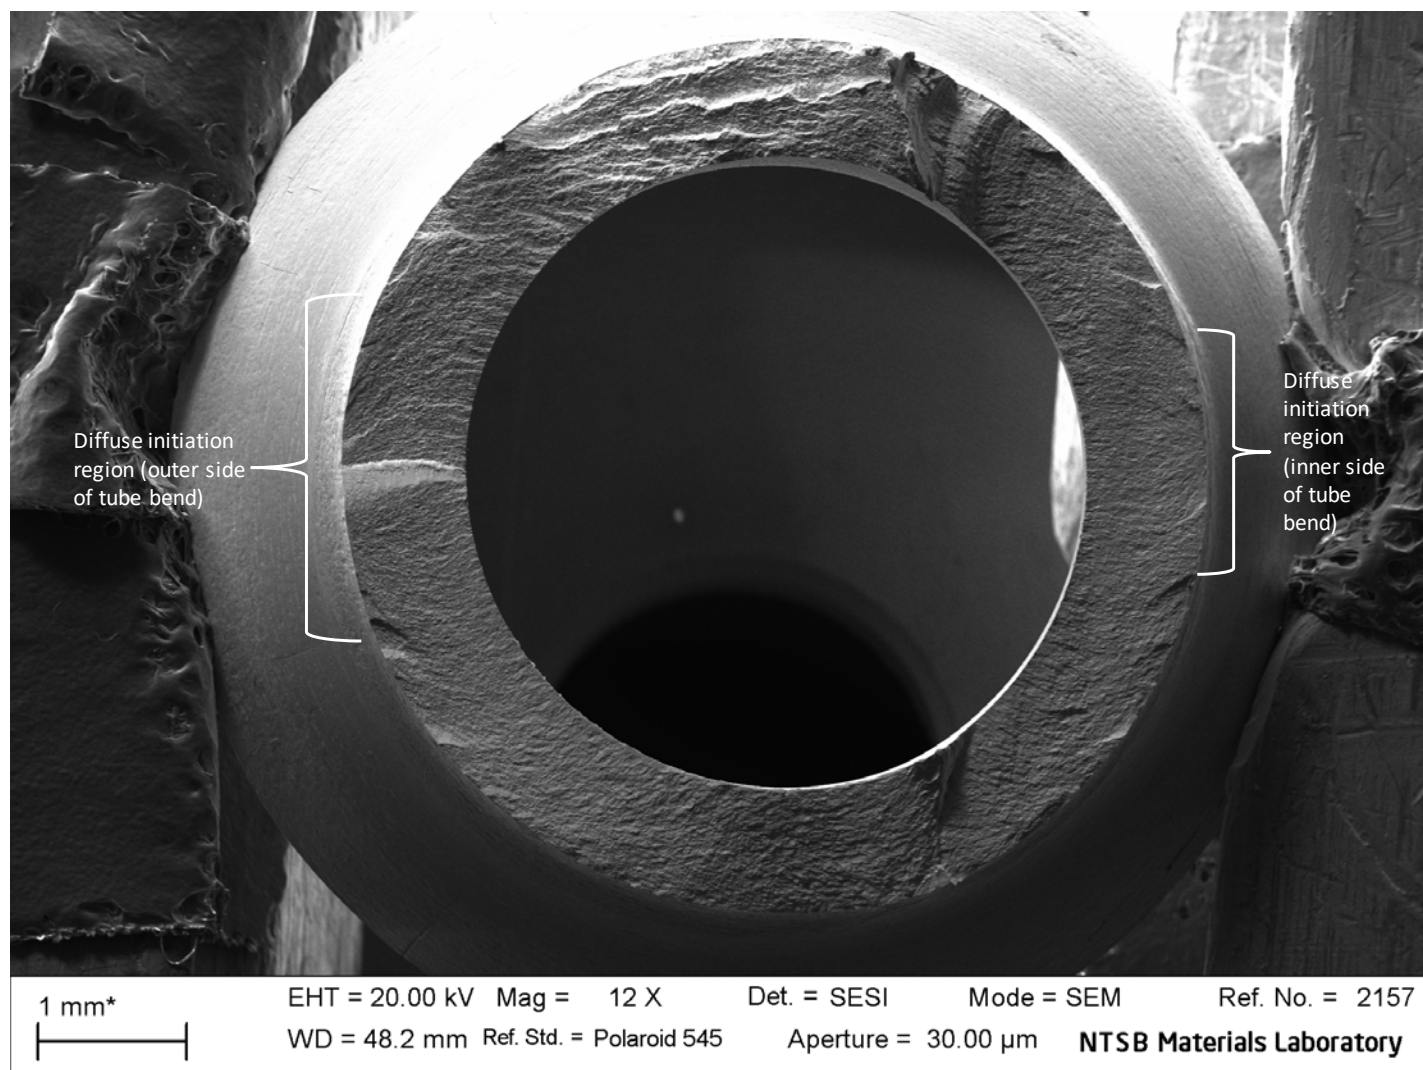
The fracture surface on the separated flare portion (see Figure 1) was examined using a Zeiss Auriga field emission scanning electron microscope (SEM). The sample was cleaned in acetone with ultrasonics prior to SEM analysis. An overall view of the fracture surface is shown in Figure 6 with the fatigue crack initiation regions indicated. Figure 7 is a duplication of Figure 6 with reference lines for the fatigue crack termini and regions of overstress fracture. Higher magnification oblique SEM images of the fatigue crack initiation regions are shown in Figures 8-11.

Figure 6 Scanning electron micrograph of the fractured flare portion of the fuel line with annotations to identify the fatigue crack initiation regions.

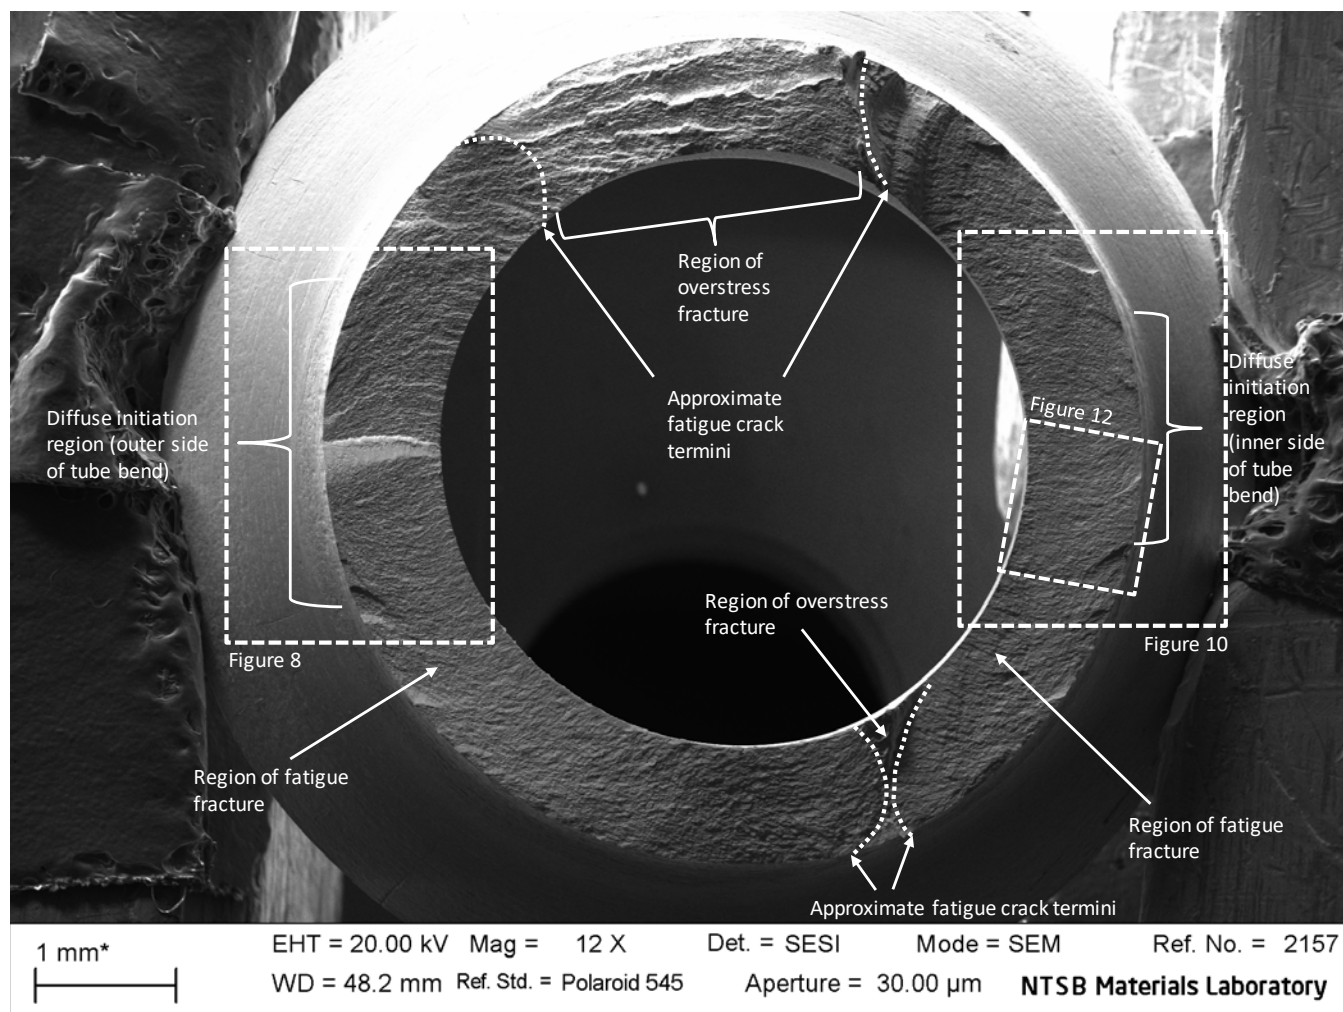
Figure 7 Scanning electron micrograph of the fractured flare portion of the fuel line with annotations to identify the fatigue crack initiation regions and the regions of final overstress fracture.

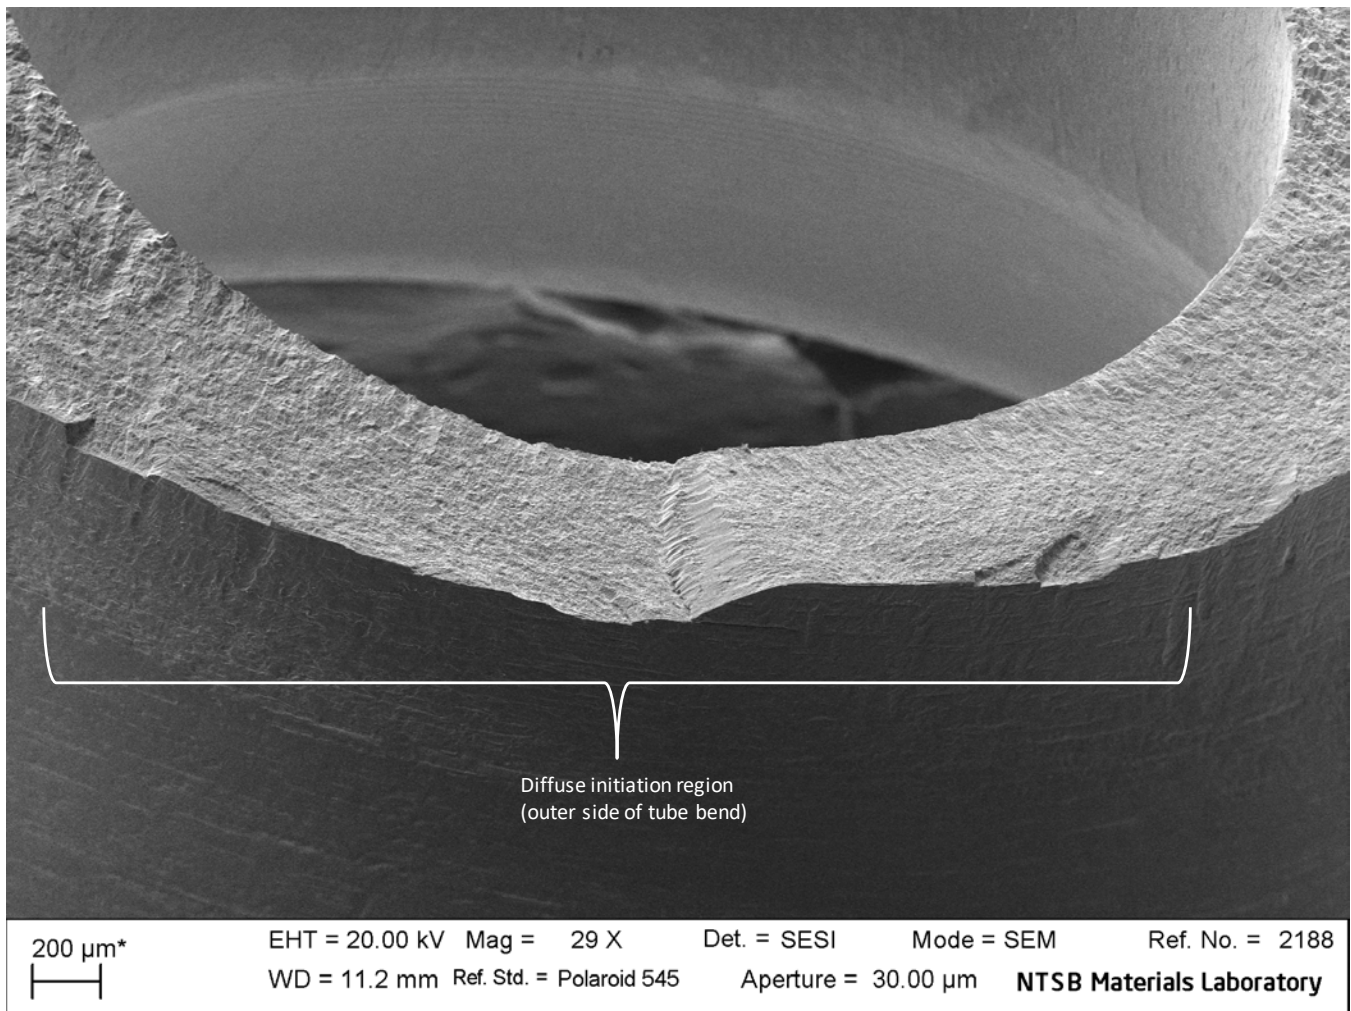
Figure 8 Close oblique scanning electron micrograph of the initiation region at the outer side of the tube bend.

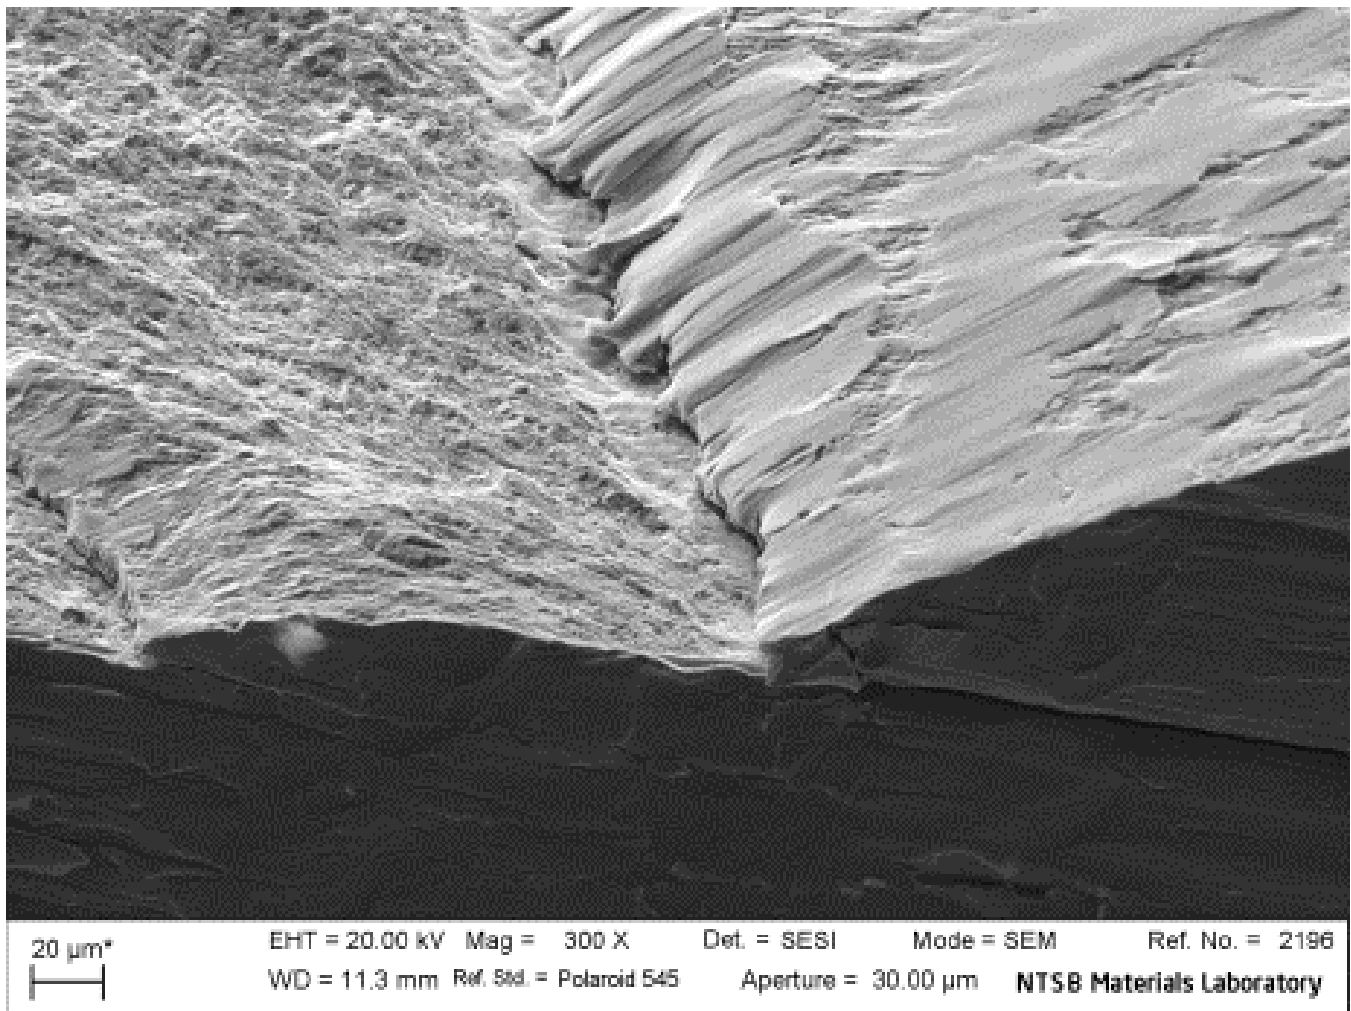
Figure 9 Closer oblique scanning electron micrograph of the initiation region at the outer side of the tube bend shown in Figure 8.

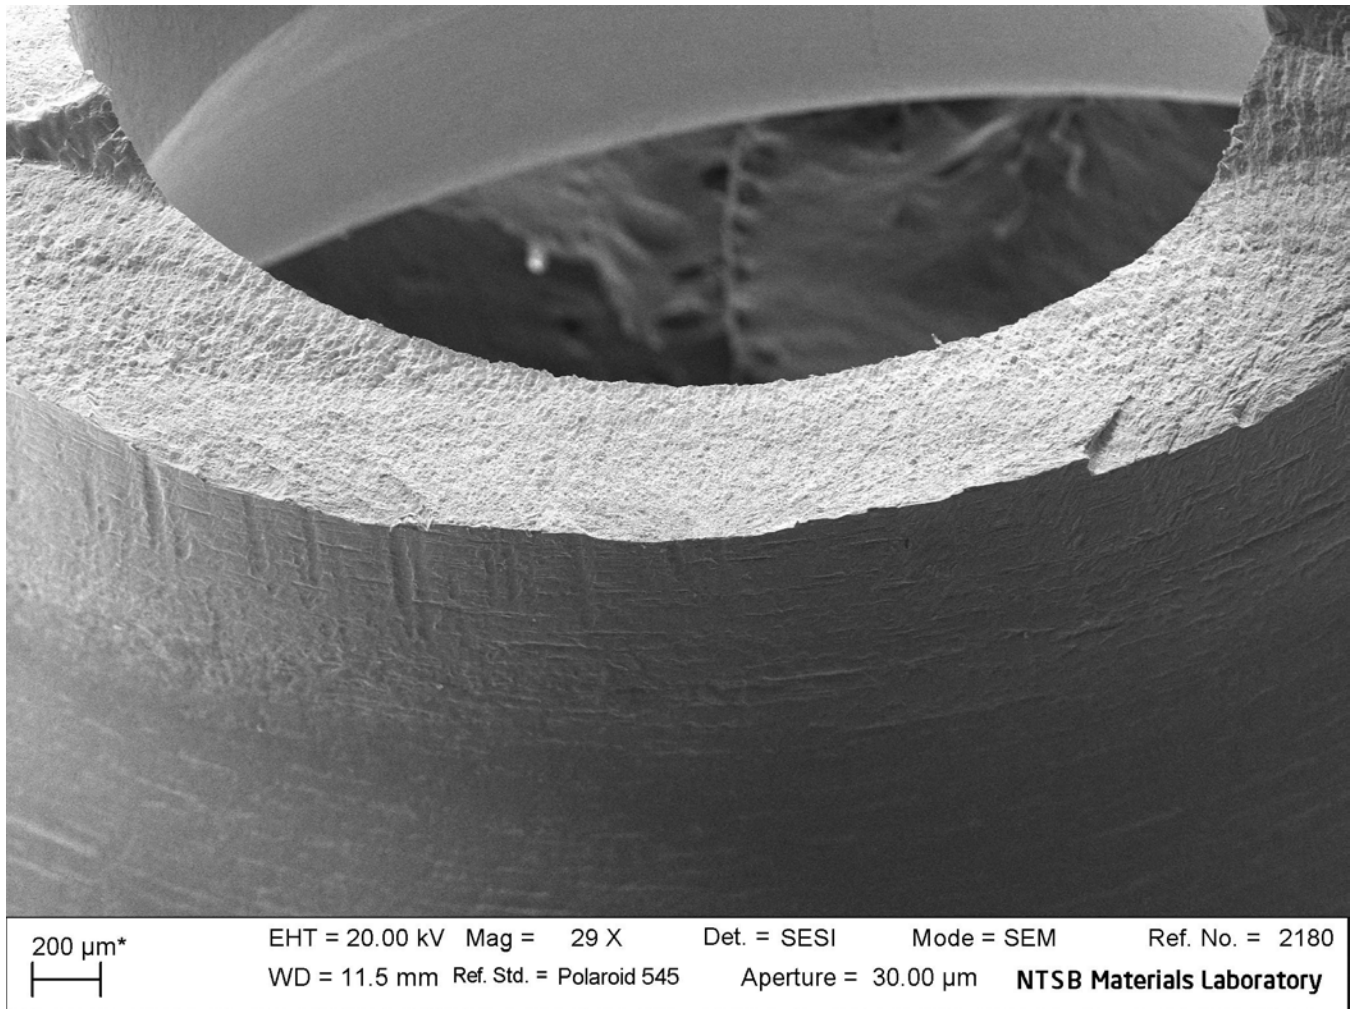
Figure 10 Close oblique scanning electron micrograph of the initiation region at the inner side of the tube bend.

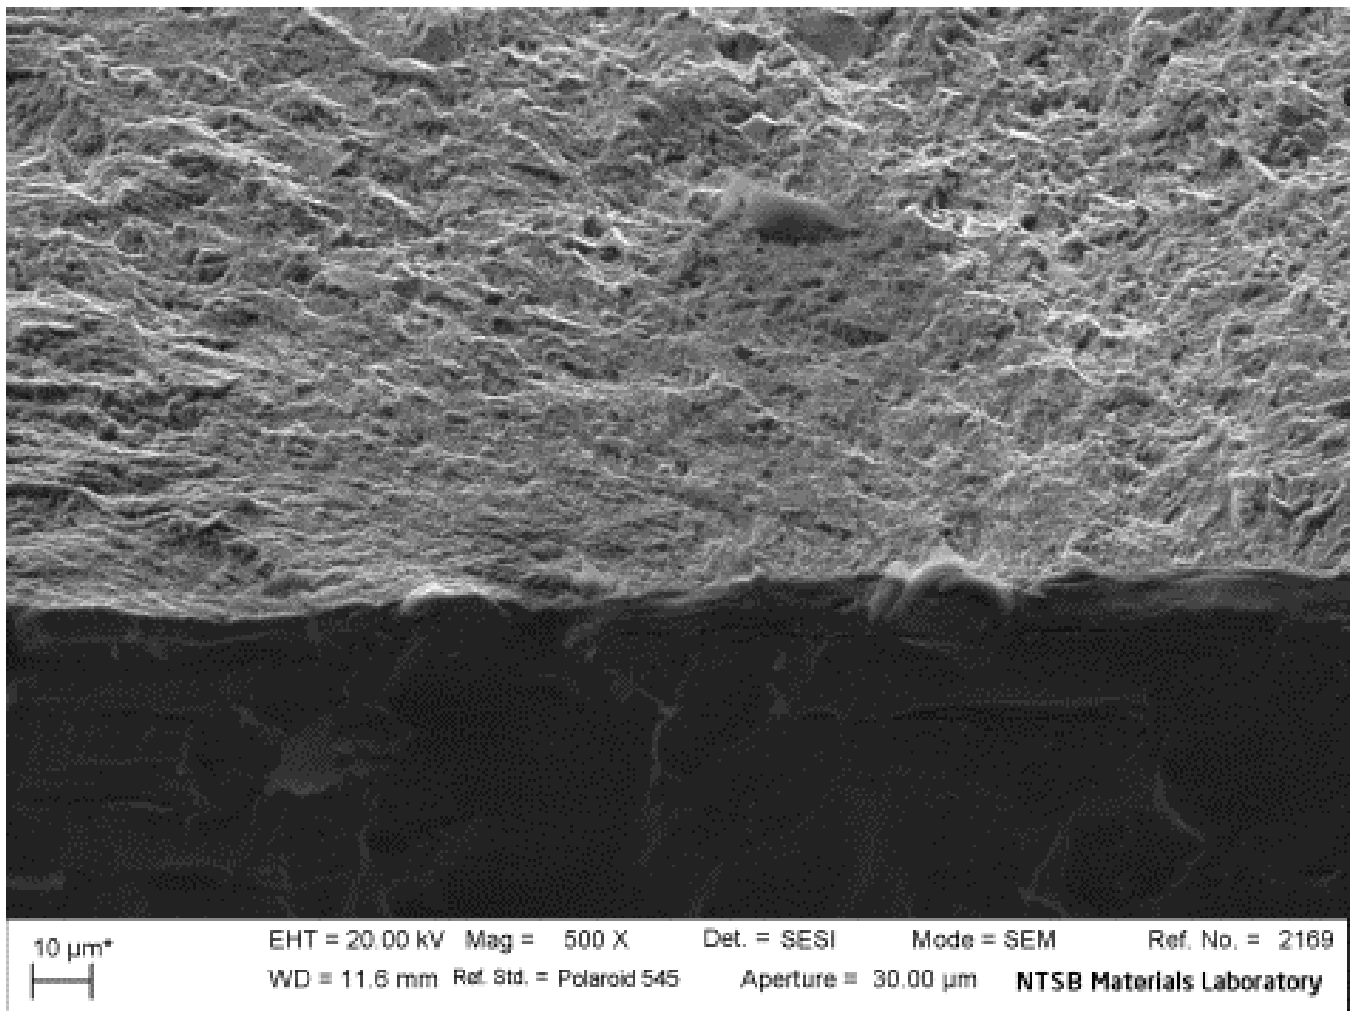
Figure 11 Closer oblique scanning electron micrograph of the initiation region at the inner side of the tube bend shown in Figure 10.

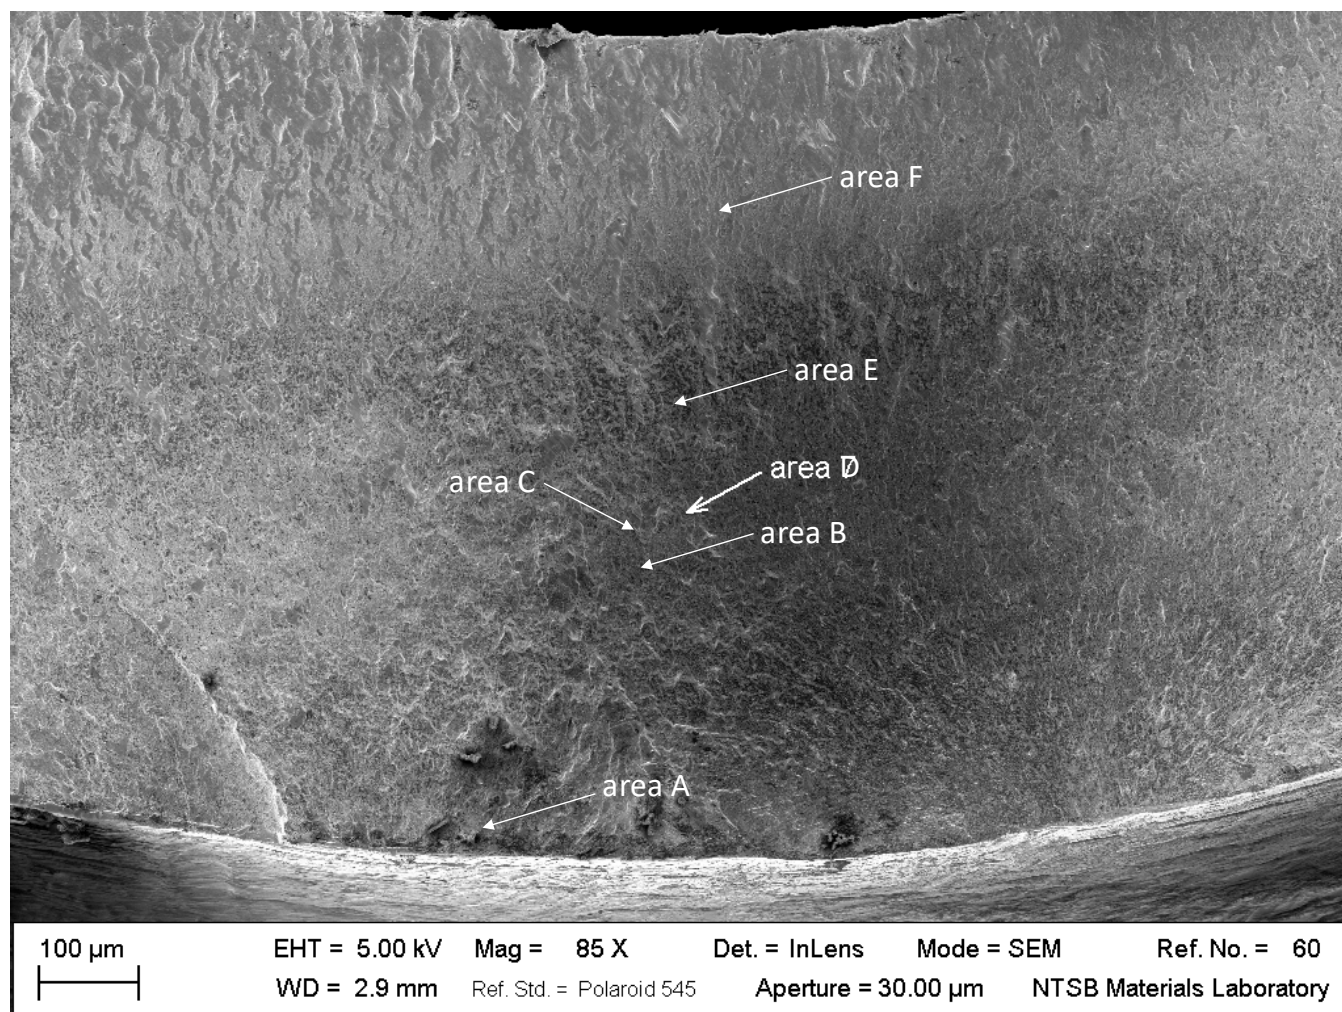
Six regions on the fracture surface, arbitrarily labelled A through F, were surveyed with the SEM as shown in Figure 12. Very fine striation features were observed in these six regions as documented in Figures 13 through 18. The variation in

Figure 12 Overall top down view scanning electron micrograph of the fracture surface on the flare portion near the center of the fatigue crack initiation region on the inner side of the tube bend. Higher magnification imaging was performed in the areas marked A through E shown in subsequent Figures 13 through 18.
