# NATIONAL TRANSPORTATION SAFETY BOARD

## MATERIALS LABORATORY FACTUAL REPORT

Report No. 16-023

Place : Hanalei, HI  
Date : January 17, 2016  
Vehicle : Airbus Helicopter EC130T2, N11VQ  
NTSB No. : WPR16FA055  
Investigator : Van McKenny, AS-WPR

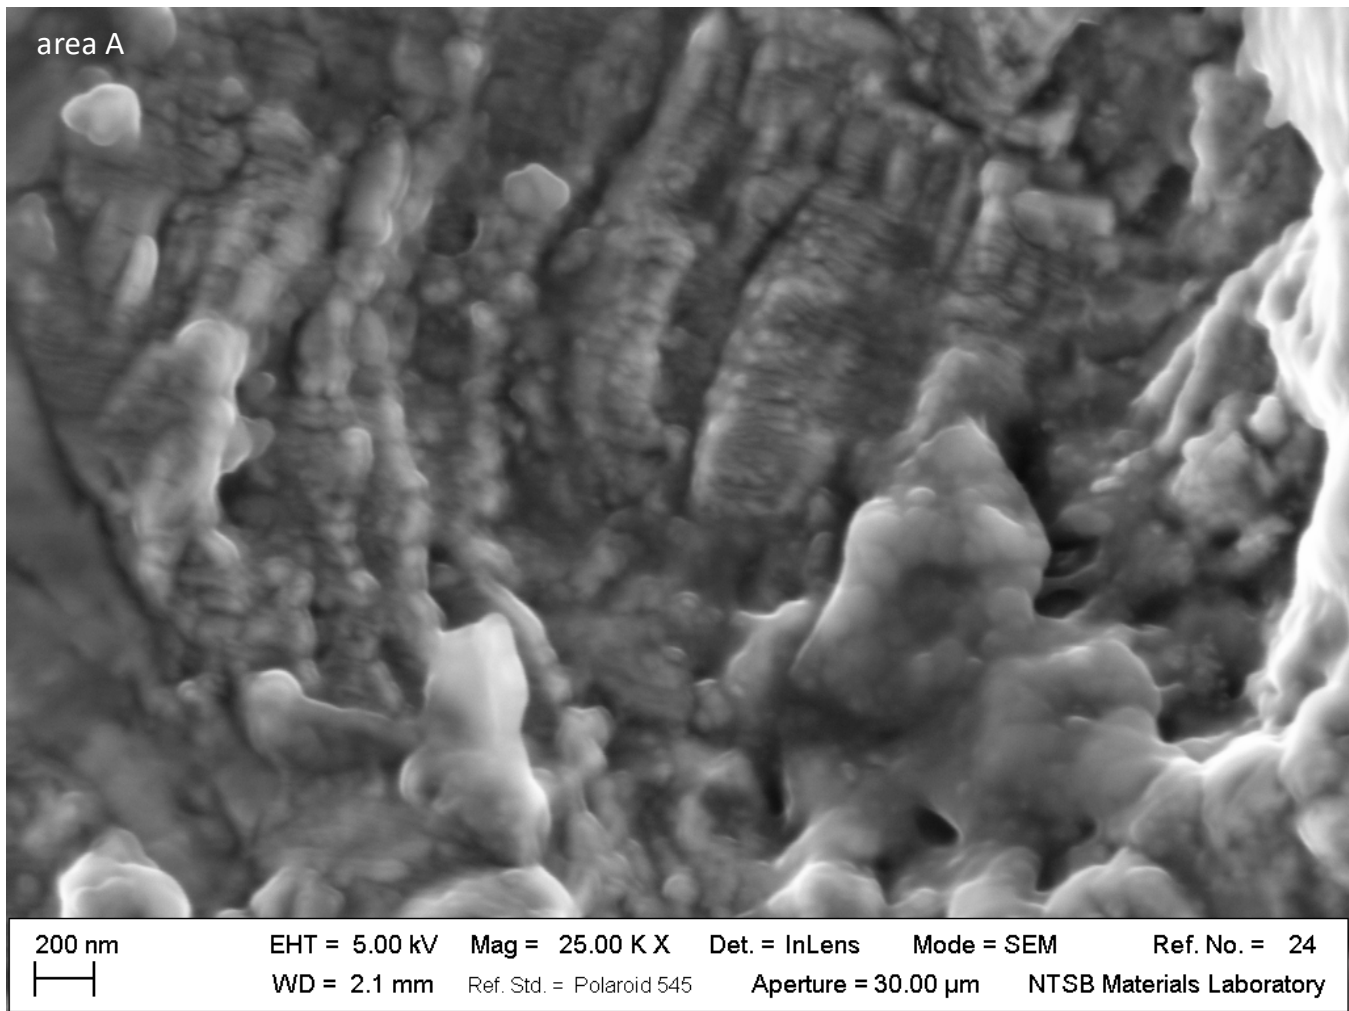
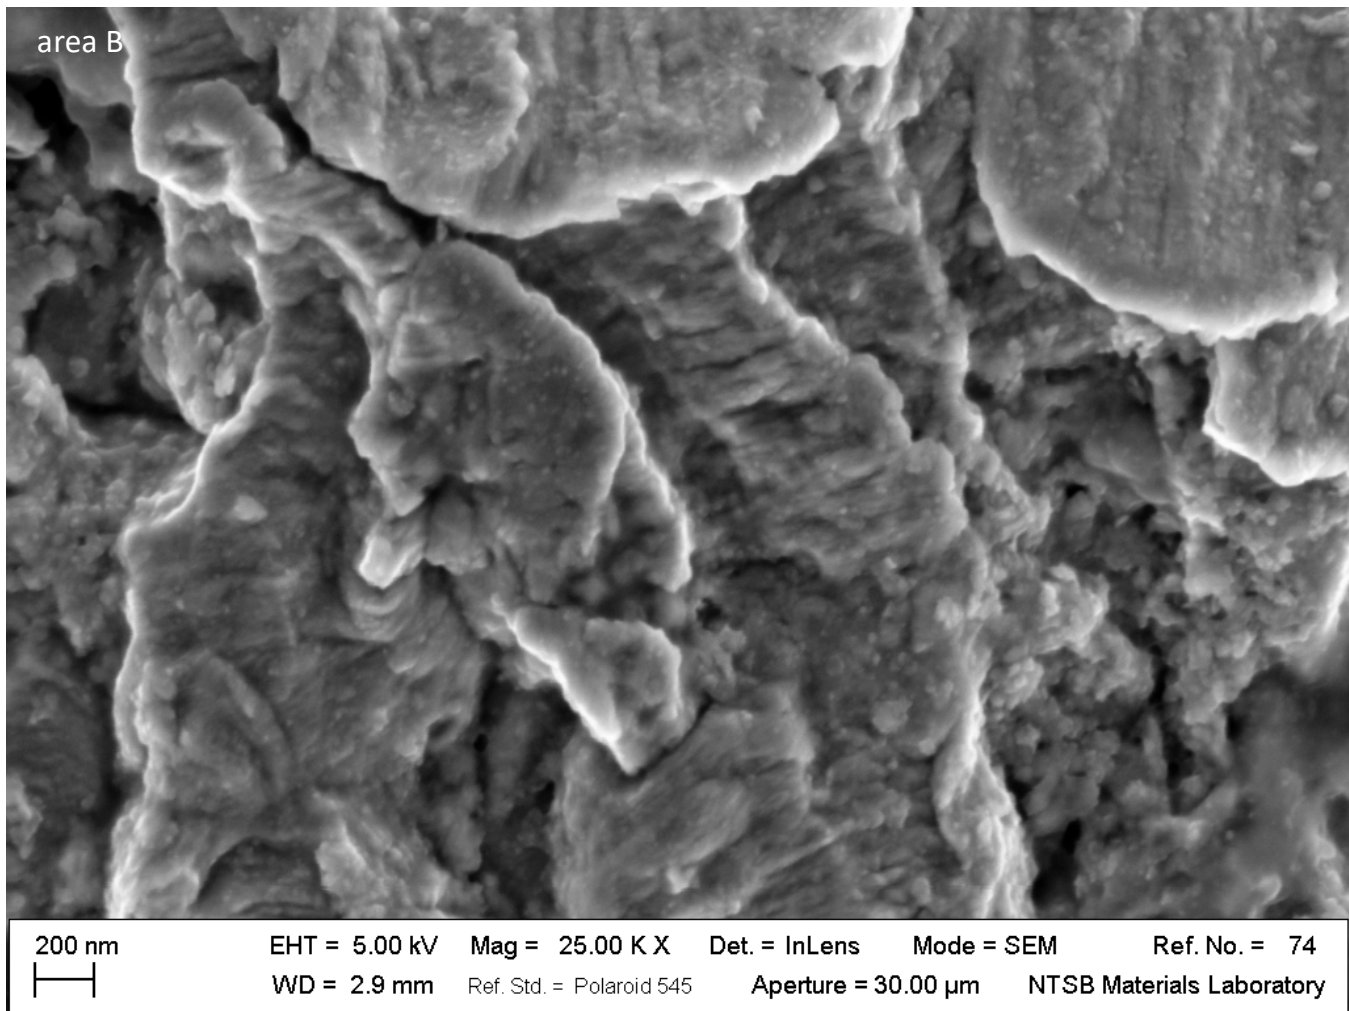
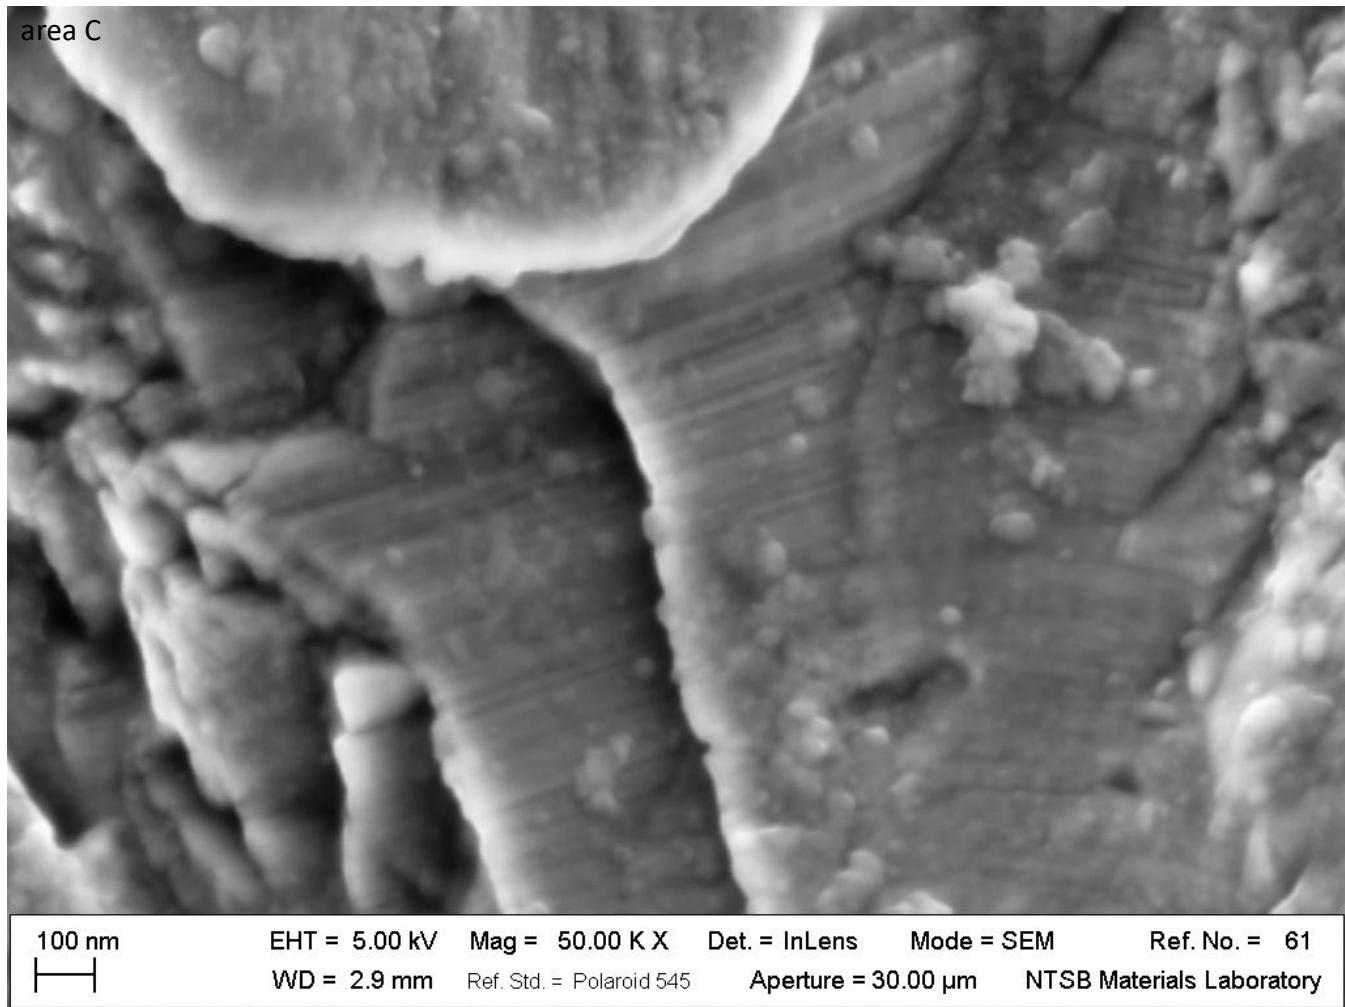
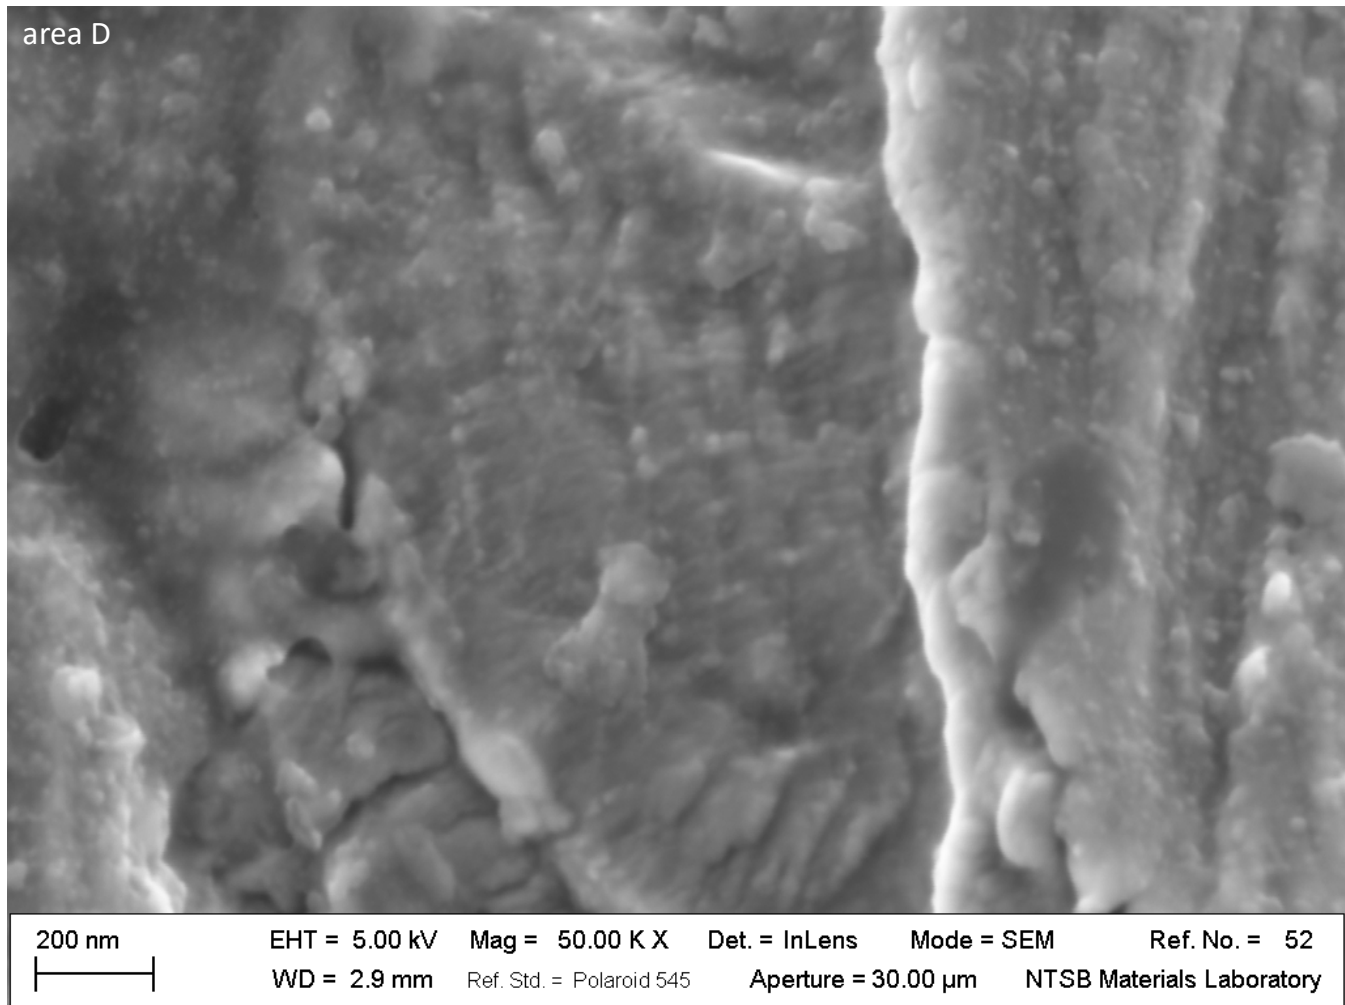
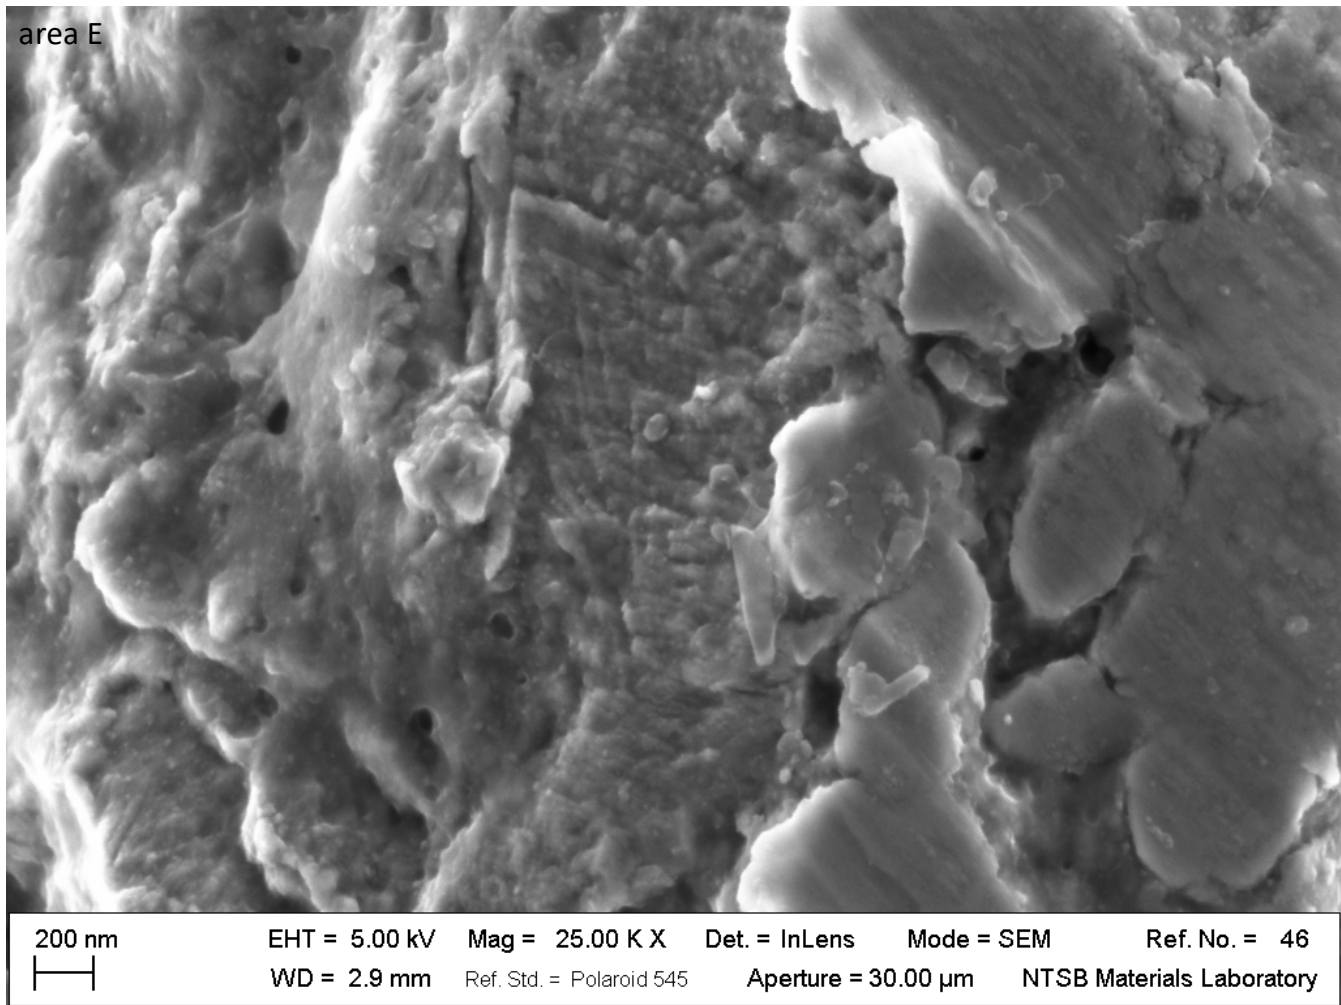
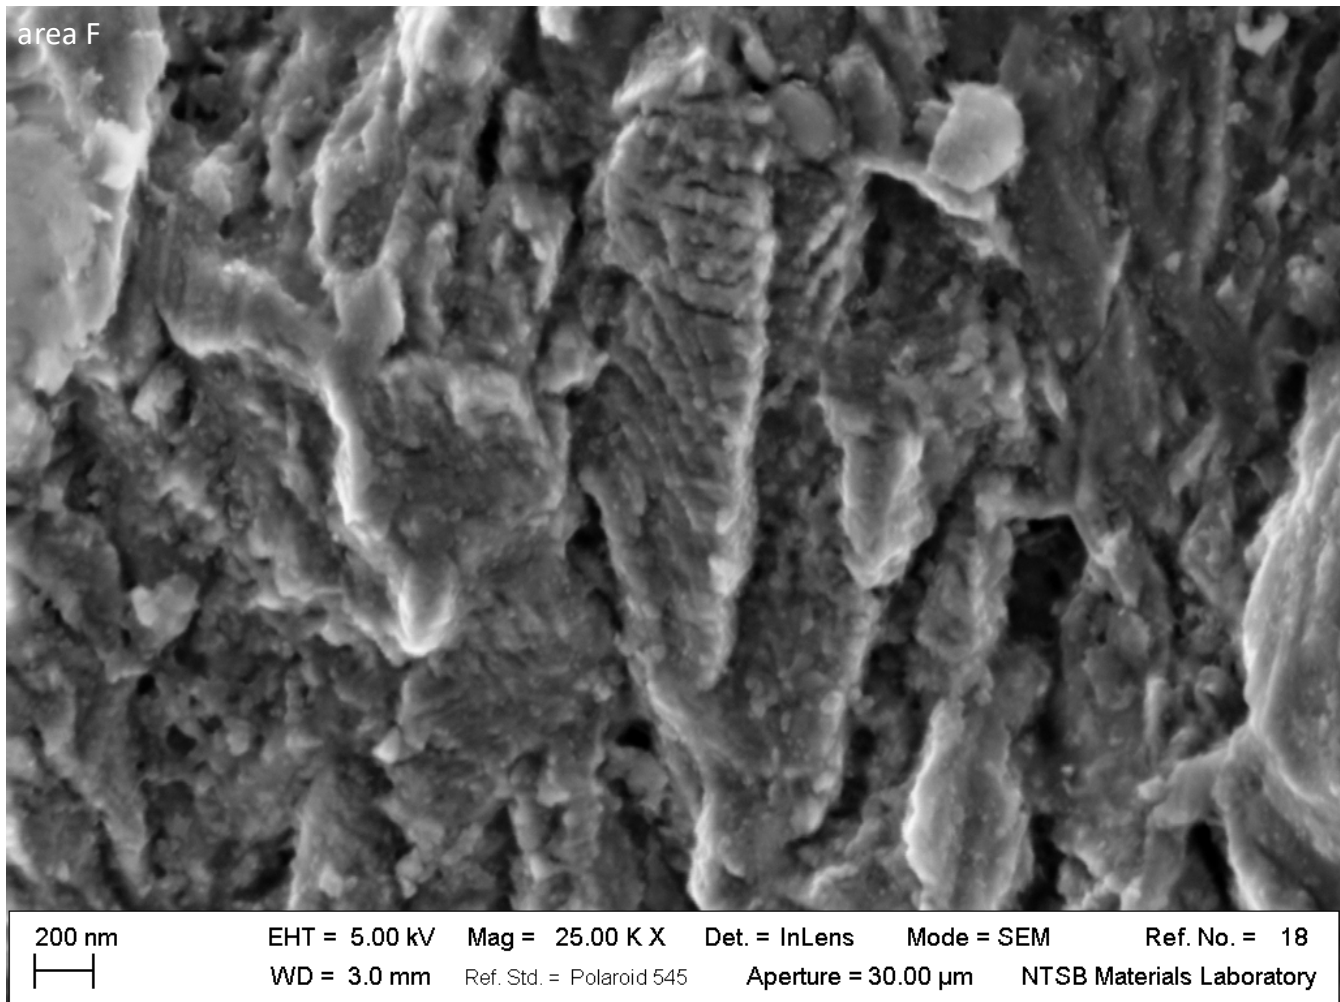
Six regions on the fracture surface, arbitrarily labelled A through F, were surveyed with the SEM as shown in Figure 12. Very fine striation features were observed in these six regions as documented in Figures 13 through 18. The variation in

the striation spacing is consistent with fatigue crack propagation under spectrum loading conditions.

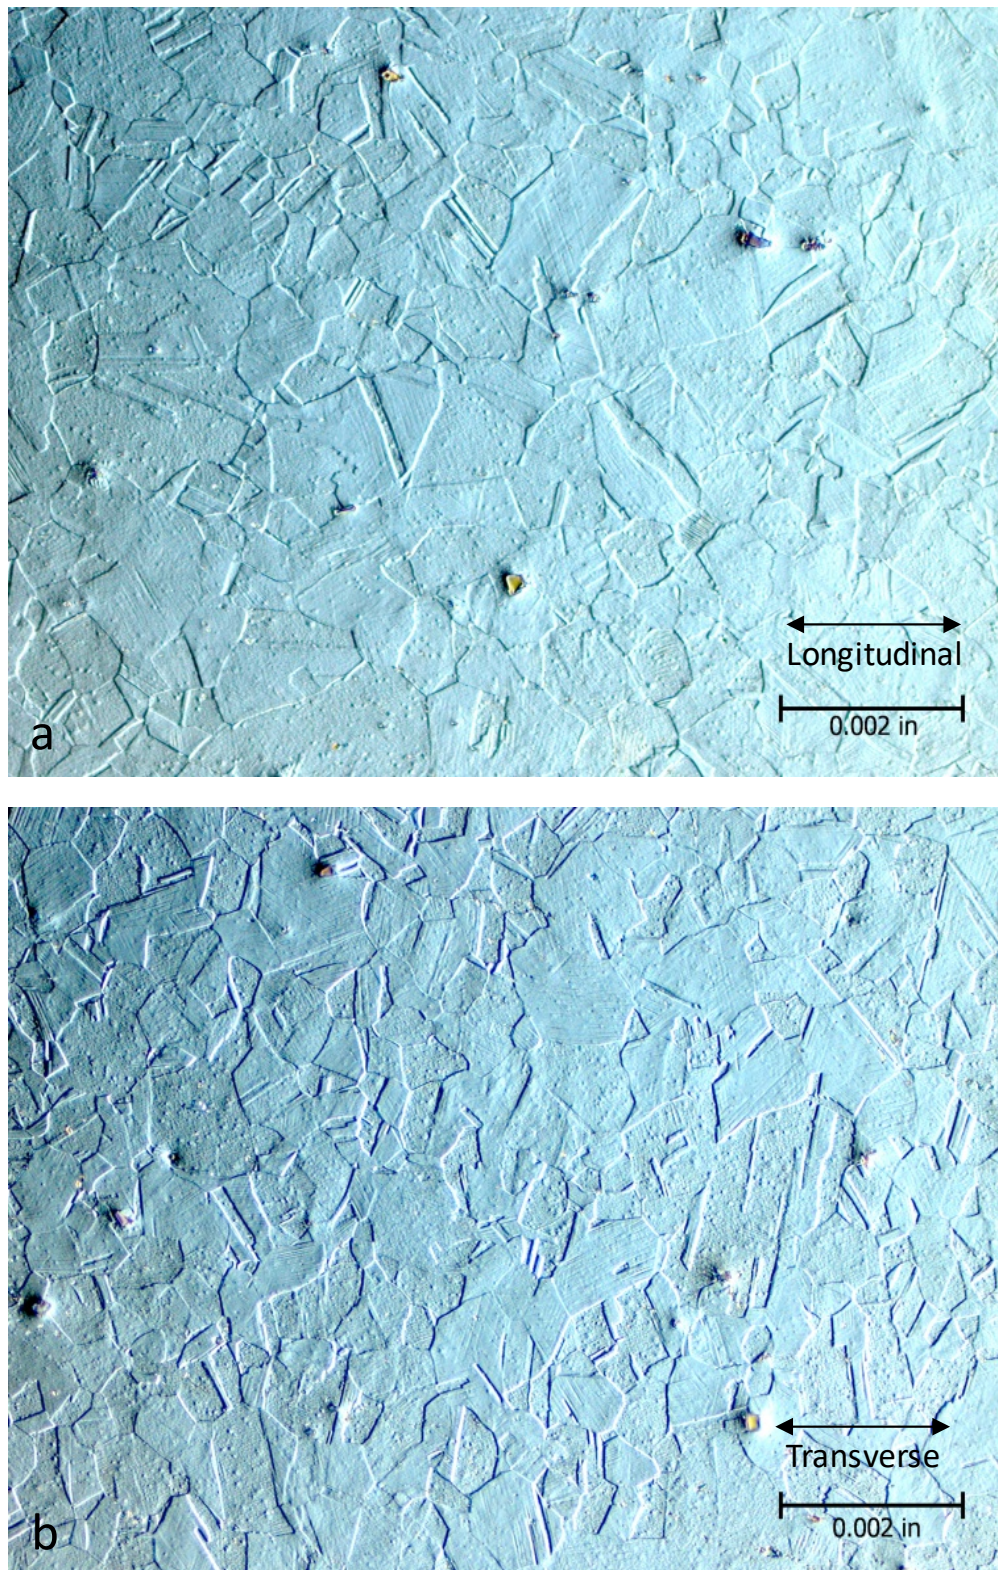
Longitudinal and transverse cross sections of the tube were taken adjacent to the fractured region for microstructural analysis. Samples were prepared in accordance with ASTM E3 and were microetched for microstructural evaluation in accordance with ASTM E407 etchant 221 (Ralph's etch). Optical micrographs are shown in Figures 19 through 21. The general microstructure is comprised of austenite grains exhibiting fine twinning. In Figure 20a, the exterior surface exhibits a shallow cold worked layer. The inside surface exhibits occasional fine laps or seams. Infrequent oriented colonies of oxide and nitride particles were observed as noted in Figure 21. In accordance with ASTM E384 the average microhardness of the tube was determined to be 539 HV500.

Figure 19 Optical micrograph of the microstructure of the tube in the longitudinal (view a), and the transverse (view b) direction (500X, Ralph's etch, differential interference contrast).

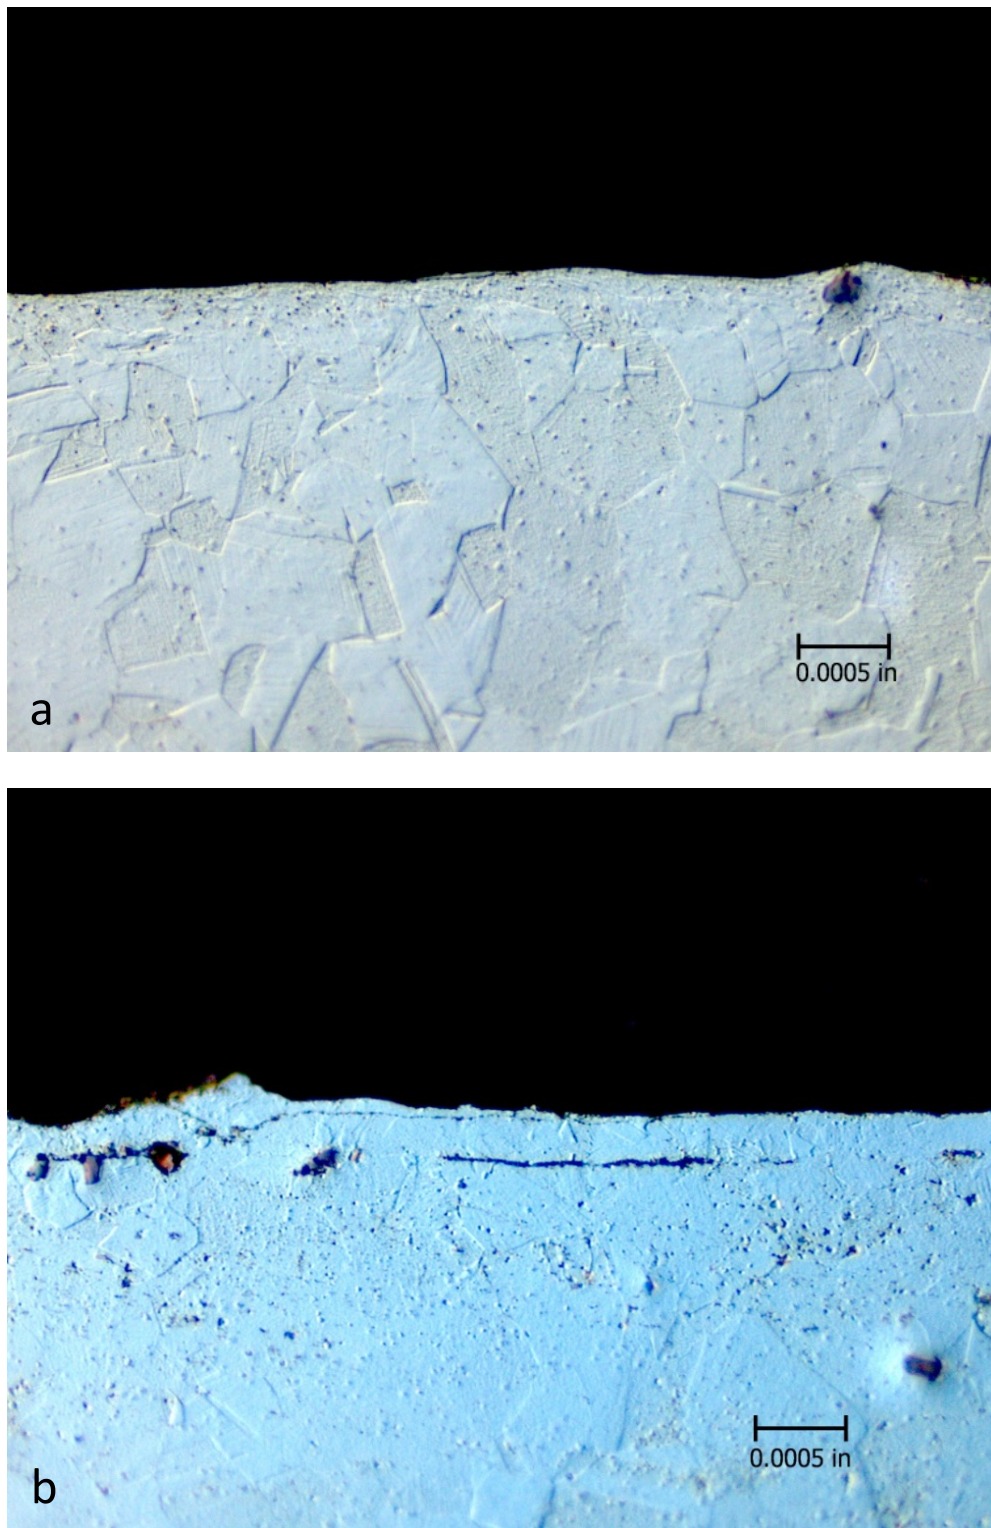
Figure 20 Optical micrographs of cross section of the tube surface microstructure. View a shows the structure below the outside diameter surface. View b shows the structure below the inside diameter surface (1000X original magnification , Ralph's etch, differential interference contrast).

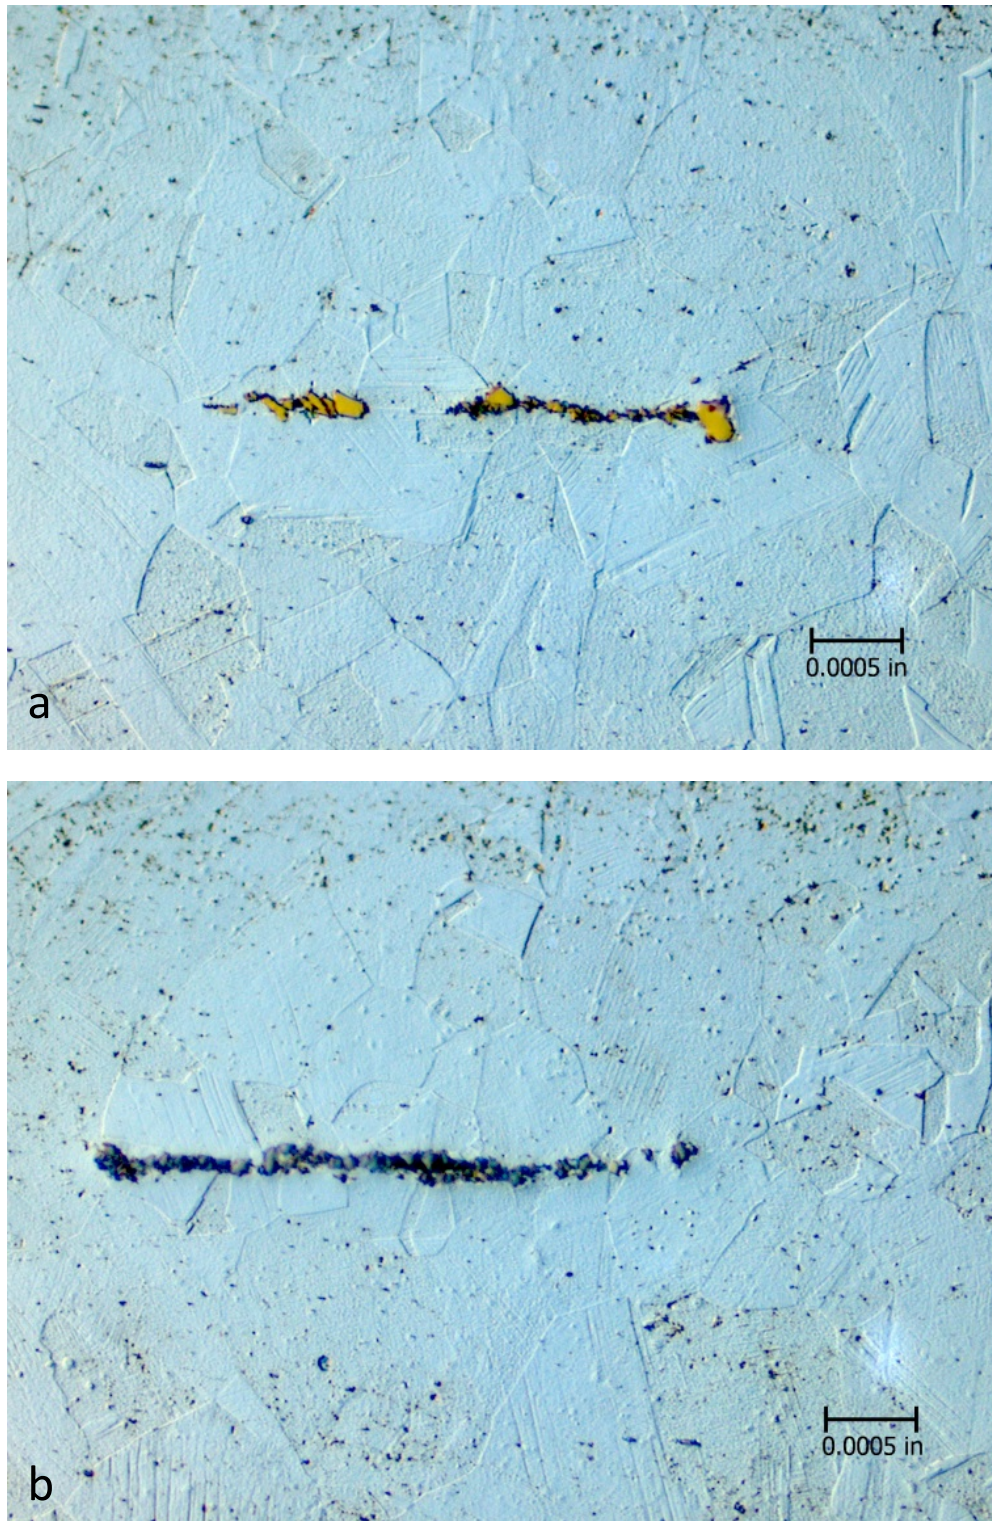
Figure 21 Optical micrographs of a transverse cross section of the tube showing infrequent, but typical colonies of nitride (view a) and oxide (view b) particles (1000X original magnification, Ralph's etch, differential interference contrast).

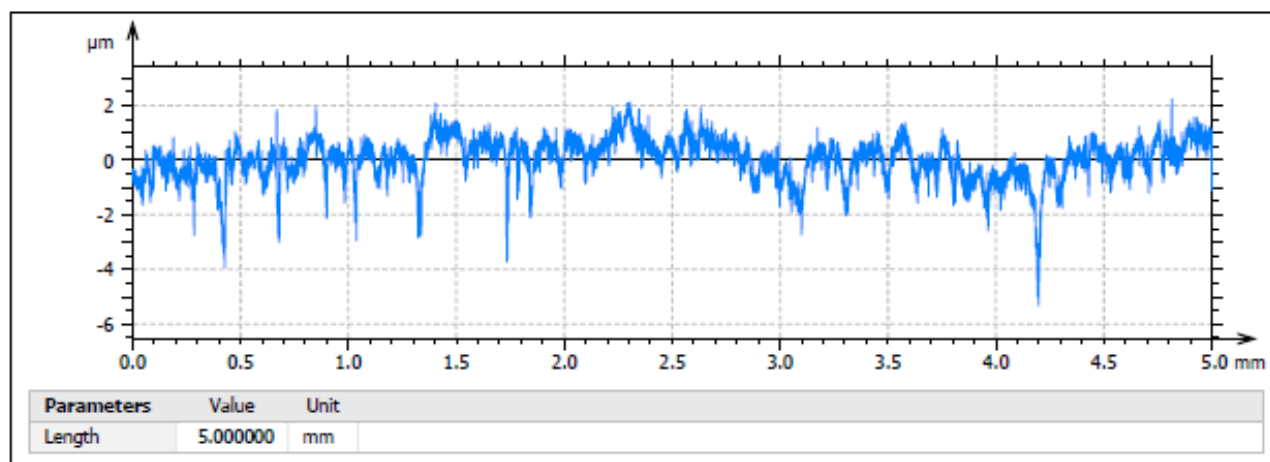
Near the fractured end of the fuel line, the surface roughness in the longitudinal direction on the outside of the tube was measured with a Nanovea ST400 non-contact profilometer using a CL1 chromatic lens. The surface metrology results are documented in Figure 22 and include an example trace of the surface profile.

Figure 22 Results of surface profile measurements on the outside surface of the tube (measurements taken in the longitudinal direction).

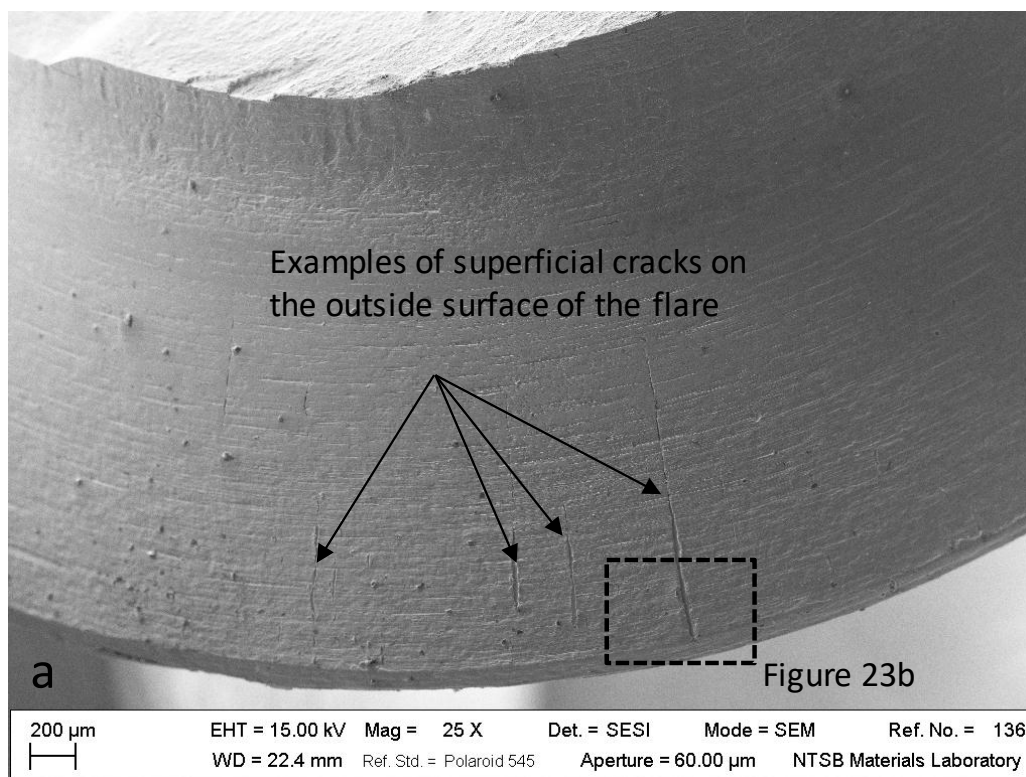
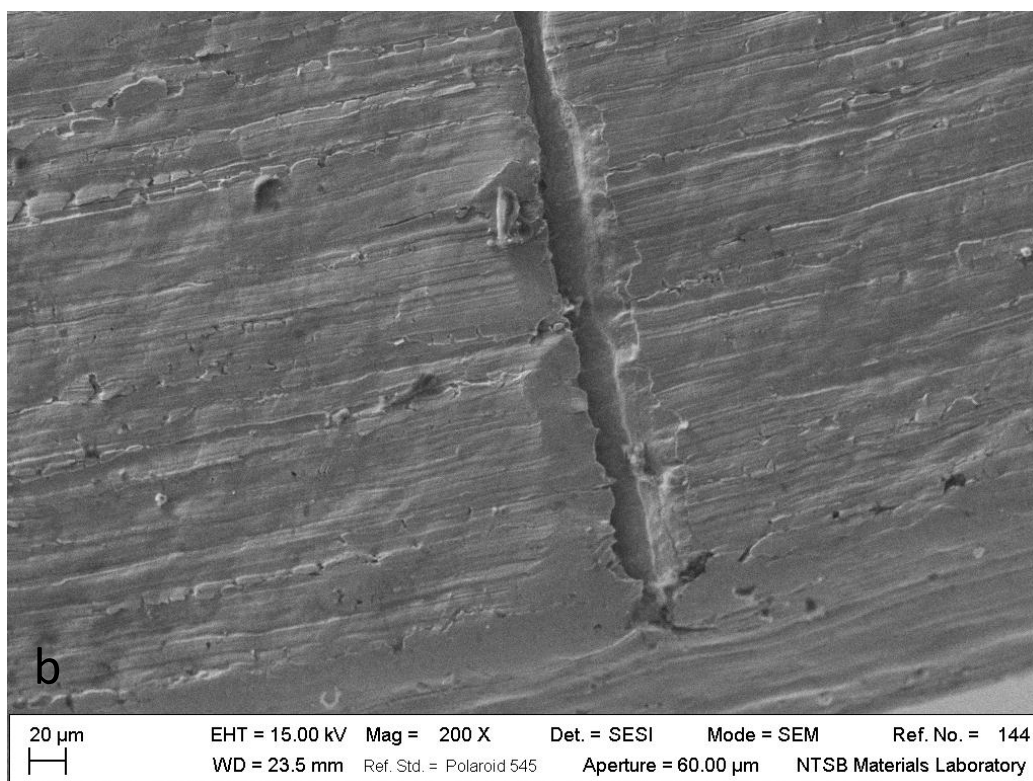
The internal and external surfaces of the flare were examined by SEM as shown in Figures 23 through 25. Longitudinal cracks propagating partially through the wall thickness of the flare were observed as identified in the figures. The presence and morphology of the cracks are consistent with their formation due to the tangential stretching (i.e. hoop stretching) of the tubing during the flaring process.

Figure 23 Scanning electron micrographs of the outside surfaces of the flared portion of the tube. View b shows a closer image of an example crack.

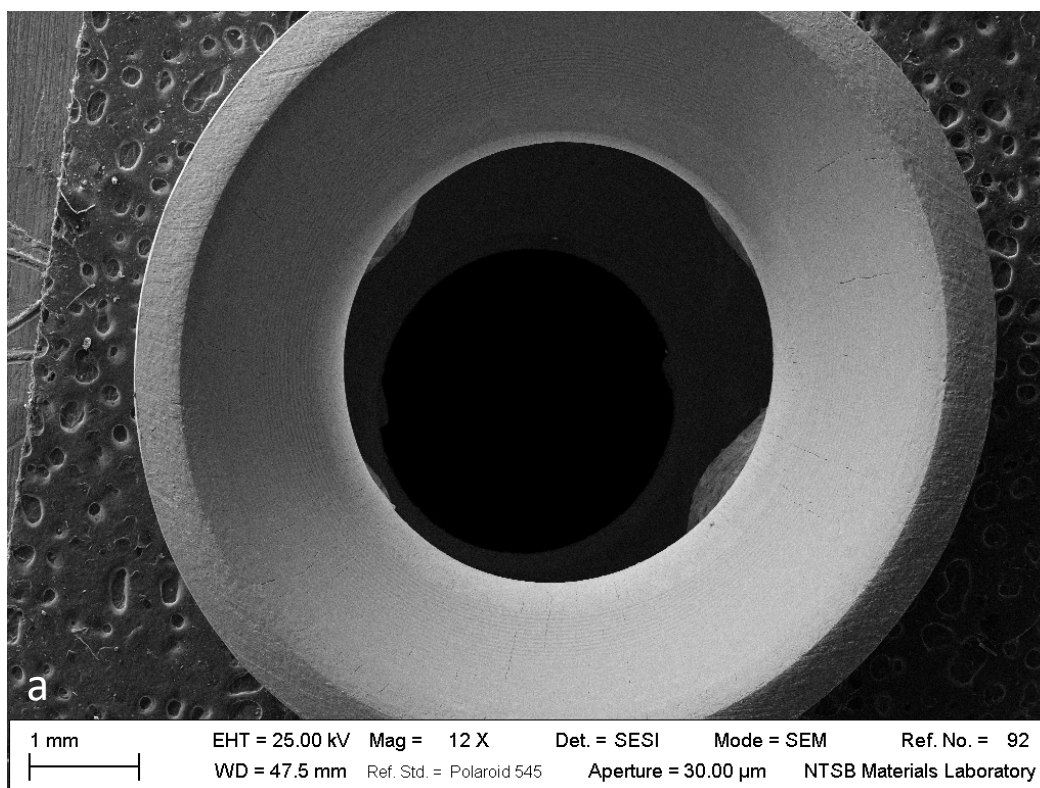
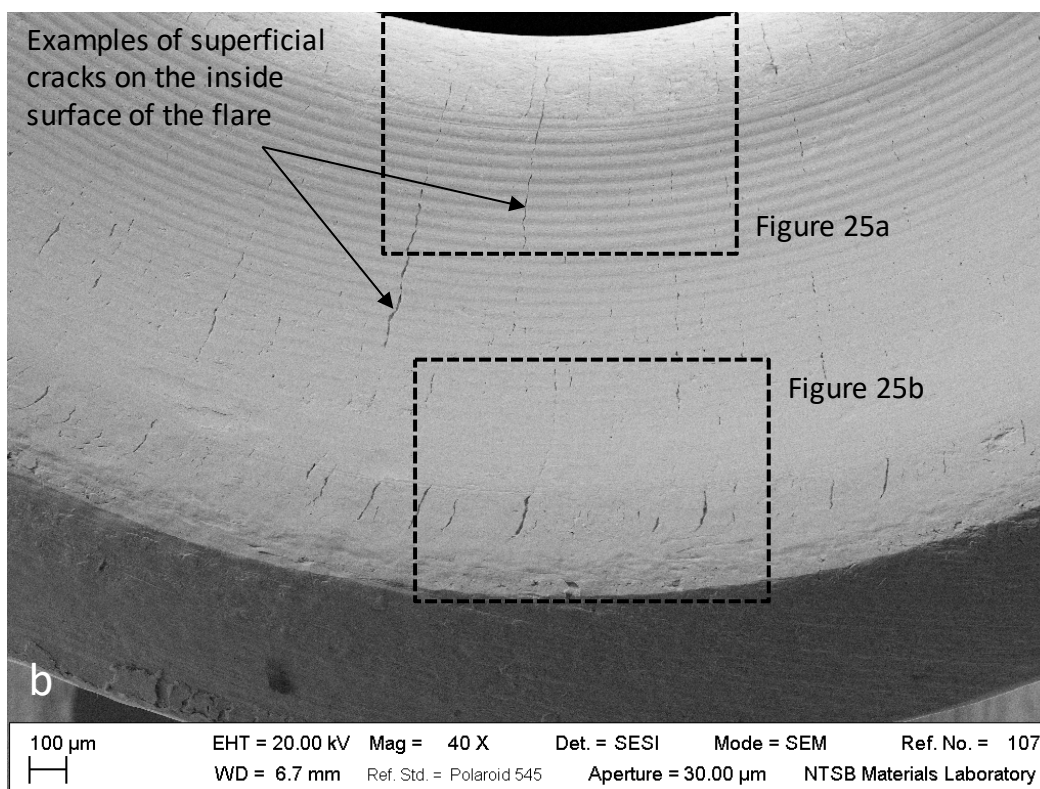
Figure 24 Scanning electron micrographs of the inside surfaces of the flared portion of the tube.

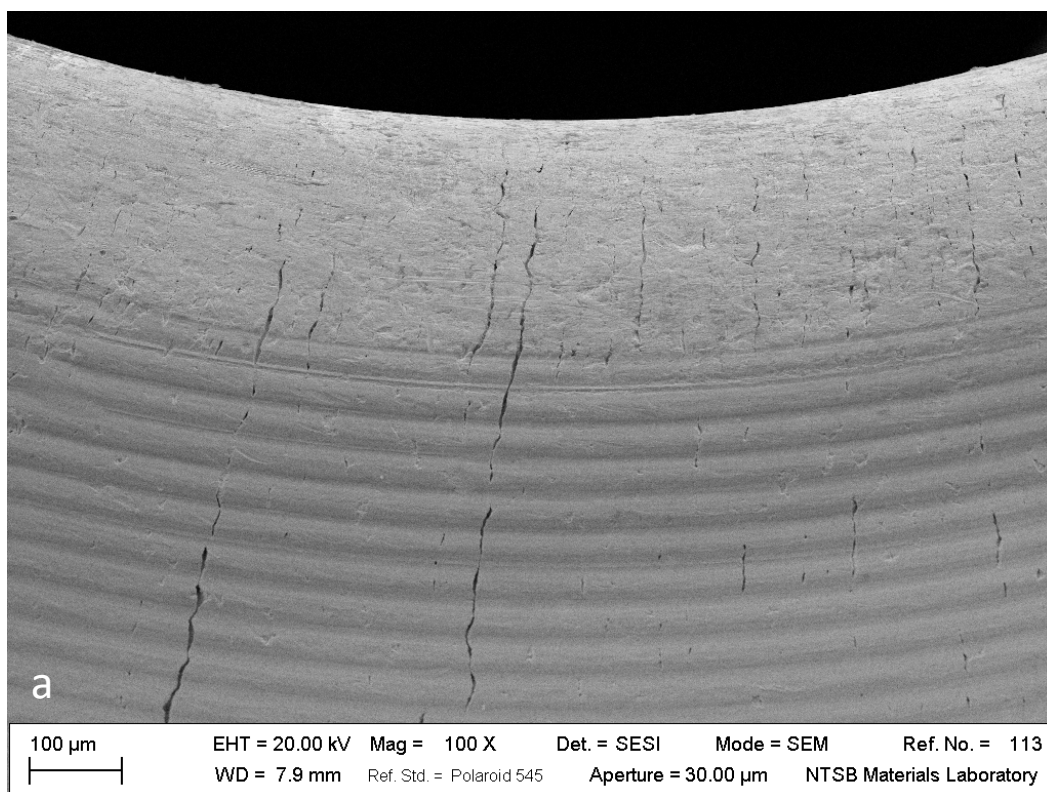
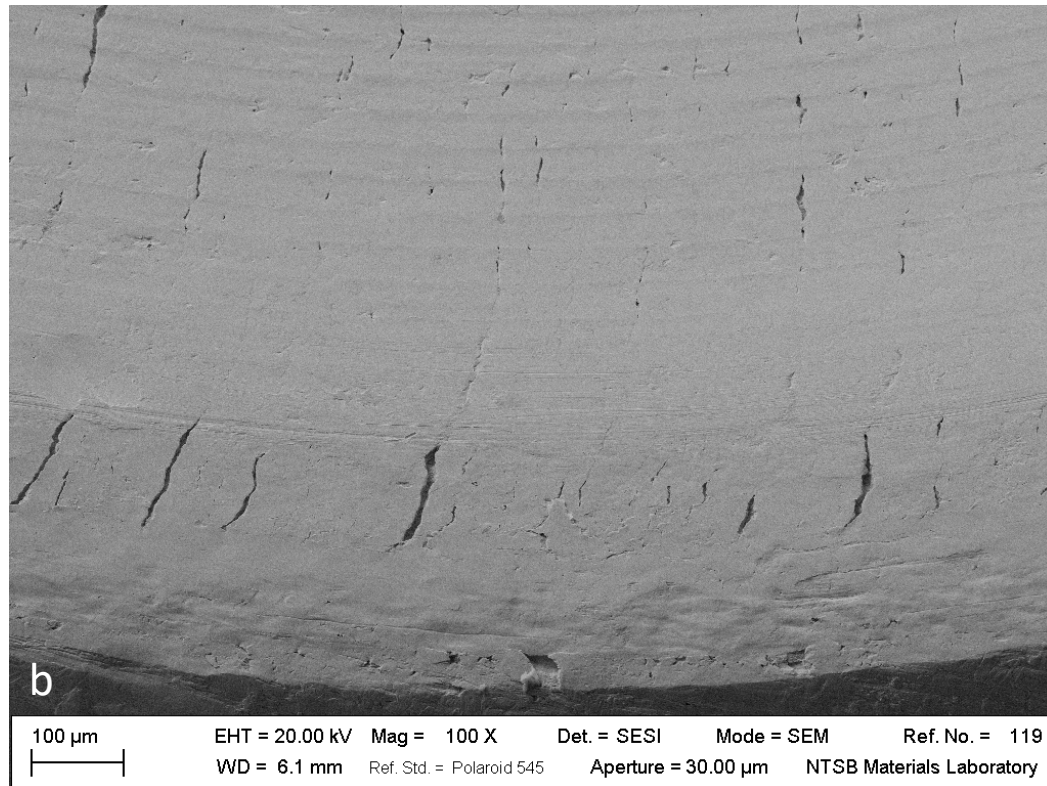
Figure 25 Closer scanning electron micrographs of the inside surfaces of the flared portion of the tube showing examples of cracks.
