# **NATIONAL TRANSPORTATION SAFETY BOARD**

## **SITE and ON-SCENE INFORMATION**

**NTSB Accident: WPR16FA086  
Accident Date: March 21, 2016**

Location: Hawthorne, California  
Date: March 21, 2016  
Aircraft: Airborne XT912, N670EM, Serial # XT912-0214  
NTSB IIC: Michael Huhn

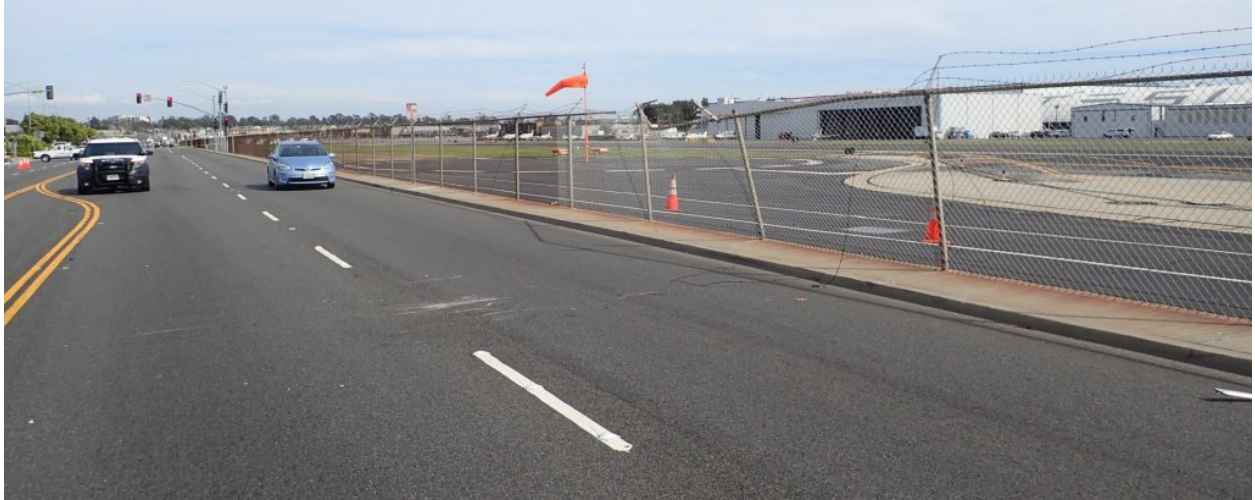
- Ground scars indicated that the aircraft struck and damaged the fence, and then first impacted the road about 15 feet north of the fence.
- The fence damage, road scar, and wreckage formed a line that was perpendicular to the runway

**Figure 4 - Fence Damage and Ground Scar (looking east)**

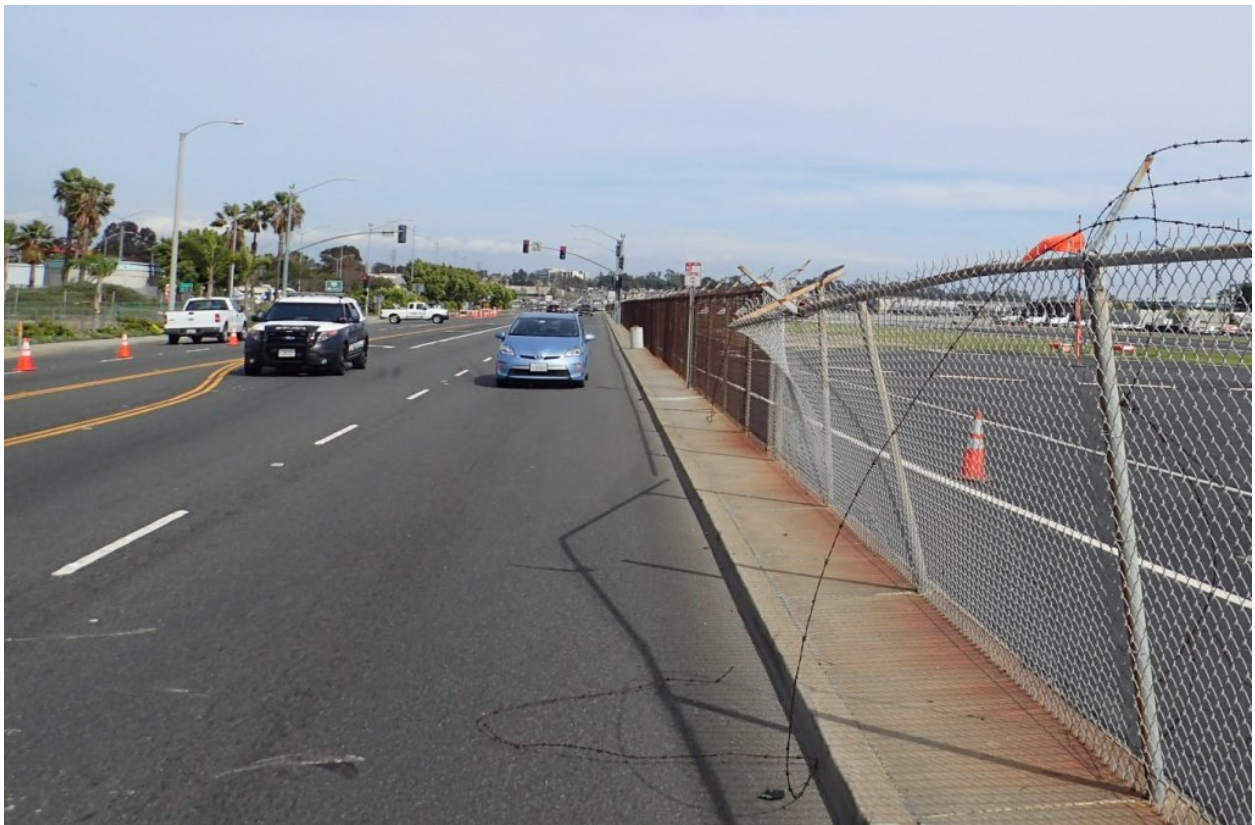
**Figure 5 - Fence Damage and Ground Scars (looking east)**

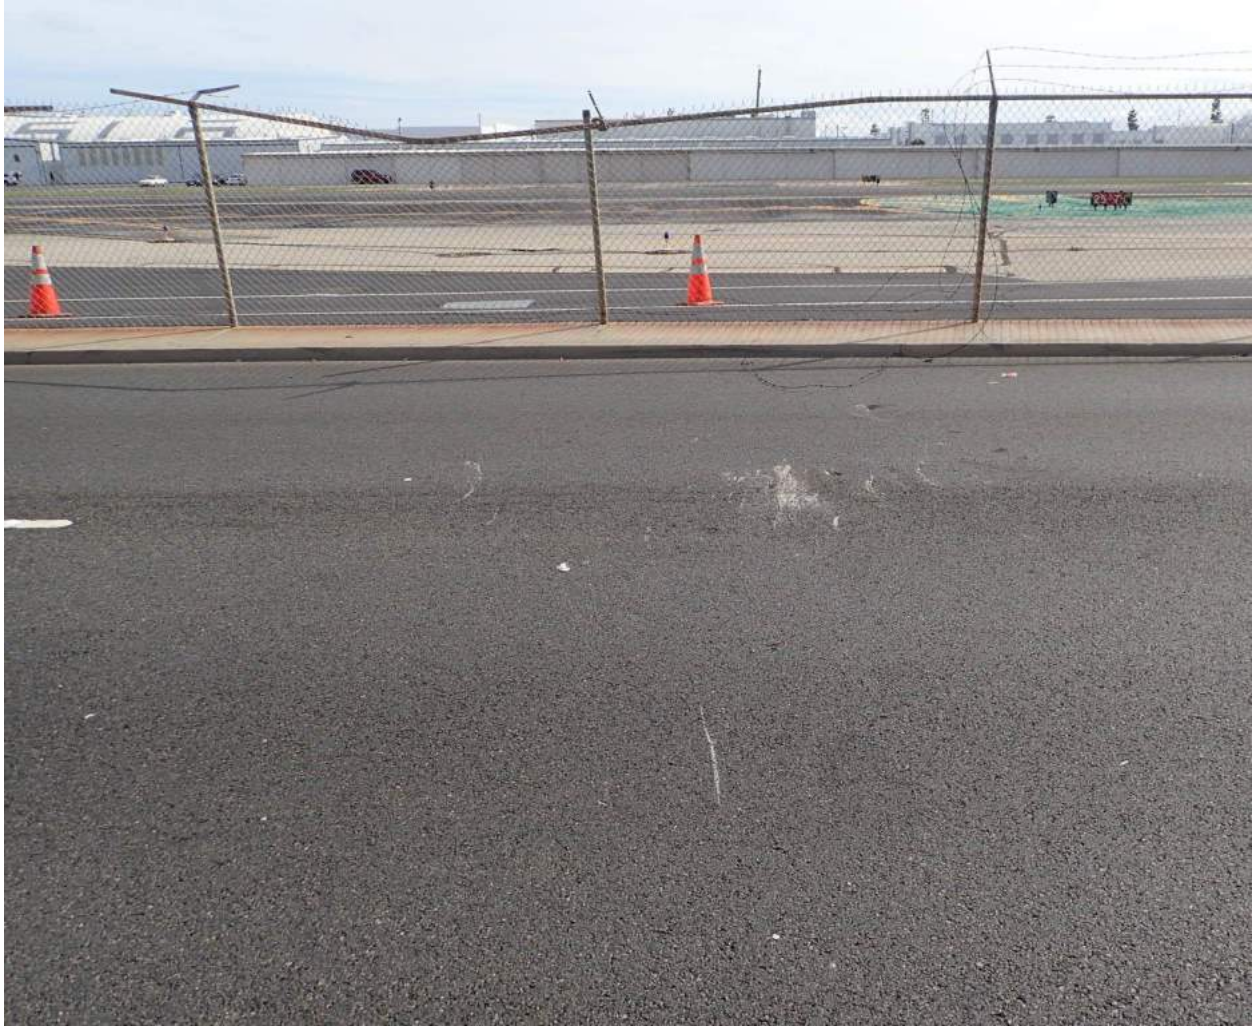
**Figure 6 - Fence Damage and Ground Scars (looking south)**

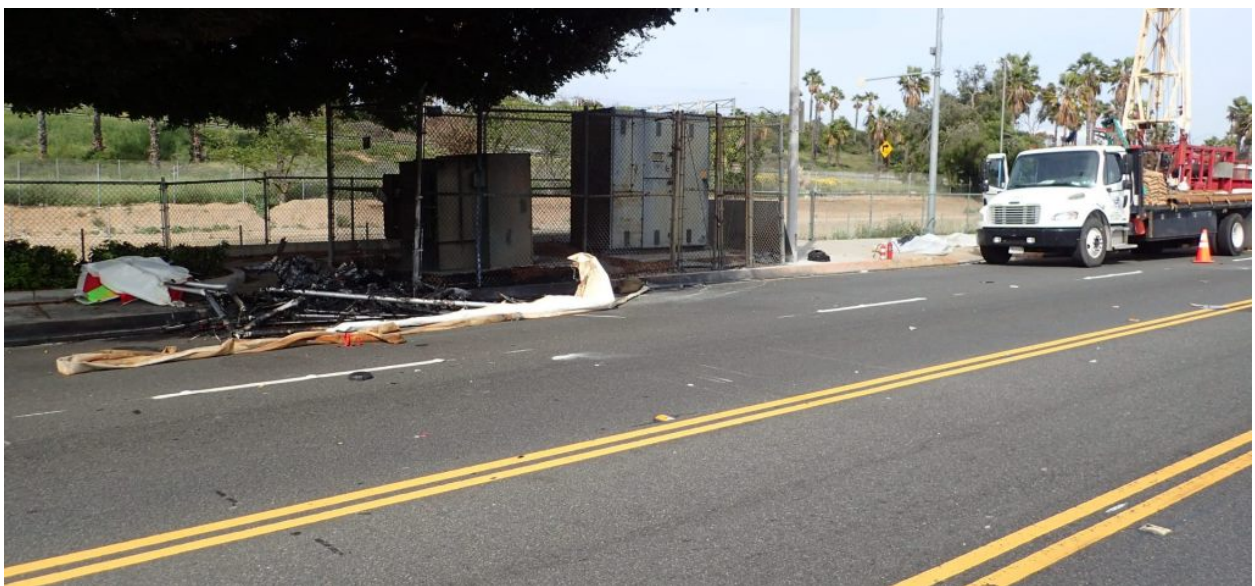
**Figure 7 - Main Wreckage (looking northeast)**

- The carriage came to rest on its right side, oriented with the nose pointed approximately southeast
- All the steel cables remained intact and securely attached to the structure at each of their respective ends

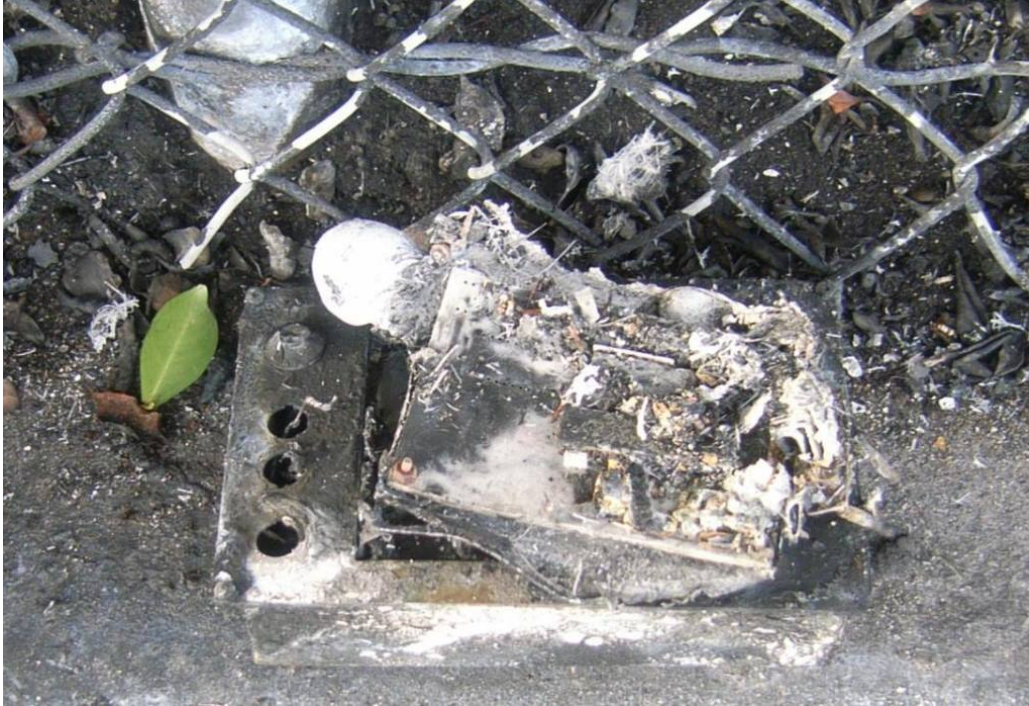
- The four instruments (airspeed indicator, radio, transponder, and EFIS (electronic flight instrumentation system)) were identified in the wreckage, but all were severely fire-damaged

- The owner reported that there were no memory cards or other memory on the EFIS unit
- The airframe recovery parachute was found out of its container;

**Figure 14 - EFIS Unit**

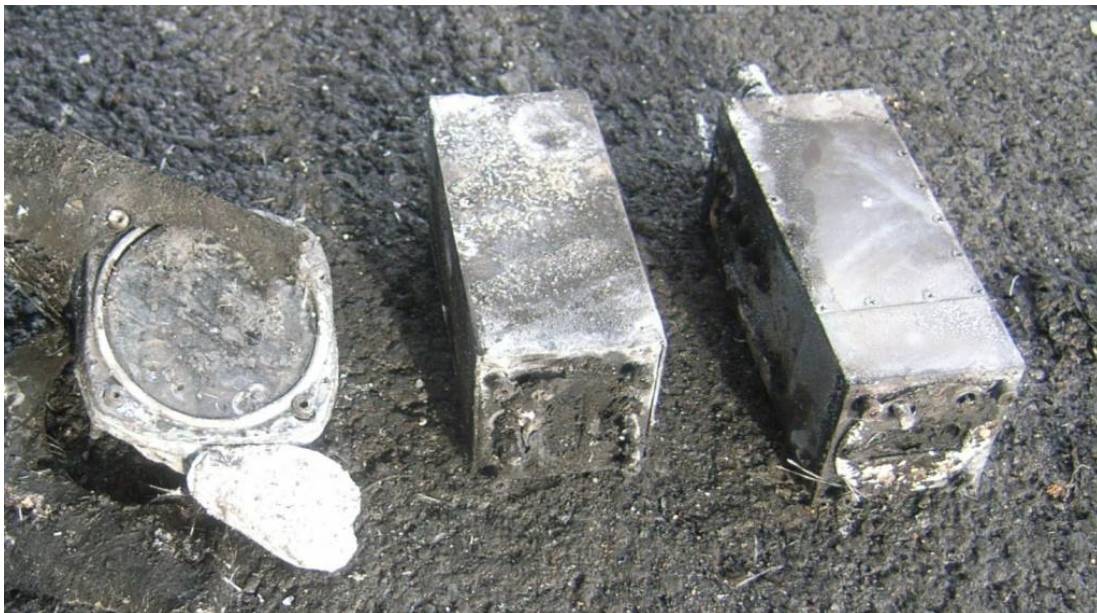
**Figure 15 - Other Aircraft Instruments**

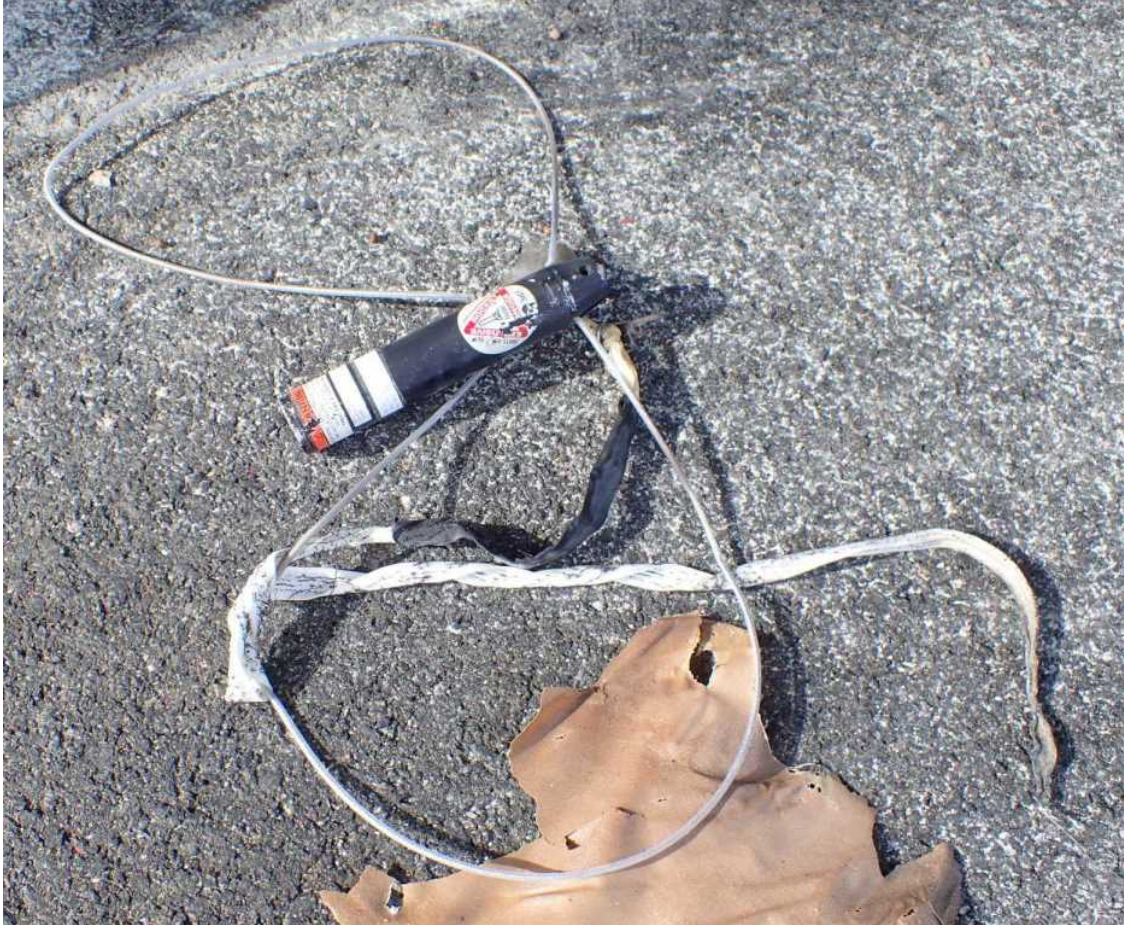
- It remained reefed/folded but partially extended lengthwise
  - Much of it was fused or consumed by fire
- The parachute extraction rocket was also found out of its container, and its propellant load appeared to have been consumed in the ground fire

**Figure 16 - Airframe Parachute Extraction Rocket**

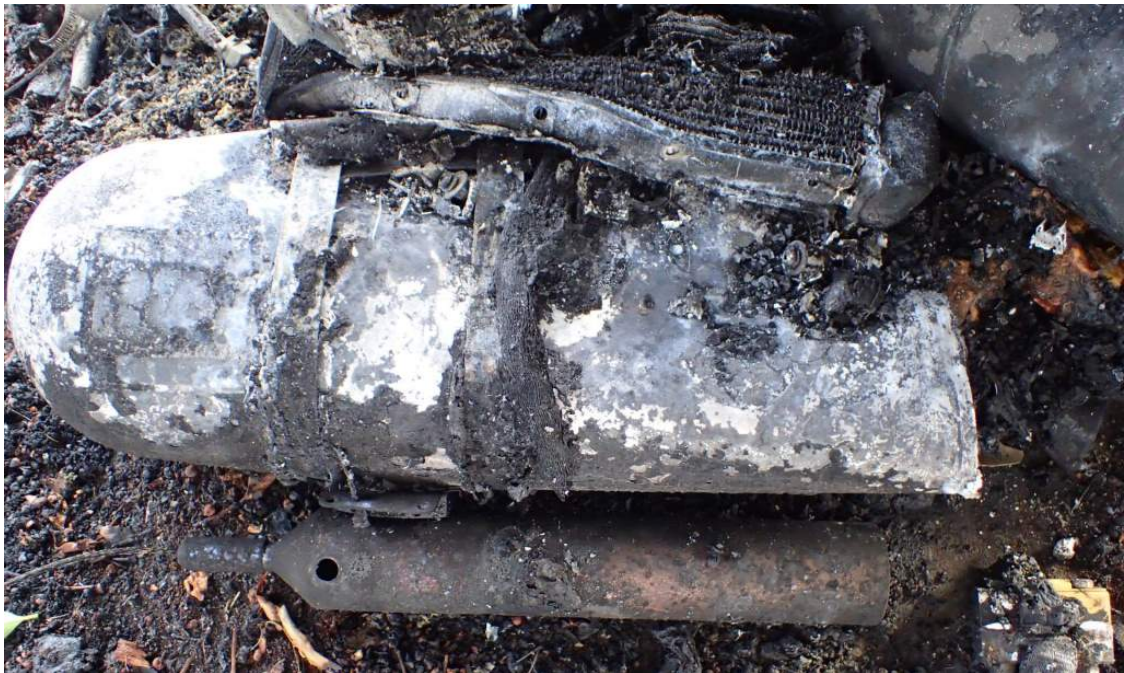
**Figure 17 - Parachute (top) and Rocket (bottom) Cases**

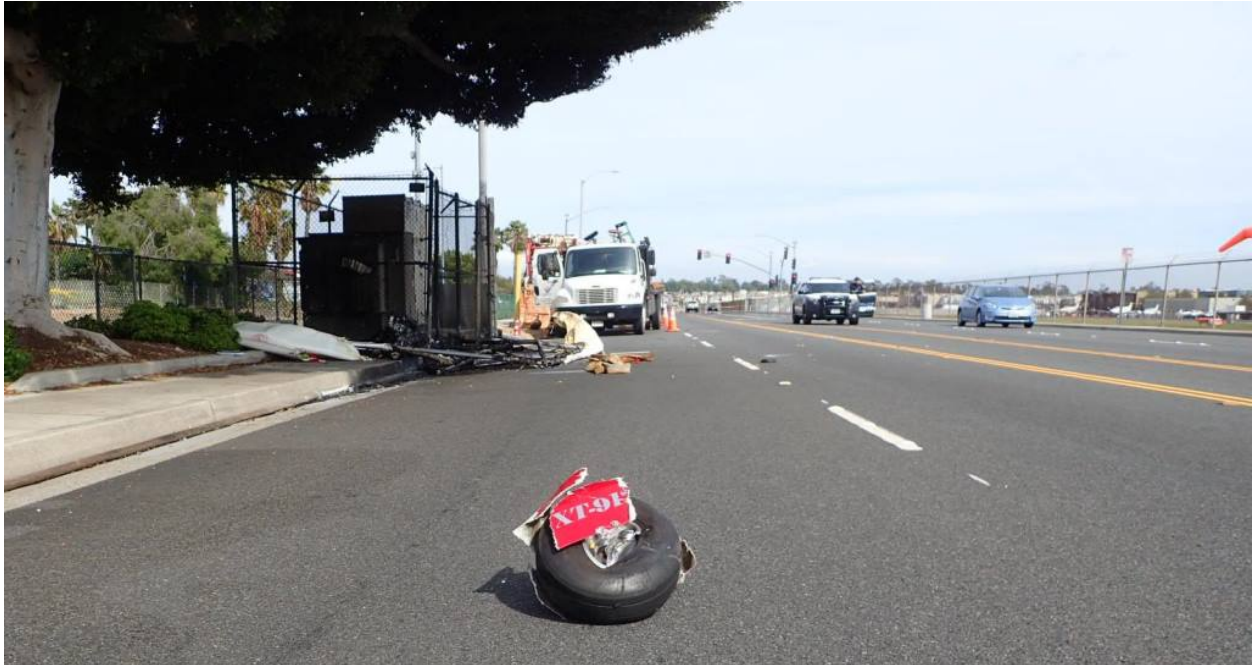
- The right wheel assembly was fracture-separated from the aircraft just above where its 3 support struts attached to the wheel assembly
- The wheel exhibited significant localized crush damage, which appeared consistent with contact with the top crossbar airport boundary steel fence

**Figure 18 - Right Main Wheel Assembly**

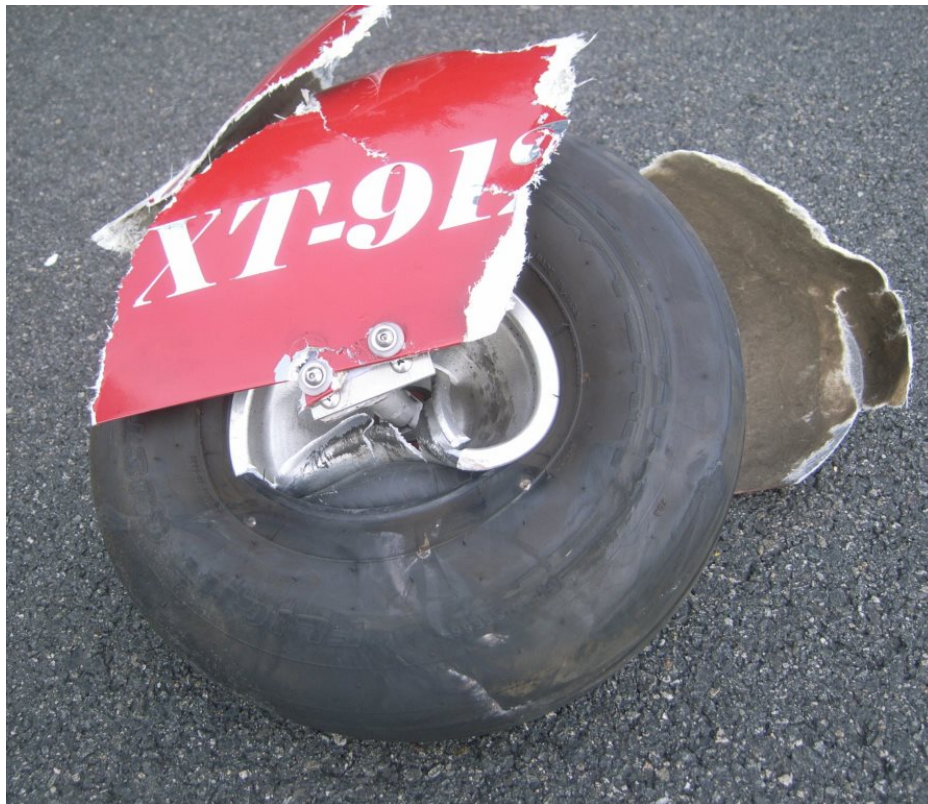
**Figure 19 - Outboard Side of Right Wheel Assembly (note damage)**

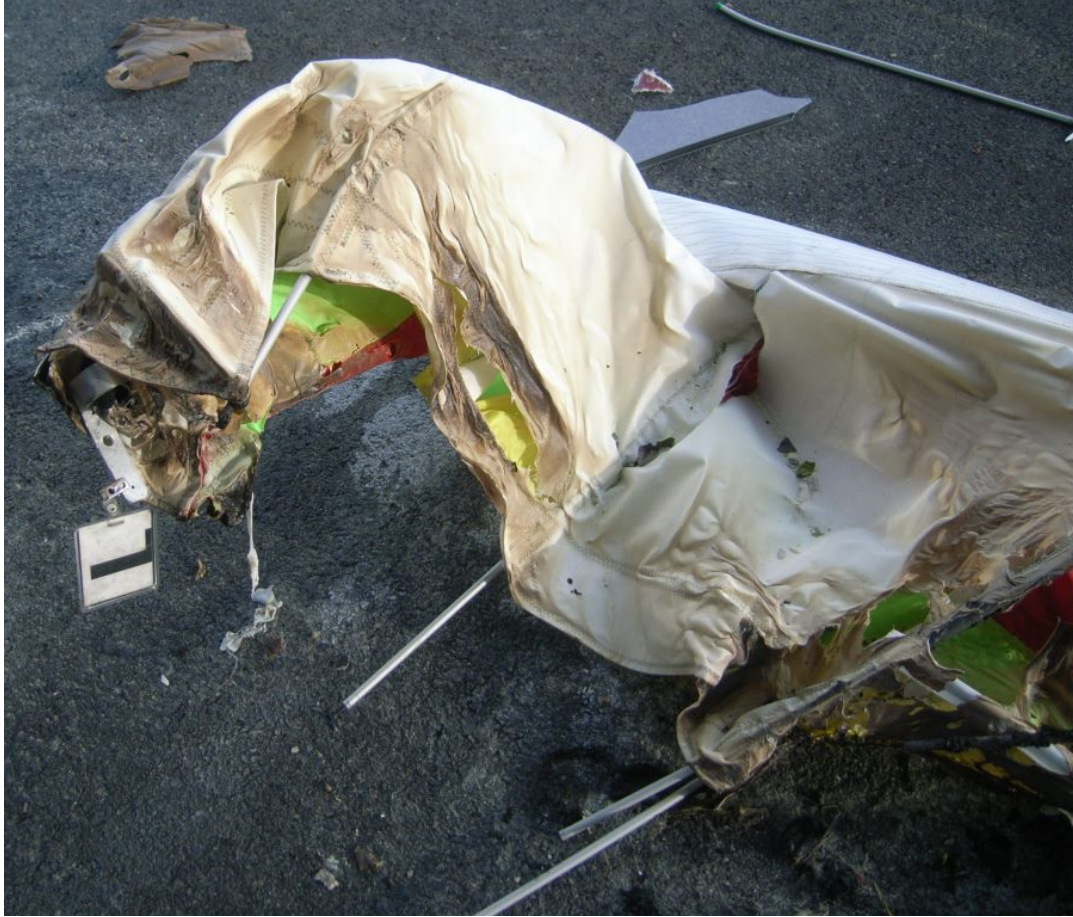
- The left wing tip and navigation light bore scraping and crush damage consistent with road impact
- The right wing forward spar/leading edge tube exhibited the following damage:

**Figure 23 - Left Wing Tip**

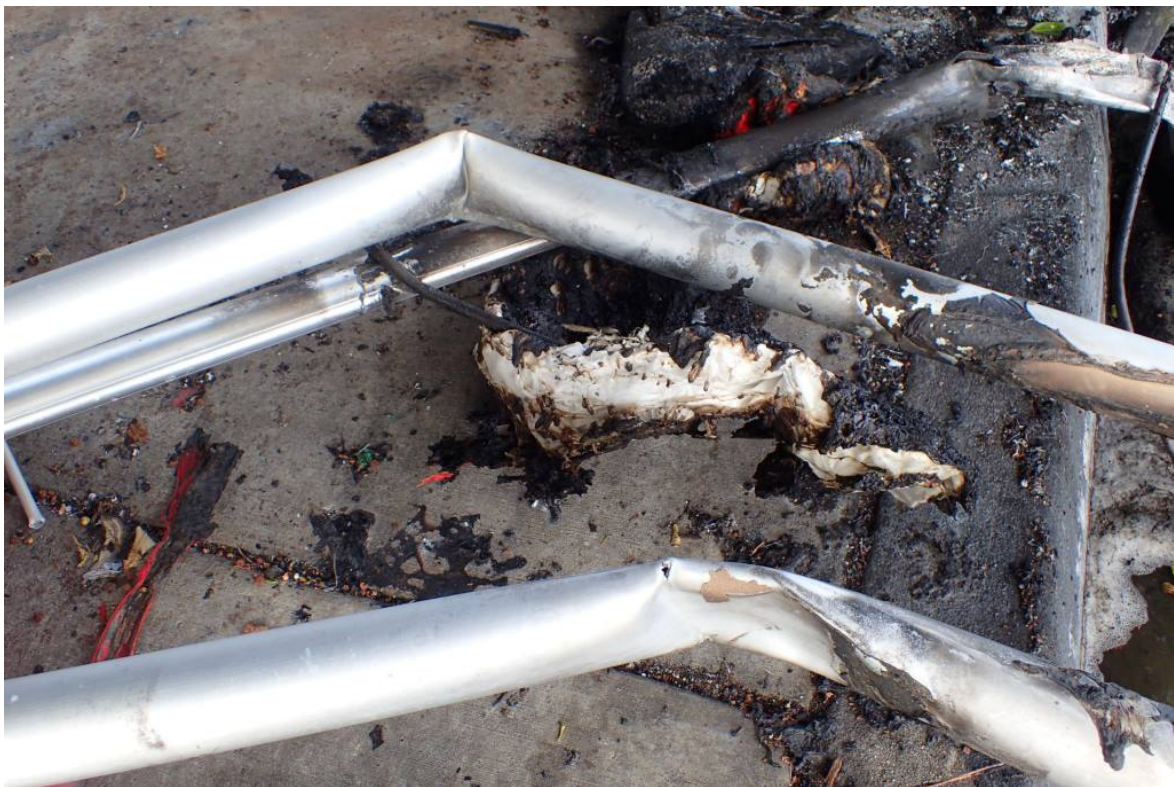
- Bent outboard segment forward about 35 degrees at the 6 1/2 ft span point. The bend location also exhibited about a 3 inch crush area, consistent with impact at that location

- Bent outboard end aft about 20 degrees at the 10 ft span point
  - Fracture separated in outboard end aft bending at the 13 ft span point
- The aft spar assembly (akin to the crossbar in the capital letter 'A') which consisted of two segments (right and left) that attached to the L & R forward spars and joined at the aircraft center was found to be attached to the right wing. The right segment bore crush damage and bending at the same span location, and similar in degree, to the LE spar damage at the 6 1/2 ft span point. The damage was consistent with both spars being deformed by impact with a single object while the spars were in their original orientation and alignment

**Figure 25 - Right Wing LE Spar (bottom) and Aft Spar (top)**

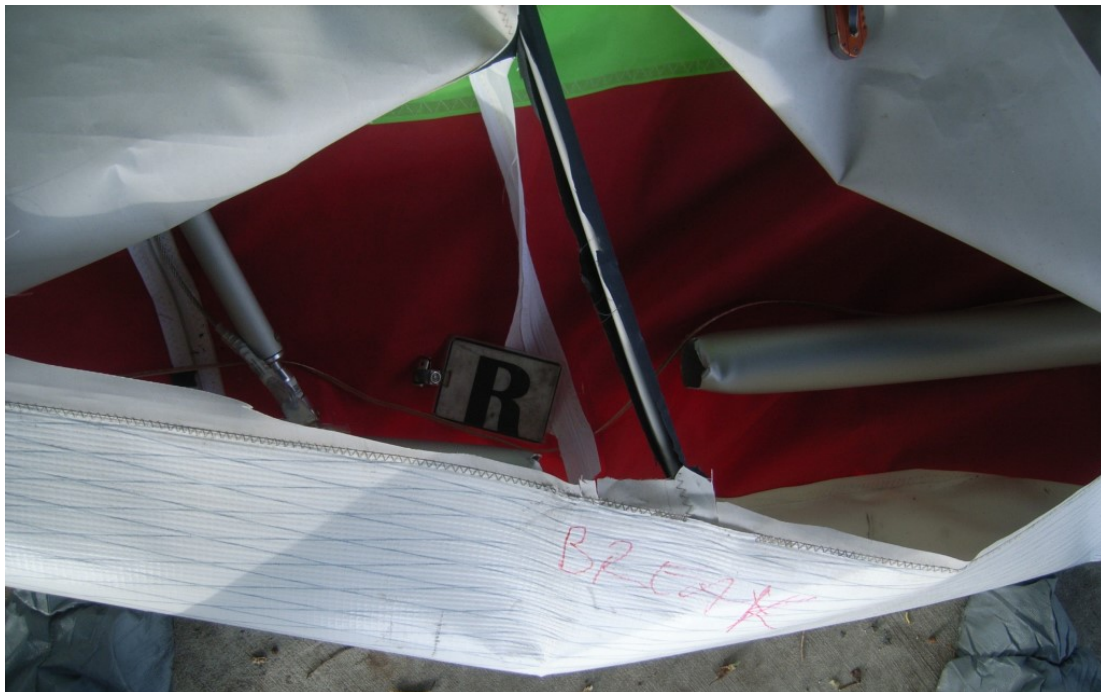
**Figure 27 - Right Wing Tip (sail opened to show spar break)**

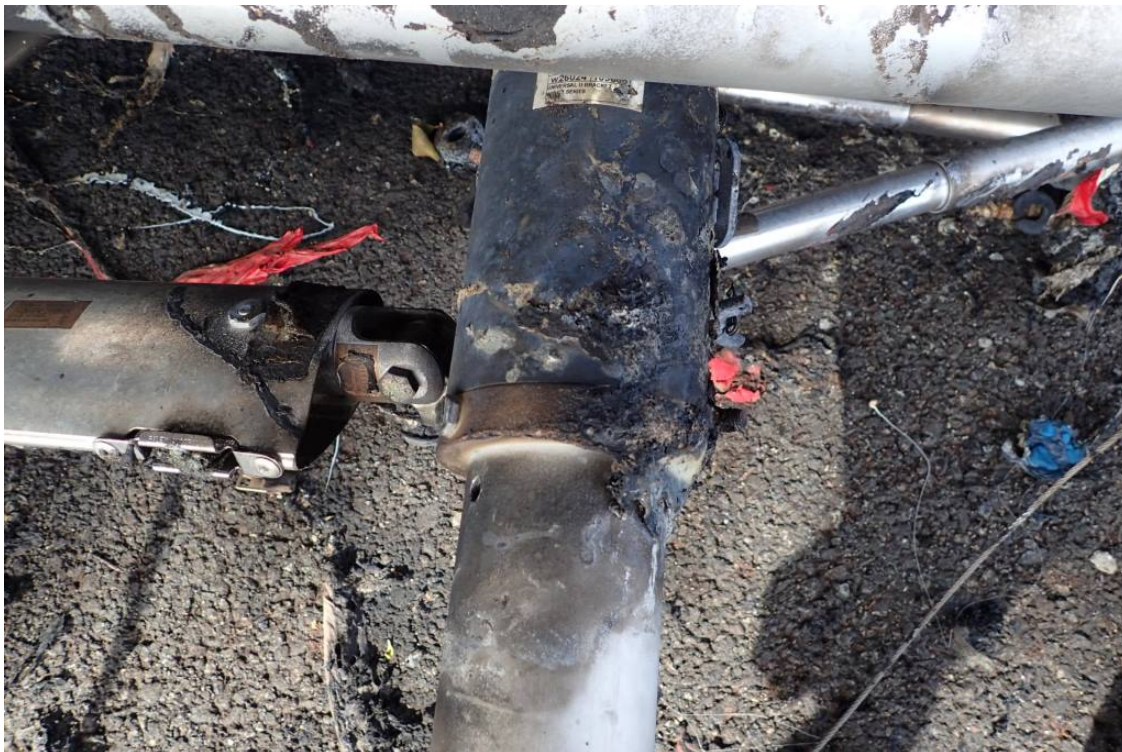
- The upper inboard end of the left inboard strut was fracture-separated from the wing assembly; the attach bolt and fitting exhibited significant bend damage, consistent with impact overload failure

**Figure 29 - Wing Strut Juncture (note fractured left upper attach; looking aft)**

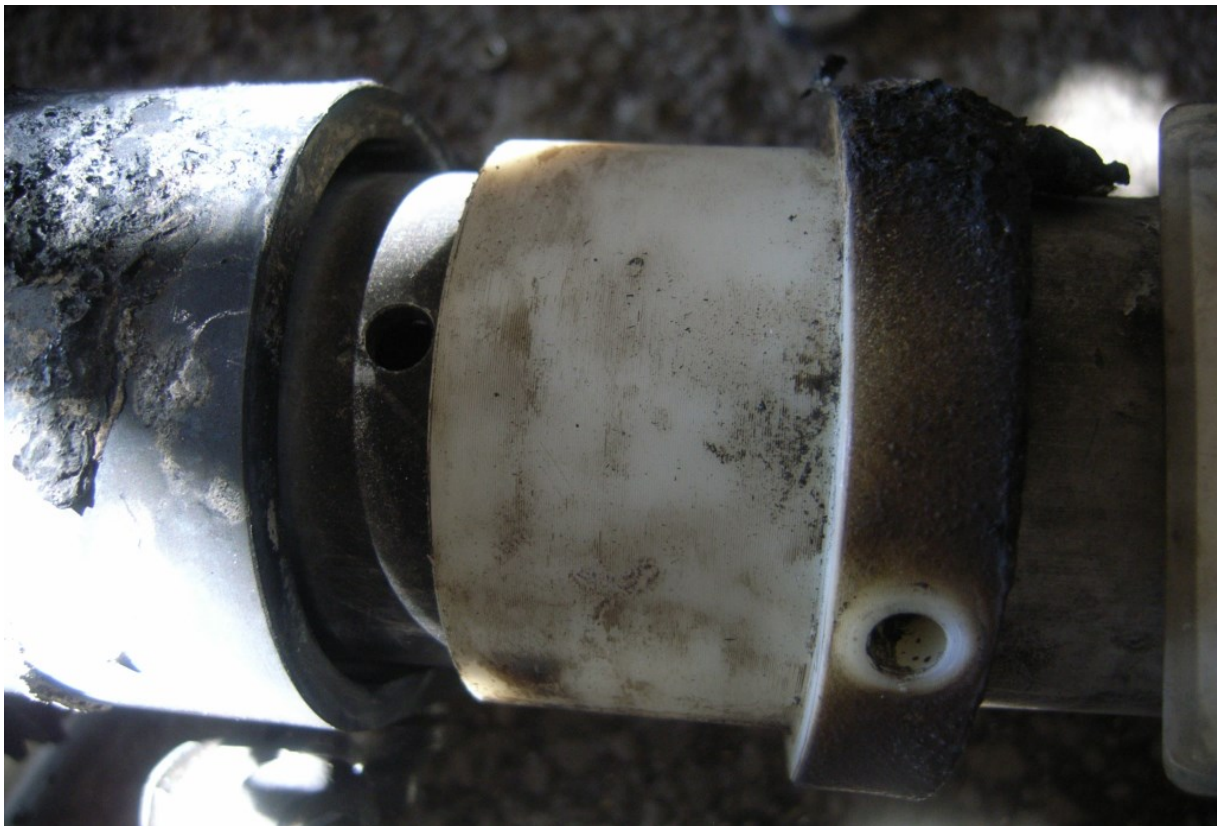
- The nylon/plastic bushings which allowed the wing to pivot in roll were exposed by investigators, and displayed no evidence of scoring or any other abnormalities that would adversely affect wing roll

Figure 31 - Wing Pivot Bearing

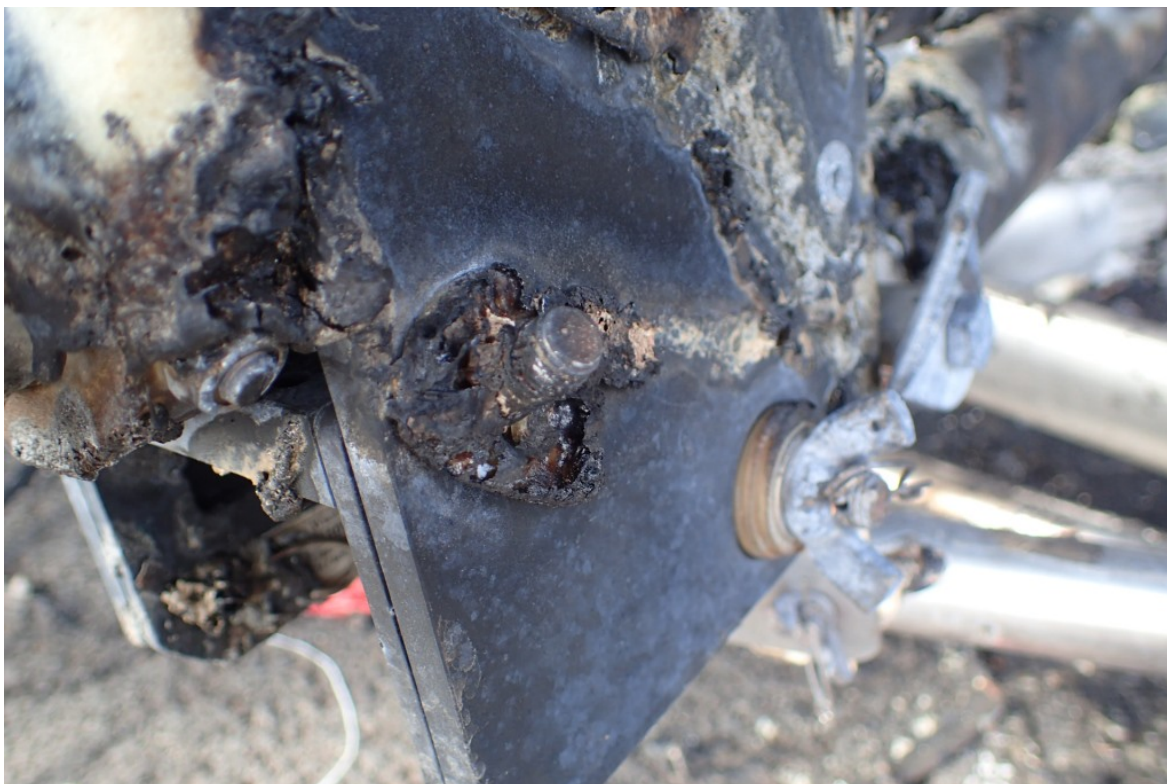
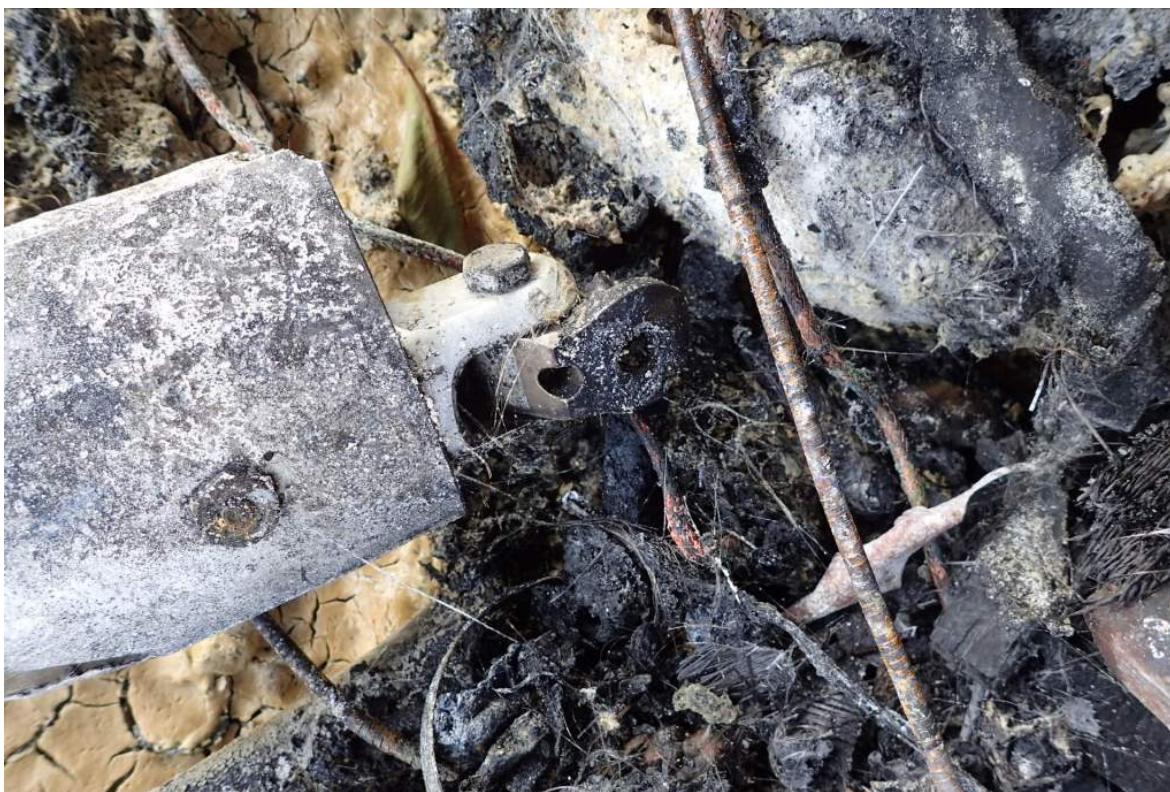
**Figure 32 - Fractured Upper Left Strut Attach**

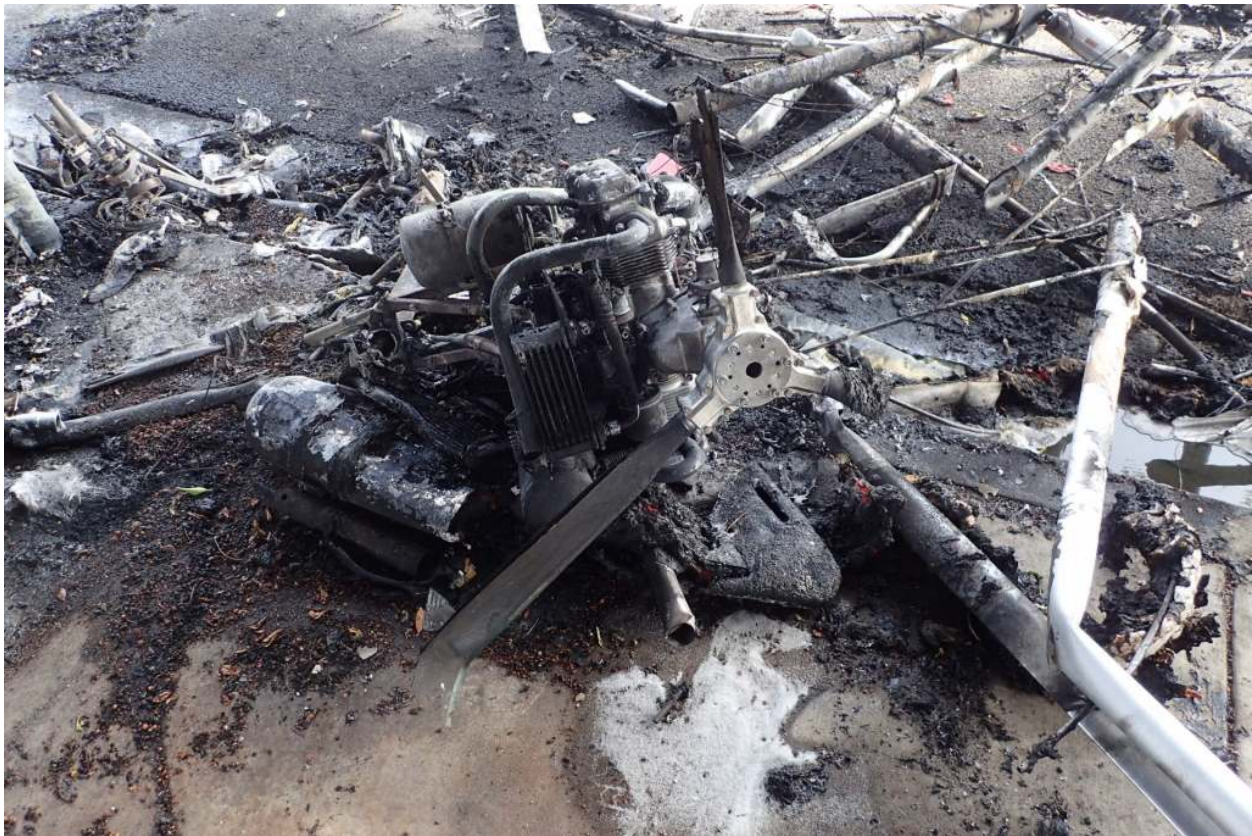
- The engine remained attached to its steel frame portion of the carriage
- The engine did not exhibit any evidence of any preimpact failures
- The engine sustained significant impact and fire damage, to the point where its pre accident integrity and operability could not be ascertained

Figure 34 - Engine in Wreckage

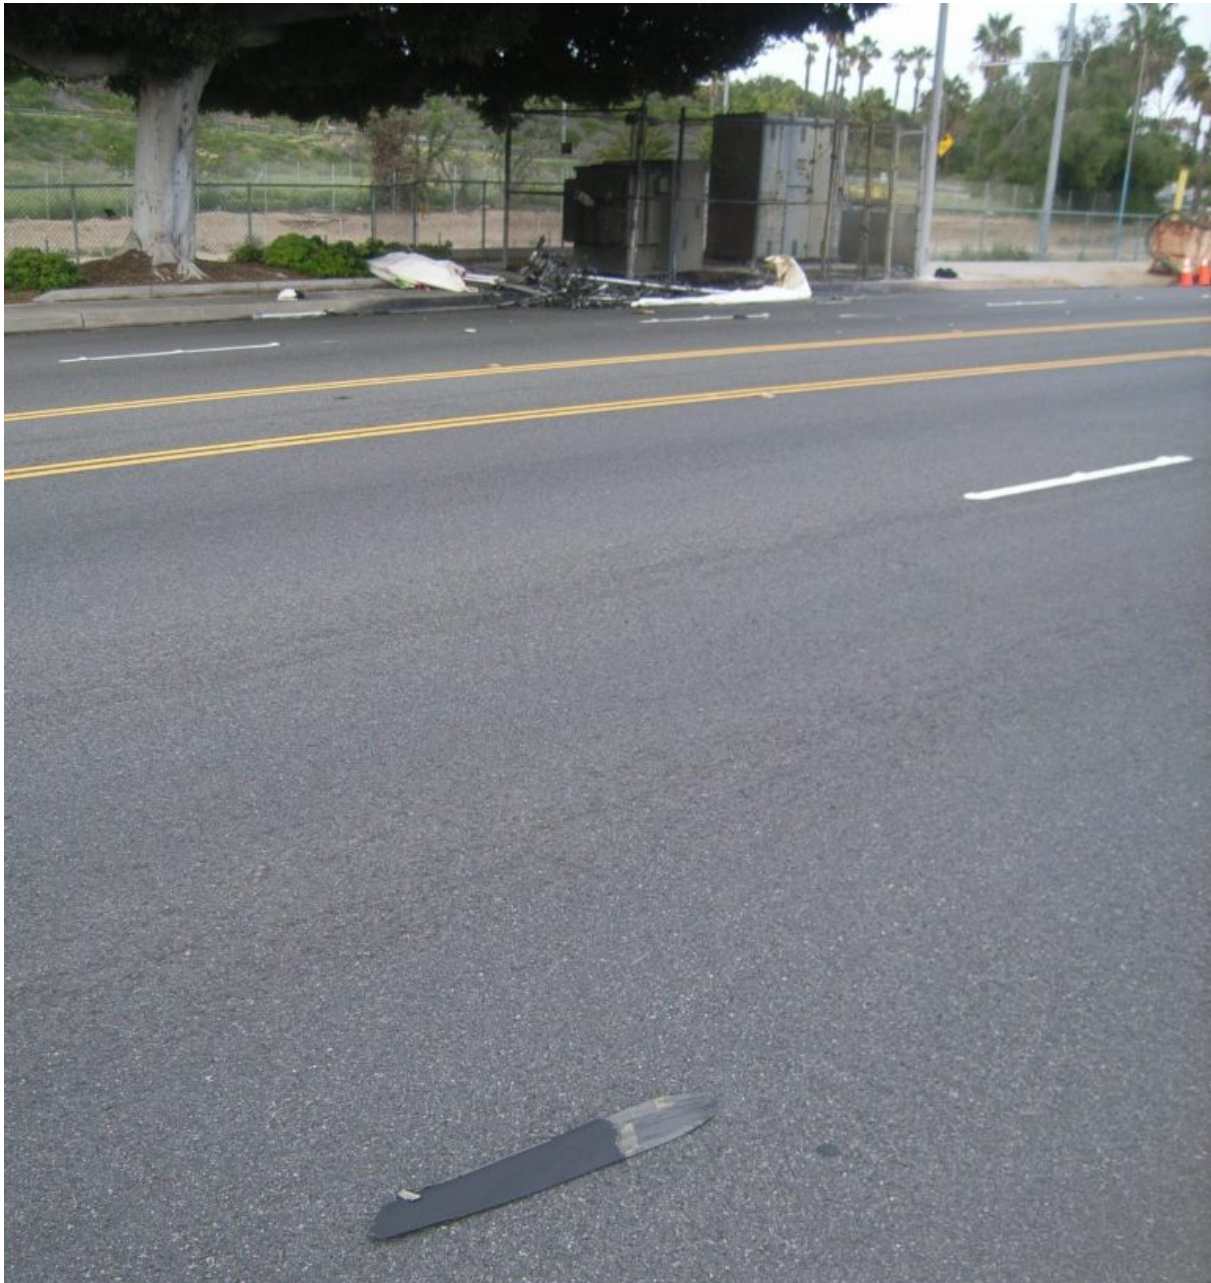
- Another propeller blade fracture was at about the 15 inch span point
  - That blade was found rotated in the hub so that its chordline was parallel to the longitudinal axis of the aircraft/engine

- The blade was not free to rotate in the hub. The fracture damage, blade rotation, and jamming were consistent with impact effects

**Figure 35 As-Found Fractured Propeller Blade**

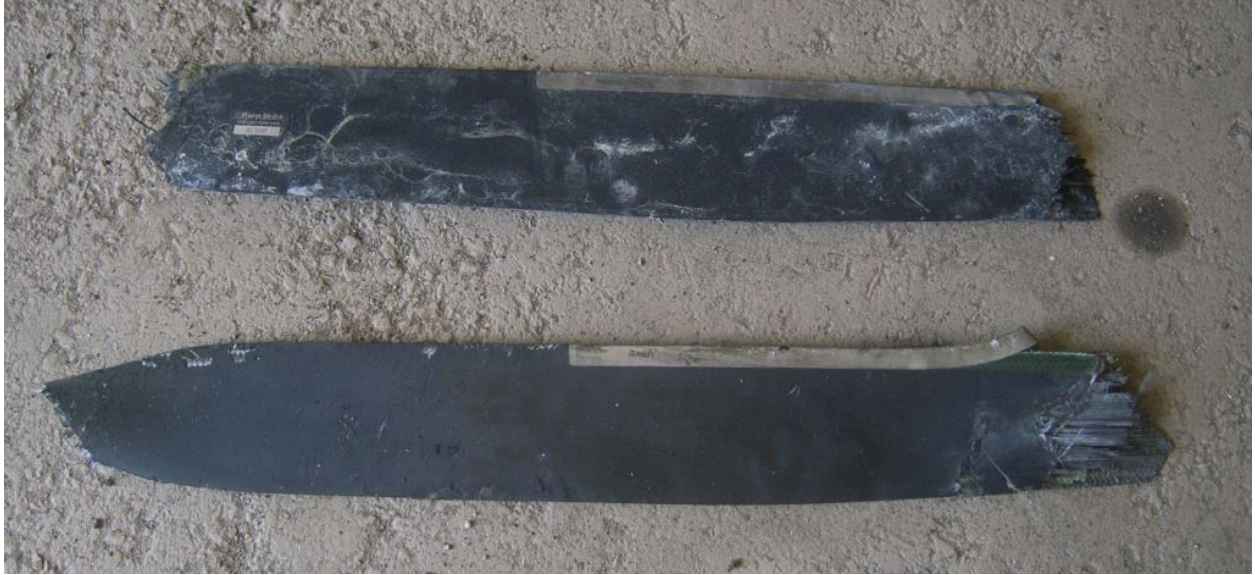
- Two propeller blades were fracture-separated from the hub; the full lengths of all three propeller blades were identified on scene
- One propeller blade fracture was at about the 8 inch span point

**Figure 36 - Two Fractured Propeller Blades**

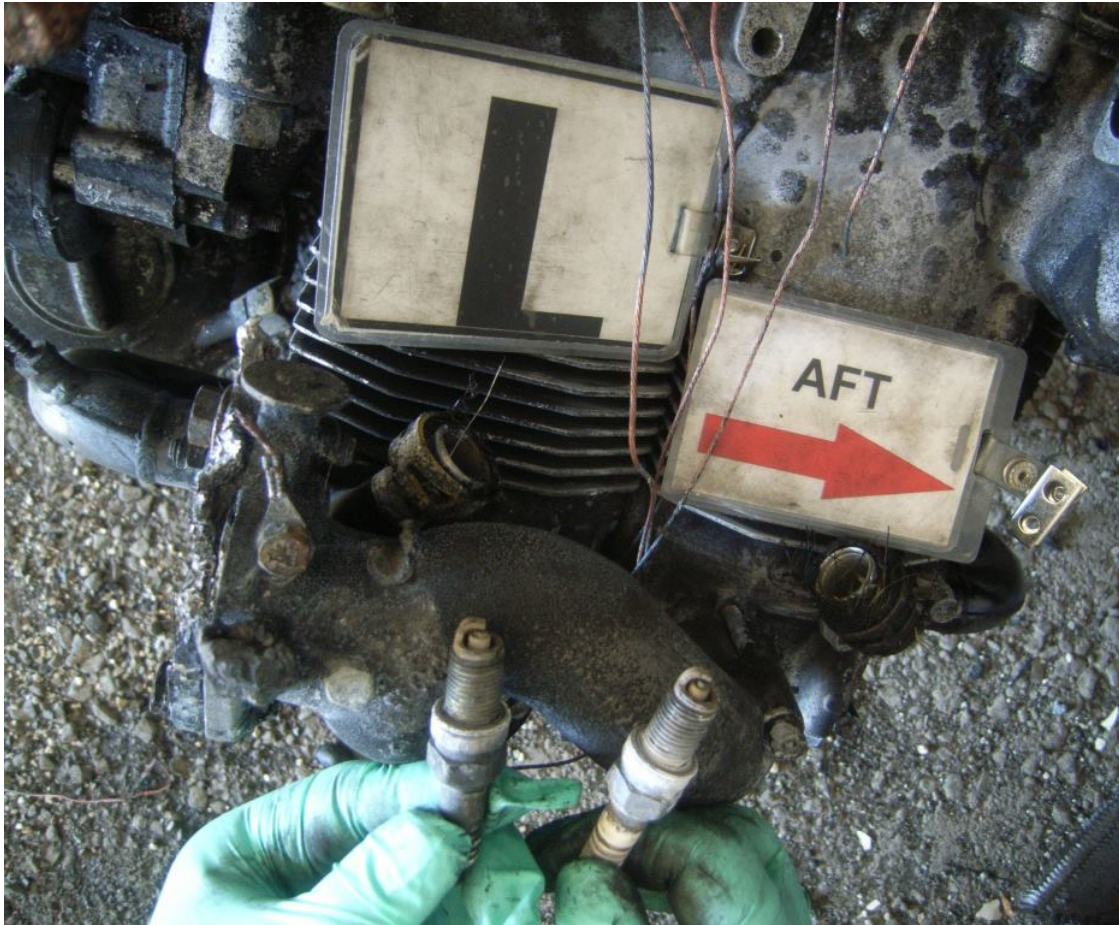
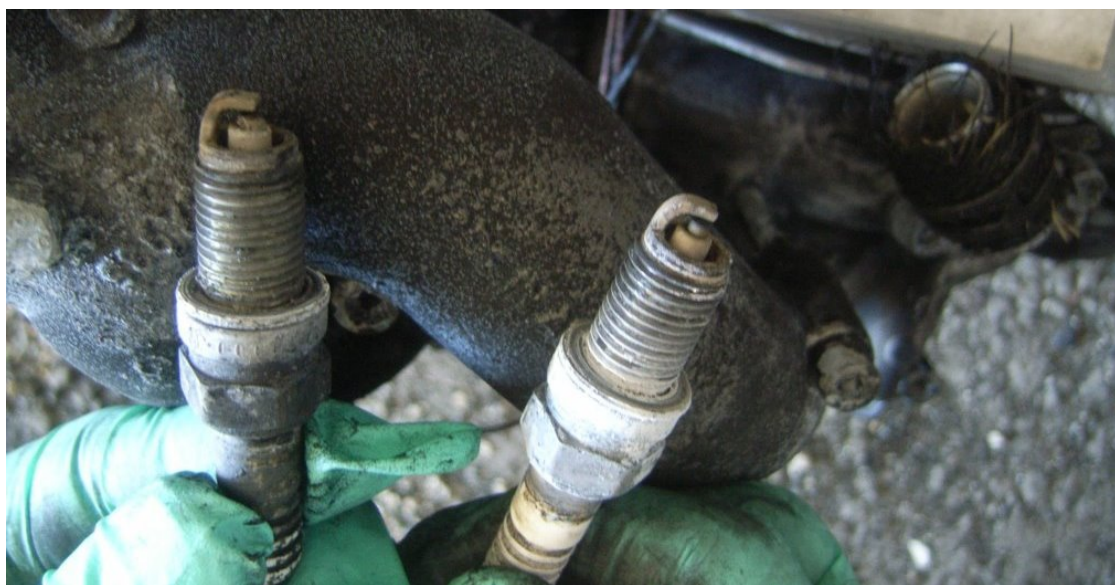
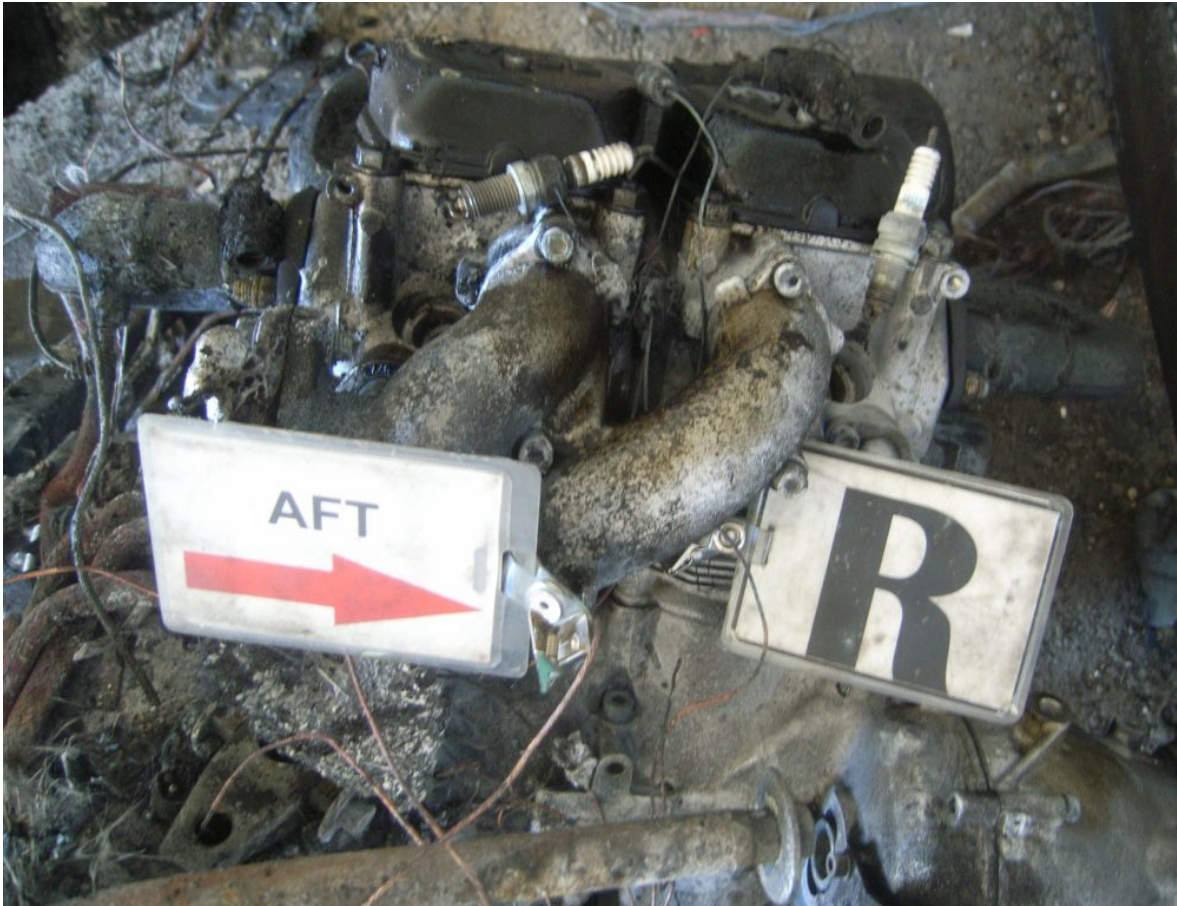
- The spark plugs did not exhibit any indications of pre-impact failure or abnormal operation
- The 3 blade Warp Drive composite propeller remained attached to the engine

**Figure 38 - Left Cylinder Bank with Spark Plugs**
