## **NATIONAL TRANSPORTATION SAFETY BOARD**

# **AIRFRAME AND ENGINE EXAMINATION**

**WPR16FA087**

Location: Astoria, Oregon  
Date: March 23, 2016  
Aircraft: North American AT-6A, N7055D  
NTSB IIC: Elliott Simpson

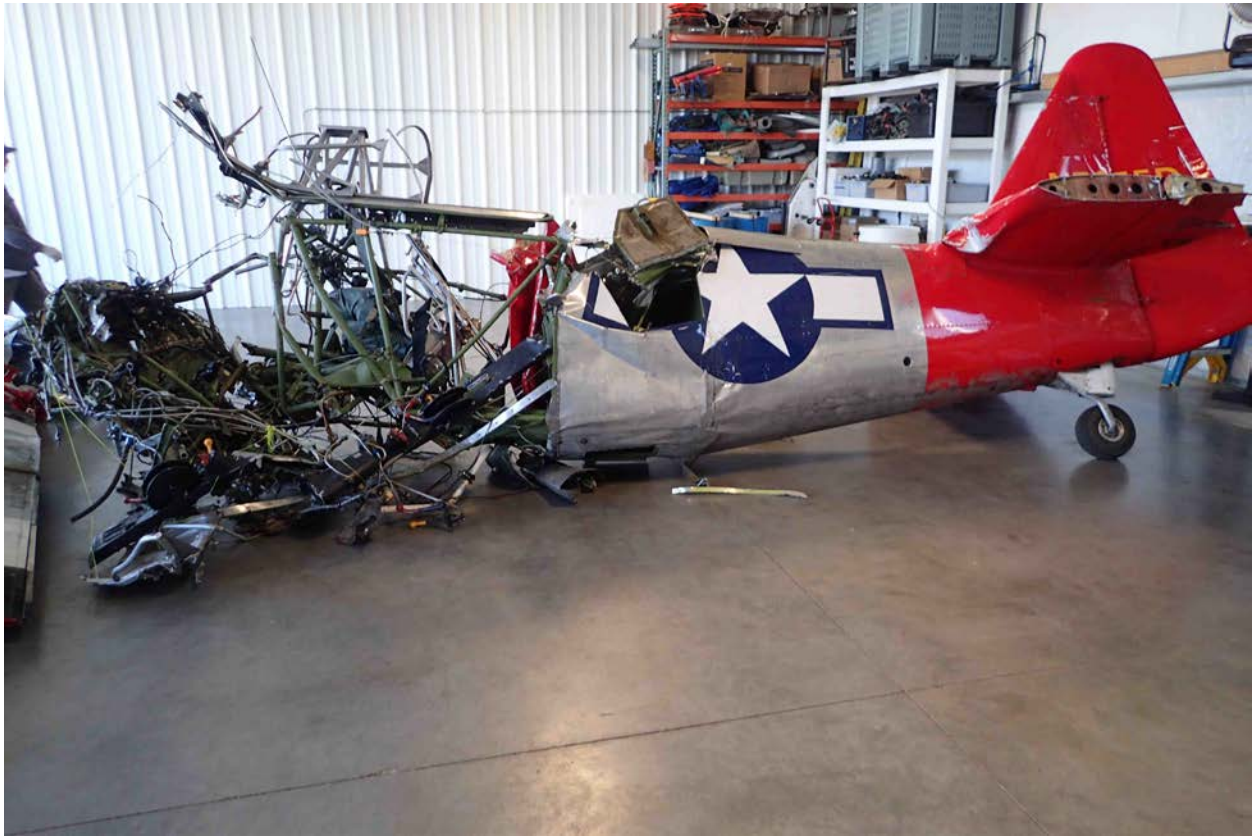
Photo 1 – Aft Fuselage

The forward fuselage sustained crush damage, compressing and fracturing most of the longerons and webs, and shedding and separating the side skins (Photo 1). Aft of the cabin, the tailcone remained intact sustaining crush damage buckling the forward skins. Aft of the damage, the horizontal stabilizer remained attached (the left horizontal stabilizer was cut off during recovery).

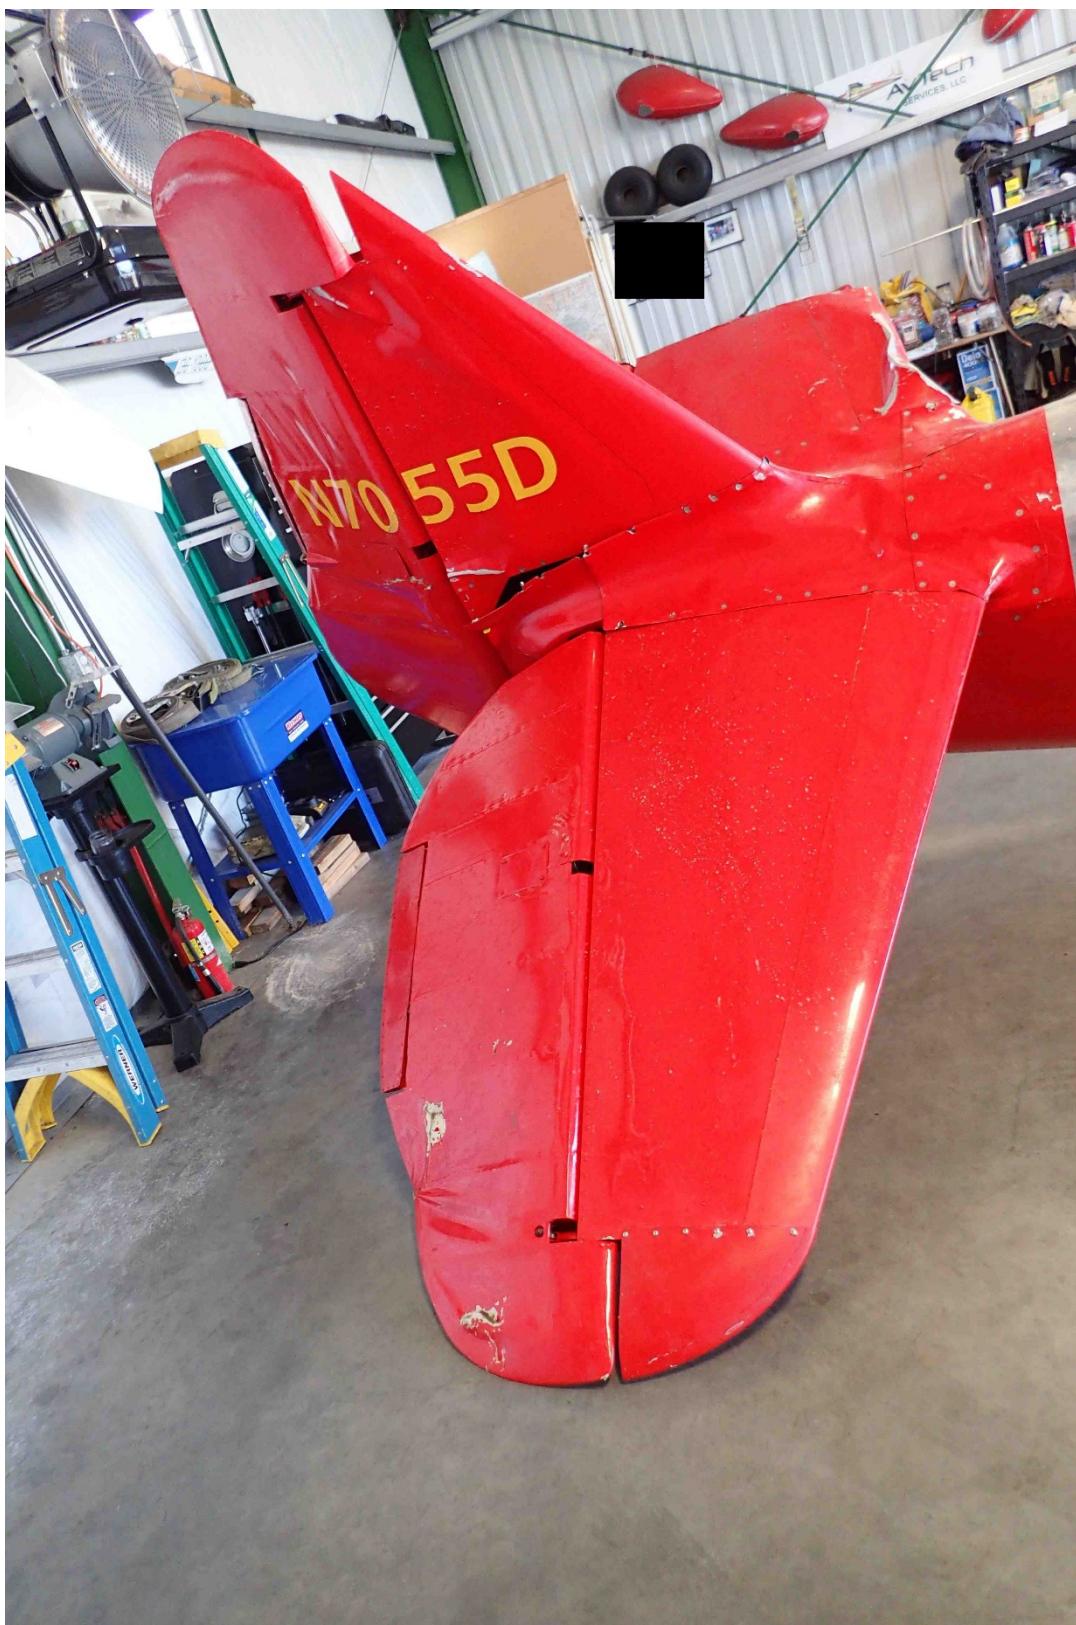
Photo 2 - Tail

The vertical stabilizer remained partially attached at the root (Photo 2). A can of lubricant was found loose with the tail cone void, sitting against the aft cabin bulkhead (Photo 3, 4).

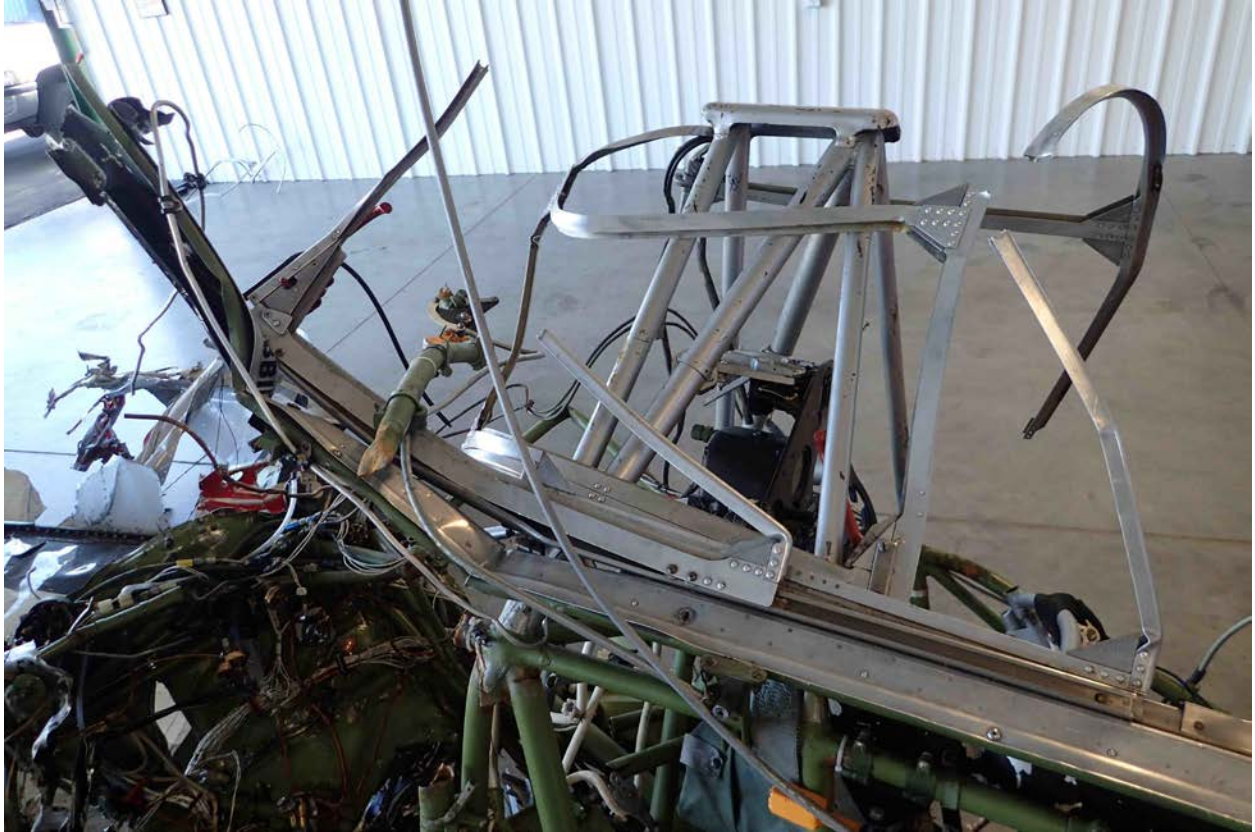
Photo 5 – Canopy Remnants on Left Side of Airframe

The sliding canopy sustained extensive damage, such that both the right side of the canopy frames and the right sliding rails had detached along with all the plexiglass and glass windshield. Examination of the remaining left-side components revealed that the rear canopy remnants were in the full-forward position (Photo 5), with the front left side of the rear canopy wrapped around the front side of the overturn pylon (Photo 6). The forward sliding canopy remained attached to the left rail, and was about 2-inches aft of the full-forward position (Photo 5).

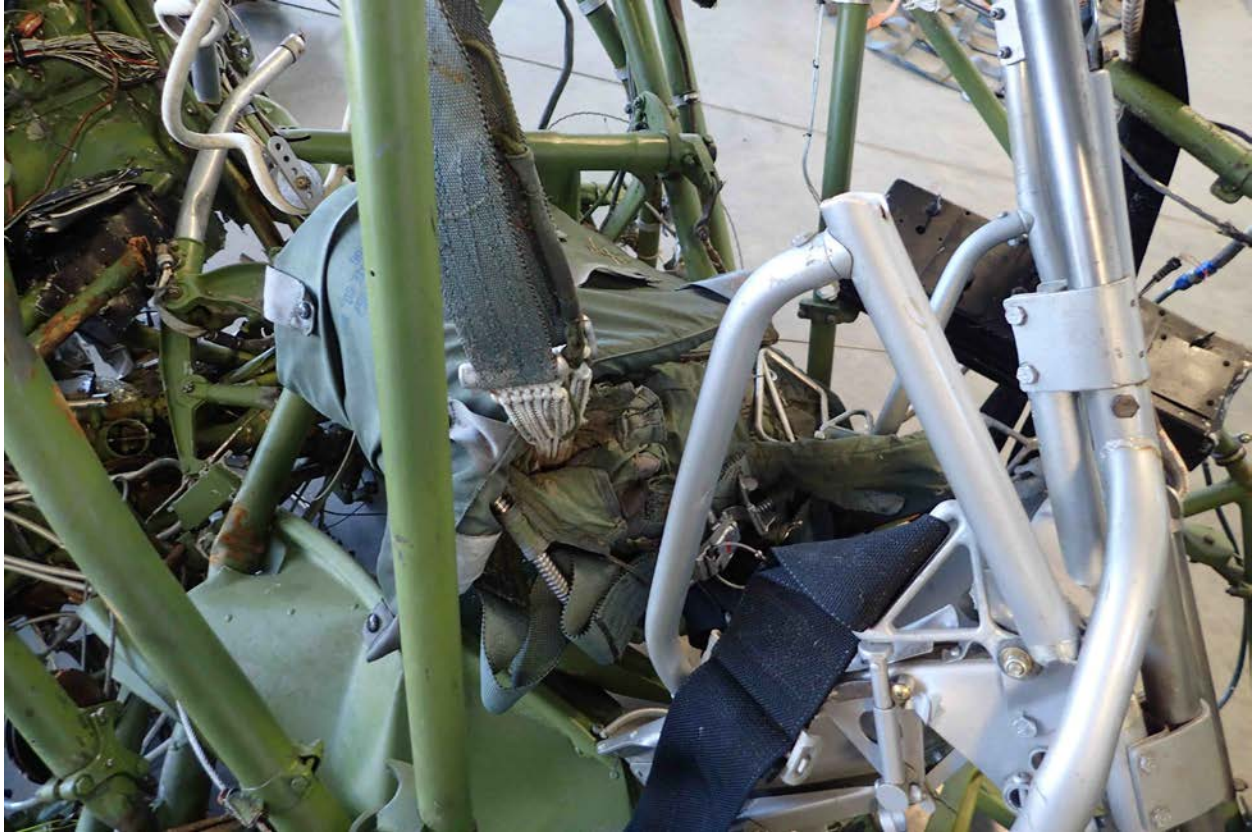
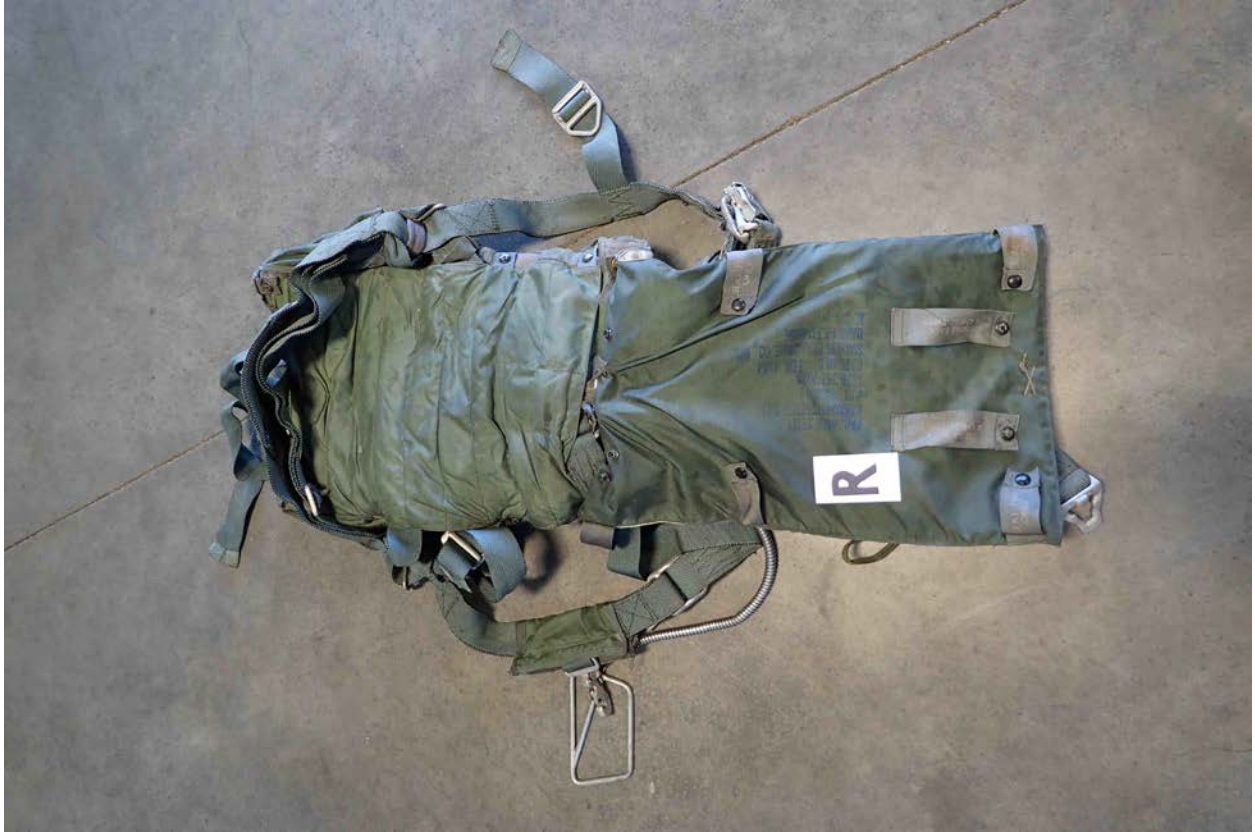
An unbuckled-parachute was located in the rear seat area; it had not been deployed (Photo 7, 8). All avionics, along with the "Hobbs" hour meter were fragmented; as such their settings could not be determined.

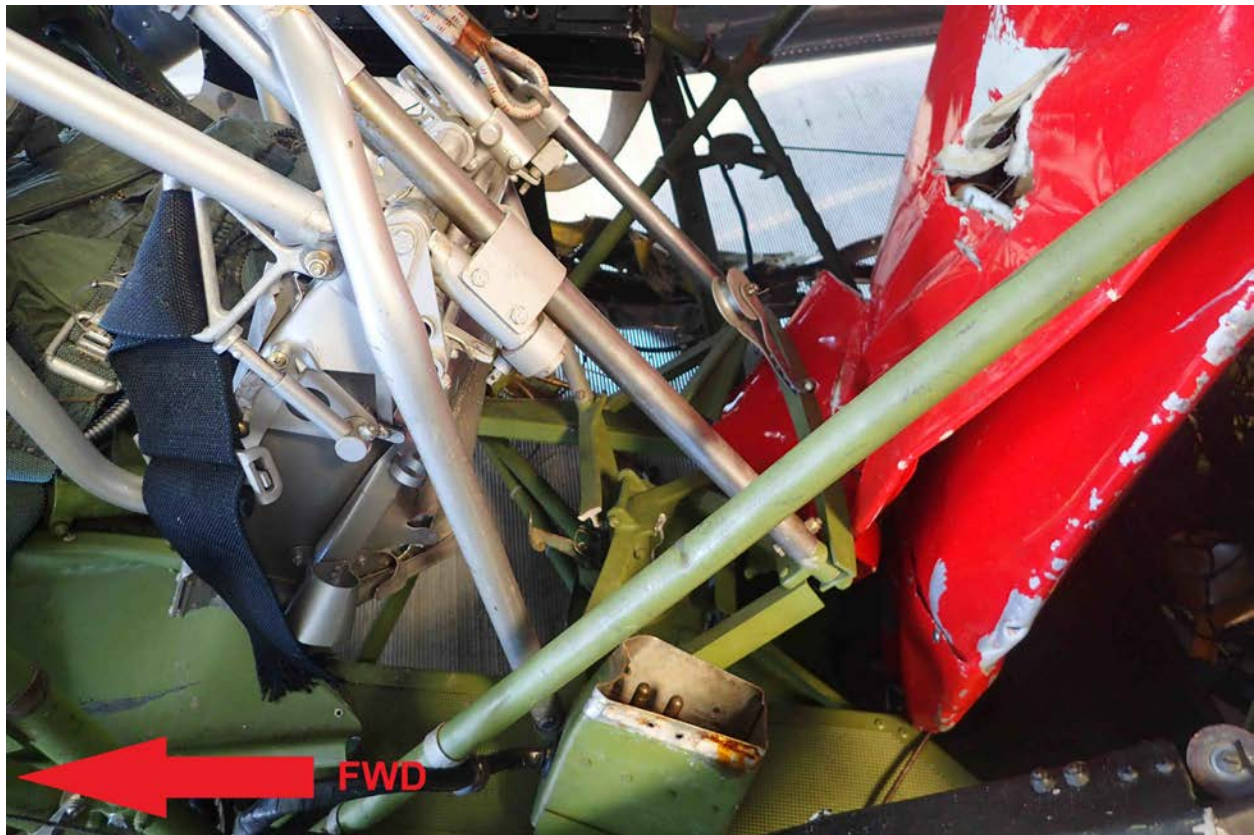
Photo 9 – Rear Seat

The rear seat was in the forward position and its back had moved about 30 degrees forward (Photo 9). Its swiveling mount remained attached to the fuselage, and three of its four "spider" mounting legs had fractured (Photo 10). The lock pedal was in the locked position (Photo 10), with its pin in forward detent.

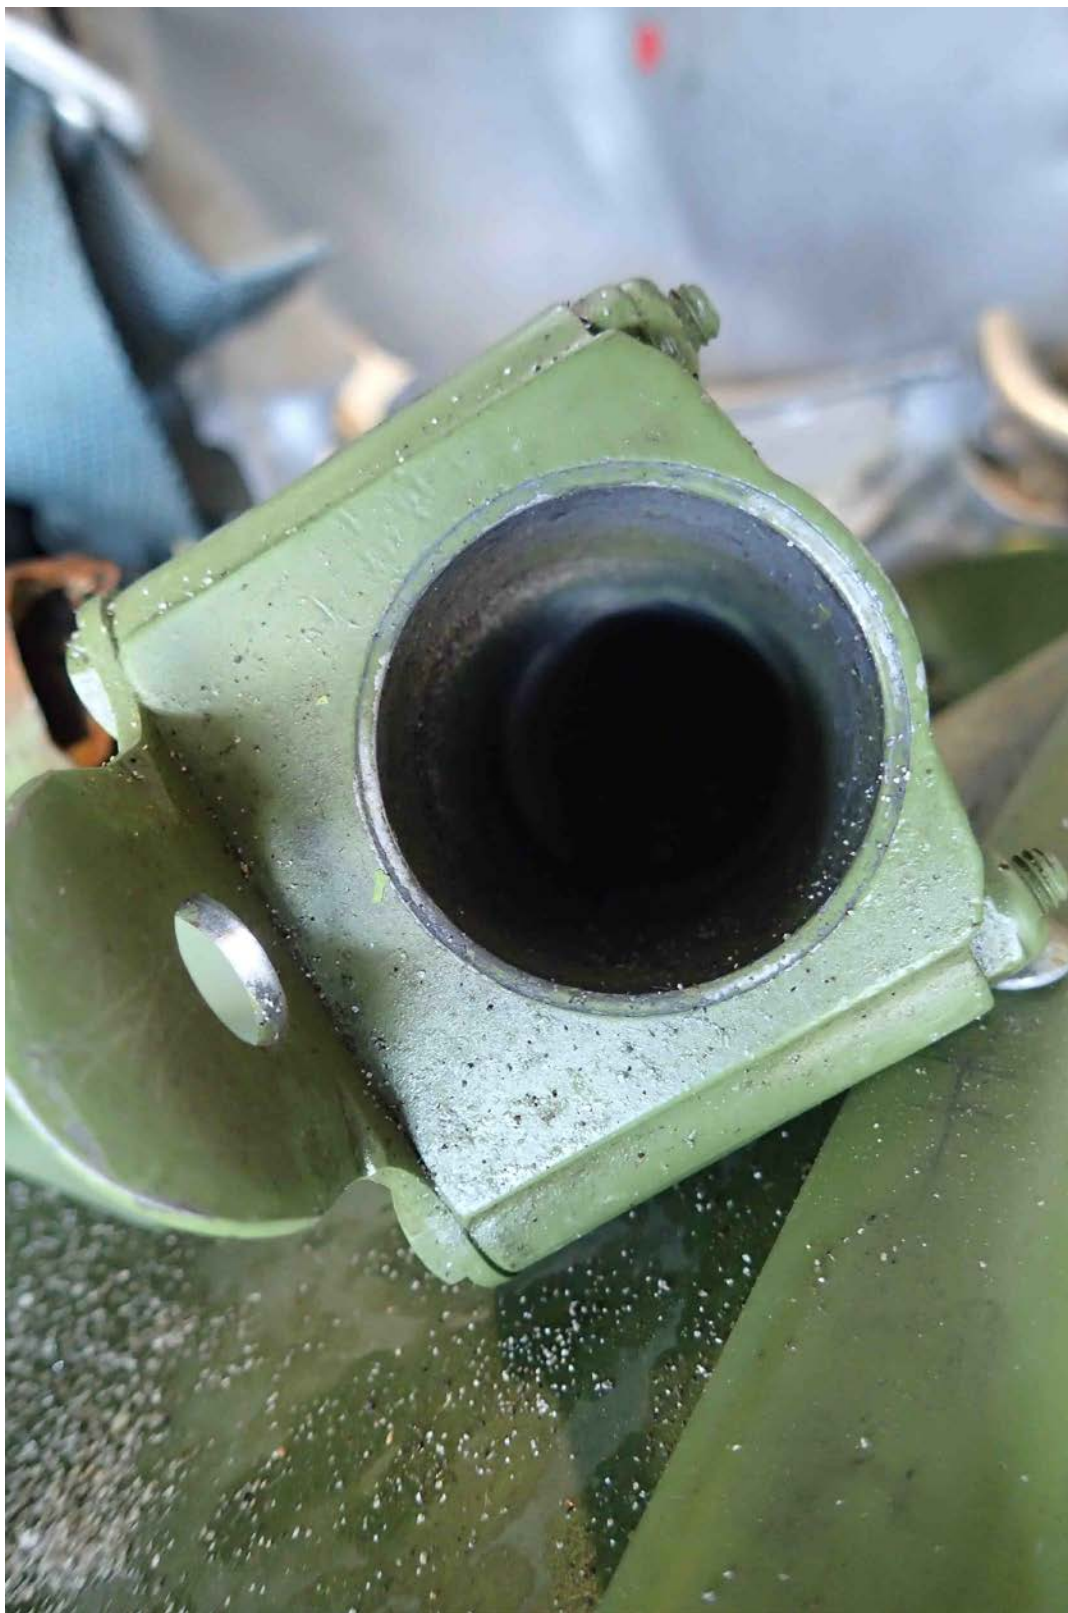
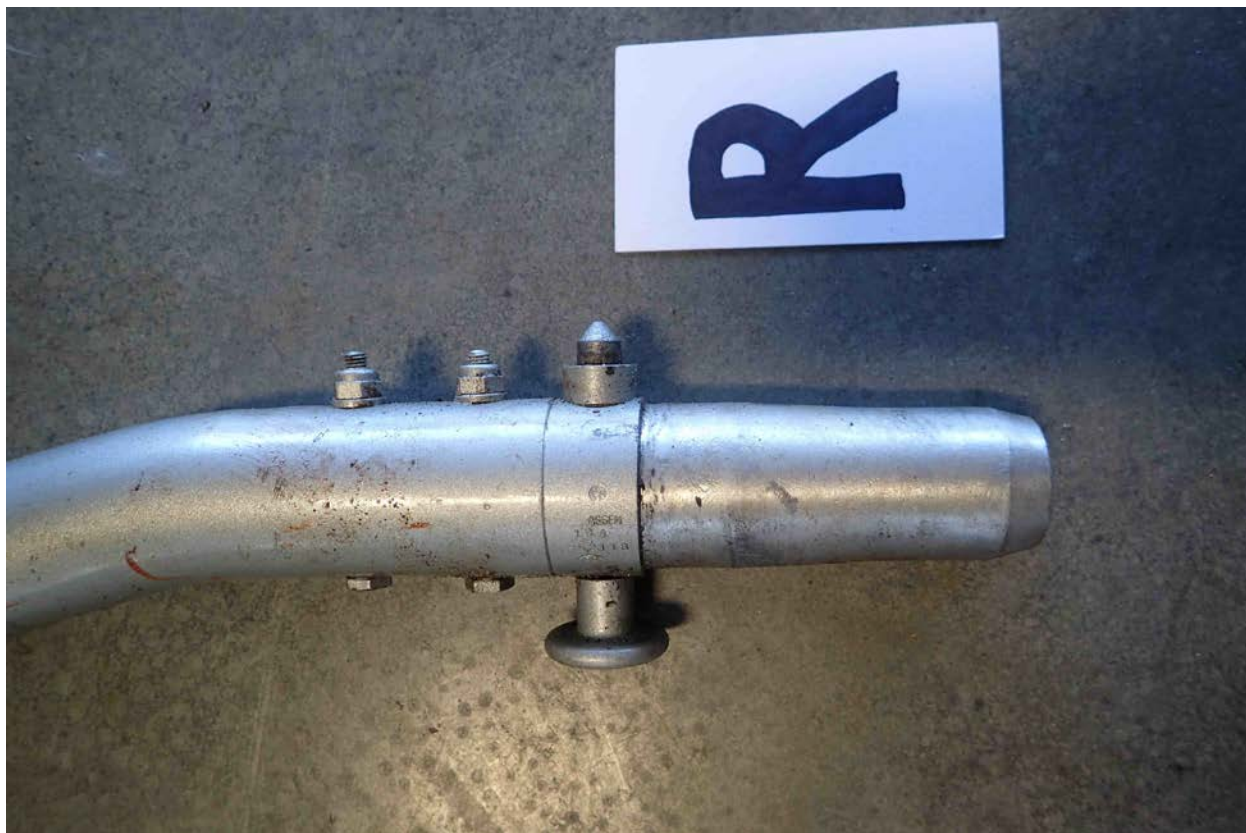
The rear control stick was located separately, and its fitting in the control system did not reveal any indications of damage (Photo 11, 12). The stick was undamaged, and its storage dock on the left side of the fuselage was broken (Photo 13).

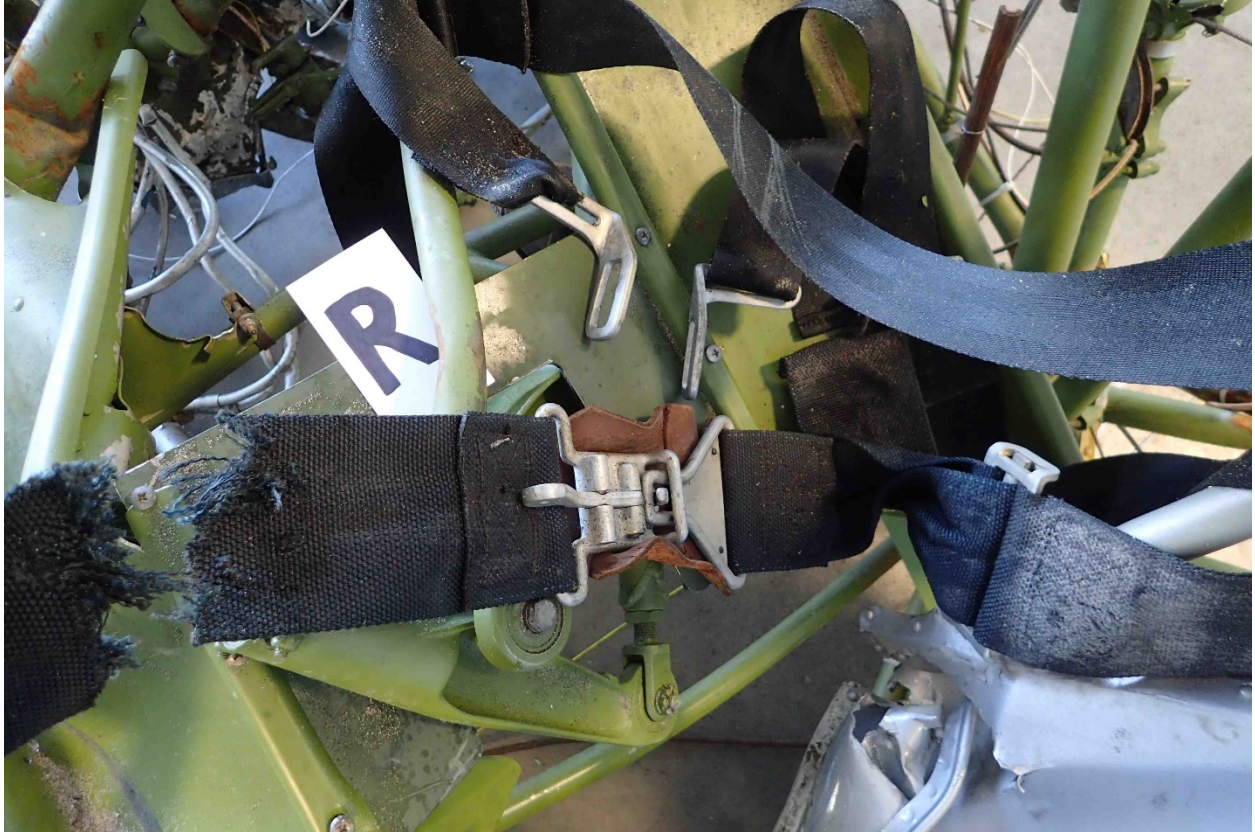
Photo 14 – Rear Seat Belt Clasp

The rear lap belt clasp was in the latched and closed position; the belt remained attached to the seat on both sides, but had been cut by Sheriff's divers during recovery of the passenger. The shoulder straps remained attached to the chair frame, and were intact. Both shoulder clasps were free, and the center belt clasp was locked (Photo 14).

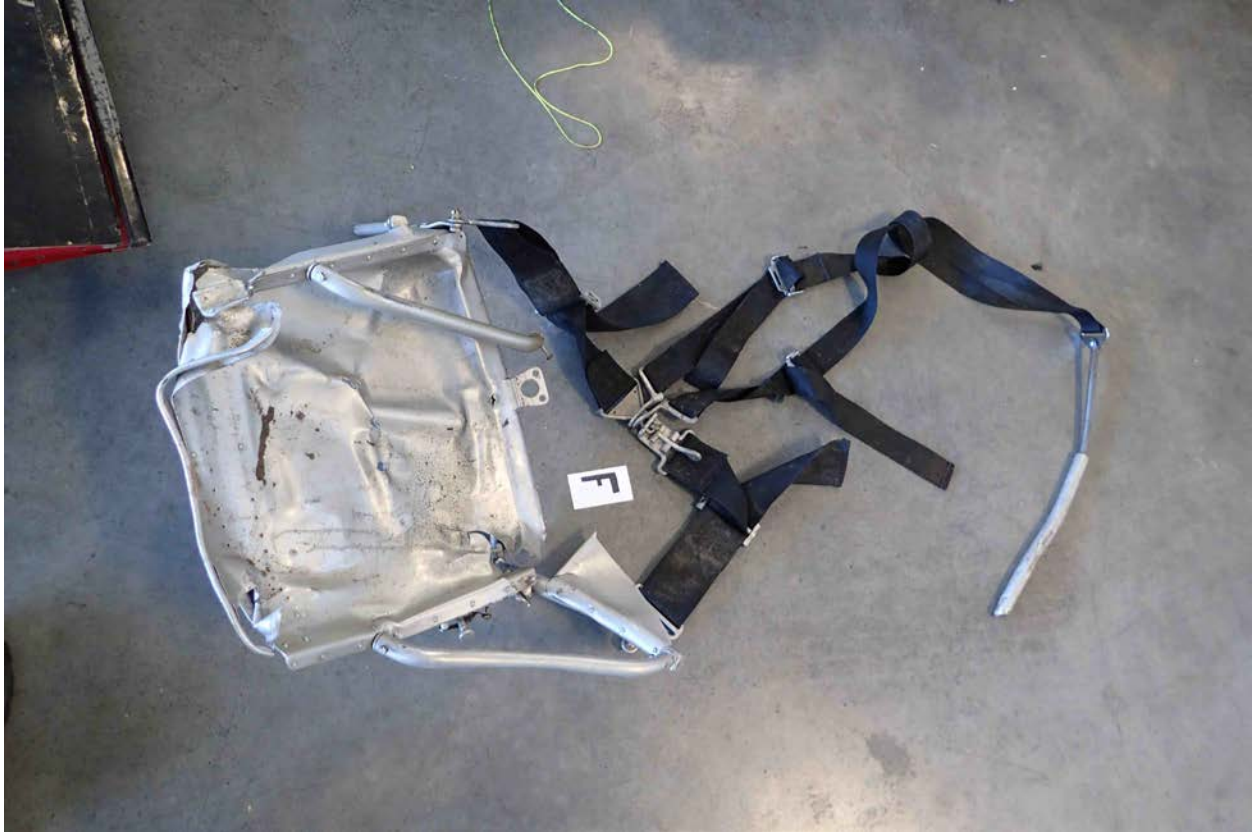
Photo 15 – Front Seat Pan and Belt

The forward seat pan had separated from the airframe. The lap and shoulder belts remained clasped together, consistent with the belt being used at the time of the accident (Photo 15). The right lap belt remained attached to the seat, the left belt had separated, with its bolt still intact, and separated from its respective lug on the seat frame. The shoulder belts remained attached to the center mounting bar, which had separated from the rear of the seat. The rear seat members remained attached to the airframe, and had separated from the seat pan.

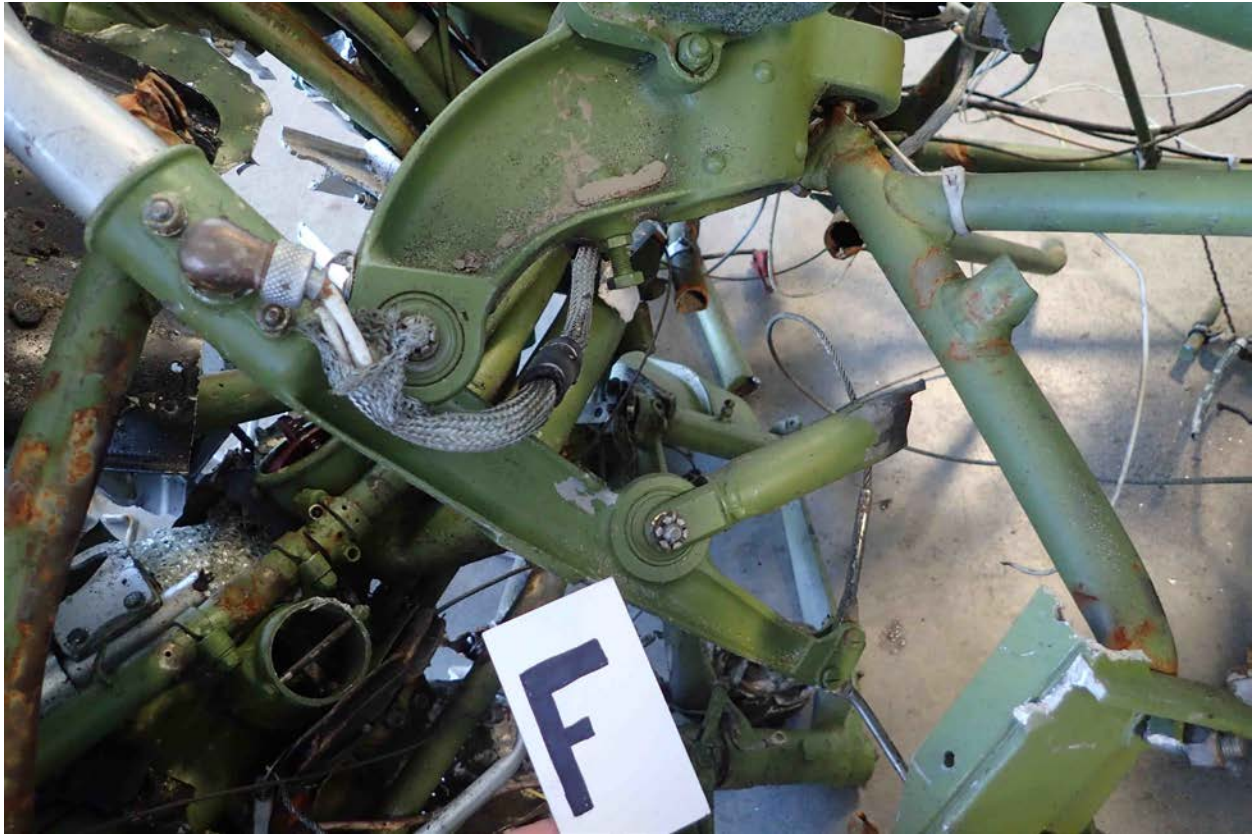
Photo 16 – Forward Control Stick Assembly

The forward control stick remained attached to its swivel joint fitting on the airframe (Photo 16).

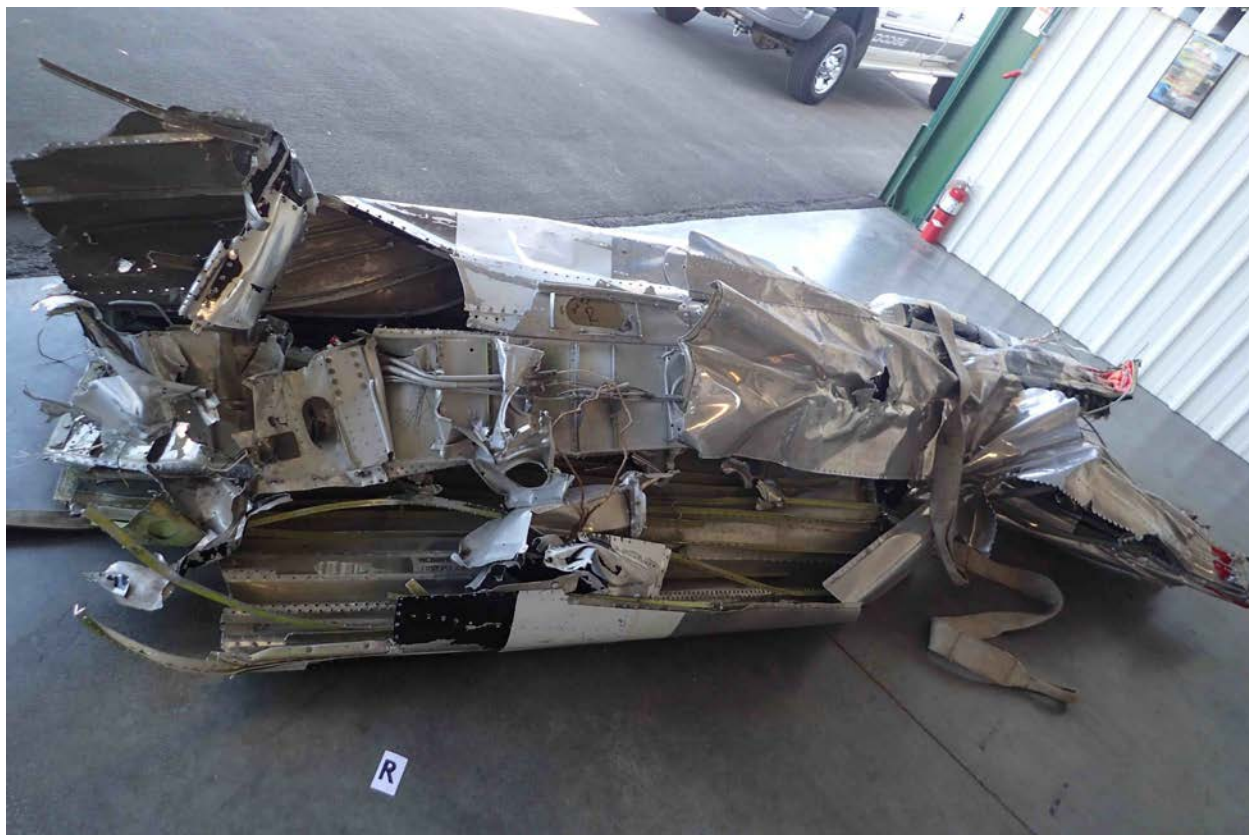
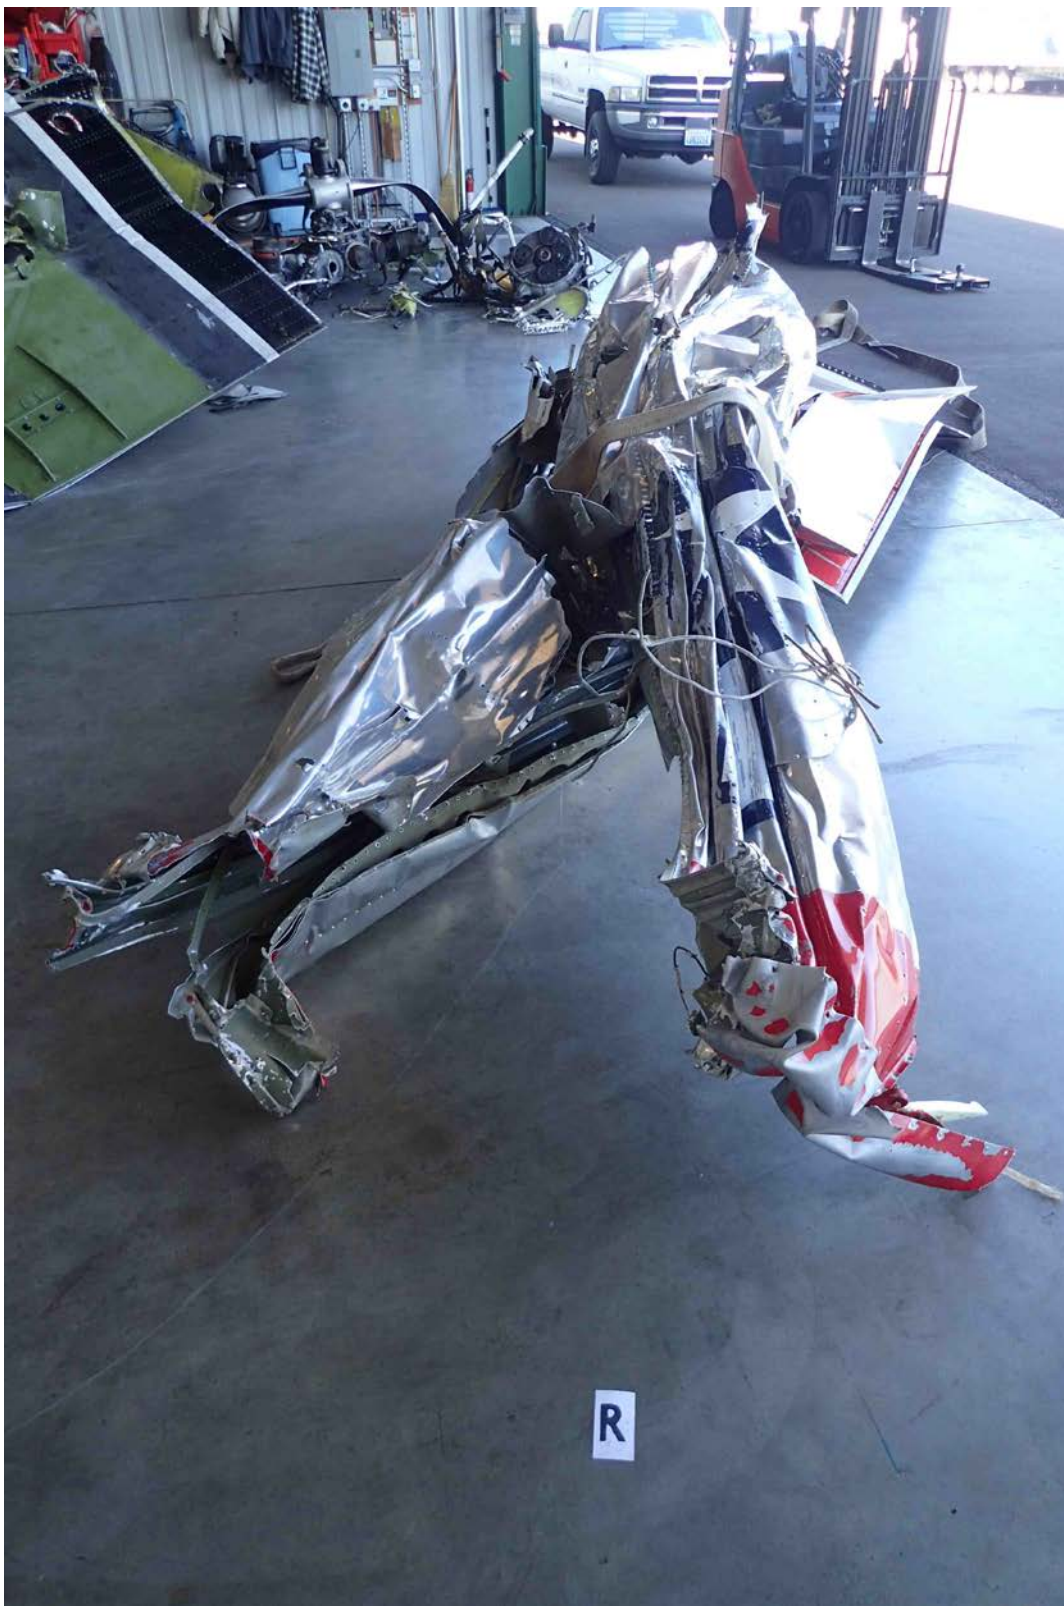
The right wing had separated from the wing center section at the wing attach point (Photo 17). The wing sustained concertina-like crush damage from the leading edge through to the aft spar (Photo 18). The flap remained attached at all three hinges and had buckled upwards about 20 degrees midspan (Photo 19). The flap actuation rod remained in place, and attached to all three extension rods, which remained attached to the flap fittings. The universal joint fitting had separated at the wing root, examination of the failure surfaces revealed grey granular features.

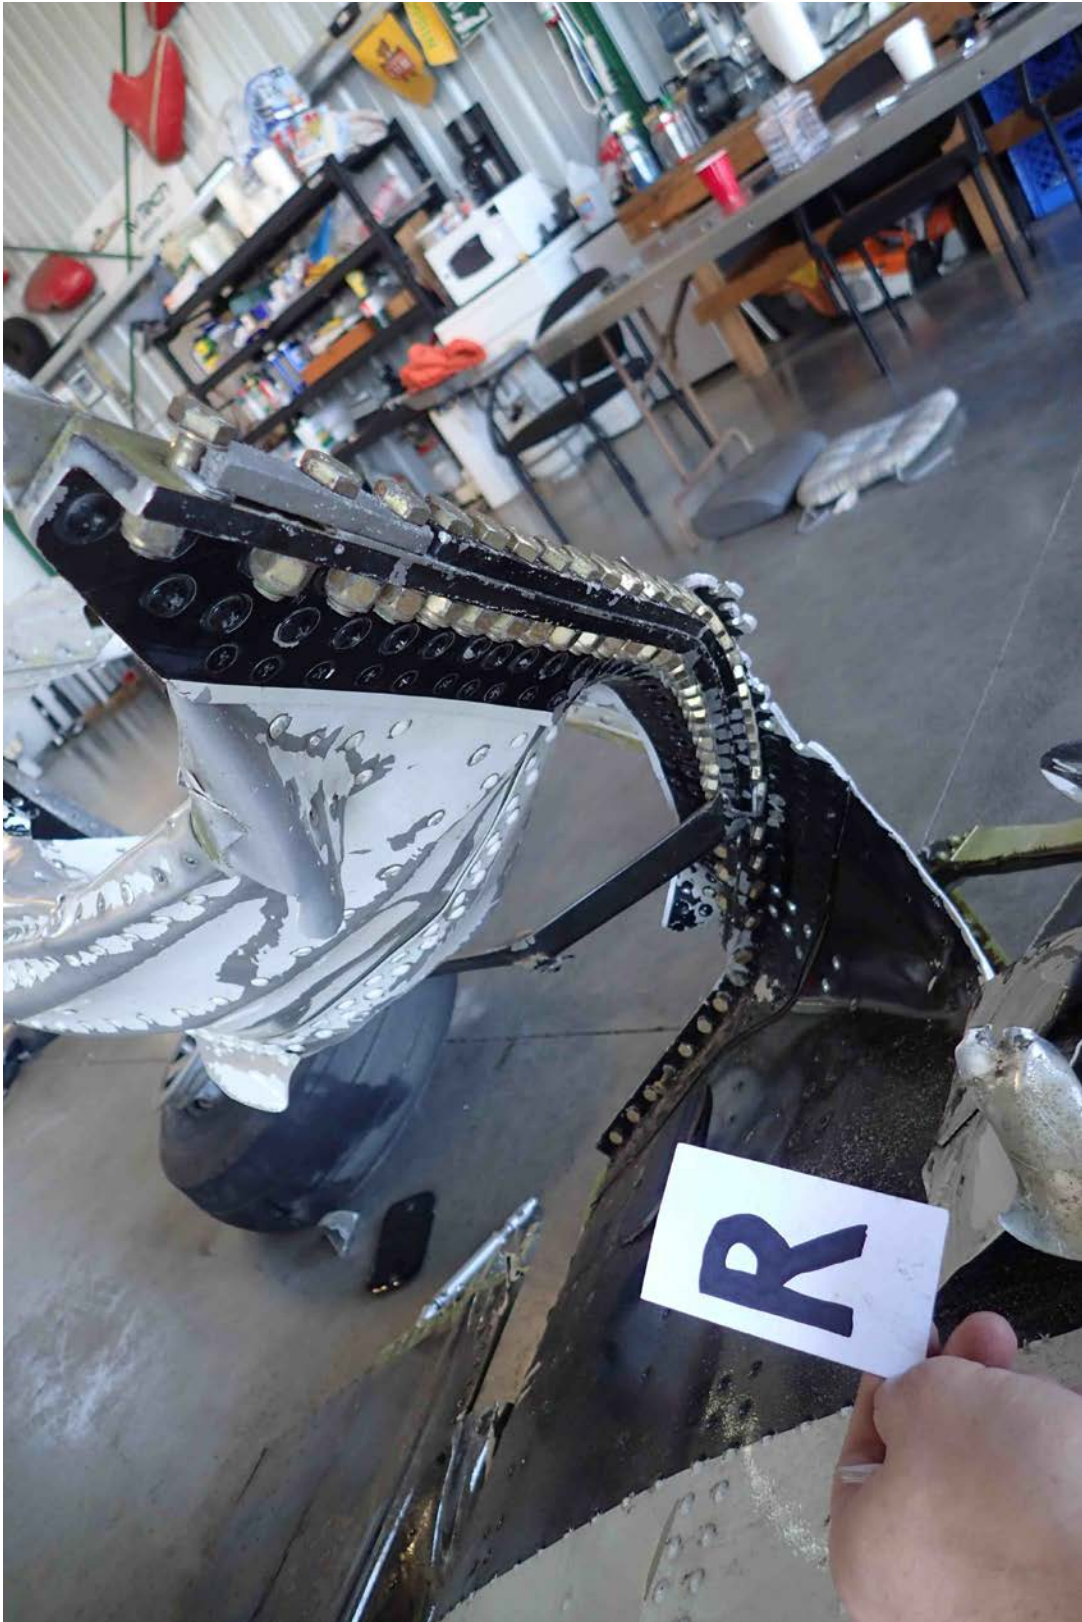
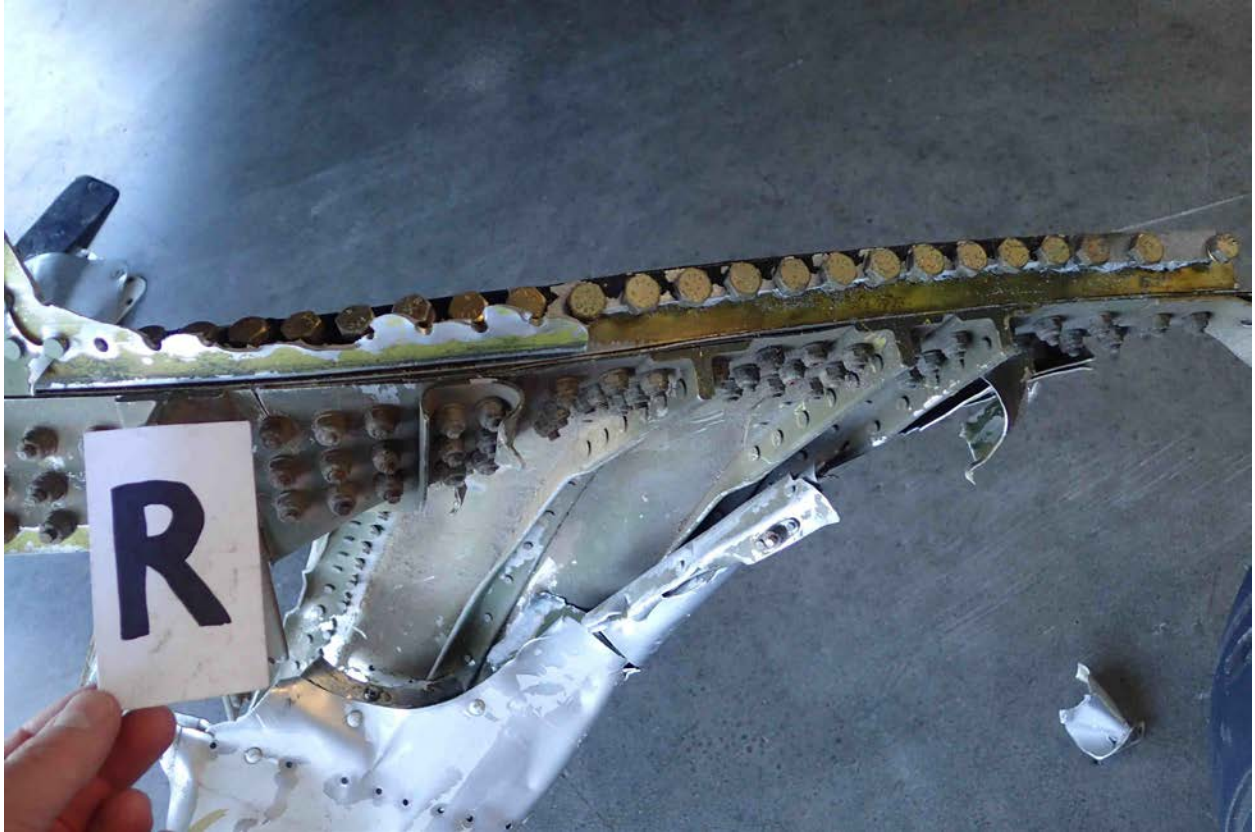
The wing attach points were examined for indications of failure of the angle attach brackets described in FAA Airworthiness Directive 2005-12-51. The lower angle bracket had peeled away from the center section, and remained attached to the lower wing skin. All separations were observed traversing through the bolt holes, and the entire area was free of indications of corrosion (Photo 20, 21). At the wing center section, the upper and lower skins appeared to have splayed open, consistent with forward impact. (Photo 22)

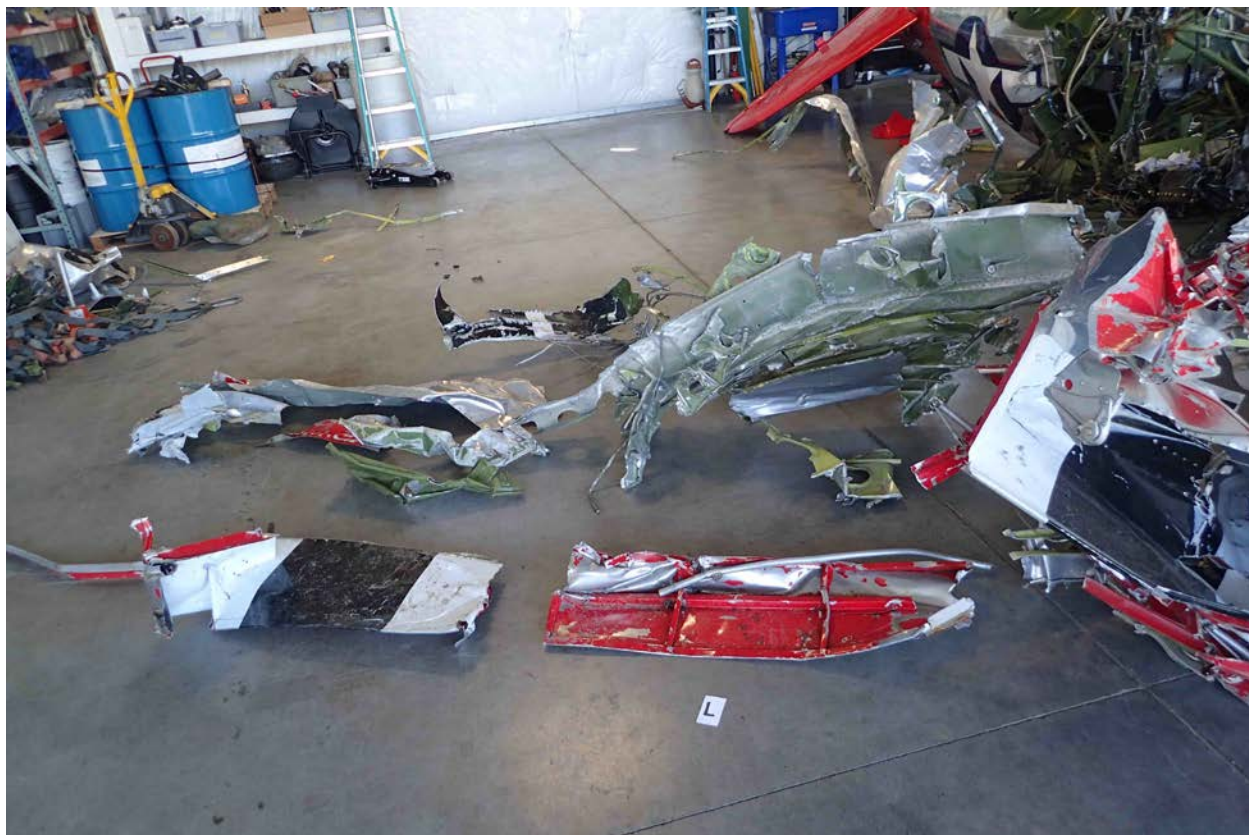
Photo 23 – Left Wing

The left wing had separated from the wing center section at the wing attach point. The wing sustained extensive fragmentation, with about 50% of all components recovered (Photo 23). The flap fragmented into three sections, with the inboard section folded upwards and attached at the wing root. The flap actuation rod had separated about midspan, and all three extension rods remained attached to their respective flap fittings.

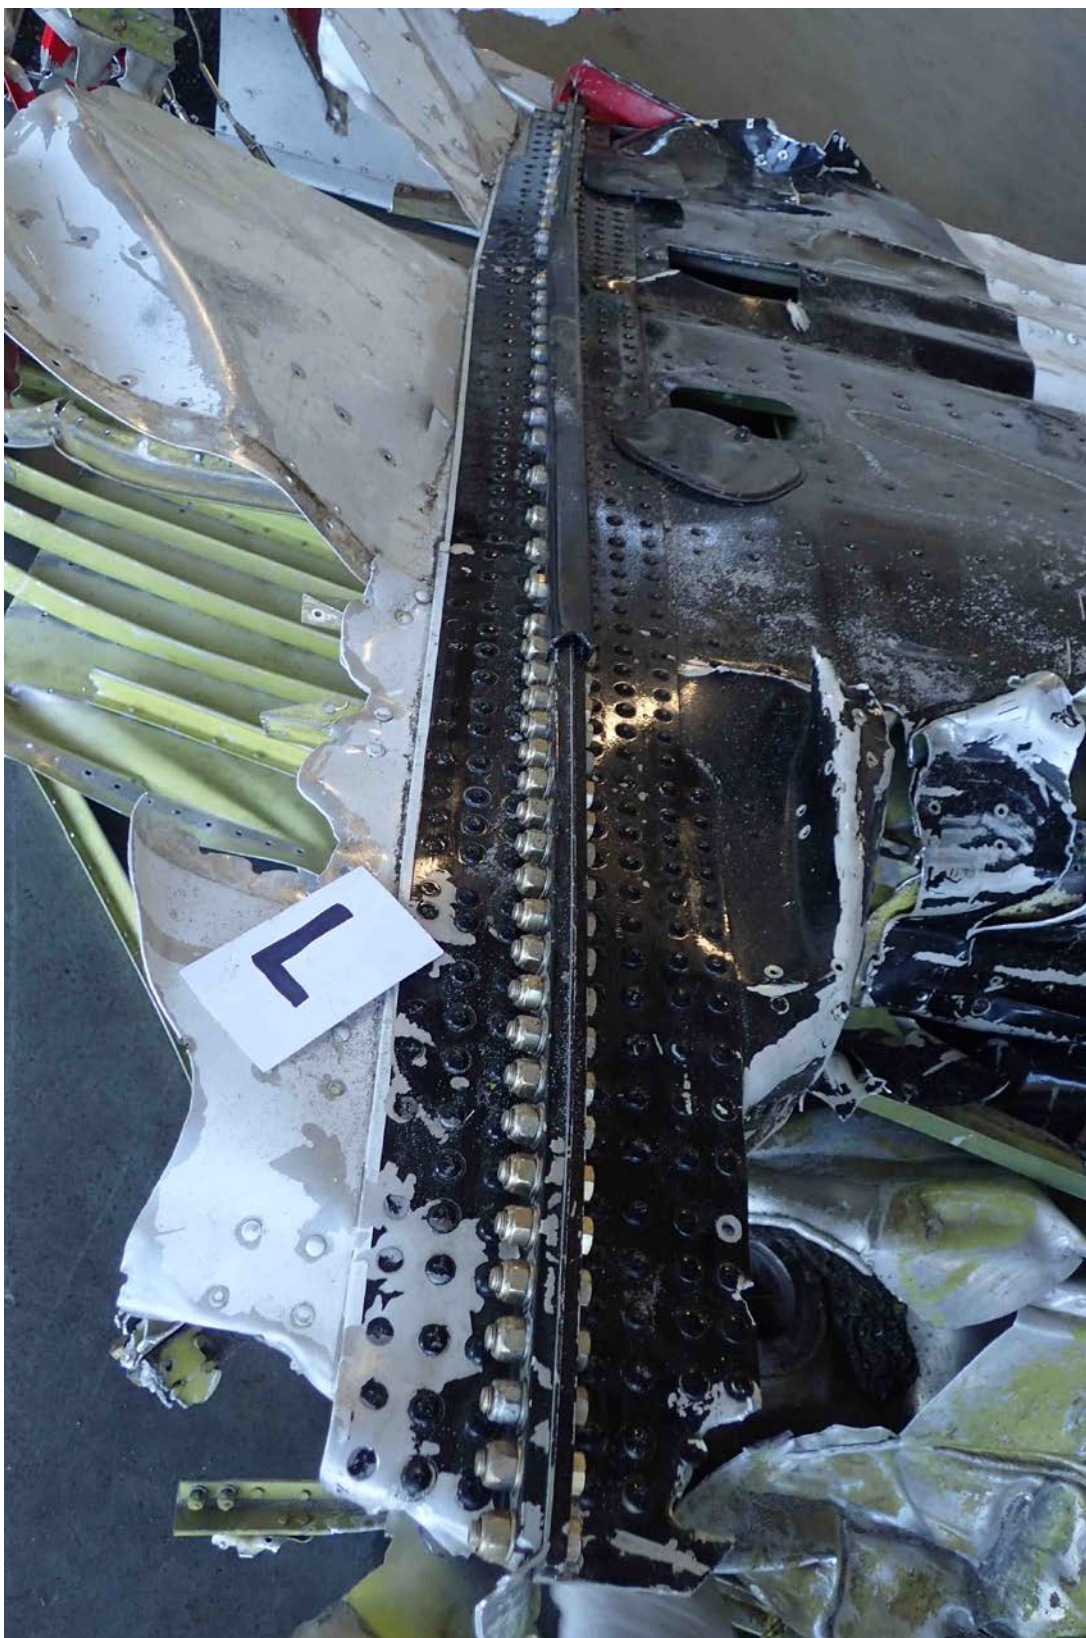
Photo 24 – Left Wing Root

The wing attach points were examined for indications of failure of the angle attach brackets described in FAA Airworthiness Directive 2005-12-51. The lower angle bracket remained intact and attached to the center section and the wing had separated outboard of the bracket (Photo 24). All separations were observed traversing either through the bolt holes, or wing skin, and the entire area was free of indications of corrosion. At the center section, the upper and lower skins appeared to have splayed open, consistent with forward impact (Photo 25).
