## **NATIONAL TRANSPORTATION SAFETY BOARD**

# **AIRFRAME AND ENGINE EXAMINATION**

**WPR16FA087**

Location: Astoria, Oregon  
Date: March 23, 2016  
Aircraft: North American AT-6A, N7055D  
NTSB IIC: Elliott Simpson

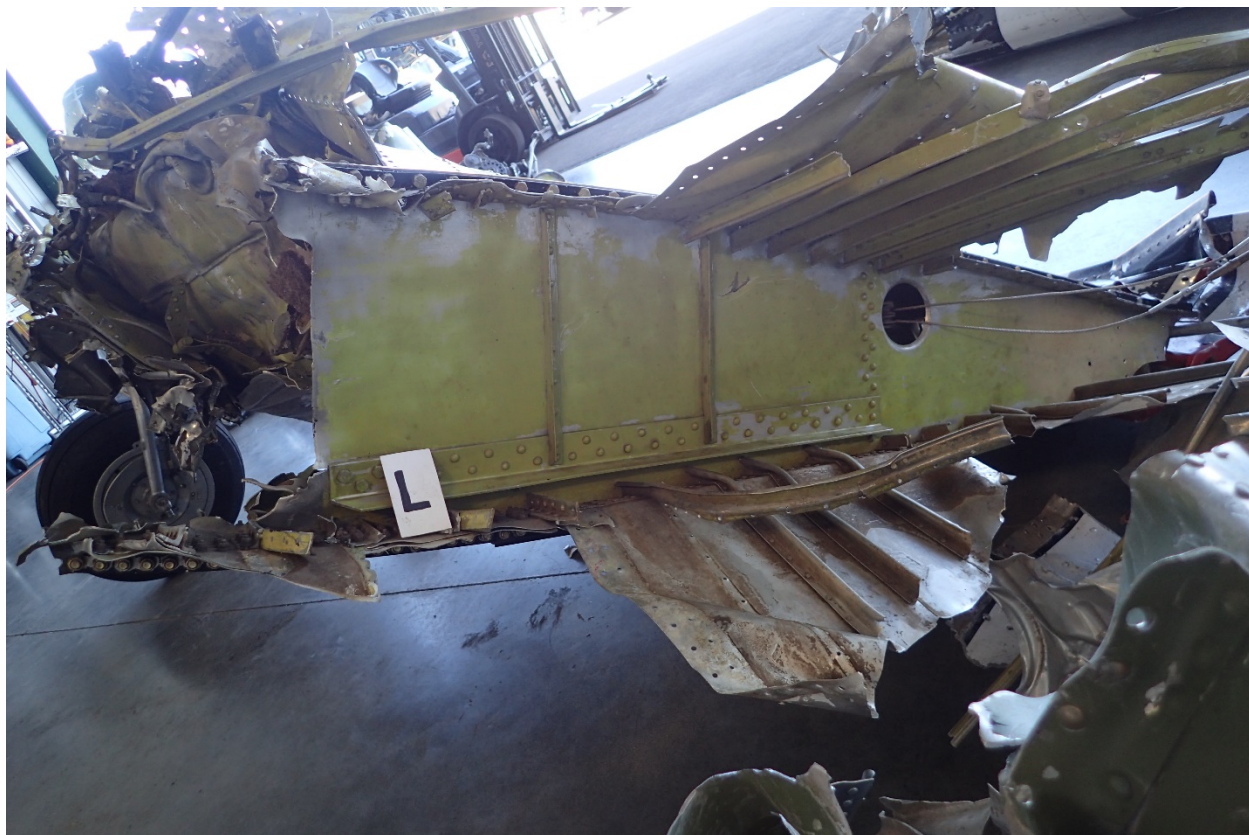
Photo 25 – Wing Root

The wing attach points were examined for indications of failure of the angle attach brackets described in FAA Airworthiness Directive 2005-12-51. The lower angle bracket remained intact and attached to the center section and the wing had separated outboard of the bracket (Photo 24). All separations were observed traversing either through the bolt holes, or wing skin, and the entire area was free of indications of corrosion. At the center section, the upper and lower skins appeared to have splayed open, consistent with forward impact (Photo 25).

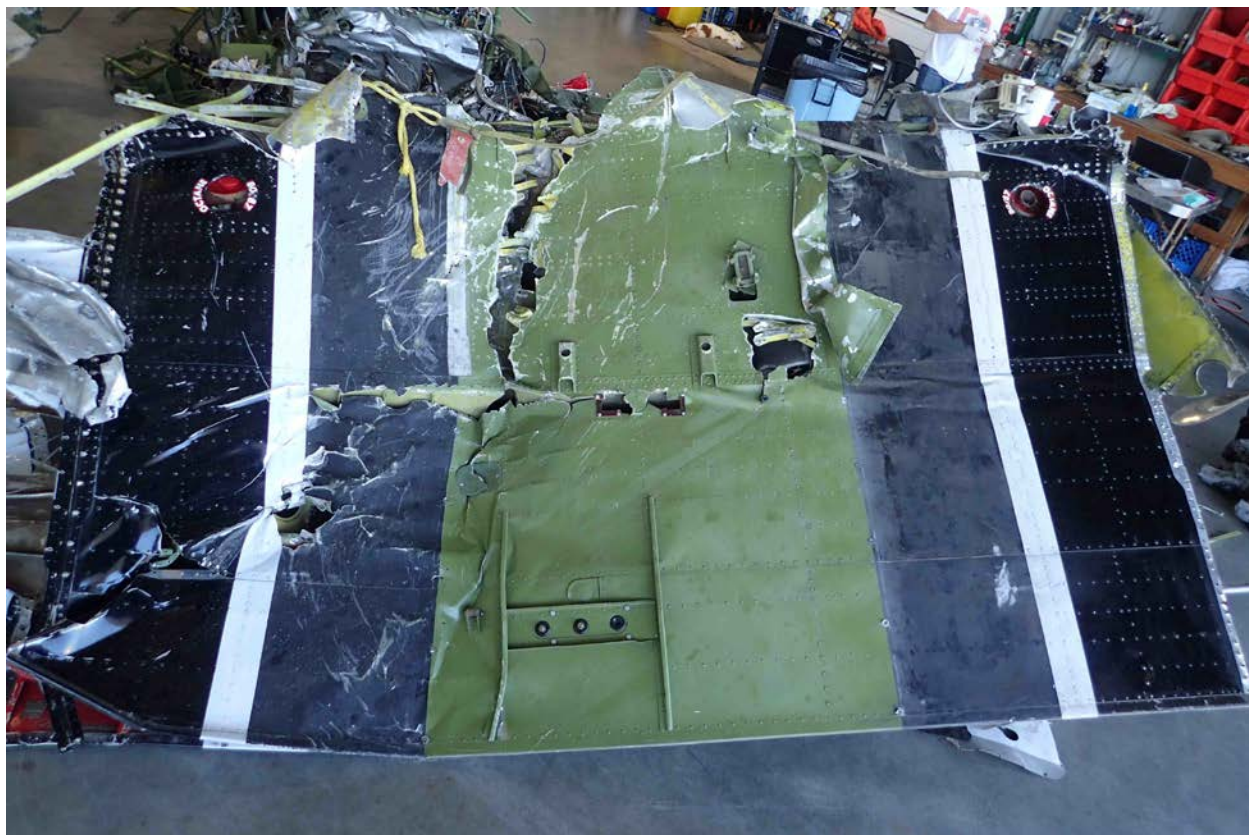
Photo 26 – Wing Center Section

The center section had separated from the airframe. The section exhibited leading edge crush damage, and was folded about 15 degrees upwards midspan (Photo 26). The right main landing gear remained attached to the box frame, and was in the extended position (Photo 27). The left main landing gear remained partially attached and separated during recovery, and was observed in the extended position (Photo 28). The right main landing gear wheel-well exhibited rubber transfer marks at the retracted tire location (Photo 29), consistent with the landing gear being retracted at impact. The landing gear actuation rod exhibited about 4 inches of extension and was bent; the lockout latch was open, consistent with the retracted landing gear position. Examination of recovery photos indicated that the center section was recovered by pulling the airplane out by the landing gear.

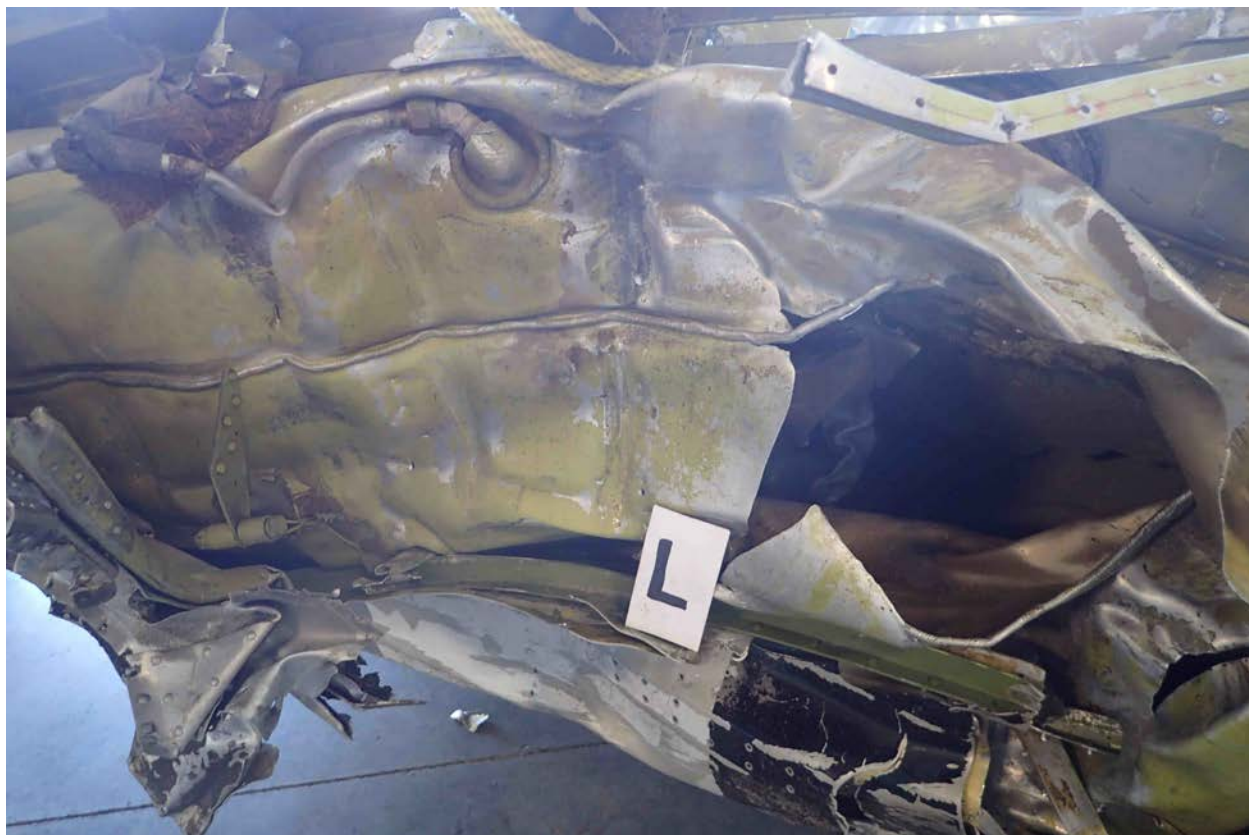
Photo 30 – Left Fuel Tank

The left fuel tank cap was in place at the filler neck, the entire leading edge and underside of the tank was breached (Photo 30). The right tank cap was missing, and the tank exhibited crush marks but was largely intact. The smell of aviation gasoline was present throughout the area of the wing center section.

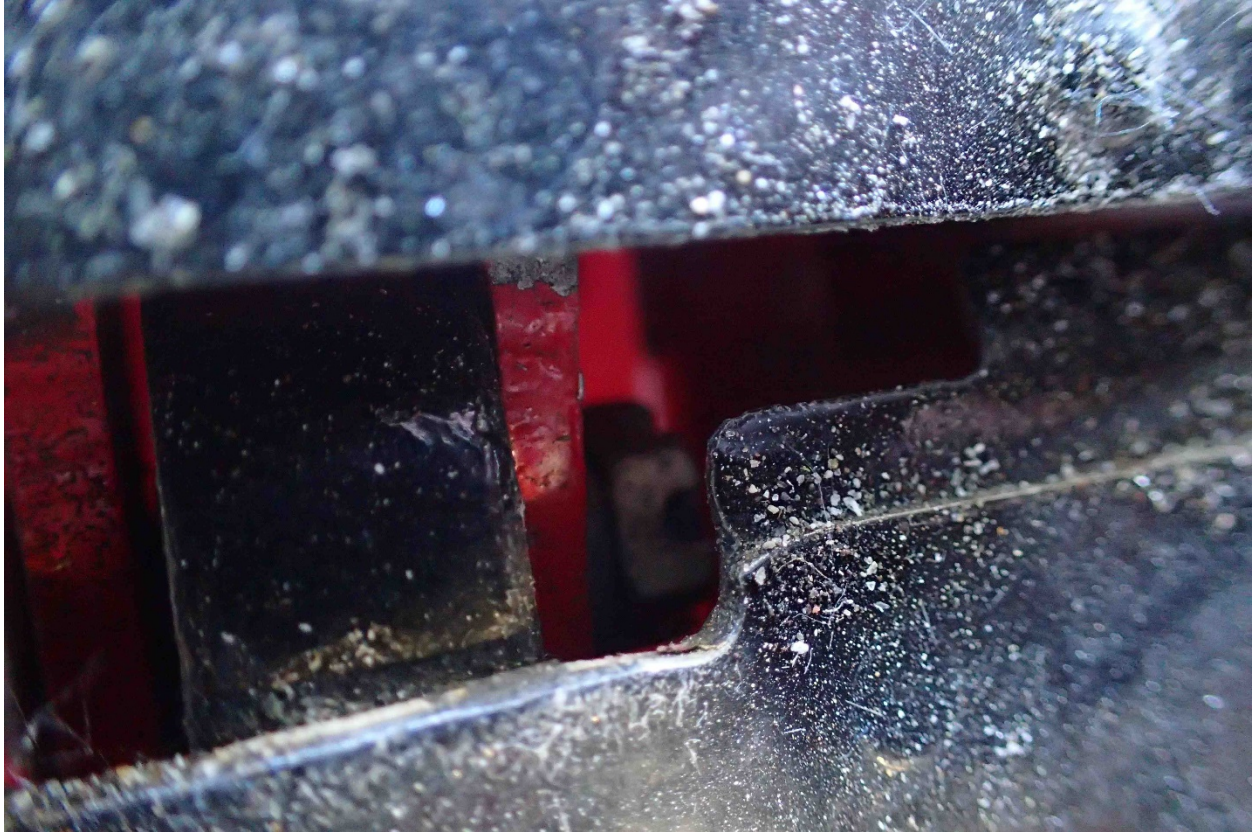
Photo 31 – Flap Hinge Bolt Without Cotter Pin

The center flap appeared to be in the retracted position when recovered (Photo 66) and remained attached at both of its outboard hinges, which were secured with castellated nuts, although no cotter pins were present (Photo 31). Two outboard flap extension pushrods were undamaged, and remained attached to the actuator rod and flap (Photo 67, 68). Both the right inboard and center section hinge bolts and nuts were not located (Photo 32, 33). The left inboard hinge tang on the outboard side had bent about 45 degrees out, and the flap casting had partially detached with dull

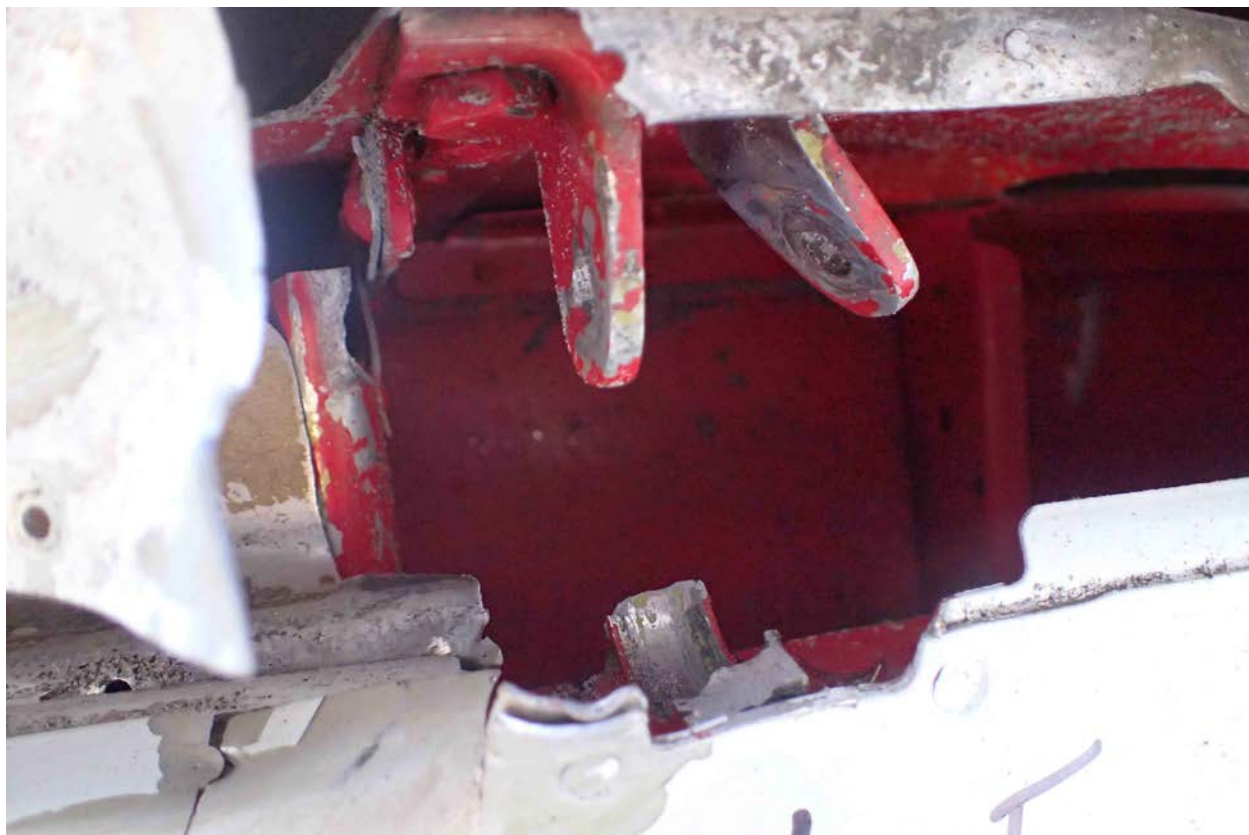
Photo 34 – Left Inboard Flap Hinge

granular surface features (Photo 34). The piston rods on both sides of the hydraulic flap actuator were in the extended position (Photo 69), and the flap actuator control arm was angled about 30 degrees relative to the longitudinal axis (Photo 70). When compared to an exemplar AT-6 flap actuating system, these setting appeared consistent with retracted flaps (Photo 71).

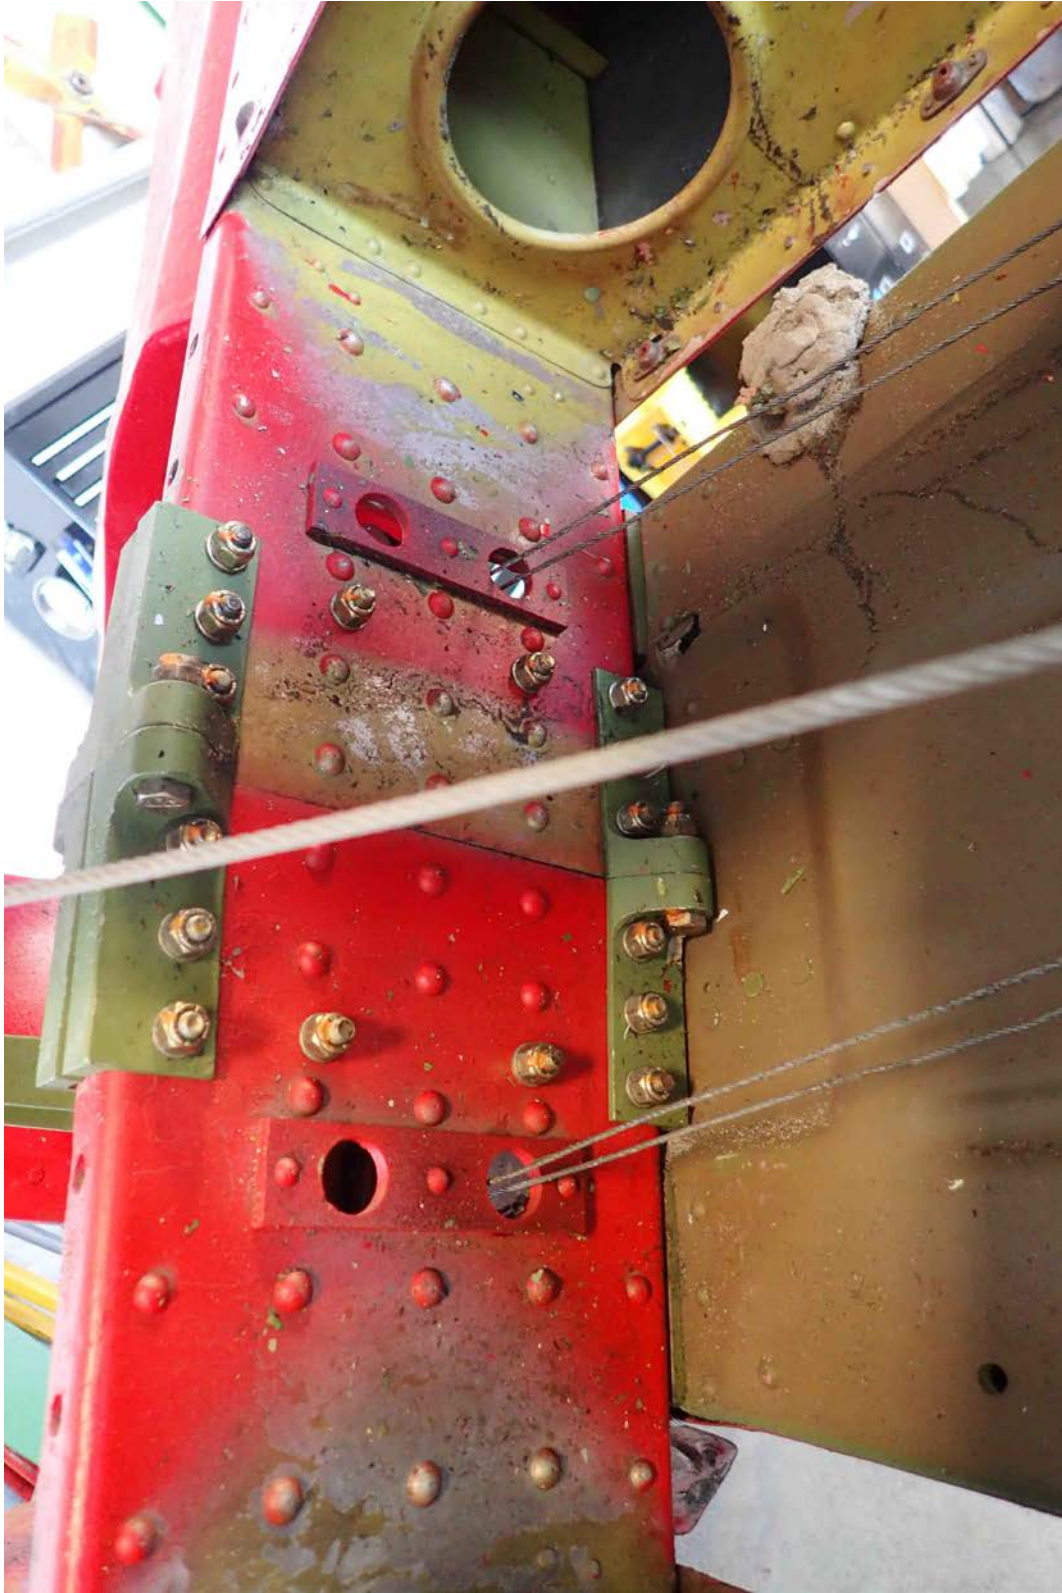
Photo 35 – Horizontal Stabilizer Root Fittings

The horizontal stabilizer remained attached to the airframe at its forward and aft spar attach fittings (Photo 35). The right elevator remained attached to the horizontal stabilizer at its hinge points. The left elevator remained attached at the inboard hinge, and had folded aft about midspan, separating from its hinge, which exhibited dull granular surfaces features at the separation point. The inboard section of the left elevator sustained a three-inch-deep indentation to its leading edge (Photo 36).

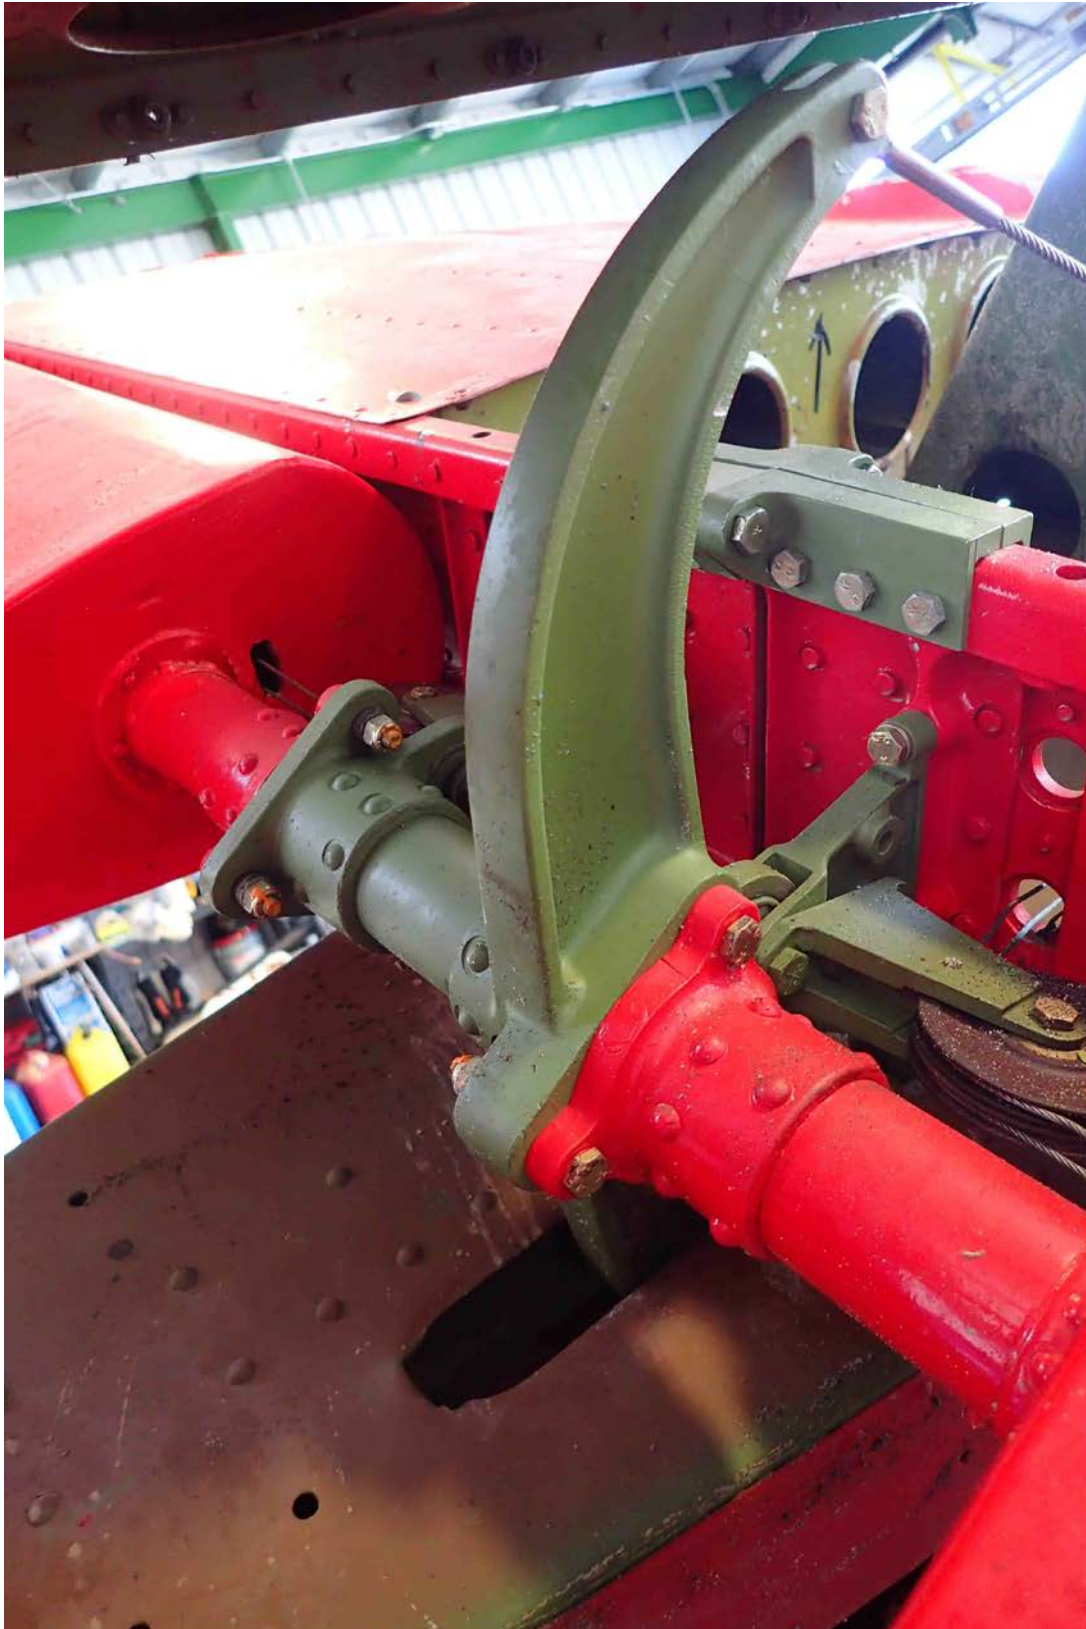
Photo 37 – Elevator Control Horn

The control horn remained attached to the elevator torque tube, which was still attached to the elevators (Photo 37). Evidence of elevator over-travel was observed to the deck skin in the tailcone, where the elevator horn appeared to have peeled the skins back (Photo 38). The upper elevator control cable was continuous through the aft fitting on the forward control stick. The lower control cable was continuous through to the forward cabin, and had separated about 4 ft from the forward fitting on the forward control stick. The remainder of the cable was intact and attached to the control stick fitting. The cable had separated with "broomstraw" features (Photo 39).

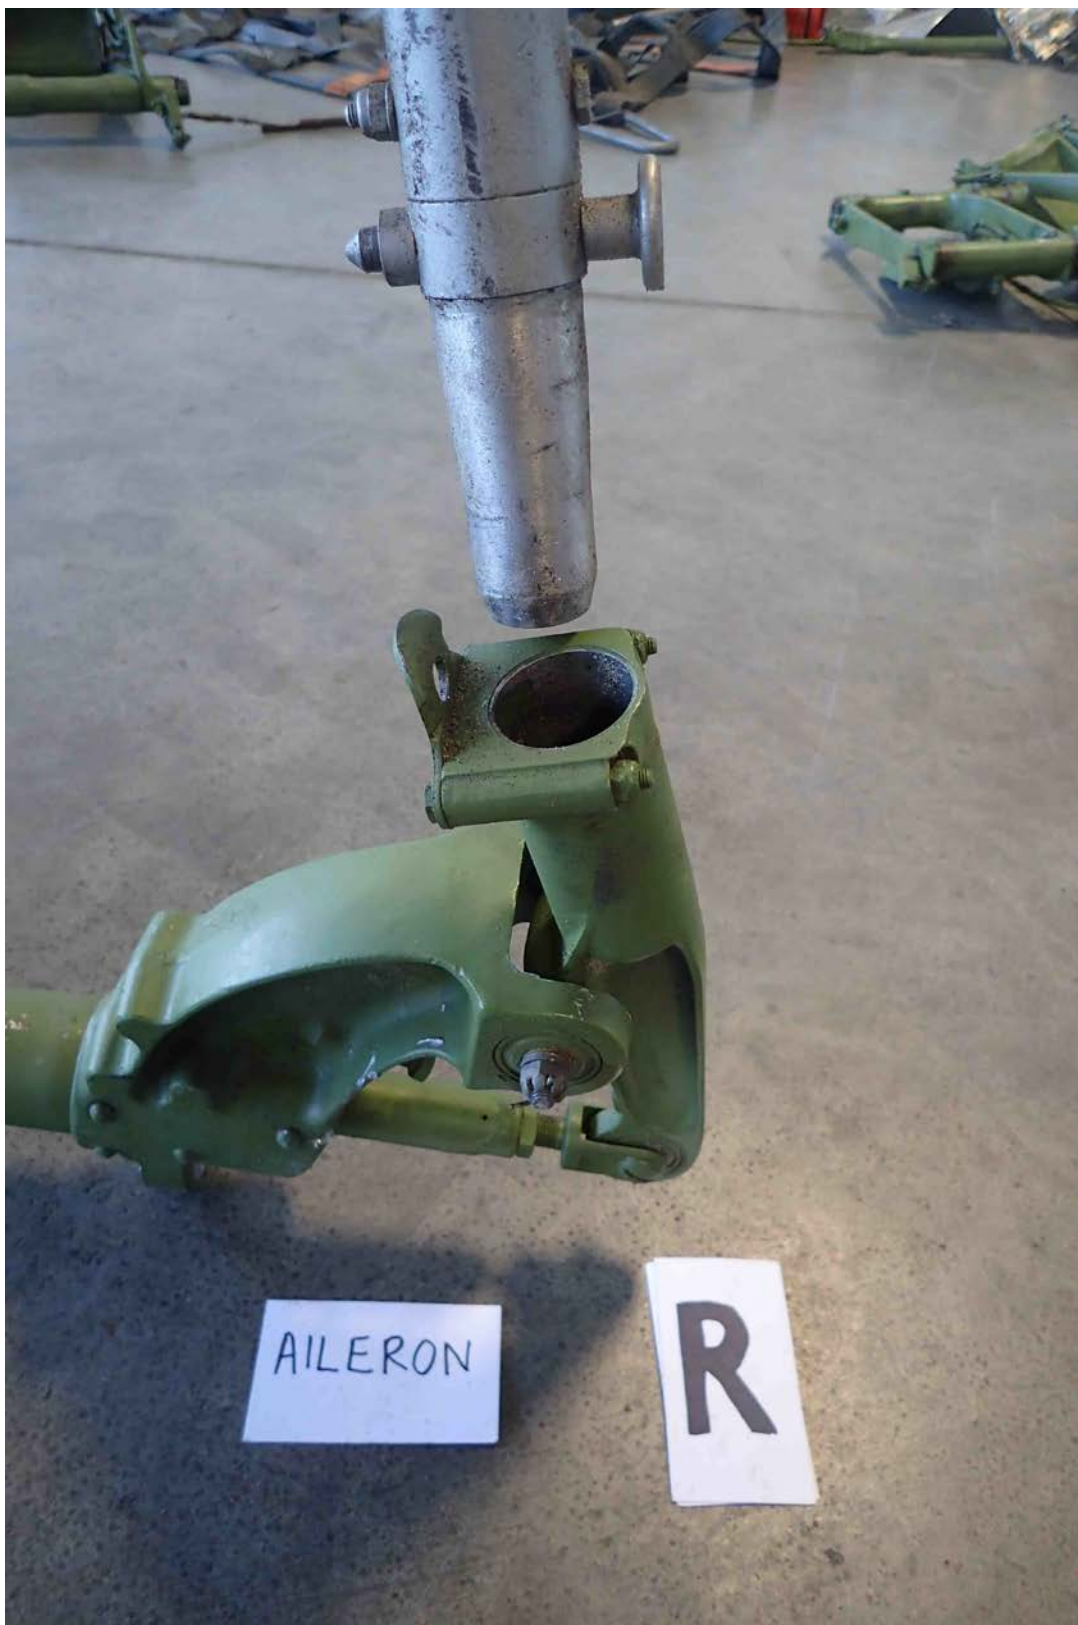
Photo 40 – Rear Control Stick Assembly

The rear control stick assembly including the fore-aft torque tube and elevator for-aft pushrod had separated from the airframe at the rear roll bearing (Photo 40). The forward section of the control stick assembly remained attached to the airframe at the forward roll bearing. The roll and elevator tubes remained attached to the rear control stick, but had both separated at the forward stick, bending aft at the separation point. The left aileron control arm had separated aft at the torque tube fitting, and remained attached to both aileron control cable fittings (Photo 41). The right aileron control arm remained attached, but was bent about 5 degrees aft (Photo 41). The aft cable attach tang had separated (Photo 42) from the left side of the control arm, and neither control cable eyebolt fitting was attached, and the bolt was not located. The separation surface exhibited dull granular features.

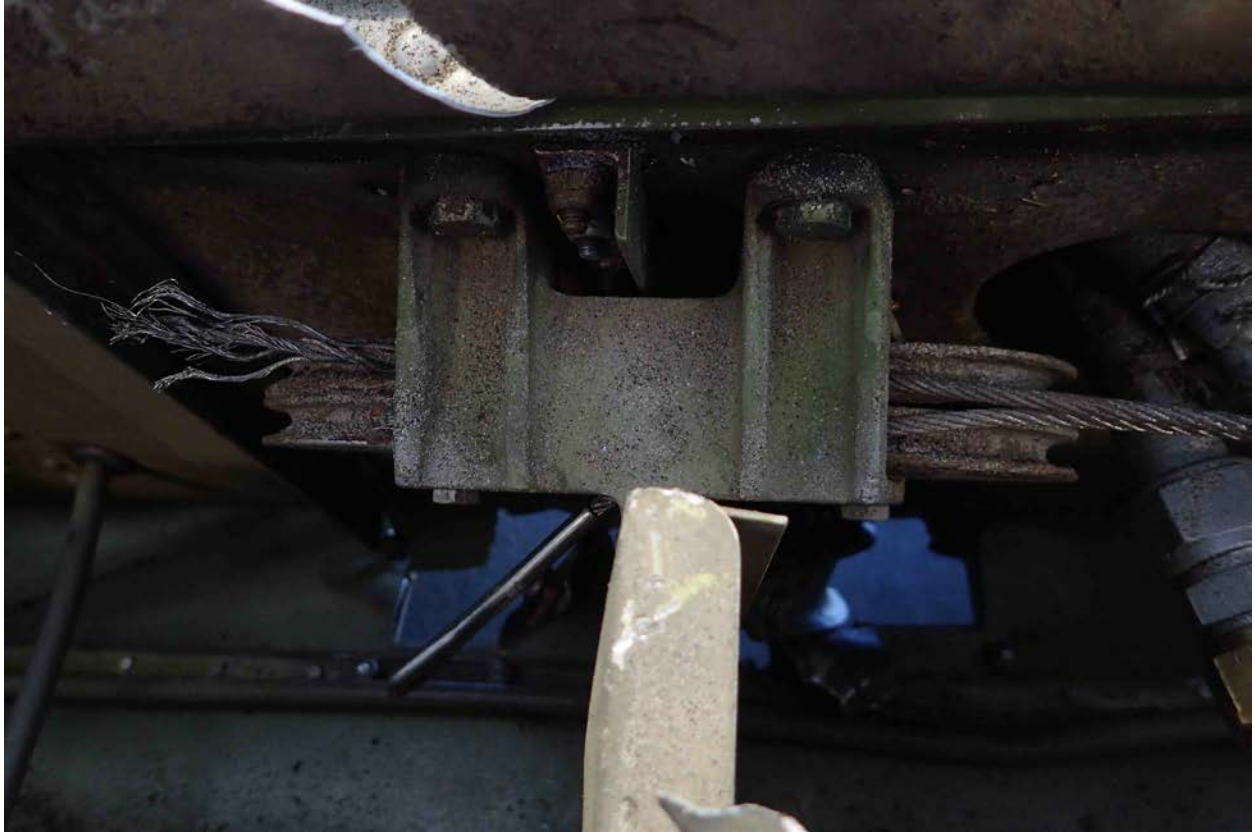
Photo 43 – Aileron Pulley

The aileron pulley assembly, located in the wing center section, remained attached to the center spar, and had been pulled away from the rivets at the center rib (Photo 43). The right control arm eyebolt cable fittings had been partially pulled through the pulley wheels (Photo 43). The separated

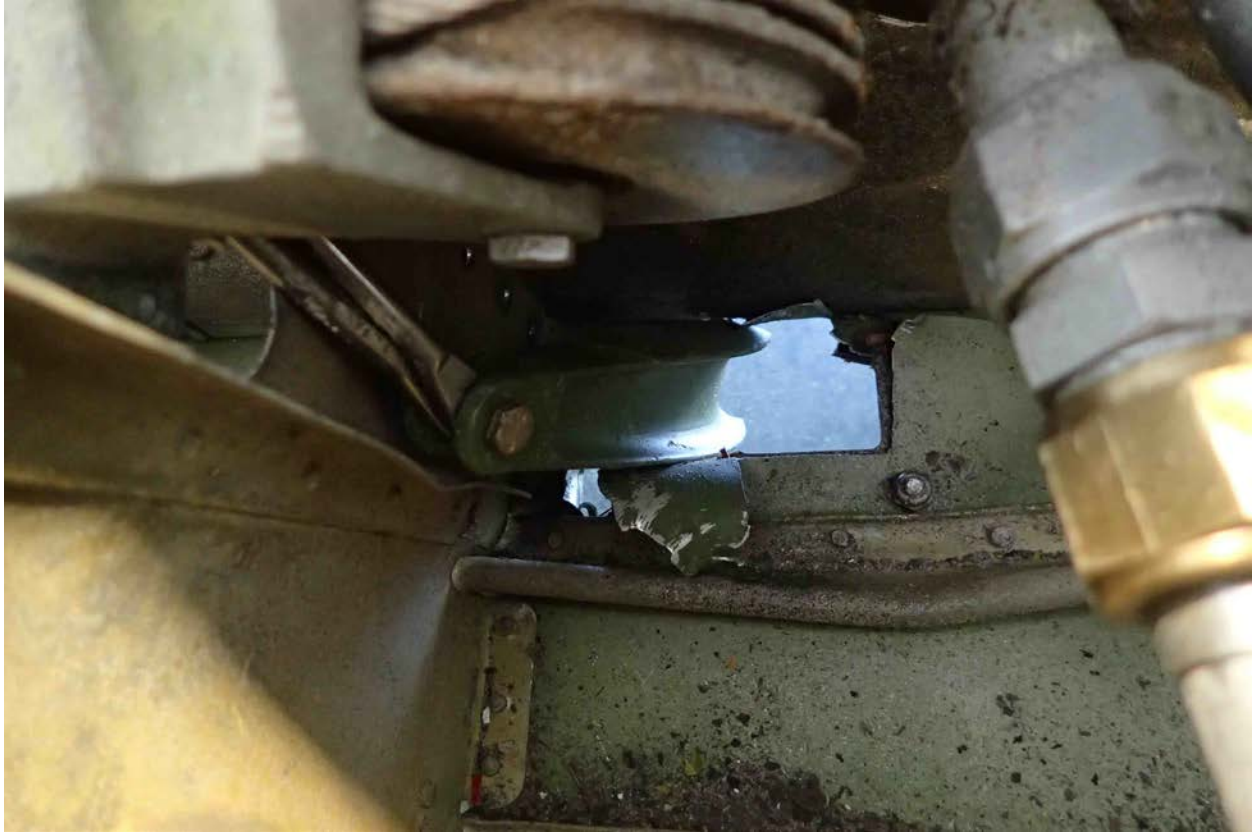
Photo 44 – Left Aileron Control Arm Cable

left control arm cable was continuous through to the left aileron bellcrank, the other cable had separated about 5 inches from its eyebolt fitting on the arm (Photo 44).

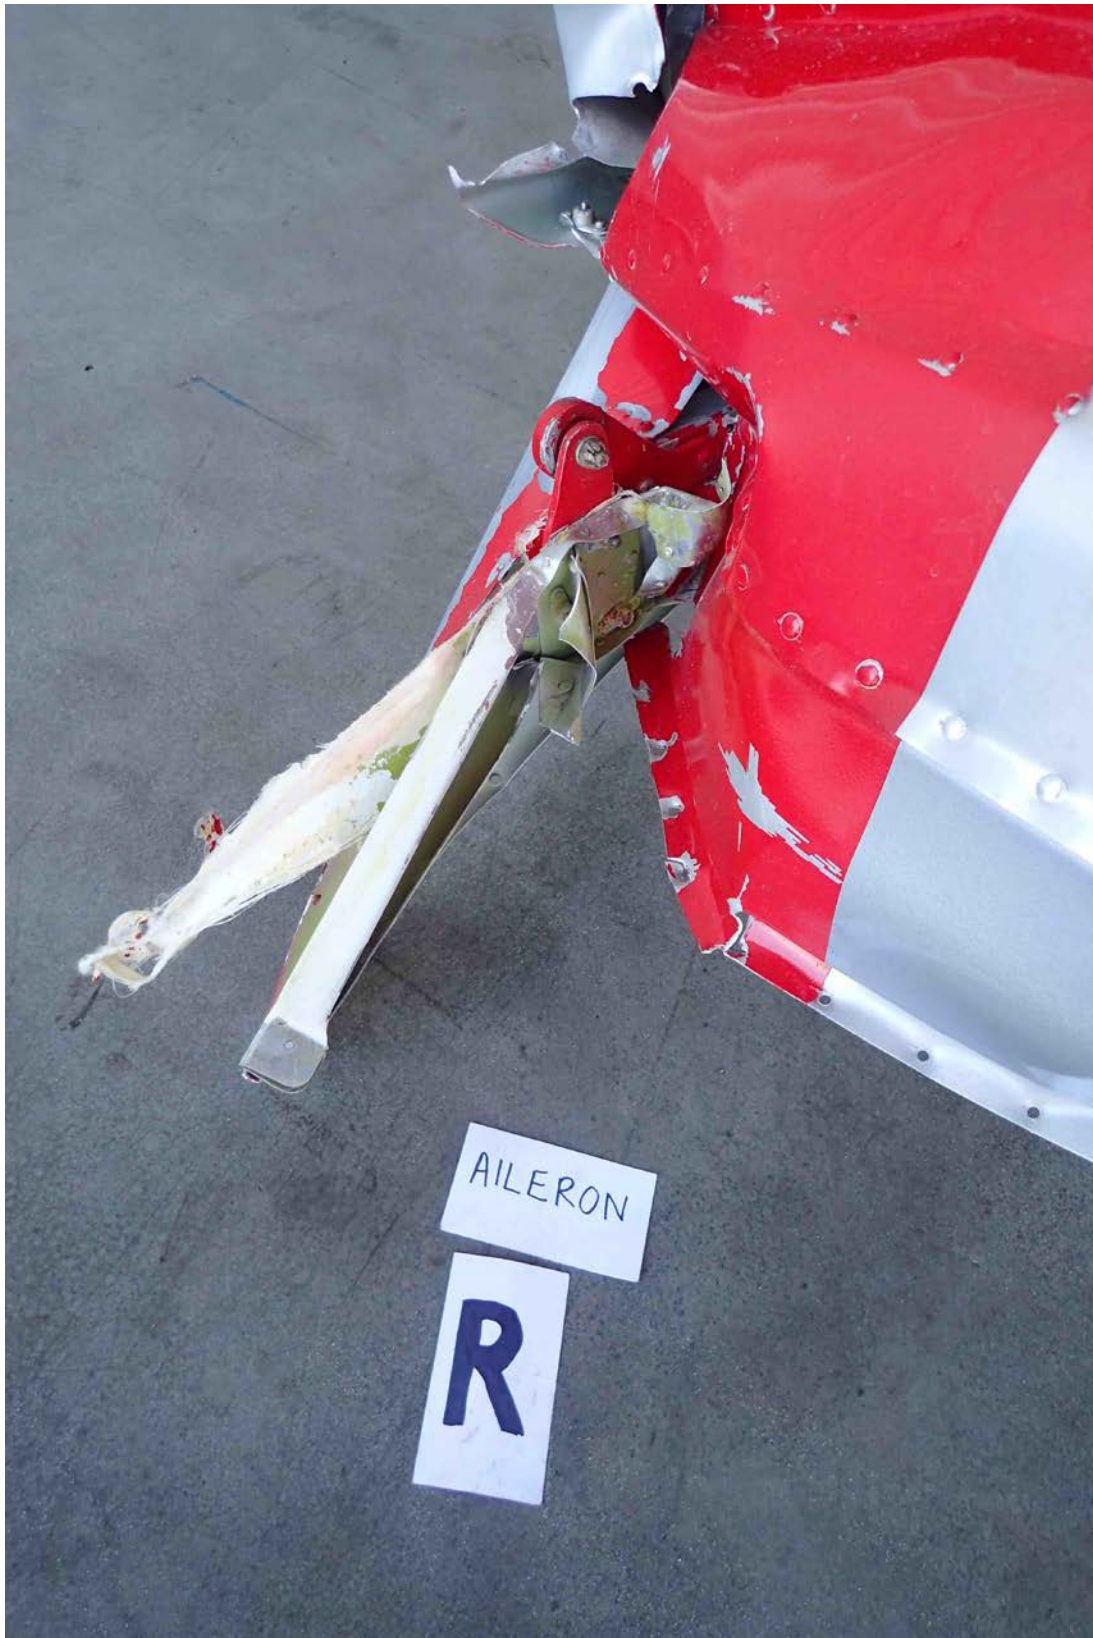
Photo 46 – Right Aileron Remnants

The right wing aileron cables had both separated from their eyebolts at the center pulley assembly. Beyond the breaks, the cables were continuous through to the aileron bellcrank. The bellcrank remained attached to its stringer and rib fittings within the wing and the entire assembly remained partially attached to the inside of the crushed wing (Photo 45). The control rod remained attached to the bellcrank, and had separated from the aileron. The only recovered piece of the aileron was the outboard aileron rib, which remained attached to its hinge and the wing training edge spar (Photo 46).

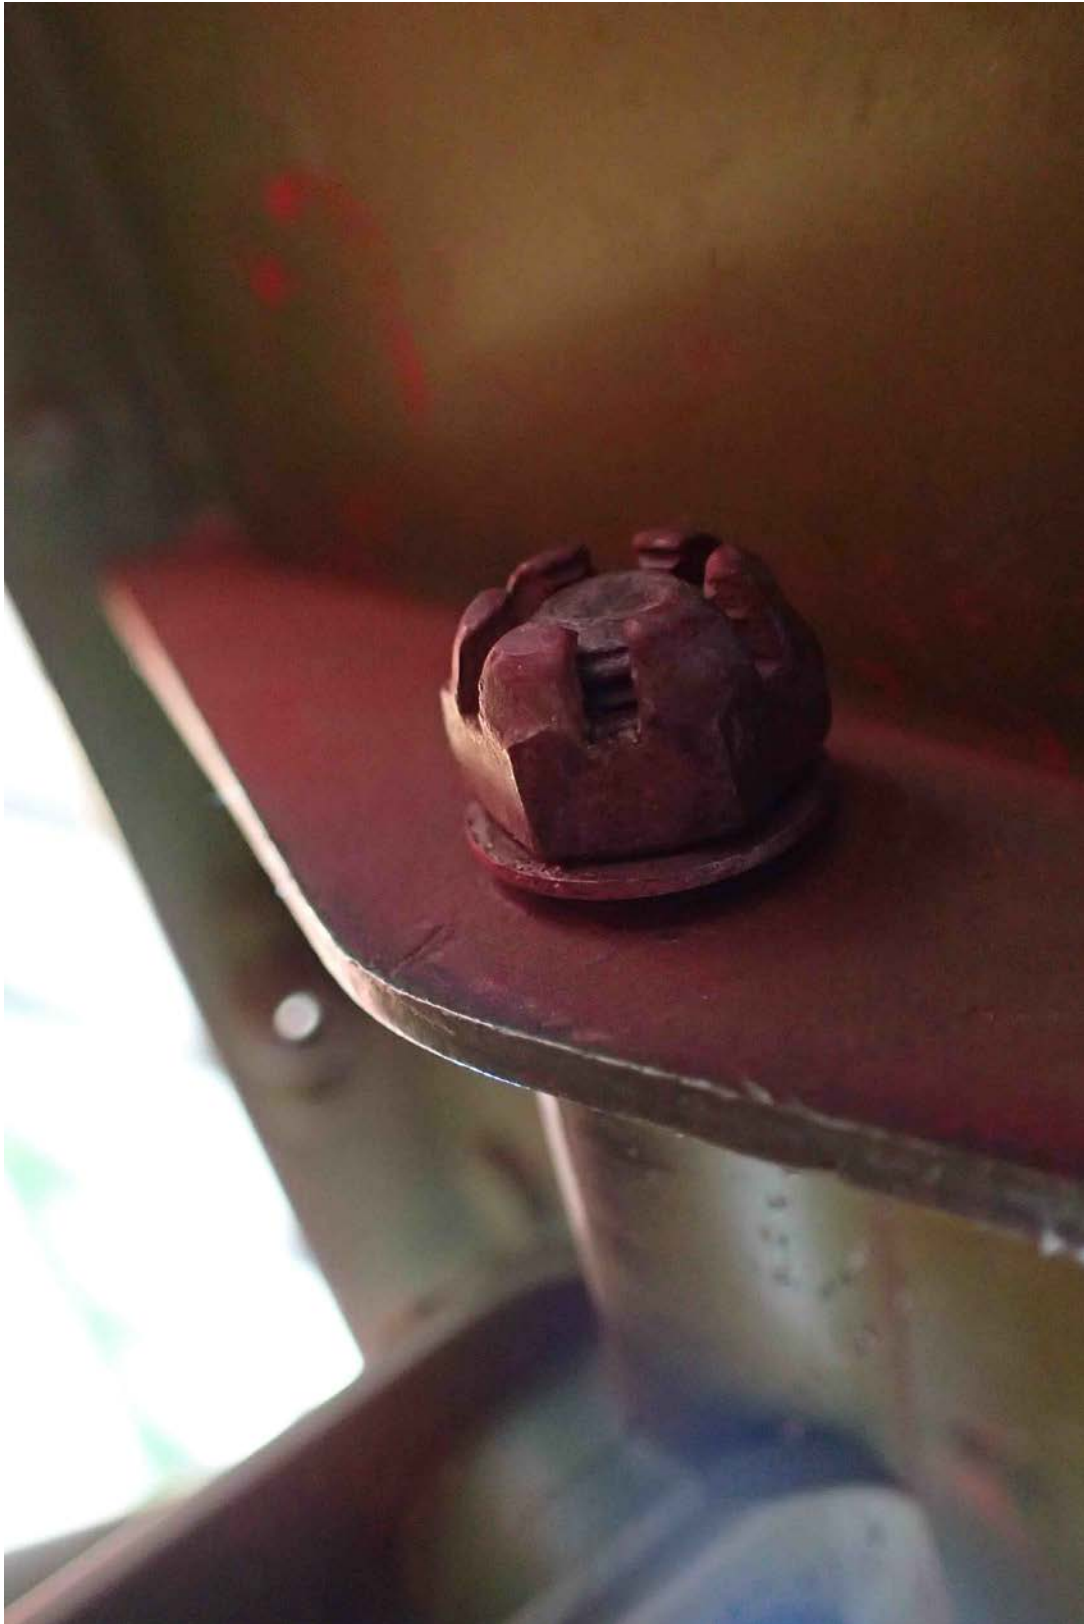
Photo 47 – Vertical Stabilizer Mounting Bolt

The vertical stabilizer remained attached at the forward spar to the pylon, however the castellated nut on the forward-aft mounting bolt was finger tight, and about 3 threads short of correct installation, and no cotter pin was present (Photo 47). The aft spar had spilt across its full length, just below the lower rib, with the rudder bending to the left.

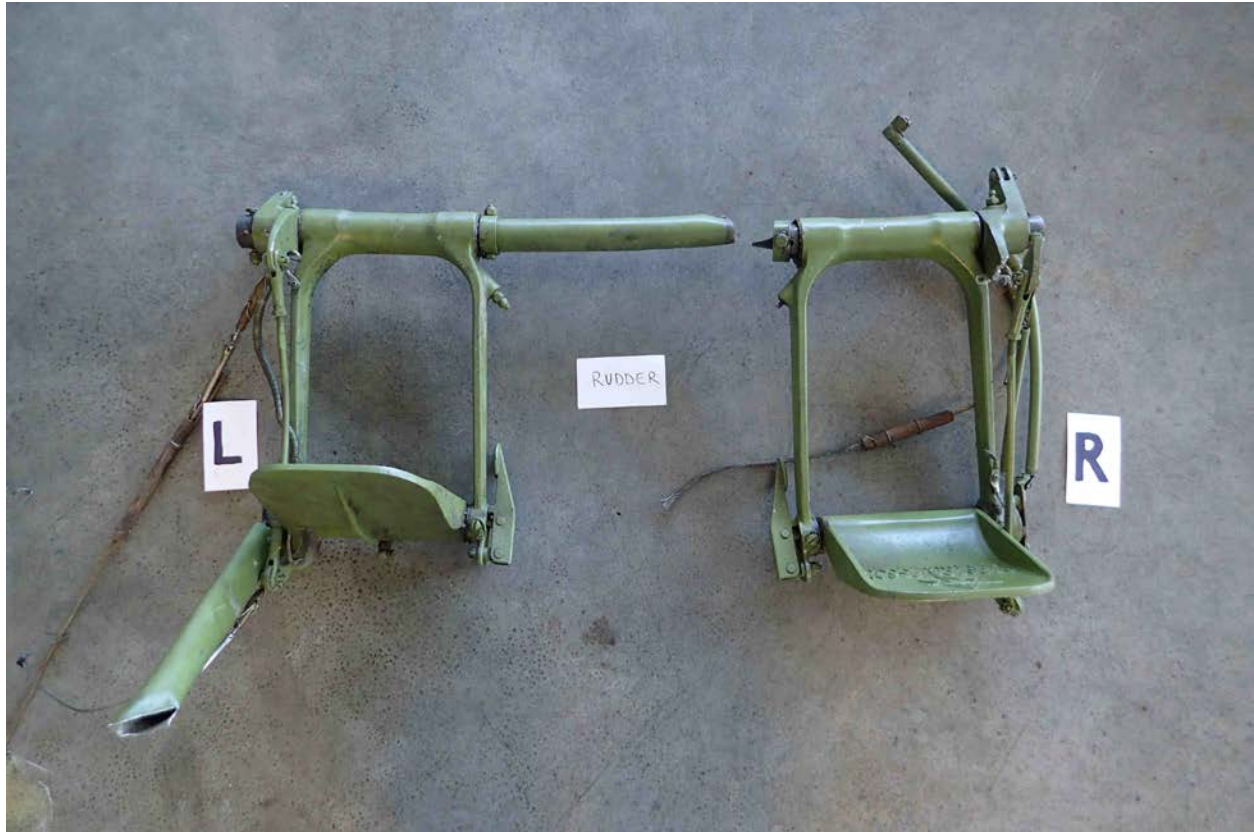
Photo 50 – Rear Rudder Pedal Assembly

The rudder remained attached to the aft spar of the vertical stabilizer at all three hinges. The control cables remained attached to the rudder horns and were continuous through the tail bellcranks and then through to the forward rudder pedal for-aft tube fittings. The forward rudder pedal assembly had broken away from the airframe at its mounting lugs, and the right pedal had separated from the torque tube (Photo 48, 49). The for-aft rudder interconnect tubes had fragmented, and separated from the front pedal attach fitting. The rear rudder pedals had separated from the airframe, and the right pedal had separated from the torque tube (Photo 50). Both brake cables remained attached to the pedals (and were cut by recovery).

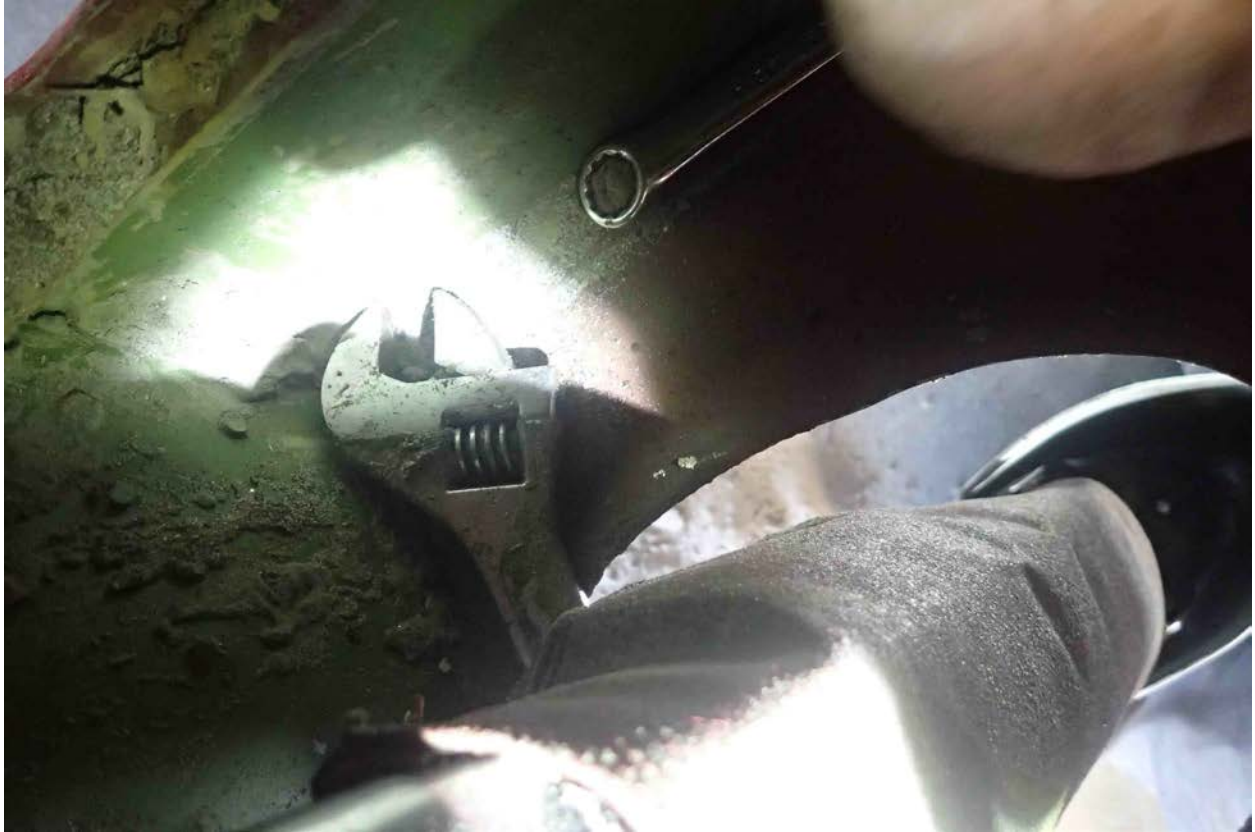
Photo 51 – Tools Found Within Tailwheel Well

A 10-inch crescent wrench (with an opening set to about 9/16 inches), along with a 9/16 wrench were found loose within the tailwheel well area above the tailwheel assembly, and below the horizontal stabilizer main spar attach points (Photo 51). The rudder cables passed through this "box" area, along with the lower elevator horn. Just forward of the box, a 3-inch-long 9/16th bolt was located. (Photo 52, 53).

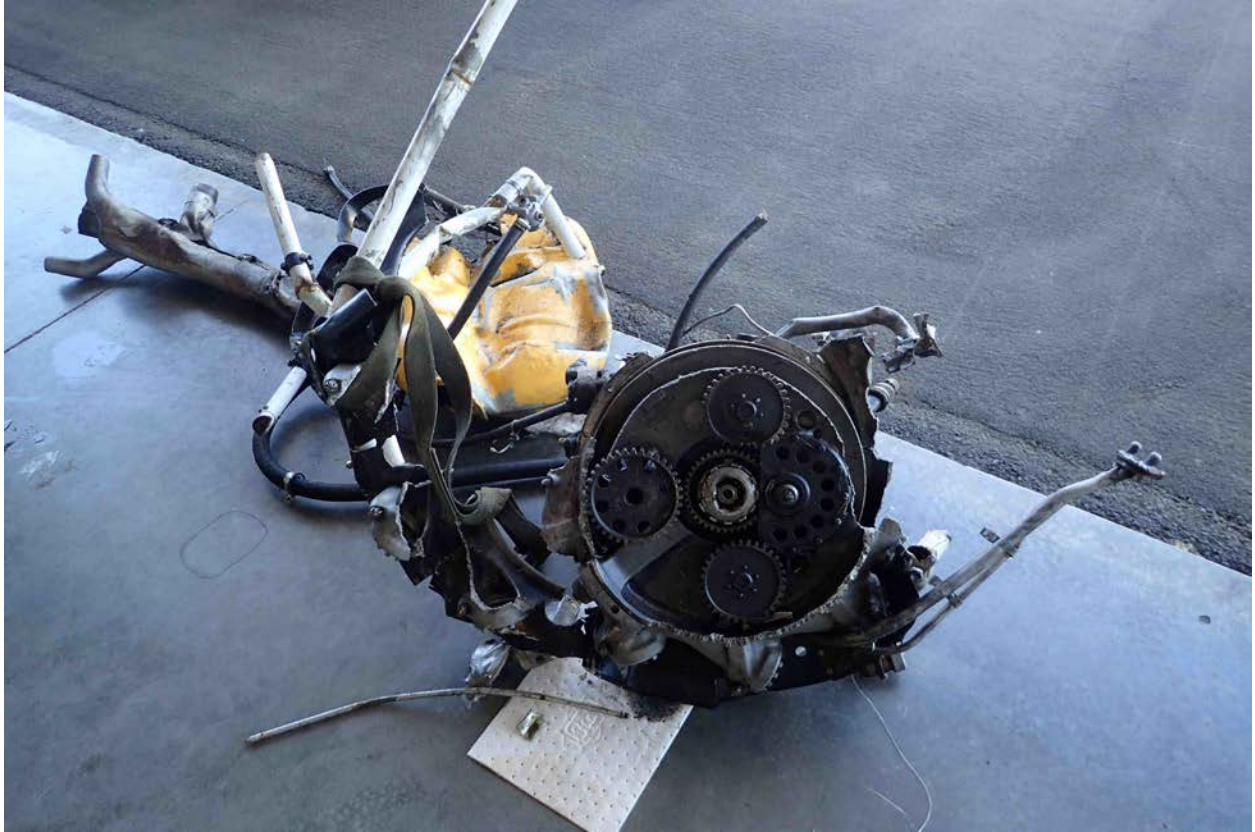
Photo 54 – Engine Accessory Case

The engine separated from the blower/accessory case, which remained attached to the engine mount (Photo 54). The engine mount was twisted and buckled, and had separated from the airframe. The accessory gears were exposed, and although exhibiting deformation damage, all teeth were intact, the area was wet with oil, and there were no indications of catastrophic failure (Photo 54). The carburetor and both magnetos had separated from the engine, and neither was located.

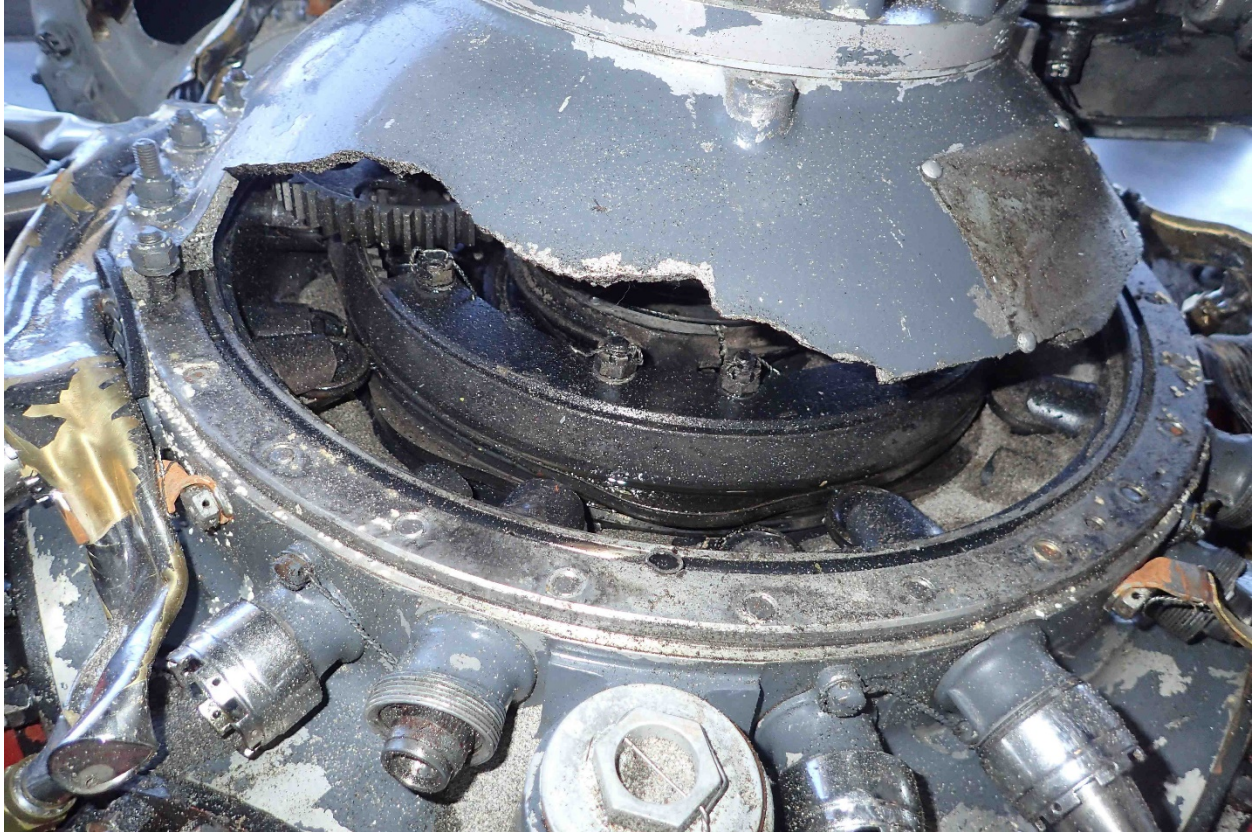
Photo 55 – Forward Engine Gearbox

The forward engine gearbox cover had fragmented, exposing the cams and followers. All gear teeth were intact, the area was wet with oil, and there were no indications of catastrophic failure (Photo 55). Cylinders one and nine had separated aft, with each piston resting undamaged within their respective bores in the "pineapple" crank case (Photo 56). The cylinder bolt heads had all separated from the bolts, which exhibited aft bending damage and were still in place in the crankcase. The majority of the forward cooling fins on the aluminum portions of cylinder's one, two, three, four, five, six, and nine had separated (Photo 57). All engine pushrods were separated with the exception of cylinder seven exhaust and induction, along with cylinder four and six exhaust, and eight induction, which all exhibited aft crush damage. All spark plug leads were severed and separated, and all spark plugs sustained varying degrees of bending damage. The rear spark plugs for cylinders three, four, and five along with the front spark plugs for the remaining cylinders were removed. All electrodes were dark in color, and exhibited wear signatures normal operation and short service life when compared to the Champion AV-27 Check-A-Plug chart (Photo 58, 59).
