## **NATIONAL TRANSPORTATION SAFETY BOARD**

# **AIRFRAME AND ENGINE EXAMINATION**

**WPR16FA087**

Location: Astoria, Oregon  
Date: March 23, 2016  
Aircraft: North American AT-6A, N7055D  
NTSB IIC: Elliott Simpson

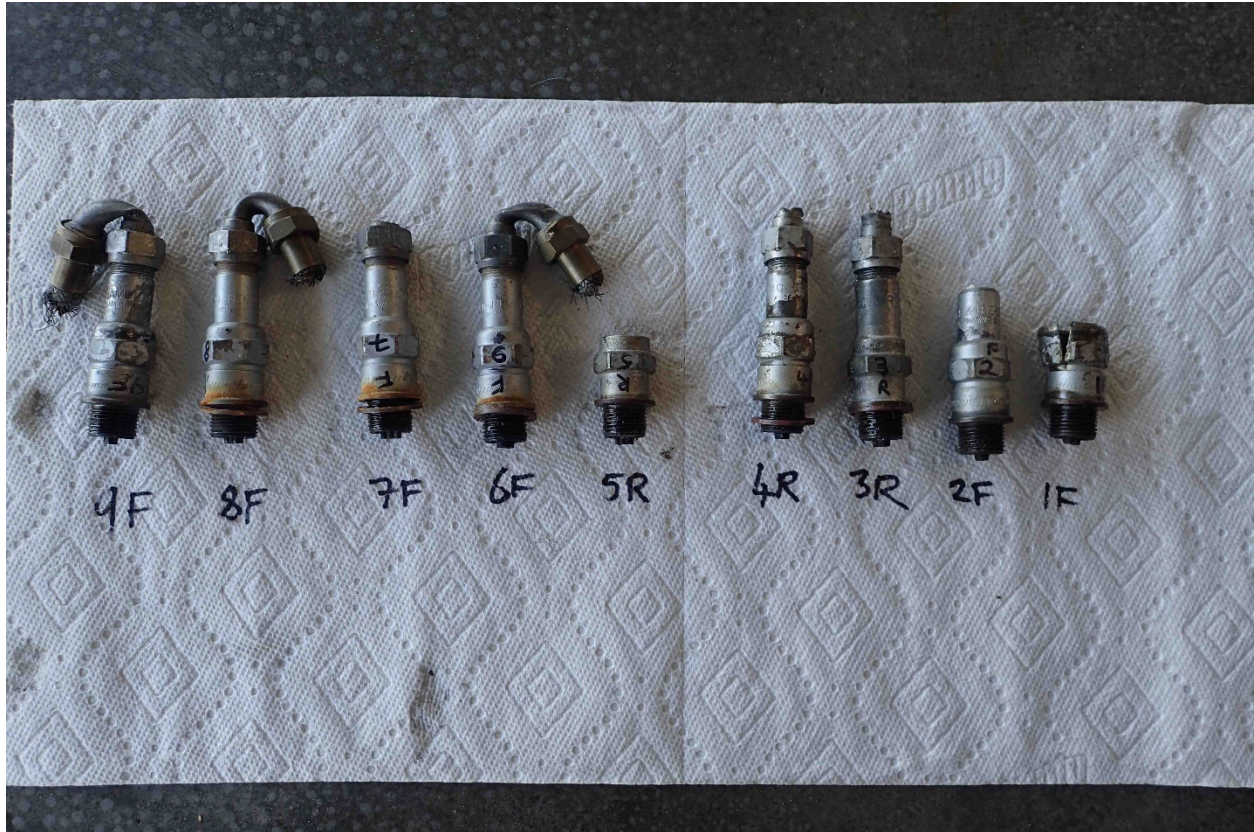
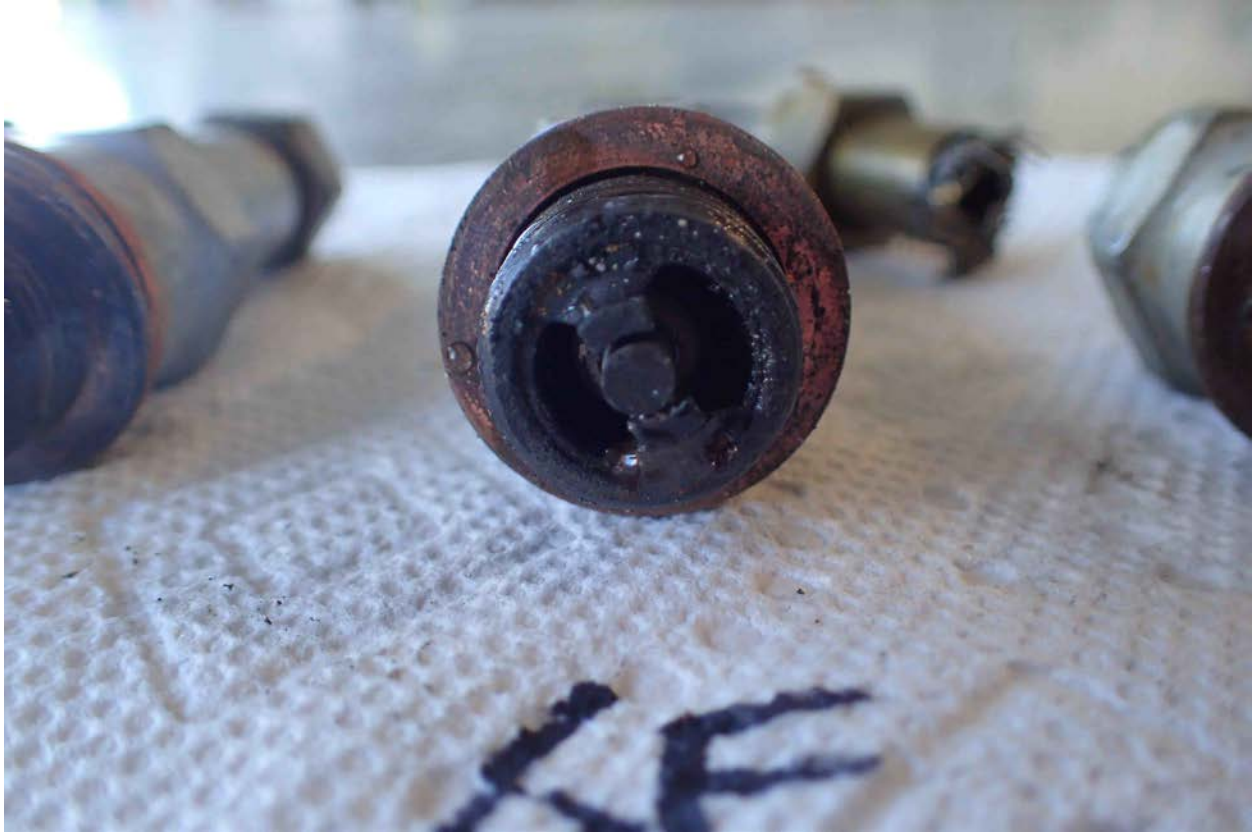
The forward engine gearbox cover had fragmented, exposing the cams and followers. All gear teeth were intact, the area was wet with oil, and there were no indications of catastrophic failure (Photo 55). Cylinders one and nine had separated aft, with each piston resting undamaged within their respective bores in the "pineapple" crank case (Photo 56). The cylinder bolt heads had all separated from the bolts, which exhibited aft bending damage and were still in place in the crankcase. The majority of the forward cooling fins on the aluminum portions of cylinder's one, two, three, four, five, six, and nine had separated (Photo 57). All engine pushrods were separated with the exception of cylinder seven exhaust and induction, along with cylinder four and six exhaust, and eight induction, which all exhibited aft crush damage. All spark plug leads were severed and separated, and all spark plugs sustained varying degrees of bending damage. The rear spark plugs for cylinders three, four, and five along with the front spark plugs for the remaining cylinders were removed. All electrodes were dark in color, and exhibited wear signatures normal operation and short service life when compared to the Champion AV-27 Check-A-Plug chart (Photo 58, 59).

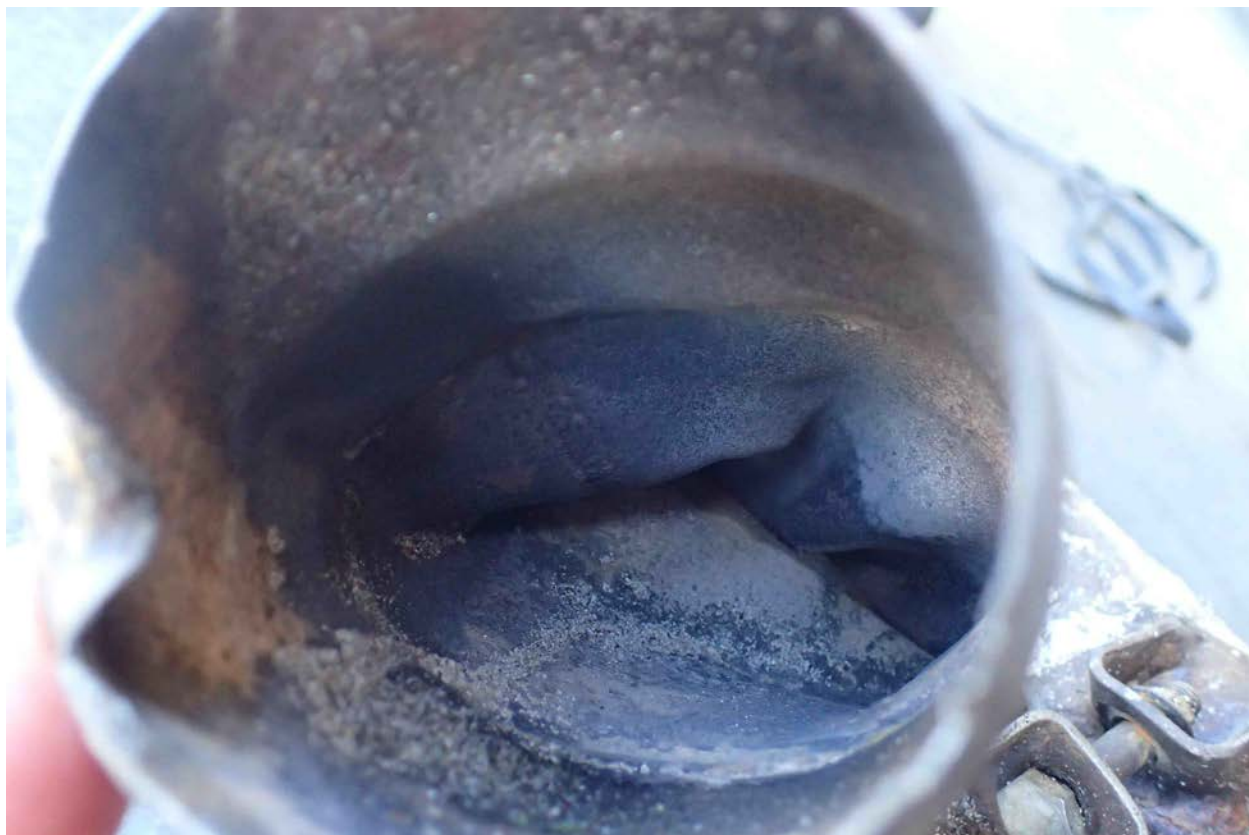
Photo 60 – Exhaust Pipe

All cylinders were examined with a borescope through the spark plug bores. There were no indications of catastrophic internal failure. The interior surfaces of the exhaust pipe contained tan deposits, and was free of oily residue (Photo 60).

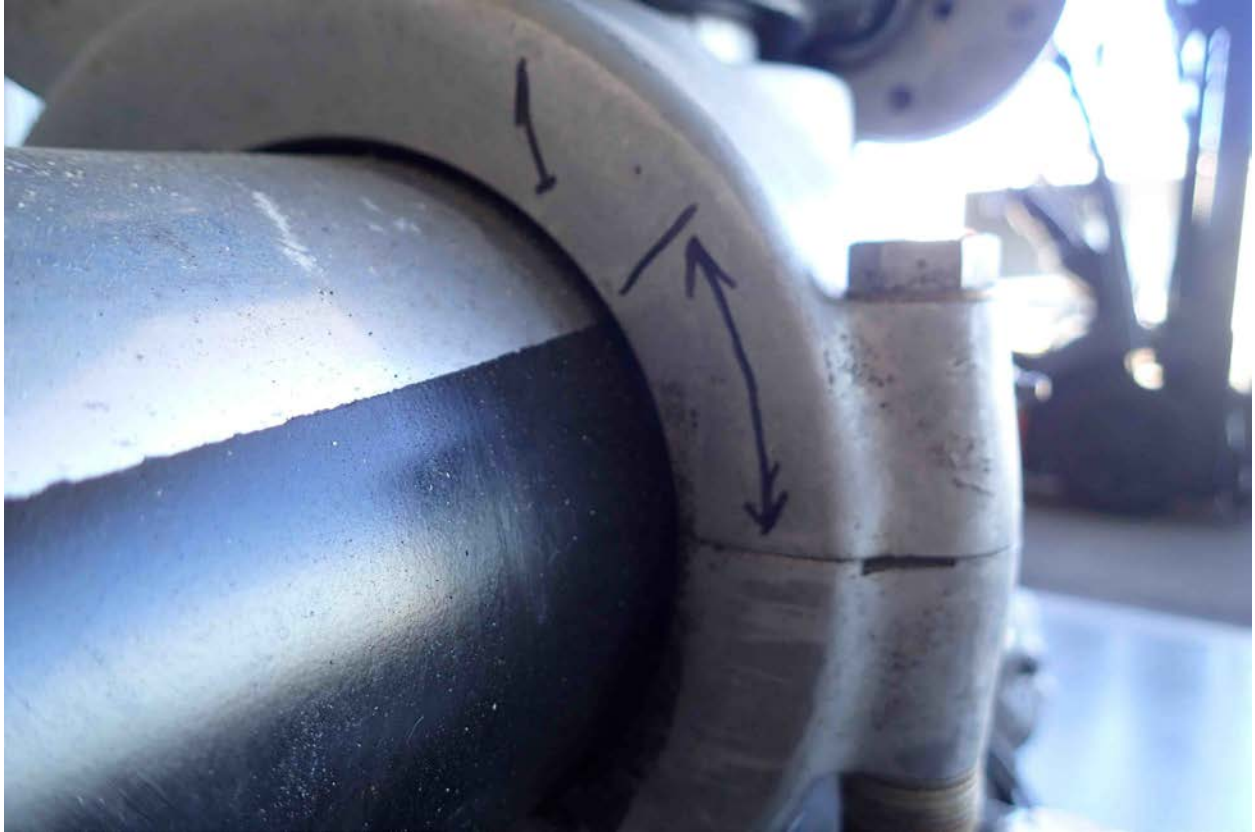
Photo 61 – Propeller Blade One Root

Both propeller blades remained attached to the hub. Both balance weights were intact. Blade number one was at about 35 degrees forward pitch (Photo 61). The blade was bent about 40 degrees aft midspan, and exhibited trailing edge wrinkles and tip twist (Photo 62, 63). The second blade was at flat pitch (Photo 64), and bent about 70 degrees aft midspan (photo 65).

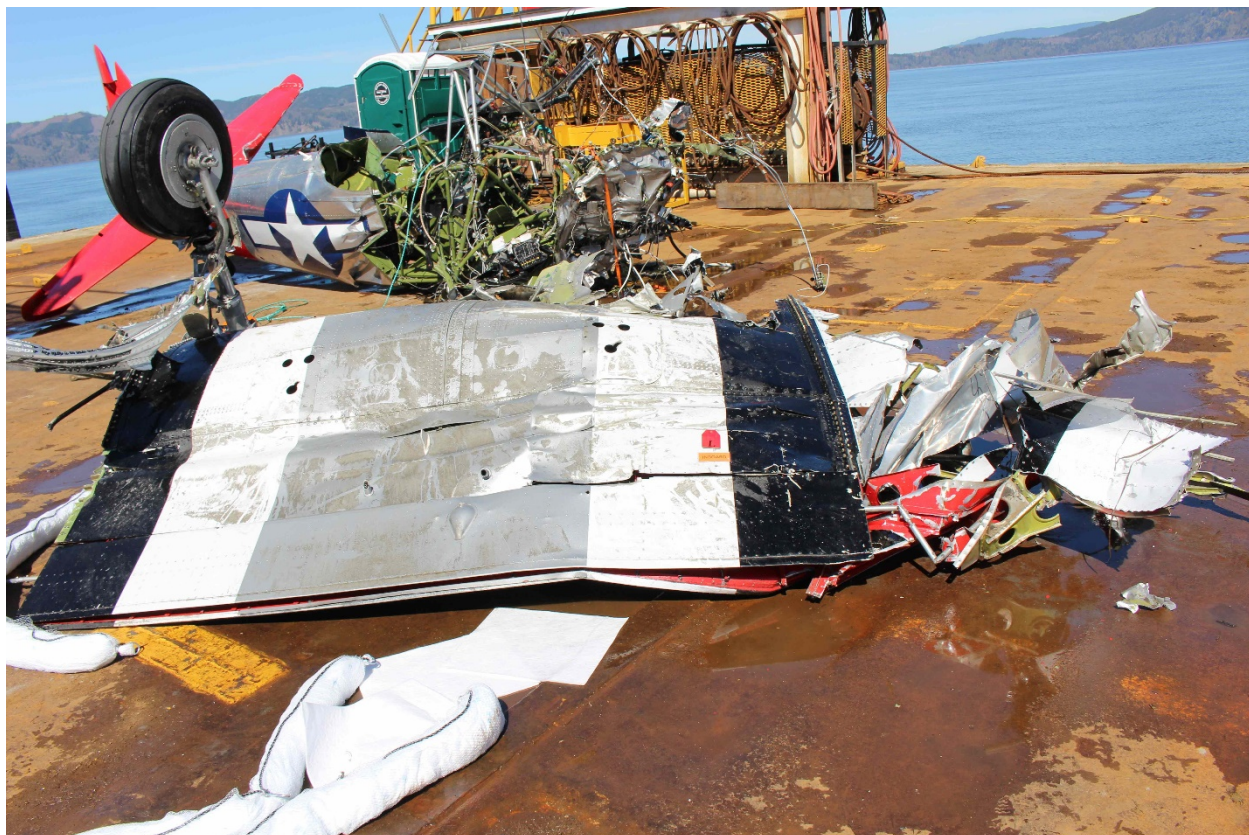
Photo 66 – Center Flap Section

The center flap appeared to be in the retracted position when recovered (Photo 66) and remained attached at both of its outboard hinges, which were secured with castellated nuts, although no cotter pins were present (Photo 31). Two outboard flap extension pushrods were undamaged, and remained attached to the actuator rod and flap (Photo 67, 68). Both the right inboard and center section hinge bolts and nuts were not located (Photo 32, 33). The left inboard hinge tang on the outboard side had bent about 45 degrees out, and the flap casting had partially detached with dull

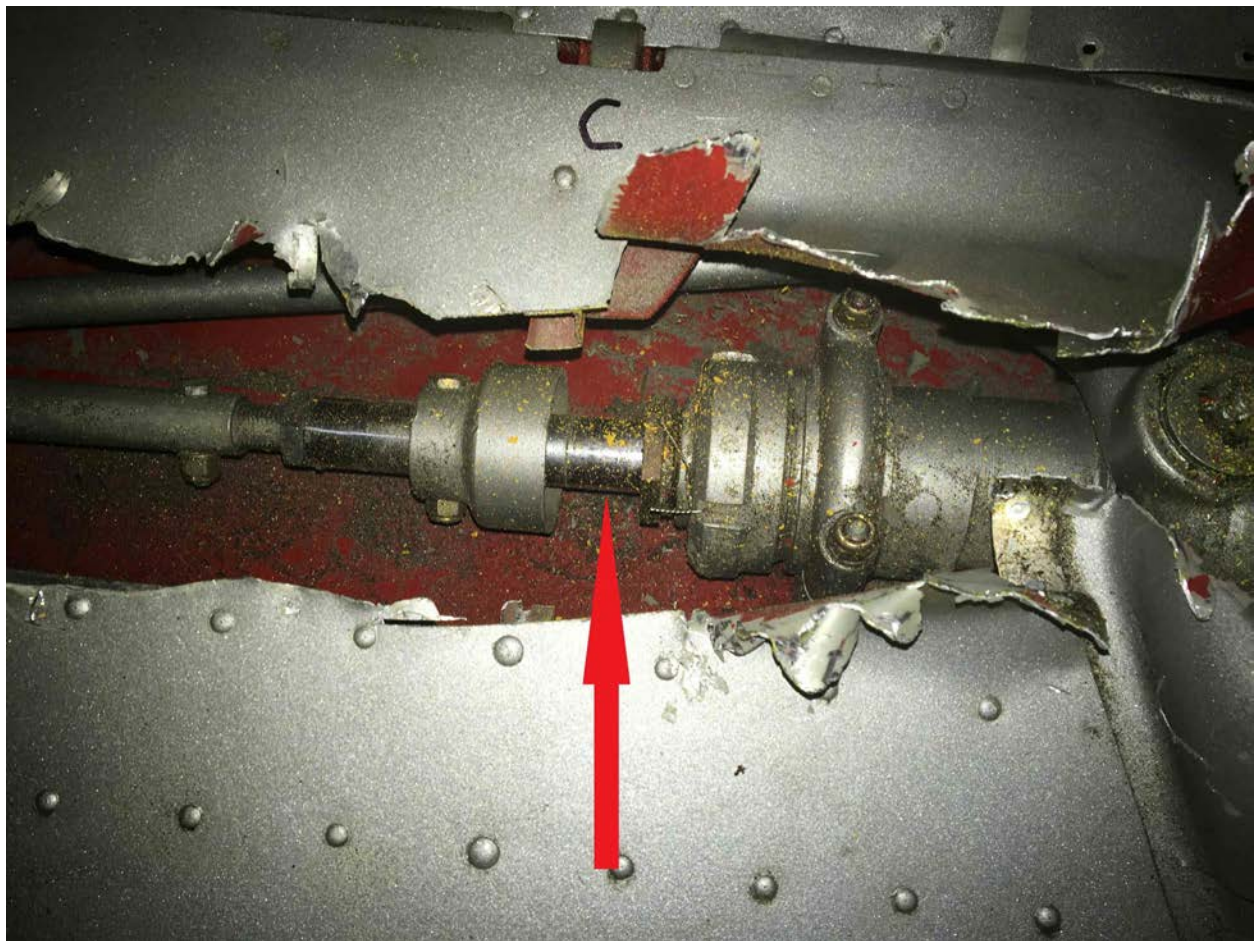
Photo 69 - Flap Actuator Piston Rod

granular surface features (Photo 34). The piston rods on both sides of the hydraulic flap actuator were in the extended position (Photo 69), and the flap actuator control arm was angled about 30 degrees relative to the longitudinal axis (Photo 70). When compared to an exemplar AT-6 flap actuating system, these setting appeared consistent with retracted flaps (Photo 71).
