## **NATIONAL TRANSPORTATION SAFETY BOARD**

### **ON SITE EXAM REPORT**

WPR16FA091

Aircraft: Nokes Matthew Lancair IV P, Registration Number: N438Y, Serial #: LIV-298

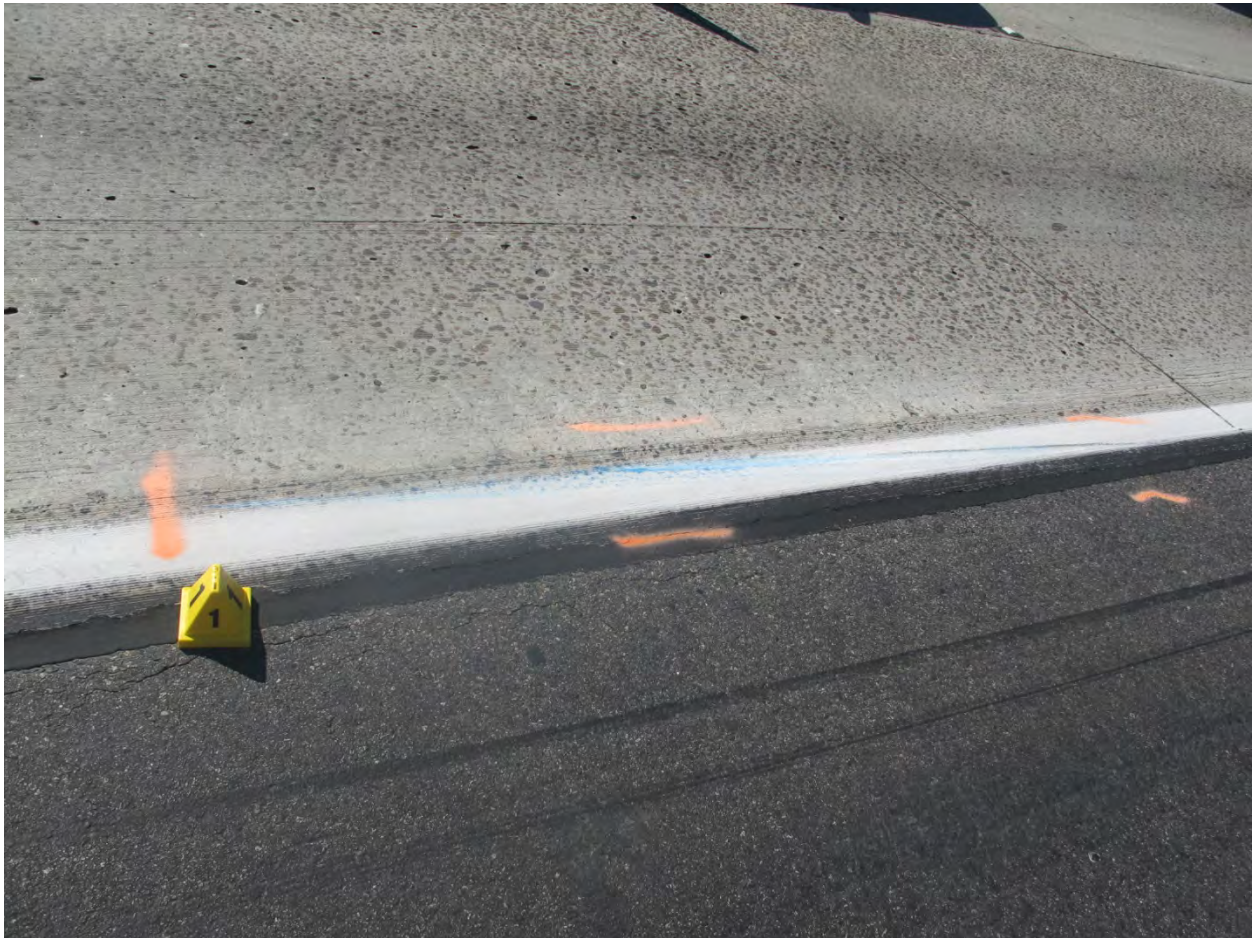
**Photo 3 Ground Scar - First Identified Point of Contact**

The first identified point of contact (FIPC) was a 12-foot long ground scar with blue paint transfer marks.

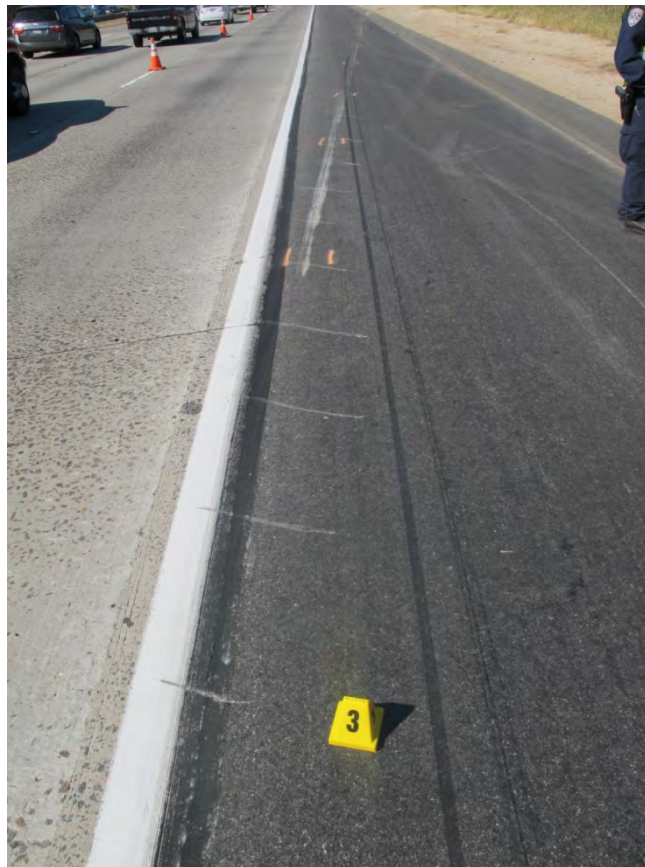
Photo 4 Strike Marks and Ground Scar

About 10 feet after the ground scar was a series of 14 strike marks that were perpendicular to the debris path, and the distance between the marks increased by increasing increments. Between the fourth and fifth strike marks (about 11 feet), another ground scar with blue paint transfer marks started. This ground scar was continuous to the wreckage.

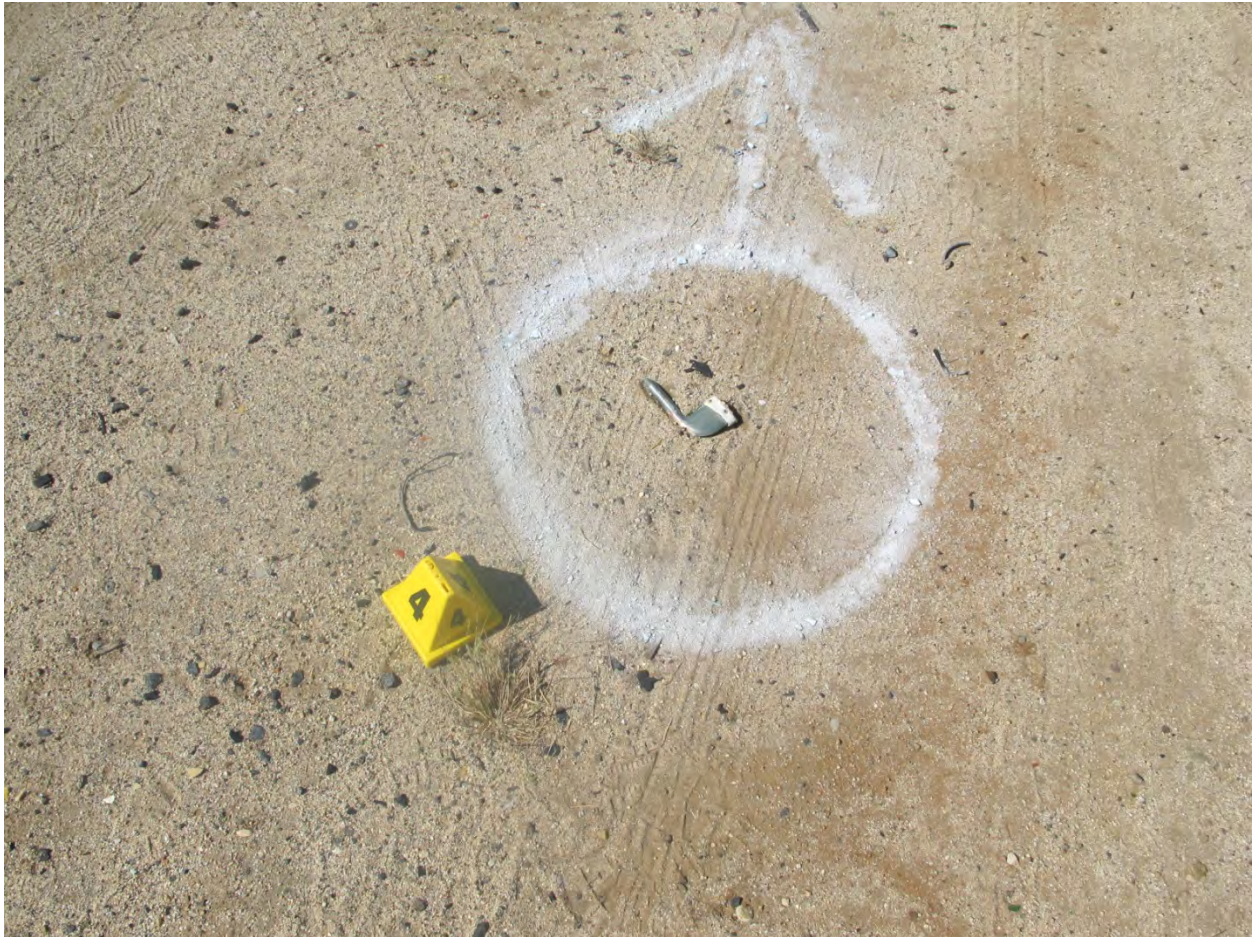
Photo 5 Separated Pitot Tube

The pitot tube (located on the bottom of the left wing outboard of the fuel tank) separated, and was in the first third of the ground scarring. Its bottom was scraped.

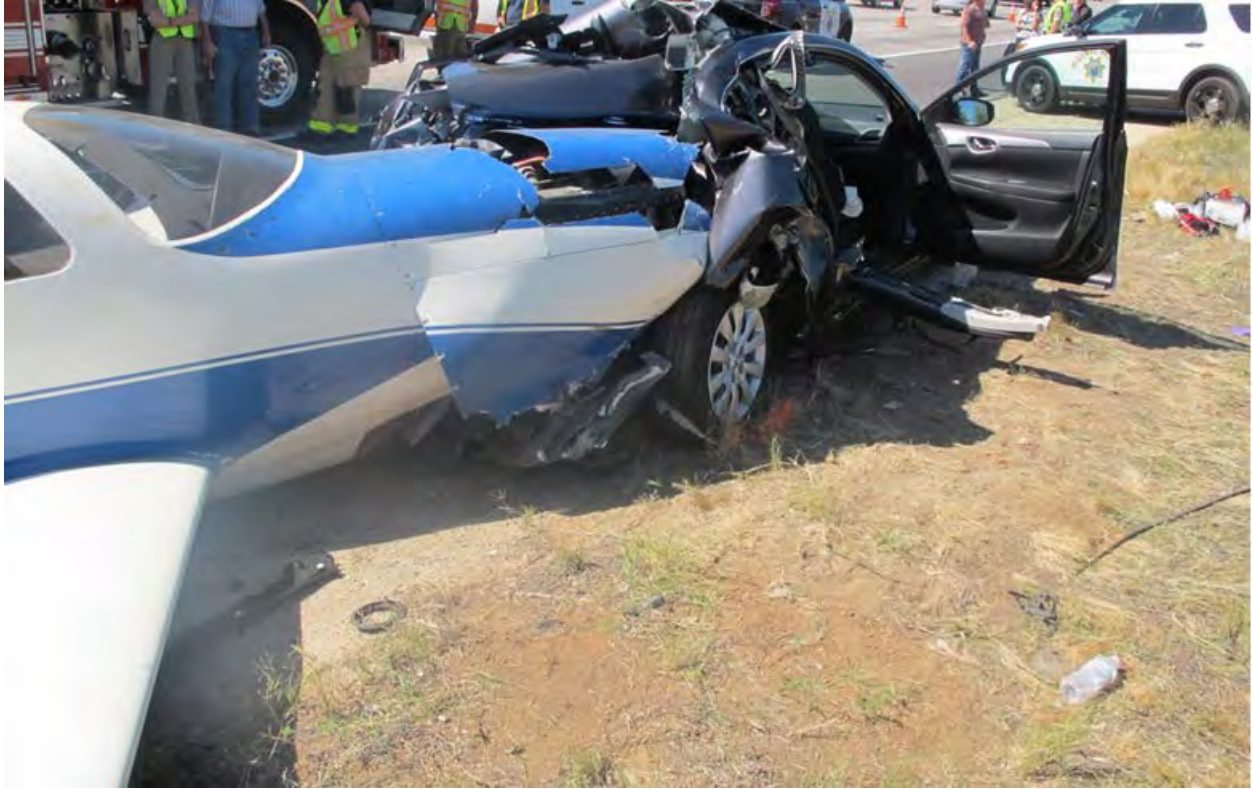
Photo 6 Plane and Car Enmeshed

The nose of the airplane crossed the left rear portion of the trunk at an angle from the left to right, and intruded into the right back seat area of the parked car. The airplane pushed the car off the shoulder and into the adjacent dirt area. The airplane's three-blade propeller and engine remained enmeshed with the car, the fuselage was in the dirt area adjacent to the freeway, and the left wing and tail came to rest on the shoulder.

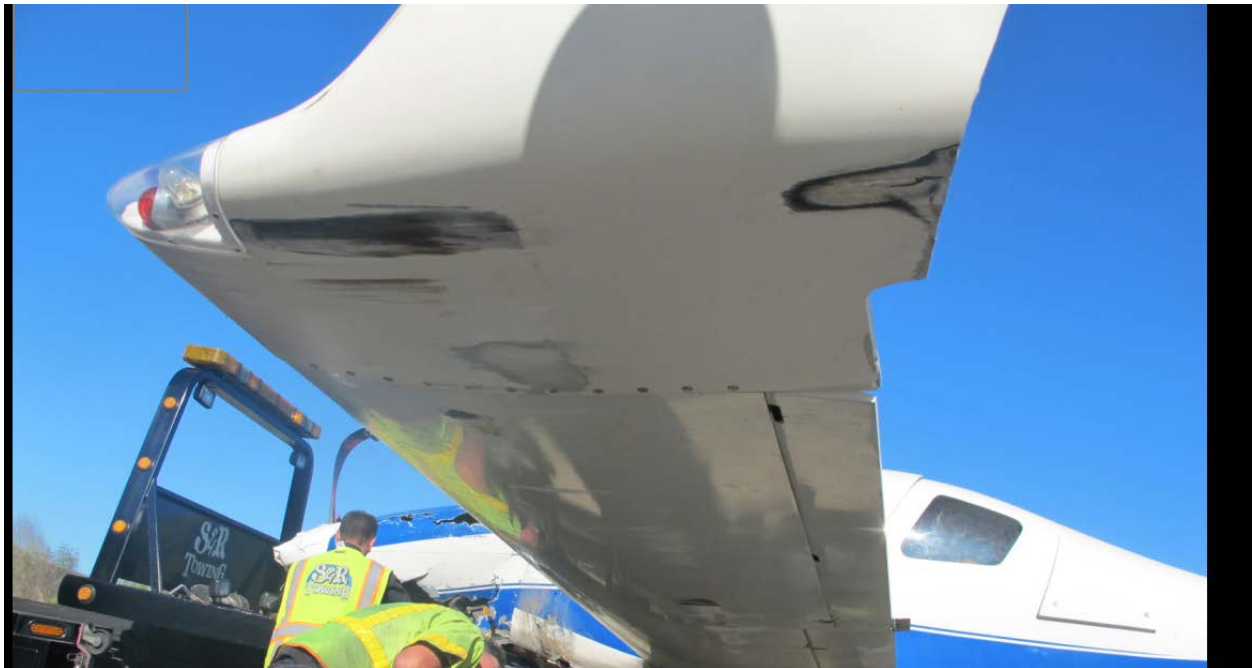
**Photo 7 Bottom of Left Wing**

The outboard bottom of the left wing tip fairing was scraped with all white paint missing over the front third and last quarter of the chord. Additional midchord scrapes on the bottom were inboard near the attachment point on the wing. The pitot tube had been mounted between the fairing and the outboard edge of the fuel tank; a hole existed where it had been mounted. The bottom of the wing had scrape marks in several areas. The left flap was in the up position.

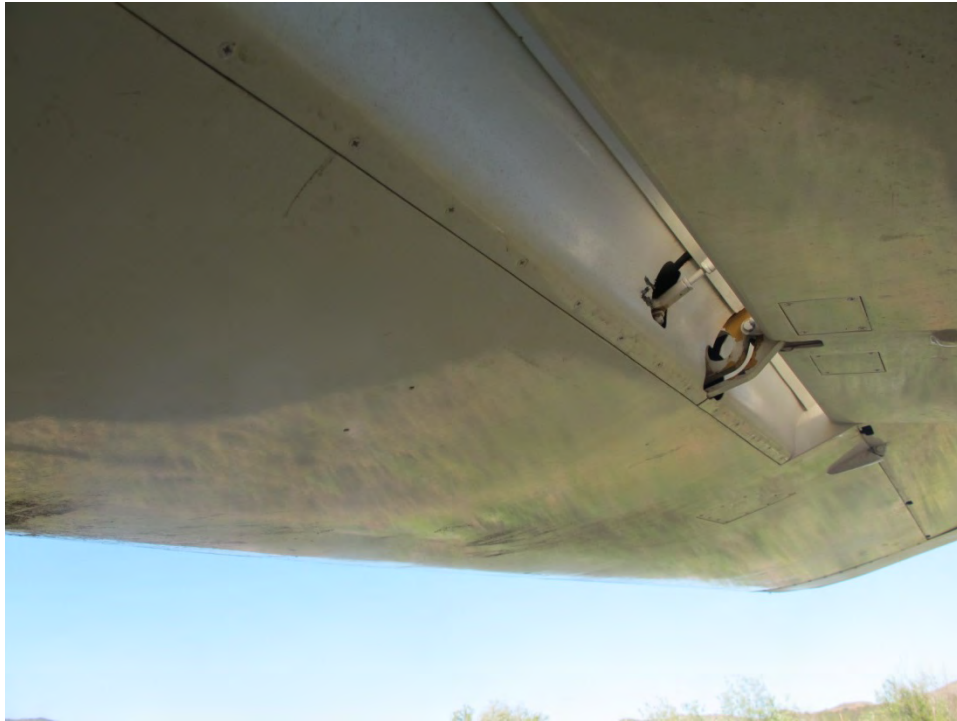
**Photo 8 Outboard Portion of Bottom of Right Wing**

The outboard portion of the right wing exhibited scrape marks. The right flap was down, and it exhibited scrape marks along the trailing edge.

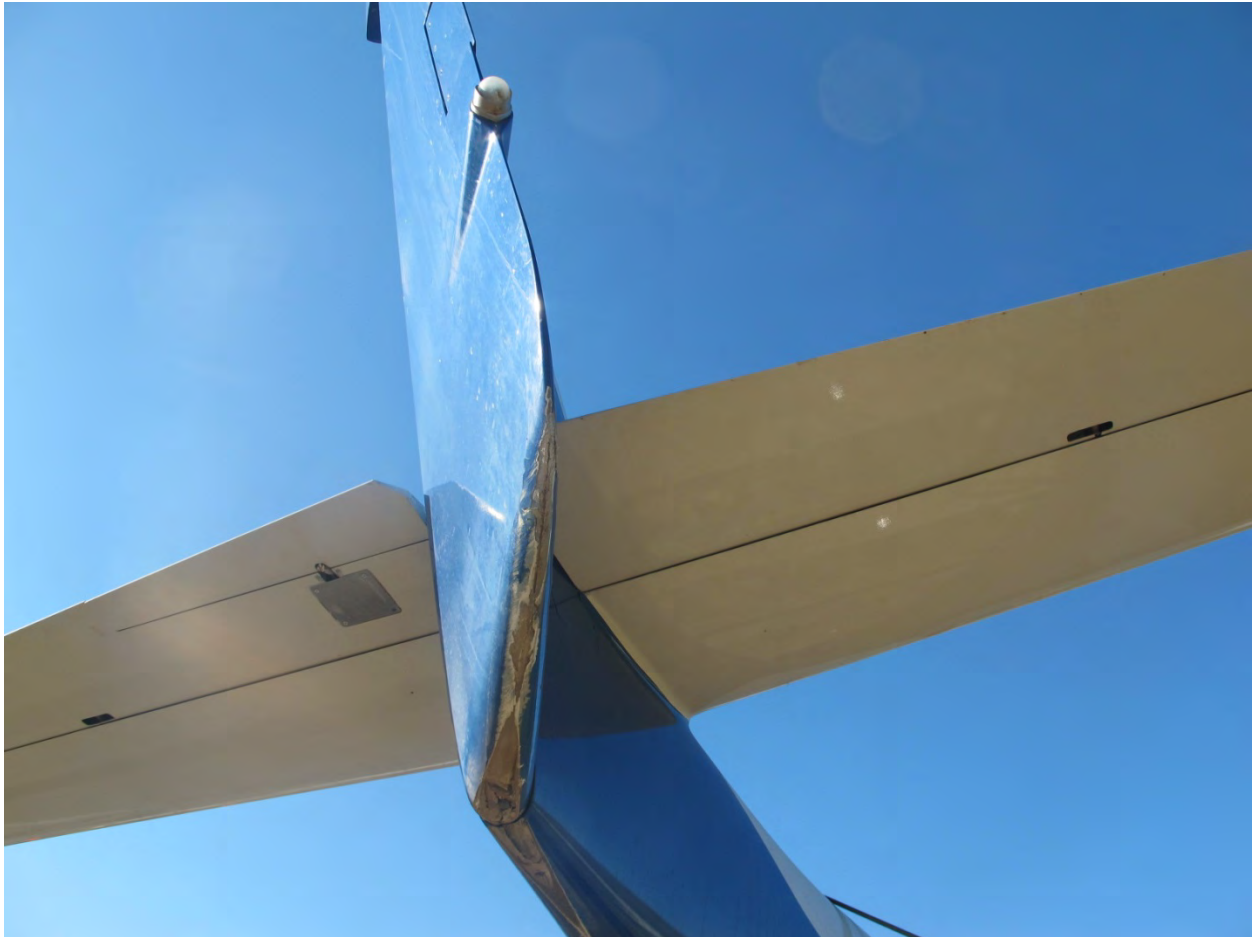
**Photo 10 Empennage**

The bottom of the empennage just forward of the rudder and the rudder both exhibited scrape marks with all blue paint missing. Investigators observed no damage on the rest of the empennage.

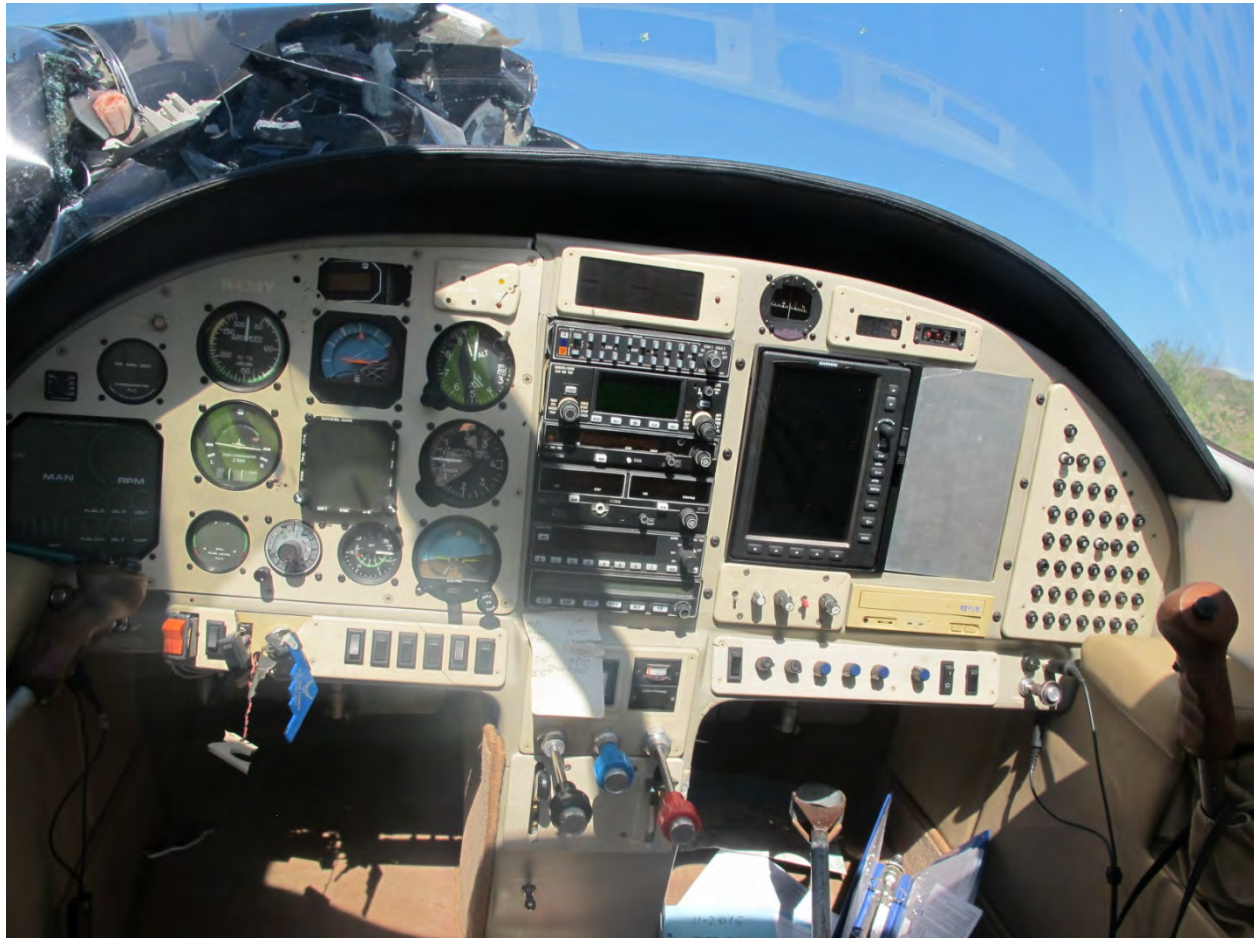
Photo 11 Cockpit

First responders reported that one of their members was a pilot, and he observed the throttle and mixture in midrange positions; he pulled them out to the idle cutoff and low throttle positions. The propeller knob was in the full forward position. The landing gear and flap control handles were in the up position.

Investigators observed the master electrical switch and ignition switches in the off positions.

The alternator field and GPS circuit breakers were popped out.

The radio master and strobe light switches were ON.

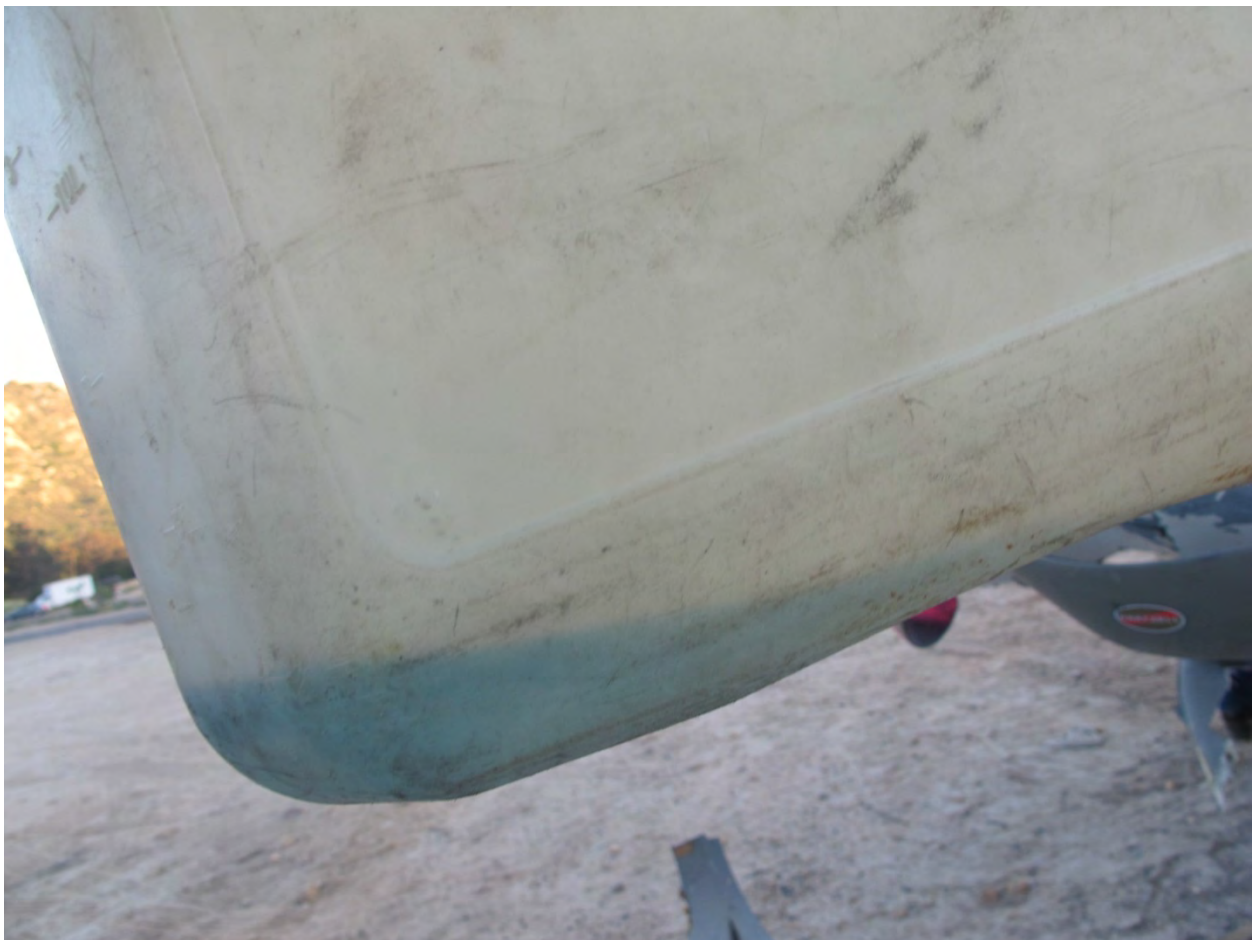
**Photo 12 Blue Fluid Drained from Left Wing Root Quick Drain**

While preparing the airplane to move it to a safer location than the side of the freeway, a small amount of fluid was observed dripping from the right wing root. After moving the airplane to a safer location, the IIC was not able to drain any fluid from the gascolator. Prior to wing removal, investigators drained approximately 1 quart of a clear blue fluid that smelled like aviation gasoline from each wing sump. A water paste test did not change color indicating that there was no water contamination.

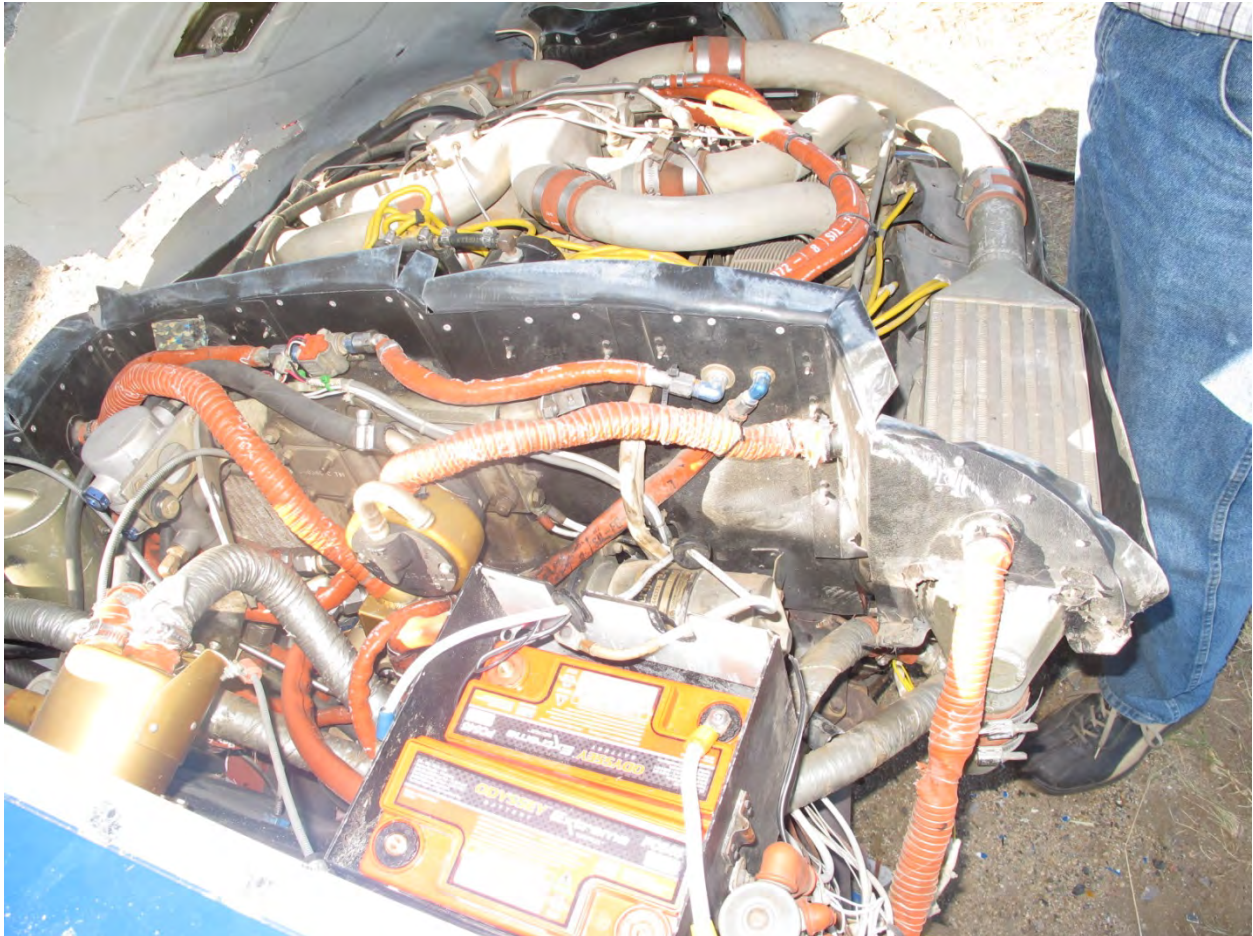
Photo 15 Top of Engine

Investigators observed no evidence of any fluids leaking, and no streaks along the airframe. They observed no evidence of catastrophic engine failure.

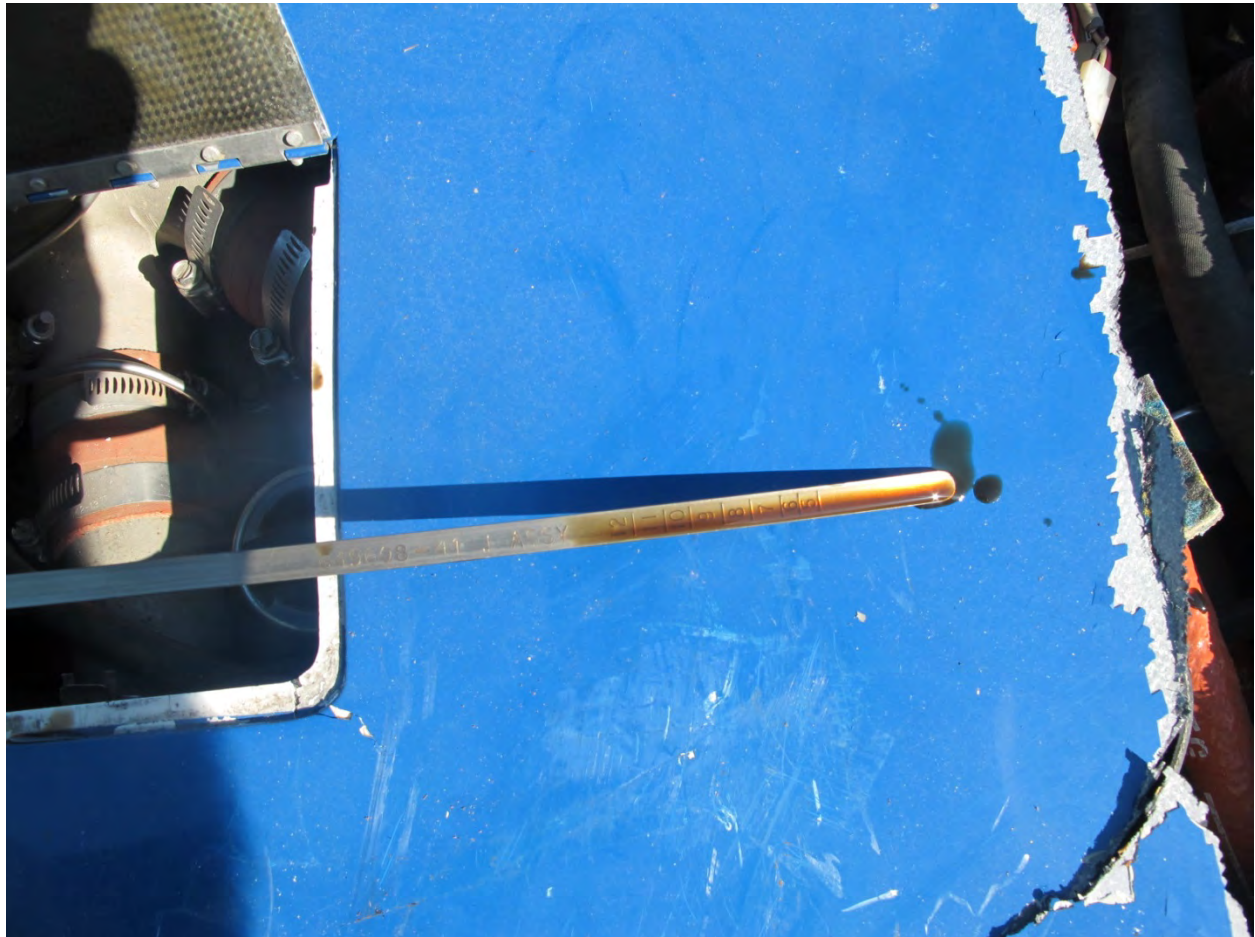
Photo 17 Oil Dipstick

Investigators observed over 12 quarts of a clear black fluid registered on the oil dipstick.
