## **NATIONAL TRANSPORTATION SAFETY BOARD**

### **AIRFRAME AND ENGINE EXAM REPORT**

WPR16FA091

Aircraft: Nokes Matthew Lancair IV P, Registration Number: N438Y, Serial #: LIV-298

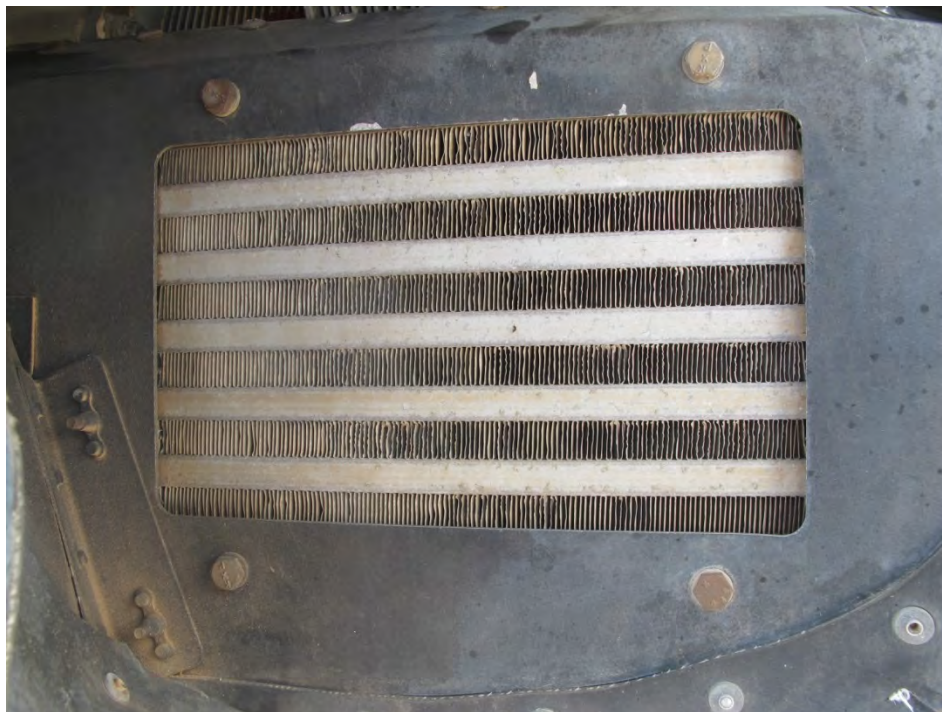
**Photo 1 Air Filter**

The air filter was clean.

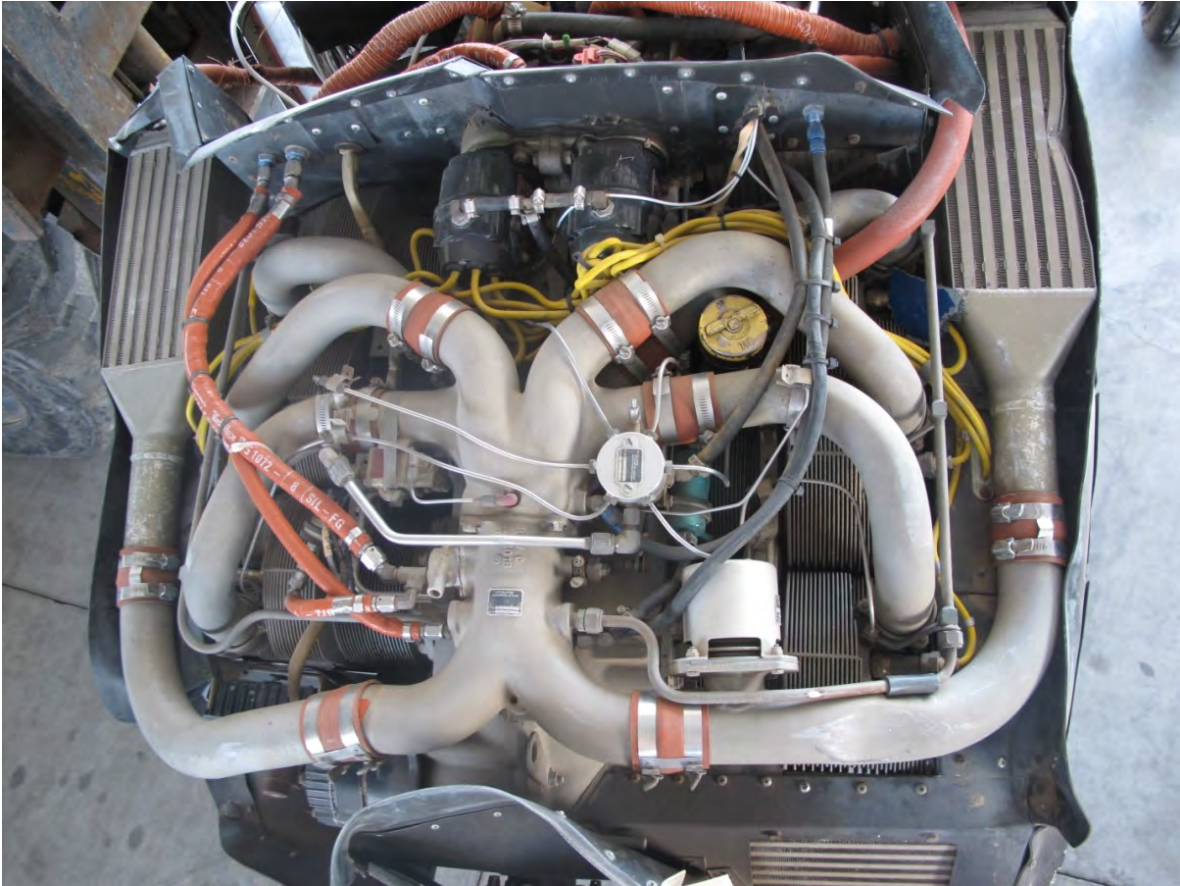
Photo 2 Top of Engine

The engine was a Continental Motors Inc. TSIO-550-E, serial number 803031, rated at 350 horsepower.

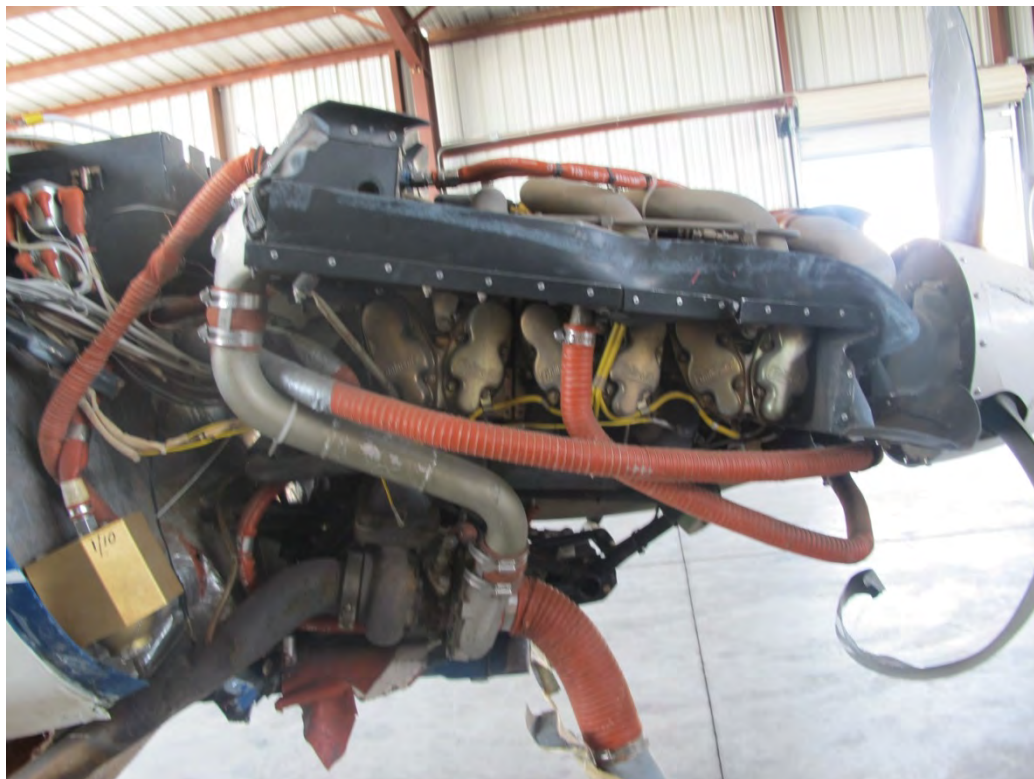
Photo 4 Right Side of Engine

Investigators left the engine in place on the airframe. They manually rotated the crankshaft with the propeller. The crankshaft rotated freely; the valves moved approximately the same amount of lift in firing order, and the gears in the accessory case turned freely. Investigators obtained thumb compression on all cylinders in firing order.

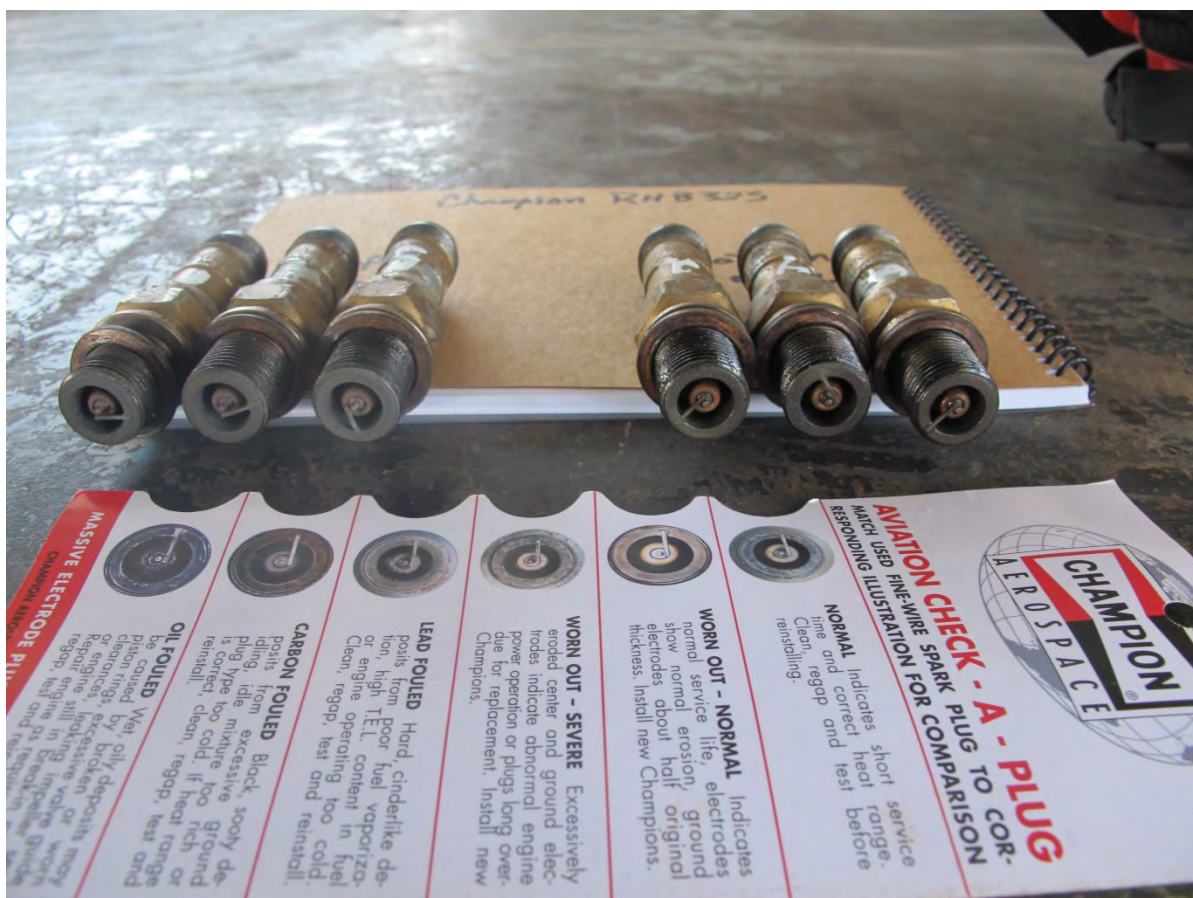
Photo 5 Spark Plugs (Top One, Three, Five, and Bottom Two, Four, Six)

Investigators removed the top spark plugs from the right side (cylinders one, three, and five) and the bottom spark plugs from the left side (cylinders two, four, and six). All electrodes were fine wire, and clean with no mechanical deformation. The spark plug electrodes were gray, which corresponded to normal operation according to the Champion Aviation Check-A-Plug AV-27 Chart.

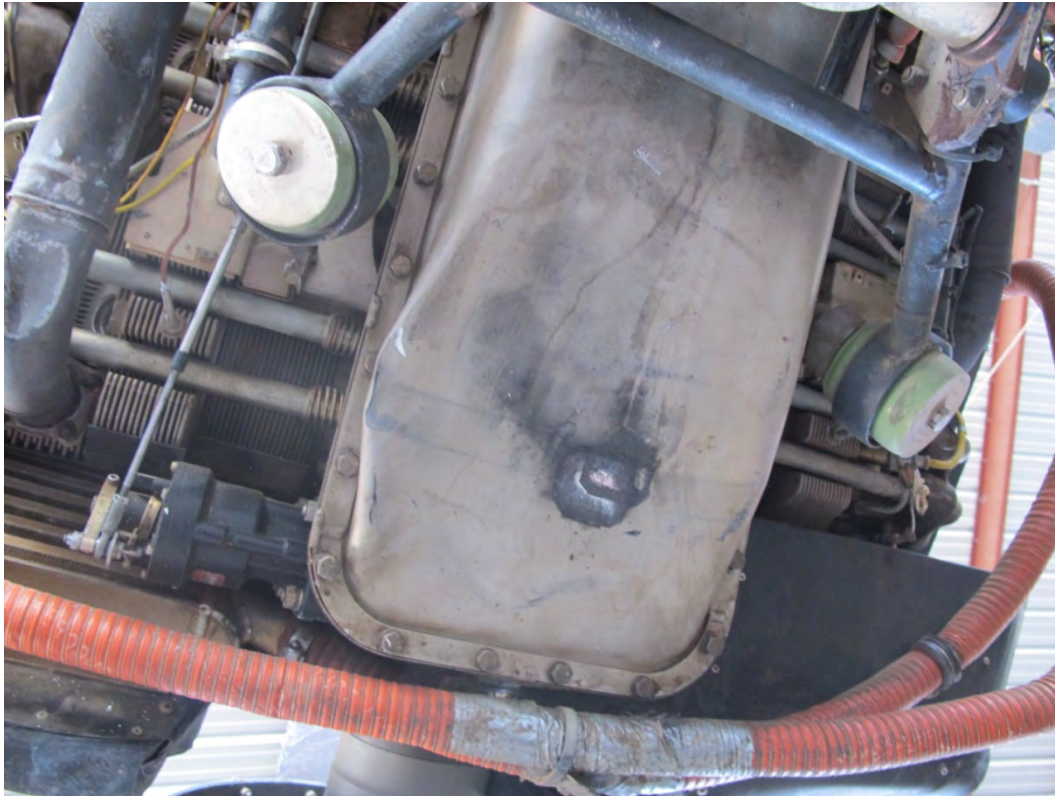
Photo 6 Oil Sump

The oil sump was crushed up.

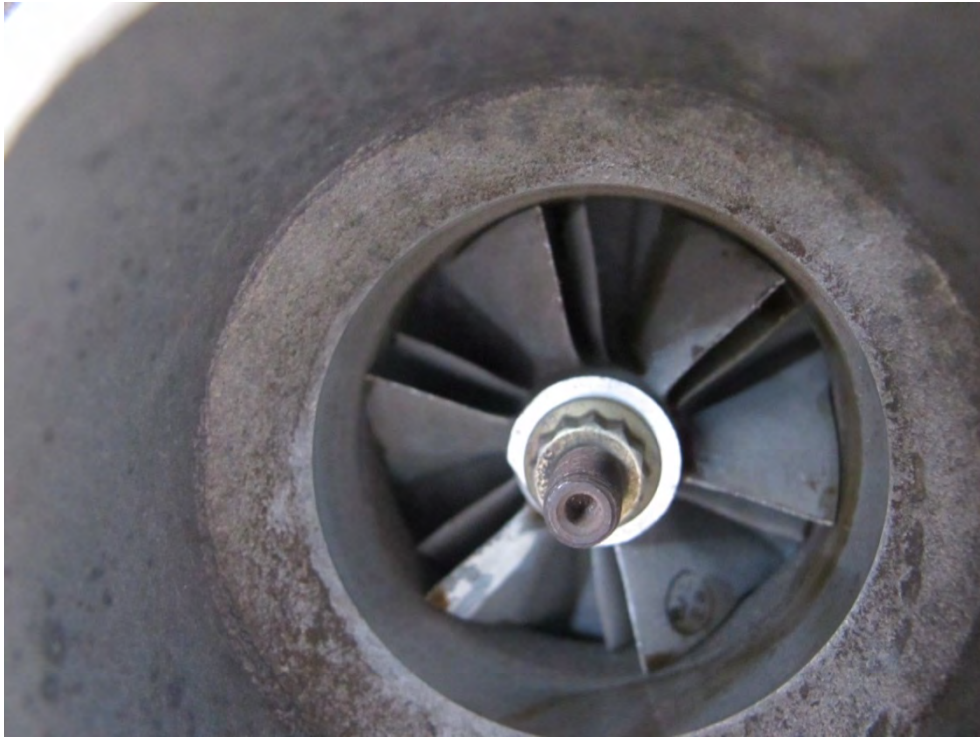
Photo 7 Right Turbocharger Compressor Vanes

The inlet for each turbocharger compressor was clear, and the rotors for each one turned freely.

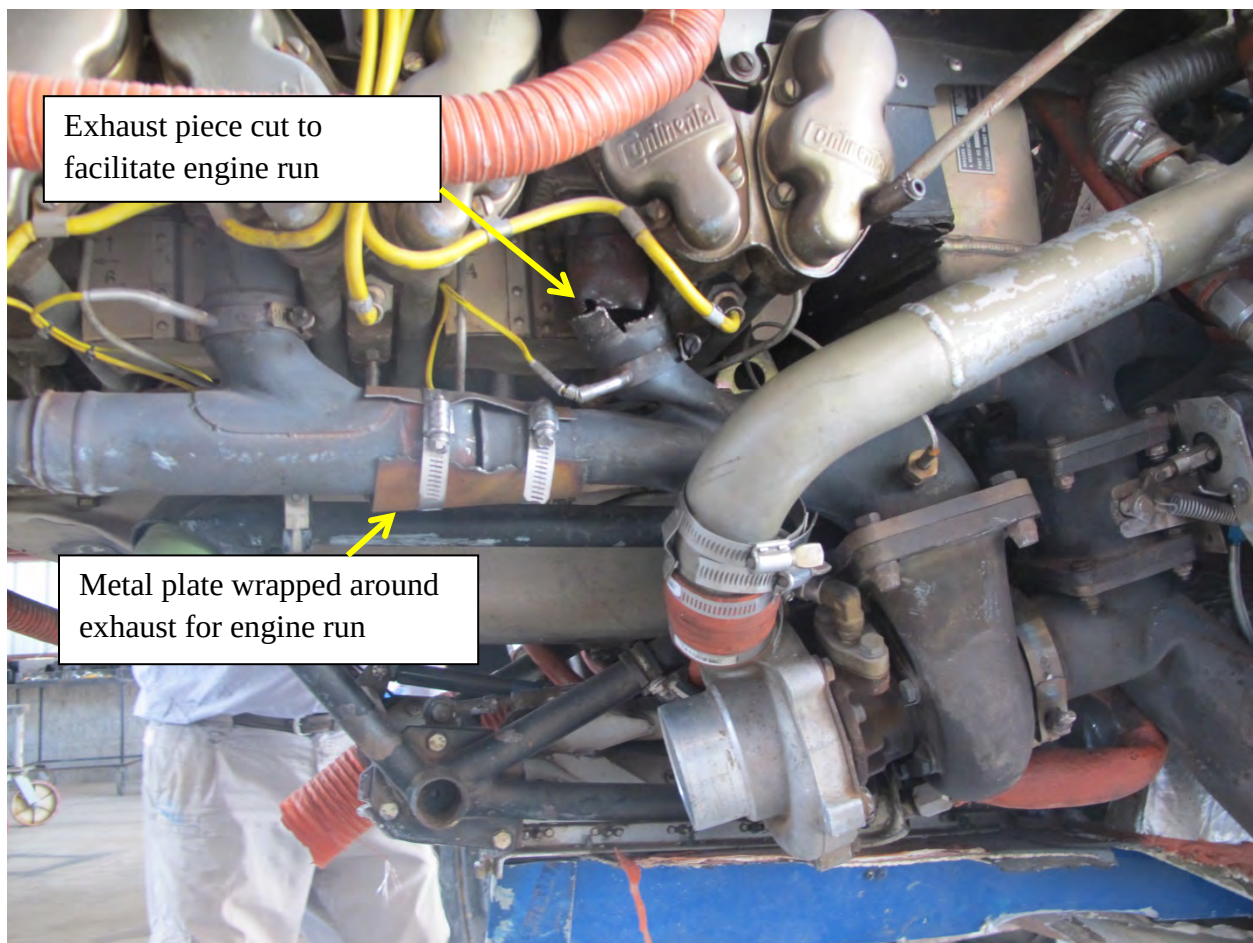
Photo 9 Engine Modifications for Engine Run

Both sides of the exhaust exhibited ductile bending. The left exhaust pipe was displaced and disconnected at the slip joint for cylinder number two and the junction from cylinder number four to number two. A metal plate was partially wrapped around the exhaust junction to prevent hot exhaust gases being directed to the engine core. The slip joint for the cylinder was cut to partially align the exhaust flow.

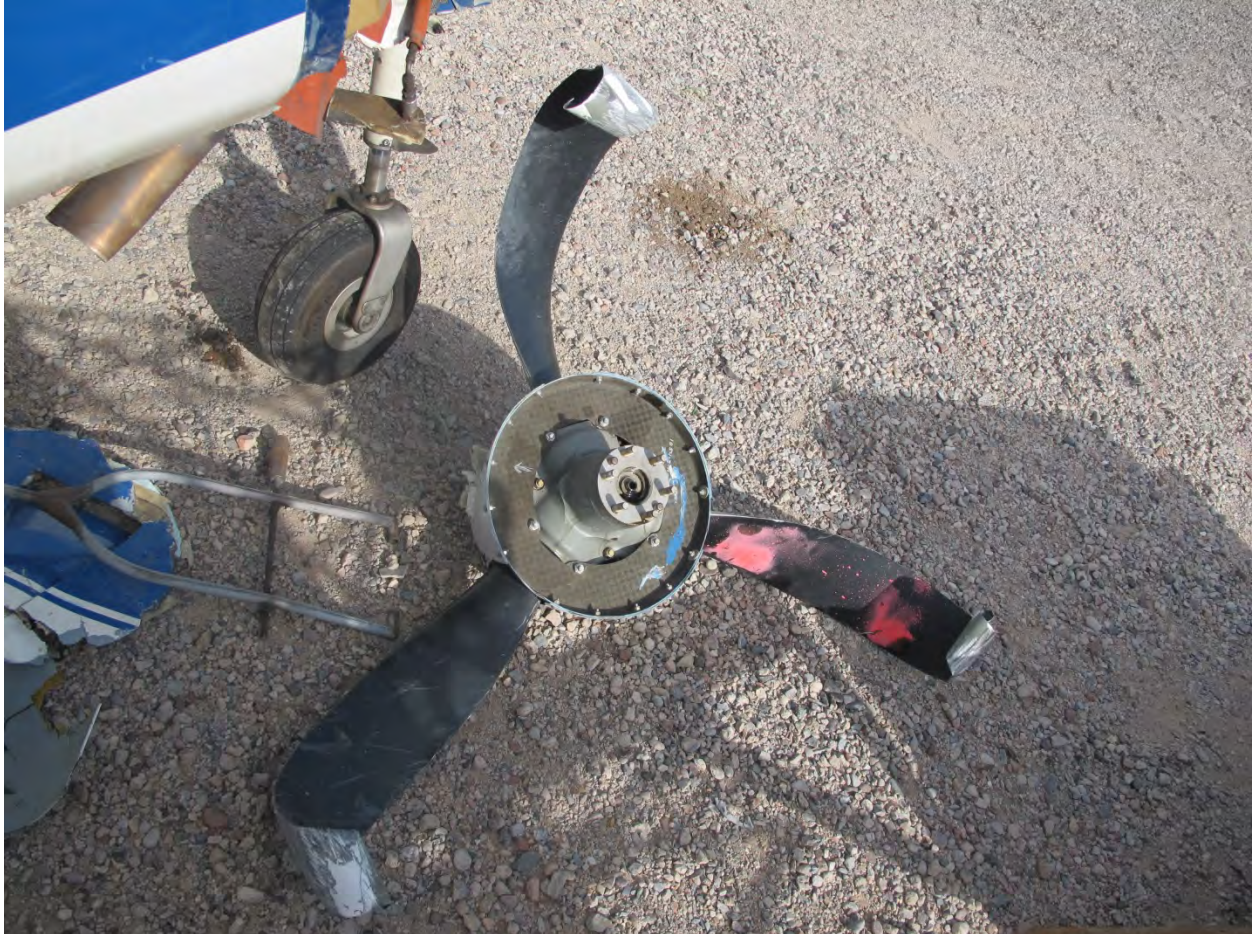
Photo 10 Propeller

All three propeller blades remained attached at the hub, but were loose, and rotated in the hub. All three propeller blades were bent aft, and all three tips curled aft.
