**MULTIDISCIPLINARY ACCIDENT INVESTIGATION TEAM NARRATIVE/DIAGRAM**

**BL-008-16**

California Highway Patrol  
Oceanside Area

**MAIT SUPPLEMENTAL**

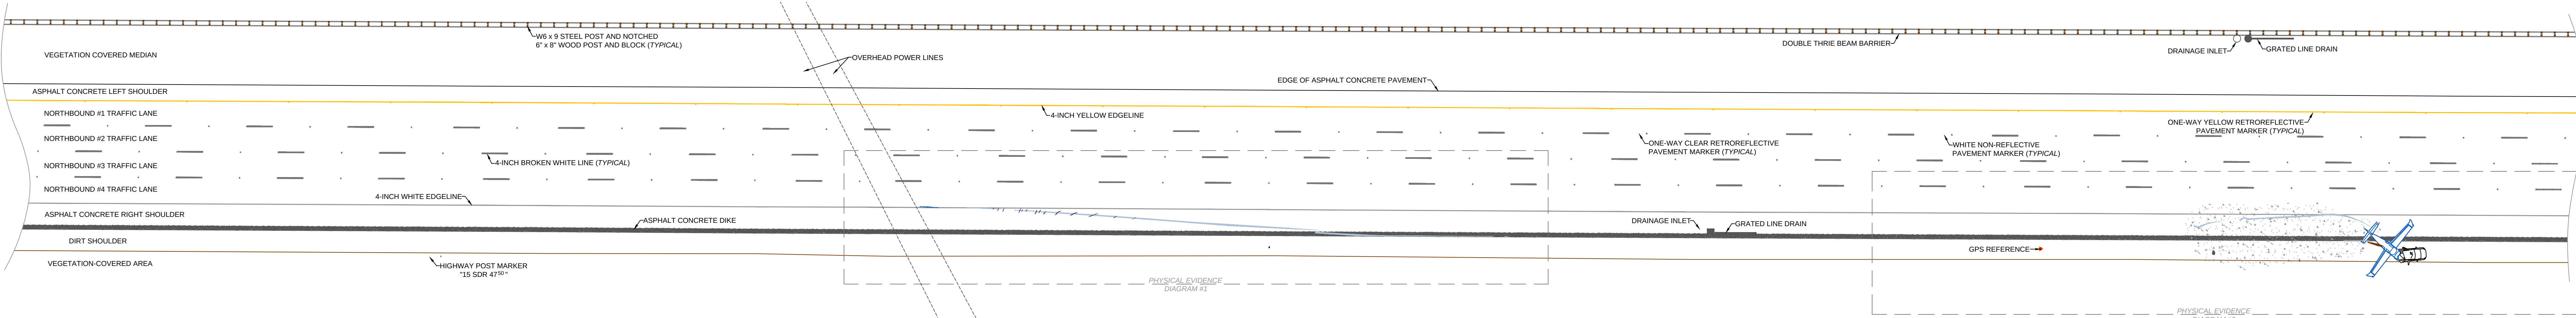
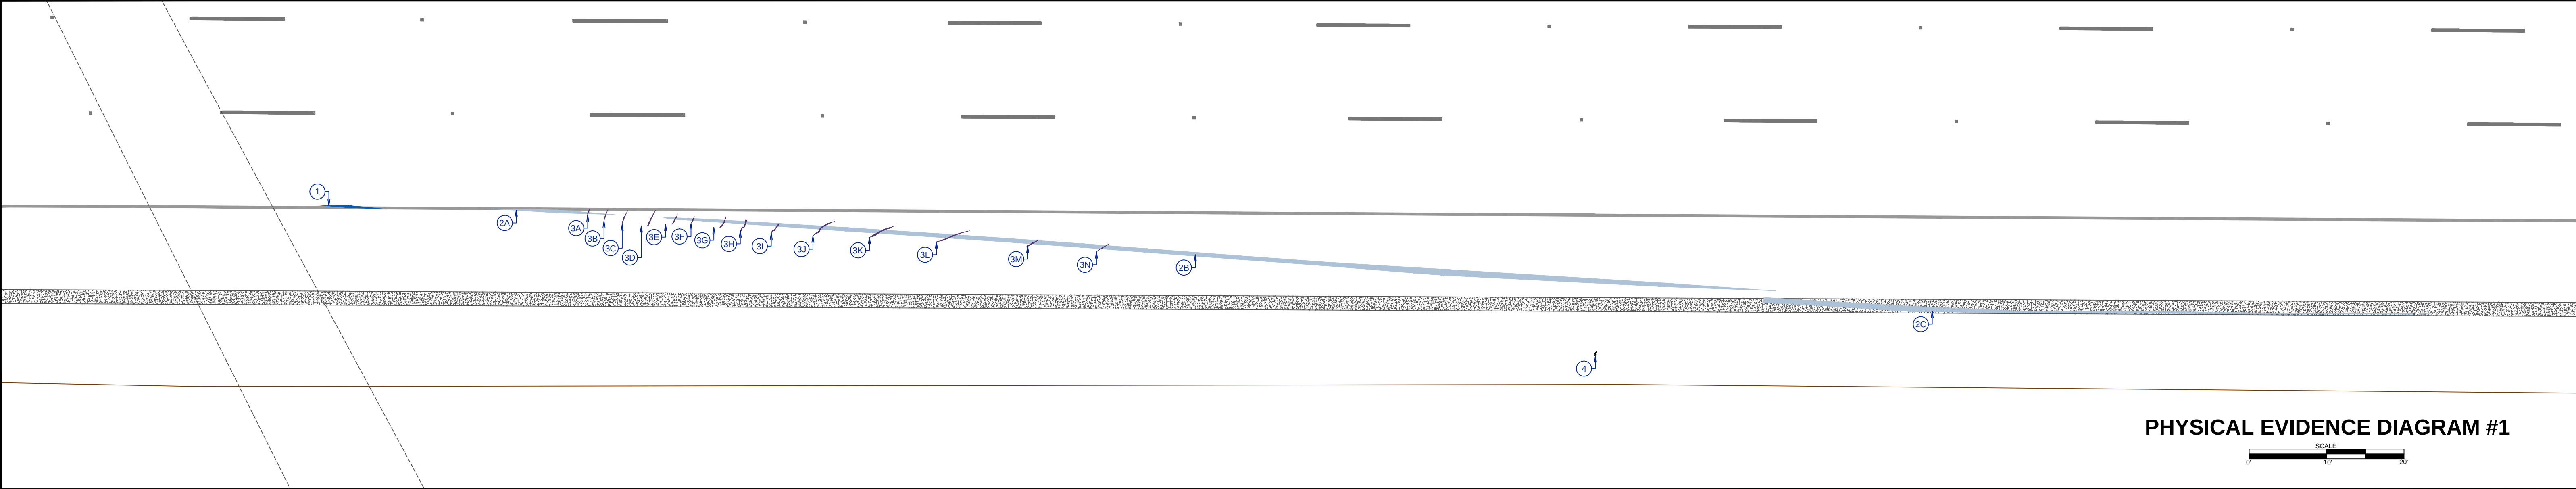
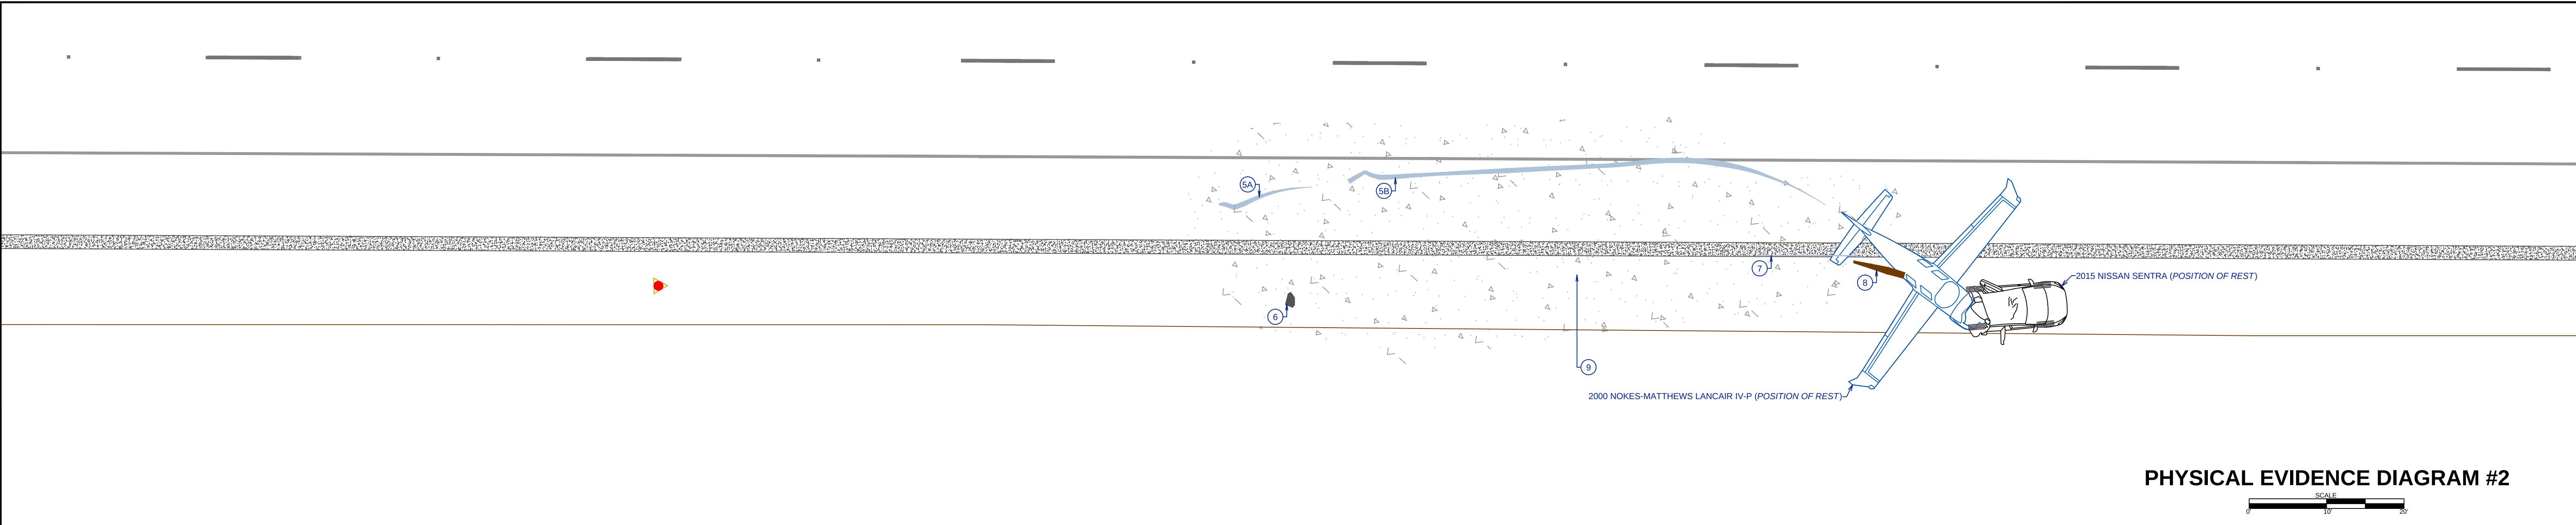
Physical evidence surveyed by MAIT investigators on April 2 is presented in Table 1.

| Item | Point(s) | Item Description and Width at Specific Data Points |
| 1 | 245 – 247 | A blue and white material transfer, 8.8 feet in length |
| 2A | 248 – 250 | A scrape/white material transfer, 16.1 feet in length |
| 2B | 251 – 259 | A scrape/white material transfer, 143.9 feet in length |

| Item | Point(s) | Item Description and Width at Specific Data Points |
|---|---|---|
| 2C | 260 – 267 | A scrape/white material transfer, 85.6 feet in length |
| 3A | 268 – 270 | A chop, 0.9 foot in length |

| Item | Point(s) | Item Description and Width at Specific Data Points |
|---|---|---|
| 4 | 322 – 324 | Metal airplane component with remnants of white fiberglass |
| 5A | 325 – 330 | A blue and white material transfer, 12.5 feet in length |

| Item | Point(s) | Item Description and Width at Specific Data Points |
|---|---|---|
| 5B | 331 – 343 | A blue and white material transfer, 63.2 feet in length |
| 6 | 344 – 349 | A gray plastic vehicle component |
| 7 | 350 – 351 | A white material transfer, 12.0 feet in length |
| 8 | 352 – 354 | A furrow, 6.8 feet in length |
| 9 | 355 – 367 | An area of shattered glass and miscellaneous vehicle components, 2,264.2 square feet in area |

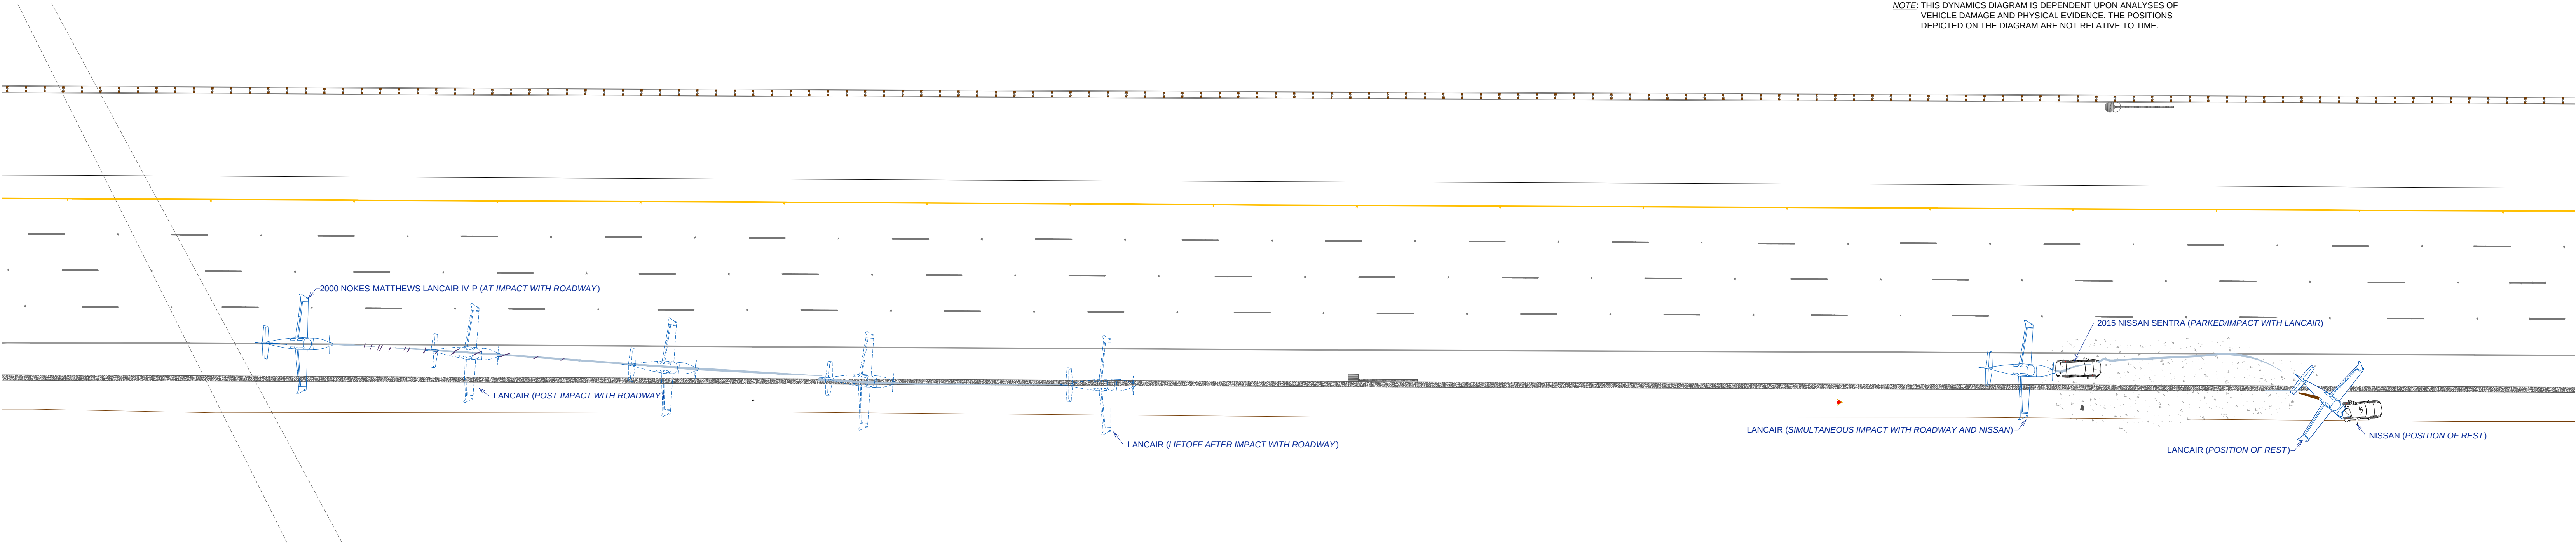
| Item | Physical Evidence Origin |
|---|---|
| 9 | An area of shattered glass and miscellaneous vehicle components deposited by the Nissan after impact with the Lancair |

NOTE: THIS DYNAMICS DIAGRAM IS DEPENDENT UPON ANALYSES OF VEHICLE DAMAGE AND PHYSICAL EVIDENCE. THE POSITIONS DEPICTED ON THE DIAGRAM ARE NOT RELATIVE TO TIME.
