**NATIONAL TRANSPORTATION SAFETY BOARD**  
Vehicle Recorder Division  
Washington, DC 20594

## **Onboard Image Recorder**

**Group Chairman's Factual Report**  
**By Sean Payne**

| Aircraft: | Extra 300, N330MT |

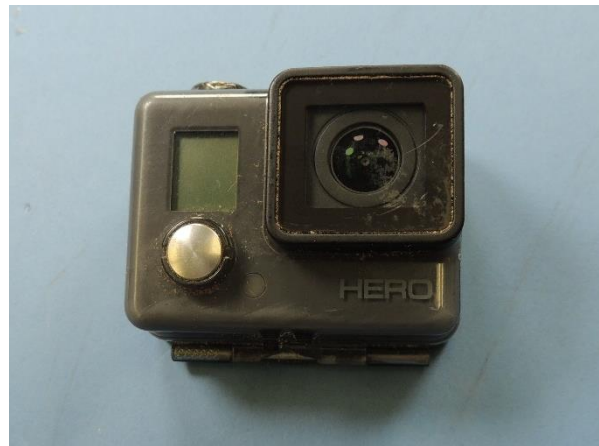
Both devices arrived to the laboratory intact but covered in debris. The GoPro HERO is shown in figure 1. The micro SD card associated with the GoPro HERO was found seated in the card slot and intact. The micro SD card was connected to a PC via a forensic write blocker and its file system was accessed. The micro SD card contained a number of .MP4 video files, one of which contained the aircraft's impact with terrain.

**Figure 1. The GoPro HERO recovered from the wreckage site.**

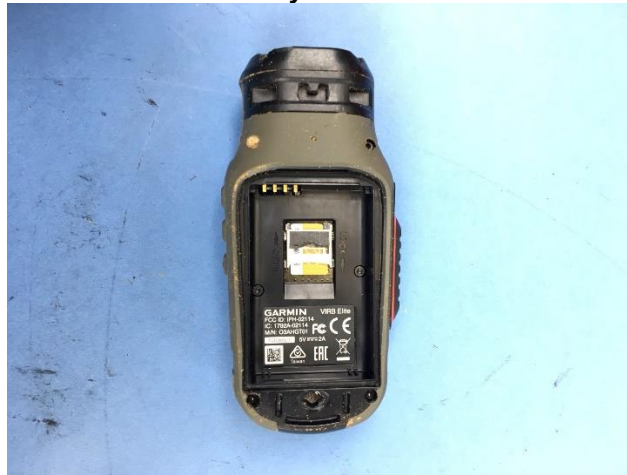
The Garmin VIRB is shown in figure 2. The micro SD card associated with the GoPro HERO was found seated in the card slot and intact. The micro SD card was connected to a PC via a forensic write blocker and its file system was accessed. The file system revealed a number of .MP4 files, however, the aircraft's impact with terrain was not captured. A disk image was made of the entire contents of the micro SD card and a video file was recovered showing the aircraft's impact with terrain after using a software method developed by the NTSB laboratory.

**Figure 2. The Garmin VIRB recovered from the wreckage site with the battery cover and battery removed.**

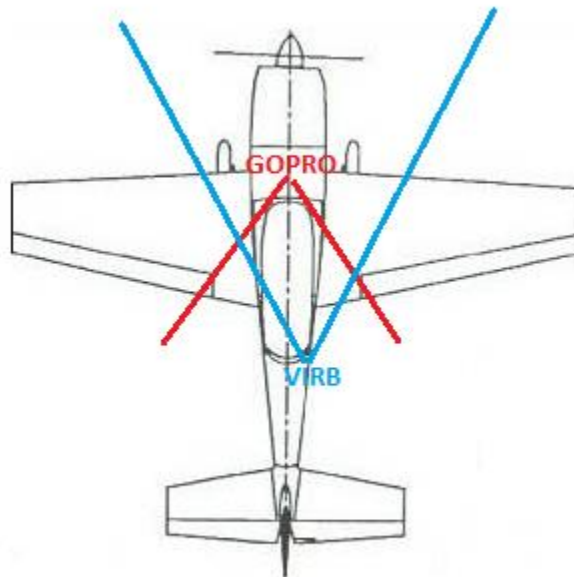
Figure 3 is a diagram that shows the approximate mounting locations of the GoPro camera and the Garmin VIRB in the accident aircraft.

**Figure 3. A diagram of the camera mounting locations in the accident aircraft.**

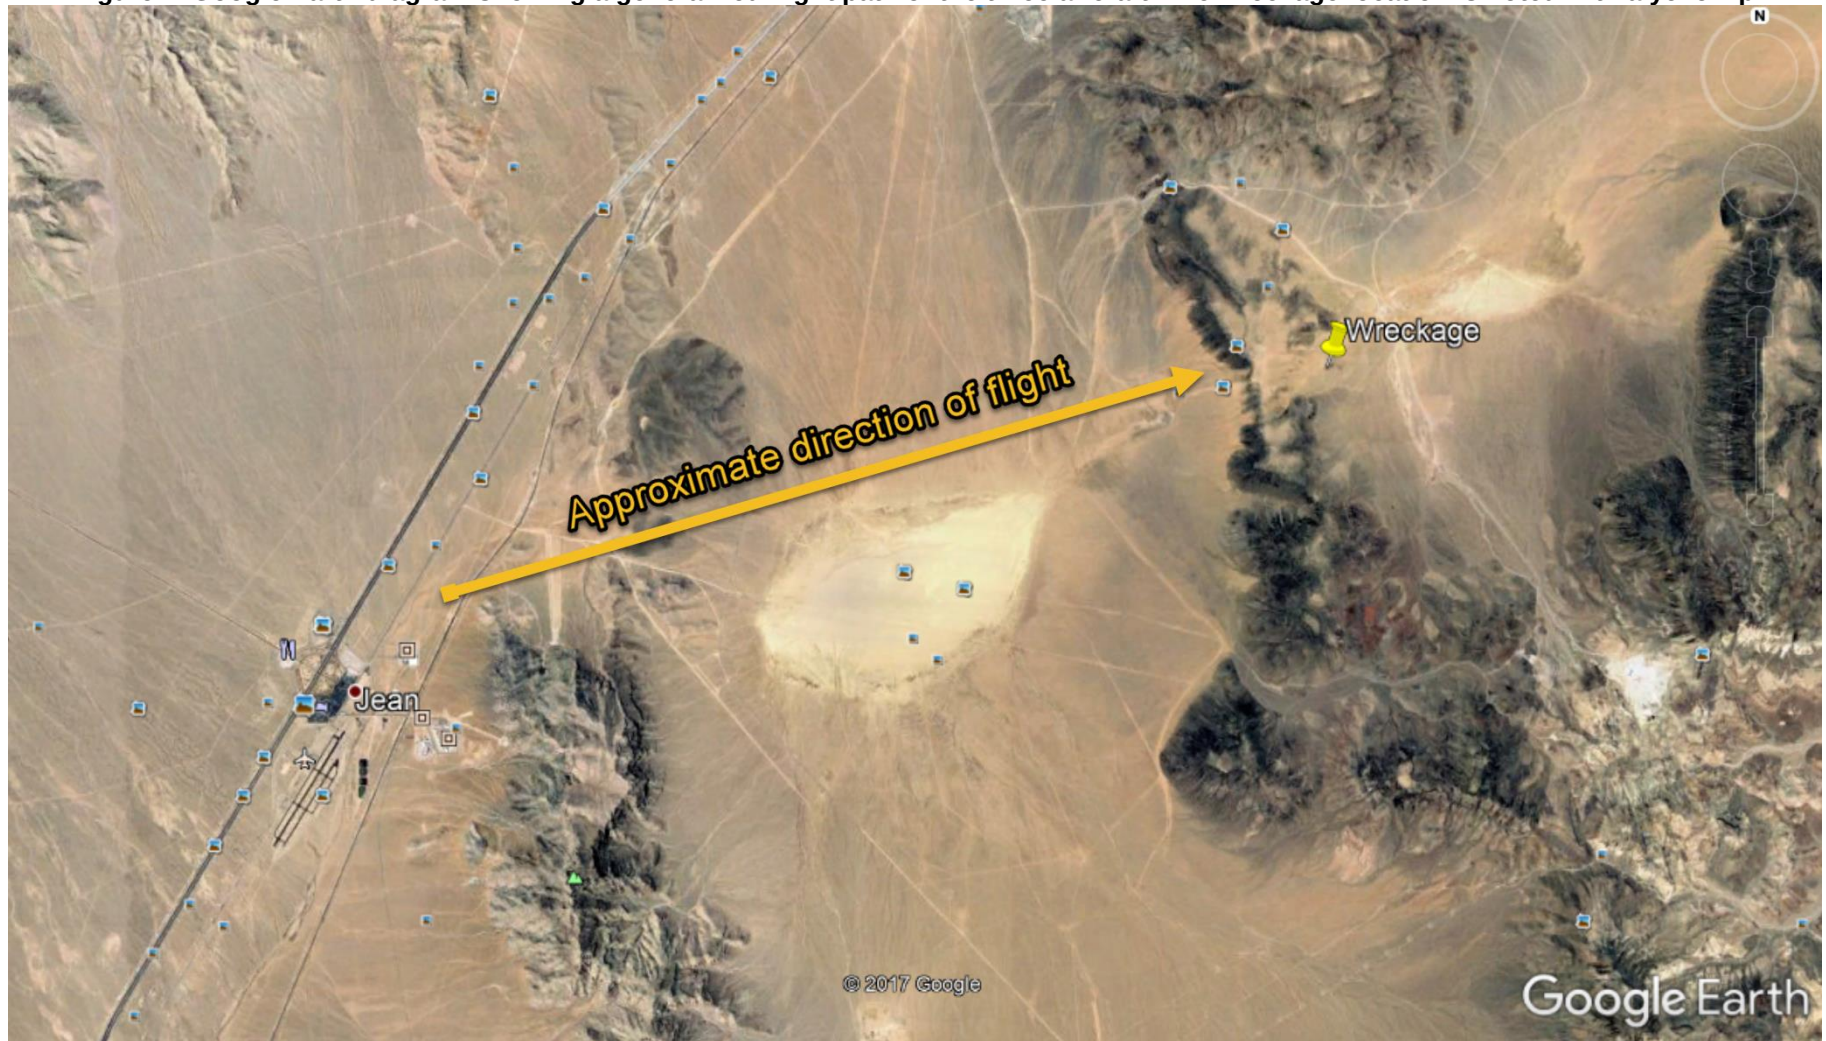
The three aircraft then took a course to the northeast from OL7 toward HND. Figure 4 is a Google Earth diagram that shows a generalized flight path of the three aircraft. The wreckage location is noted with a yellow pin.

Figure 4. Google Earth diagram showing a generalized flight path of the three aircraft. The wreckage location is noted with a yellow pin.

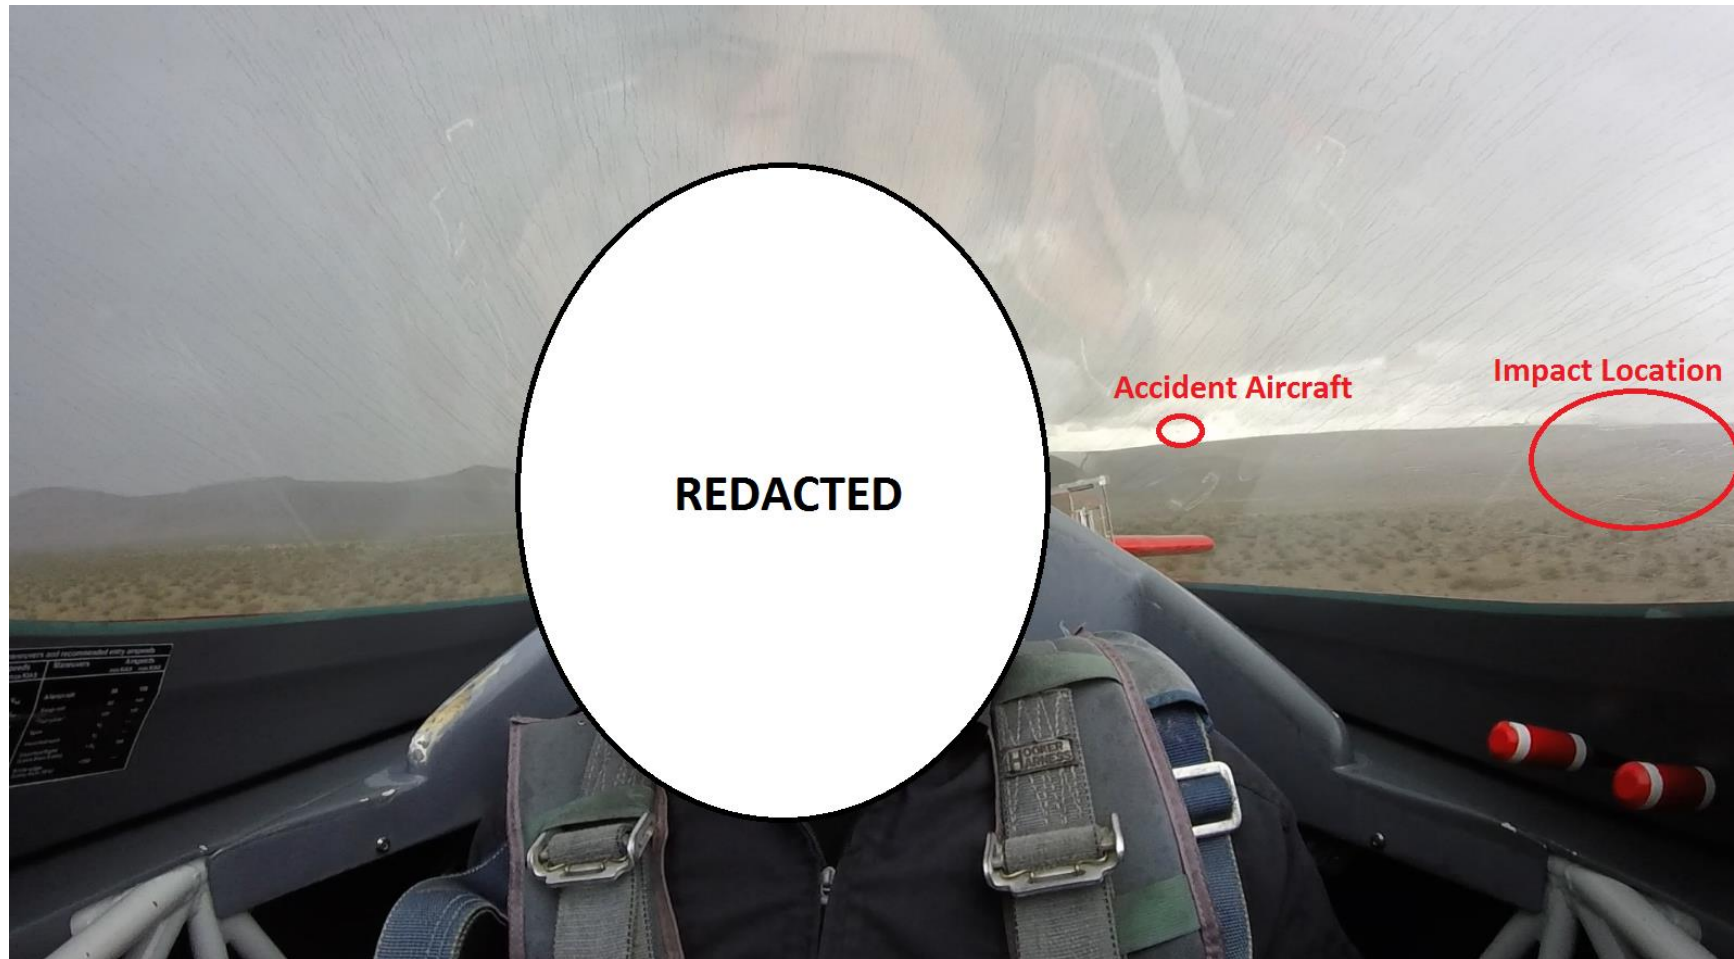
Figure 5. The accident aircraft seen above the first ridgeline. The impact location is also denoted.

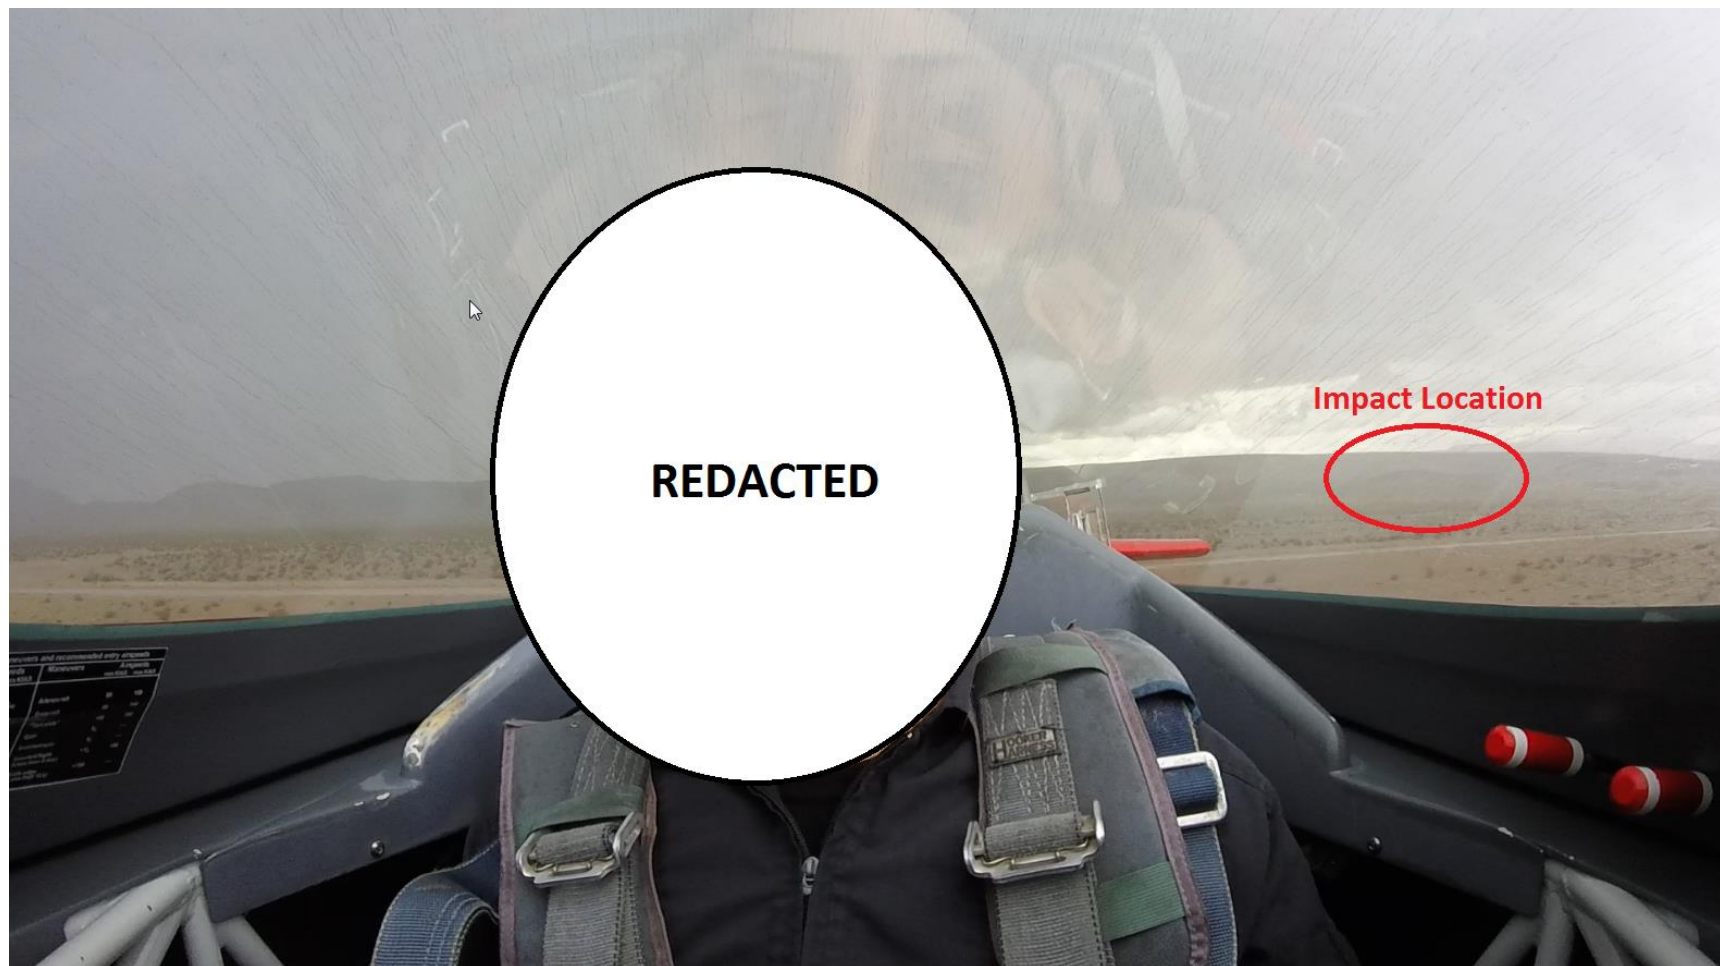
Figure 6. The accident aircraft is no longer visible in front of the first ridge. The small hill which was the accident location is denoted.

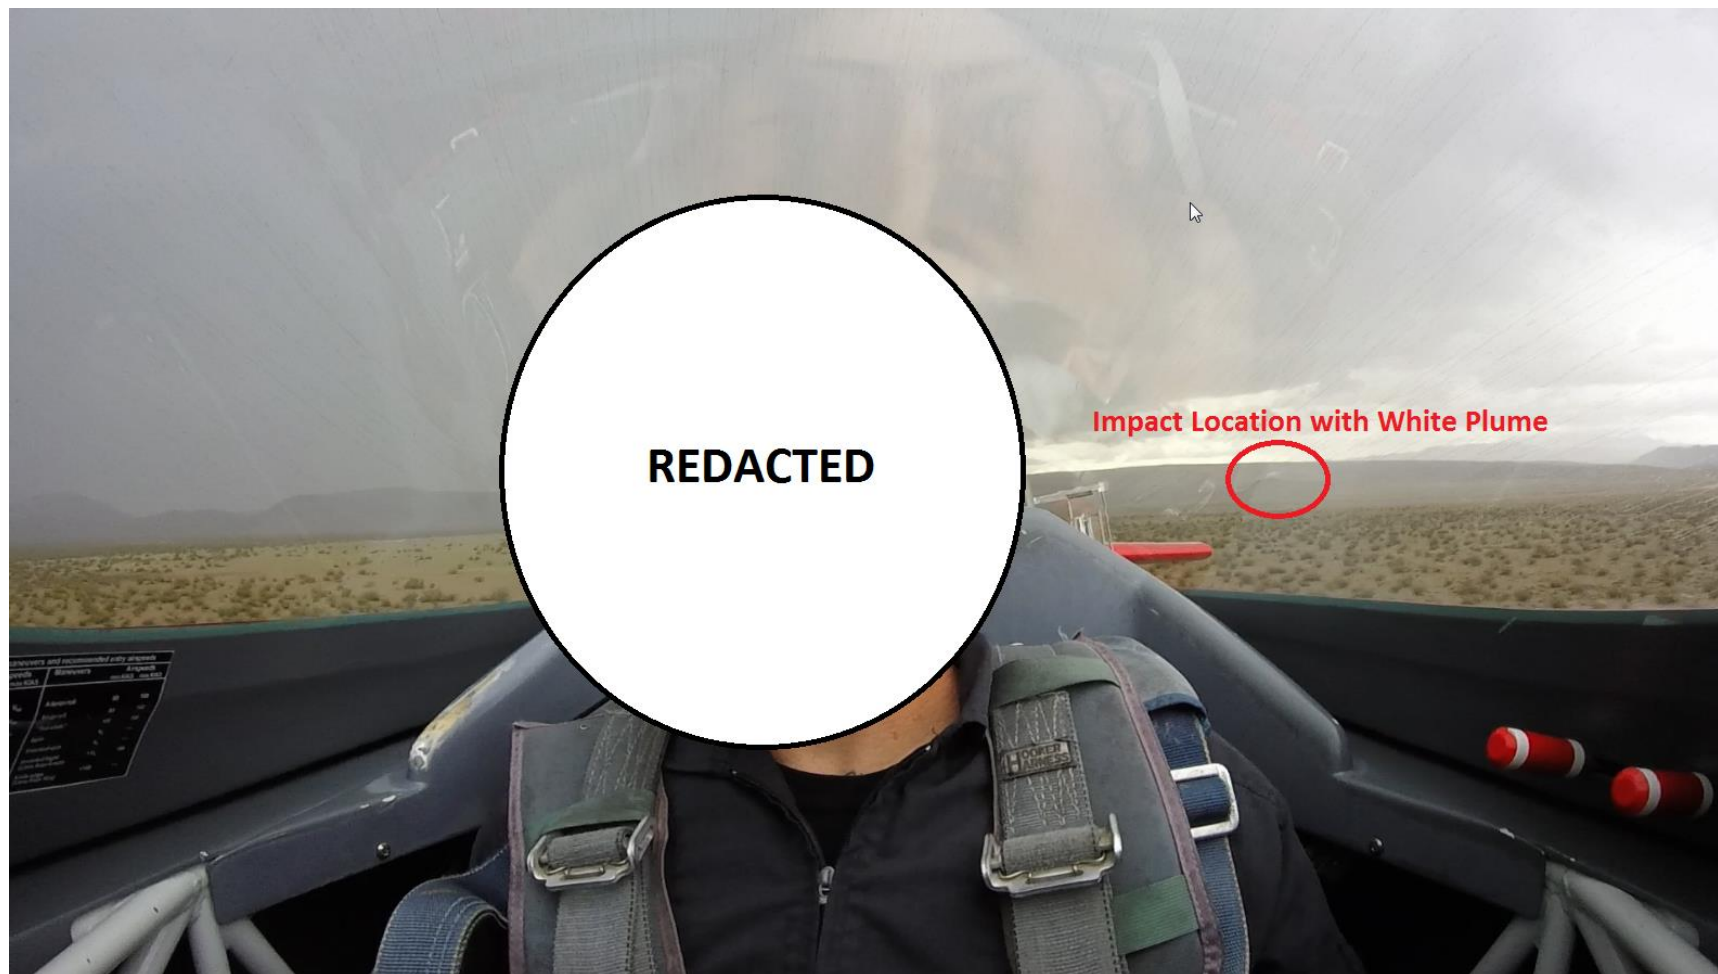
Figure 7. A white plume in the vicinity of the accident location.
