## **NATIONAL TRANSPORTATION SAFETY BOARD**

### **ONSITE EXAMINATION NOTES**

**WPR16FA097**

Location: Henderson, Nevada  
Date: April 30, 2016  
Aircraft: Extra Flugzeugproduktions-UND, EA-300/L,  
N330MT, Serial # 1316  
NTSB IIC: Albert Nixon

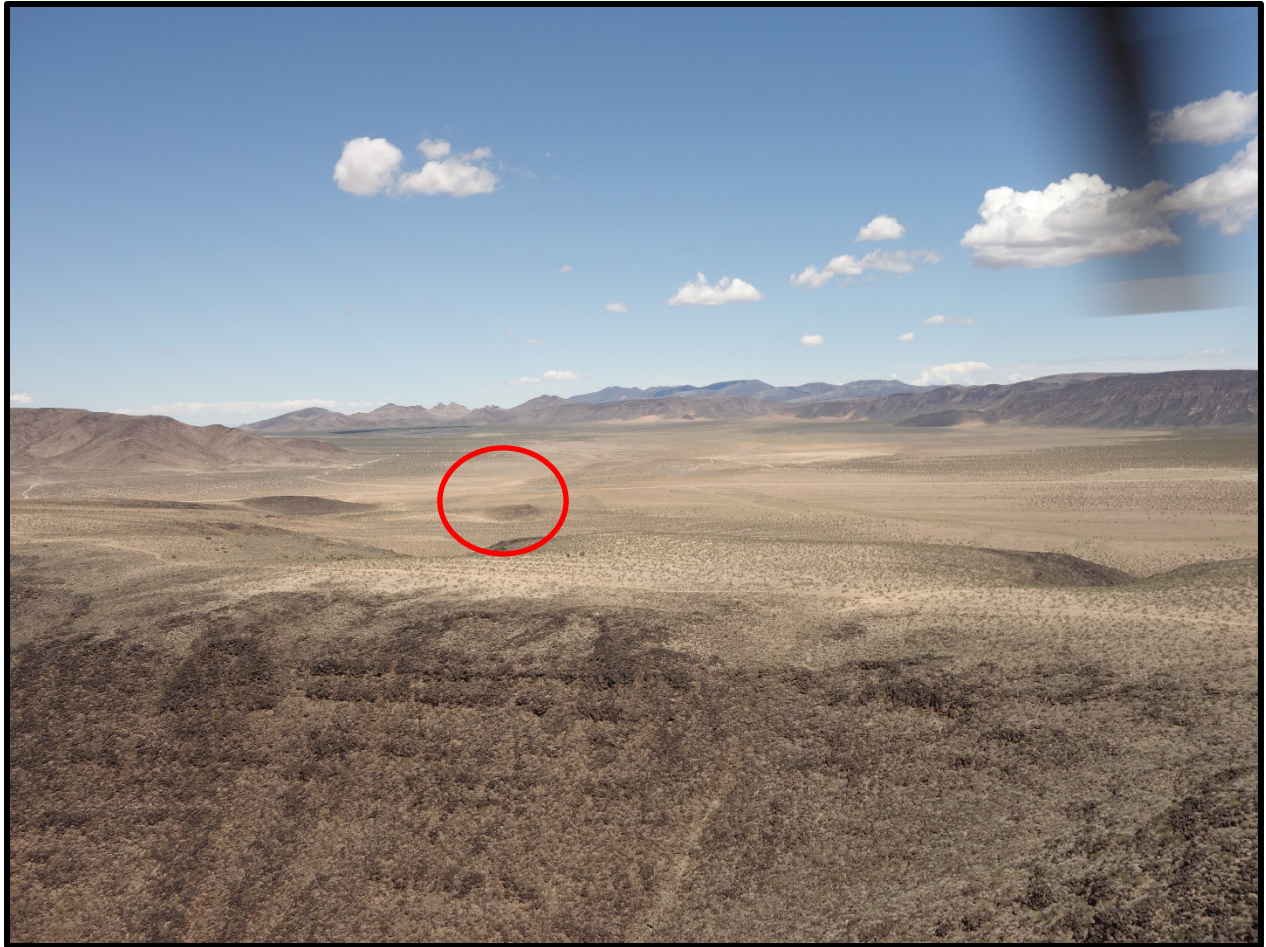
consisted mostly of dark-brown colored lava rocks and its dimensions were about 650 ft long by 350 ft wide, with a high elevation of about 3,109 ft. The contour of the hill was orientated to the northeast/southwest. The desert floor to the southwest side of the hill was about 40-50 ft lower than the hill elevation. The hill was about 3,000 ft northeast of the dry lake bed ridgeline.

**Figure 1: The Hill Impacted and the Surrounding Area.**

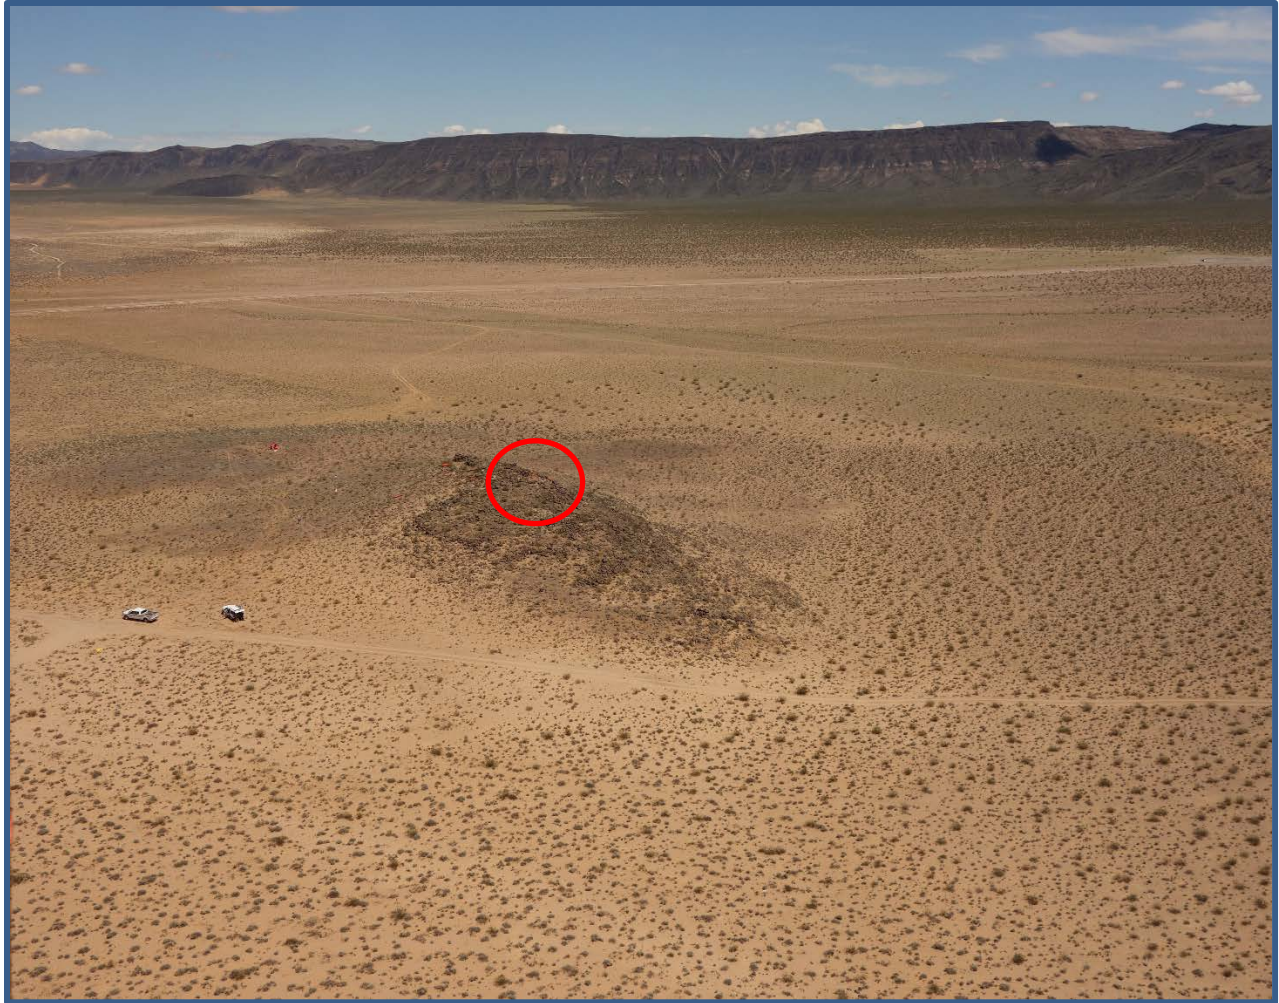
Dark brown colored marks were observed on the bottom of the tail section of the fuselage and on the horizontal stabilizers, consistent with striking the lava rocks at the initial impact point.

**Figure 2: The Hill that was Impacted.**

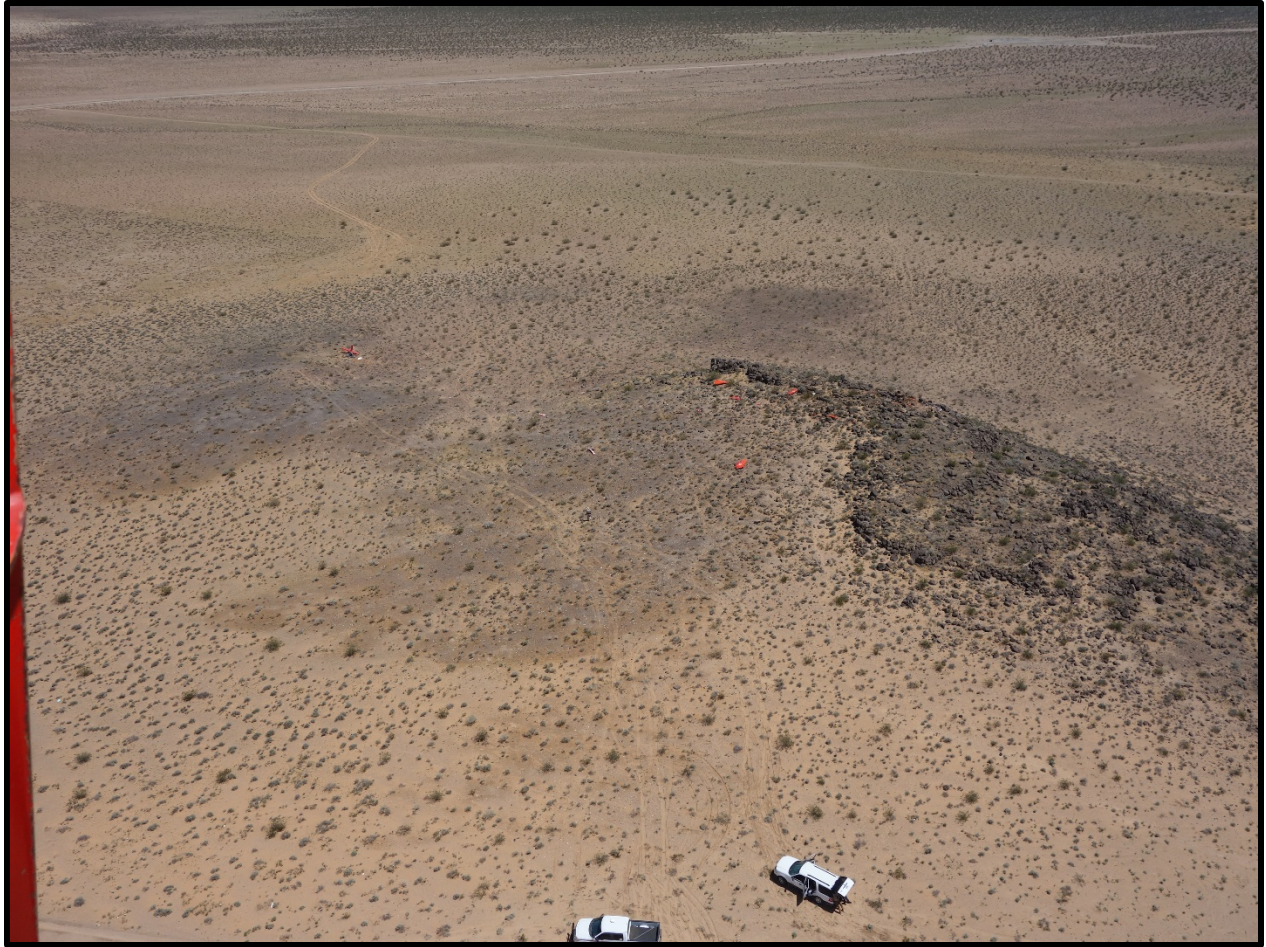
The engine was separated from the fuselage and located about 400 ft past the main wreckage, where it struck and breached a wire fence. The engine came to rest inverted. All the tubing had separated, and the bottom of the engine case was breached. The propellers had separated. Fragments of the composite propeller blades were observed near the initial ground impact scars.

**Figure 3: The Wreckage Debris Trail.**
