## **NATIONAL TRANSPORTATION SAFETY BOARD**

# **AIRFRAME AND ENGINE EXAMINATION**

**WPR16FA097**

Location: Henderson, Nevada  
Date: April 30, 2016  
Aircraft: Extra Flugzeugproduktions-UND, EA-300/L,  
N330MT, Serial No. 1316  
NTSB IIC: Albert Nixon

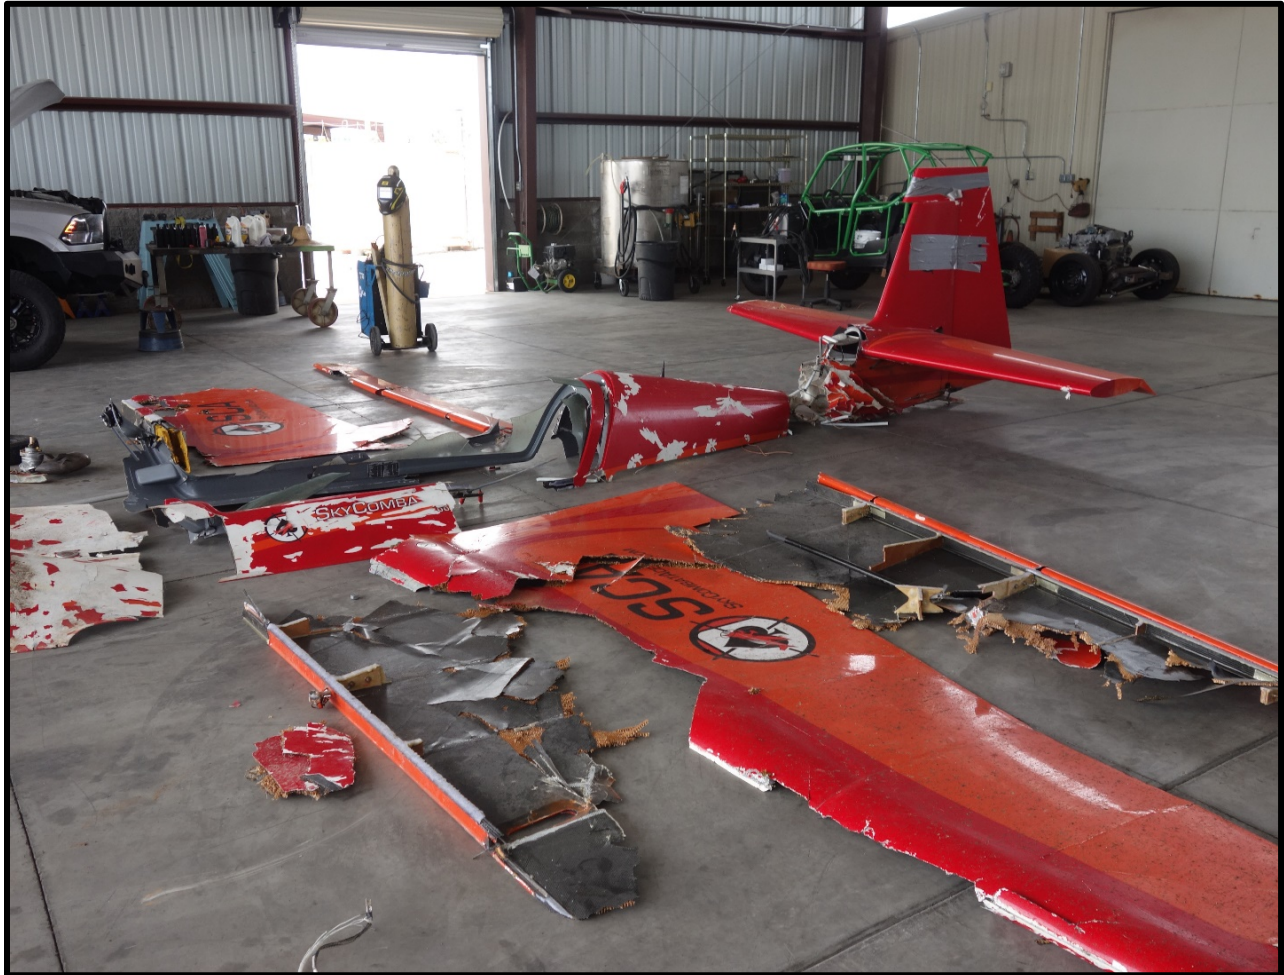
Examination of the composite airframe revealed that both wings had separated. The top portion of the left-wing top separated about two ft from the wing root. The bottom portion of the left wing separated mid-span. The right-wing separated into about 4 major sections and several more smaller fragments of the wing were recovered.

On the empennage section, the vertical stabilizer and horizontal stabilizer were relatively intact. The rudder and elevators remained attached at all their respective attachment points. The aft control rod was intact, and movement was appropriate with elevator movement. Flight control continuity was established to the cockpit controls despite impact damage. Impact separations of

the control rods and cables were consistent with overload. The tailwheel was separated. Windshield fragments were all observed to be clear of debris or contamination.

**Figure 1: View of the Airplane Wreckage Laid Out.**

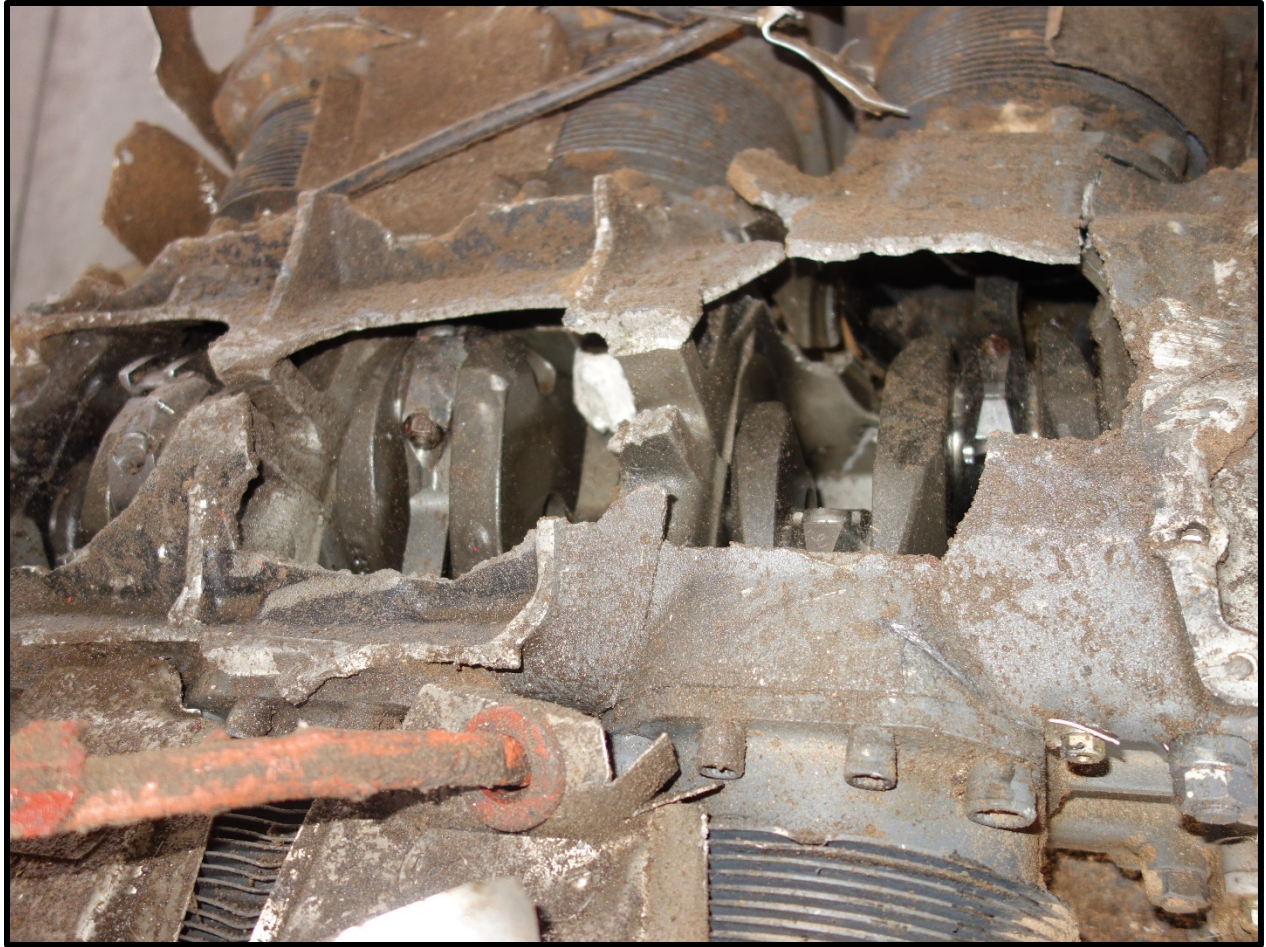
Examination of the Lycoming AEIO-580-B1A engine, serial number L-244-79E revealed that it separated from the airframe and sustained substantial impact damage. The bottom side of the engine and the accessory section had impact damage.

**Figure 2: View of the bottom of the Engine.**
