## **NATIONAL TRANSPORTATION SAFETY BOARD**

### **SUMMARY OF AIRPLANE EXAMINATION**

**(WPR16FA103)**

| Aircraft: | Piper PA28 |

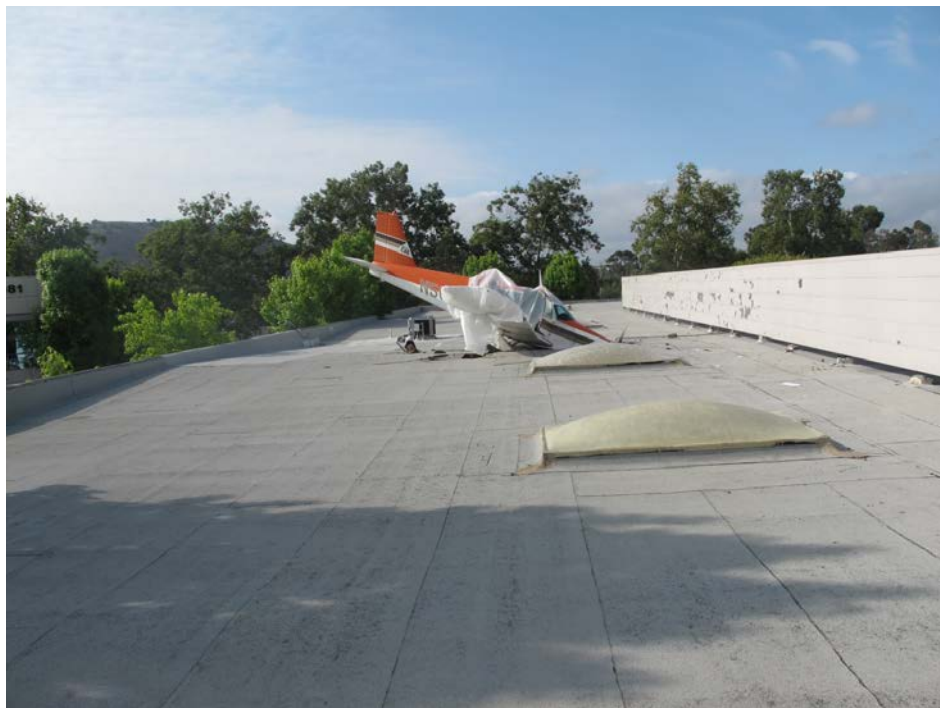
Figure 1 - right side view of airplane on roof

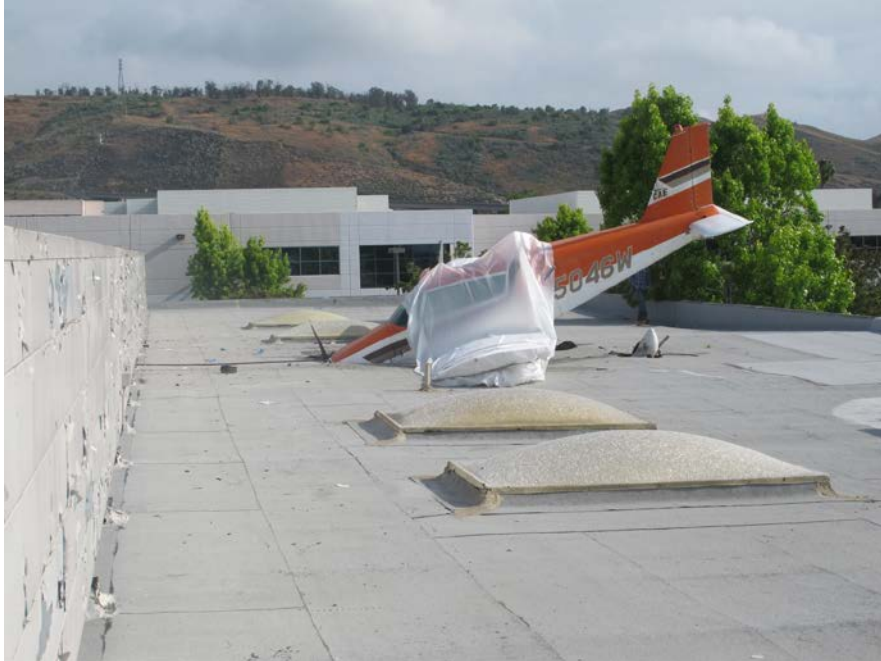
Figure 2 - left side view of airplane on roof

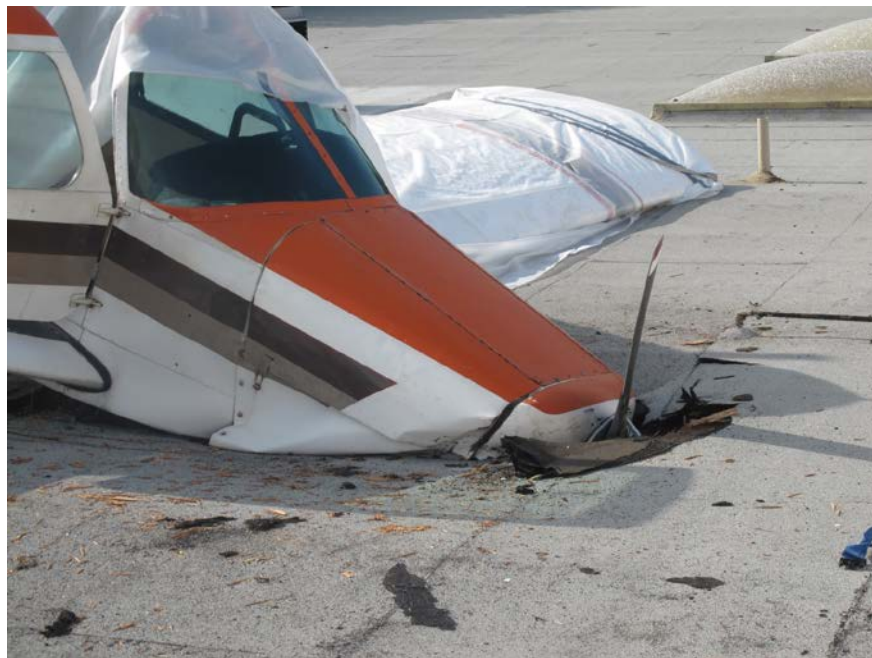
Figure 3 - nose of airplane imbedded in roof

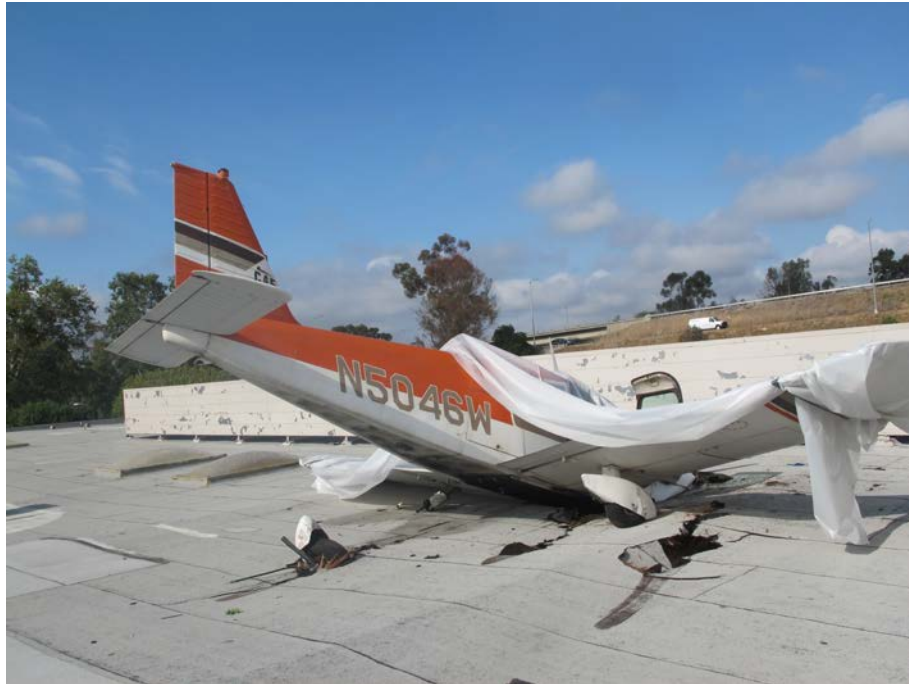
Figure 4 - right rear view of airplane on roof

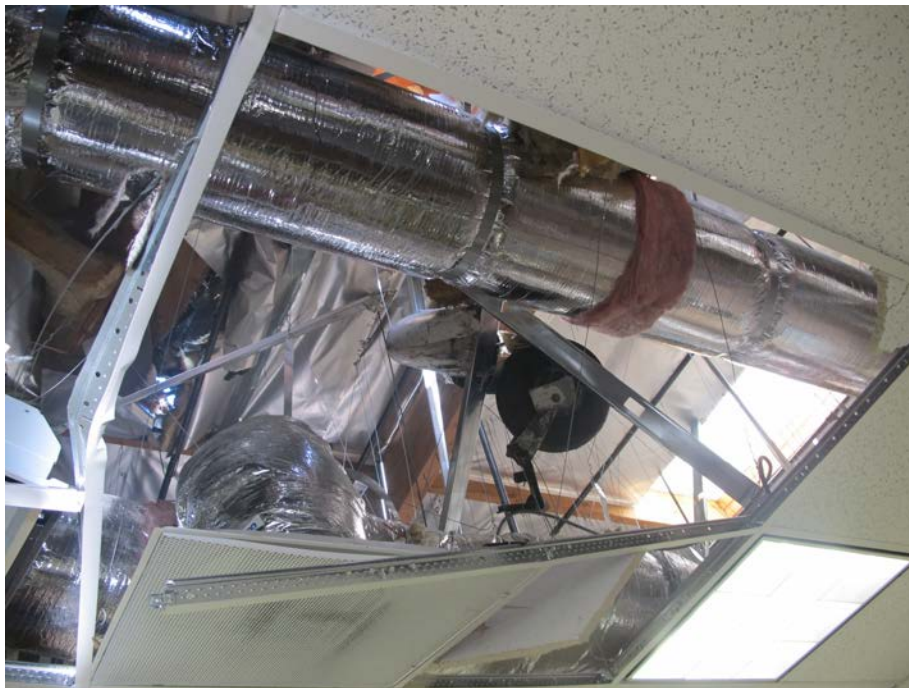
Figure 5 - separated nose wheel in ceiling of building

The nose landing gear assembly separated from the engine mount assembly due to roof impact. The nose gear assembly had gone through the roof and was found lodged in the building structure above the acoustical ceiling tiles. Impact damage was also present aft of the firewall on the belly skins.

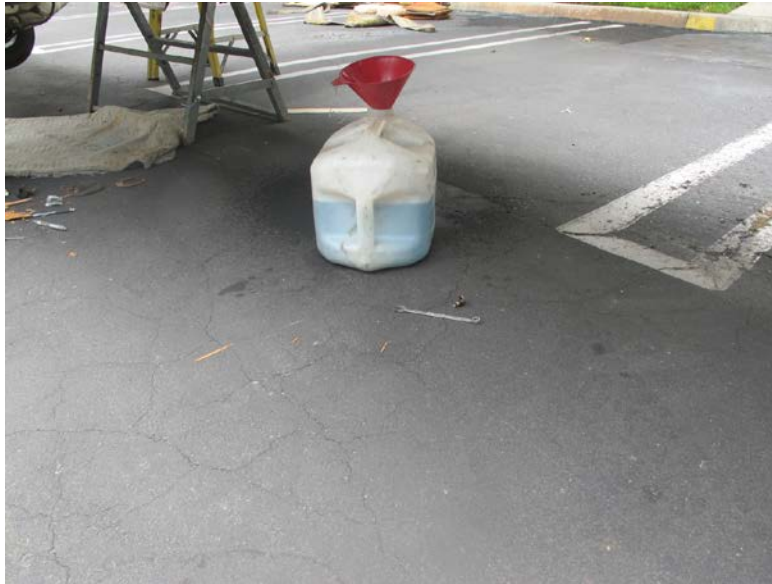
Investigators drained about 7.5 gallons of fluid from the left wing tank fuel drain; it was a light blue fluid that smelled like aviation gasoline. There was no visible contamination.

Figure 6 - container of fluid drained from left fuel tank

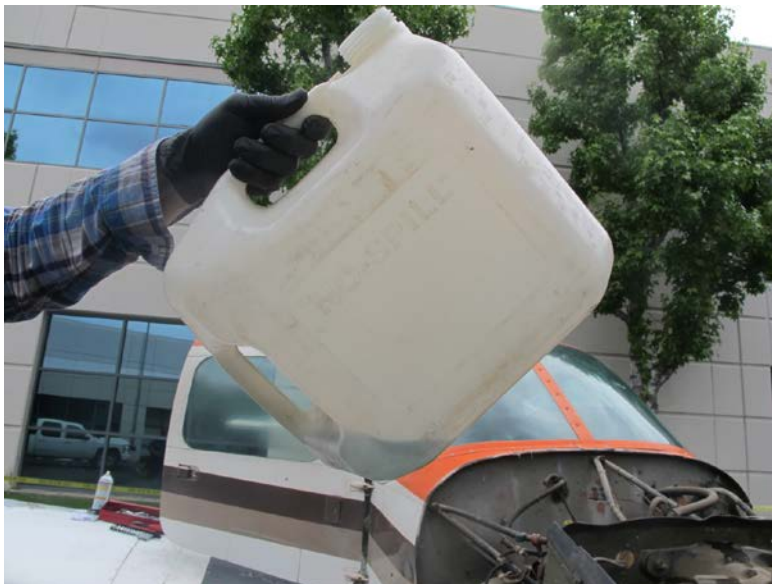
Investigators drained about 1 quart of fluid from the right wing fuel drain; it was a light blue fluid that smelled like aviation gasoline. There was no visible contamination.

Figure 7 - container with all fluid drained from right fuel tank

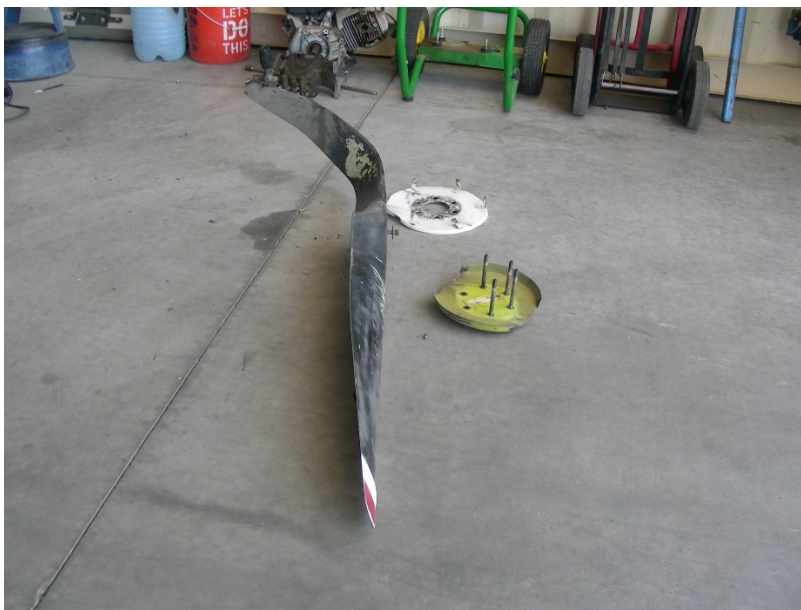
The two-bladed, fixed pitch propeller remained attached at the crankshaft flange. The spinner was attached to the propeller. The propeller blades remained attached to the propeller hub. One blade had been bent aft resulting from the collision.

There was no conclusive evidence observed on the propeller blades consistent with the absorption of rotational energy sustained at the time of impact.

Figure 1- photo of propeller post recovery
