# NATIONAL TRANSPORTATION SAFETY BOARD

MATERIALS LABORATORY FACTUAL REPORT

Report No. 17-019

Place : Santa Paula, California  
Date : May 28, 2016  
Vehicle : Moore VariEze, N80681  
NTSB No. : WPR16FA118  
Investigator : Tealeye Cornejo, ASI-WPR

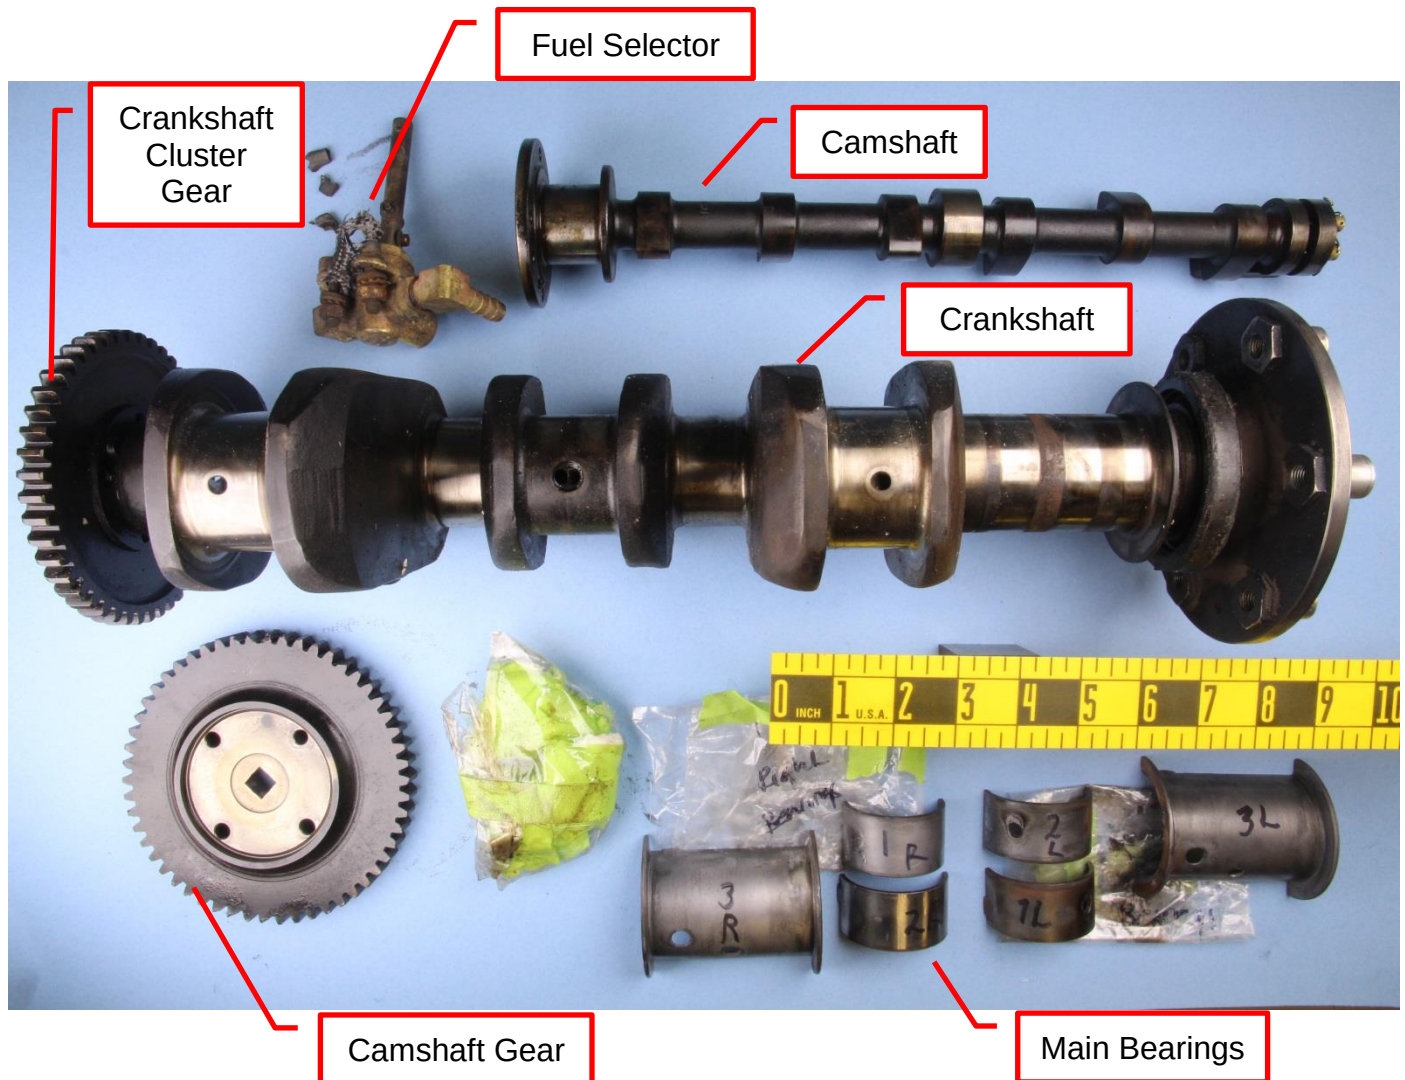
The as-received components are displayed in figure 1. The crankshaft was intact but discolored at several bearing locations. The crankshaft was steel stamped "N02EA902" on the flange perimeter along with timing marks. All three main bearings journals and cylinder 2 and 3 journals were darkened on the same side consistent with baked on oil from heating on one side of the nonrotating engine.

Figure 1. Overall view of the as-received components with label. The fuel selector valve was received with the engine components but not examined. Engine forward at right.

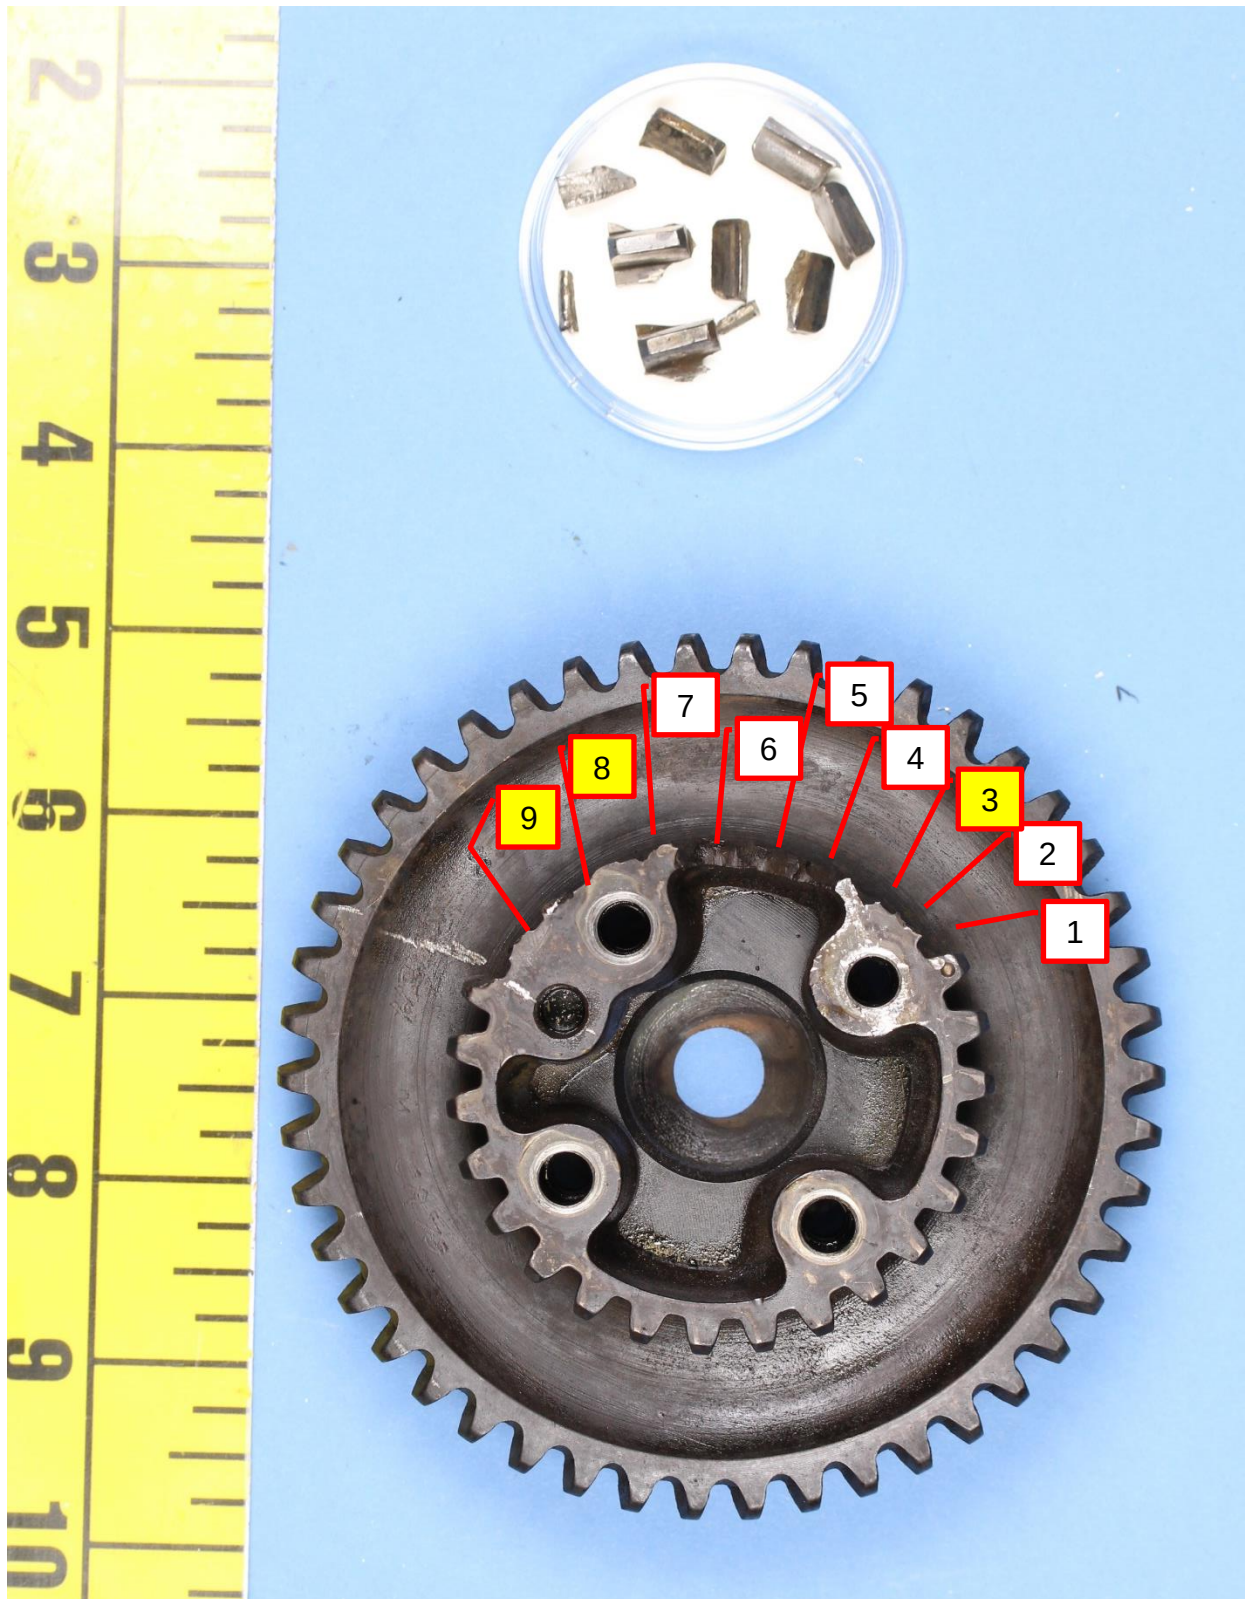
Nine consecutive gear teeth were fractured from the cam drive gear ring of the crankshaft gear cluster as shown in figure 2 (gear rotation clockwise). Large pieces of eight teeth were recovered from the oil sump along with some small pieces, as shown at the top of figure 2. Close examination positively identified the gear ring locations of 6 of the recovered gear pieces. Looking forward at the gear, the fractured teeth were numbered counterclockwise, as shown. The #1 tooth was also marked as one of the two location indexing teeth for the camshaft gear. Six teeth were fractured generally through base of the tooth and gear ring fractures liberated the remaining three teeth (4, 5 and 6).

Figure 2. View looking forward at the cluster gear with recovered teeth at top. Fractured teeth on cam drive gear ring are numbered with yellow boxes indicating teeth not identified in the recovered ones. End of crankshaft still attached.

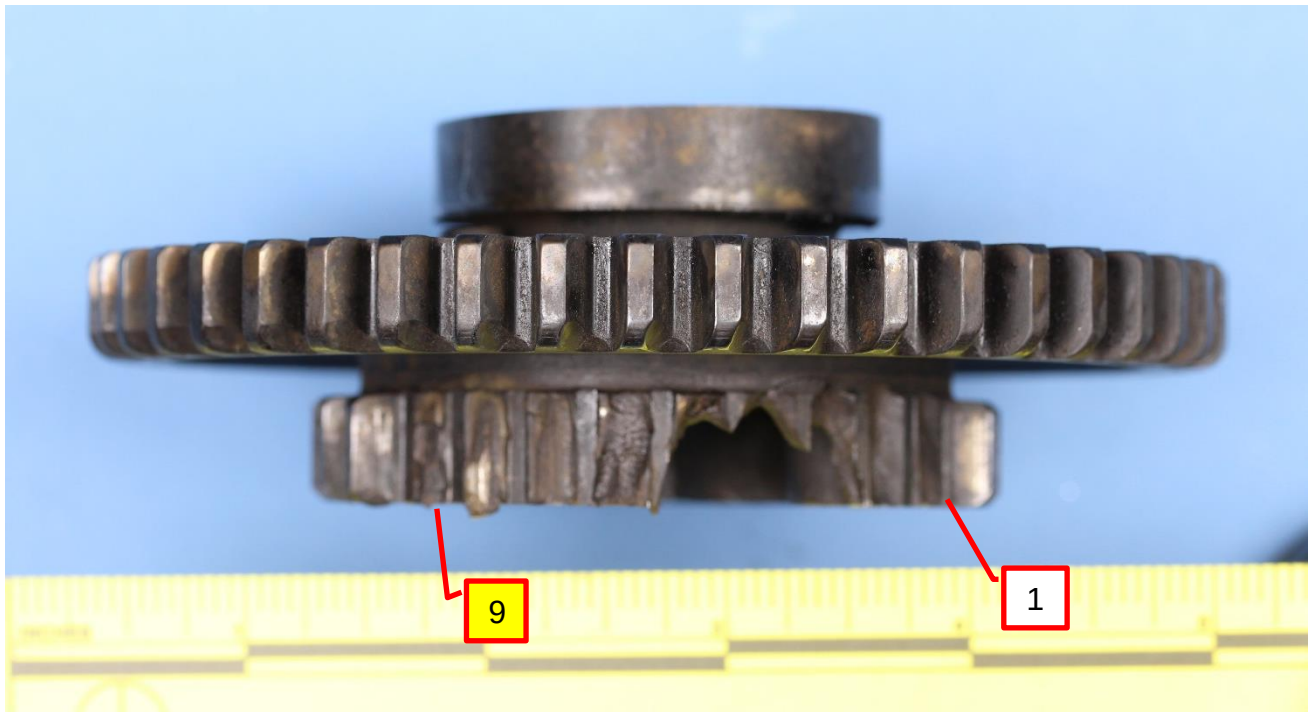
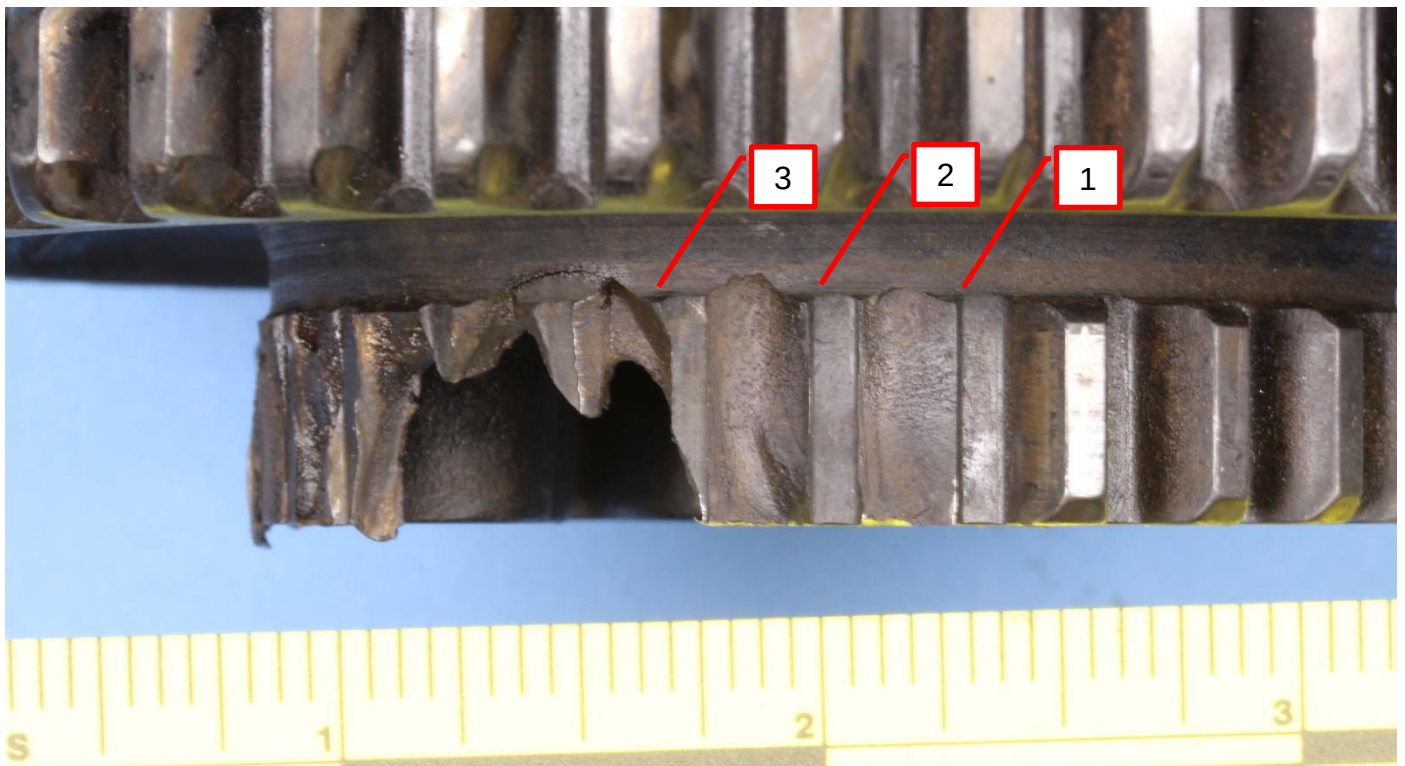
Figure 3 displays a radial view of the fractured teeth with #1 and #9 identified. Magnified optical examination of the fractures after cleaning revealed fatigue progression beach marking on the fracture surfaces of teeth #1 #2 and #3. The remaining teeth fractures were overstress in nature.

As shown in figure 3, the fatigue progressed almost entirely through the cross sections of teeth #1 and #2. The fatigue in tooth #3 was about 25% of the section. In all three fractures, the fatigue initiated at the sharp forward-pressure face corners of the teeth. Scanning electron microscope imaging confirmed the fatigue initiation location as shown in figure 5 for teeth #1 and #2. Initiation was near the base of each tooth, about 0.025 inch outboard of the root diameters.

Figure 3. Radial view of the cluster gear looking at the area of fractured teeth on the cam drive gear ring. Lower view shows a closer view of the fatigue fractured #1, #2 and #3 teeth with lines pointing to origin locations.

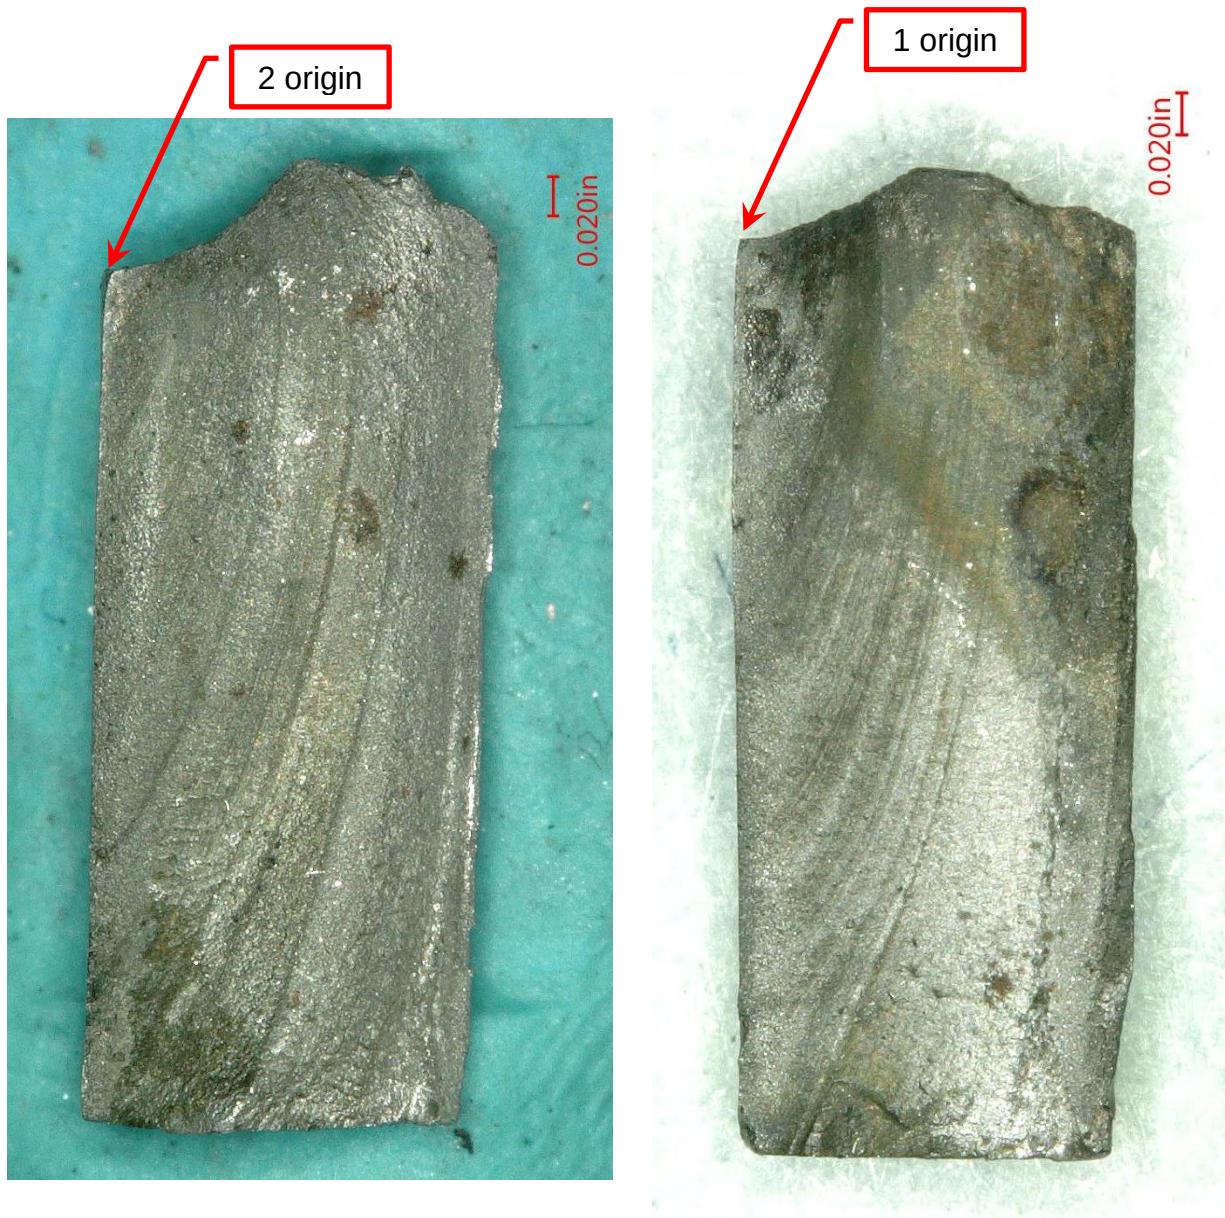
Figure 4 Magnified views of the fracture faces on separated teeth #1 and #2 showing fatigue origins and beach marks. Progression was through almost entire cross section of each tooth.

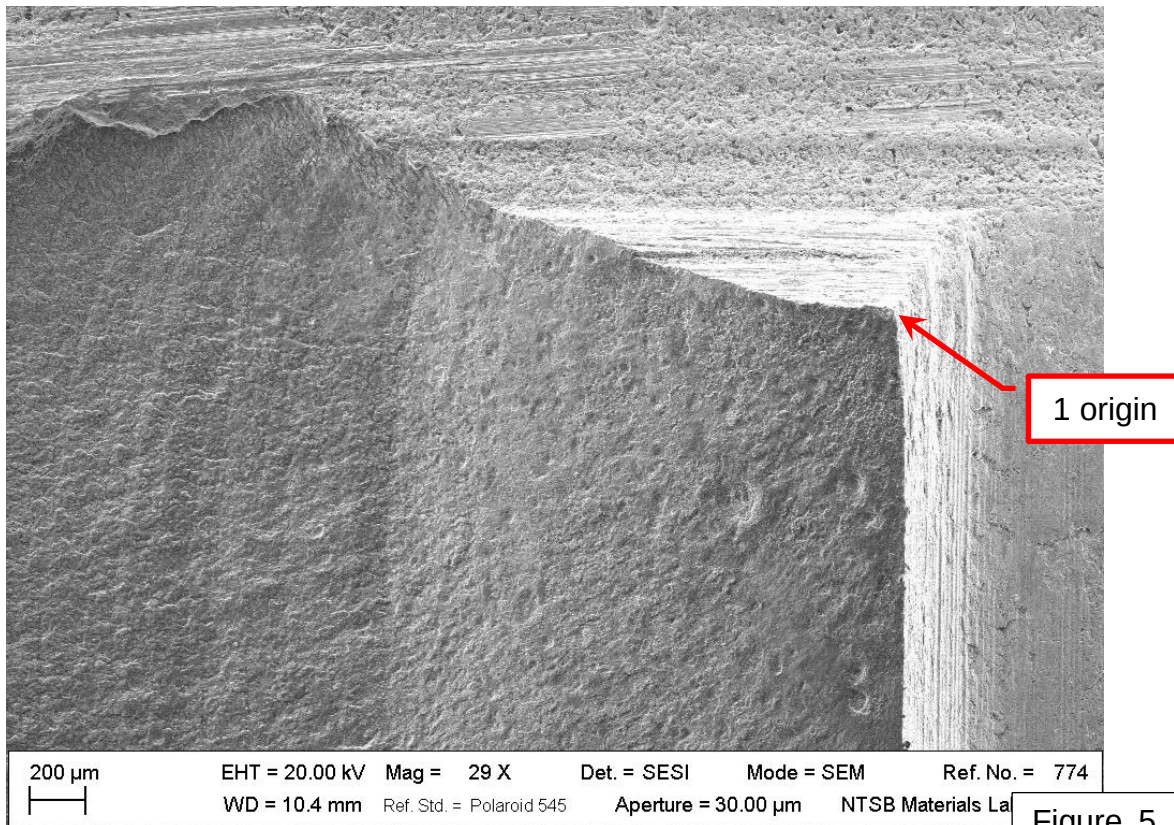
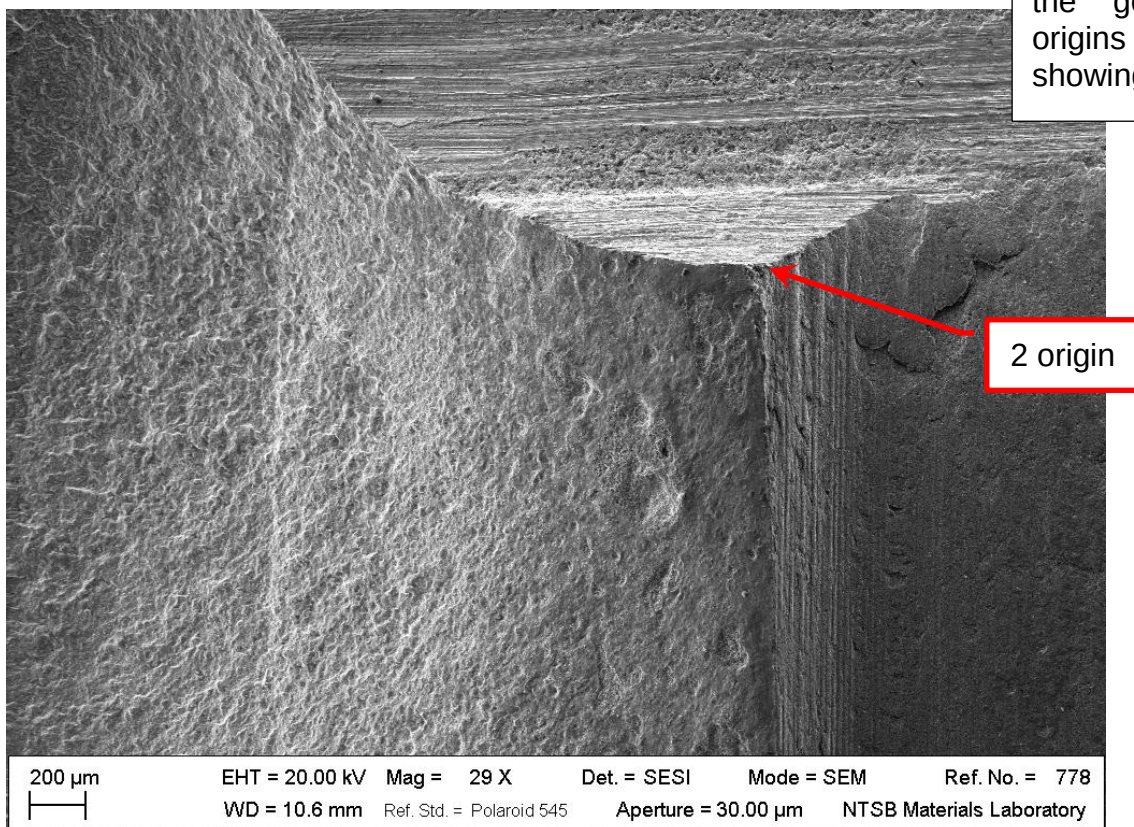
Figure 5. SEM views of the gear side fatigue origins on teeth #1 and #2 showing the sharp corners

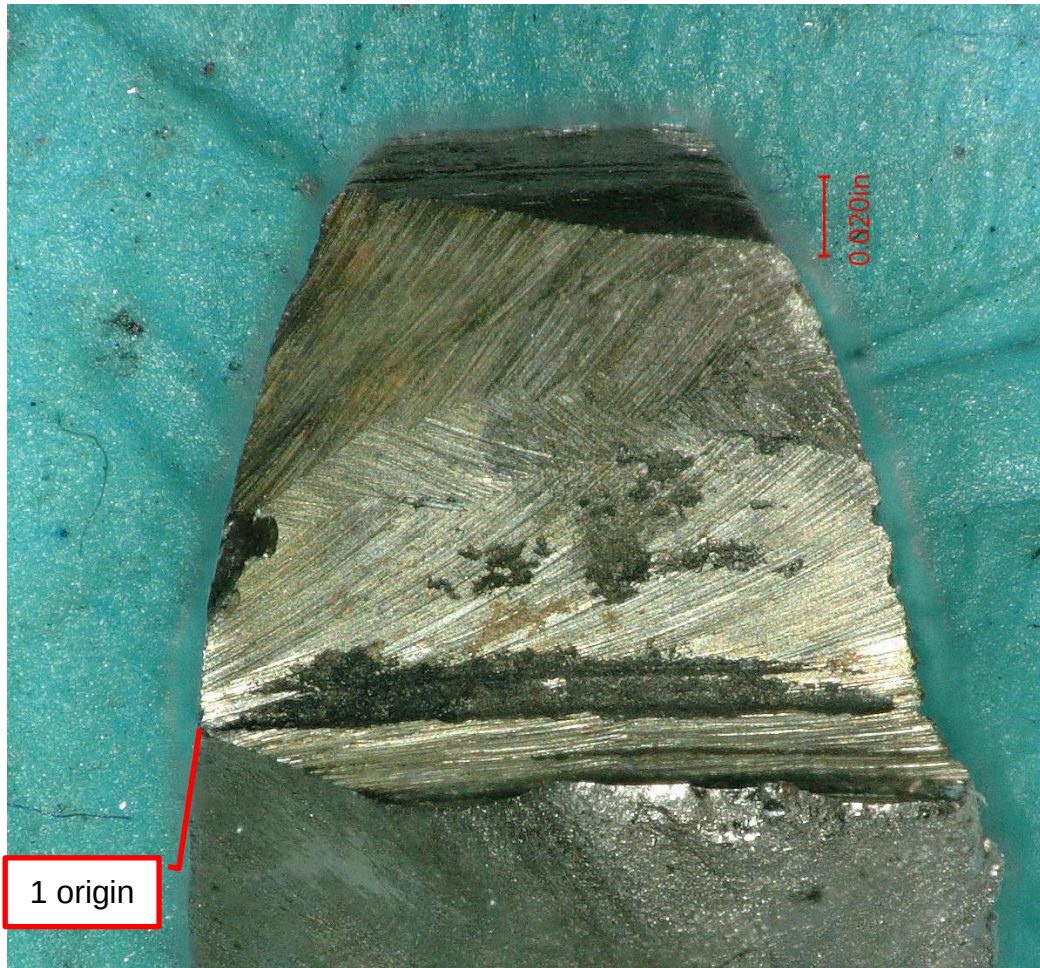
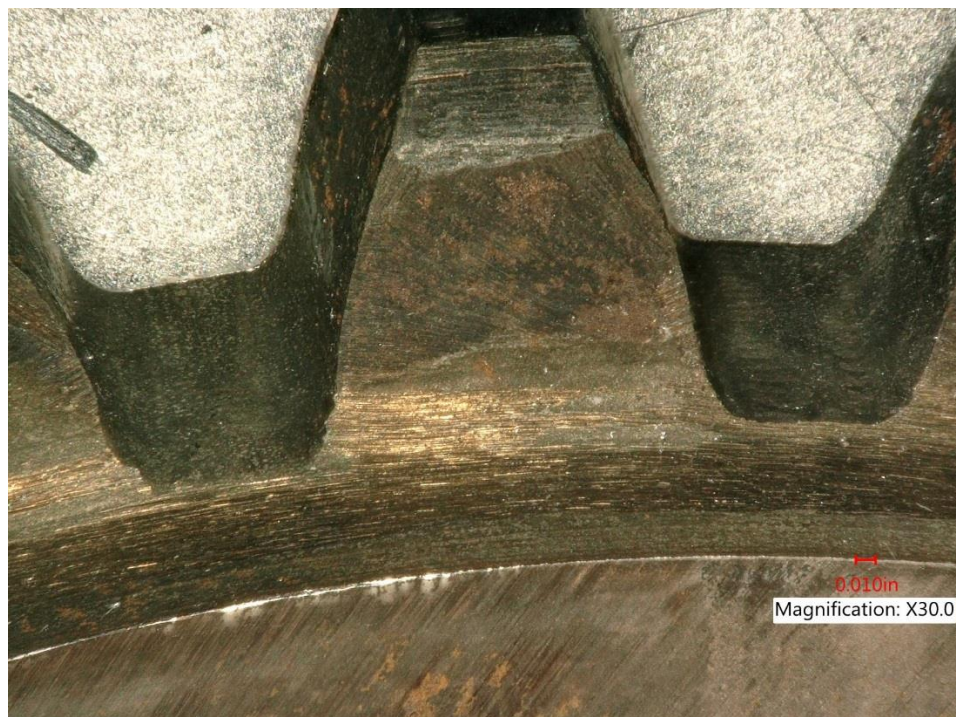
Magnified inspections found that the forward faces of teeth #1, #2 and #3 had been non-uniformly ground as exemplified by the face of the #1 tooth shown in the upper view of figure 6. Further inspections found similar grinding marks on most of the remaining gear teeth in the gear ring.

Figure 6. Optical views showing typical grinding on forward faces of teeth. Separated #1 tooth at top and a typical intact tooth below.

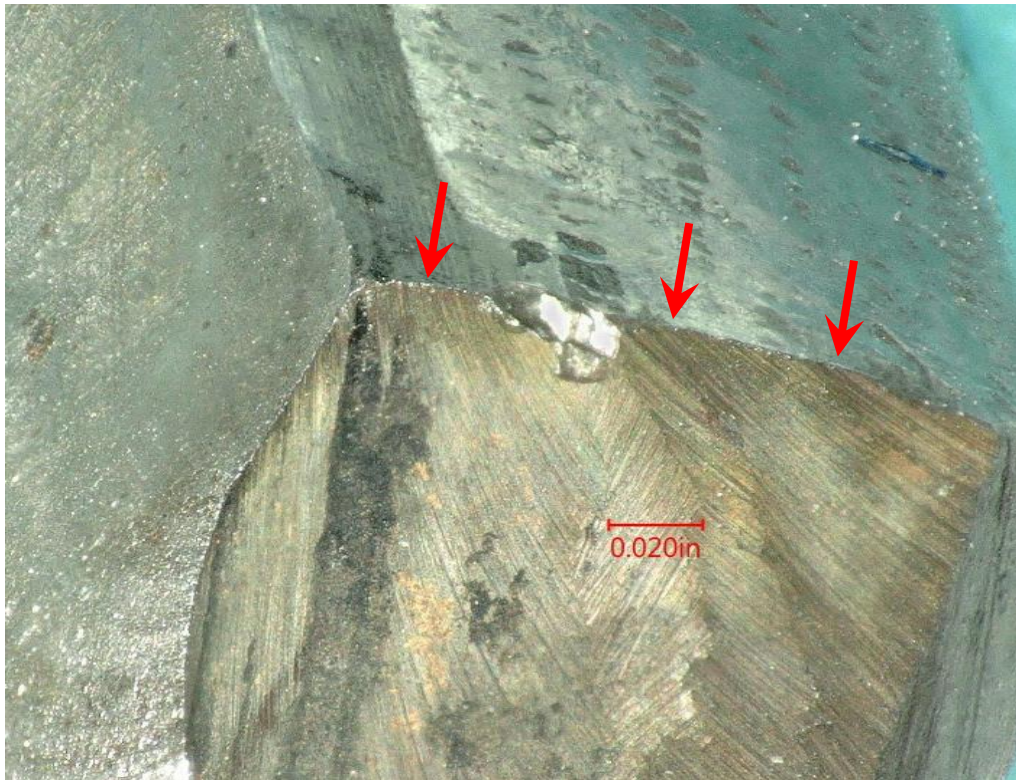
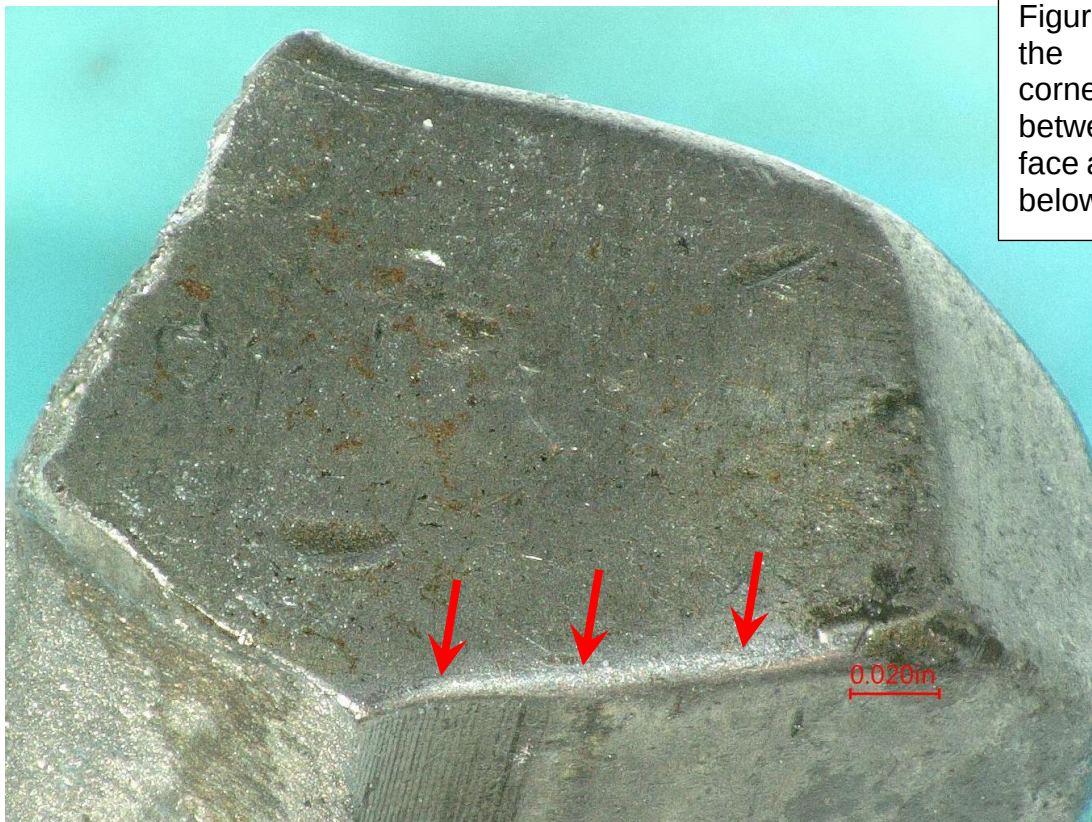
Figure 7. Views illustrating the differences in the corner shapes (arrows) between the forward tooth face at top and the aft faces below.

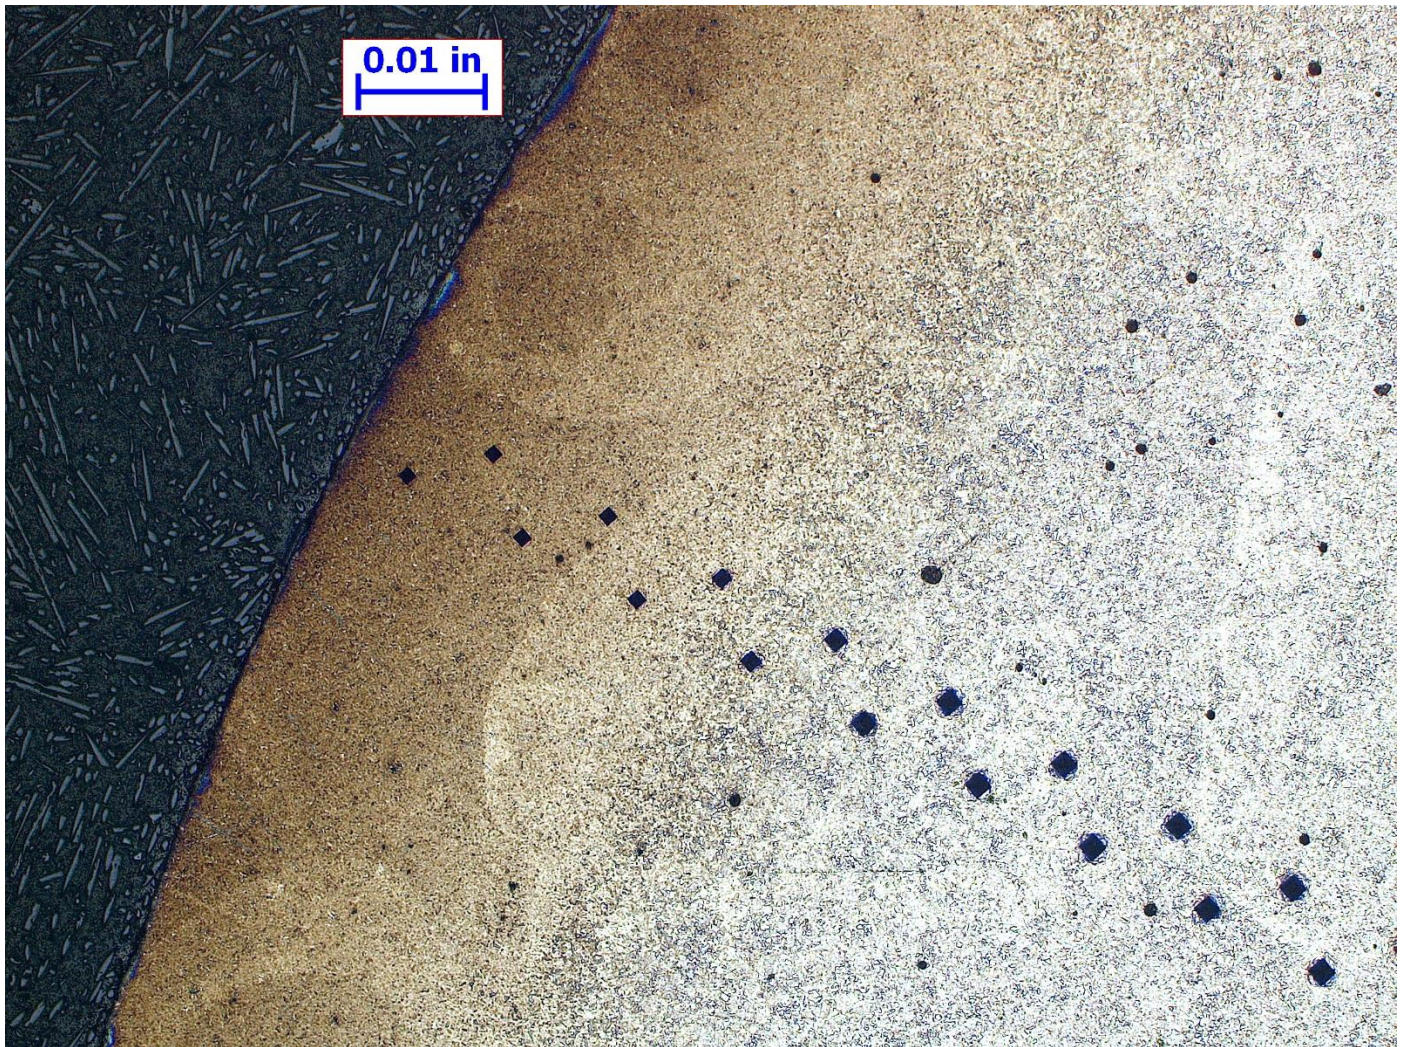
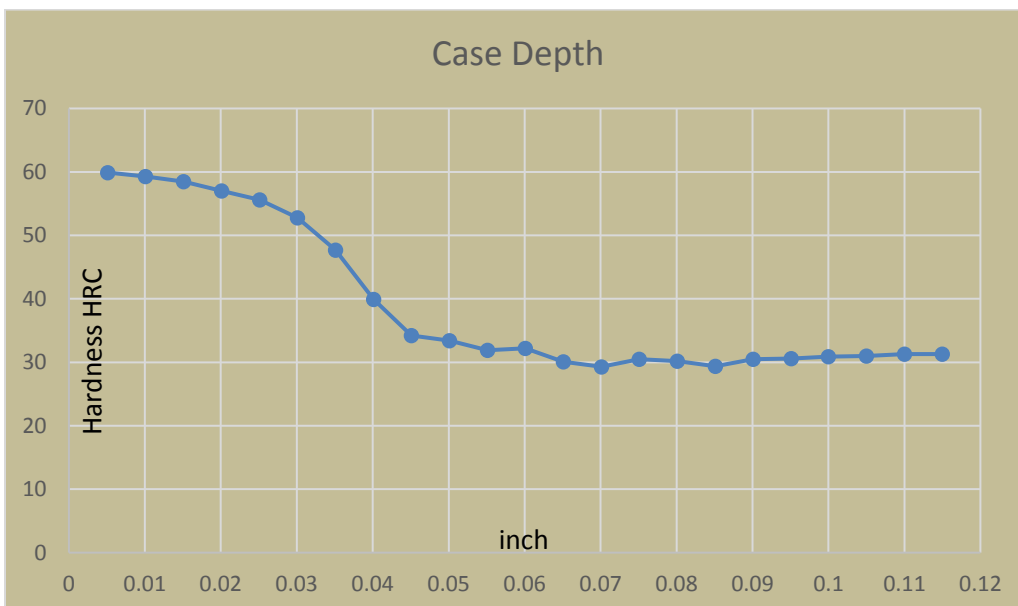
A transverse metallographic section was cut through four intact gear teeth opposite the fractured teeth. Etching the polished specimen with 2% Nital<sup>1</sup> revealed a microstructure typical of a carburized case on the gear tooth profiles. A typical area is shown in the upper view of figure 8 with indentations from a microhardness. Graphical results of the traverse is shown below. HRC 50 depth is about 0.032 inch with the depth at HRC 40 about 0.040 inch. Total case is over 0.050 inch.

Figure 8. Optical micrograph, above, of a transverse section of tooth showing the carburized case and core microstructures. 2% Nital. Graph at left shows hardness profile through the case.

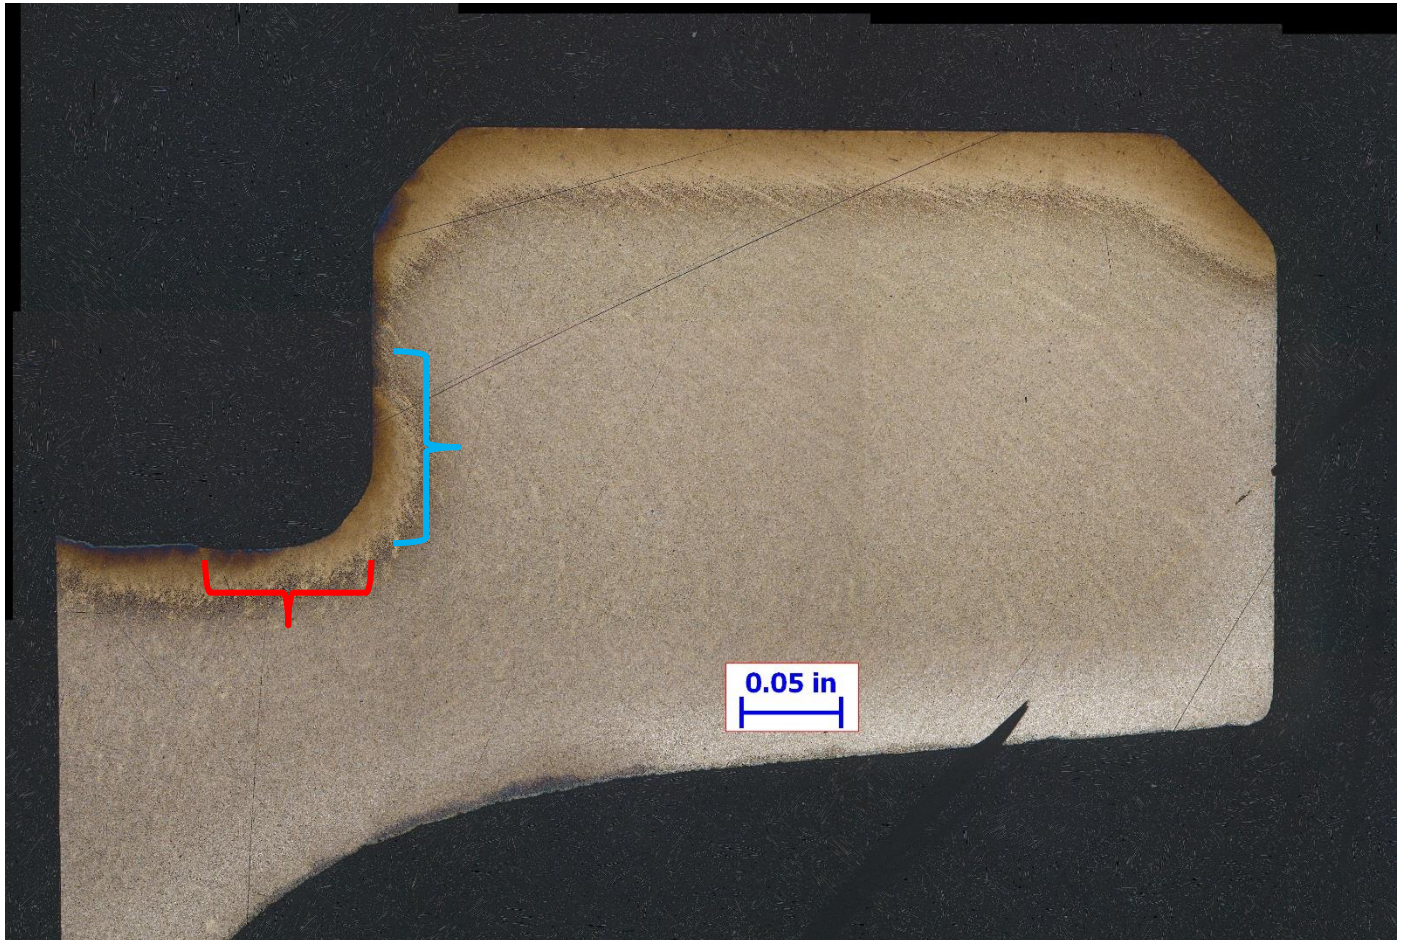
A longitudinal cross section through a typical tooth with grinding on the forward face is displayed in figure 9. No significant microstructural changes were noted with the areas of grinding of the forward face (blue bracket) and inter-gear diameter (red bracket).

Figure 9. Longitudinal microsection through a typical tooth showing grinding on the forward face (blue bracket) and the connecting diameter (red bracket).
