**NATIONAL TRANSPORTATION SAFETY BOARD  
Western Pacific Regional Office  
Federal Way, Washington**

**Examination Report  
June 13, 2016  
Santa Paula, California**

NTSB Accident Number: **WPR16FA118**  
IIC: **T. Cornejo**  
Aircraft: **N80861 – Experimental VeriEze**

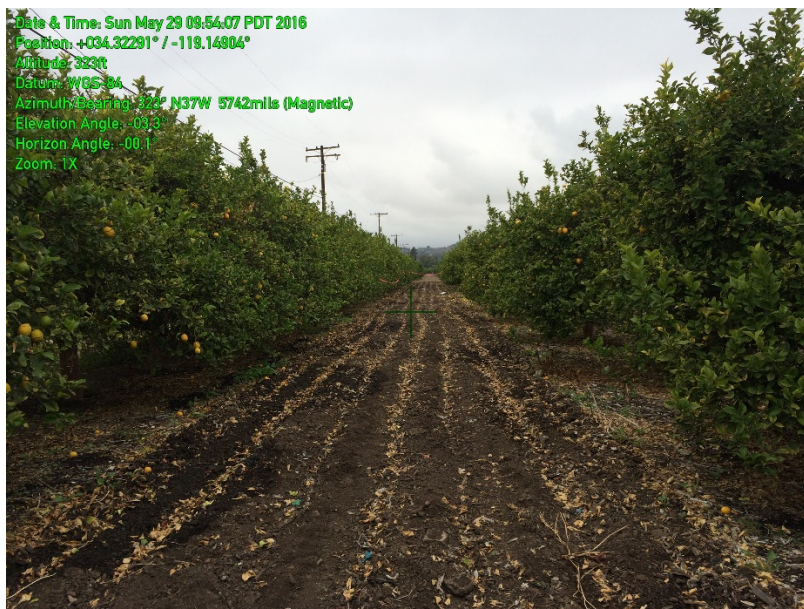
Photo 01 – Debris path (NTSB)

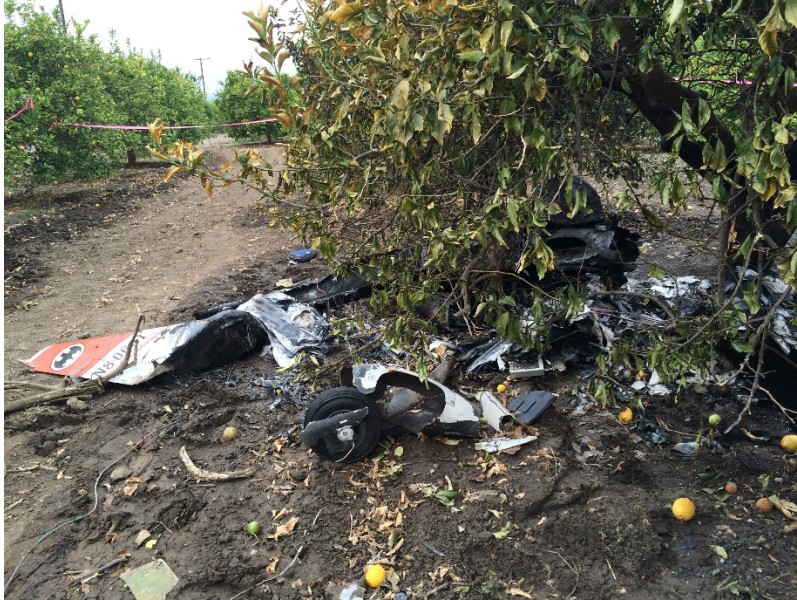
Photo 02 – Main Wreckage (NTSB)

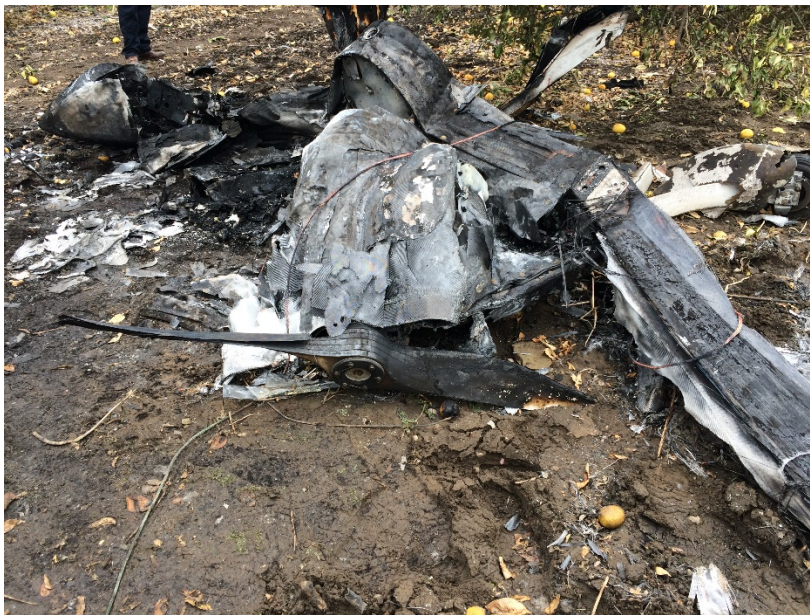
Photo 03 – Front View of Main Wreckage (NTSB)

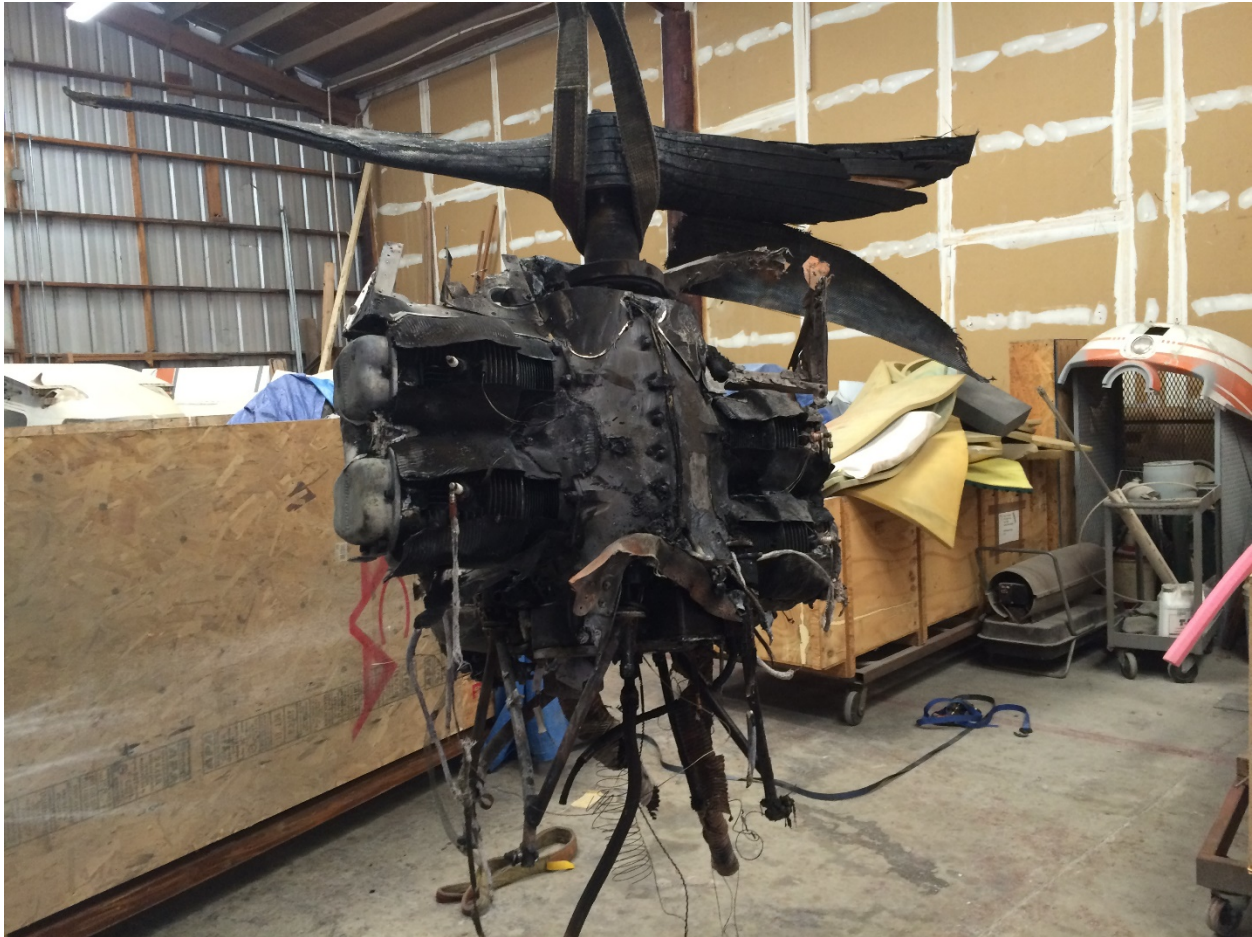
Photo 04 – Top View of Engine (NTSB)

The engine was manually rotated the engine via the propeller with movement of the intake/exhaust valves/rocker arms observed. However, no compression obtained at the cylinders.

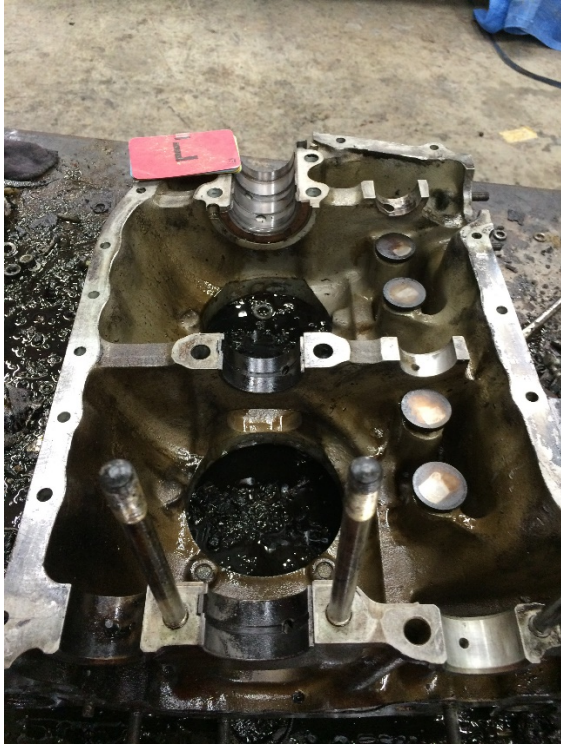
Photo 05 – Left Half of Engine Case (NTSB)

The Nos 1 and 2 bearings on the left side were black in color.

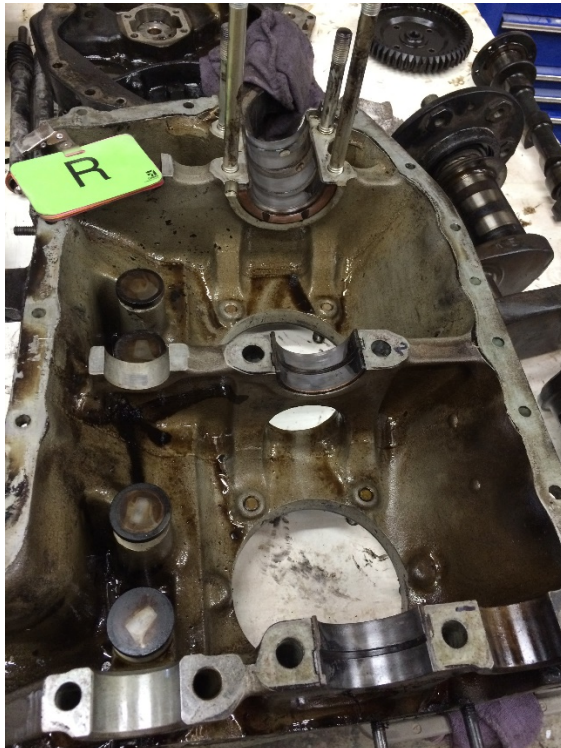
Photo 06 – Right Half of Engine Case (NTSB)
