## **NATIONAL TRANSPORTATION SAFETY BOARD**

### **SUMMARY OF AIRPLANE EXAMINATION – WPR16FA120**

#### **A. ACCIDENT**

| Aircraft: | Rockwell International S-2R |

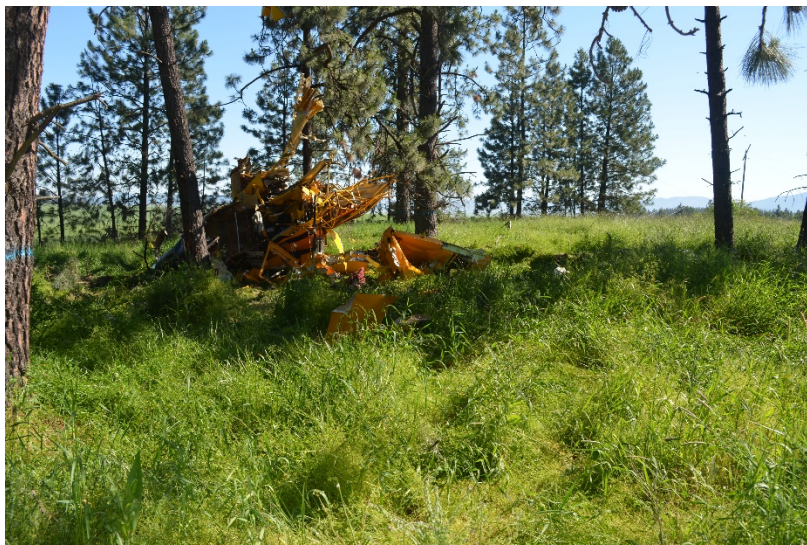
Figure 1 - view of main wreckage looking north

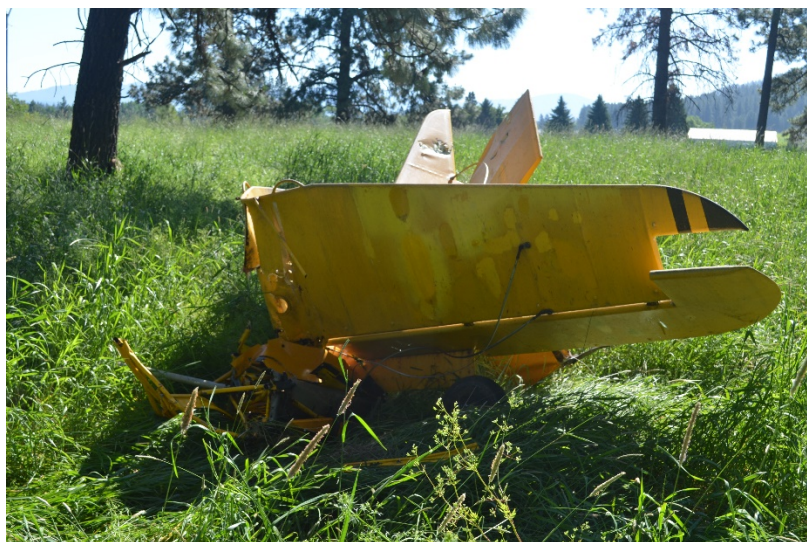
Figure 2 - view of empennage looking southeast

The aft fuselage from the cockpit to the empennage sustained significant impact damage, was bent twisted and mangled throughout, and had separated from the empennage. The empennage was located about 40 south of the main wreckage.

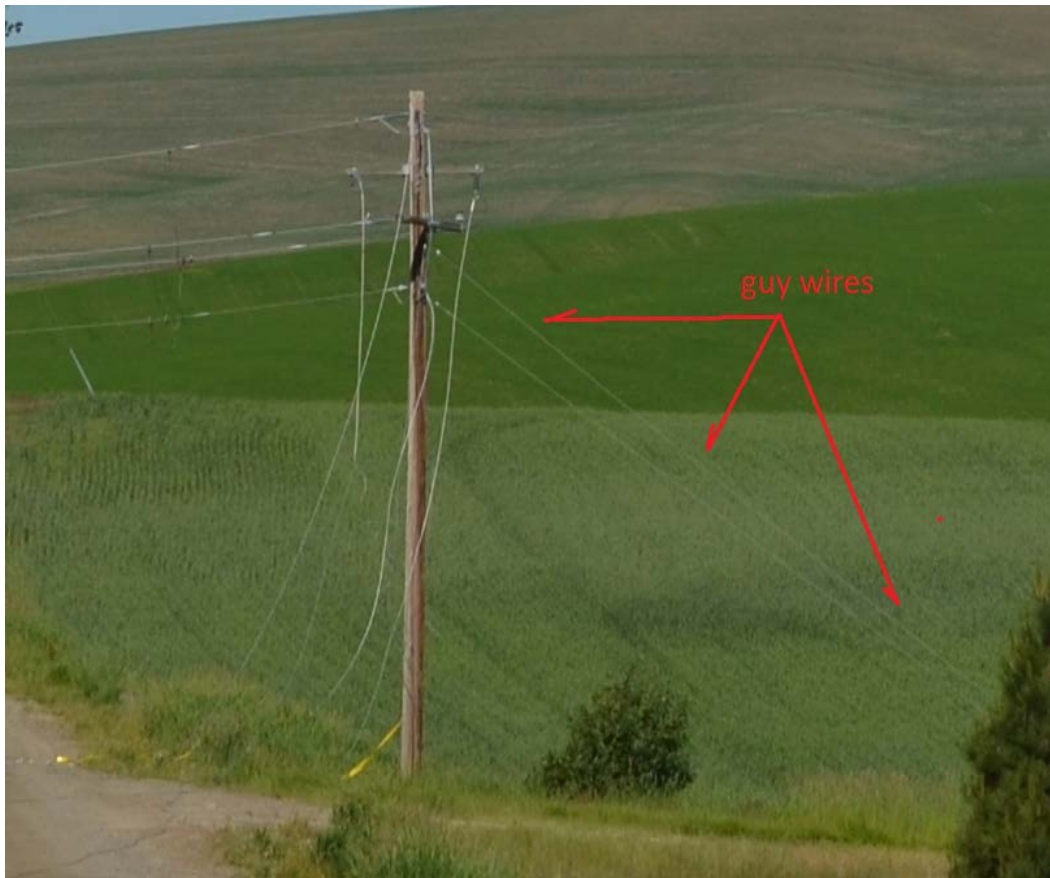
However, during the survey of the area an outboard section of the airplane's right wing, which measured about 2 feet in length, was located about 160 ft east-southeast of the guy wires. Additionally, black and yellow paint chips, consistent with the airplane's wing's paint scheme, were located about 100 ft southeast of the guy wires. The physical evidence was consistent with the outboard section of the right wing having impacted the guy wires, which then resulted in the airplane veering to the right, colliding with the powerlines that bordered the field to the south, and then proceeding uncontrollably across the country road and into the stand of trees on a southeasterly heading. The airplane subsequently impacted numerous trees on a heading of about 140 degrees before finally impacting a tree with its left wing. This resulted in the airplane spinning around to the left and coming to rest on a heading of about 320 degrees, which was nearly the reciprocal of the heading from which the airplane had entered the stand of trees after having collided with the powerlines.

Figure 3 - photo of guy wires looking west in the direction from which the airplane was approaching

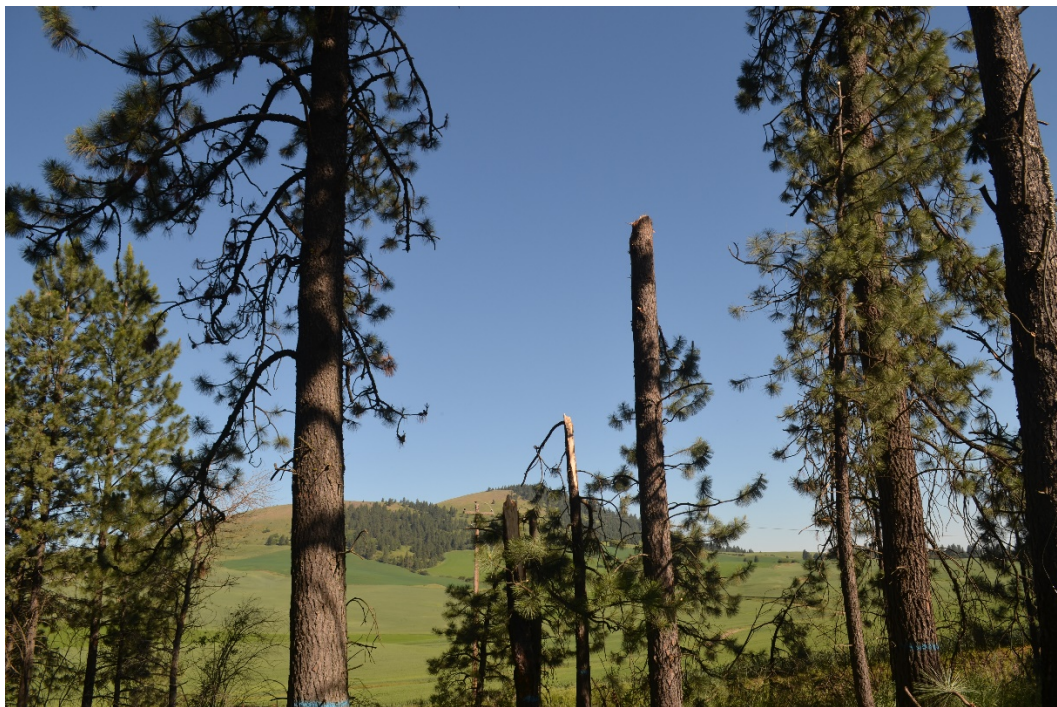
Figure 4 - photo looking northwest at trees impacted after impact with powerlines
