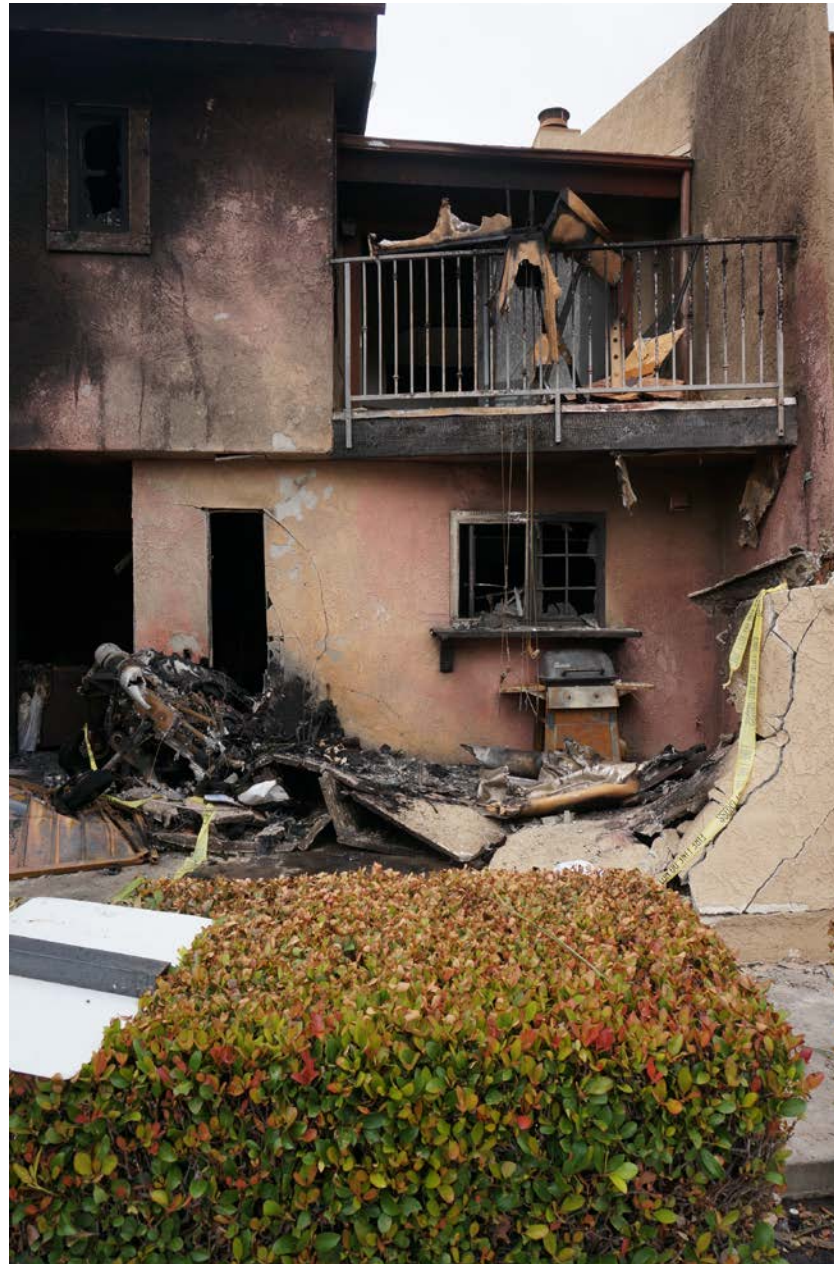
**Photo 1 – Main wreckage**

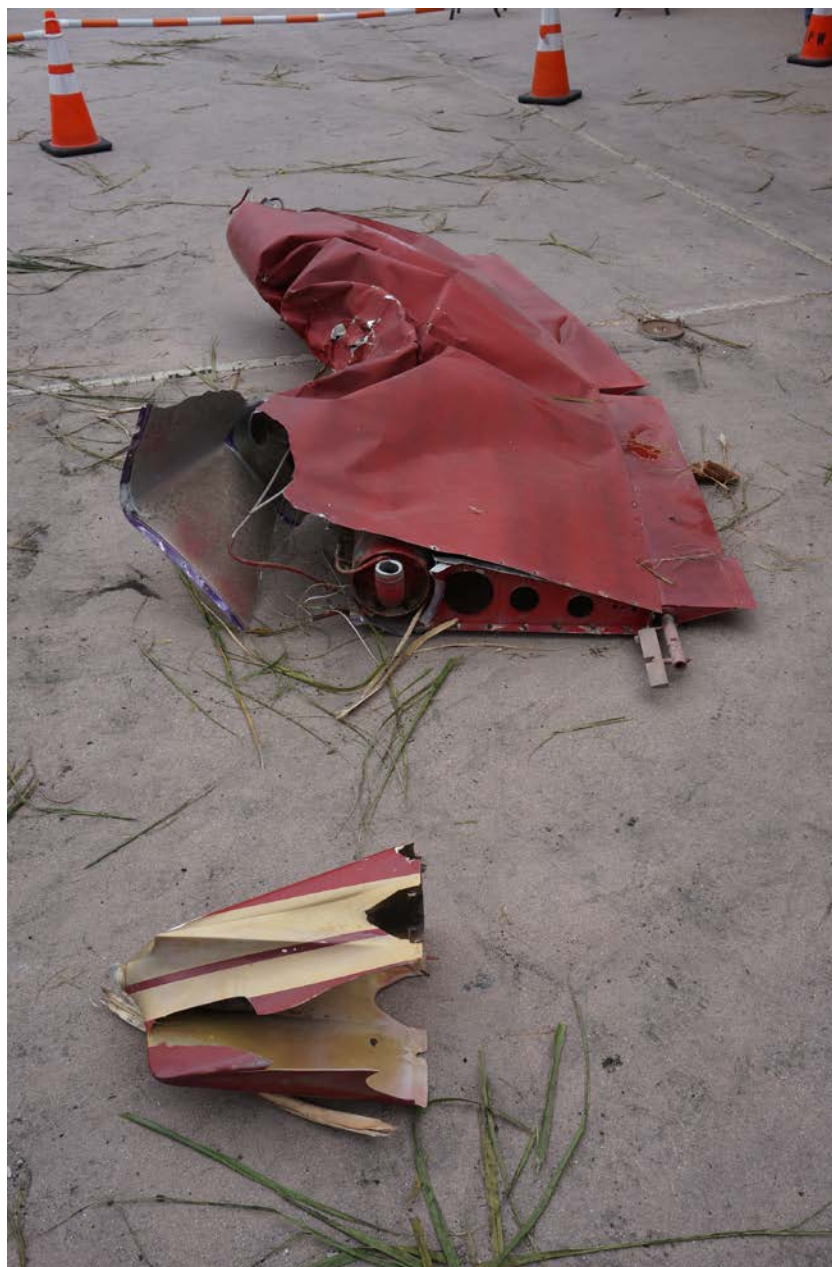
**Photo 2 – Left wing**

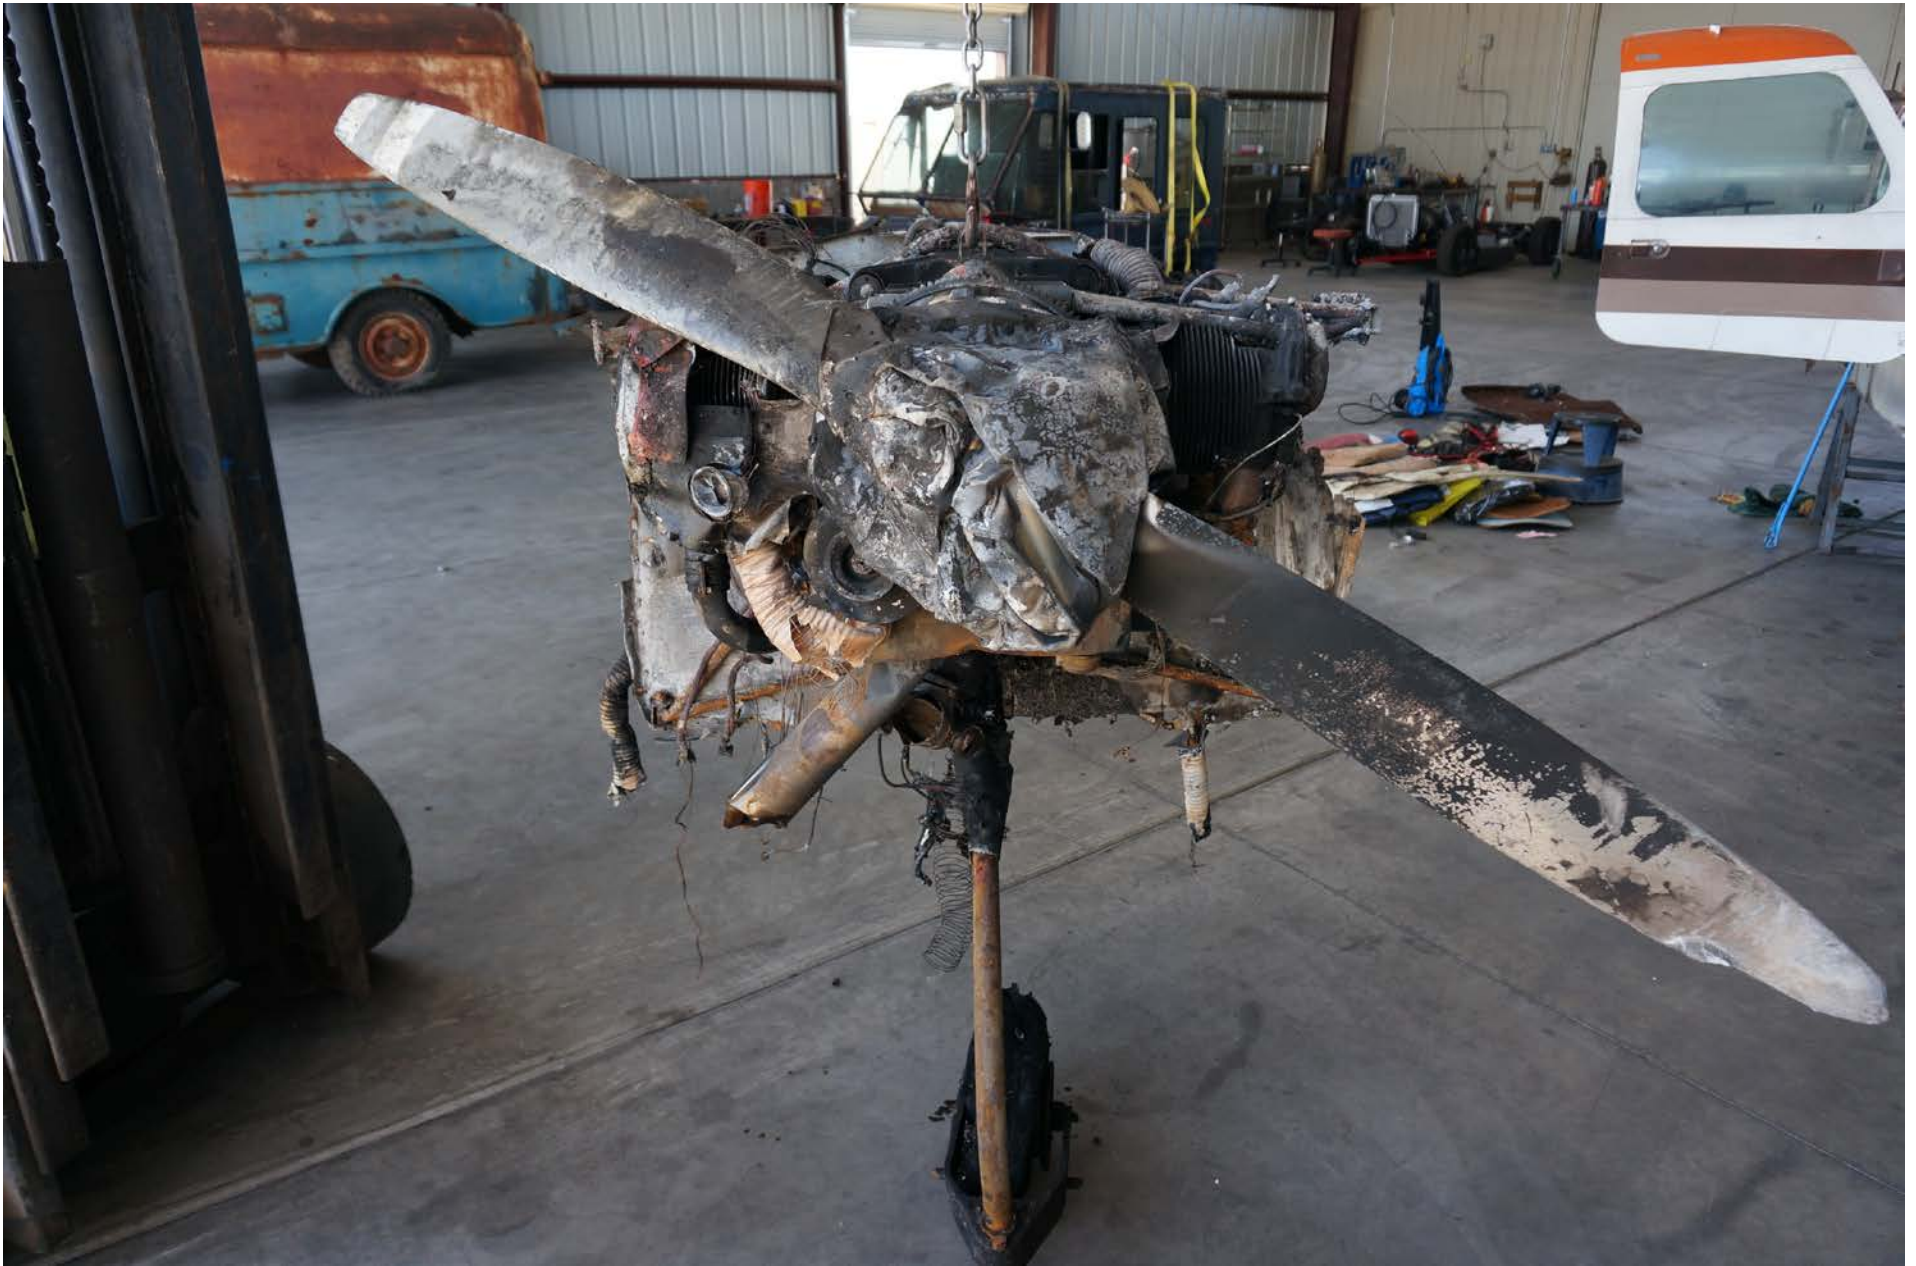
**Photo 3 – Engine from front after recovery from accident site**

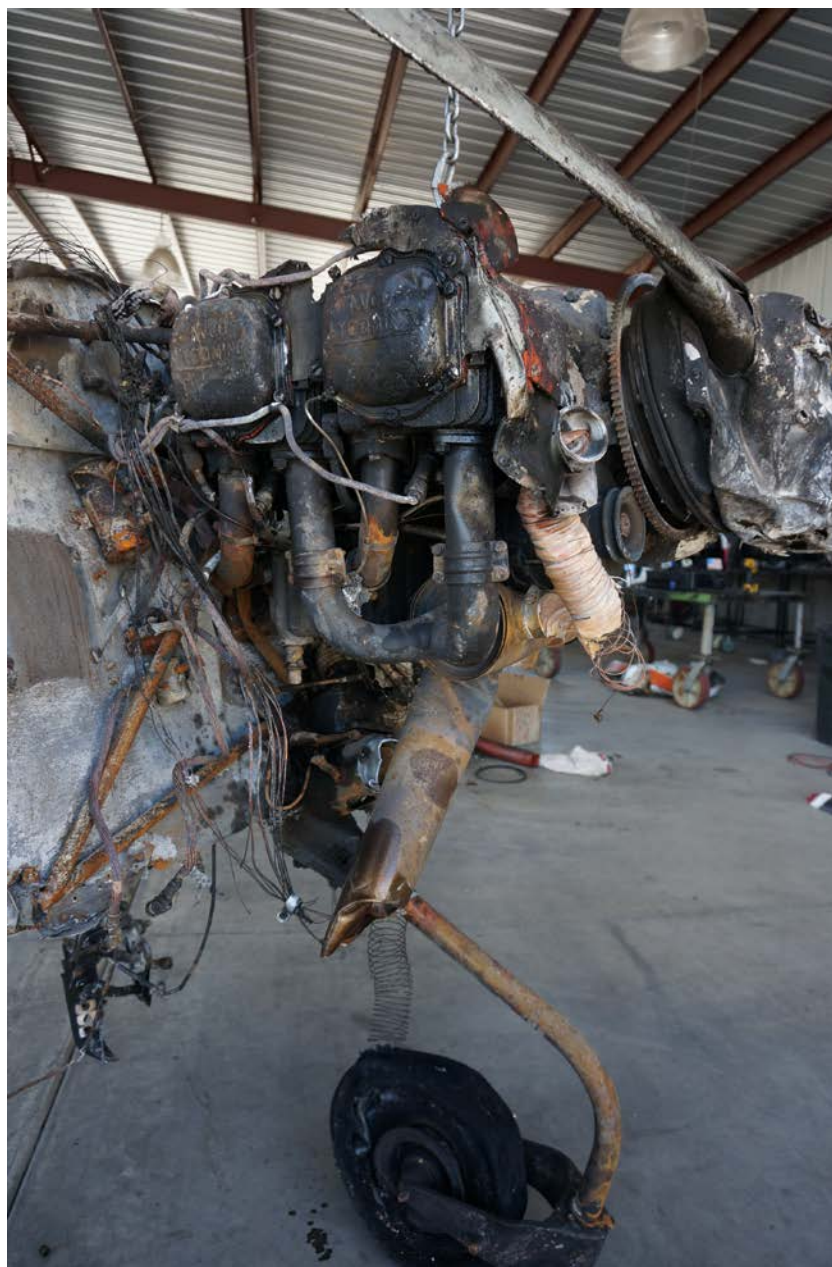
**Photo 4 – Engine from right side**

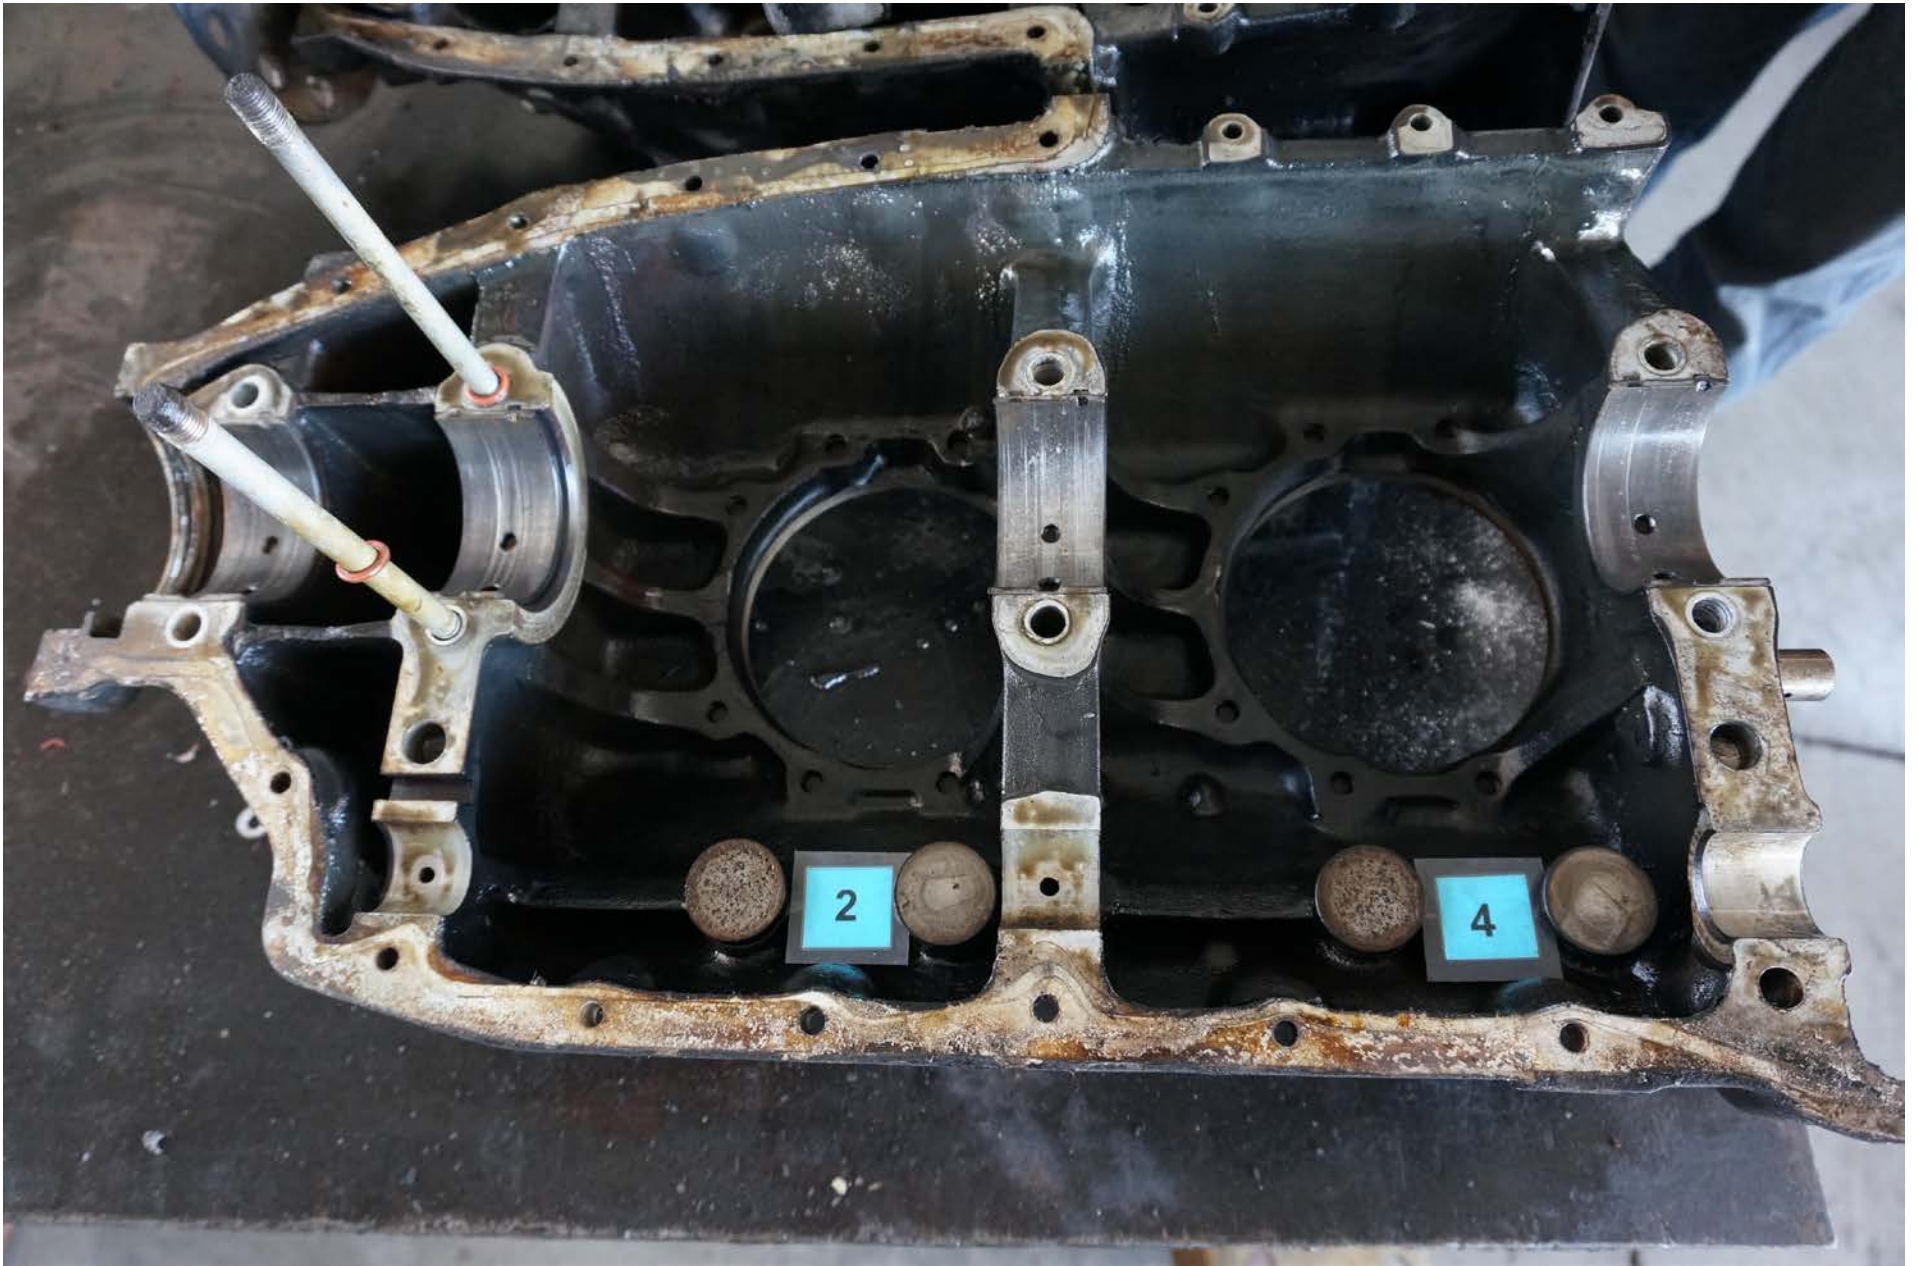
**Photo 5 – Engine case half displaying main bearing scoring and spalling of intake valve tappet faces**

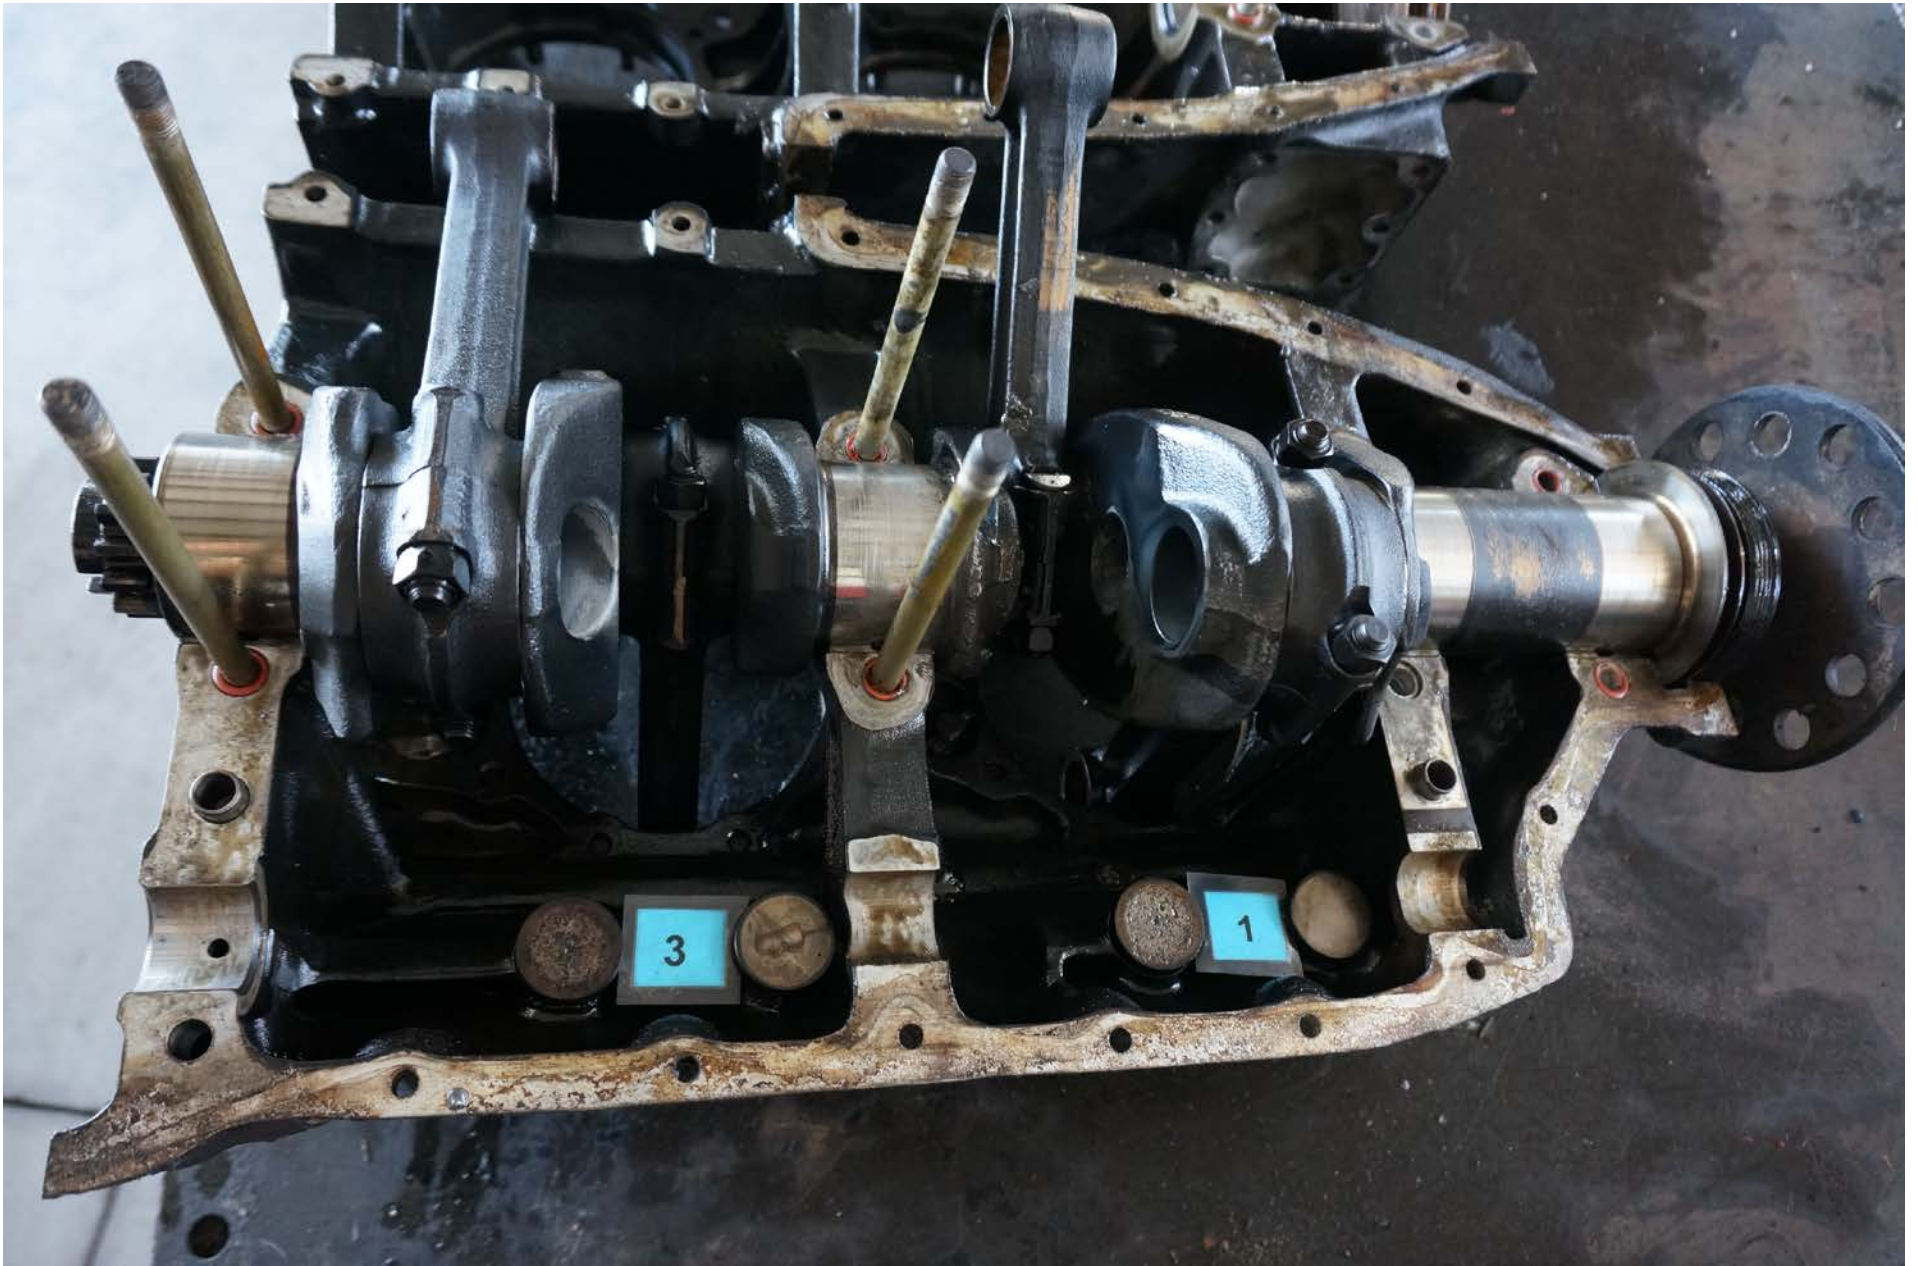
**Photo 6 – Other case half displaying spalling of intake valve tappet faces**

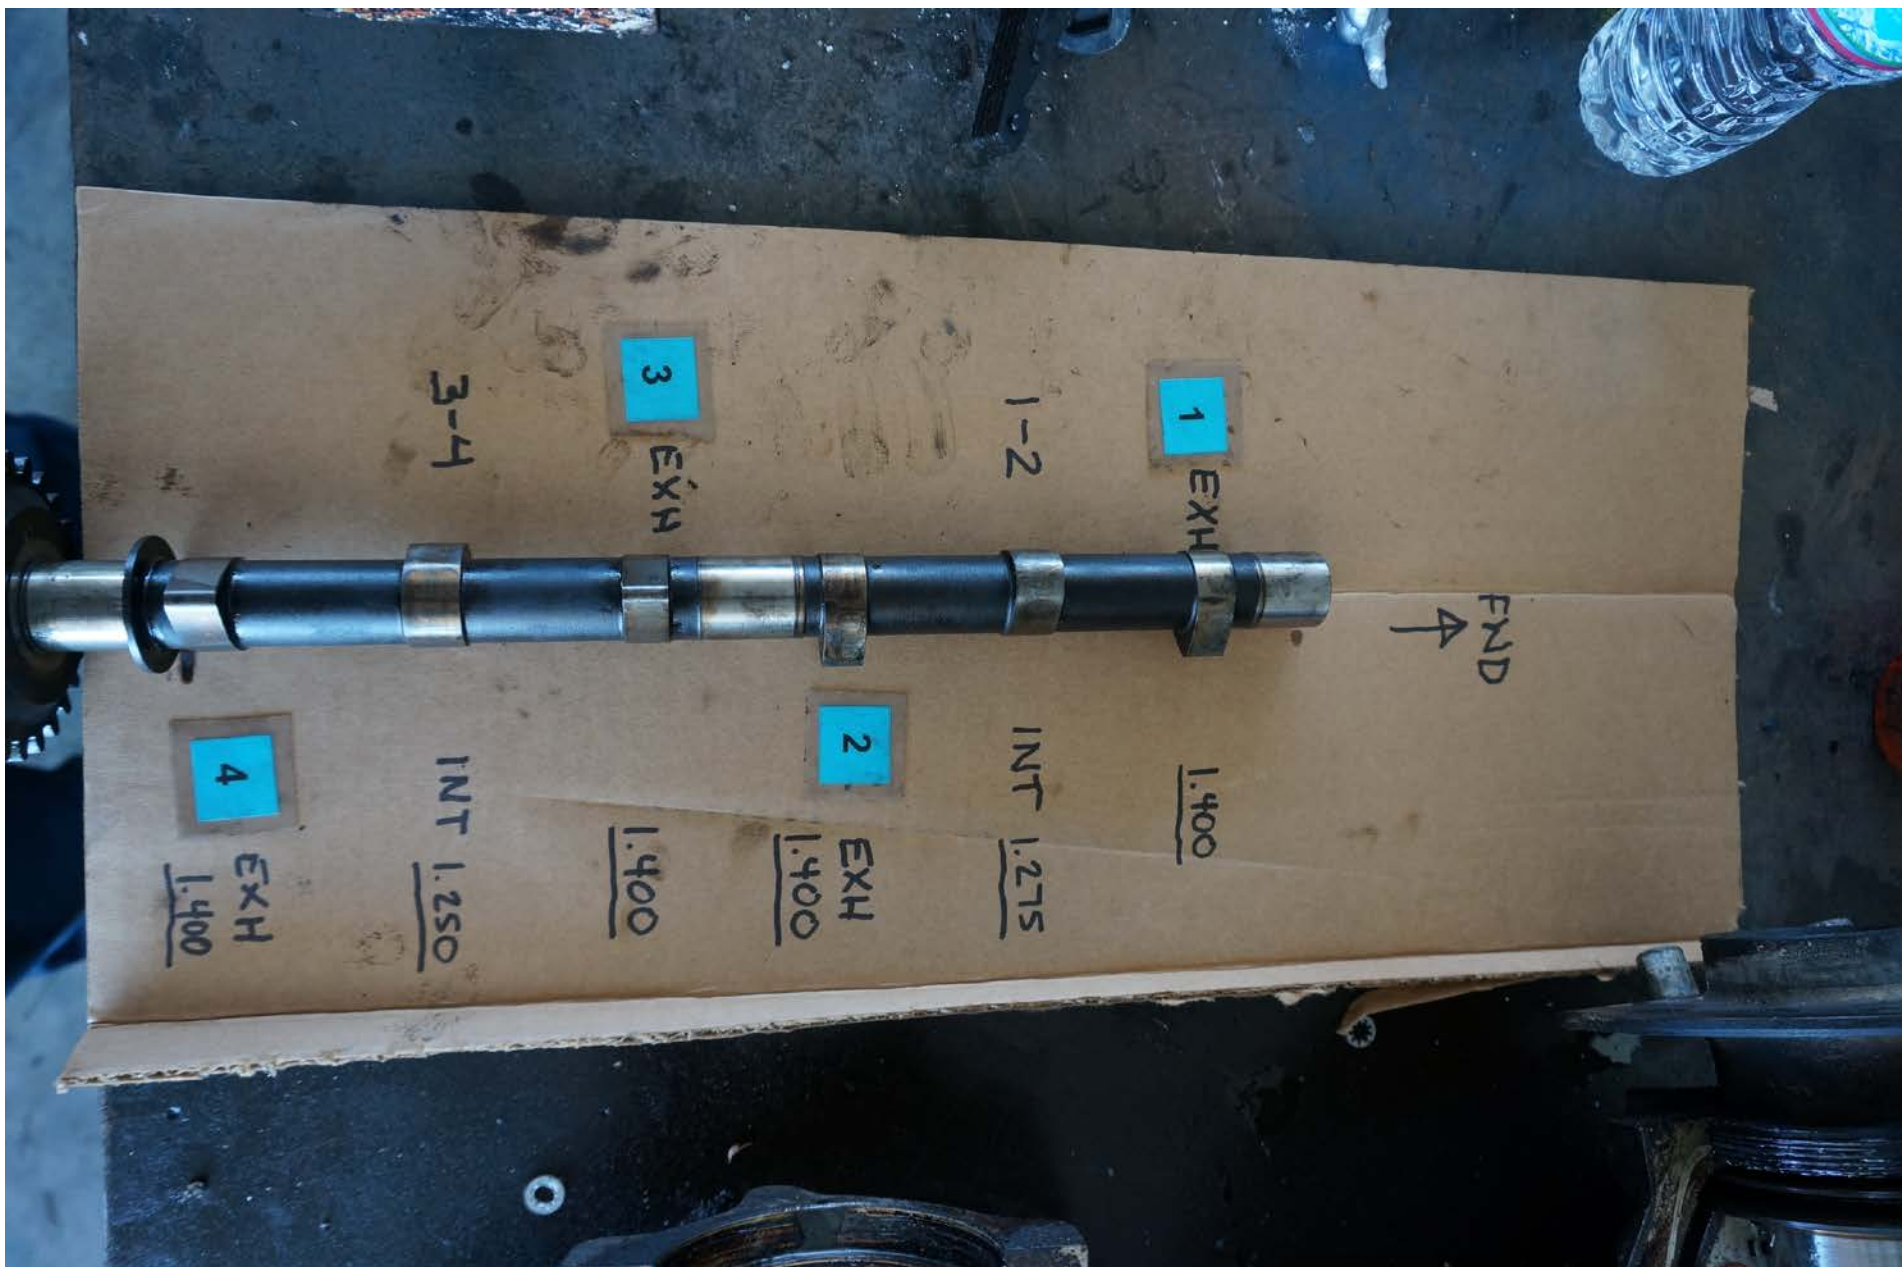
Photo 7 – Camshaft displaying wear to intake valve lobes

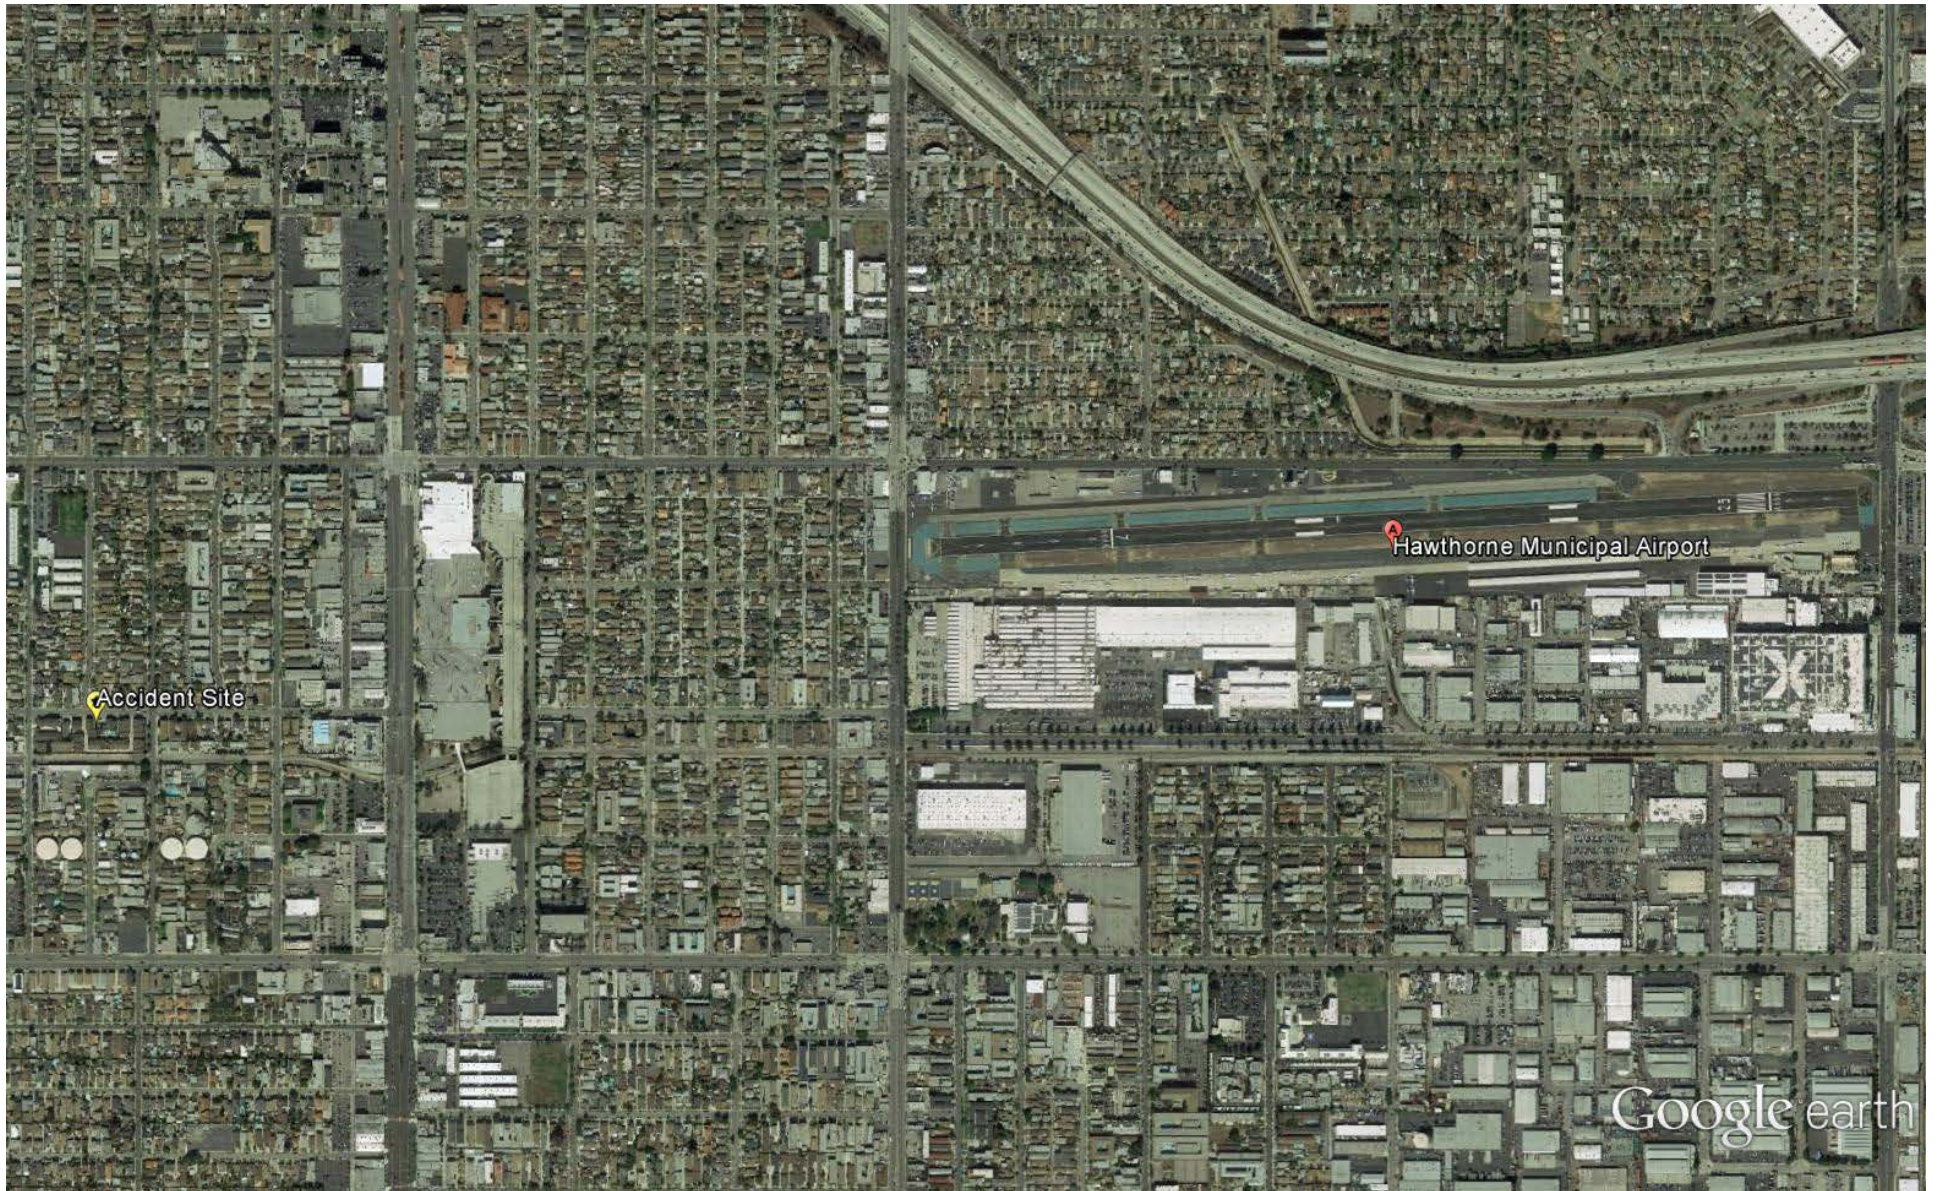
**Photo 8 – Overview of accident location**
