## Factual Narrative

### HISTORY OF FLIGHT

On June 19, 2016, about 1152 Pacific daylight time, a Piper PA-23-150, N1270P, was destroyed ~~when it after~~ collided ~~ed~~ with a ~~commuter railcar wash~~ building ~~following a loss of engine power~~ during an approach to land at Hayward Executive Airport (HWD), Hayward, California. The airline transport pilot was fatally injured. The airplane was registered to and operated by the pilot under the provisions of ~~Title 14~~ Code of Federal Regulations (CFR) Part 91. Visual meteorological conditions prevailed, and no flight plan was filed for the local ~~personal~~ flight ~~that-~~. ~~The personal flight~~ departed HWD about 1035.

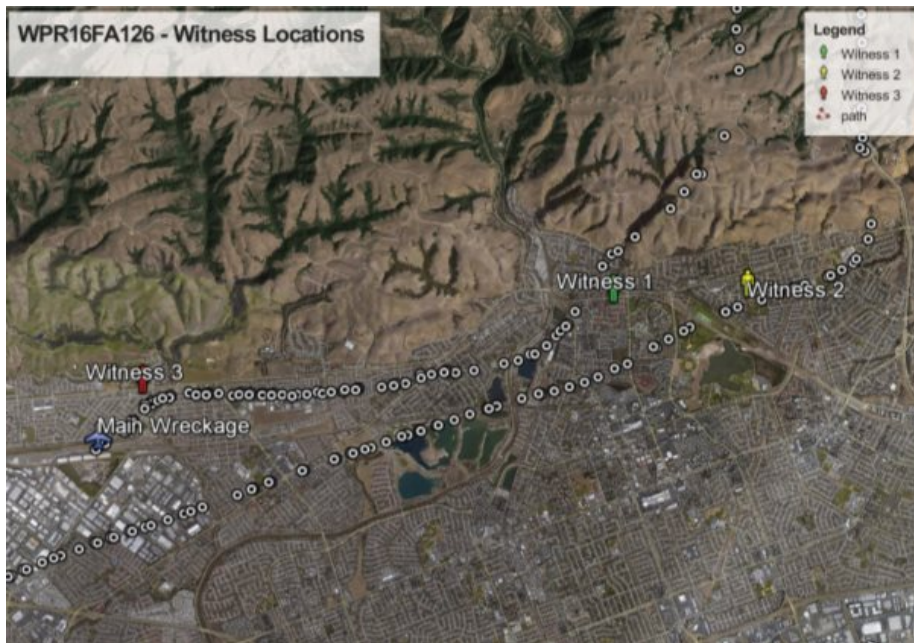
Figure 1 – Witness Locations

A total of three eyewitnesses were interviewed; two ~~who of which~~ observed-saw the airplane flying inbound to land (witnesses 1 and 2) and ~~one who another that~~ observed-saw the airplane moments before it impacted the building in the rail yard (witness 3).

Witness 1 reported that she heard ~~the airplane and~~ an abnormal sound from inside her home. She went outside and observed-saw an airplane approaching her house from a group of hills located to the east. The airplane appeared to be losing altitude, and the engine made a "sputtering sound," which she also described as "cutting out." The sound repeated when the airplane ~~reached-flew~~ above her property and again seconds later after it passed her home.

Witness 2 was located about 10 miles southeast of HWD near the airplane's outbound leg and about 1 mile south of the airplane's inbound leg. Witness 2 stated that he was working in his yard all morning and initially observed-saw a red and white ~~colored~~ airplane on a southeast~~ern~~ heading ~~about at~~ approximately 1,750 feet. He never observed-saw any smoke, but heard a sound that resembled an engine "backfiring." The airplane subsequently made a left turn, ~~and~~ proceeded eastbound, and disappeared behind a group of hills. About 30 minutes later, he observed-saw the same airplane northeast of his house flying towards the airport. The witness reported hearing ~~more~~ sounds ~~that resembled like~~ an engine "popping" and "backfiring." He added that he did not observe-see any smoke, foreign object debris, or fluids coming from the airplane, ~~and he but~~ further remarked-said that the engine "backfiring" sounds were much louder than those he heard during the airplane's ~~outin~~ inbound leg.

Witness 3 was located about 1/2 mile from the accident site. According to Witness 3, he Witness 3 observed ~~He saw the~~ airplane flying abnormally low over a group of houses ~~before noon on the day of the accident. The witness stated that he observed~~ He reported that the airplane was in a wings level descent for a few seconds before it suddenly entered a steep left turn, with the right wing about approximately 70 degrees to the horizon. The airplane then disappeared behind a residential area. About Approximately 10 seconds later he heard a loud impact sound, ~~and,~~ shortly thereafter, plumes of smoke emerged-came from the airplane's direction. ~~He added that he may have been downwind of the accident because he smelled fuel burning.~~
