**NATIONAL TRANSPORTATION SAFETY BOARD**  
Office of Research and Engineering  
Washington, D.C. 20594

## **Video Study**

**NTSB Case Number:**  
**WPR16FA152**

Location: Columbia, California  
Date: July 27, 2016  
Time: 4:45 PDT  
Aircraft: Cessna 310B

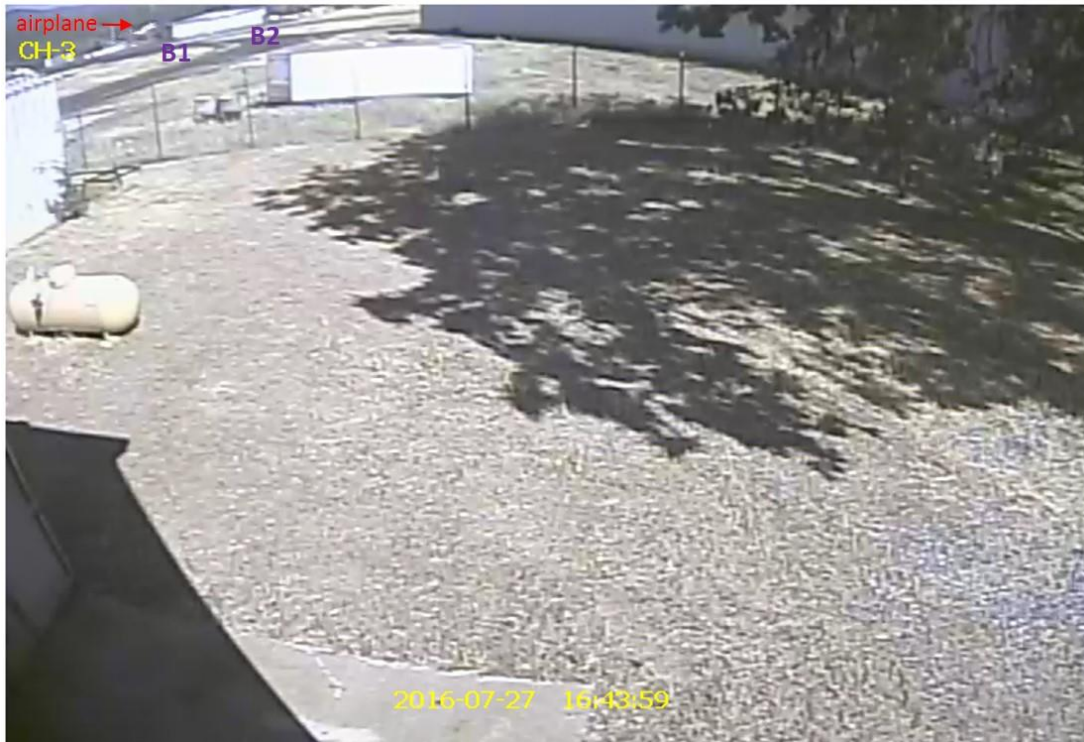
Figure 1. Frame from East Camera Video

Figure 1 shows a frame from the East Camera video. The camera used a wide angle lens that caused the barrel distortion seen in the figure. The distortion did not affect the speed analysis described below. The image of the airplane shortly after it entered the field of view is marked in the figure. Also marked are B1 and B2, corners of a building that is visible in the video and in Google Earth images.

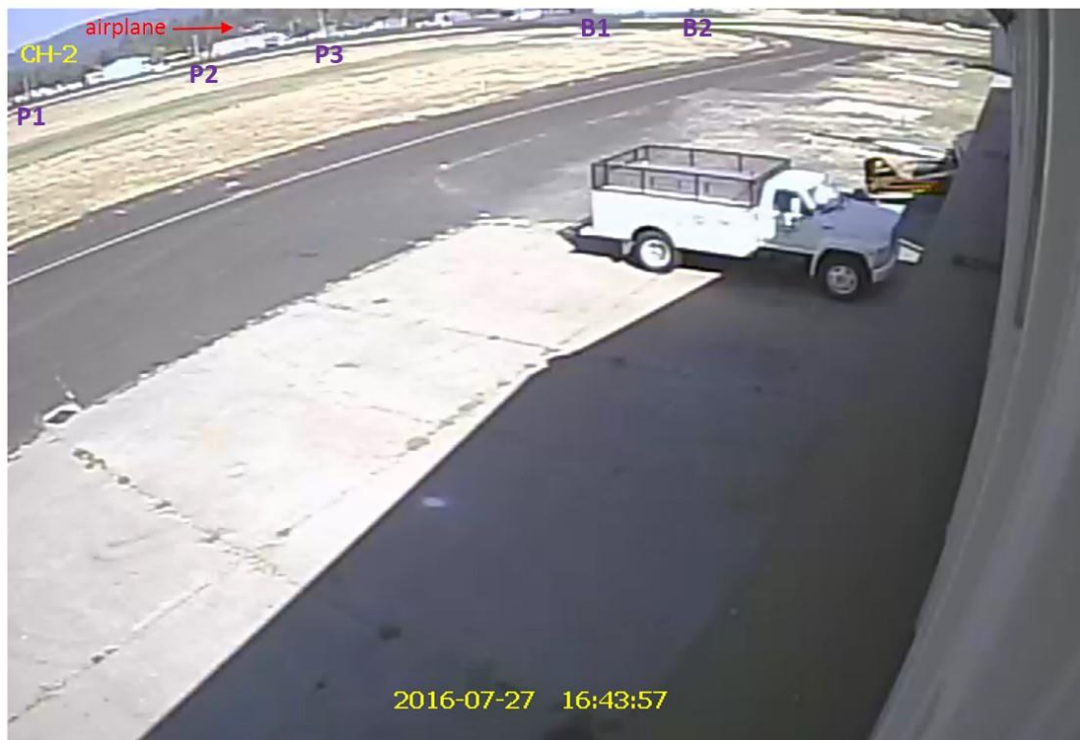
Figure 2. Frame from Hangar Camera Video

Figure 2 shows a frame from the Hangar Camera video. The frame shows the two building corners, B1 and B2, that are also seen in Figure 1. Also seen are three light poles at locations marked by P1, P2 and P3. These light poles are visible in Google Earth images.

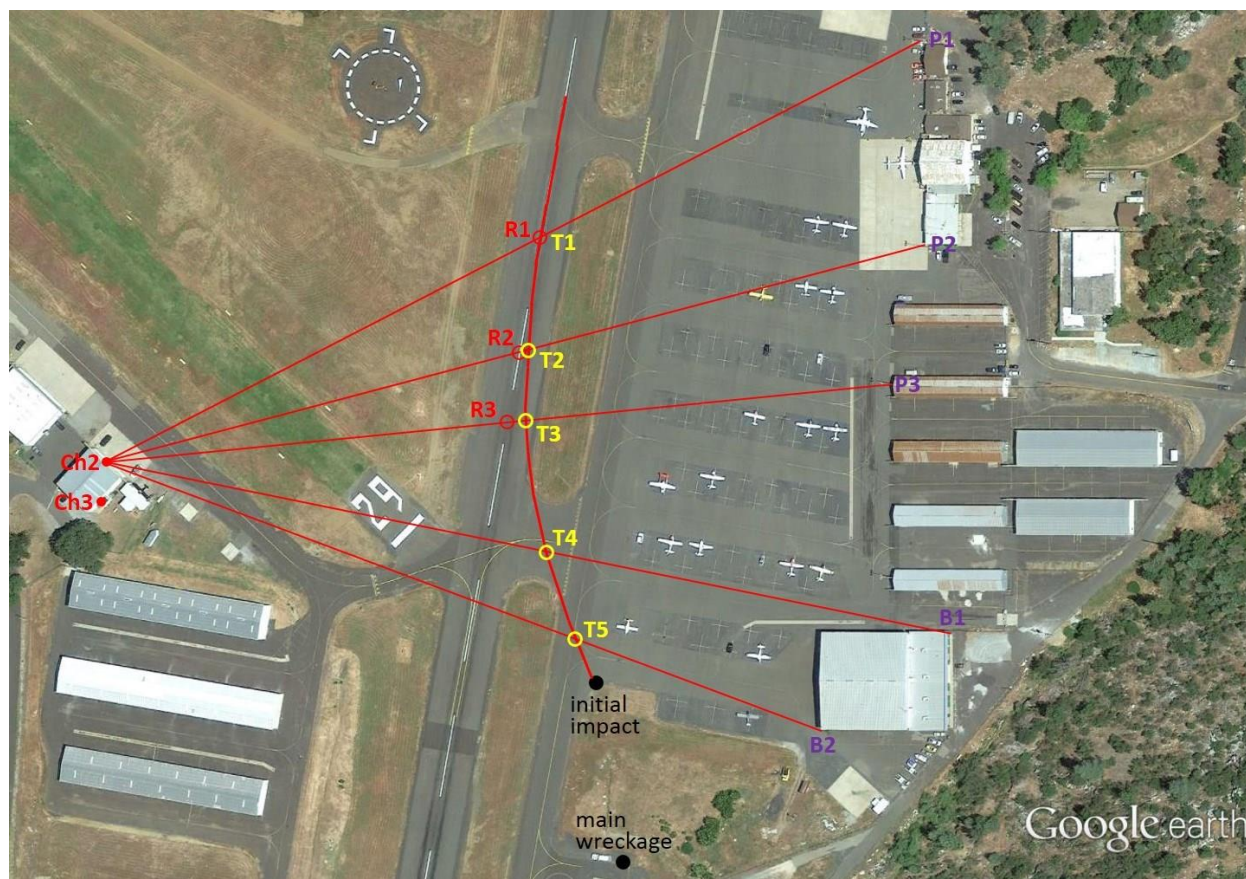
**Figure 3. Aerial Image of Accident Site**

Figure 3 is an aerial image from Google Earth that shows the locations of B1, B2, P1, P2 and P3. Also shown in the figure are the locations of the two cameras, East Camera (Ch. 3) and Hangar Camera (Ch. 2), the point of first ground impact, and the location of the main wreckage.

Lines of sight from the Hangar Camera to locations B1, B2, P1, P2 and P3 are shown in red. If the airplane takeoff was successful, it would have followed runway points R1, R2 and R3. However, based on the location of the initial impact, it deviated east of the runway. Curve T1-T2-T3-T4-T5 is an estimated hypothetical ground track of the accident airplane. It is not based on the videos because they do not provide any information on distances along the lines of sight from the cameras to the airplane. The estimated shape of the ground track is based on assuming that the airplane was initially moving aligned with the runway and then it deviated to east to reach the initial impact location shown in Figure 3.

Ground speed of the airplane was estimated based on times derived from the videos and the ground track geometry shown in Figure 3. The times when the airplane was at locations T1-T5 shown in Figure 3 were estimated based on the video frame times when the airplane nose was at locations P1, P2, P3, B1 and B2 in Figures 1 and 2. The distances from location T1 to locations T2-T5 along the assumed trajectory were estimated based on the aerial image in Figure 3. Table 1 lists the times and the distances flown when the airplane was at trajectory locations T1-T5.

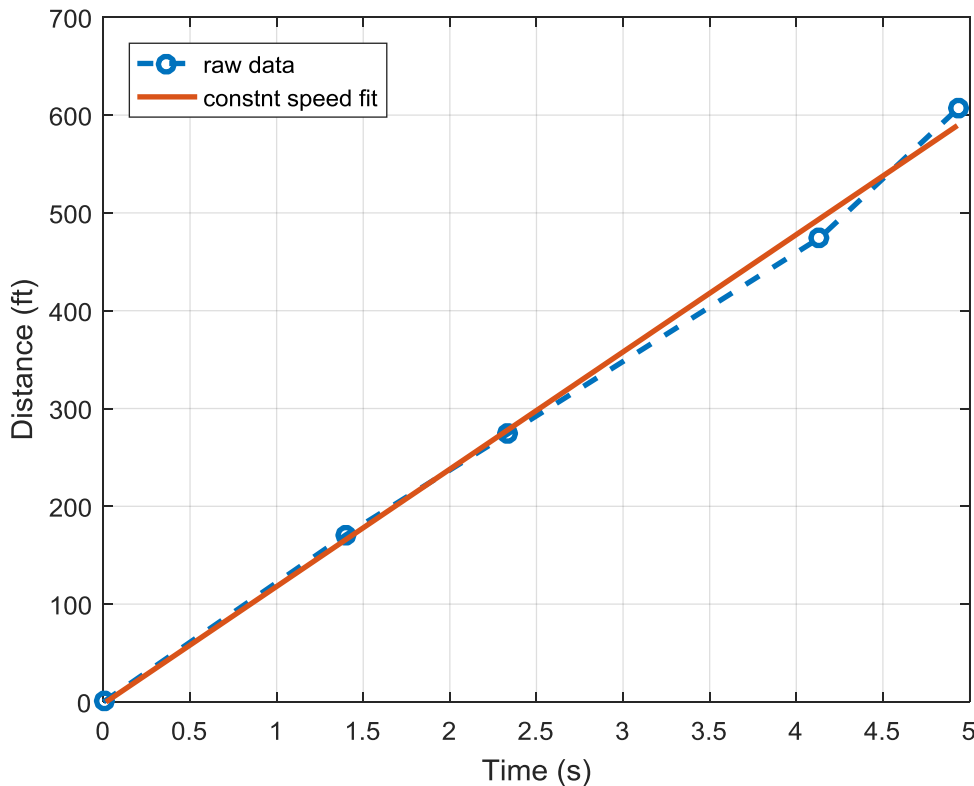
**Figure 4. Distance vs. Time along Airplane Ground Track**

Figure 4 shows a plot of the data in Table 1. It also shows a constant speed fit to the data. The nominal constant ground speed estimate, the slope of the fitted line, is 71 knots. Because of possible inaccuracies due to low resolution of the videos and due to the estimated ground track, the estimated ground speed is specified as  $71 \pm 3$  knots.
