## **NATIONAL TRANSPORTATION SAFETY BOARD**

### **GYRO INSTRUMENT AIR PRESSURE SYSTEM**

**NTSB Accident: WPR16FA158  
Accident Date: August 2, 2016**

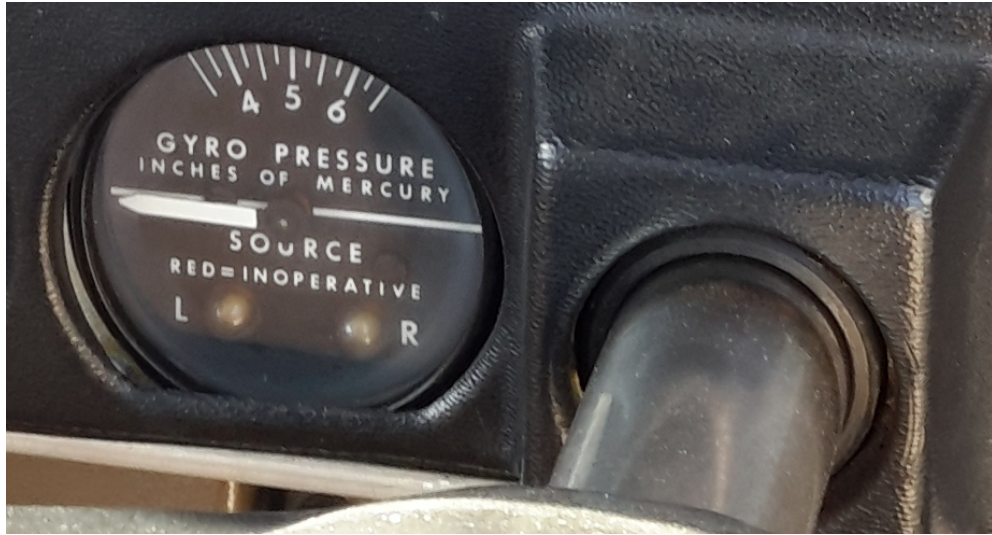
Figure 3 - Pressure Gauge

As seen in Fig 3, the upper portion of the gyro pressure instrument was equipped with an indicating scale and needle, and two button indicators (one each per L & R pump system) situated on the lower portion of the instrument. The indicators were normally white/neutral, but changed to red when pressure from the respective pump or system side was lost.

Based on the above examination findings, the left "button indicator" should have been red. The indicators were not identified in the wreckage, and the pilot's son had reported that to his knowledge there were no abnormal indications or unaddressed maintenance items. Therefore, neither the timing of the pump failure, nor the functionality of the indicator system could be determined.
