## **NATIONAL TRANSPORTATION SAFETY BOARD**

### **SITE and EXAMINATION INFORMATION**

**NTSB Accident: WPR16FA158  
Accident Date: August 2, 2016**

Location: Flagstaff, Arizona  
Date: August 2, 2016  
Aircraft: Piper Seneca II, N82806, Serial # 34-8170021  
NTSB IIC: Michael Huhn

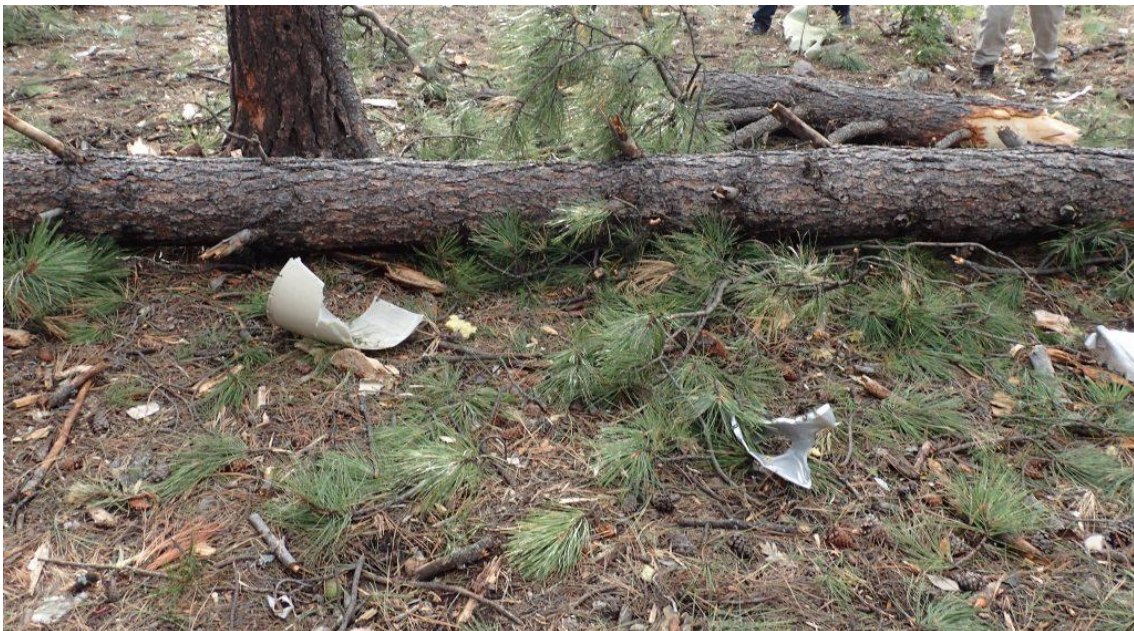
Figure 1 - Treefall from Impact

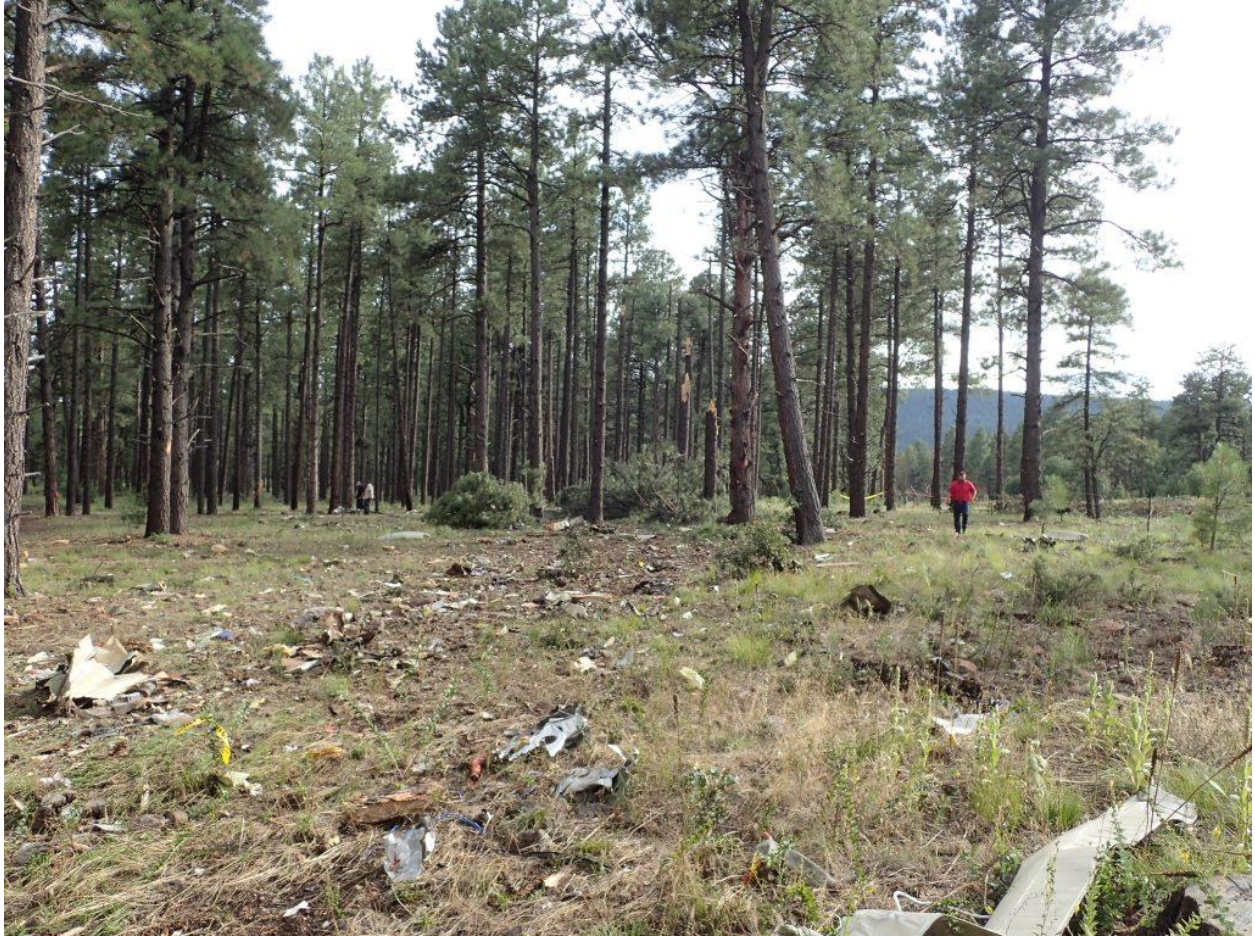
**Figure 2 - View of Tree Swath, Treefall, and Debris Field (partial)**

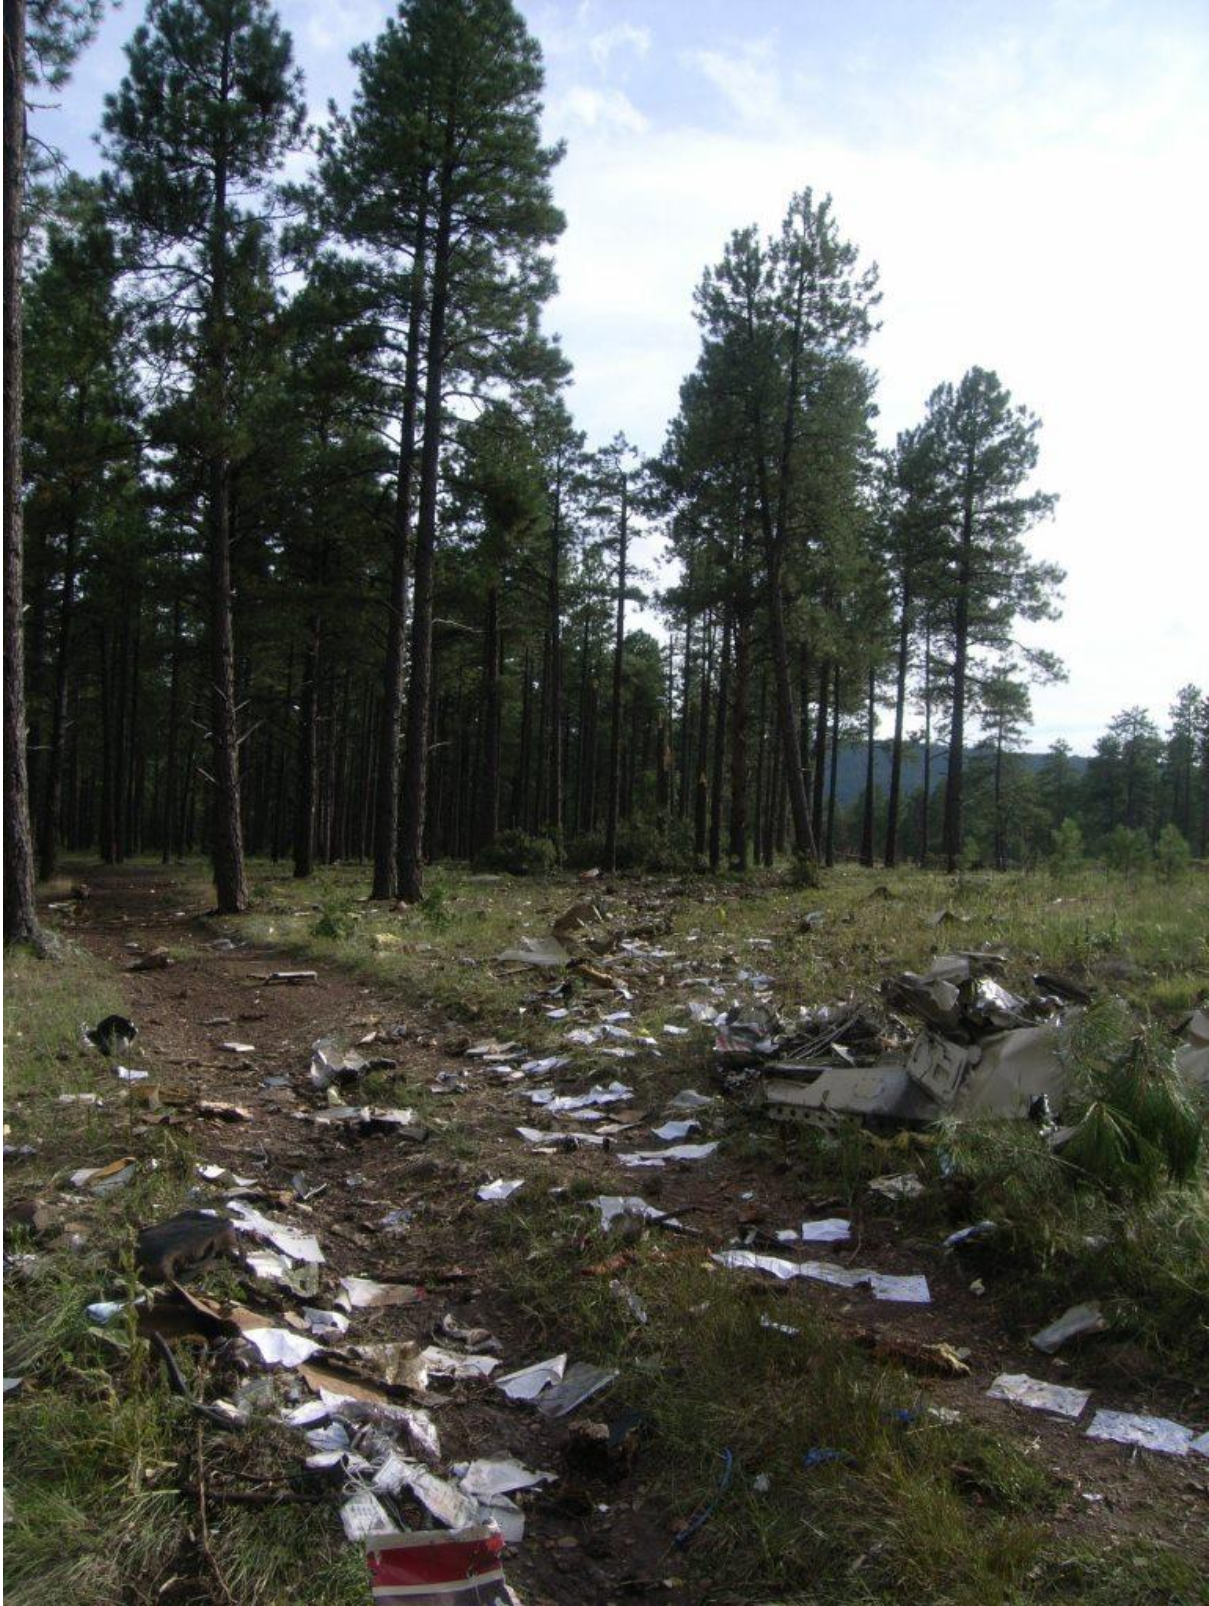
**Figure 3 - Tree Swath and Debris Field (partial)**

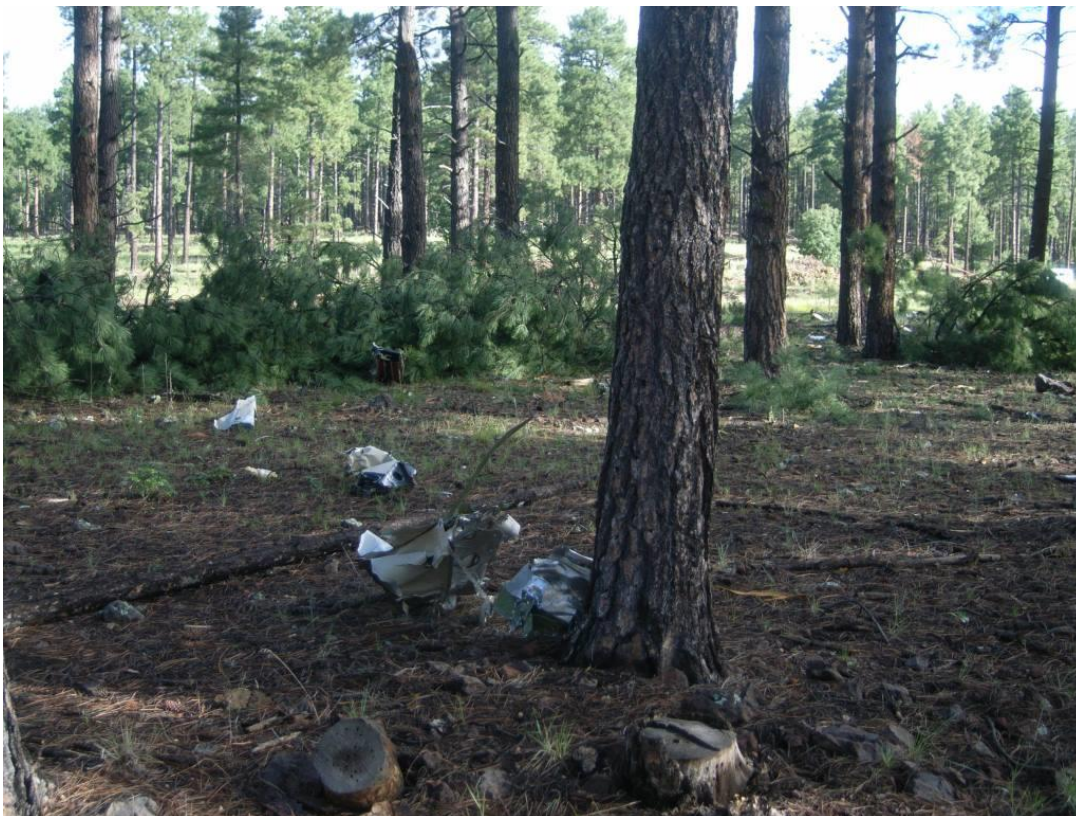
**Figure 4 - Treefall and Early Debris**

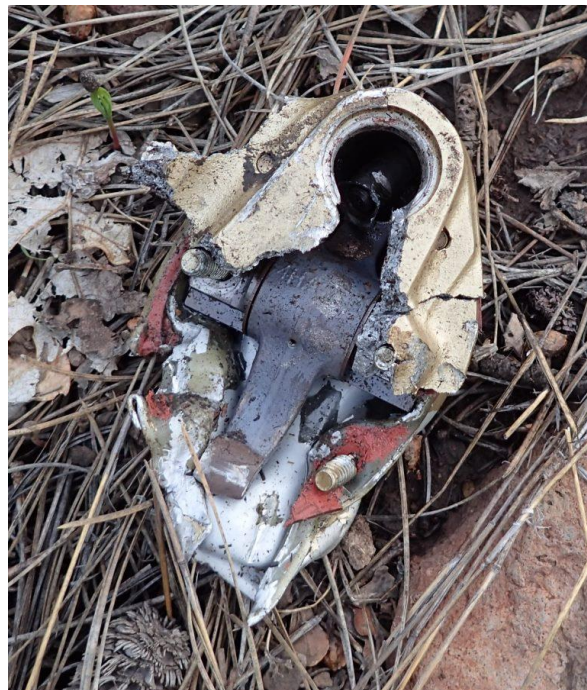
**Figure 12 - Engine Fragment**

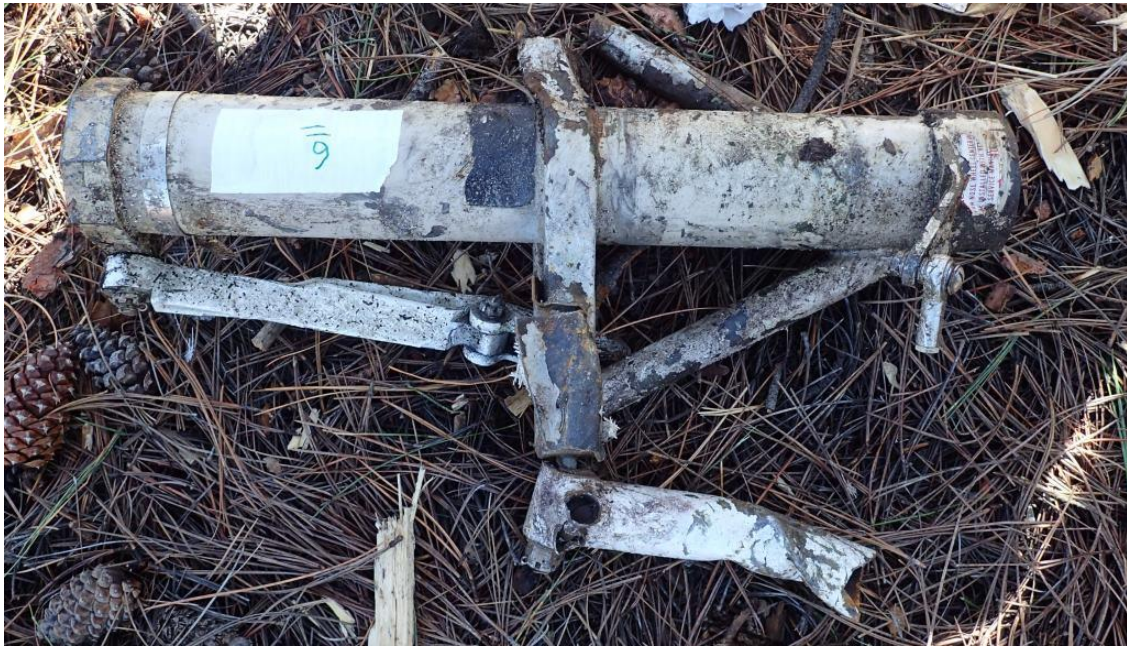
Figure 15 - Nose Landing Gear Segment

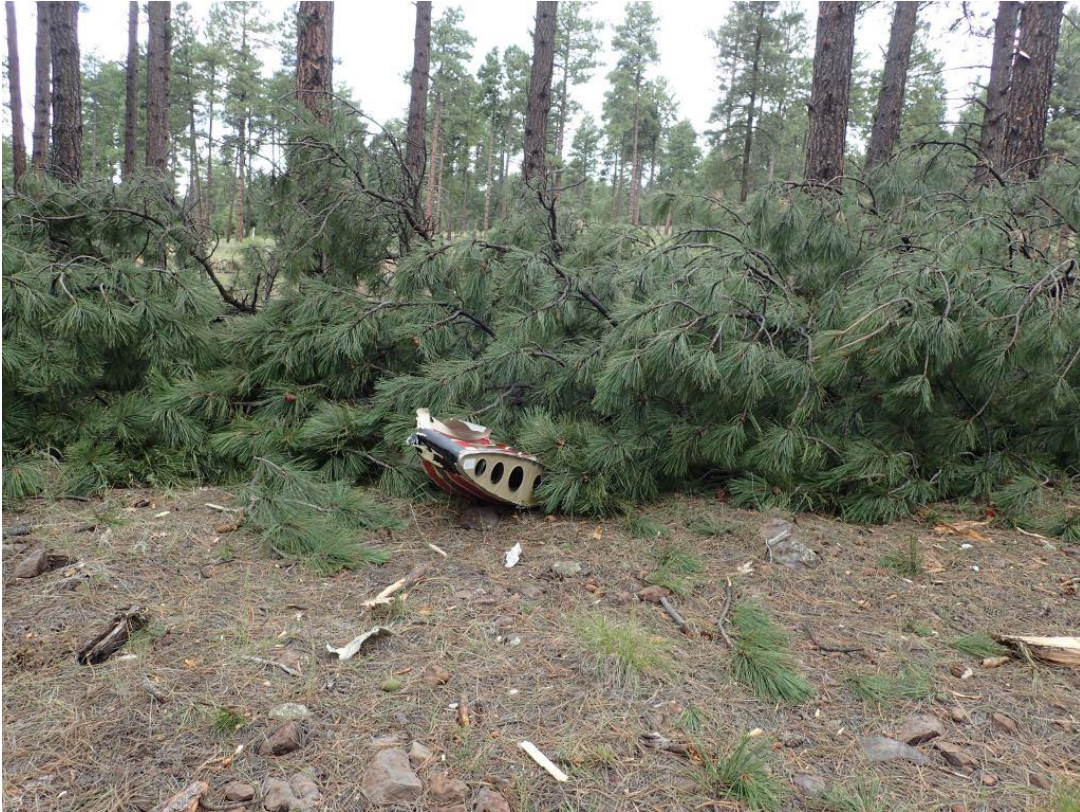
**Figure 16 - Early Right Wing Fragment and Treefall**

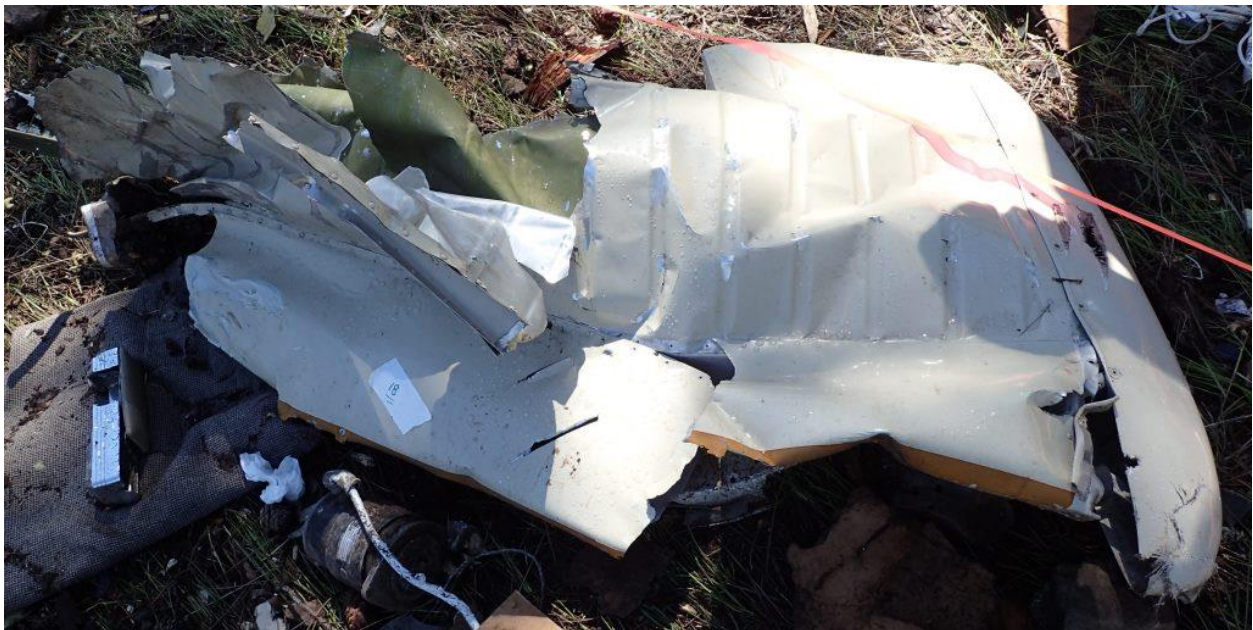
**Figure 17 - Left Stabilator Fragment**

- The chordwise fracture was located about 1 foot left of centerline
  - The left stabilator segment had two parallel slash cuts on the upper forward surface whose origin could not be determined
- The vertical stabilizer and rudder were fragmented into multiple pieces, some of which were not located/identified.
  - Fragments of the upper rudder and stabilizer (#1, 3, 4) were the earliest items in the debris field

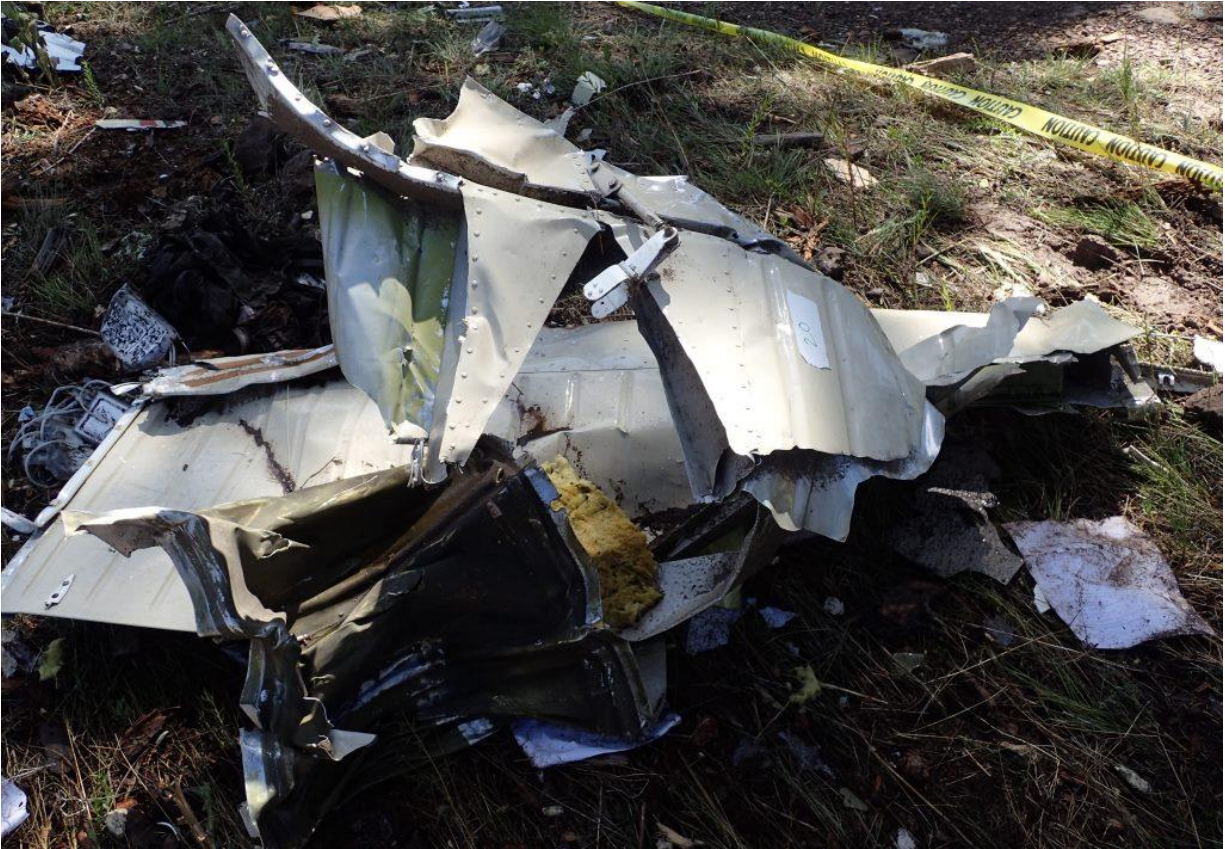
**Figure 18 - Right and Center Stabilator Fragment**

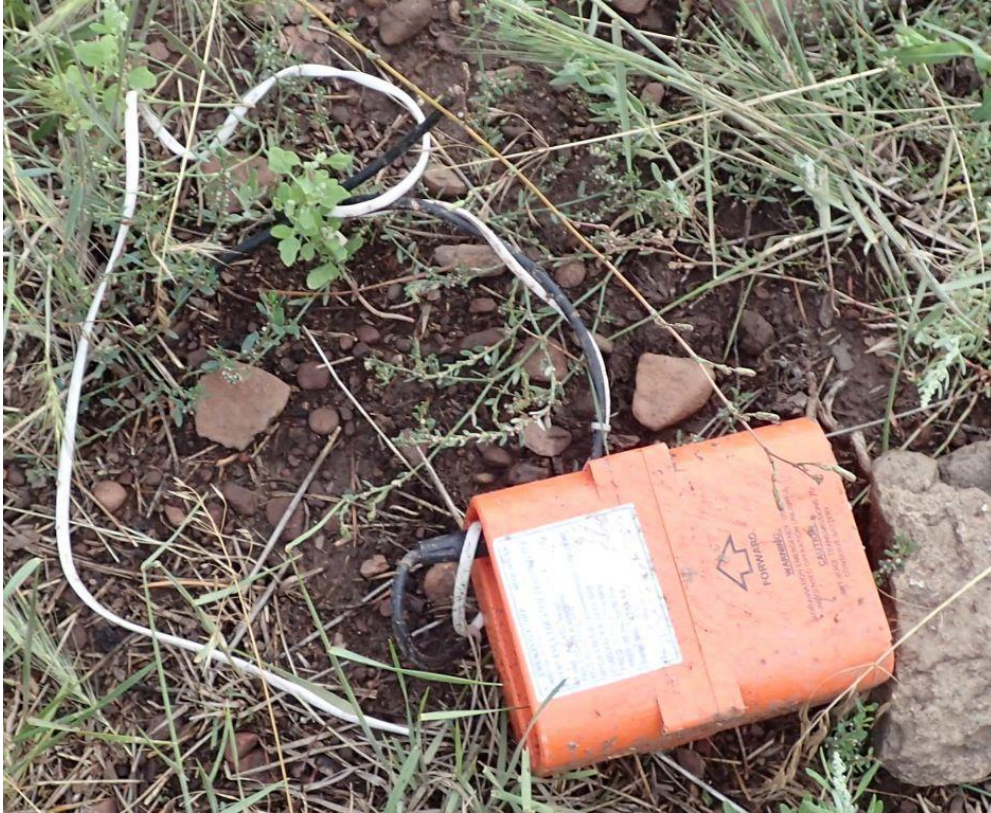
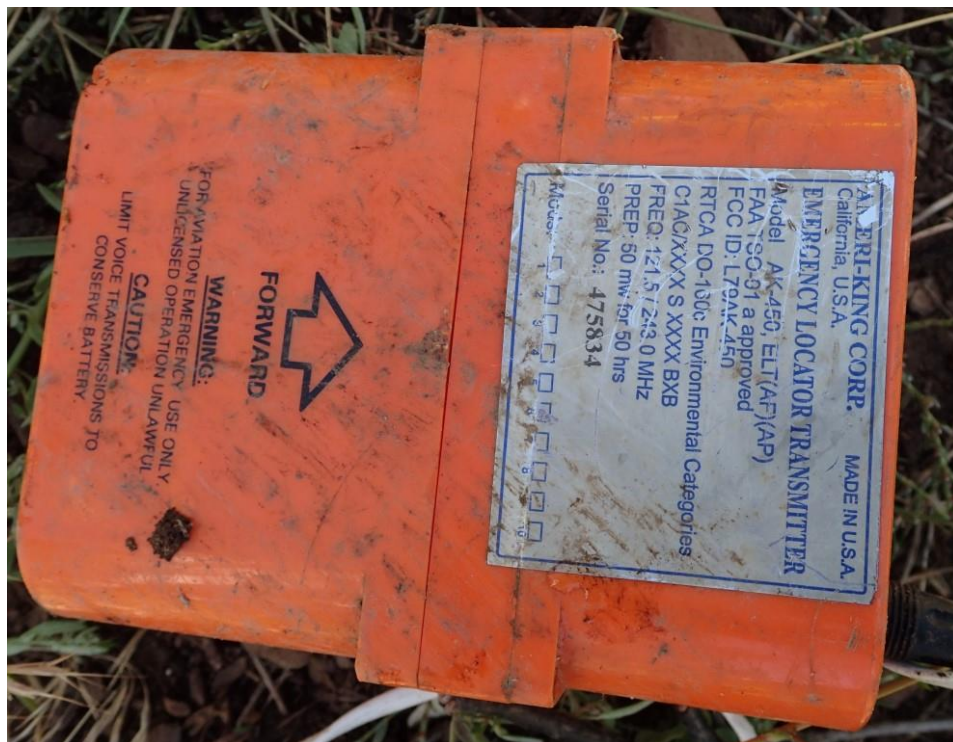
- The ELT was completely fracture-separated from the airframe and antenna
- The pitot cover was found free in the wreckage; its condition was consistent with it not being installed at the time of impact

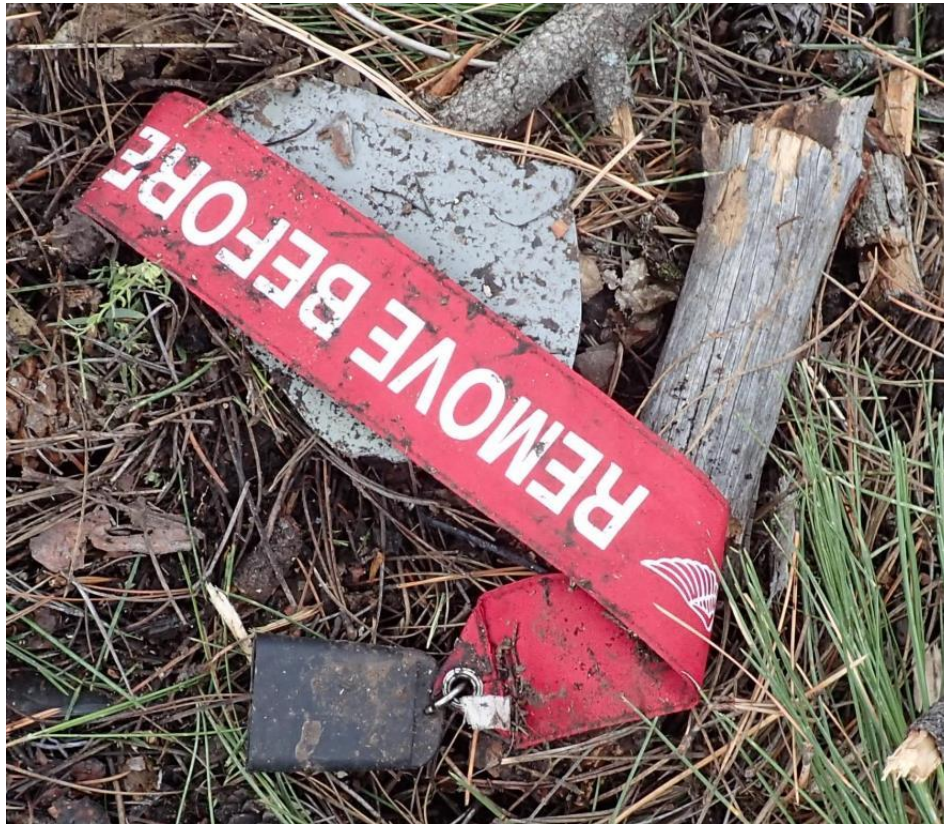
Figure 29 - Pitot Cover

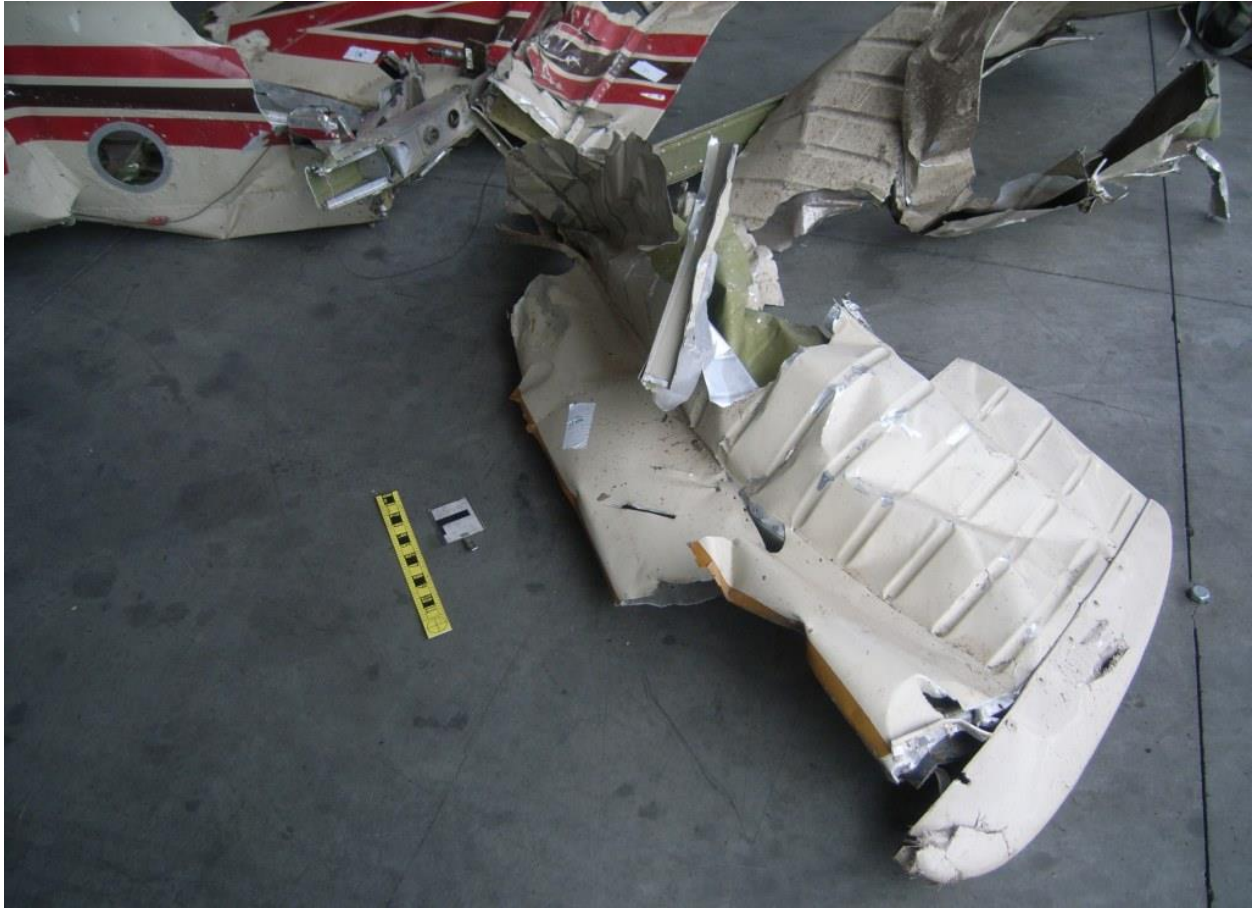
**Figure 35 - Left Stabilator**

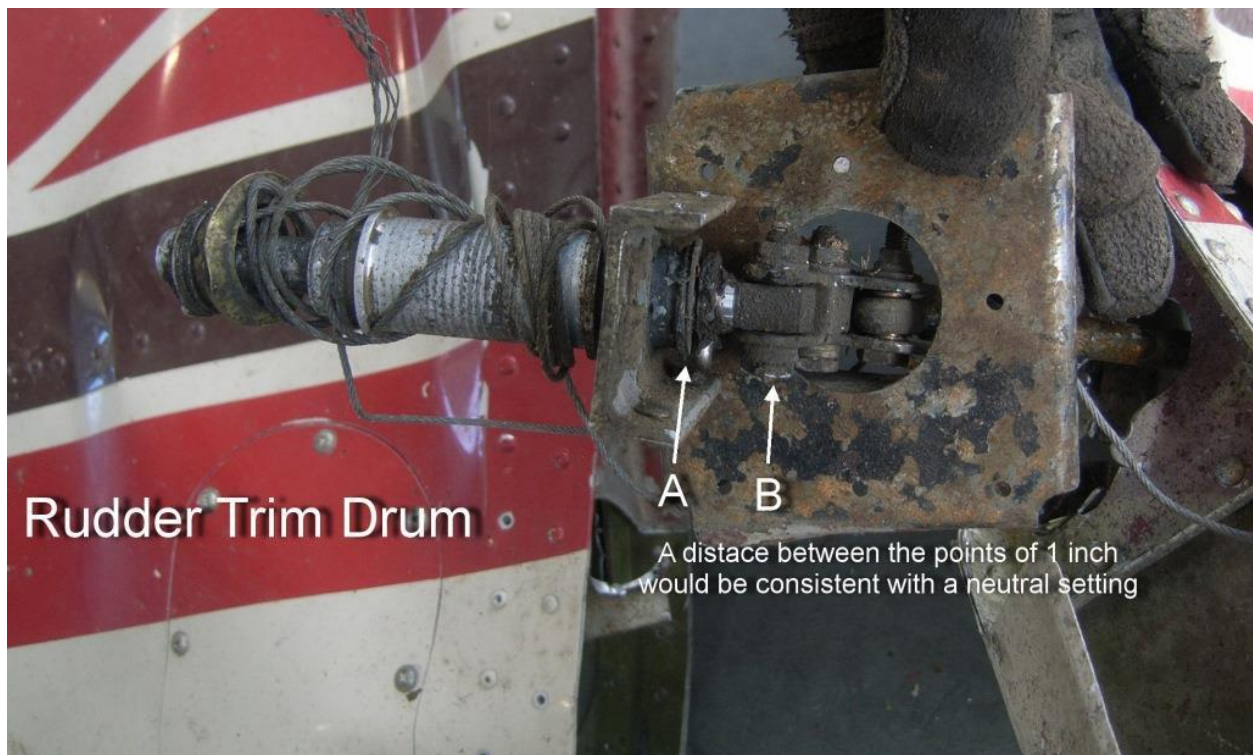
- The rudder trim actuator (drum) remained attached to the lower rudder
  - The actuator extension measurement and thread count were consistent with an approximately neutral setting of the rudder trim tab

**Figure 47 - Rudder Trim Drum**

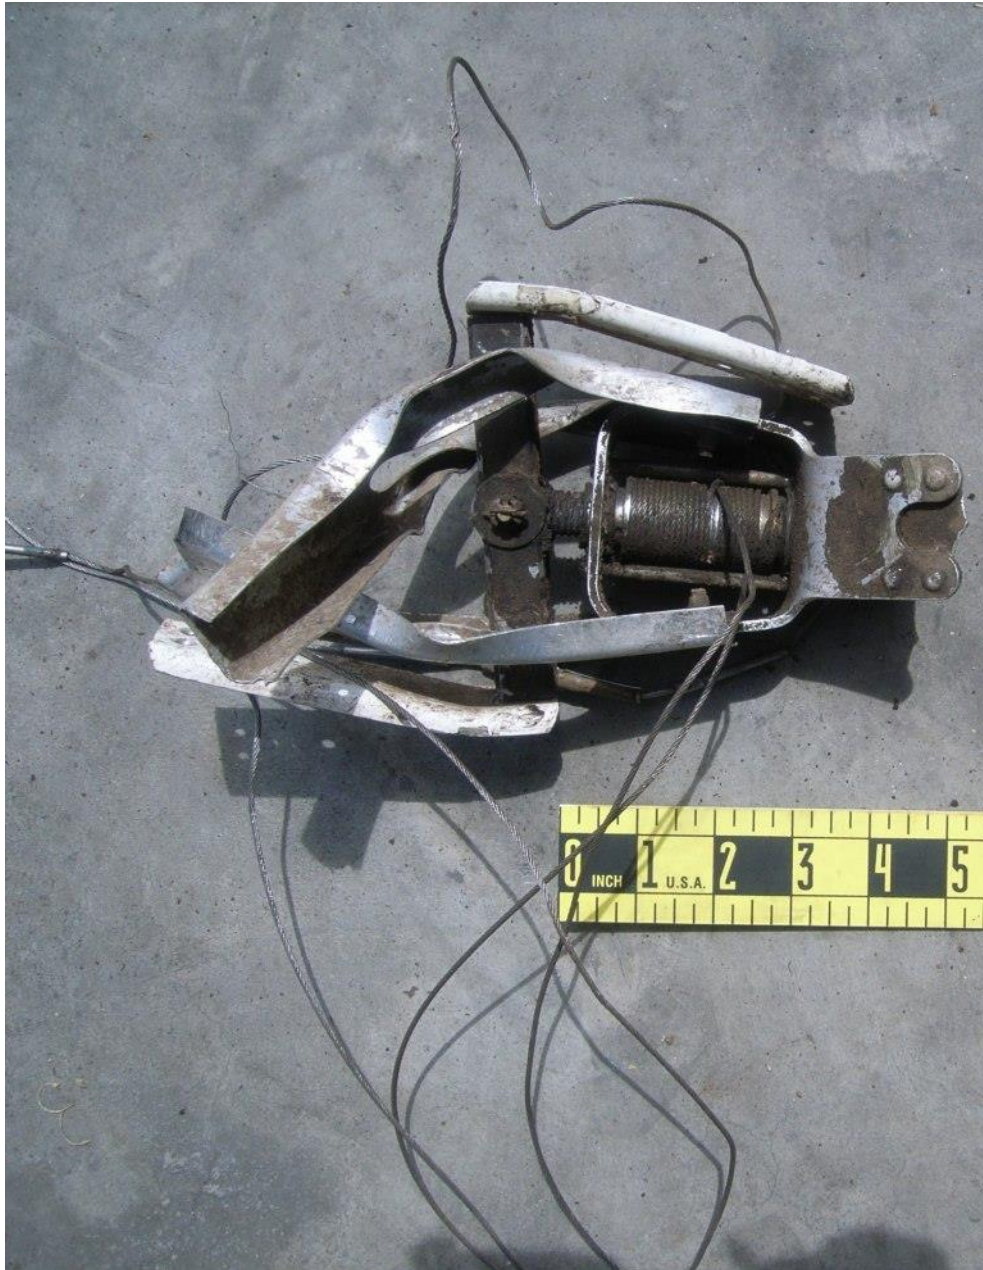
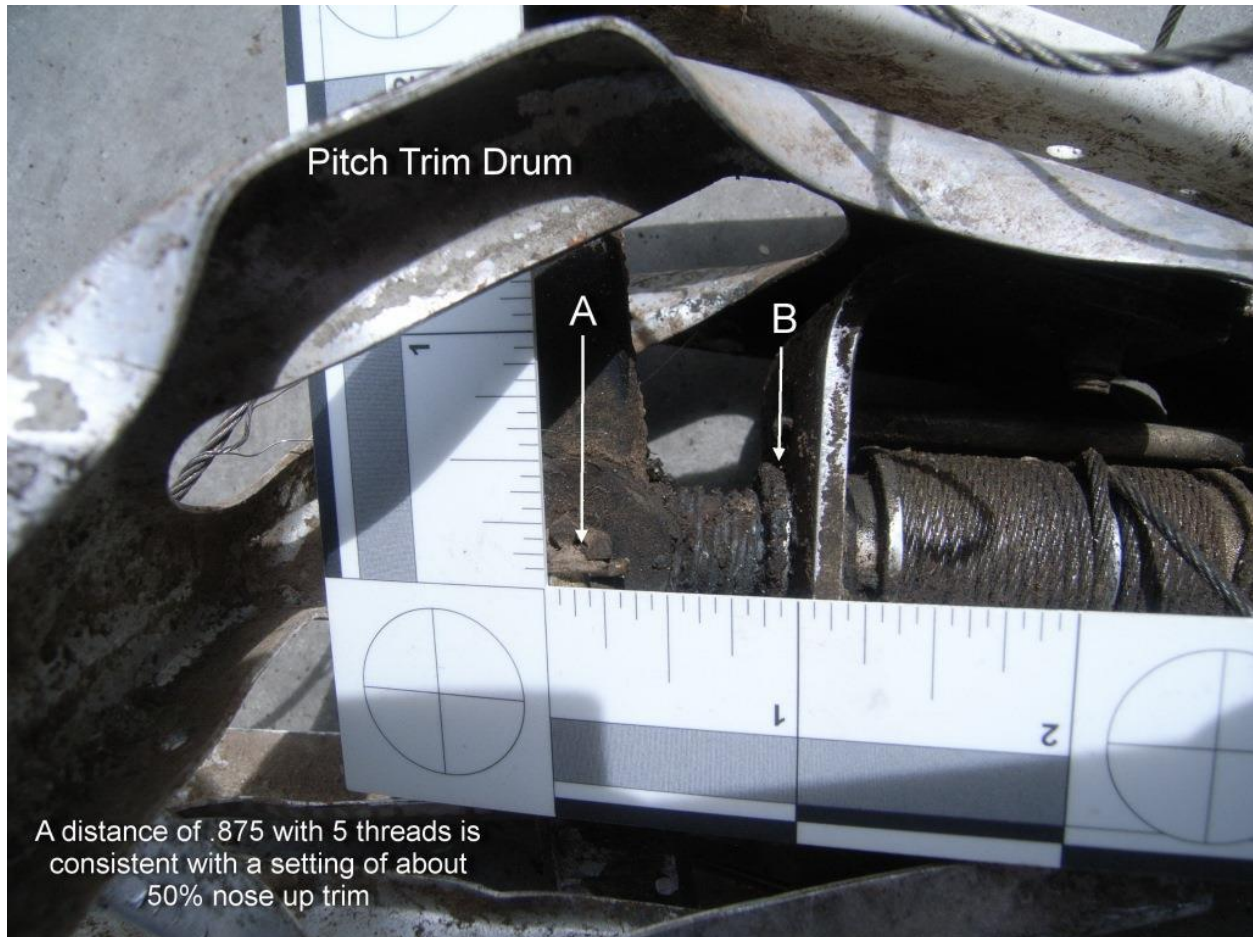
- A completely-liberated trim actuator was identified by a Piper representative as the pitch trim actuator (drum)
  - The pitch trim drum position was about "50% nose up"
  - Normal travel for the stabilator pitch trim tab is  $10^{\circ} 30' \pm 1^{\circ}$  nose up (tab down) and  $6^{\circ} 30' \pm 1^{\circ}$  nose down (tab up).

**Figure 48 - Pitch Trim Drum**

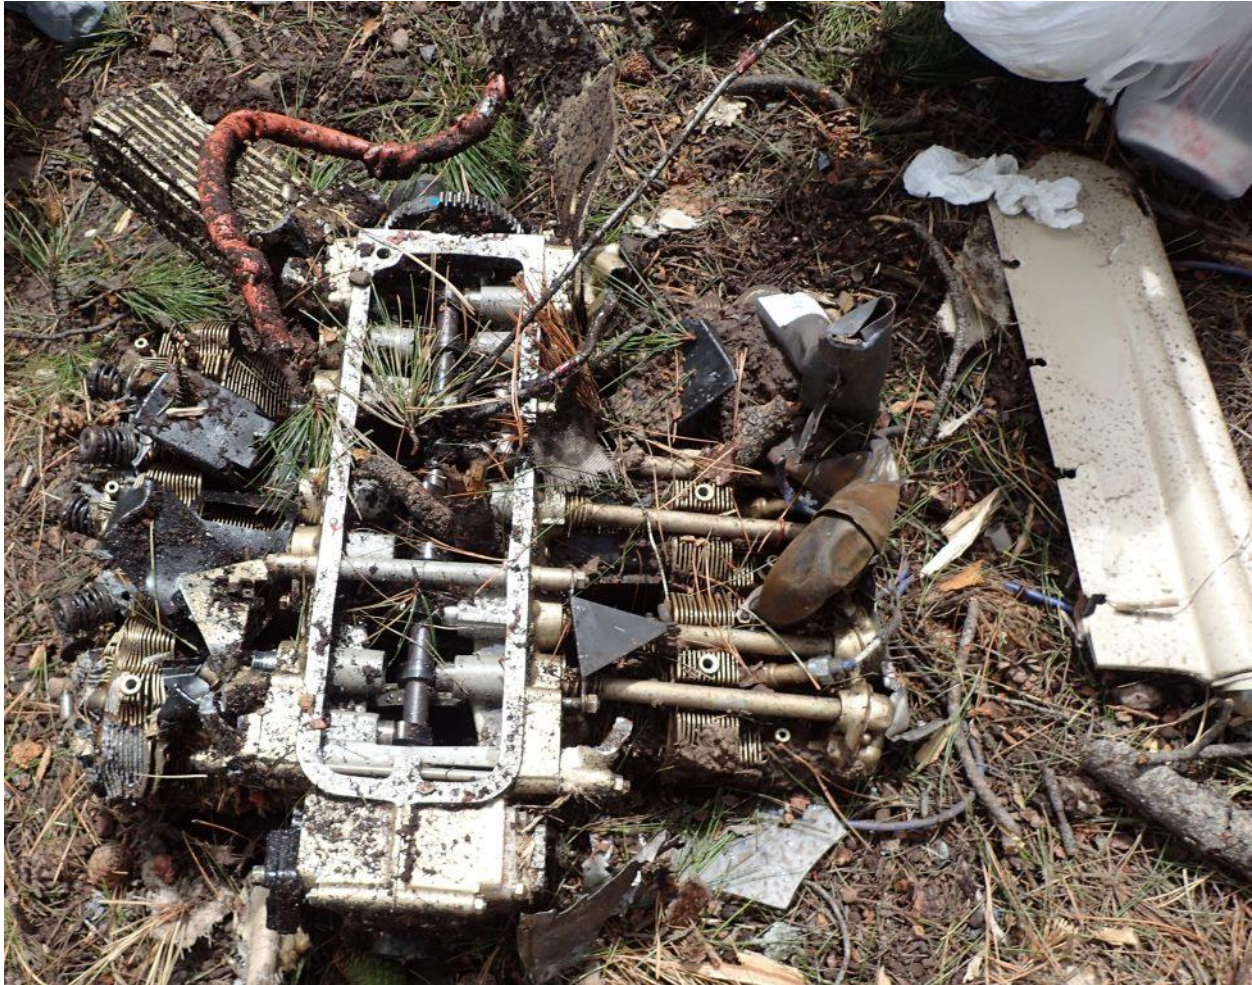
NOTE- This engine directly impacted Tree 8, at a point about 6 ft agl.

Figure 54 - Left Engine

- Engine sustained a significant amount of impact damage
- All six cylinders remained attached and had impact damage
  - The even numbered cylinders were removed for visual inspection of the internal portion of the engine
  - Odd cylinders inspected with lighted borescope. No anomalies noted
- Crankshaft was partially rotated by hand tool and crankshaft continuity was established.
- Camshaft continuity was established by examining camshaft through even numbered cylinder bays
- Connecting rods were examined through the even numbered cylinder bays; all connecting rods were unremarkable
- Pistons displayed normal operating and combustion signatures

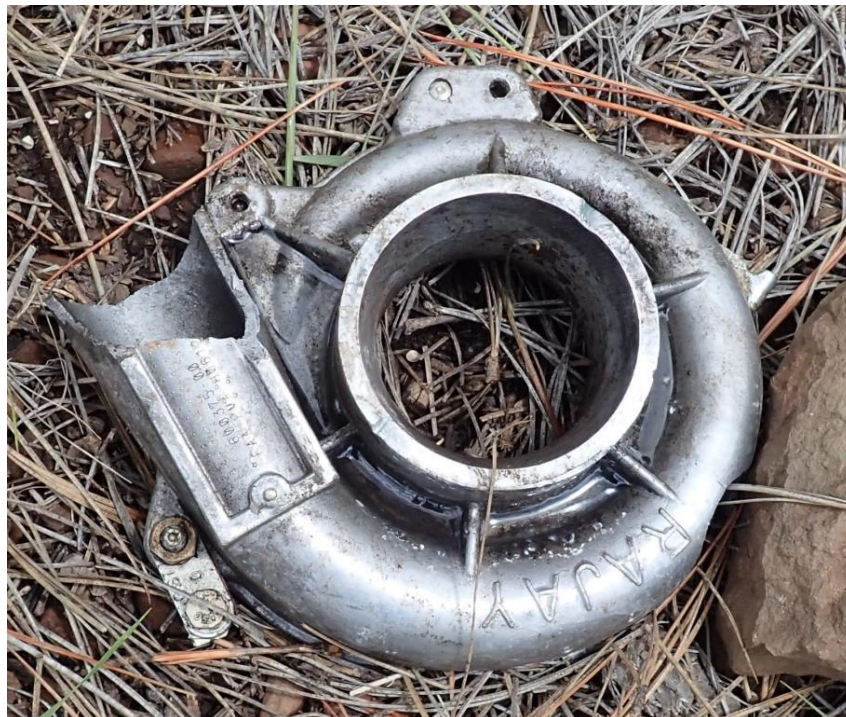
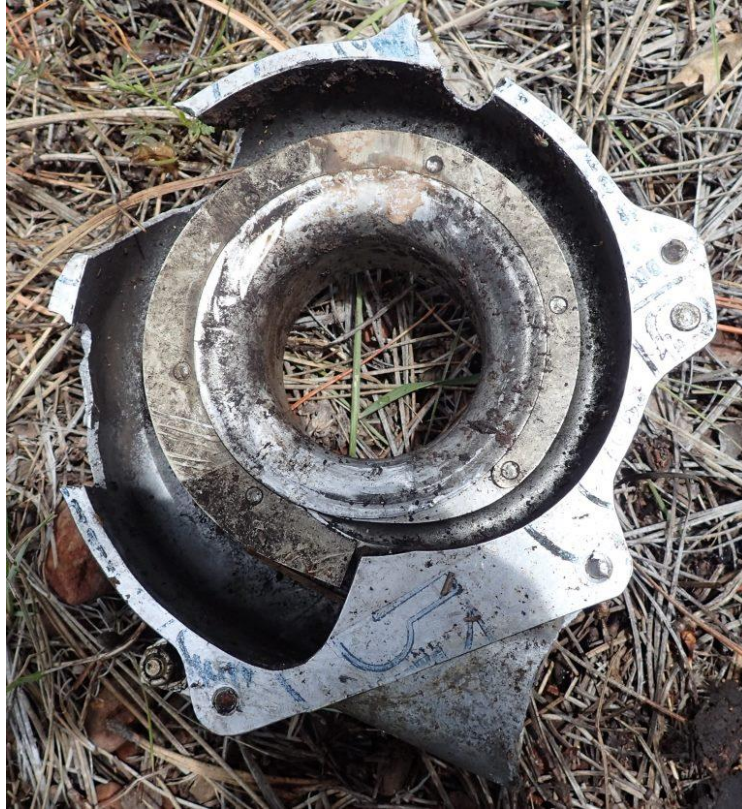
- Both turbochargers were located along the wreckage path and displayed impact damage
- Both turbochargers were capable of rotation
- The compressor of one of the turbochargers had fracture-separated and was not located
- Both overboost valves remained attached to the induction system and were impact damaged

Figure 55 - Turbocharger Fragment (exterior)

**Figure 56 - Turbocharger Fragment (interior)**

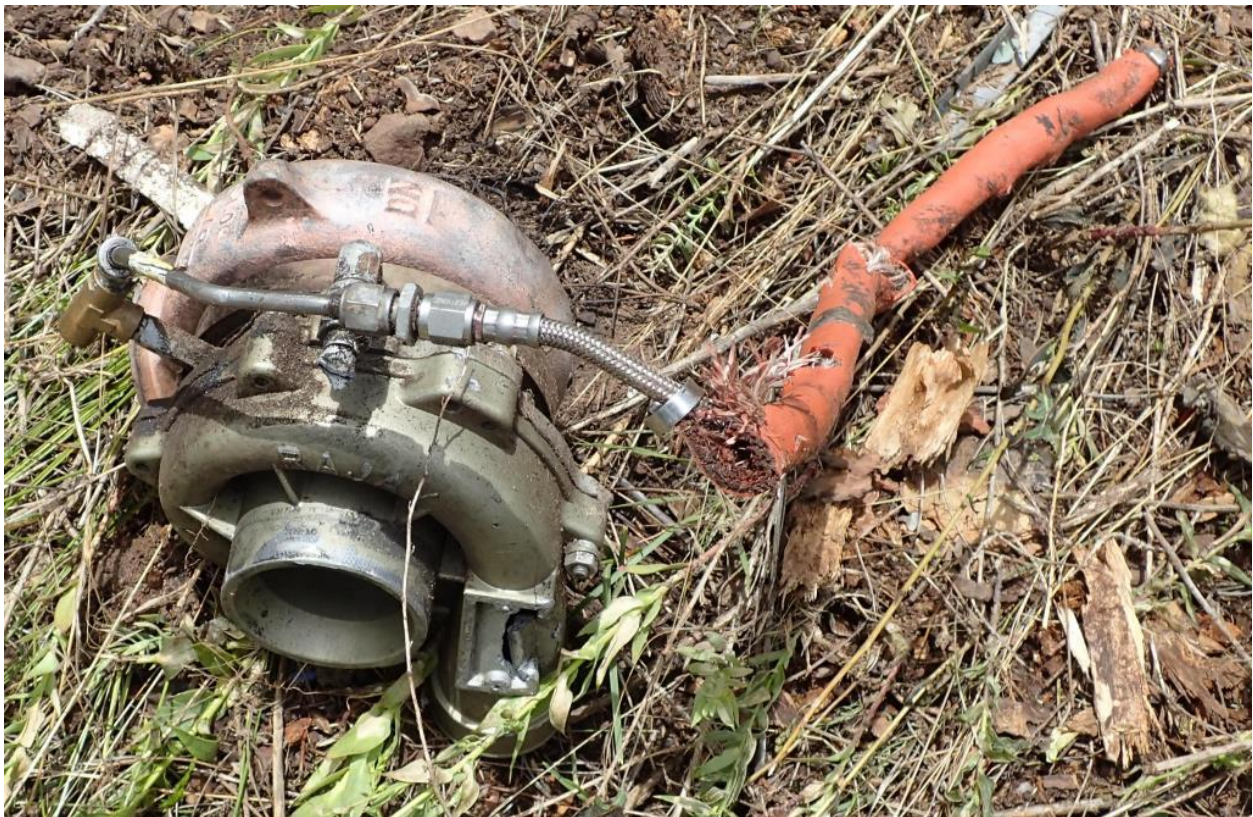
**Figure 57 - Intact Turbocharger**

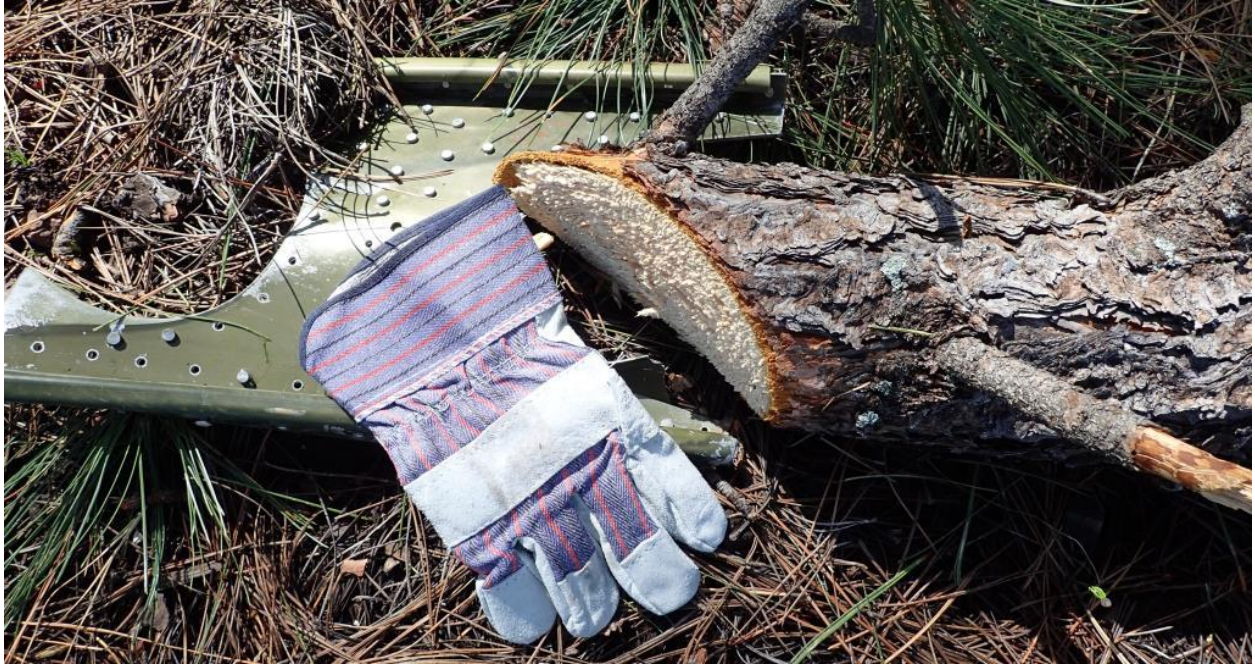
There were several branches cut at clean  $\sim 45^\circ$  angles, consistent with propeller cuts, located near the initial impact point

Figure 58 - Cut Limb

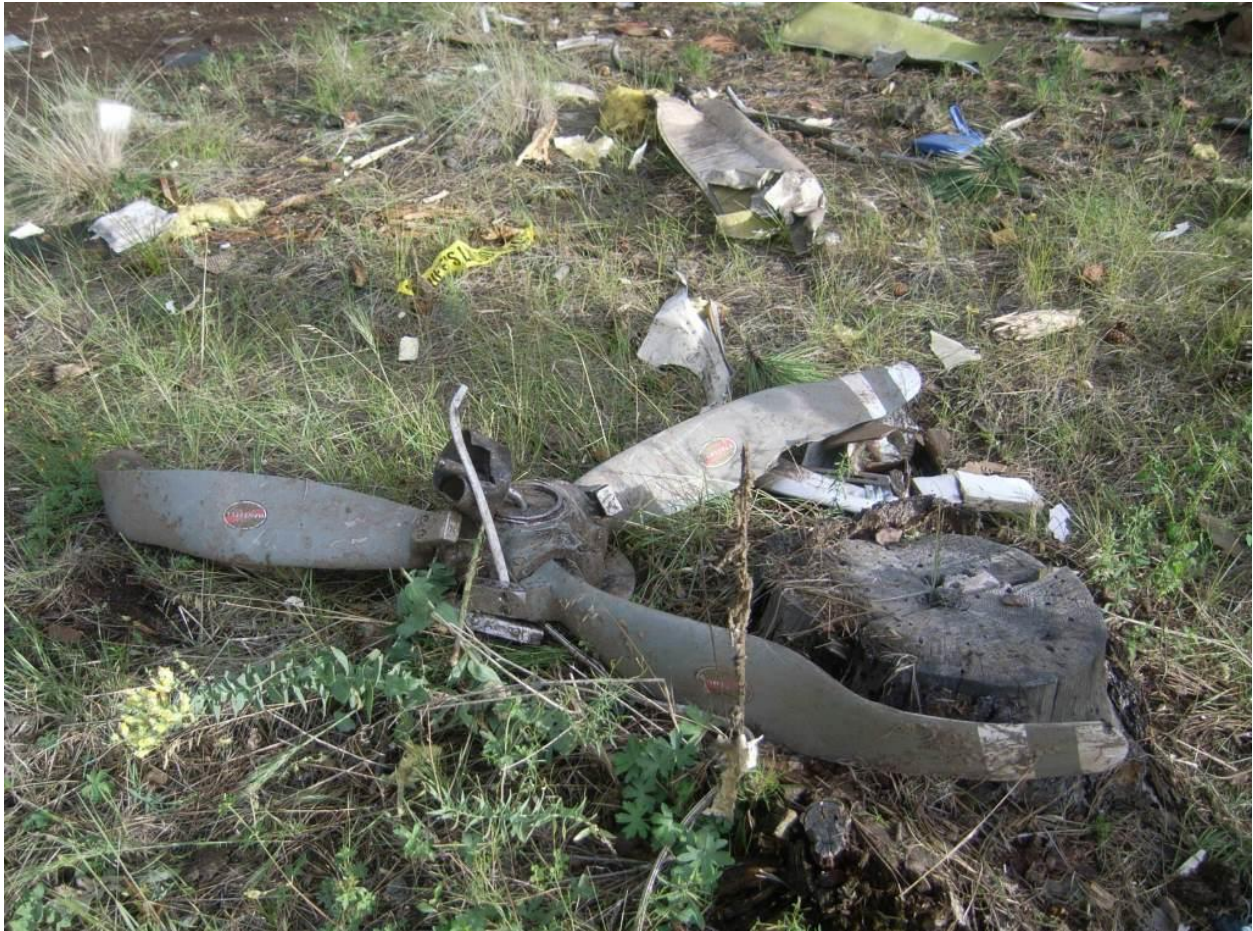
- The left propeller was fracture-separated from the engine and was located in the debris field
- All three propeller blades displayed bending and twisting deformation
- All of the blades had several leading edge gouges
- The blades appeared to be in normal (non-feathered) pitch positions
- The spinner was fracture-separated from the propeller

**Figure 59 - Left Propeller**
