## **NATIONAL TRANSPORTATION SAFETY BOARD**

### **SITE and EXAMINATION INFORMATION**

**NTSB Accident: WPR16FA158  
Accident Date: August 2, 2016**

Location: Flagstaff, Arizona  
Date: August 2, 2016  
Aircraft: Piper Seneca II, N82806, Serial # 34-8170021  
NTSB IIC: Michael Huhn

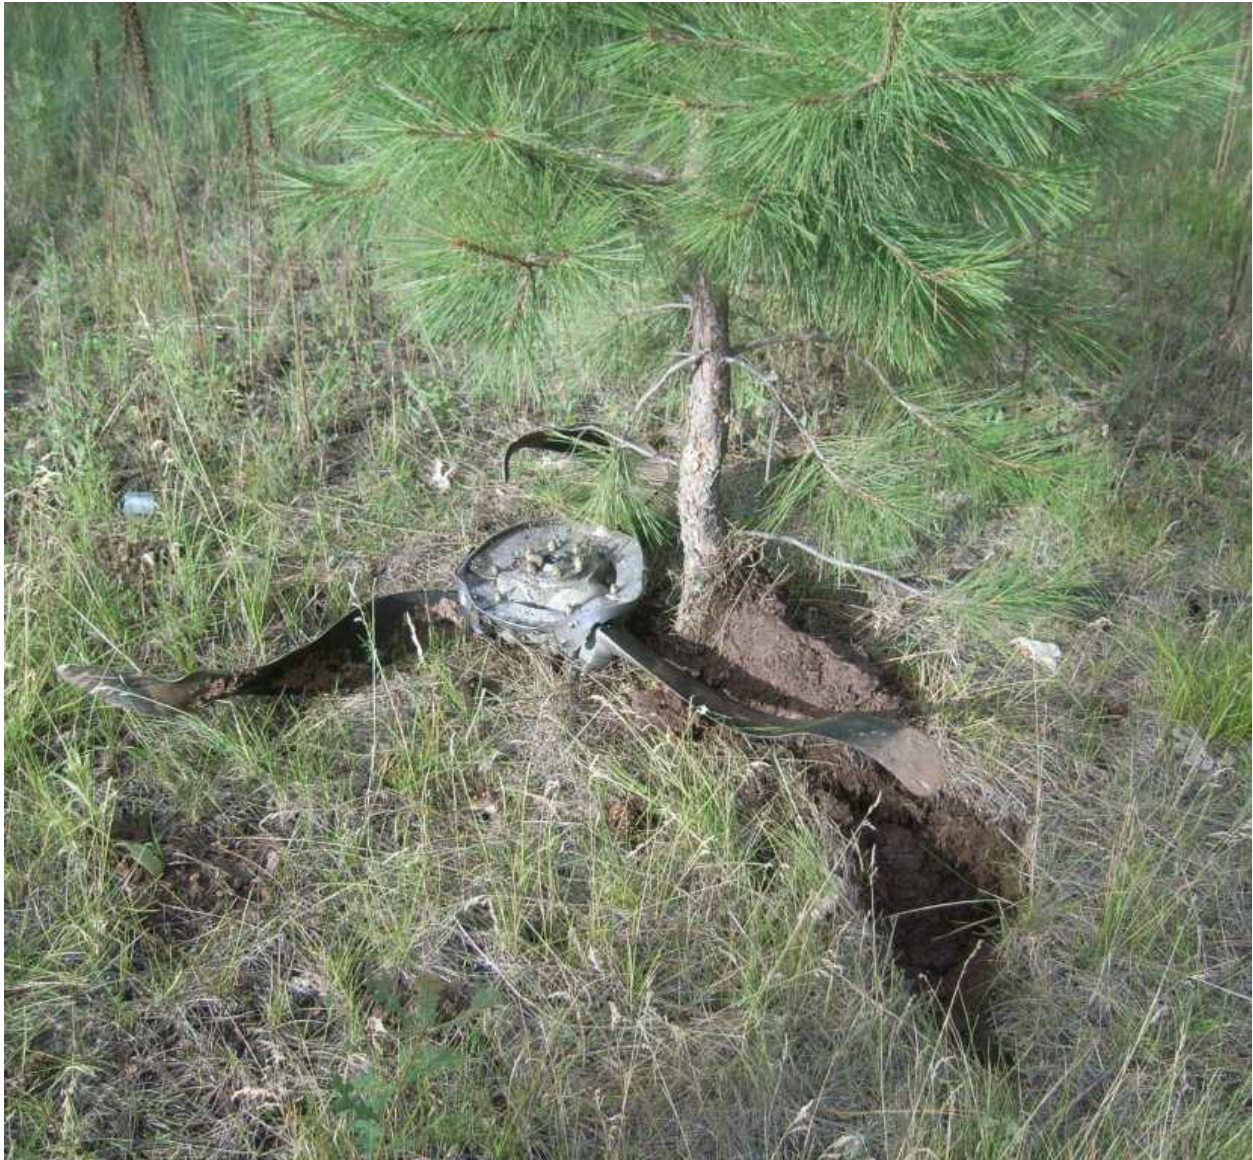
- The right propeller was fracture-separated from the engine and was located in the debris field
- All three propeller blades displayed twisting and bending deformation
- The blades appeared to be in normal (non-feathered) pitch positions
- The spinner was fracture-separated from the propeller, and retained the actuating piston

**Figure 60 - Right Propeller**

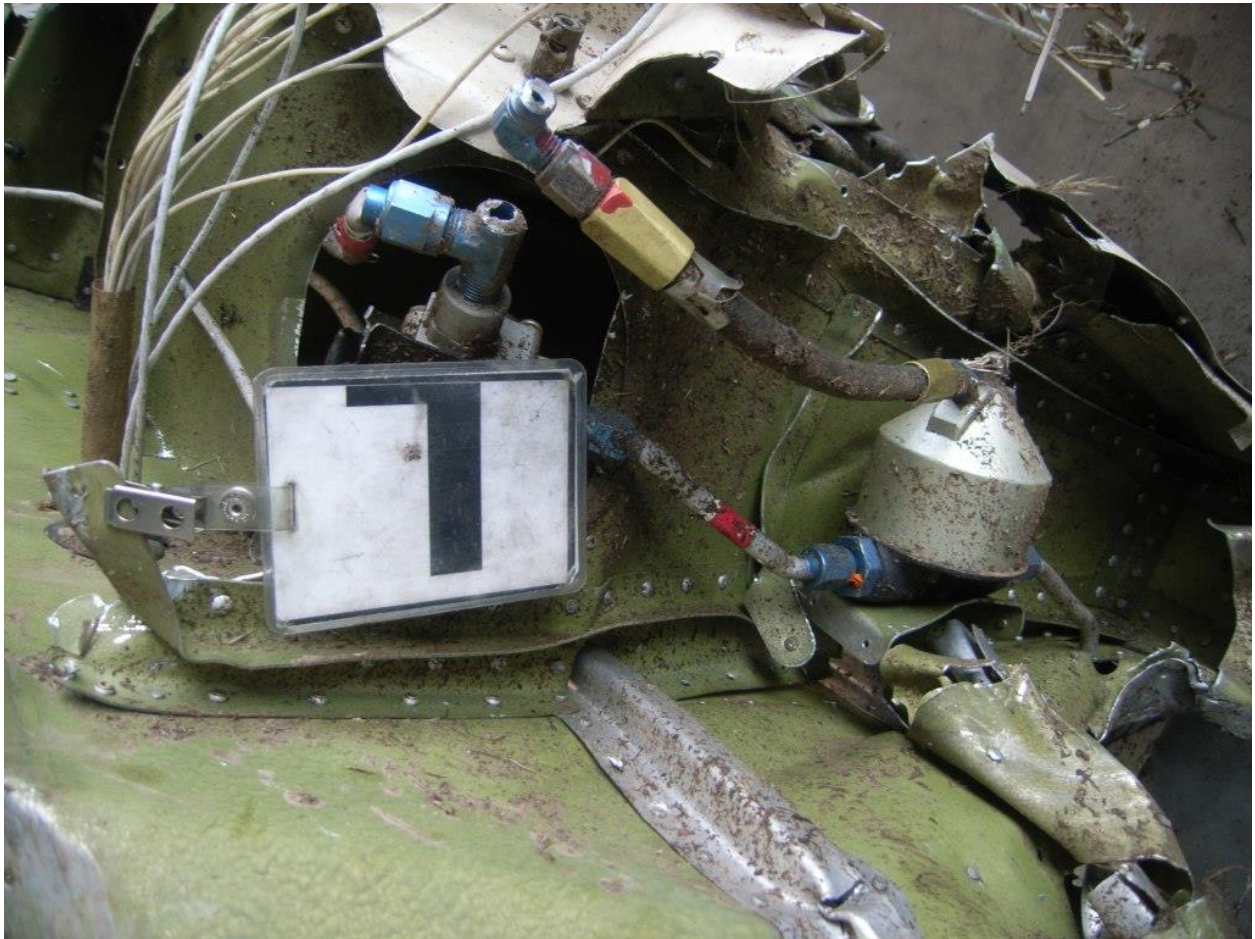
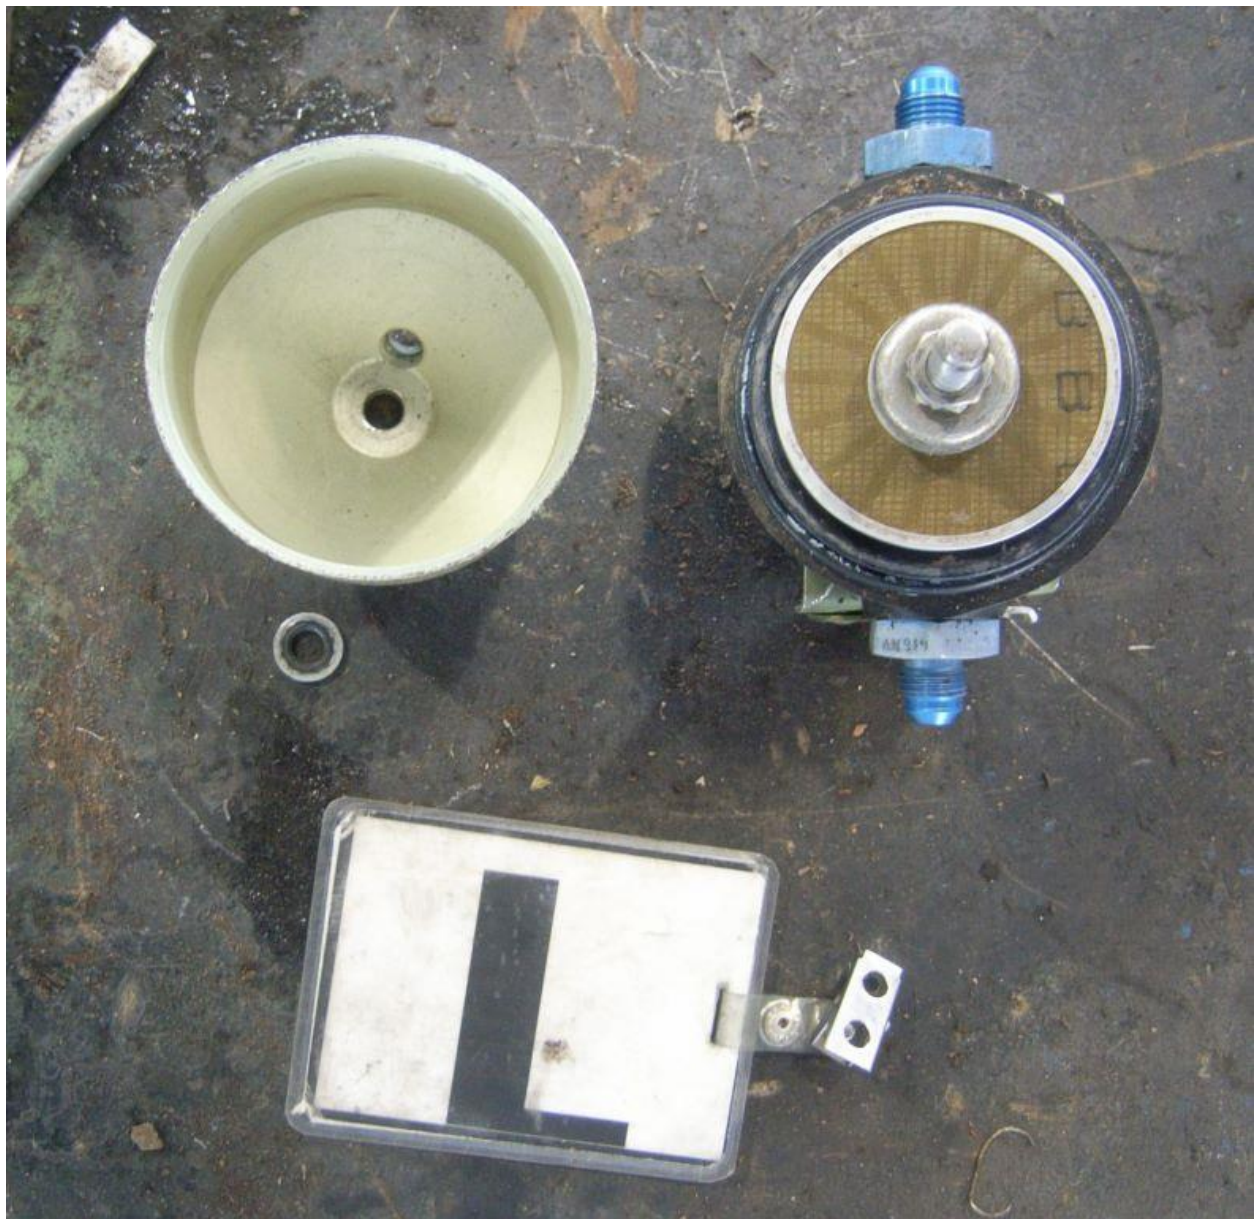
- Two fuel strainers remained affixed to their respective (left and right) wing ribs.
- Both were relatively intact, except for displacement and some fractured fuel lines
- Both were removed from their mounts, and opened for internal examination
- Both were of the metal-cup, stacked-wafer design
- Left Strainer
  - Bowl/cap securely attached to one another
  - Devoid of fuel
  - No observed contamination or corrosion in bowl
  - Filter elements clean/unoccluded

Figure 61 - Left Fuel Strainer (in situ)

**Figure 62 - Left Strainer (disassembled)**

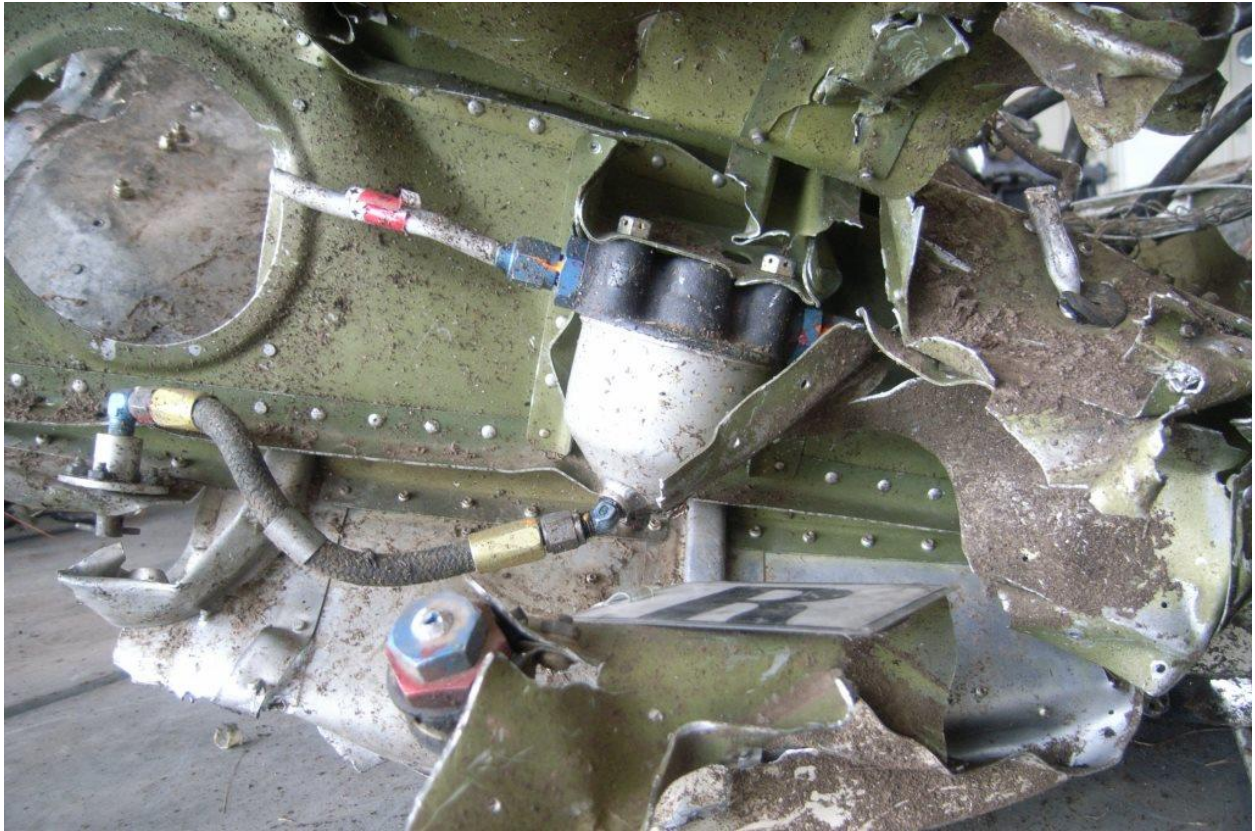
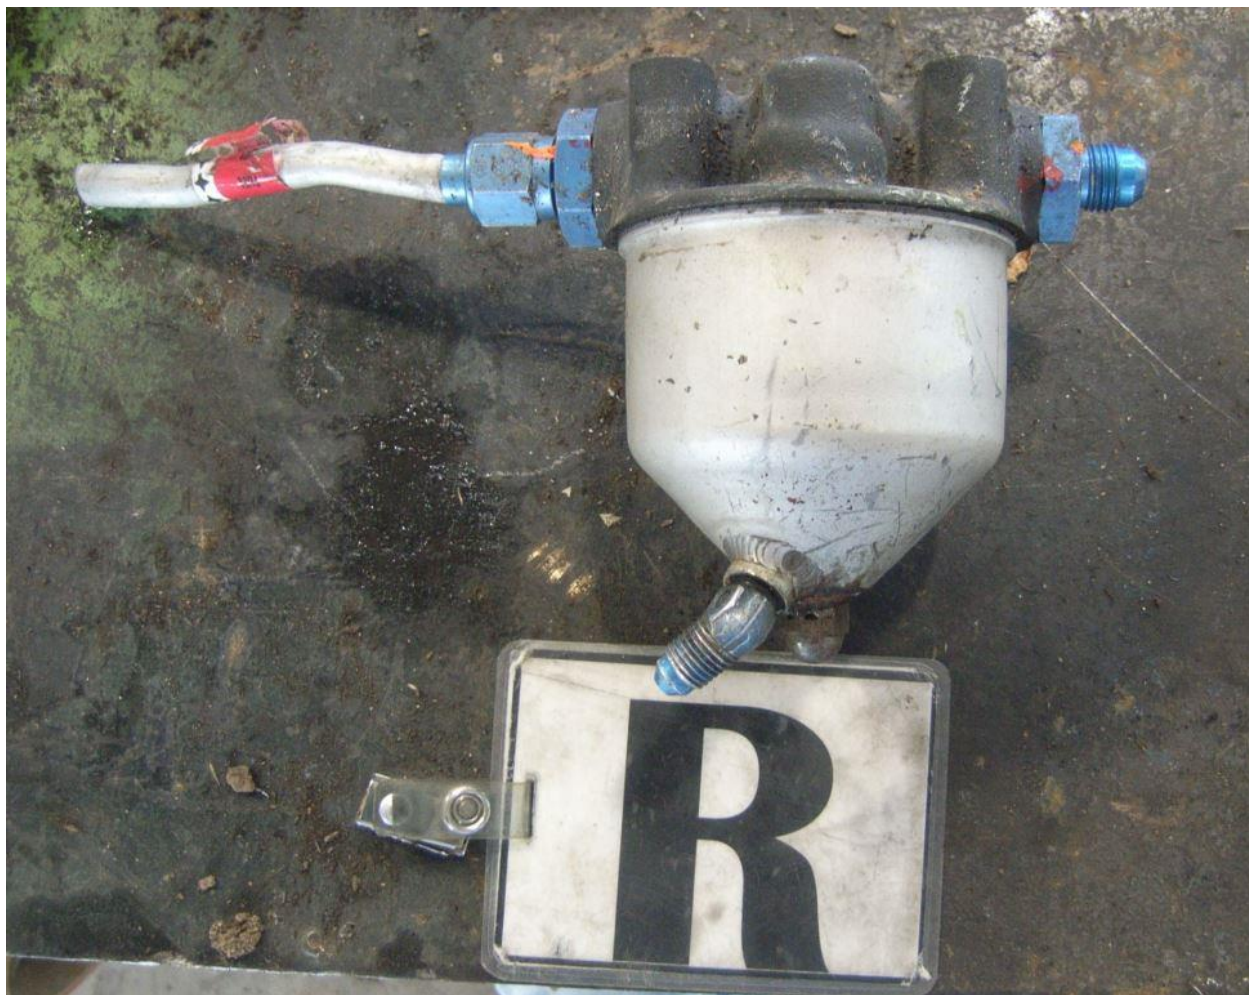
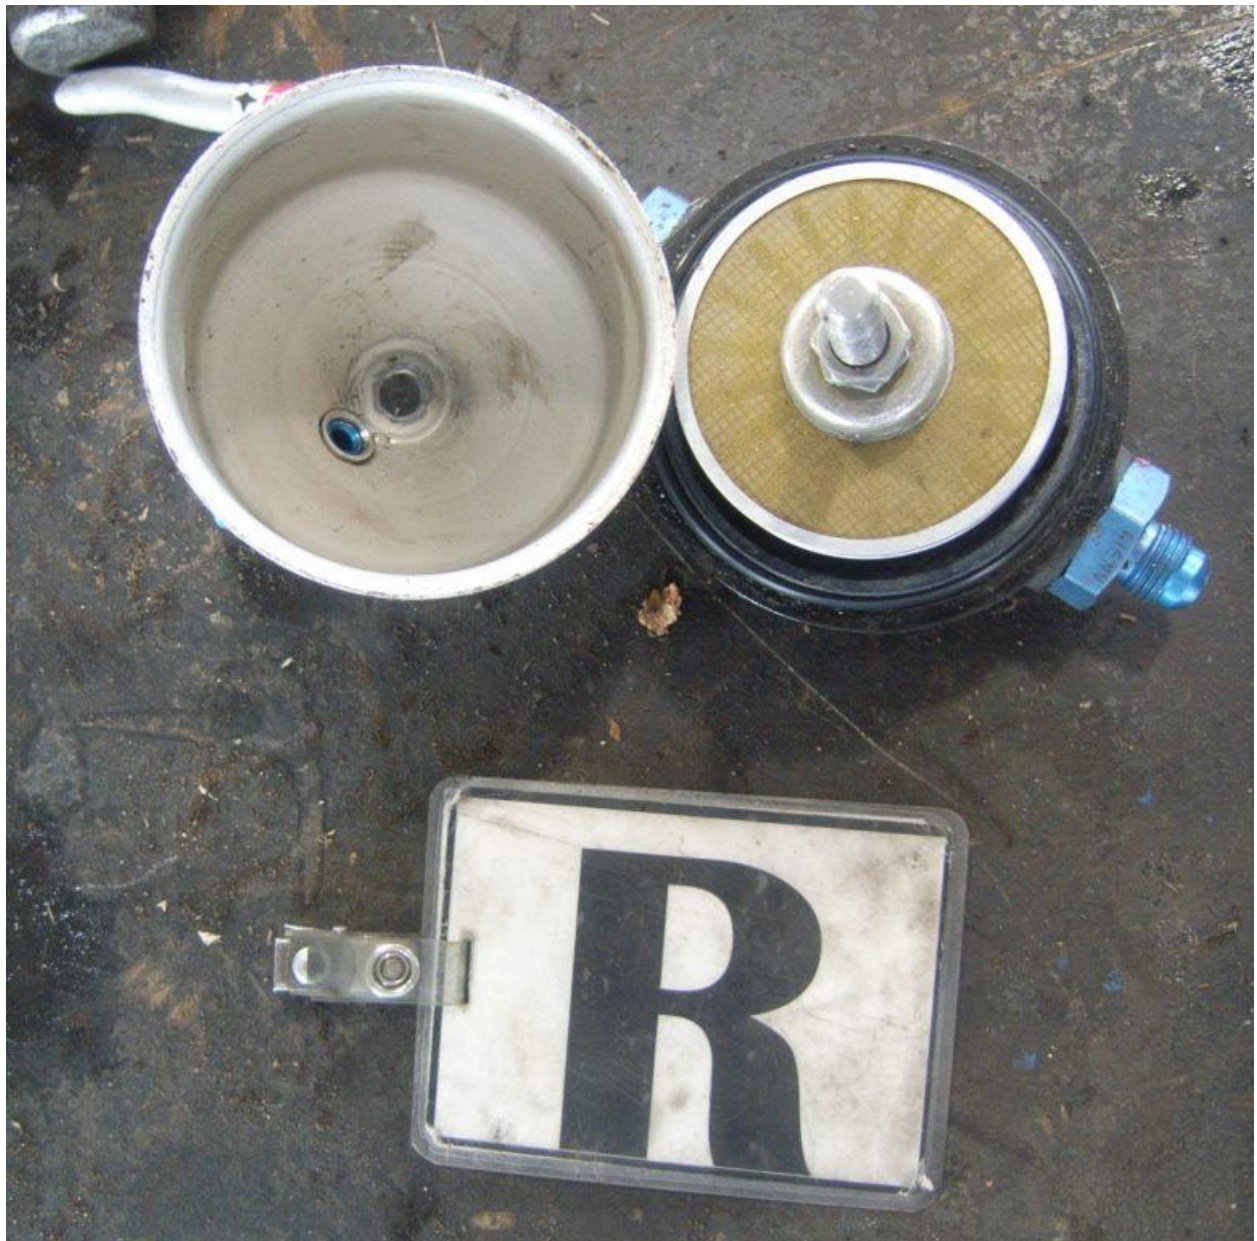
- Right Strainer
  - Bowl/cap securely attached to one another
  - Trace amounts of fuel (clear/straw-colored avgas)
  - No observed contamination or corrosion in bowl
  - Filter elements clean/unoccluded

**Figure 63 - Right Fuel Strainer (in situ)**

**Figure 64 - Right Strainer (removed from aircraft)**

**Figure 65 - Right Strainer (disassembled)**
