# **NATIONAL TRANSPORTATION SAFETY BOARD**

## **DEBRIS FIELD INFORMATION**

**NTSB Accident: WPR16FA158  
Accident Date: August 2, 2016**

Location: Flagstaff, Arizona  
Date: August 2, 2016  
Aircraft: Piper Seneca II, N82806, Serial # 34-8170021  
NTSB IIC: Michael Huhn

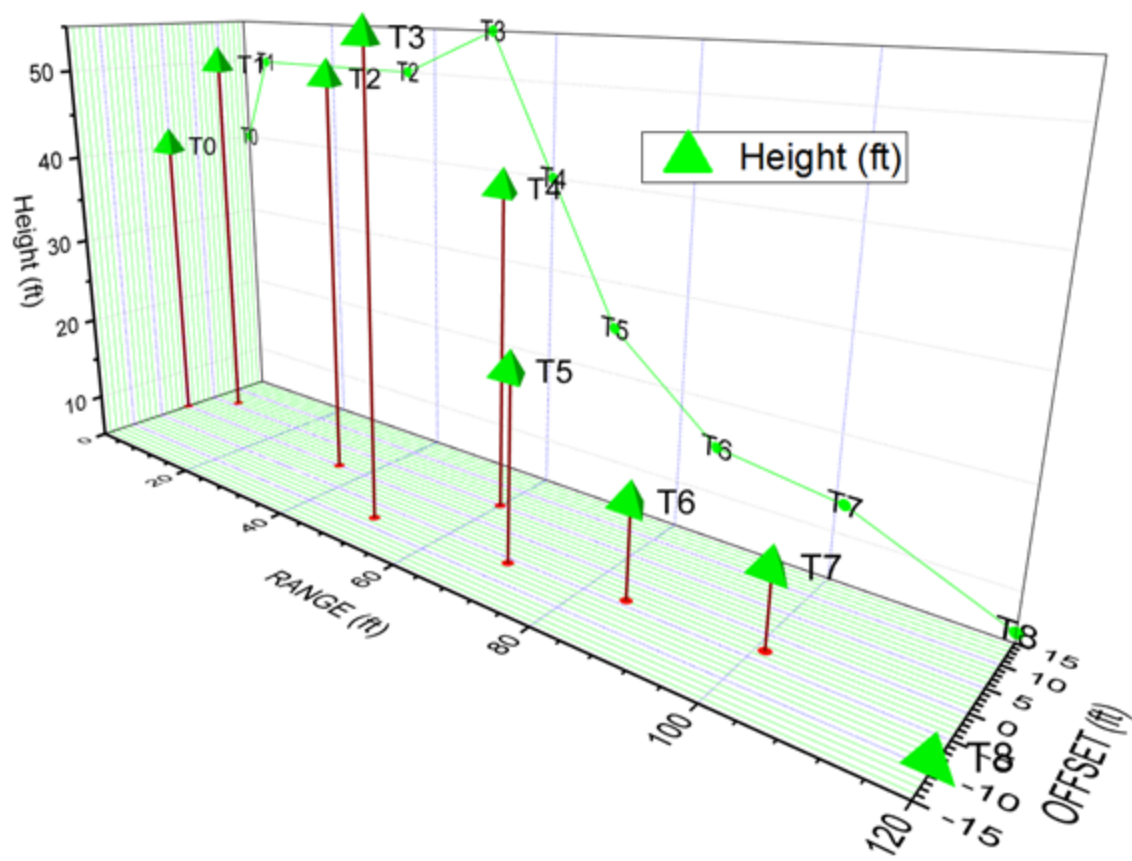
Orthographic View of Affected Trees

- The airplane "topped" (cut/broke off tops of) eight trees (including Tree 0)
  - These tree locations, and their remaining heights, were catalogued
- Several other trees bore minor to major impact scars, but only one of those was catalogued
- Tree fracture points not necessarily vertically coincident with airplane impact locations

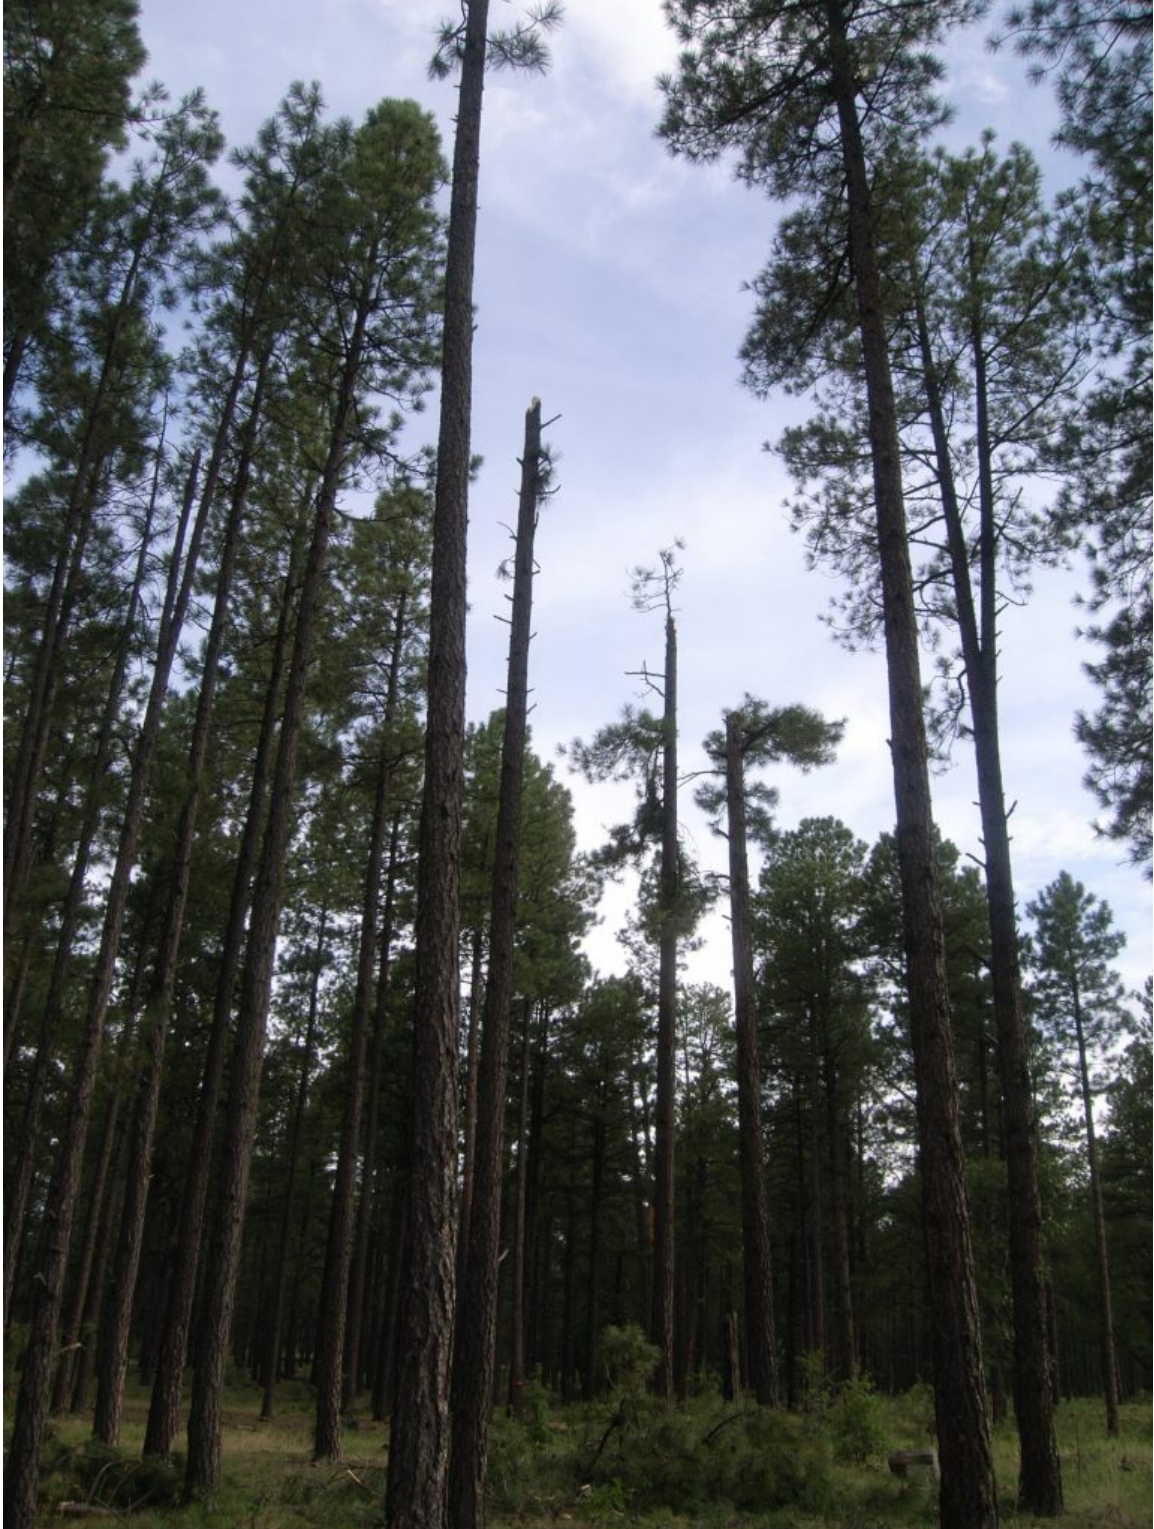
**Figure 1 - Topped Trees (View back against flight direction)**

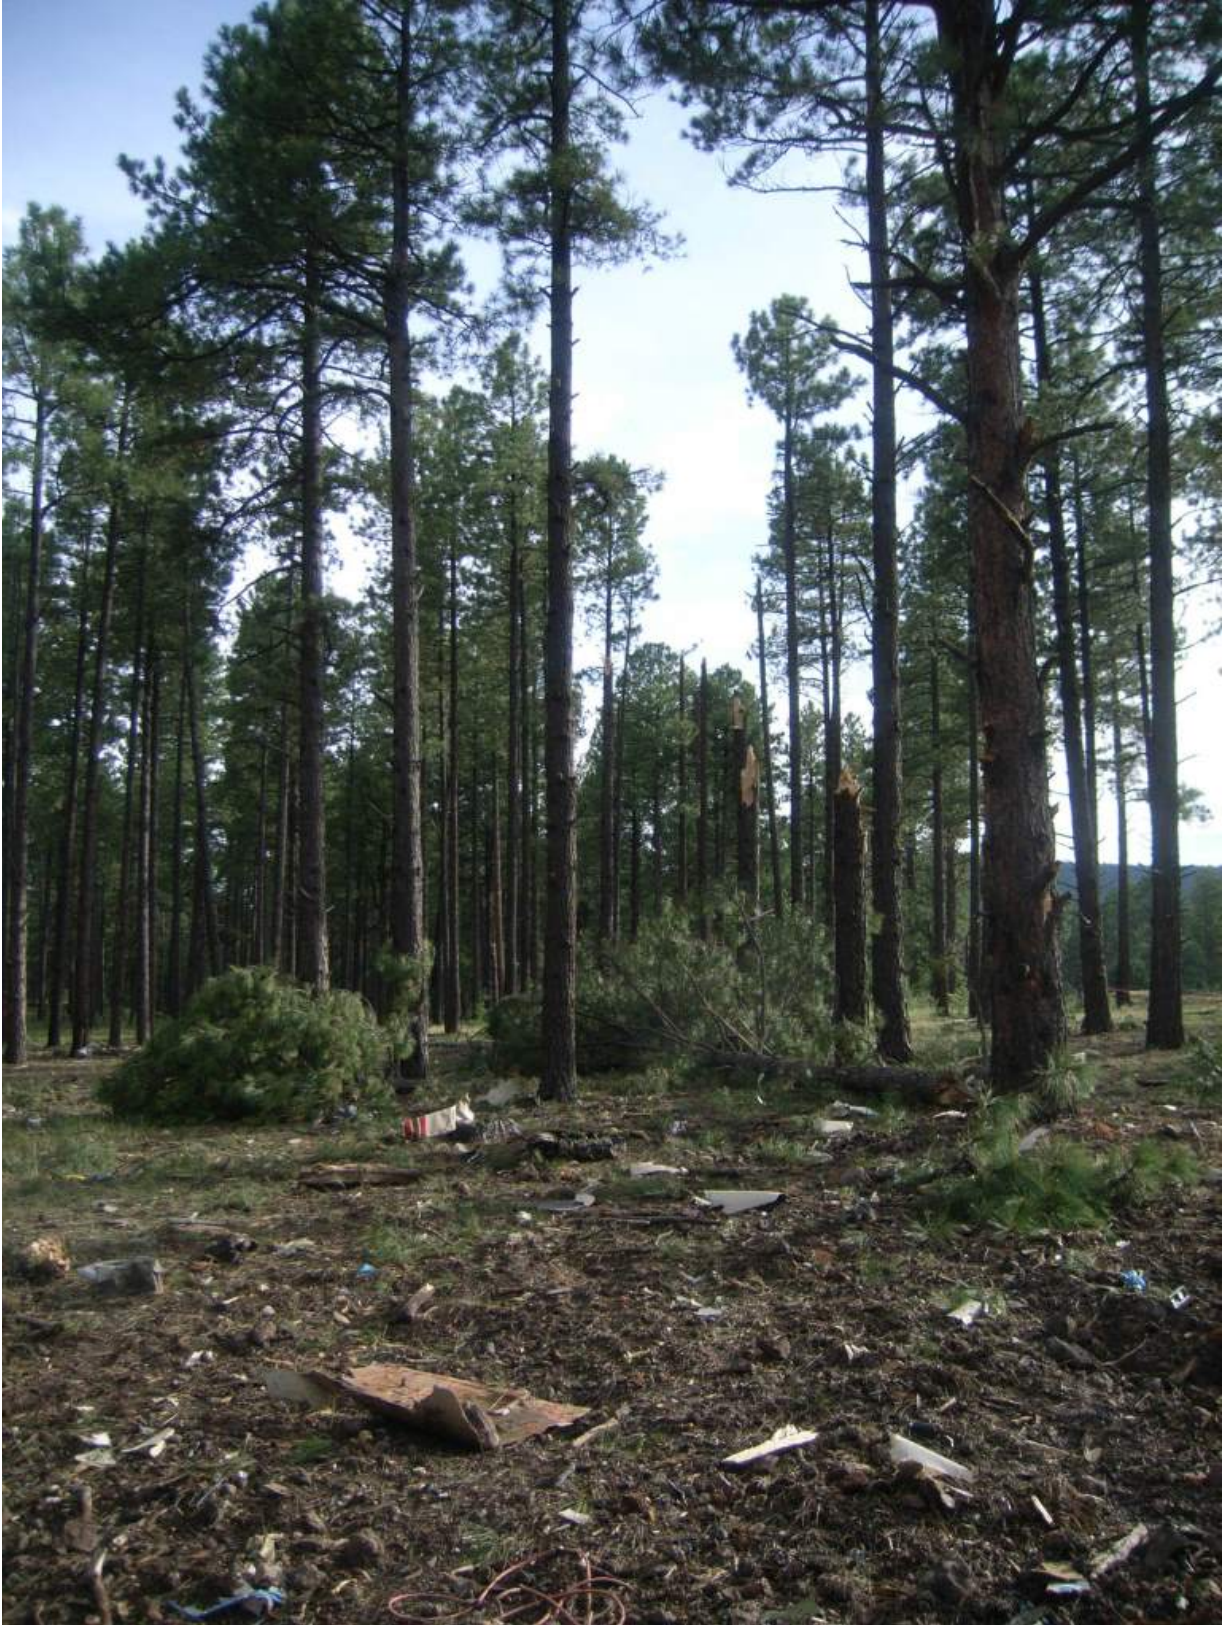
**Figure 2 - Debris Path and Tree Swath (View back against flight direction)**

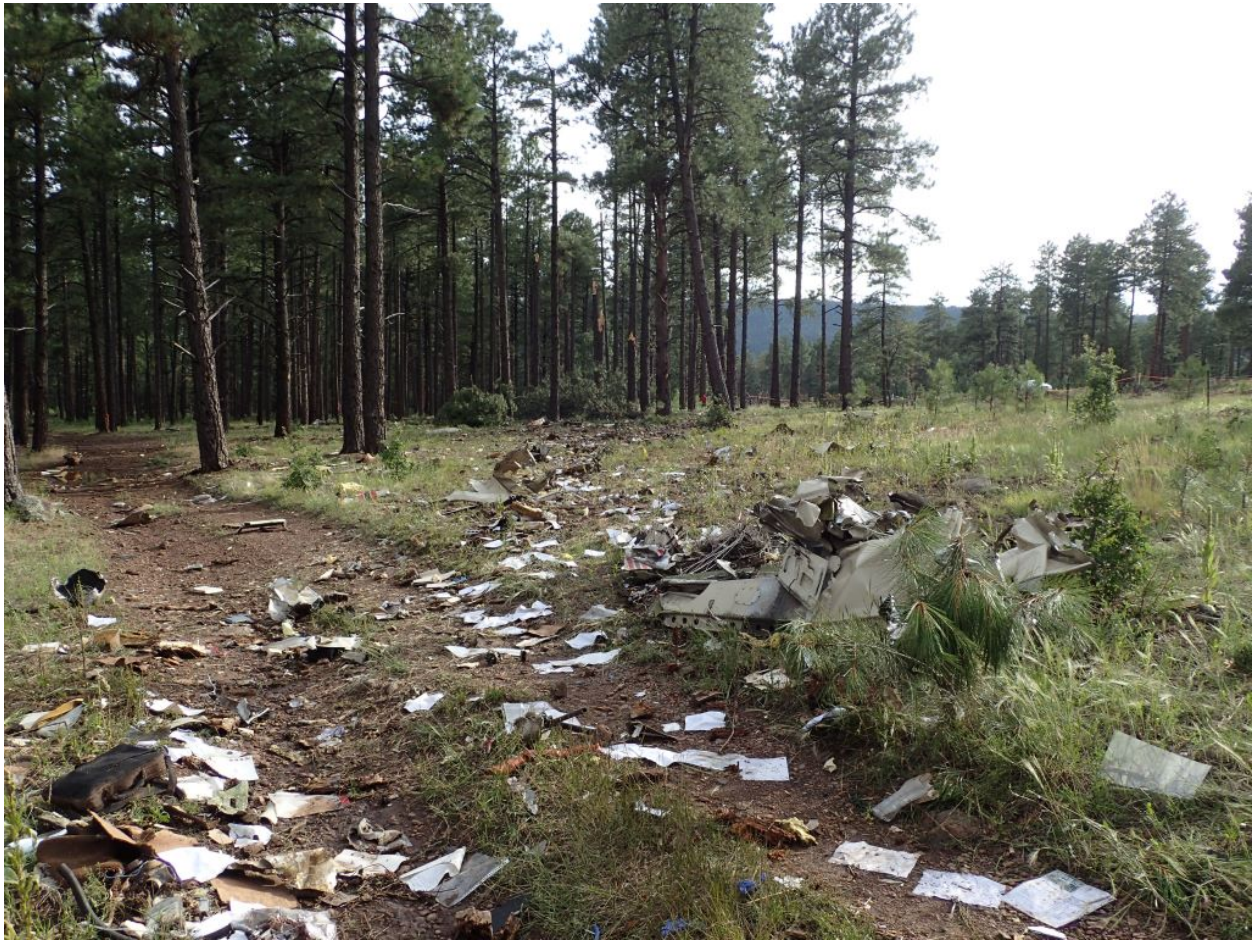
**Figure 3 - Debris Path and Tree Swath (View back against flight direction)**

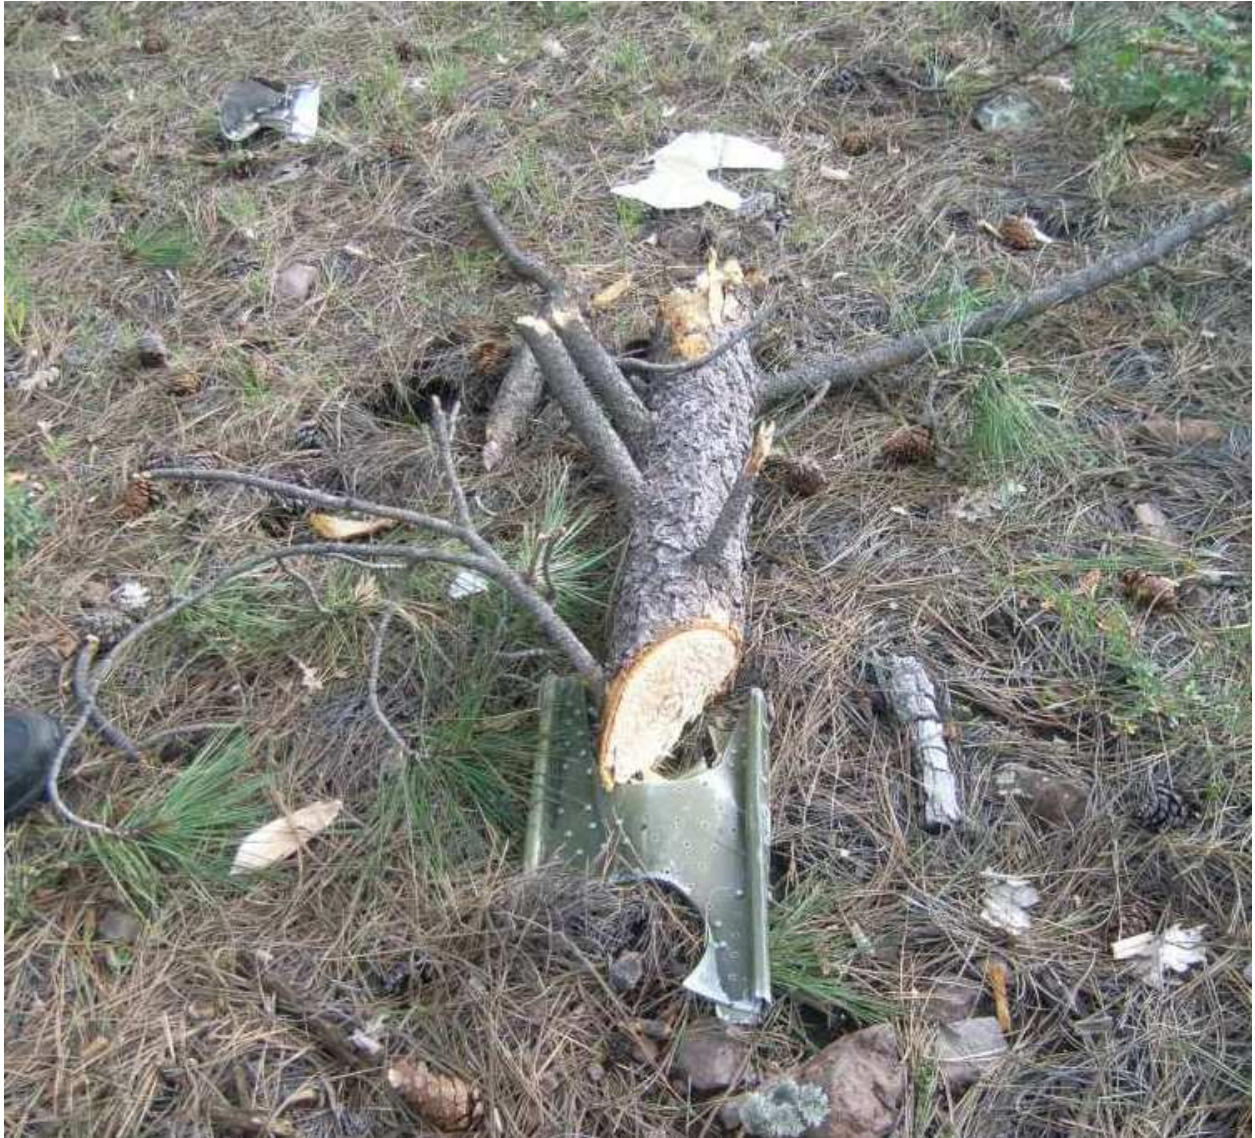
- The trees appeared to be primarily mature pine trees, from about 50 to 80 feet tall
- The topped trees ranged from about 10 to 15 inches in diameter at their fracture points
- A cluster of tree tops, branches, and limbs was situated from about 70 to 100 feet from Tree 0, approximately straddling the reference line
  - The cluster was not a result of any efforts by the first responders or other personnel to gather or re-locate the debris
- Many smaller-diameter & shorter limbs were scattered throughout the first 100 feet of the debris field
- Many tree limbs (up to about 6 inches in diameter) exhibited clean, fresh, diagonally-cut ends consistent with being severed by the propellers

**Figure 4 - Exemplar Cut Limb**

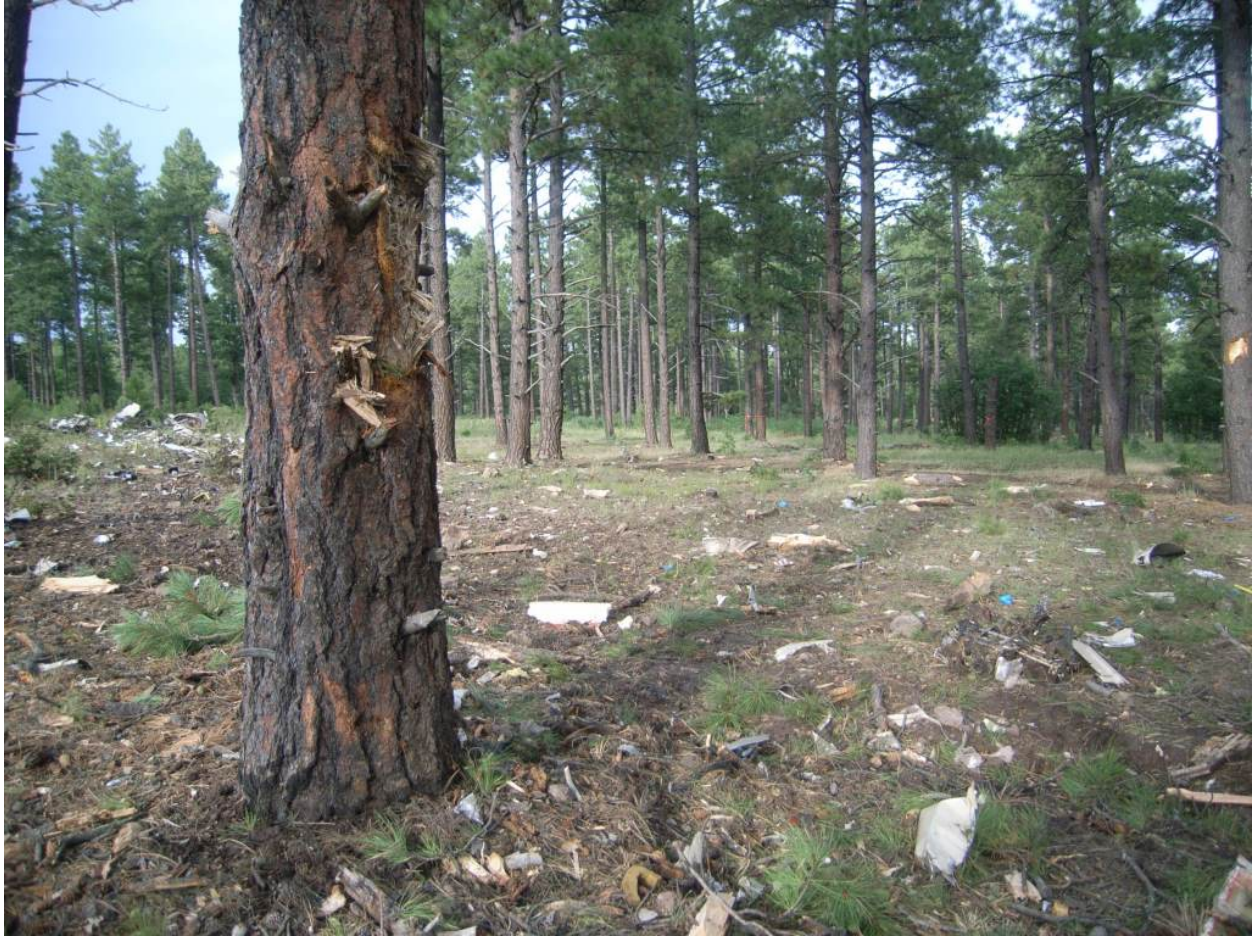
| ID # | TREE DESIGNATION or DESCRIPTION | Height (ft) | RANGE (ft) | OFFSET (ft) |
|---|---|---|---|---|
| T8 | Non Topped tree (w L Engine Impact 6 ft agl) | 6 | 120 | -10 |

**Figure 5 - Tree 8 (with L engine impact mark)**

| ID # | PART NAME & DESCRIPTION | Height<br>(ft) | RANGE<br>(ft) | OFFSET<br>(ft) | A/C<br>LEFT,<br>CENTER,<br>or RIGHT | FLIGHT<br>CONTROL<br>or AERO<br>SFC |
|---|---|---|---|---|---|---|
| 46 | Left Engine (direct strike, tree 8) | 0 | 135 | 5 | L | |

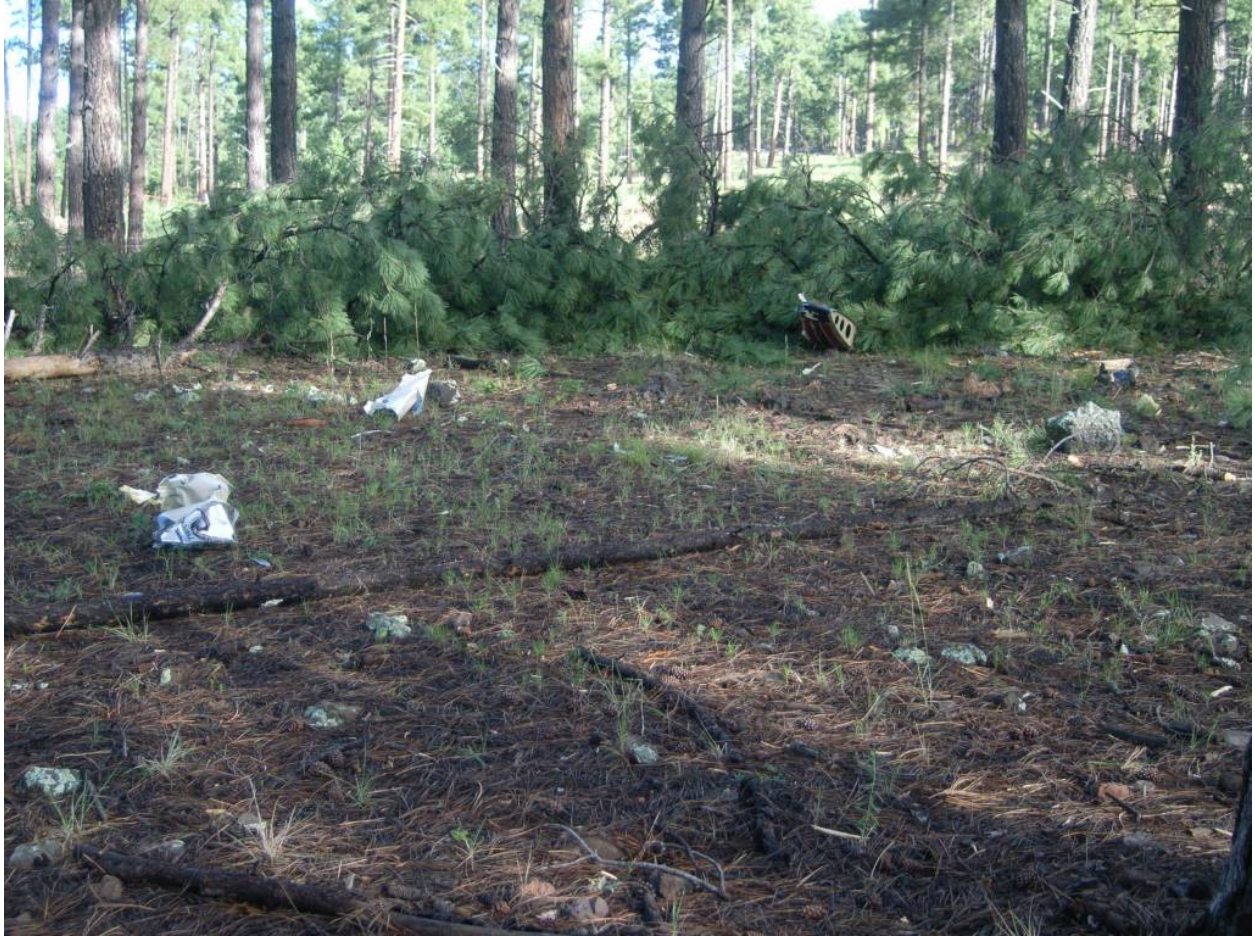
**Figure 6 - Cluster of Tree Tops (with multiple R wing fragments)**
