## **NATIONAL TRANSPORTATION SAFETY BOARD**

# **AIRFRAME AND ENGINE EXAMINATION**

**WPR16FA169**

Location: Madras, Oregon  
Date: August 28, 2016  
Aircraft: Boeing A75N1 Stearman  
N999PP, Serial #: 75-2389  
NTSB IIC: Dennis Hogenson

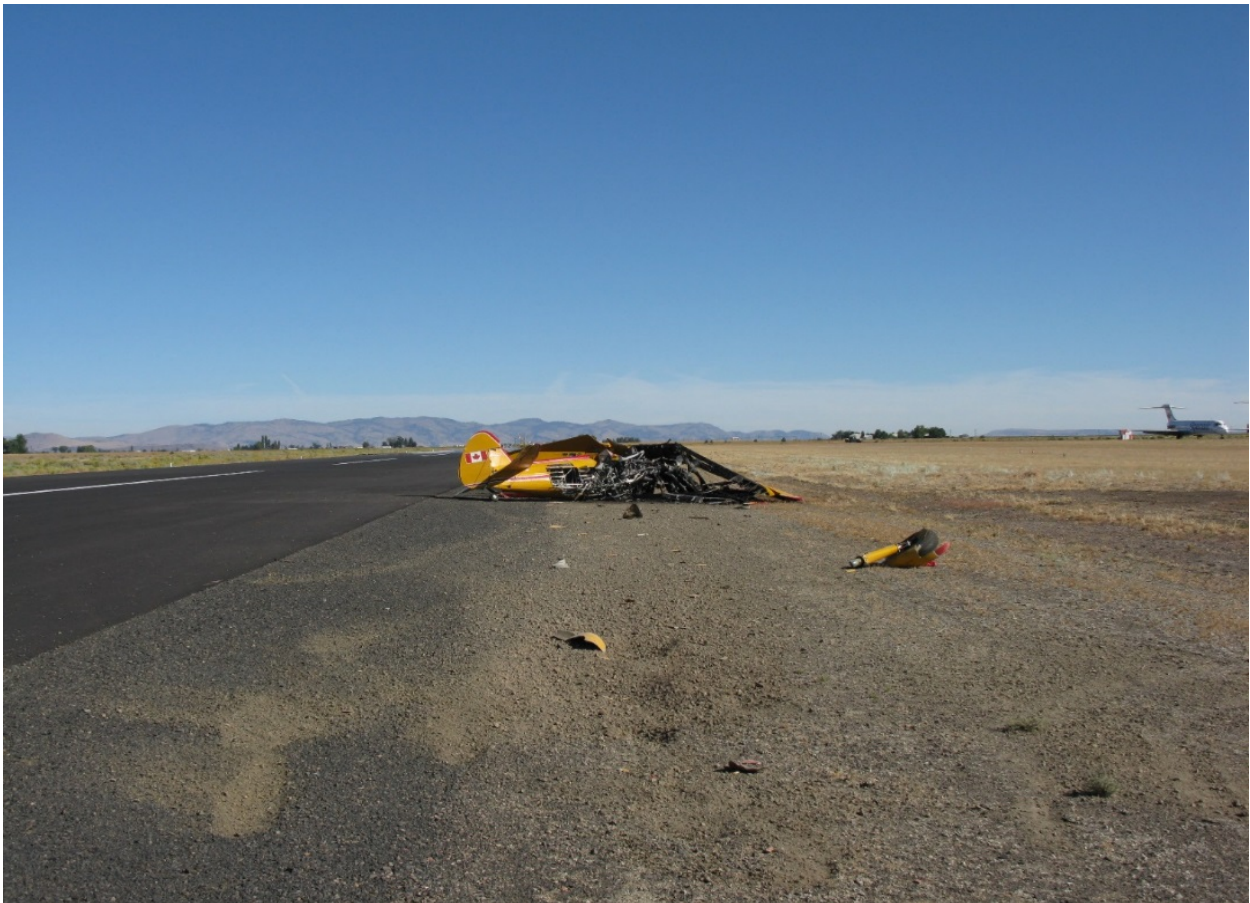
The wreckage was located adjacent to runway 34 approximately 3,400 feet from the approach threshold. The first identified point of contact (FPIC) was followed by an approximate 120-foot long debris path that terminated at the wreckage. The forward right fuselage, engine bay and right wings (upper and lower) were consumed by post impact fire.

**Figure 1: View of Airplane Wreckage**

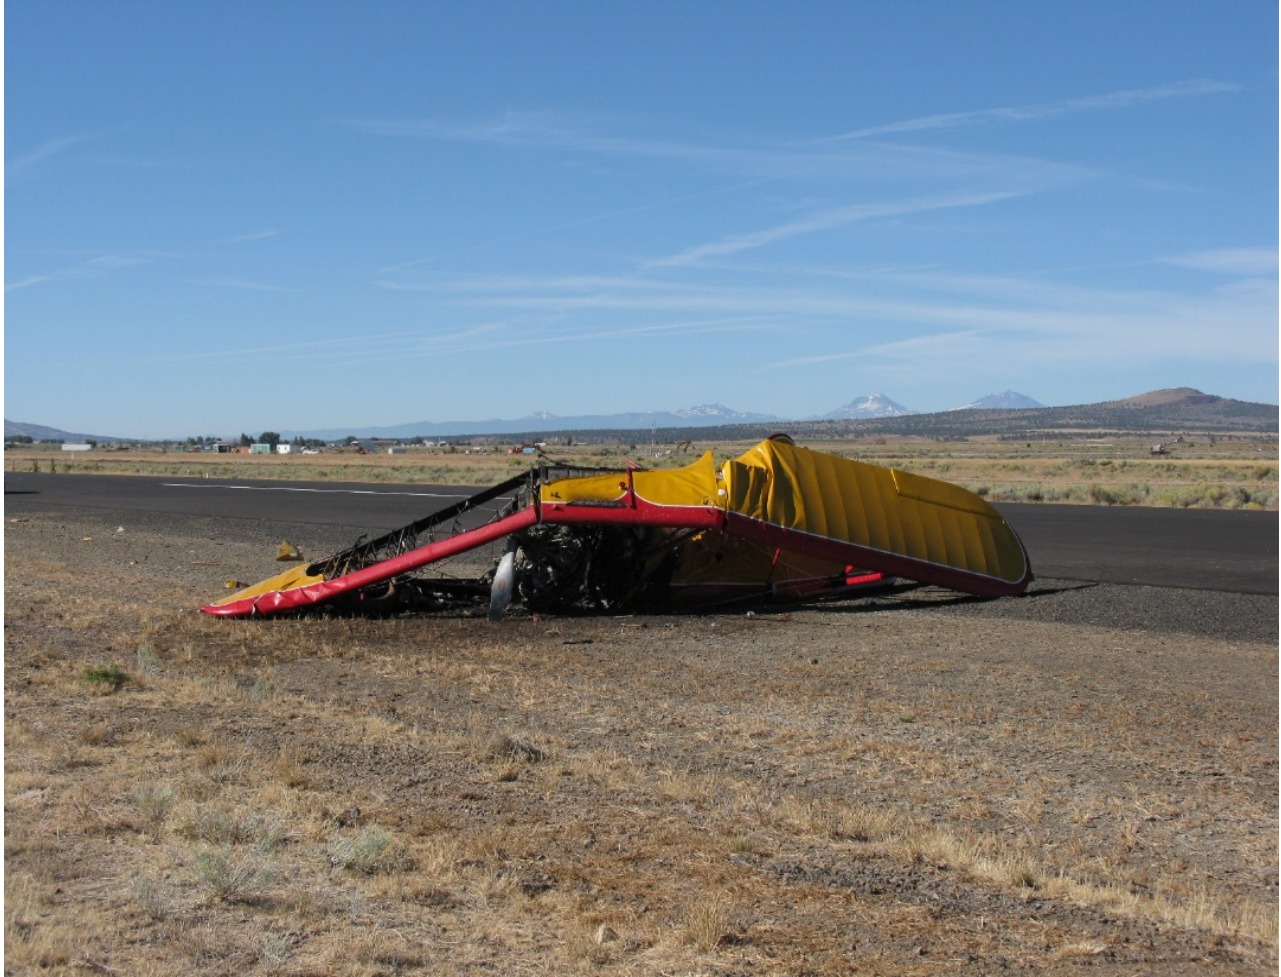
**Figure 2: Forward View of Airplane Wreckage**

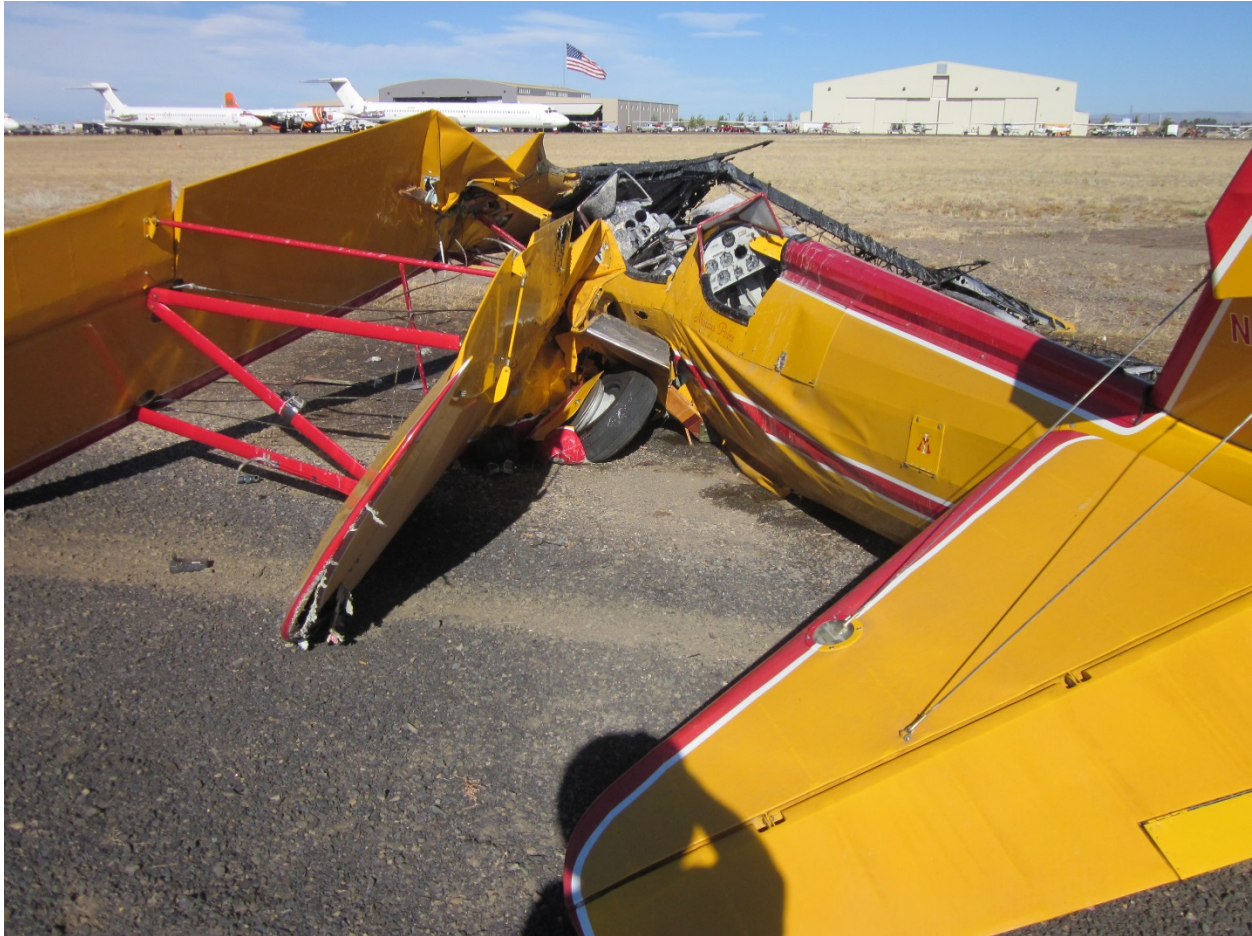
The wings remained attached to the fuselage and support braces and struts. The vertical stabilizer, left and right horizontal stabilizers remained attached to the empennage. The vertical and left horizontal stabilizer displayed no obvious signs of damage. The right horizontal stabilizer was bent upward towards the outer edge. Both the rudder and elevator moved freely.

**Figure 3: Left Aft View of Wreckage**

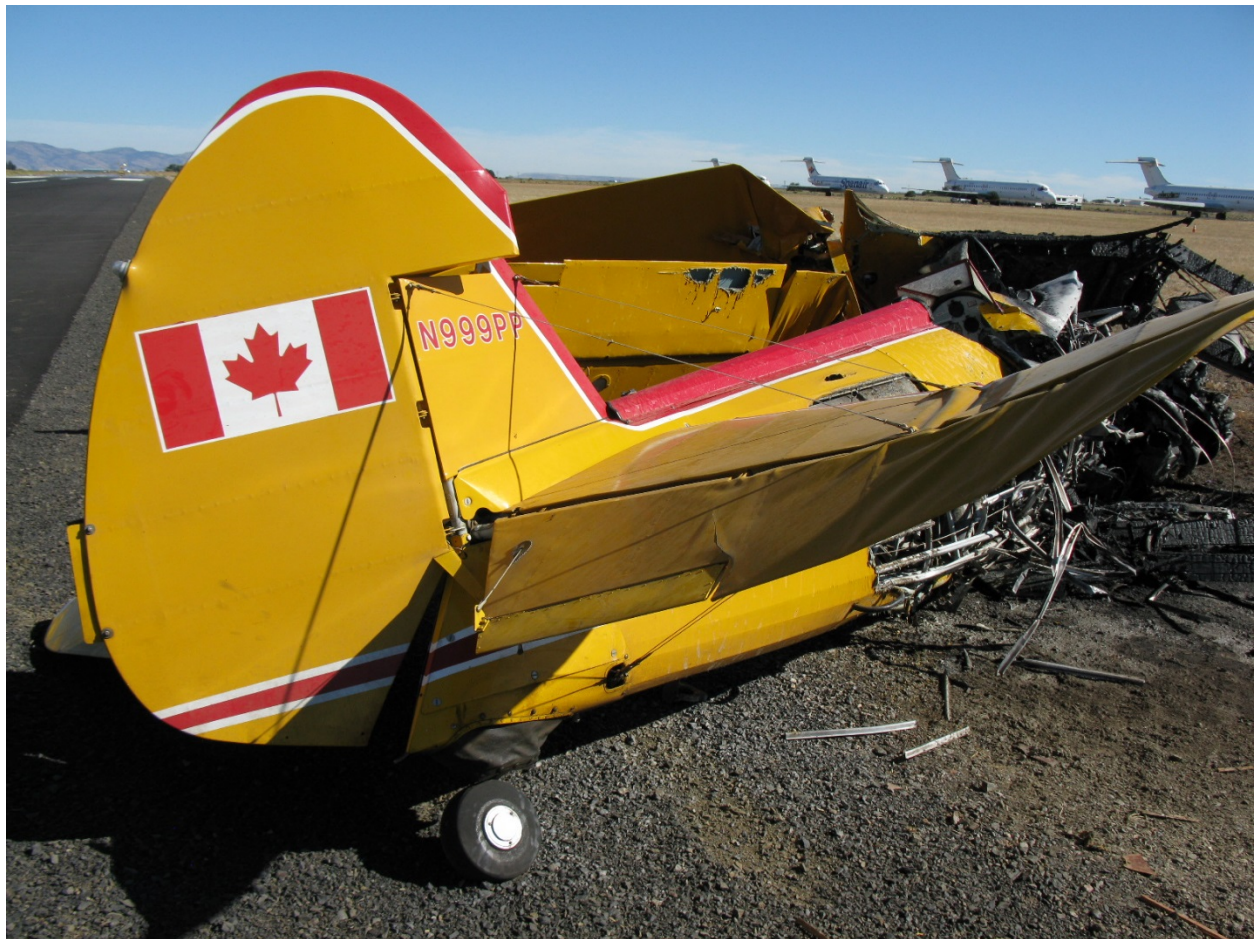
**Figure 4: Right Horizontal Stabilizer and Elevator Impact Damage**

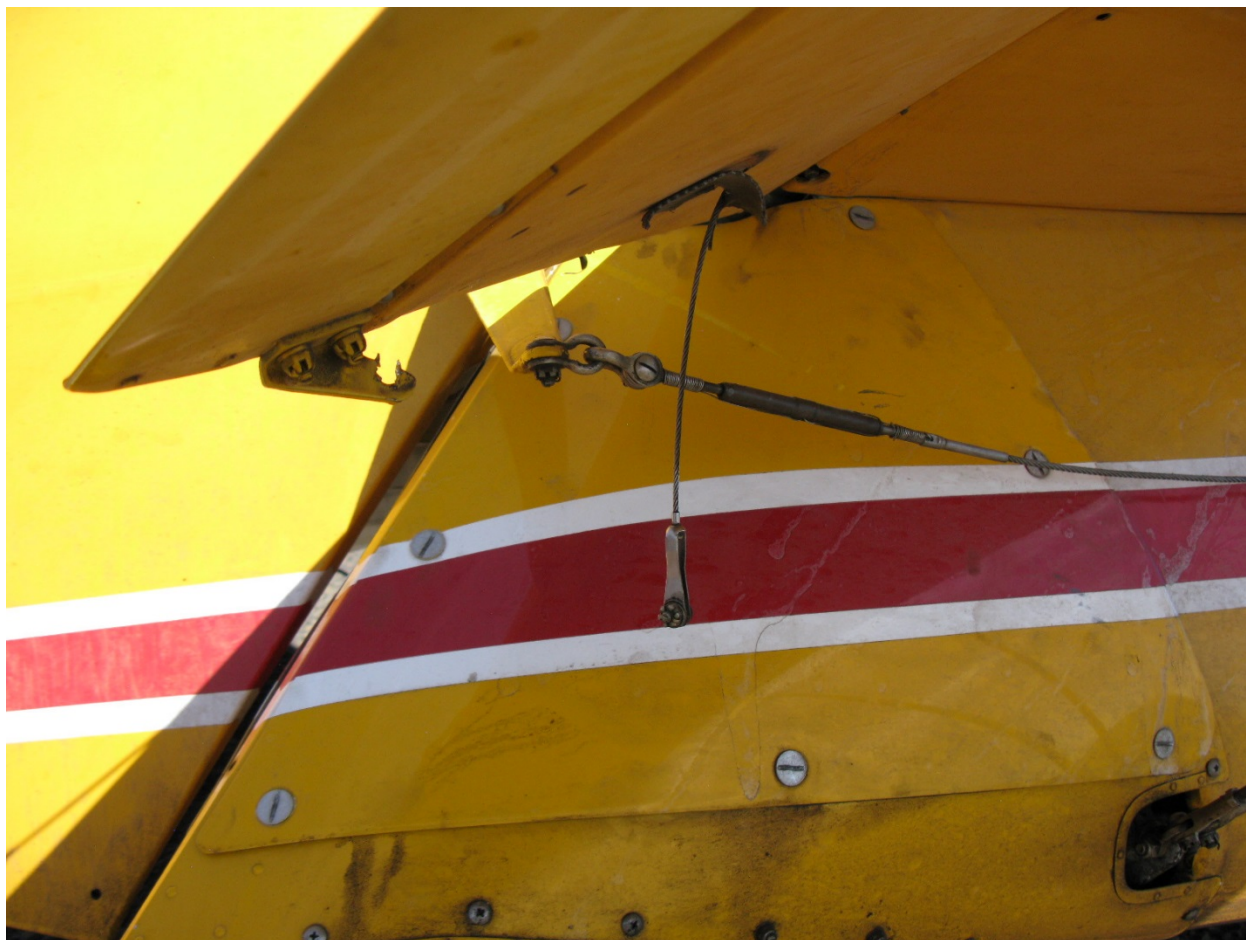
**Figure 5: Right Elevator Lower Trim Cable Broken Free**

The left elevator trim cables remained attached to the trim tab; the right elevator top trim cable remained attached to the trim tab. The lower trim cable was separated at the from the lower trim tab horn. The fracture of the eyehole appeared to be consistent with overstress separation from impact forces.

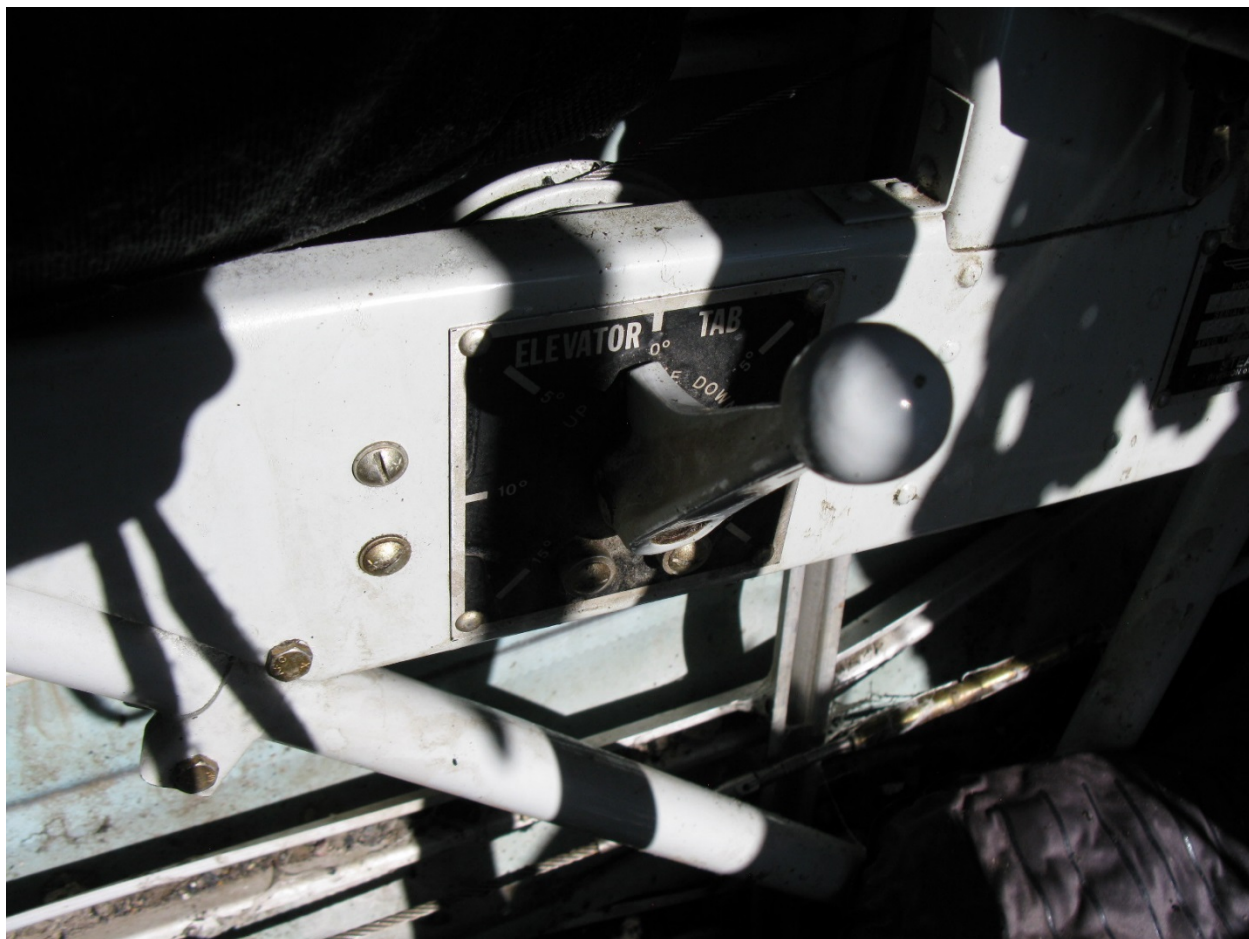
The elevator trim control lever was set to 0 degrees and remained connected by cable to the the elevator trim tabs; however due to deformation of the airfram its was not possible to actuate the trim control lever by hand.

**Figure 6: Elevator Trim Control set 0 Degrees Trim**

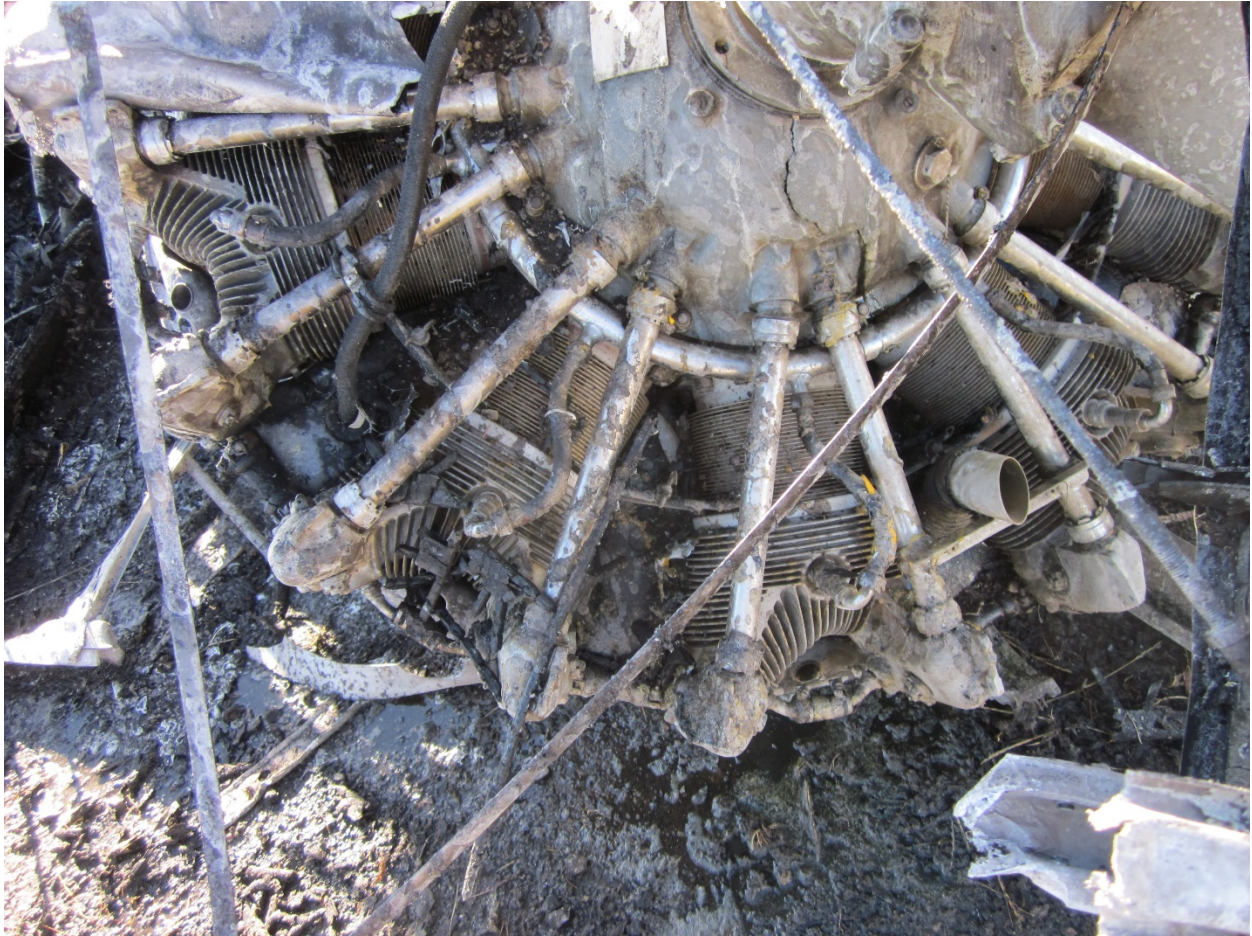
**Figure 7: Close-up, Engine Impact Damage**

The Pratt & Whitney R-985 engine was broken free of its mounting assembly and was located adjacent to the main wreckage. Propeller blade “A” was positioned towards the lower cylinders and bent aft approximately 90 degrees at mid span. The blade was twisted and length-wise striations towards the tip of the blade were noted. Propeller blade “B” was positioned towards the top cylinders. The blade was bent aft, exhibited chord-wise striations and “S” bending.

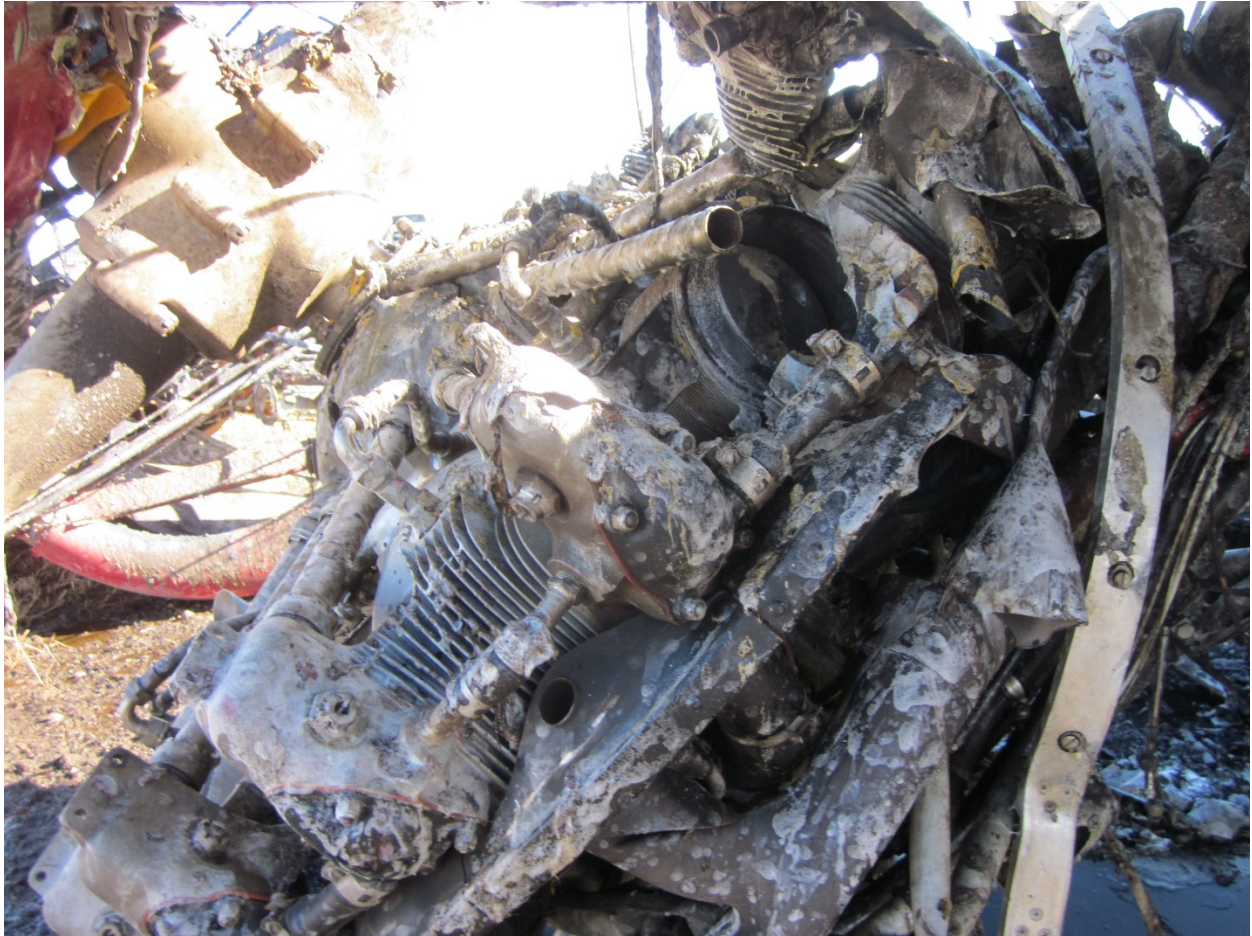
**Figure 8: Close-up, Engine Impact Damage Lower Cylinders**

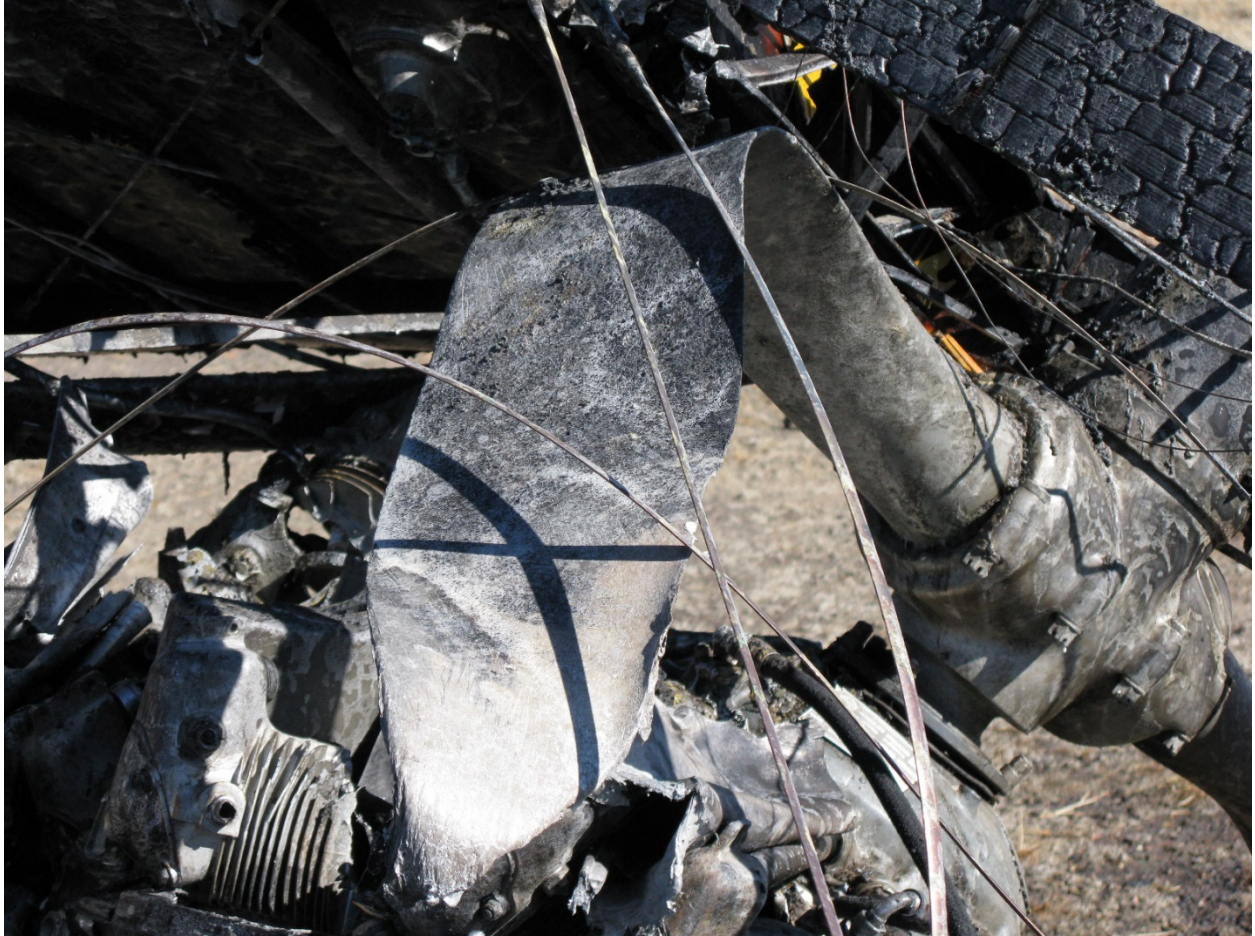
**Figure 9: Propeller blade “A” Damage**

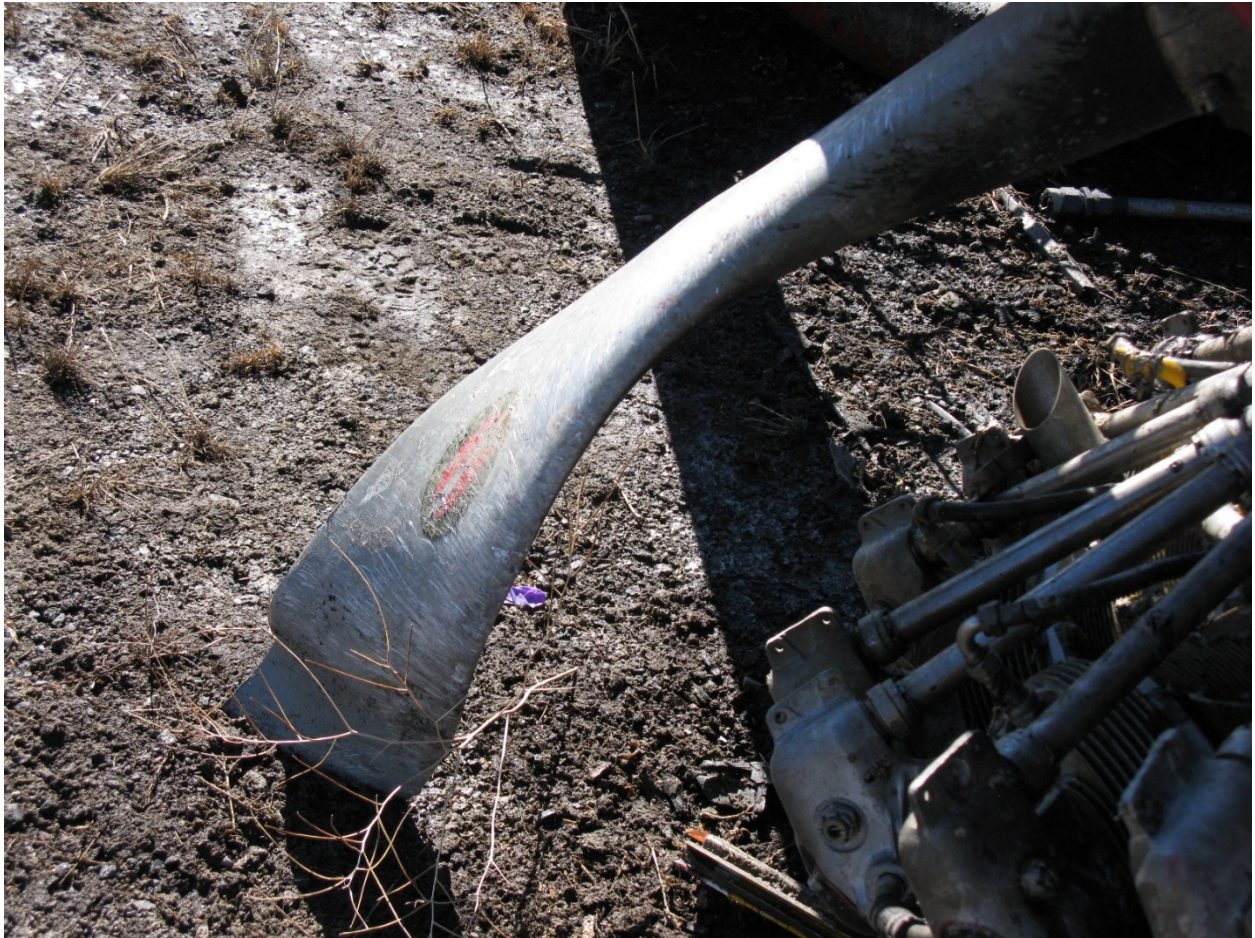
**Figure 10: Propeller Blade “B” damage**
