## **NATIONAL TRANSPORTATION SAFETY BOARD**

### **Engine Exam Summary**

**WPR16FA169**

Location: Madras, Oregon  
Date: August 27, 2016  
Aircraft: Boeing Stearman  
NTSB IIC: Hogenson

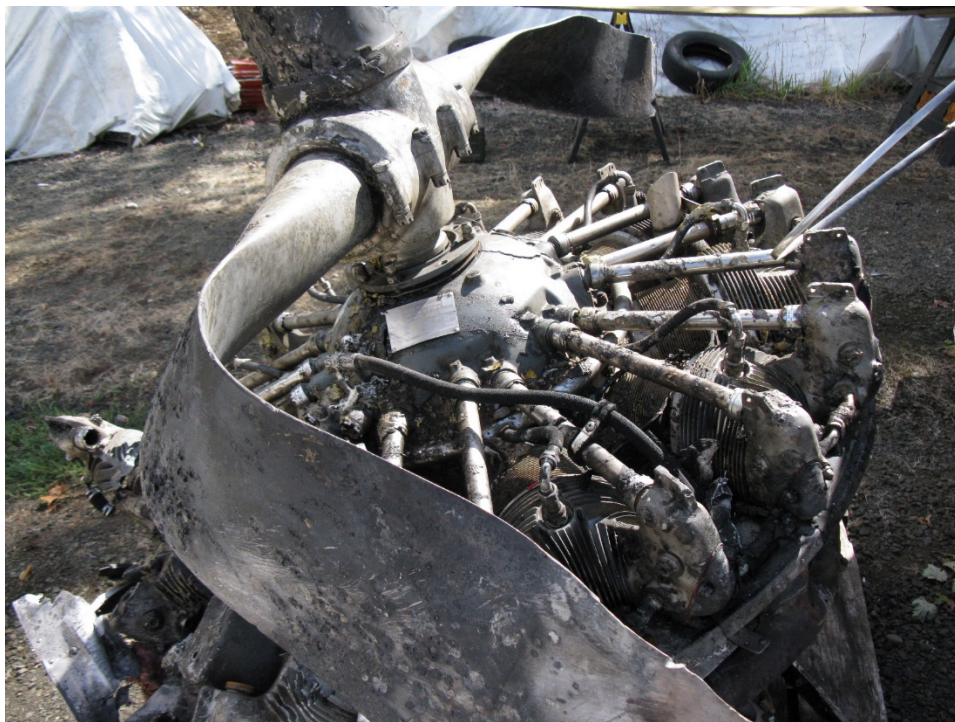
The propeller remained attached to the crankshaft and extensive impact damage was noted. Propeller blade “A” was positioned in line with the lower cylinders and bent aft approximately 90 degrees at mid span. The blade was twisted and length-wise striations towards the tip of the blade were noted. Propeller blade “B” was positioned in line with the top cylinders. The blade was bent aft, exhibited chord-wise striations and “S” bending.

**Figure 1: Engine and Propeller Post Recovery**

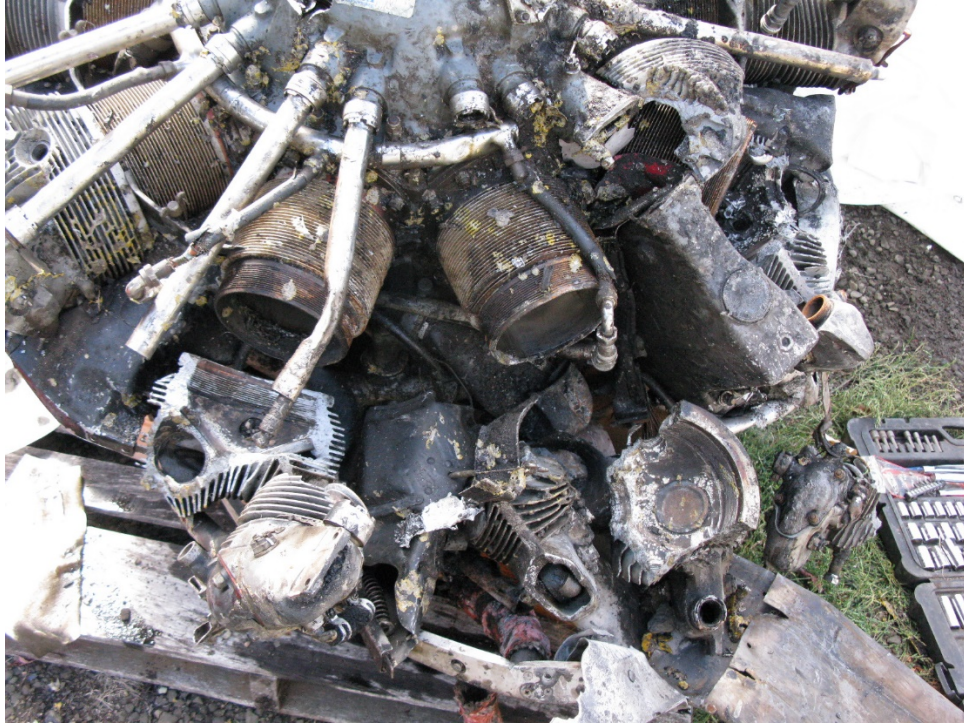
A visual inspection of the engine revealed impact damage throughout the engine assembly with concentrated damage to cylinders assemblies 4,5 and 6. The engine case showed no evidence of case breach or preimpact catastrophic failure. A large crack in the case, near the propeller flange, was observed and attributed to impact damage. Cylinder barrels 4,5 and 6 remained affixed to the engine case; however, the cylinder heads and associated overhead components were displaced and sustained extensive impact related damage. Combustion deposits were noted in the

combustion chambers and residual oil was present on the cylinder bores. The remaining cylinders were in place and no anomalies were noted. The ignition assembly and associated harnesses sustained impact related damage; however, all components were accounted for and no preimpact anomalies were noted.

Figure 2: Engine and Damaged Cylinders
