## **NATIONAL TRANSPORTATION SAFETY BOARD**

### **SUMMARY OF AIRPLANE EXAMINATION**

**(WPR16FA170)**

| Aircraft: | Cessna 182D, N9936T |

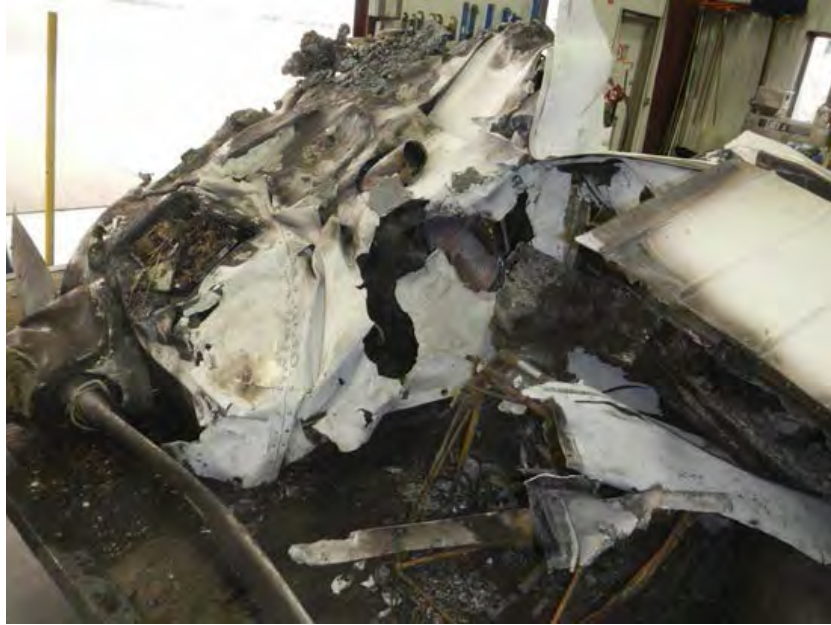
Figure 1 - photo of engine as received

The engine remained partially attached to the airframe and exhibited thermal and impact damage. The induction and exhausted systems were impact damaged and the oil sump was crushed upward. The airframe firewall was wrapped around the rear of the engine.

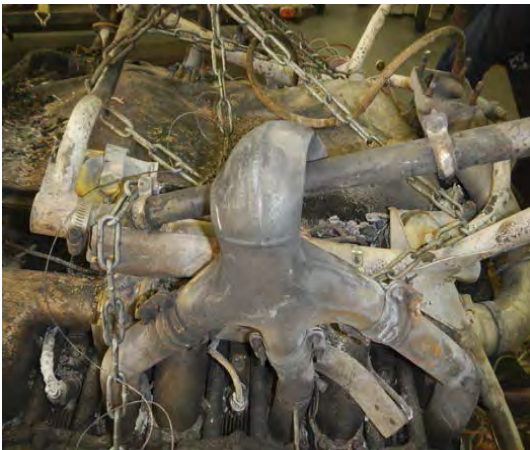
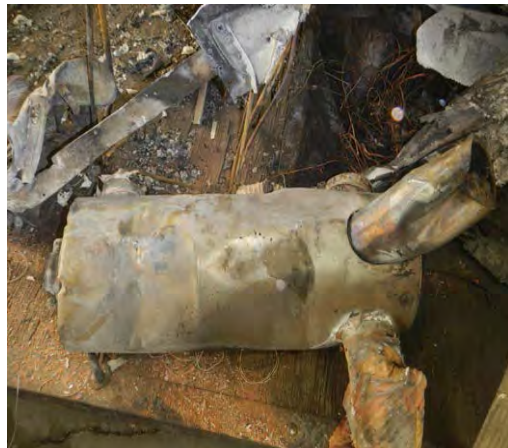
The exhaust system was crushed upward and the muffler was partially crushed and pushed into the oil sump. The induction system balance tube was crushed into the crankcase. The induction Y was partially separated.

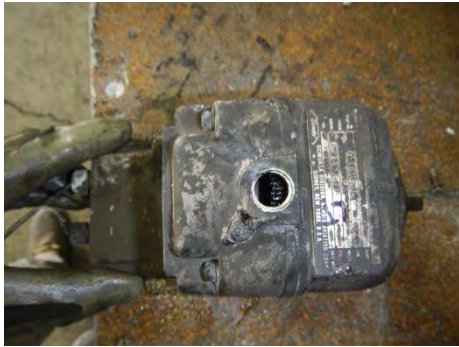
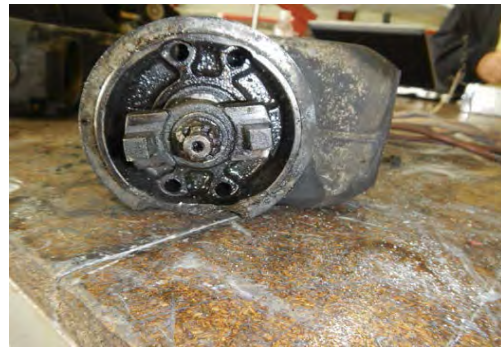
The left magneto was partially separated from the engine at the mounting flange and exhibited impact and thermal damage. The magneto rotated freely by hand but did not produce a spark. Water was observed to be leaking from the magneto. The magneto was taken to magneto repair station by the NTSB for further inspection. According to the NTSB, the left magneto did not function due to thermal damage.

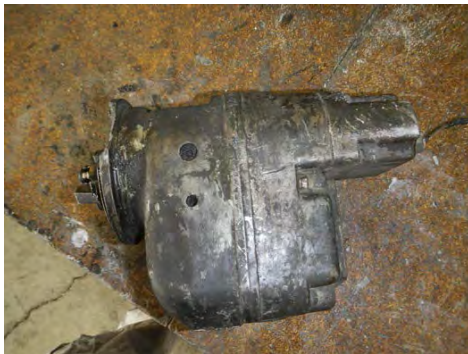
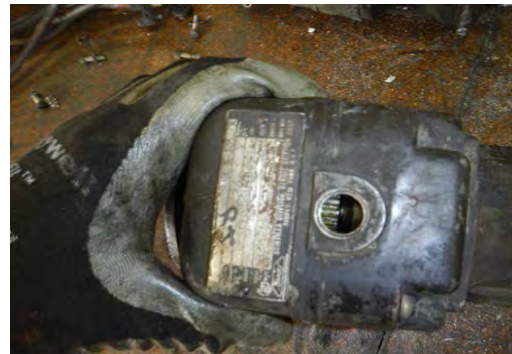
The right magneto was partially separated from the engine at the mounting flange and exhibited impact and thermal damage. The magneto rotated freely by hand but did not produce a spark. Water was observed to be leaking from the magneto. The magneto was taken to magneto repair station by the NTSB for further inspection. According to the NTSB, the right magneto functioned properly producing spark on all terminals.

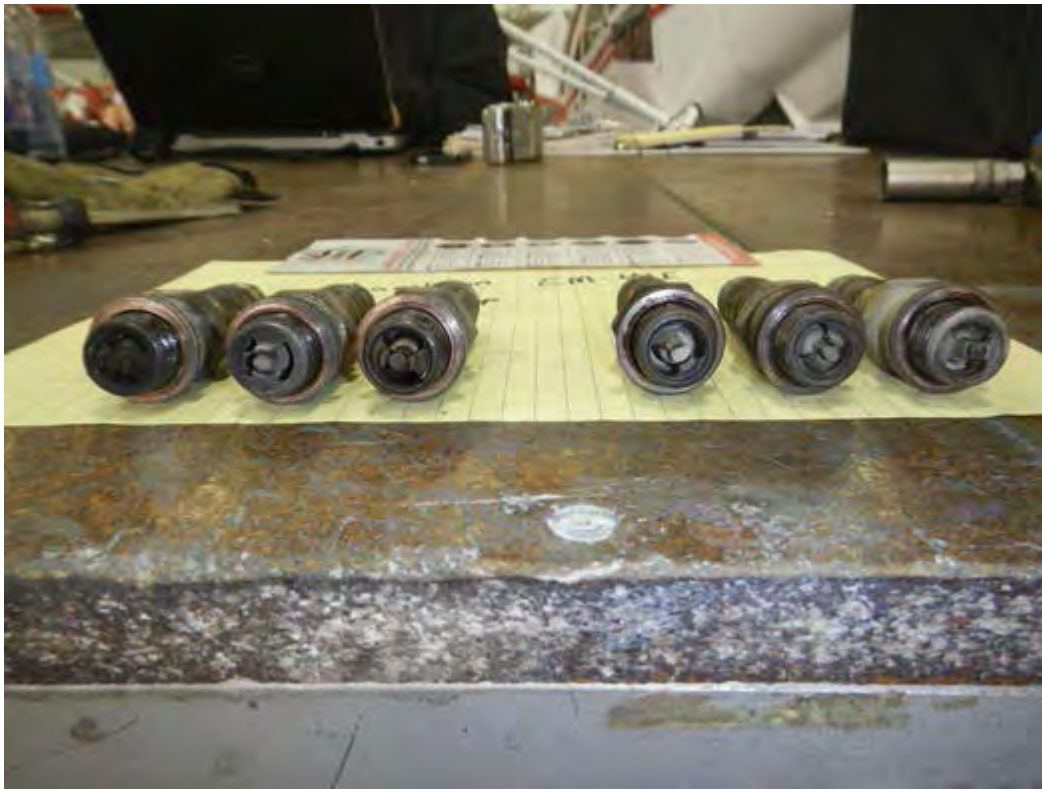
Figure 8 - photo of condition of spark plugs

The spark plugs exhibited light and dark colored combustion deposits, and the electrodes were worn out when compared to the Champion Check a Plug chart.

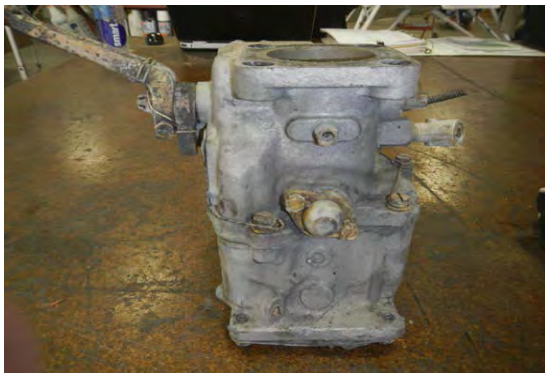
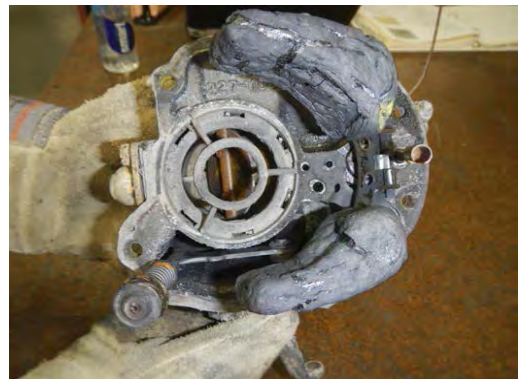
The carburetor remained attached to the induction wye, and was thermally damaged. The mixture control arm and shaft were bent. The throttle control arm moved with resistance, however, debris from the post impact fire was observed around the throttle plate. The fuel screen was removed and found to be free of debris. The fuel bowl was removed, with thermal damage to all of the interior components observed.

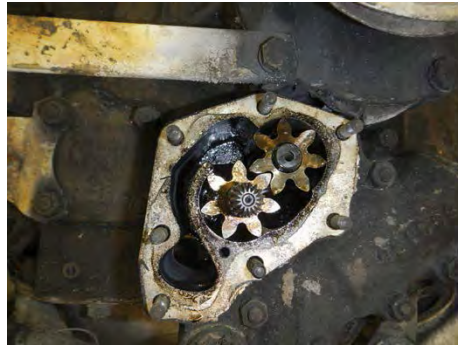
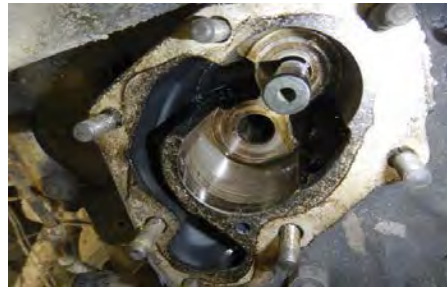
The oil pump was disassembled. The pump housing contained oil and exhibited normal operating signatures and evidence of light particle passage.

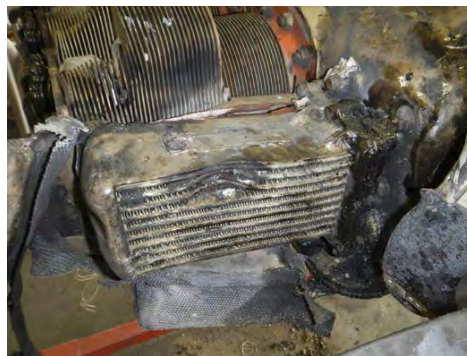
Figure 13 - photo of oil cooler

The oil cooler remained attached to the engine and exhibited impact and thermal damage.

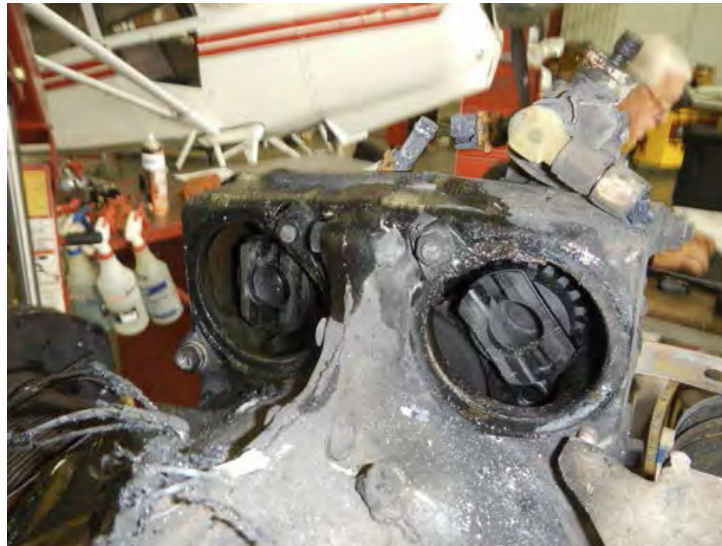
Figure 14 - photo of accessory gears

Continuity to the accessory gears was established when the crankshaft was rotated by hand using the propeller.

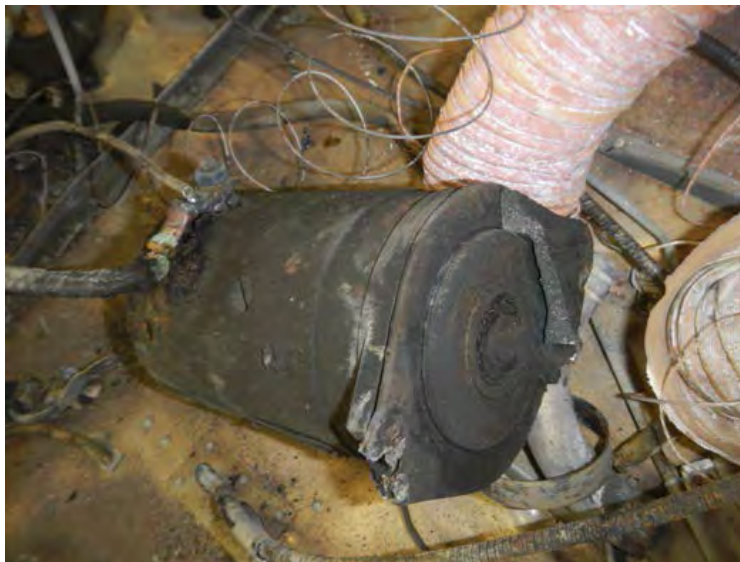
Figure 15 - photo of separated starter

The starter had broken free from the starter adaptor, with the adaptor observed damaged at the starter mounting flange.

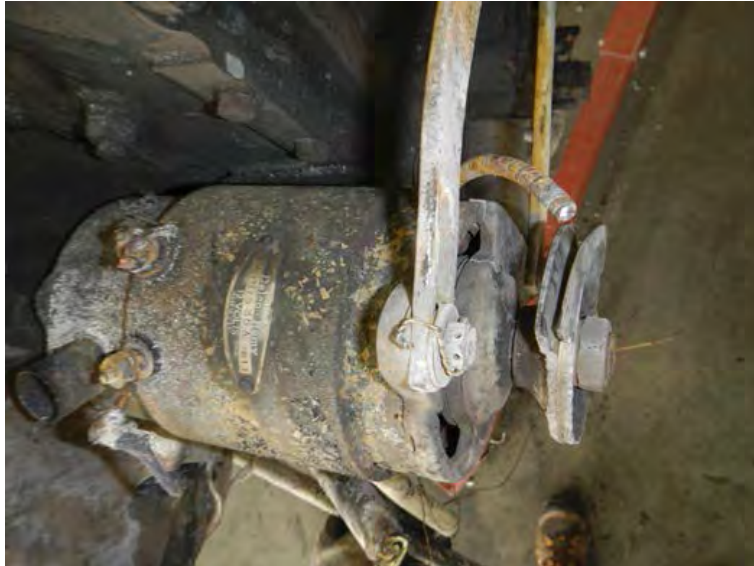
Figure 16 - photo of generator

The generator remained attached to the engine and exhibited thermal and impact damage.

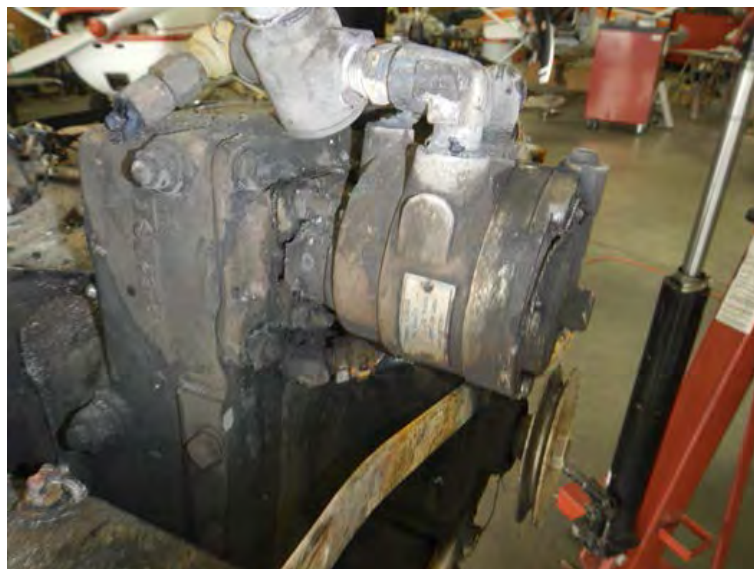
Figure 17 - photo of vacuum pump

The vacuum pump was removed and disassembled by the Textron investigator and no anomalies were noted.

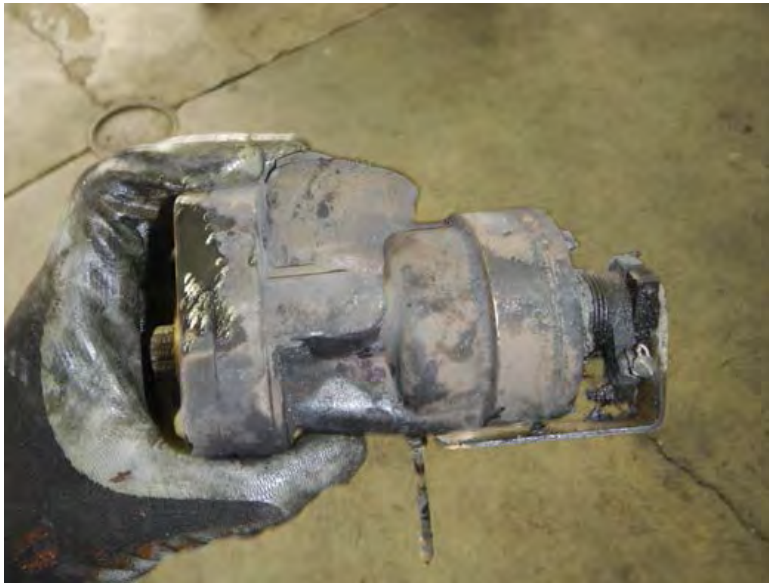
Figure 18 - photo of propeller governor

The propeller governor was removed and the drive gear turned freely by hand and oil was noted being discharged. The control arm moved freely by hand from stop to stop.

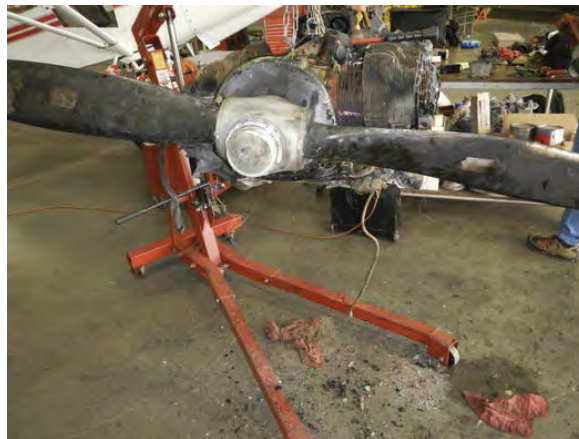
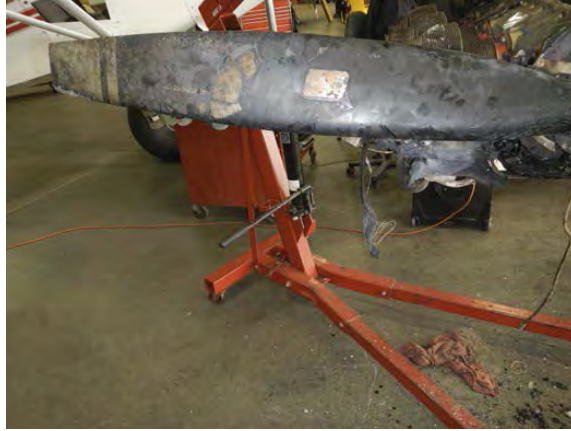
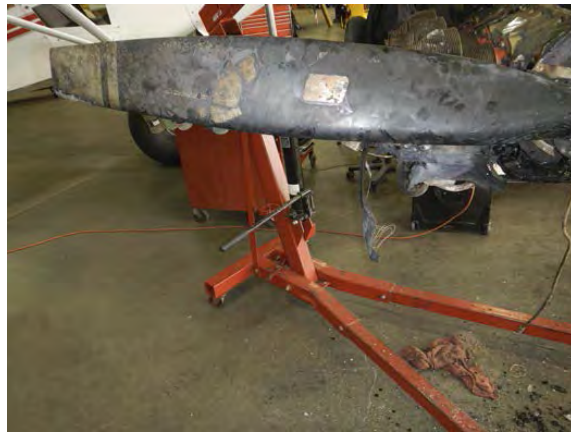
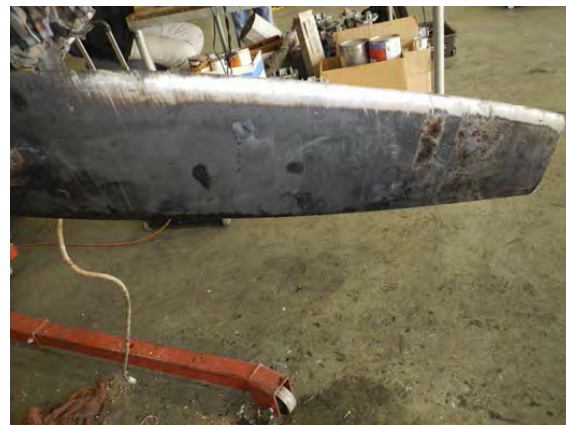
One of the propeller blades was observed to be bent slightly forward and exhibited leading edge polishing. No damage was observed on the other propeller blade. Both propeller blades remained attached to the hub and the hub remained attached to the crankshaft flange.

The two-bladed propeller remained attached to the crankshaft propeller flange. Blade one was relatively undamaged. Blade two was loose in the hub and bent slightly forward at mid blade and exhibited leading edge polishing and chord wise scratches.
