# **NATIONAL TRANSPORTATION SAFETY BOARD**

## **SITE & ON-SCENE INFORMATION**

**WPR16FA172**

**Aircraft:** Beechcraft A36, N985CA, Serial #: E-1901

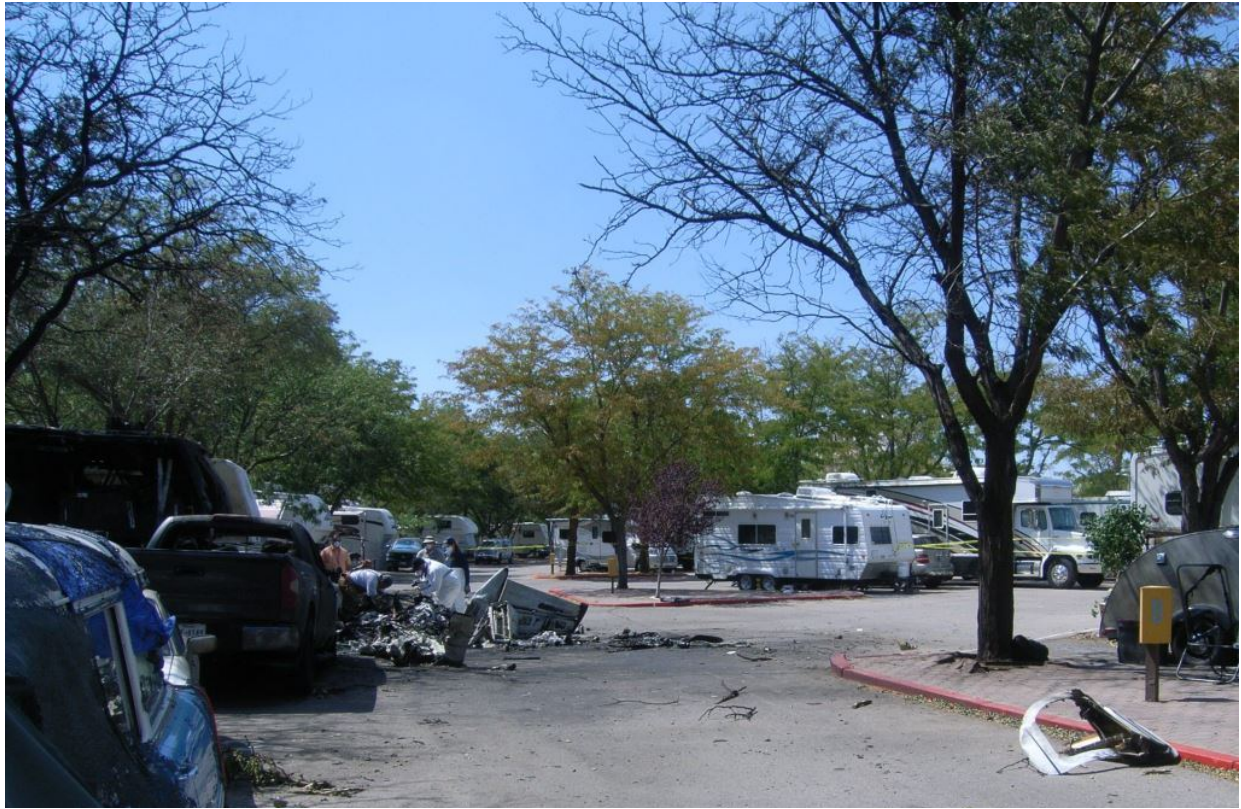
Several ground vehicles were damaged by the post-impact fire, but no persons on the ground were injured. Ground scars, tree damage, and wreckage distribution were all consistent with a near-vertical descent trajectory. With the exception of a few small fragments and the forward right cabin door, the wreckage was entirely contained within a semi-circle approximately 25 feet in radius. Ground scars and airplane damage patterns were all consistent with a vertical, airplane nose-down, impact attitude.

**Figure 1 - Overall Site**

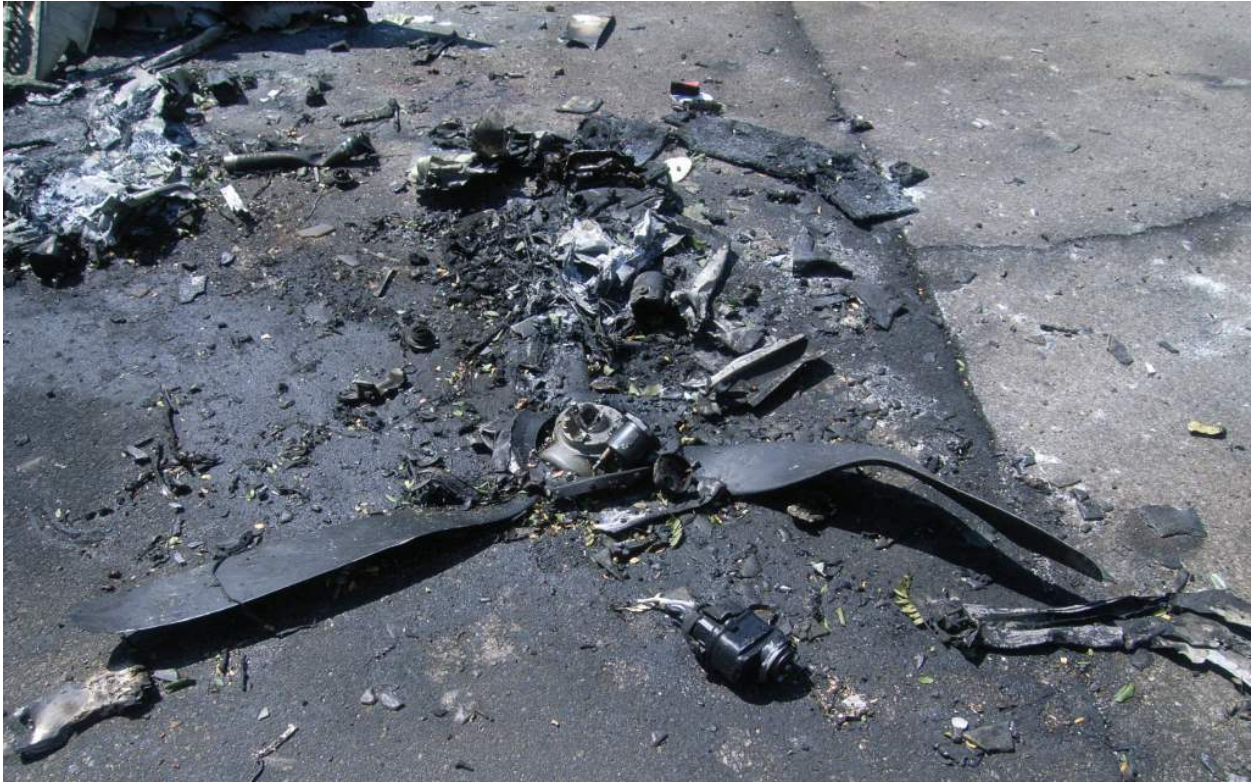
The bulk of the wreckage was very tightly contained, and consisted of the remains of both wings, and the fuselage, empennage, and engine. The propeller was embedded flat (lying horizontal) in the asphalt, about 15 feet northeast of the main wreckage. The forward right cabin door was situated about 35 feet east-northeast of the main wreckage. Two wing leading edge fragments, and an electronic tablet, were found in the parking lot about 30 feet south of the main wreckage. All components in the main wreckage exhibited extensive aft crushing and/or thermal damage or consumption.

Figure 8 - Propeller (in situ)

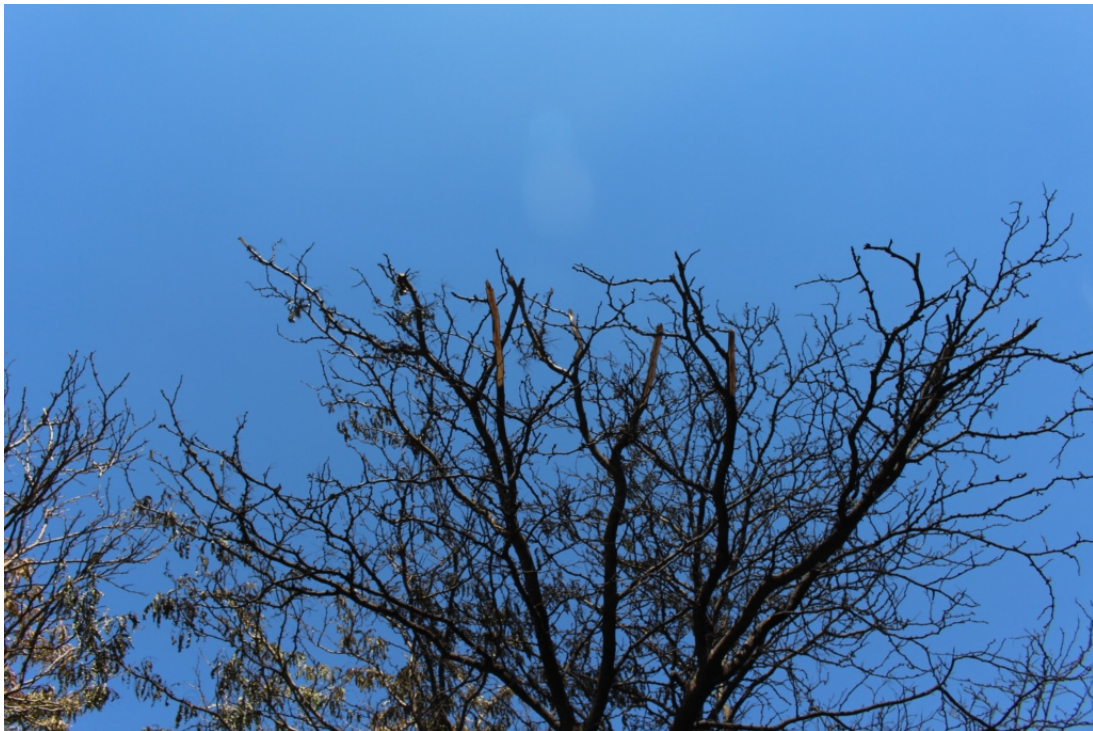
Multiple tree limbs directly above the propeller displayed evidence of strike damage. No other impact-related tree or pavement damage was observed.

Figure 12 - Cut/Broken Tree Branches (Located directly above propeller)

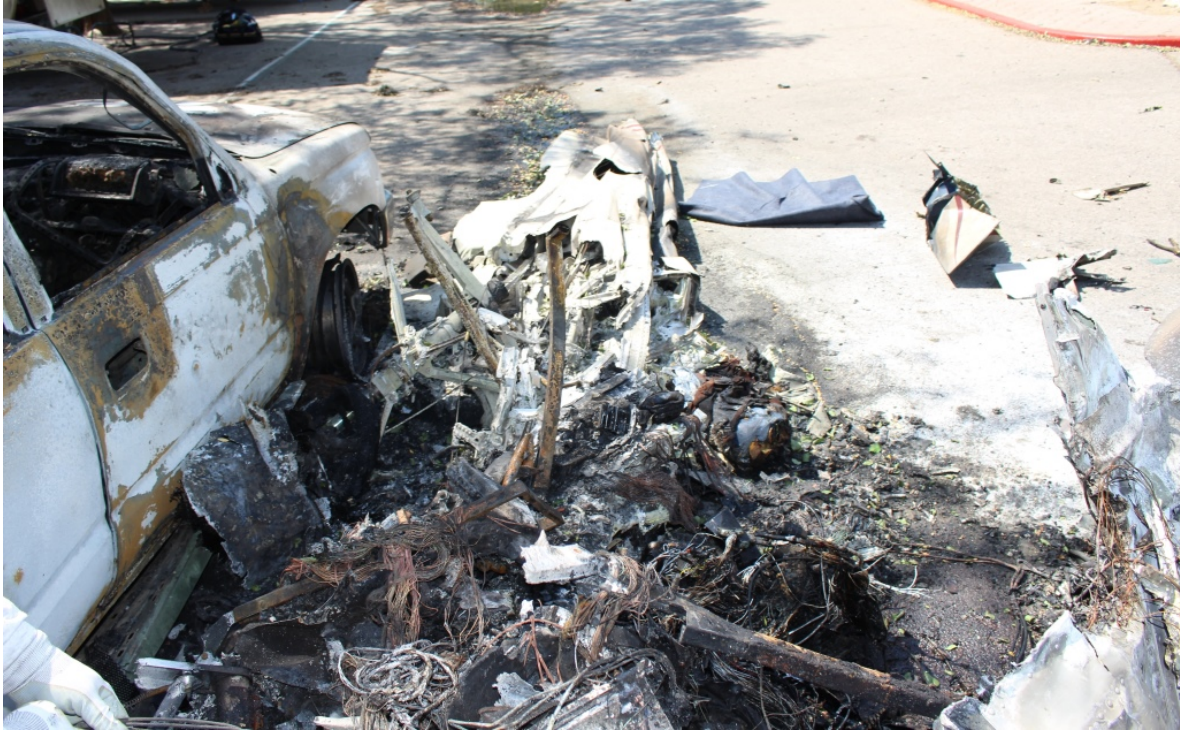
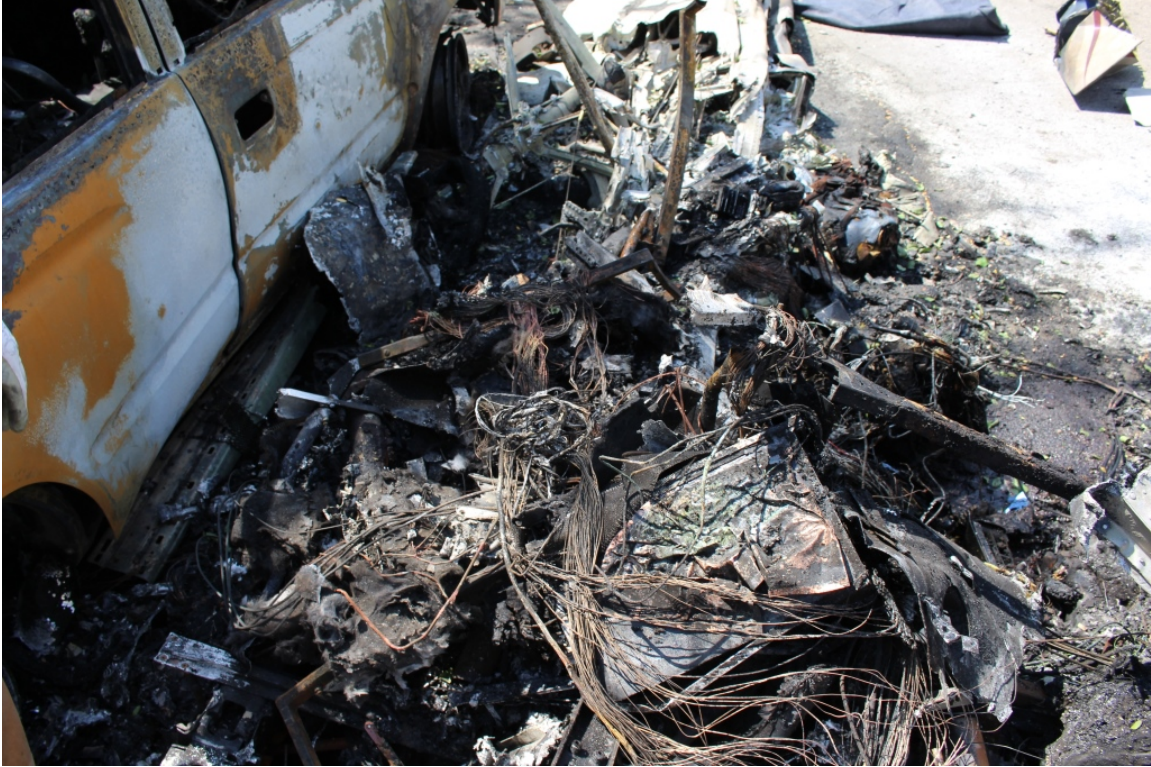
The fuselage sustained extensive impact and thermal damage. The top cabin roof section was completely destroyed by post impact fire. The seat assemblies were mostly destroyed by the post impact fire. The cabin floor area sustained impact damage and was mostly destroyed by the post impact fire.

**Figure 13 - Cockpit/Cabin Wreckage**

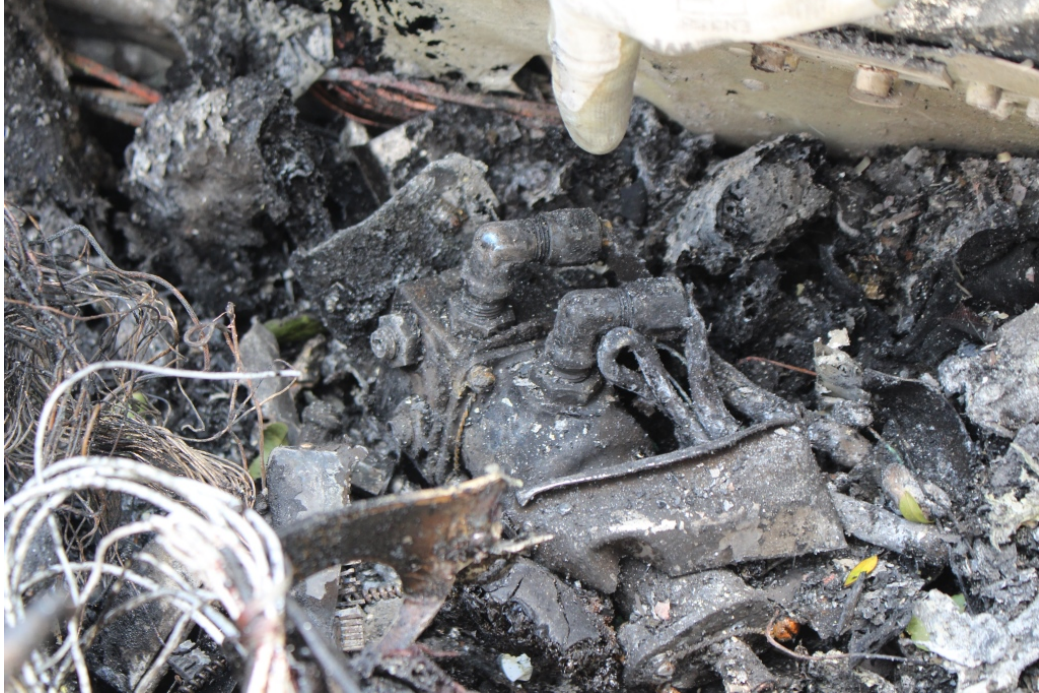
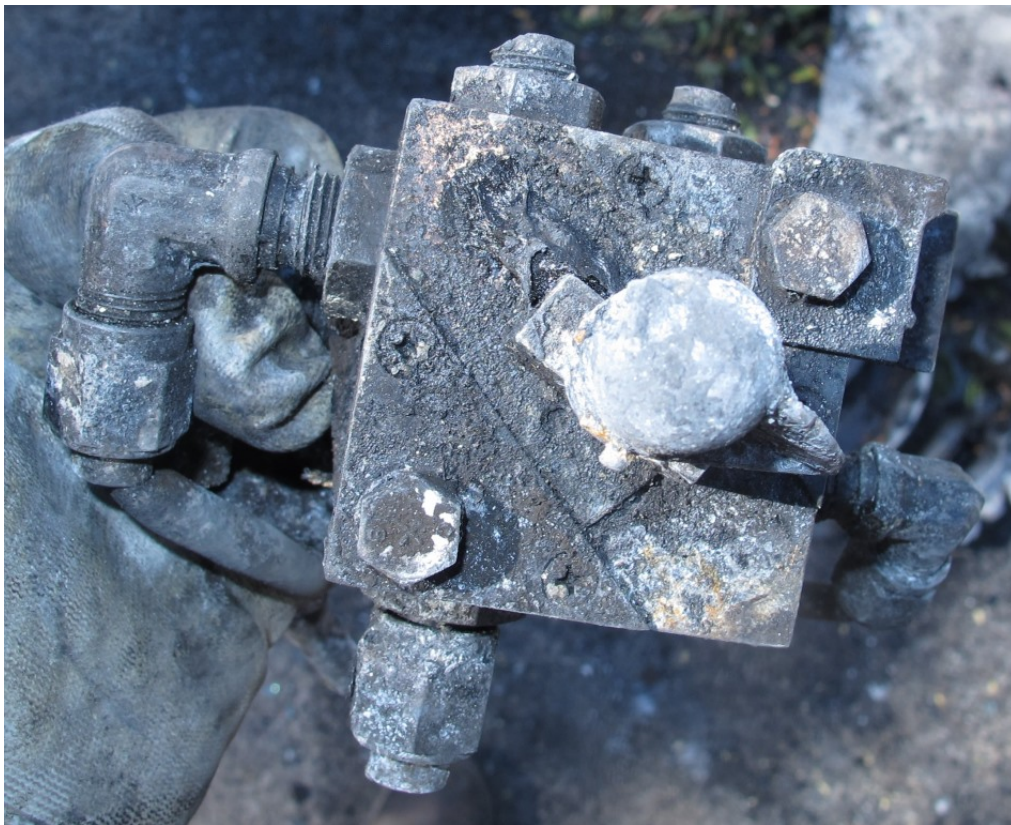
The fuel selector valve was fracture-separated from the fuselage and was located within the main wreckage. The valve was determined to be set to the "right tank" position.

**Figure 15 - Fuel Selector Valve (in situ)**

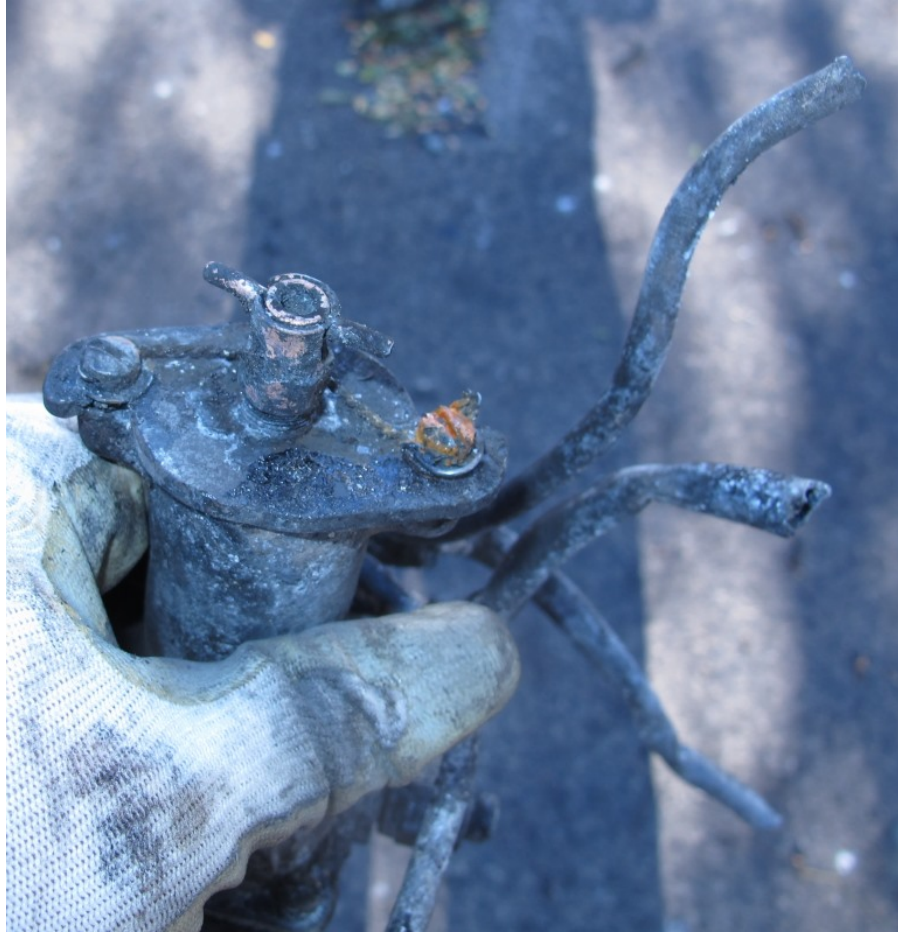
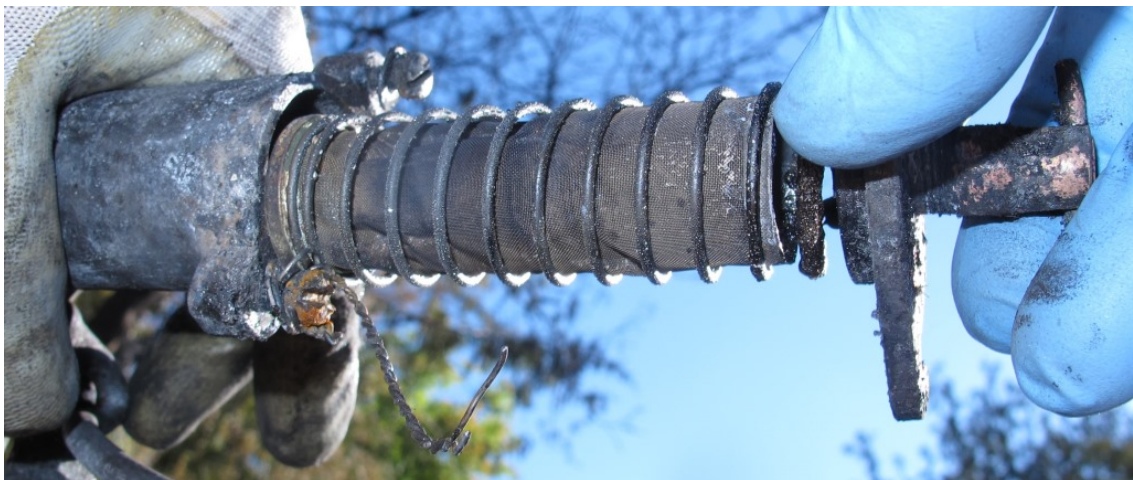
The fuel strainer was fracture-separated from the fuselage and was located within the main wreckage. There was no fuel in the strainer, and the strainer screen was free of contaminants.

**Figure 17 - Fuel Strainer**

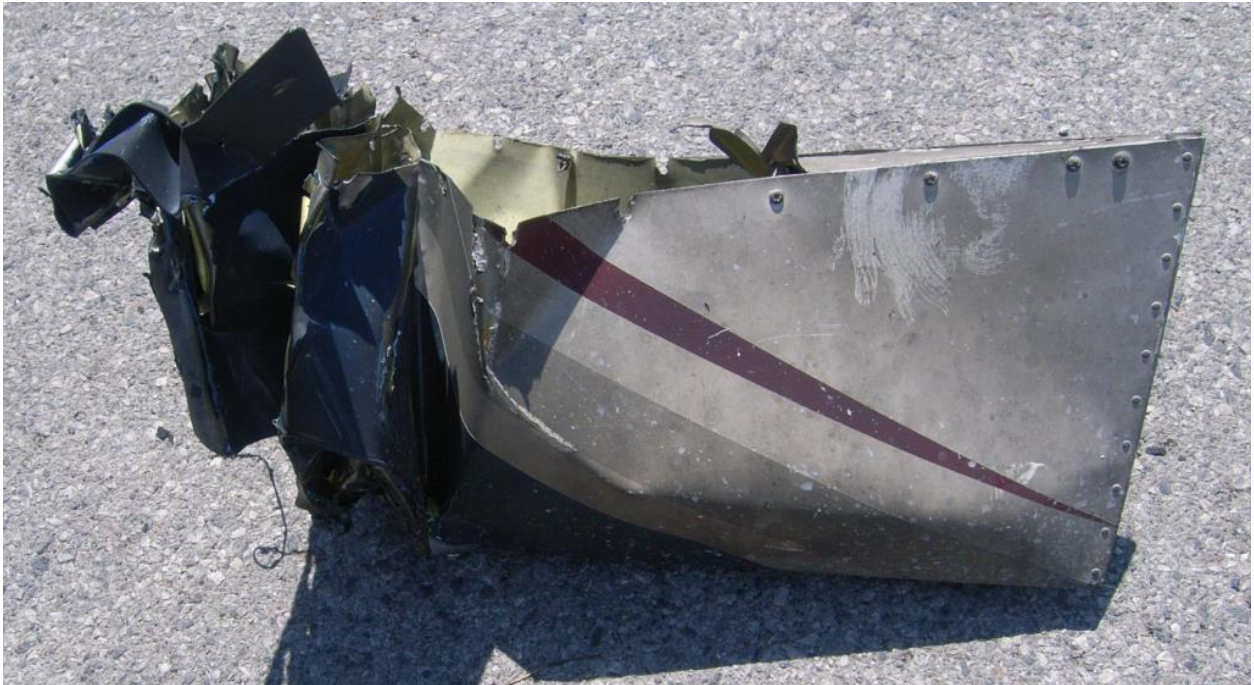
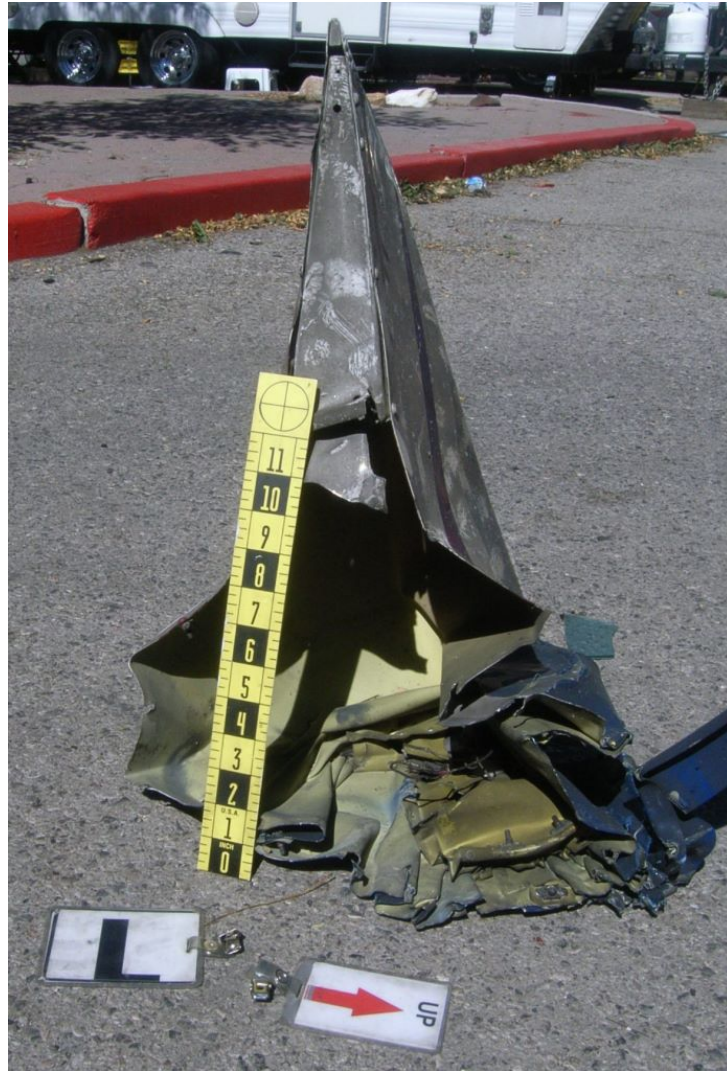
The left aileron remained attached to the wing, and extensive wrinkle/crush-type deformation was noted. The left wing tip had fracture-separated from the wing, and exhibited direct and significant fore-aft crush damage.

**Figure 20 - Left Wing Tip (showing aft crush)**

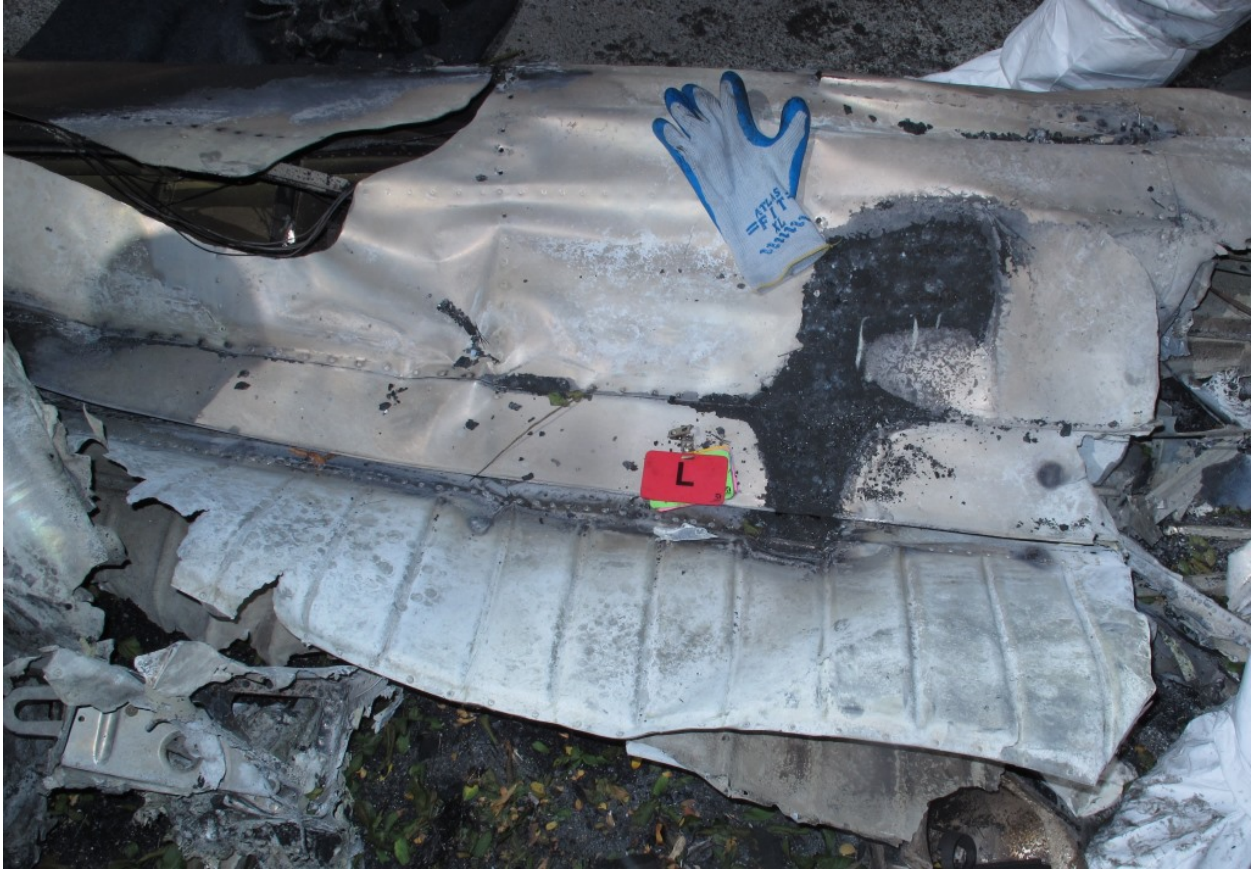
The left flap was almost completely consumed by fire. The steel flap jackscrew extension was unable to be measured, because its aluminum housing had been consumed by the fire. One of the left flap tracks and its roller assembly was identified in the wreckage. Although its roller position was almost fully-forward, consistent with the left flap being in the fully retracted position, due to impact and thermal disruption, it could not be determined whether that was a reliable indication of the in-flight (pre impact) flap position.

**Figure 21 - Left Flap and Wing Portions**

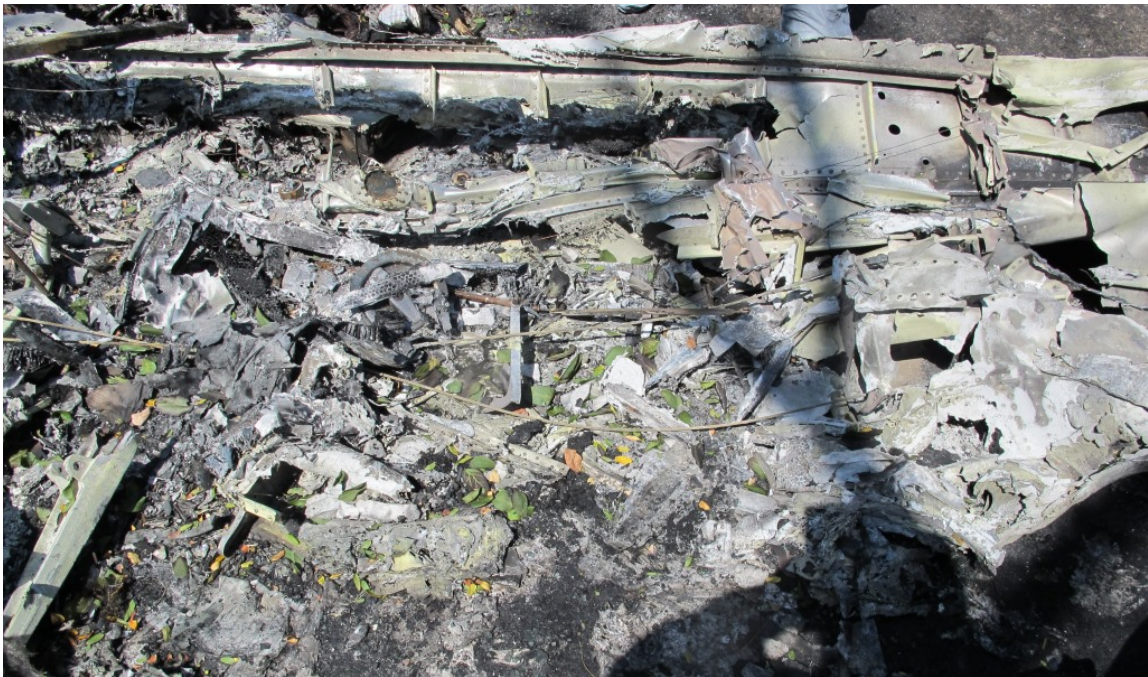
The right flap was almost completely consumed by fire. The steel flap jackscrew extension was unable to be measured, because its aluminum housing had been consumed by the fire. Both of the right flap tracks and their roller assemblies were identified in the wreckage; the roller positions were almost fully-forward, consistent with the right flap being in the fully retracted position. However, similar to the case with the left flap roller, the reliability of this roller position as an indication of the in-flight (pre impact) flap position could not be determined.

**Figure 22 - Right Flap and Wing Portions**

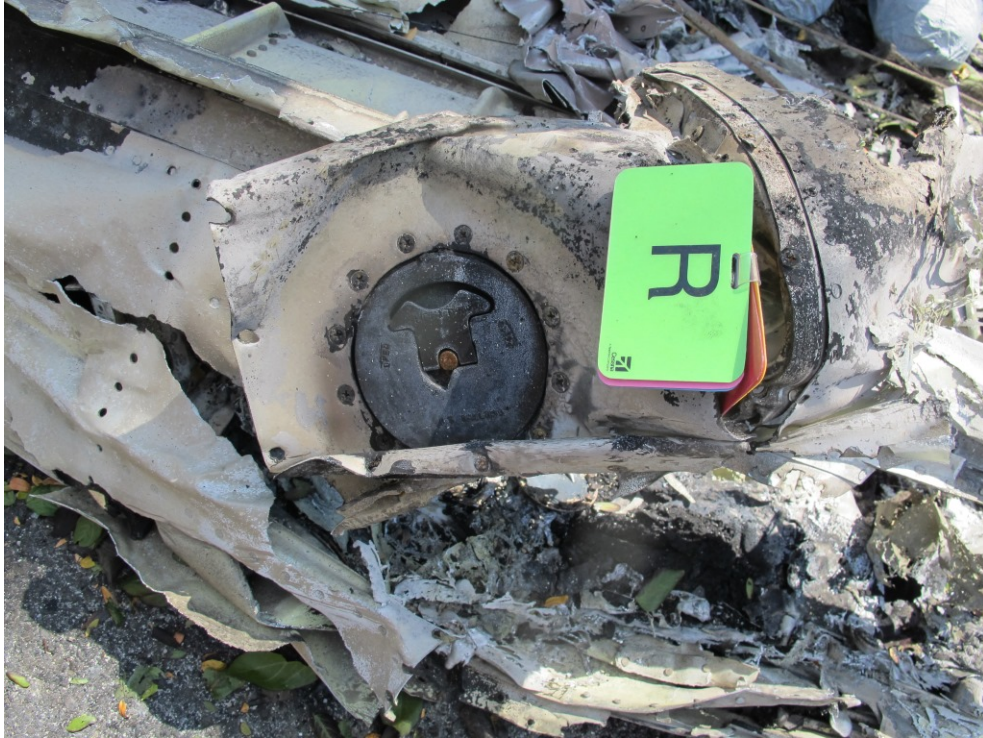
The left wing fuel bladder was consumed by fire. The left fuel cap and fueling port were not identified in the wreckage. The right wing fuel bladder was destroyed by fire. The fuel cap remained securely installed in the fueling port. Two fuel quantity float and sending unit assemblies were found fracture-separated from the airplane and clear of the main wreckage; neither was sooted or fire-damaged.

**Figure 25 - Right Fuel Cap and Receptacle**

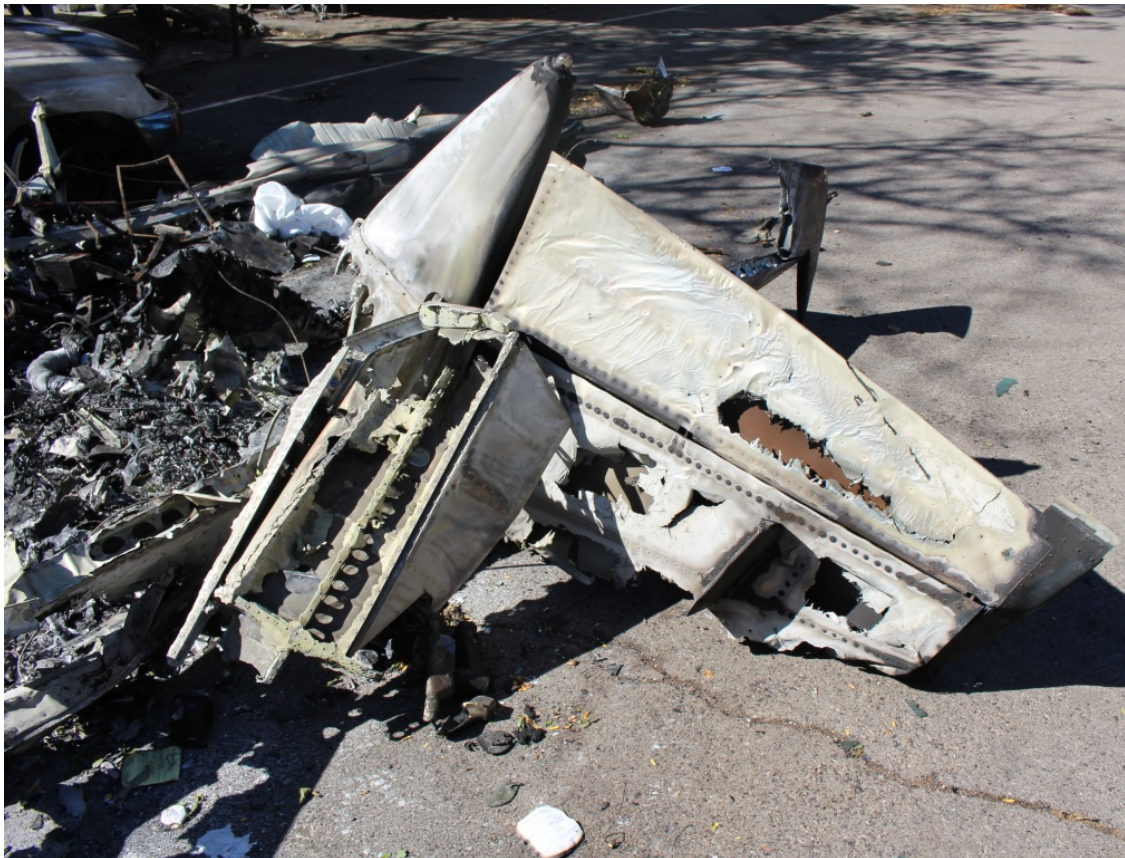
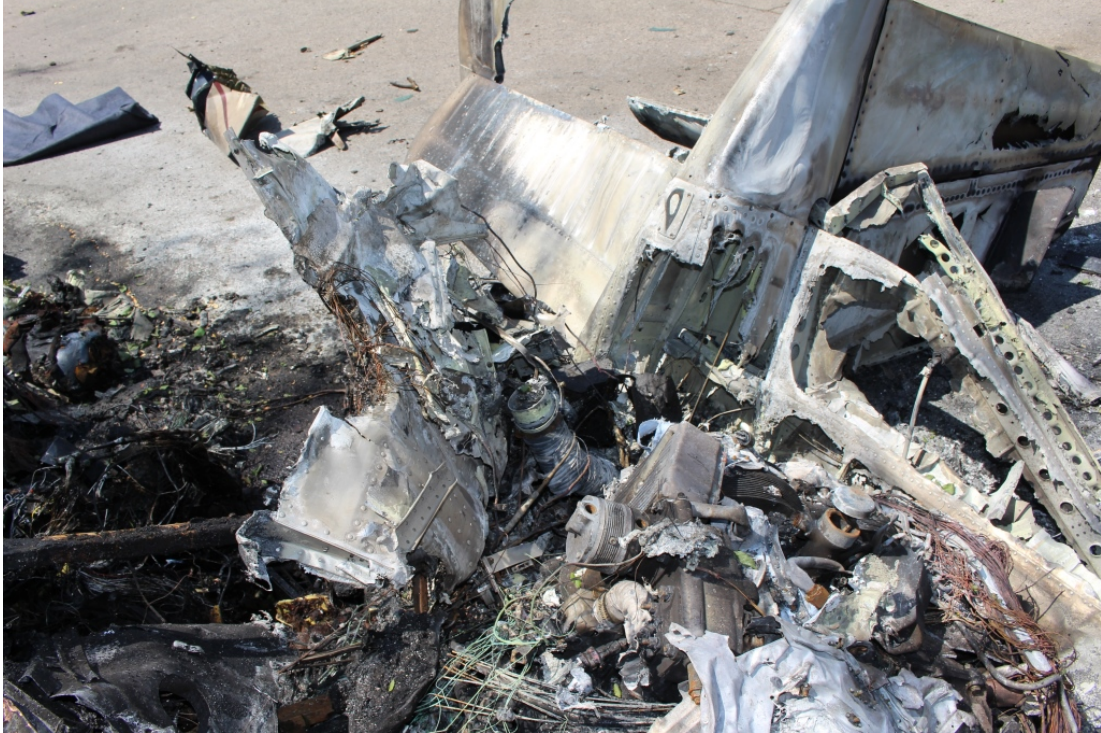
The aft fuselage, including the three stabilizers, was fracture- and/or thermally- separated from the fuselage near fuselage Station 233. The entire assembly exhibited moderate thermal damage, but retained its overall shape and most primary structure.

Figure 28 - Empennage

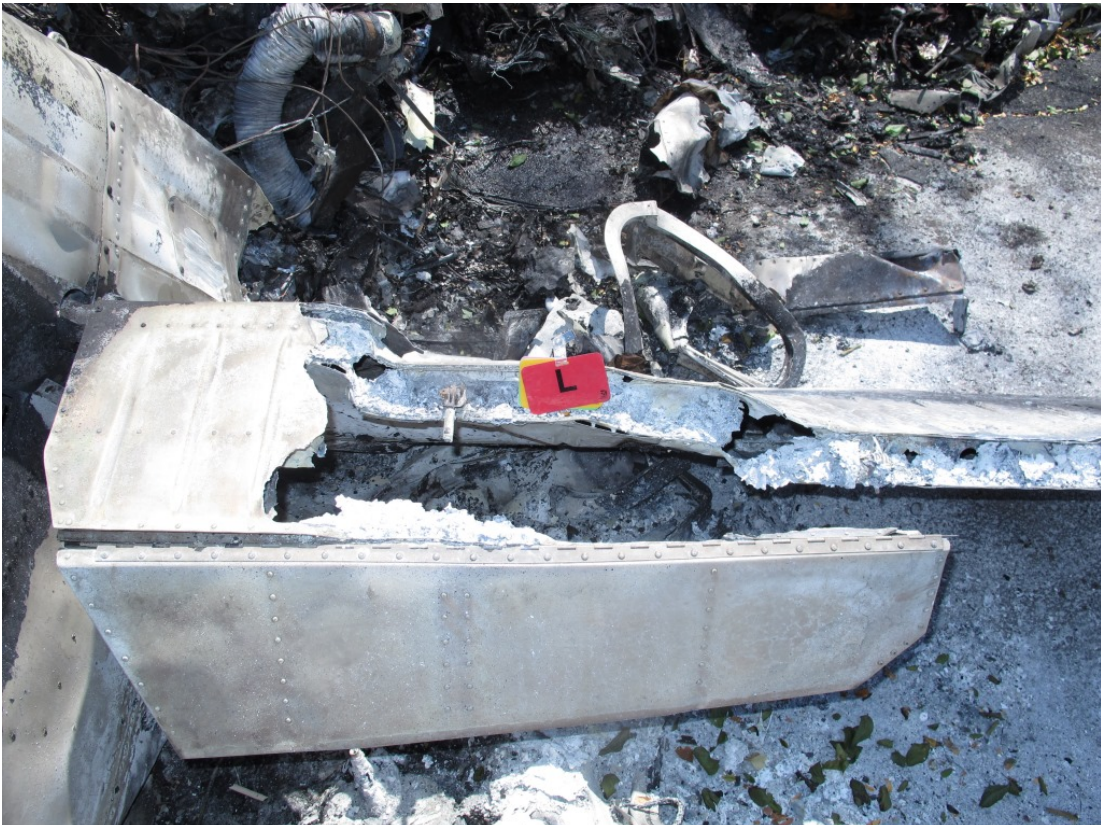
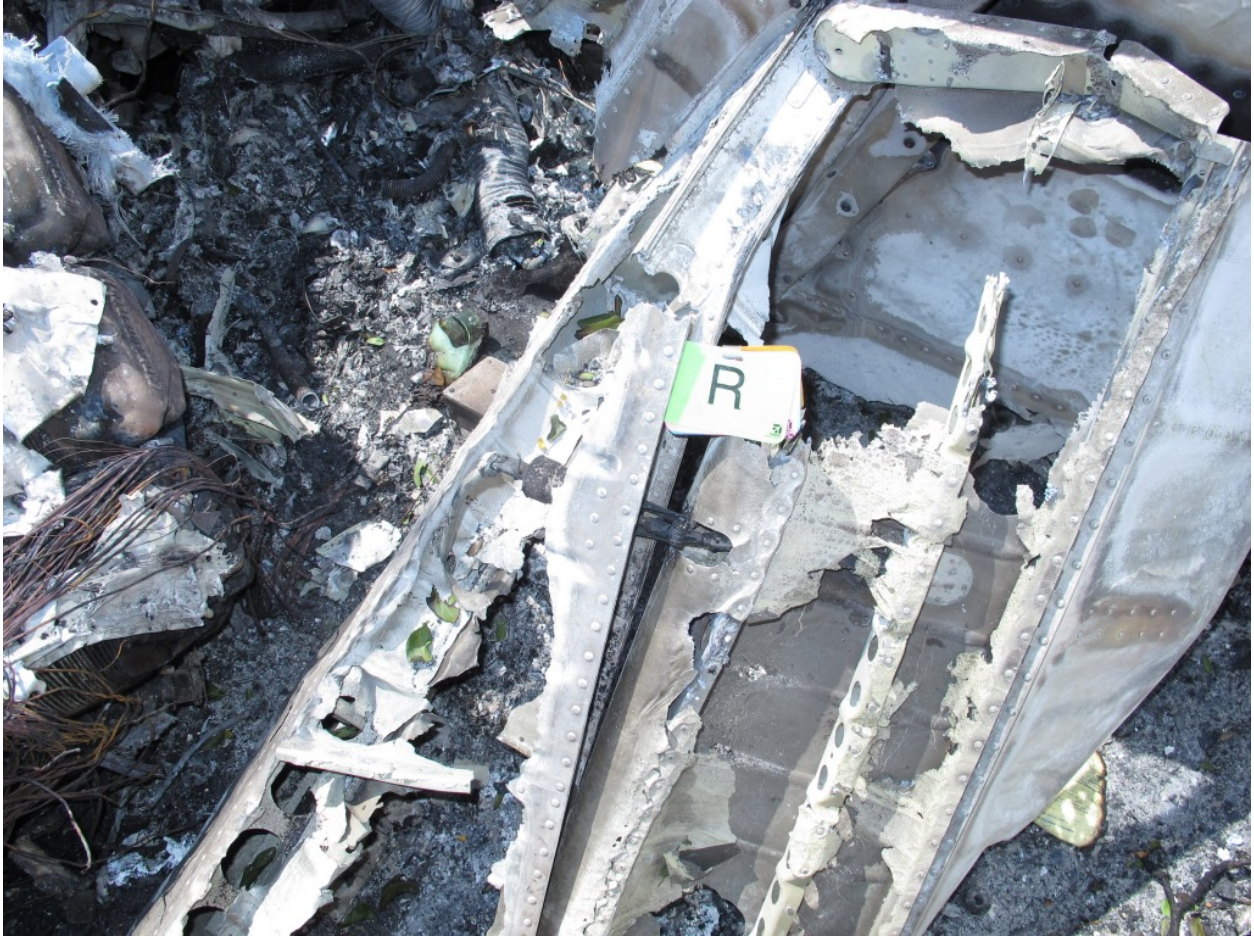
The two horizontal stabilizers remained attached to the aft fuselage, and both elevators remained attached to their respective stabilizers. The left elevator balance weight remained attached to the left elevator. The right elevator balance weight had fracture-separated the right elevator, but was located in the wreckage. The extension of the left pitch trim actuator was measured to be 1.4 inches, consistent with a neutral (faired) position. The extension of the right pitch trim actuator was measured to be 1.5 inches, also consistent with a neutral (faired) position.

**Figure 30 - Left Horizontal Stabilizer/Elevator**

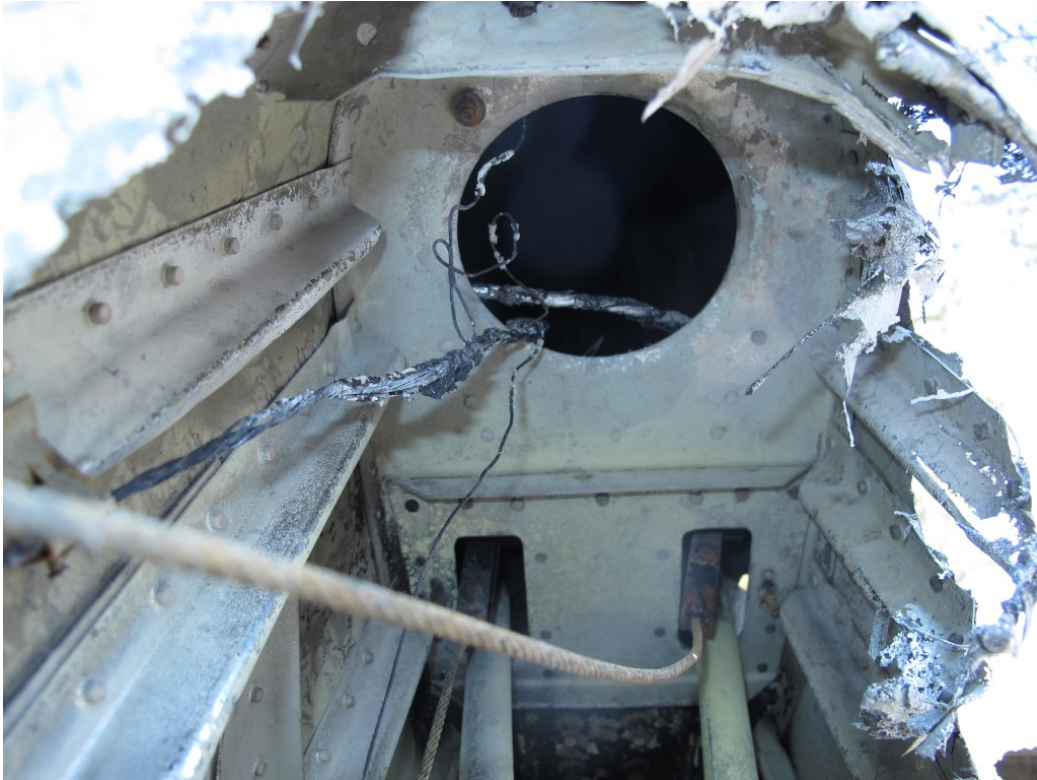
The rod ends for the two push-pull rods that extended from the aft fuselage elevator bellcrank to the elevators were identified, and had sustained thermal damage. Both rods were observed attached to their respective elevator-actuating arms, but their forward sections were not identified in the wreckage, and were presumed to have been separated and partially or fully consumed by the fire.

The rudder cables were observed attached to the rudder bellcrank at the base of the rudder, and traced forward to the forward cockpit on the left side. The rudder cables terminated in the region of the rudder forward bellcrank; damage in that region precluded absolute determination of rudder control continuity.

**Figure 32 - Aft Fuselage with Rudder Cables and Elevator Rods**

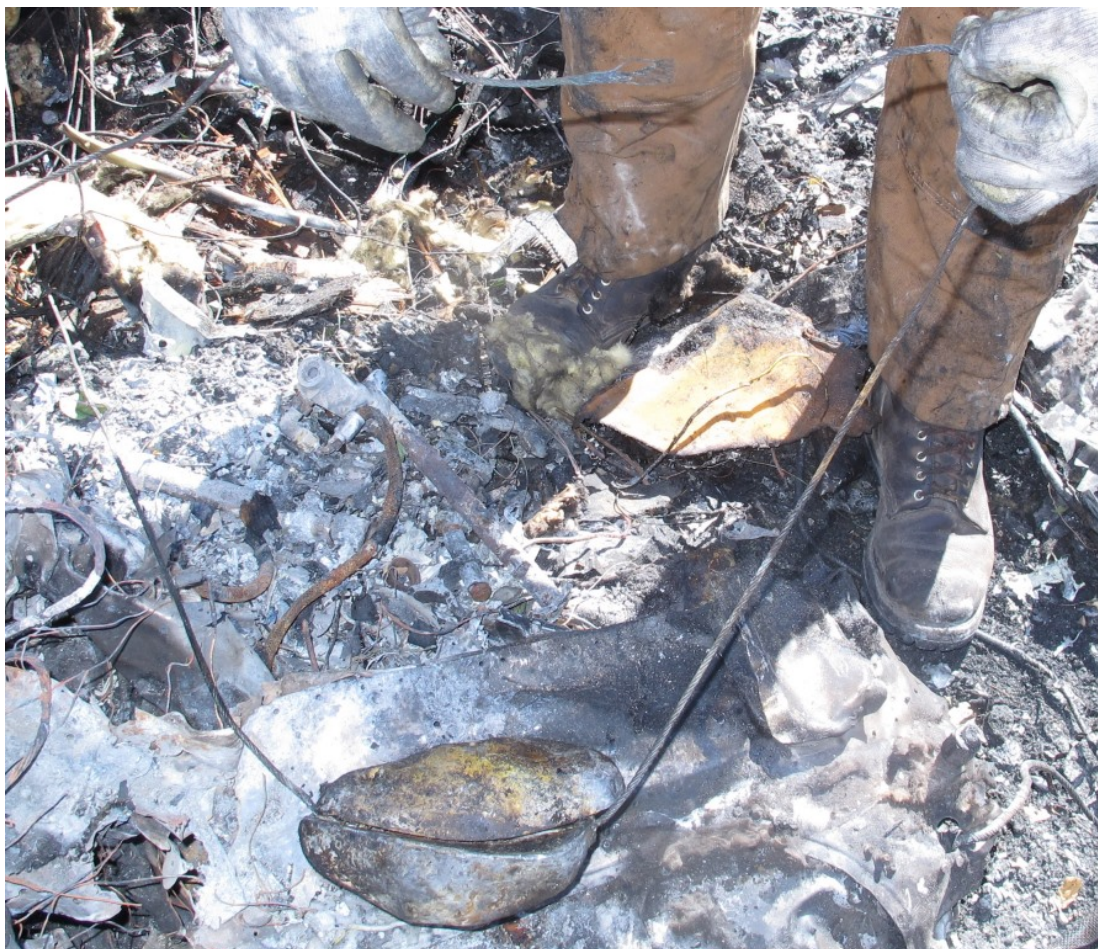
The aft fuselage elevator aluminum bellcrank was not located in the wreckage, and was presumed to have been consumed in the fire. However, the elevator control cable terminal ends that attached to this bellcrank were identified, and their attachment bolts, with their retaining hardware, remained installed in the aft cable ends. The elevator cables were traced to the forward cockpit area and were observed with a separation consistent with tension overload near the elevator bob weight.

**Figure 33 - Pitch Bobweight and Failed Cable Ends**

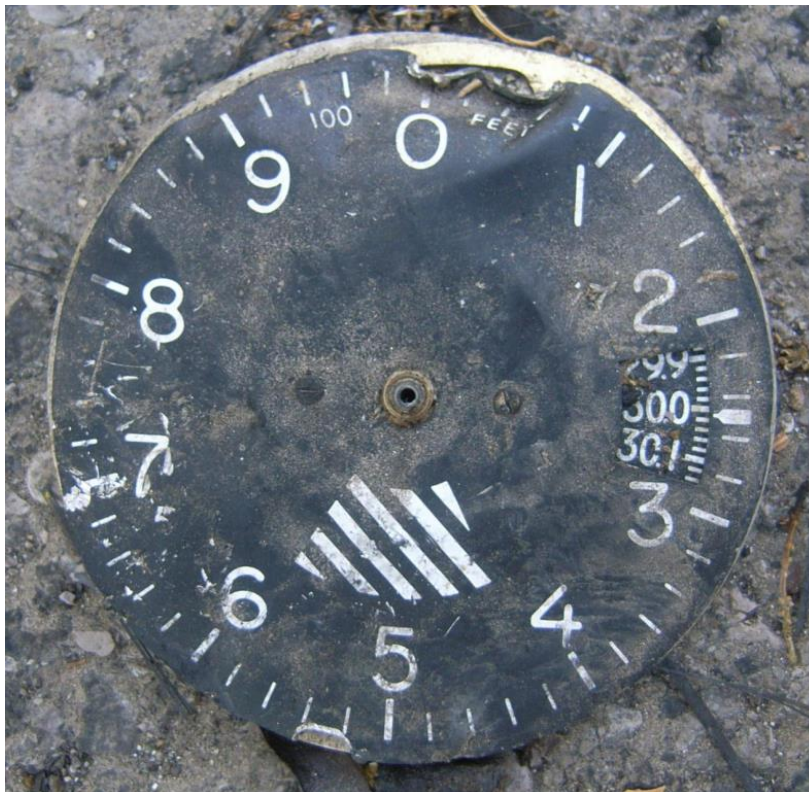
Most of the cockpit instruments and controls were destroyed by the combination of impact and fire. Most of the instruments that were not destroyed were not identifiable. The face of the altimeter was fracture-separated from the housing, and was found in the main wreckage. The setting observed in the Kollsman window was 30.02.

Figure 36 - Altimeter Face

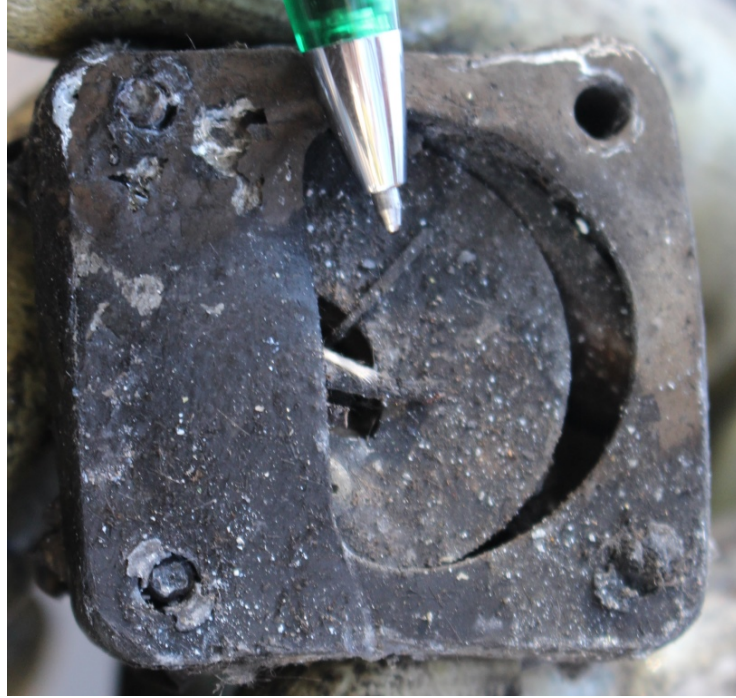
The cockpit flap position indicator was found loose in the debris, and was observed to indicate that the flaps were in the up/retracted position. According to a Textron Aviation representative, the flap position indicator needle will revert to the "flaps up" indication when electrical power is removed from the gauge.

**Figure 37 - Cockpit Flap Position Indicator**

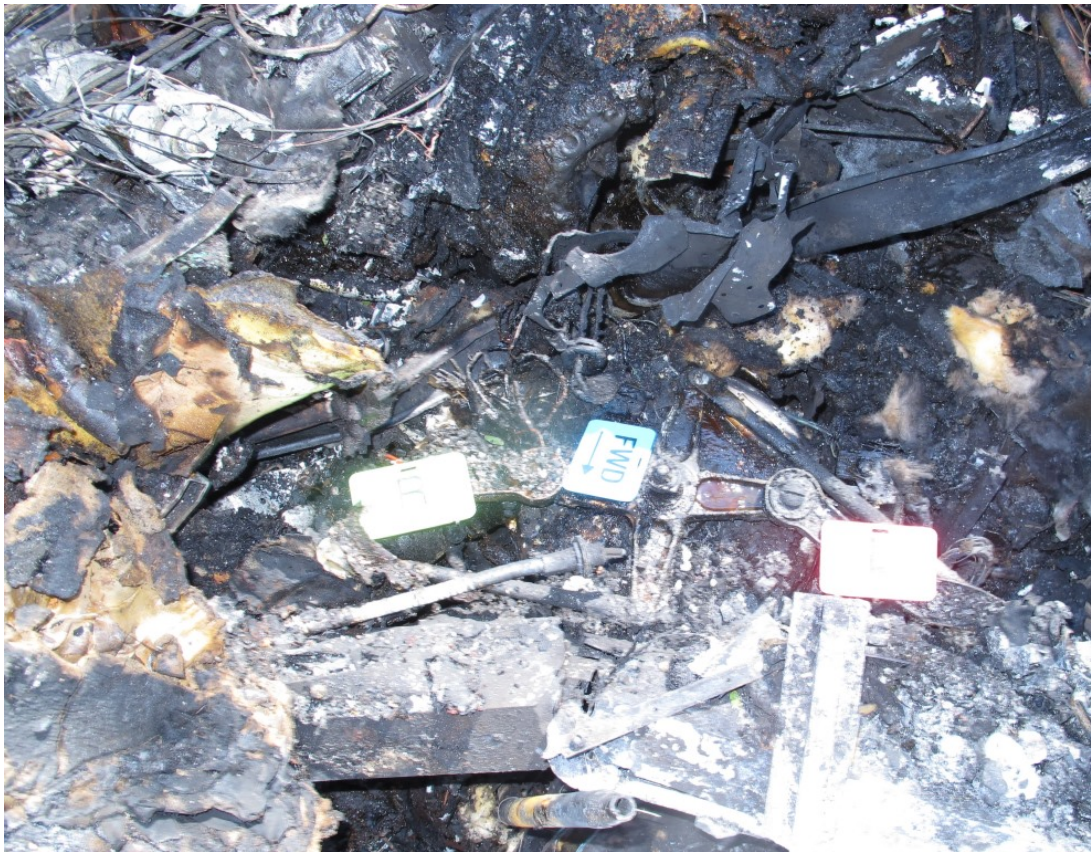
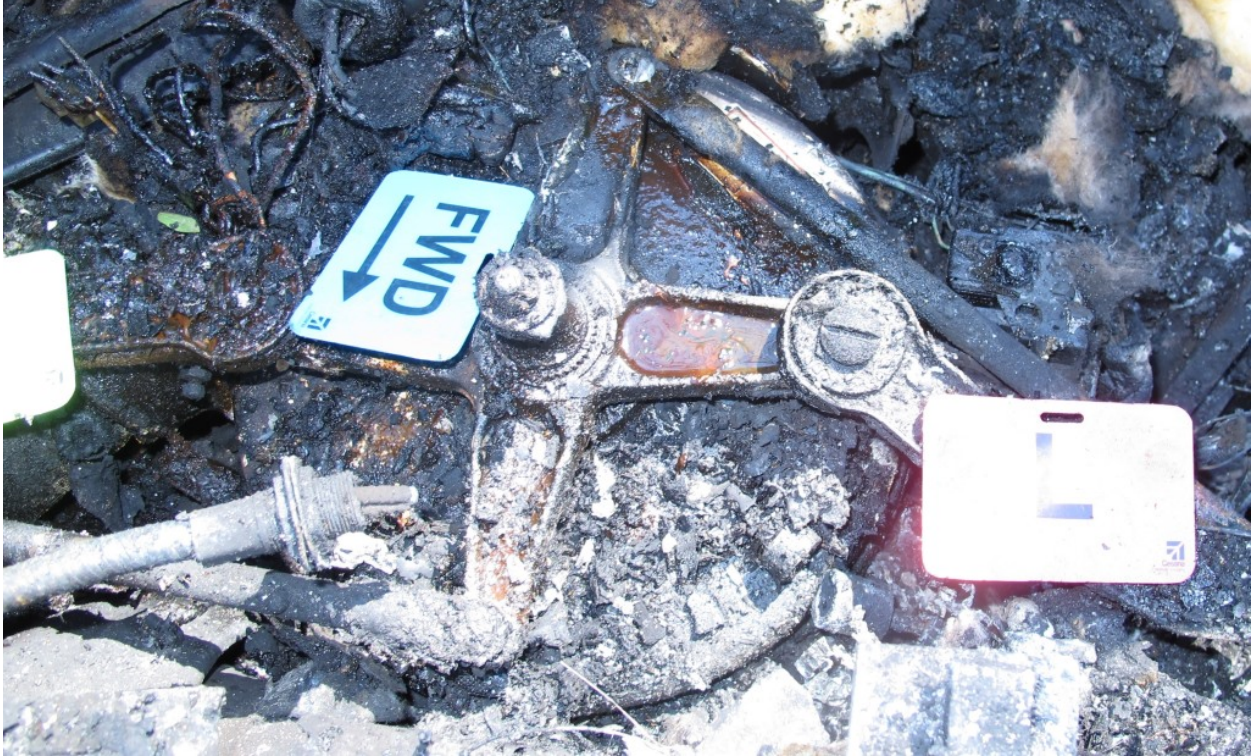
The three main landing gear assemblies, including struts, wheels, and tires, were all identified in the wreckage. The positioning of the components of the landing gear retraction/extension bellcrank assembly in the center fuselage was consistent with the landing gear being in the extended position at impact.

**Figure 41 - Center Fuselage Landing Gear Actuating Linkage Assembly**
