# **NATIONAL TRANSPORTATION SAFETY BOARD**

## **SITE & ON-SCENE INFORMATION**

**WPR16FA172**

**Aircraft:** Beechcraft A36, N985CA, Serial #: E-1901

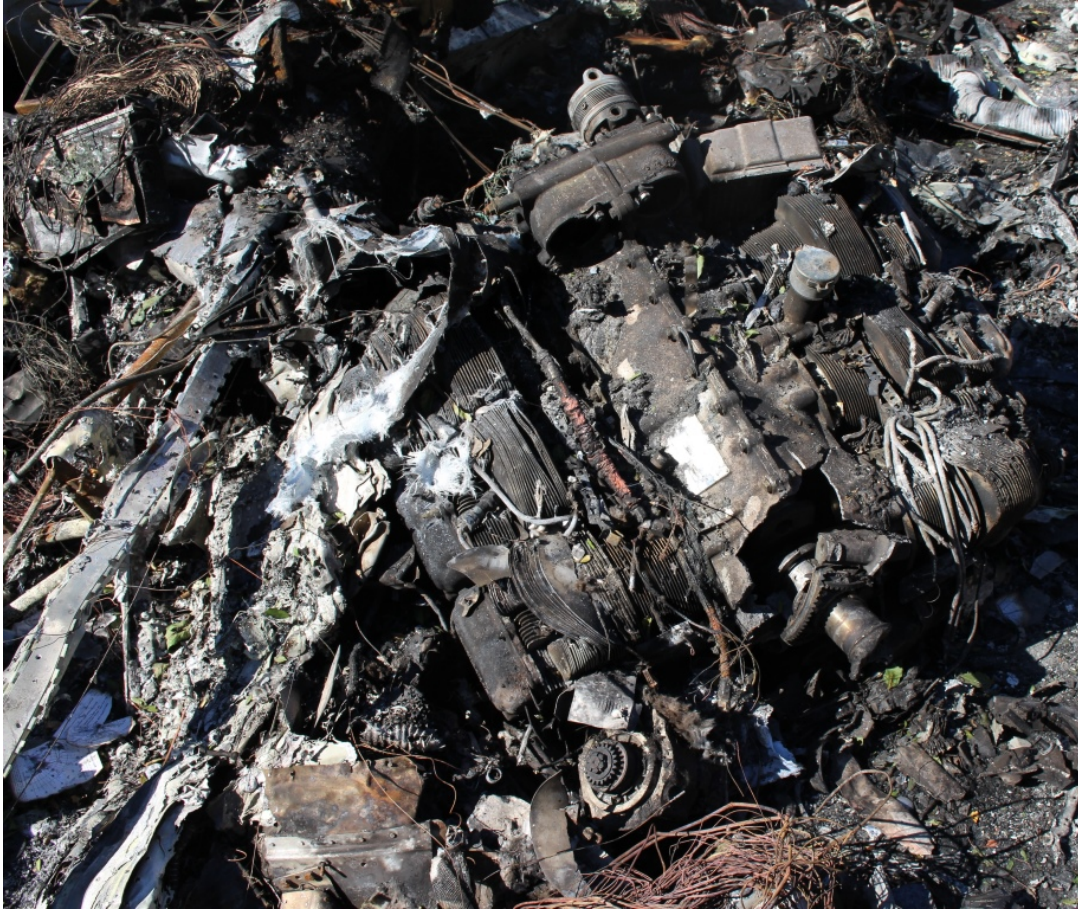
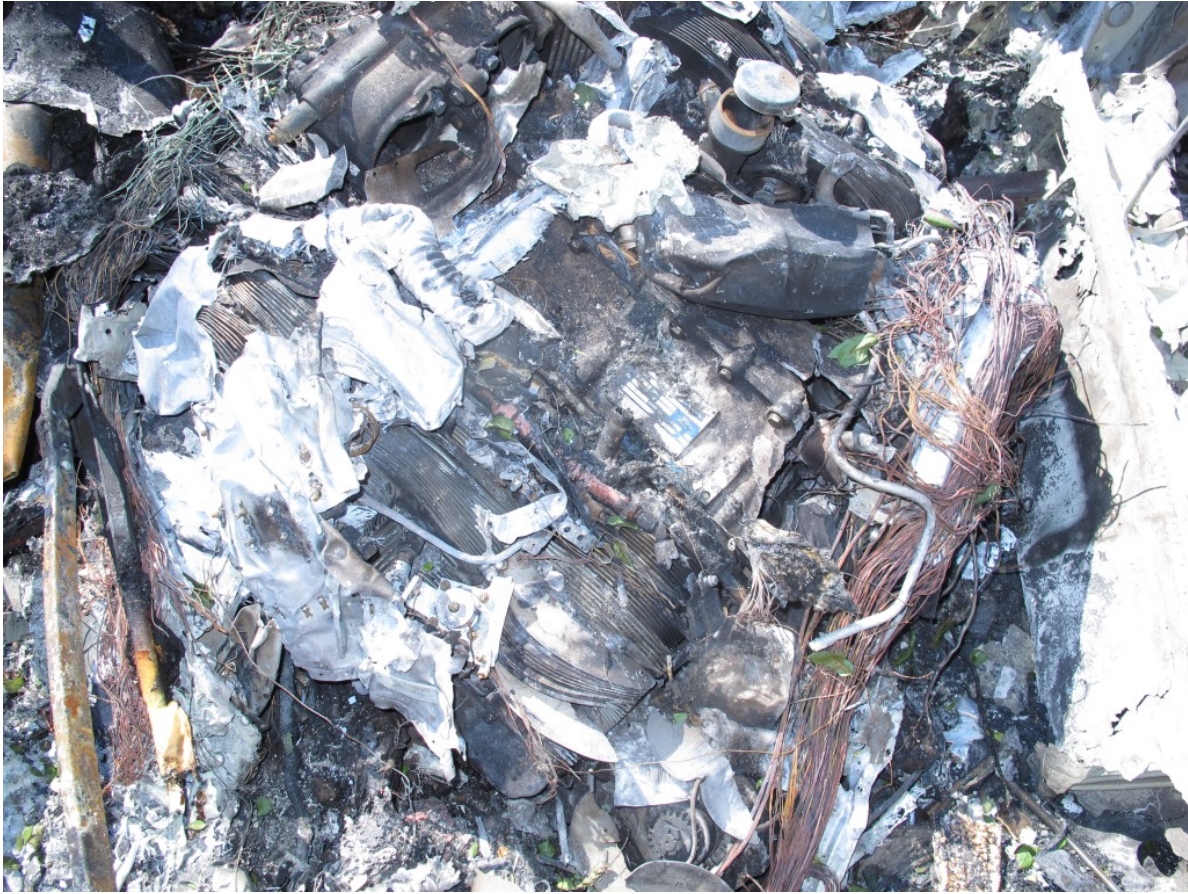
The engine crankcase halves were mostly intact, with the exception of the lower- forward portion; that region had fractured and exposed some internal components. The No. 6 connecting rod exhibited a bending deformation on the fore-aft direction, consistent with the crankshaft translating aft in the engine. The crankshaft propeller flange separated and remained with the separated propeller. The forward crankshaft main bearing saddle and bearings separated and were found outside of the crankcase, in the debris pile adjacent to the engine. The "face gear" remained attached to the forward crankshaft, but was impact damaged.

**Figure 43 - Engine (in situ)**

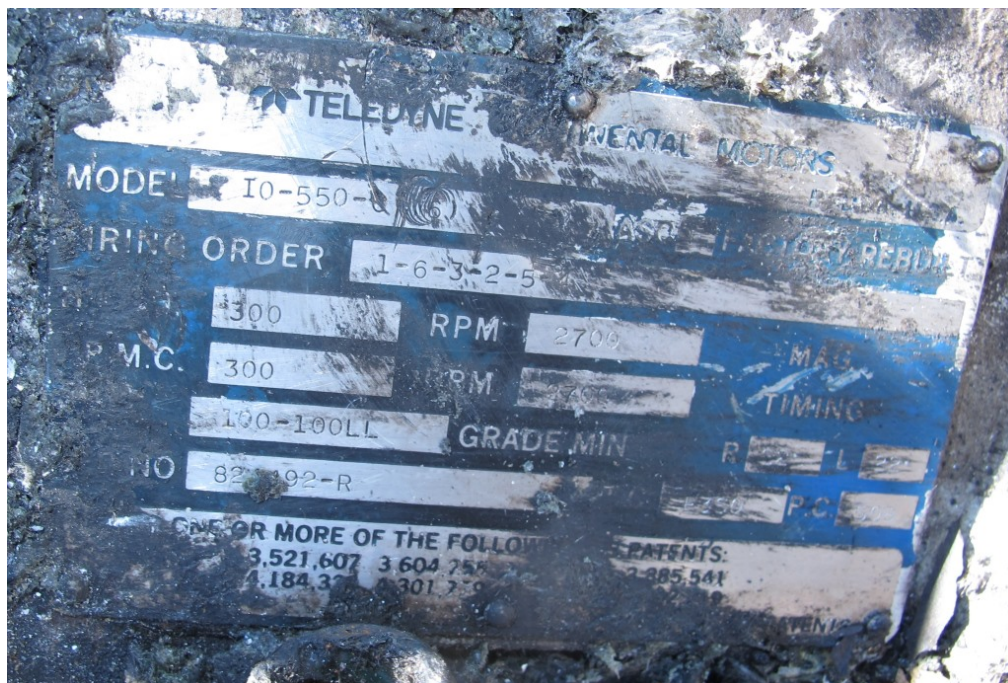
The engine was situated within the main wreckage. According to the engine manufacturer's representative, the data plate identified the engine as having been built as a model IO550C, and then field-converted (as opposed to being converted by Continental Motors) to an IO550B.

Figure 45 - Engine Data Plate

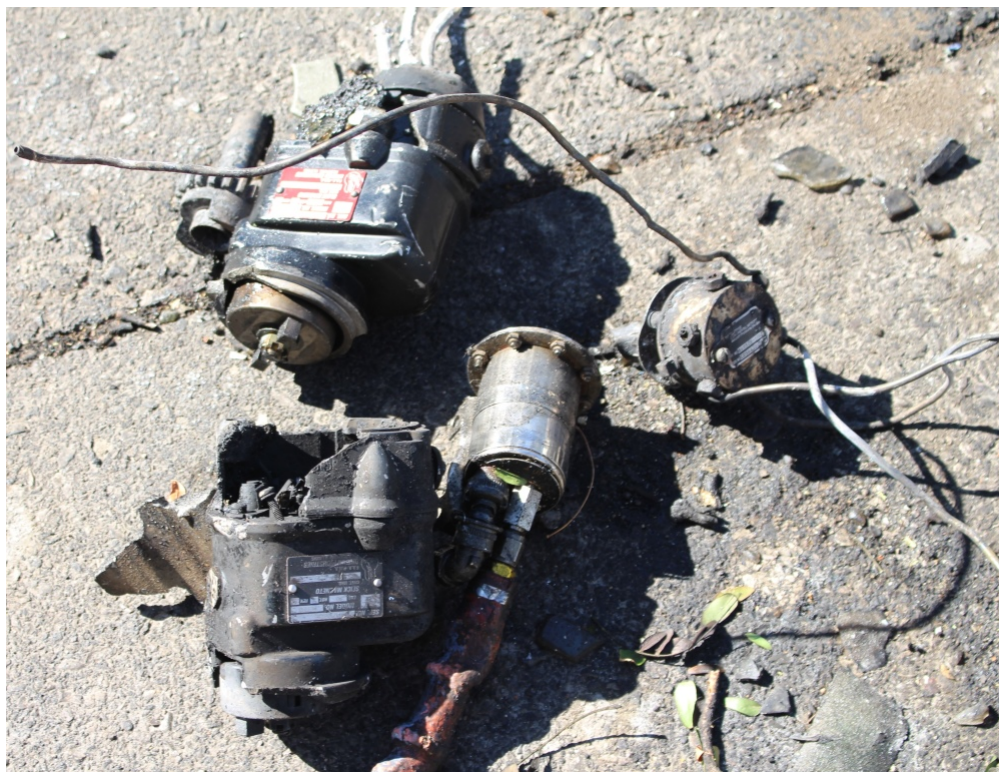
The left and right magnetos were fracture-separated from the engine, and were found near the propeller. One magneto drive gear was found near the propeller. The second magneto drive gear was found embedded in debris near the engine data plate on the upper right crankcase half. The magneto mounting rings failed at the hold-down brackets. The ignition leads were thermally distressed and/or fracture/impact separated.

**Figure 49 - Fracture-Separated Engine Components**

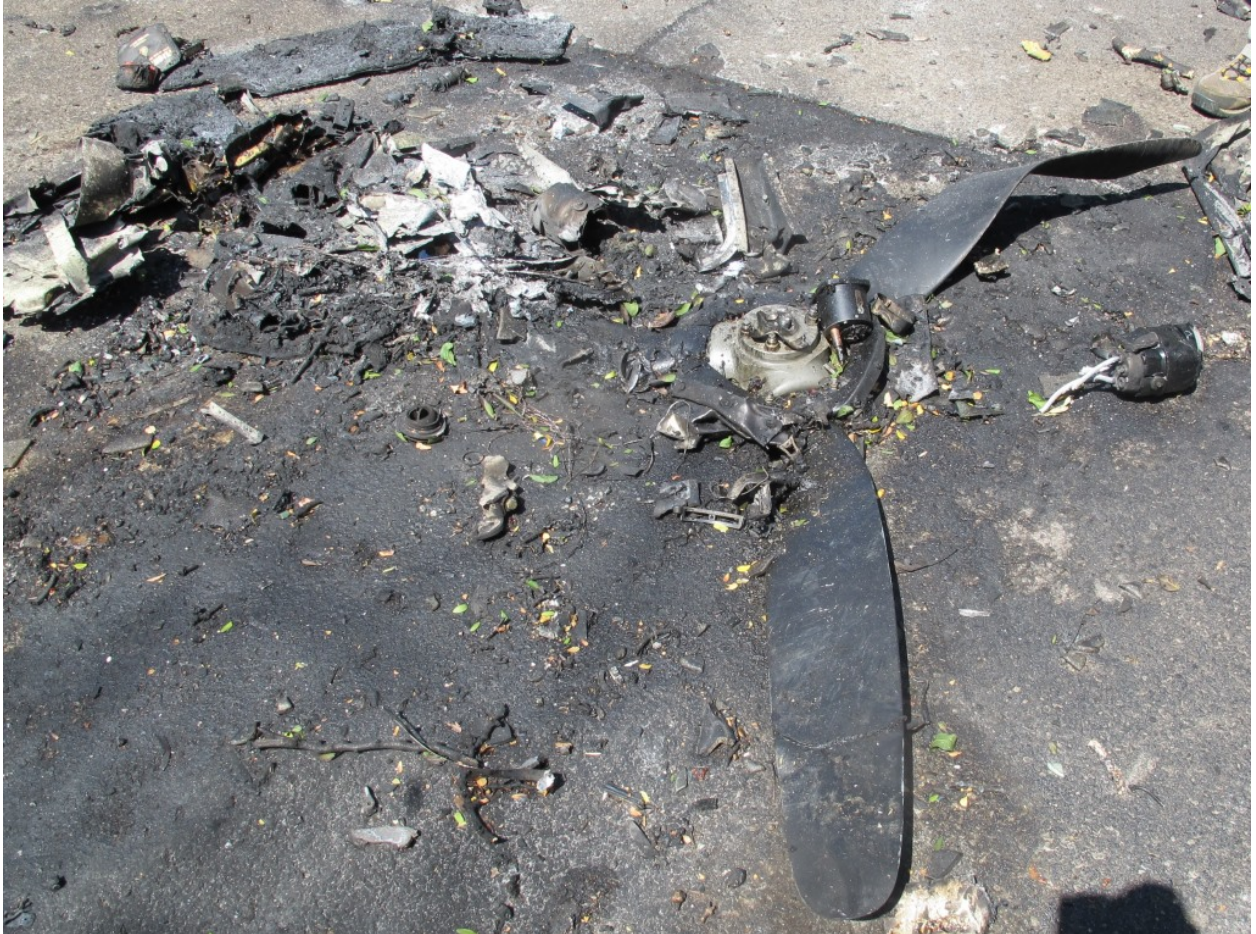
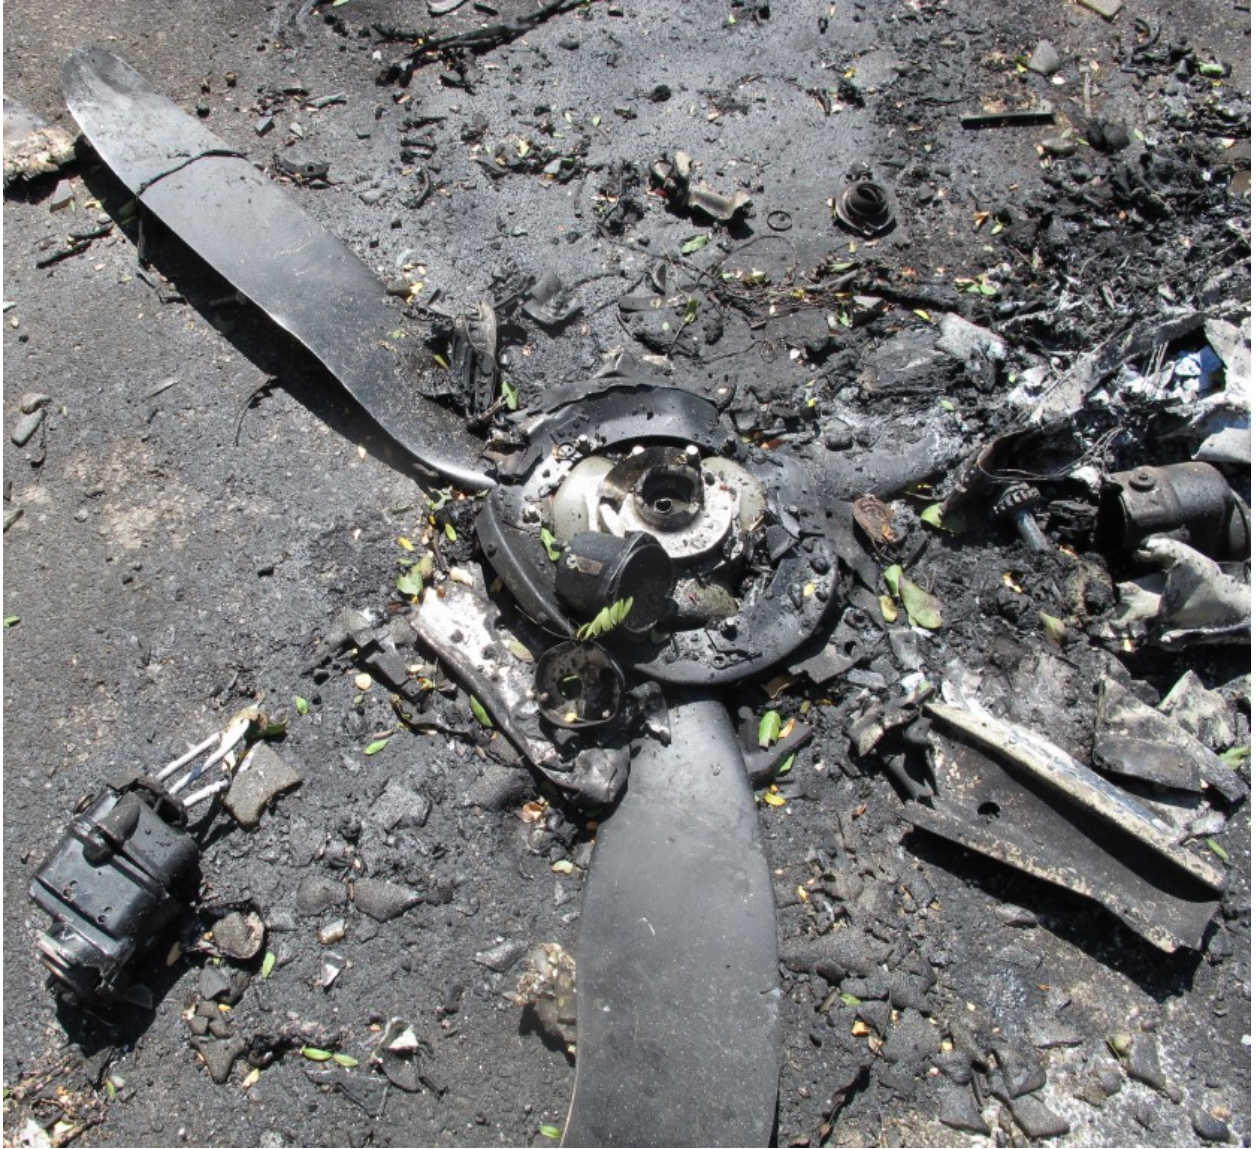
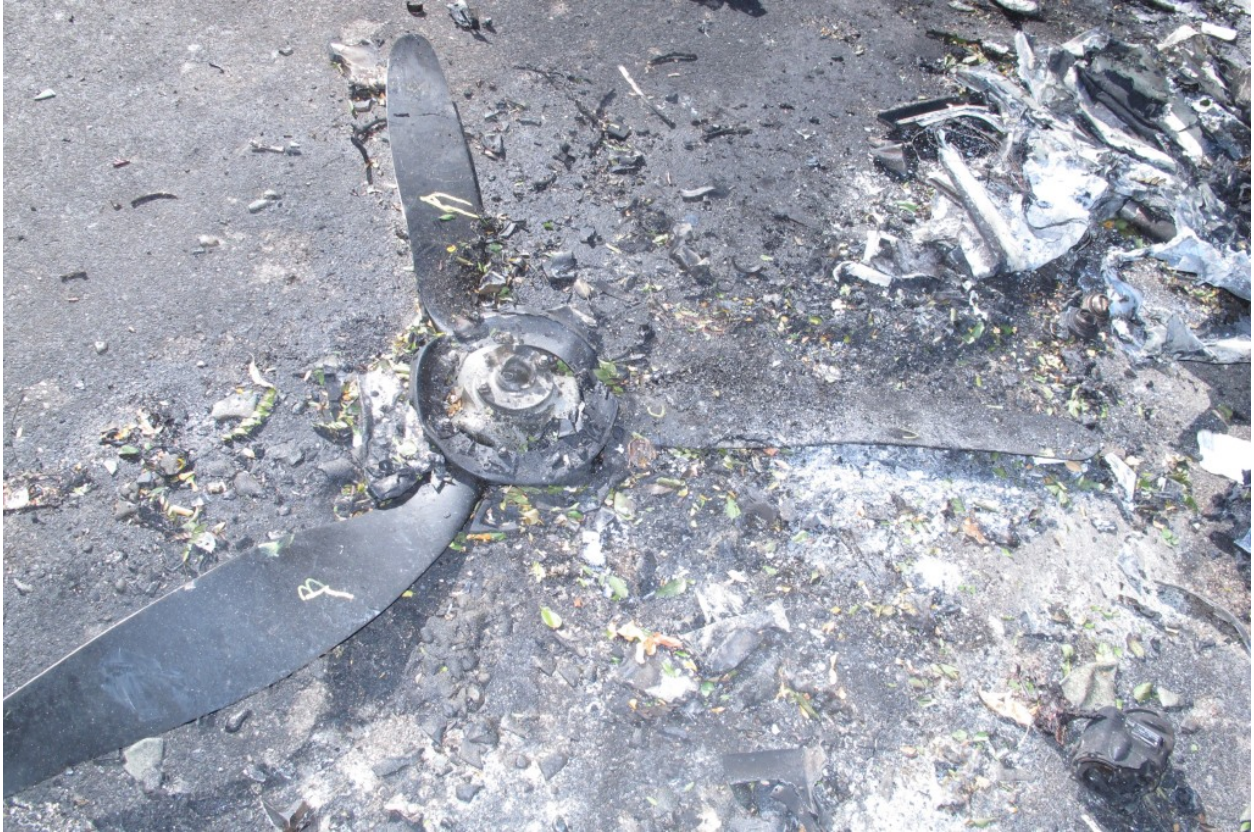
The propeller and hub assembly was fracture-separated from the engine crankshaft. All three blades remained installed in the hub. The assembly was found with the forward ("blade back," or cambered) side down, partially embedded in the asphalt. The propeller impact damage and the ground scars were consistent with the impact occurring with the plane of rotation parallel to the ground plane. For identification/discussion purposes, the propeller blades were marked as A, B, and C.

**Figure 52 - Propeller (in situ, blades labeled)**

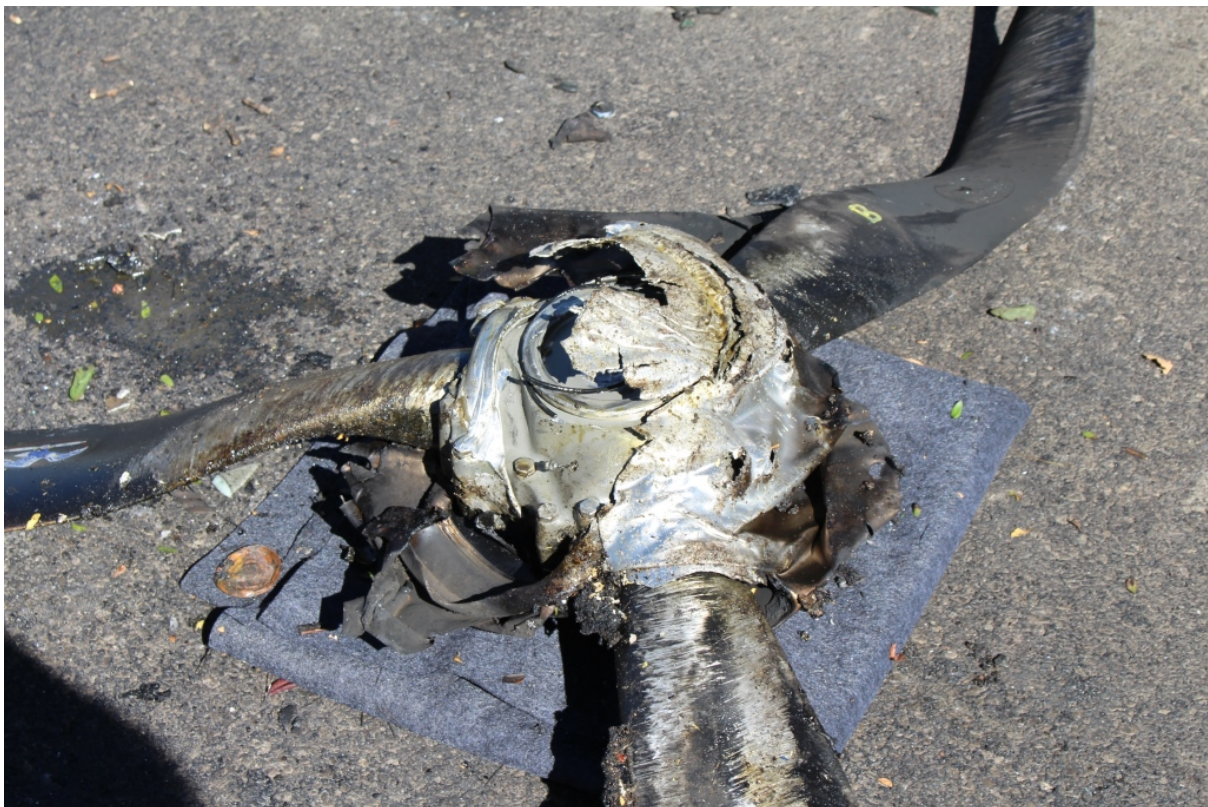
The propeller spinner, spring, and dome exhibited severe crush/impact damage, and portions remained in the impact depression when the propeller was lifted from the pavement.

**Figure 55 - Propeller Hub and Spinner**

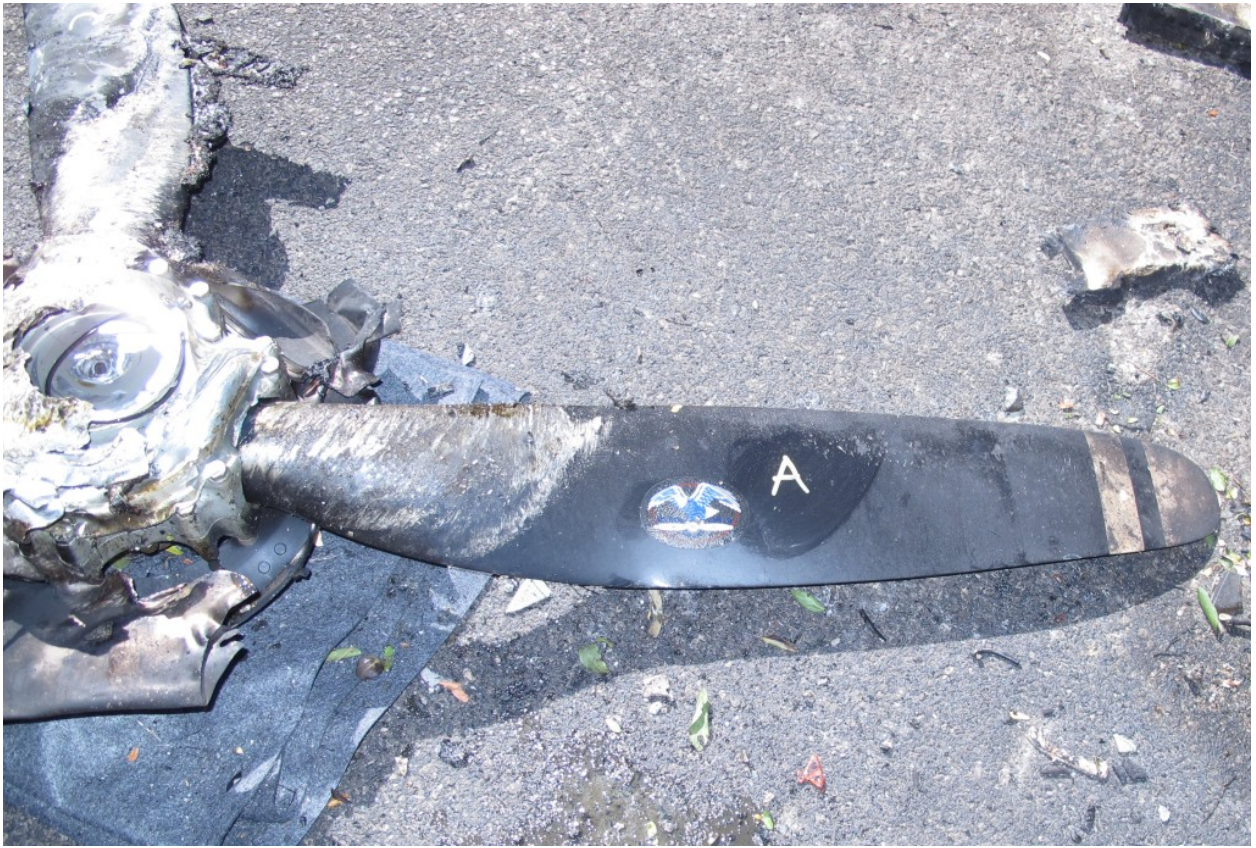
Blade A exhibited the least amount of impact damage, with slight aft bending beginning approximately 16" from the blade root. Chordwise scoring/scratching and paint transfer was present from the blade root to approximately 10 inches outboard, on the blade back (cambered) side.

**Figure 56 - Blade A Cambered Side**

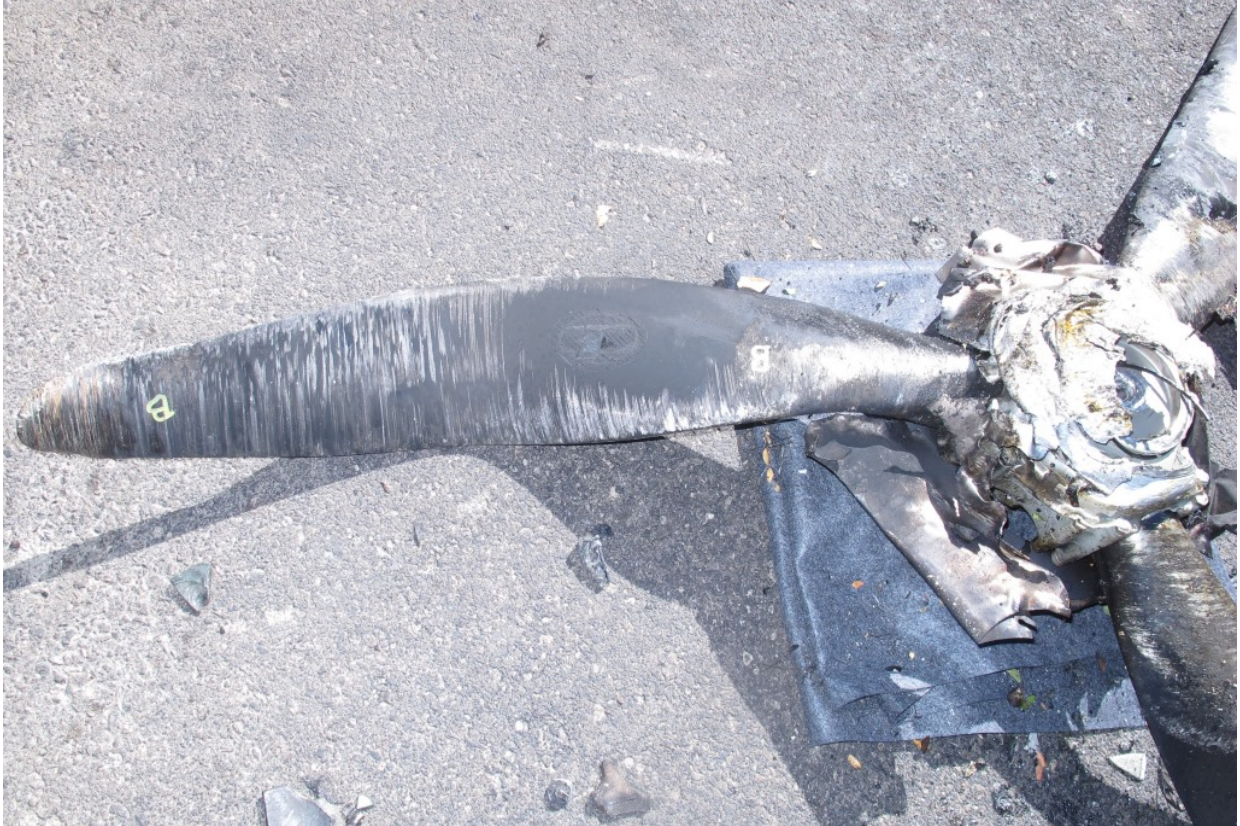
Blade B exhibited forward bending, and slight twisting beginning approximately 10 inches from the blade root. Chordwise scoring/scratching was present on the blade back (cambered) side, along the entire span of the blade.

**Figure 57 - Blade B Cambered Side**

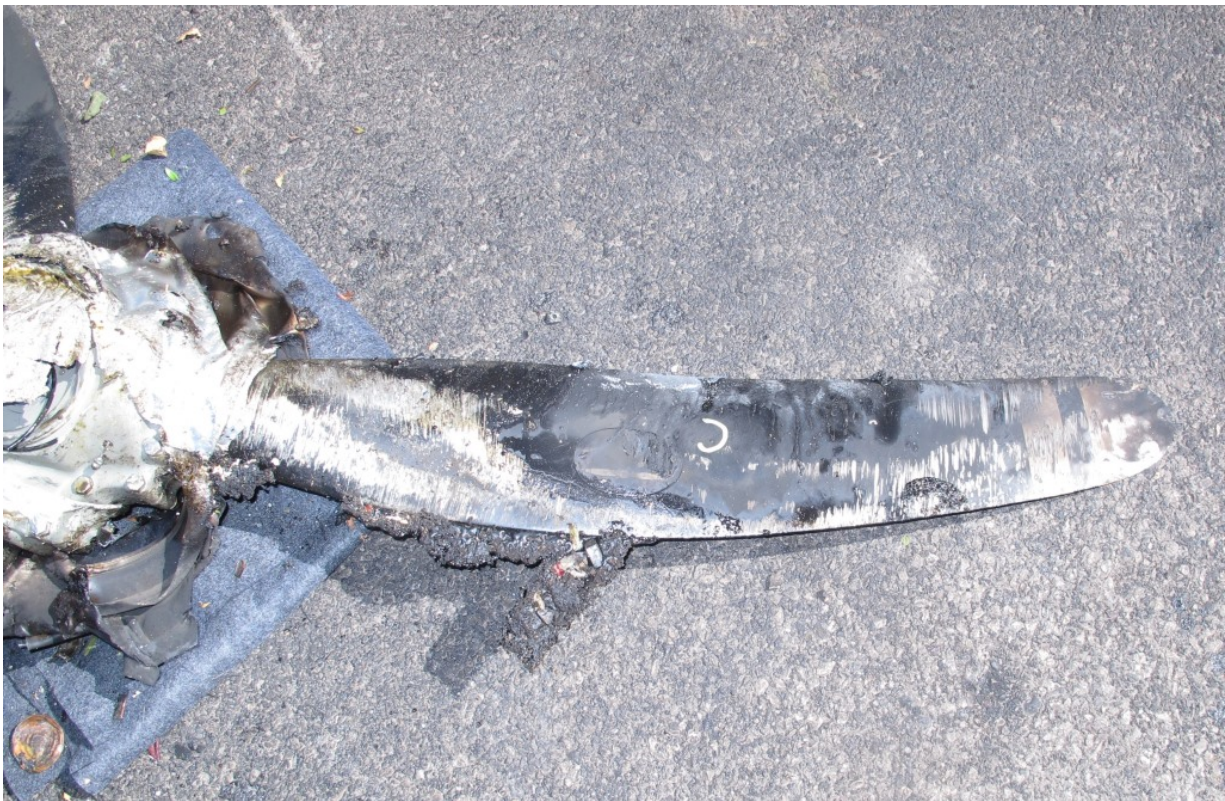
Blade C essentially retained its manufactured profile and shape. It exhibited chordwise scratches from the blade root outboard to about 2 inches from the blade tip, on the blade back (cambered) side.

**Figure 58 - Blade C Cambered Side**
