# Continental Motors

## ENGINE FIELD INSPECTION REPORT

| <b>ENGINE MODEL</b> | IO550C-6F converted to IO550B |
| <b>FILE NUMBER</b> | 16-143 |

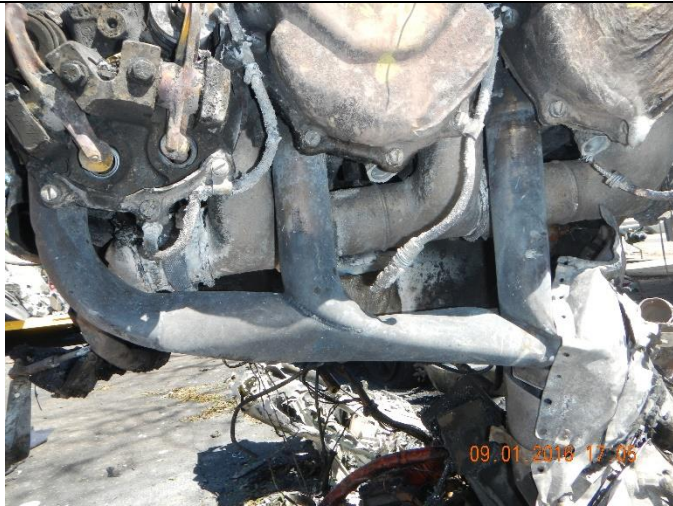
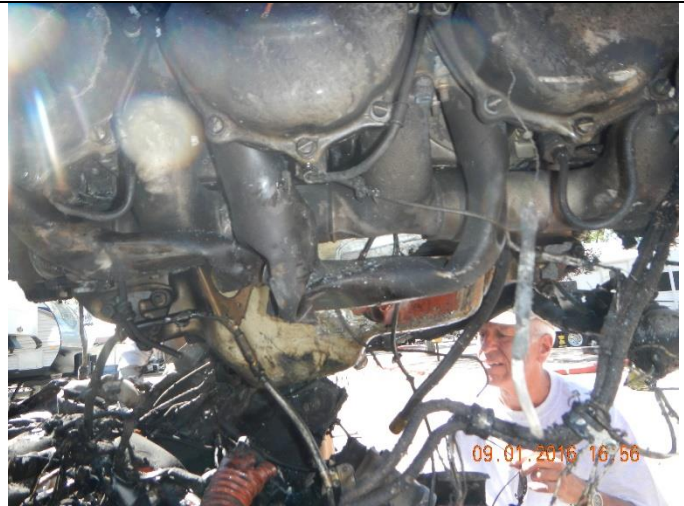
The exhaust system was impact damaged but remained attached to the individual cylinder port. The collectors were impact damaged as were the mufflers and individual tail pipes.

The exhaust system remained attached but was heavily damaged during the impact sequence.

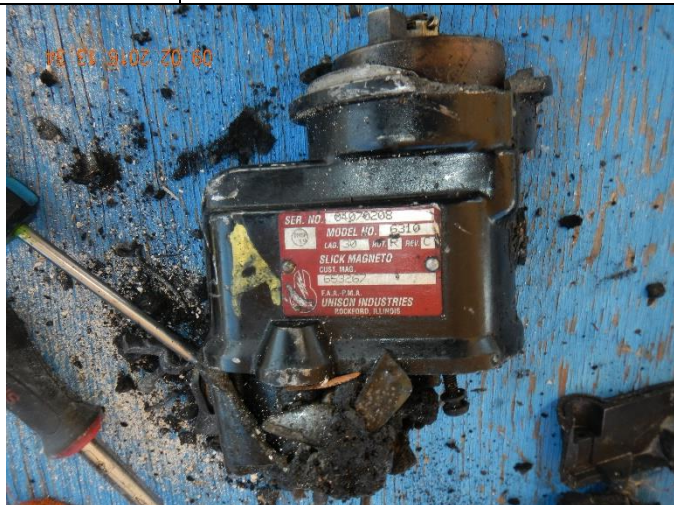
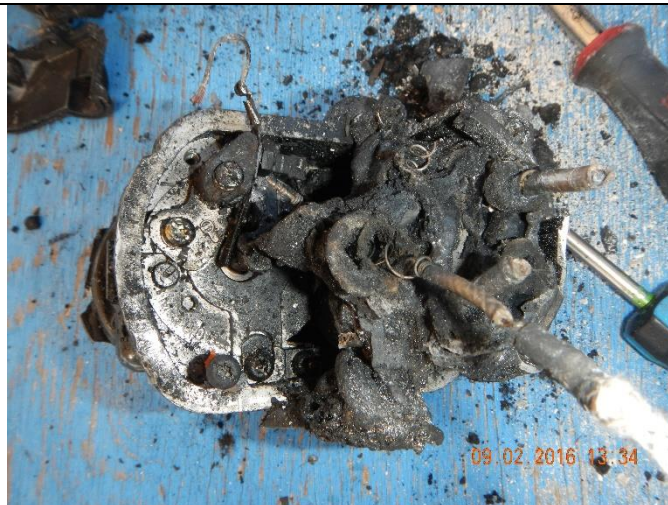
### MAGNETO "A"

Condition: The magneto received impact and thermal damage. The internal components were severely damaged and a functional test was not possible.

NOTE: Both magnetos separated from the engine but were discovered in the wreckage. Position orientation could not be established.

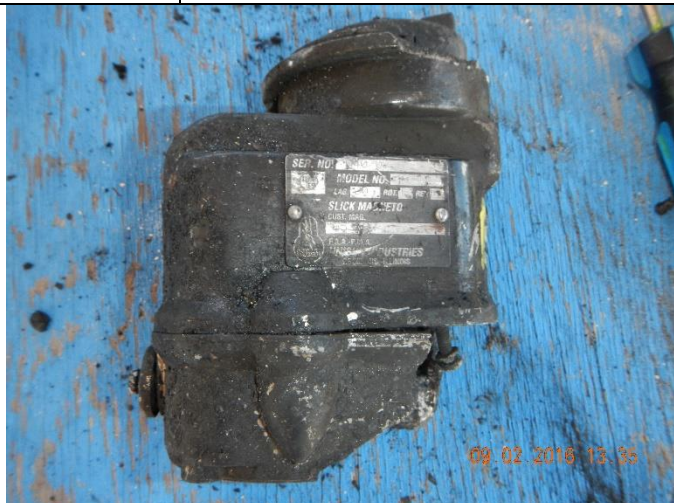
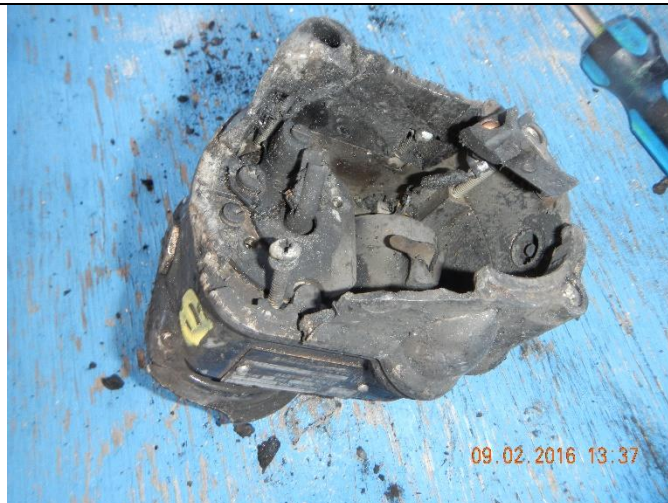
### MAGNETO "B"

Condition: The magneto received impact and thermal damage. The internal components were severely damaged and a functional test was not possible.

NOTE: Both magnetos separated from the engine but were discovered in the wreckage. Position orientation could not be established.

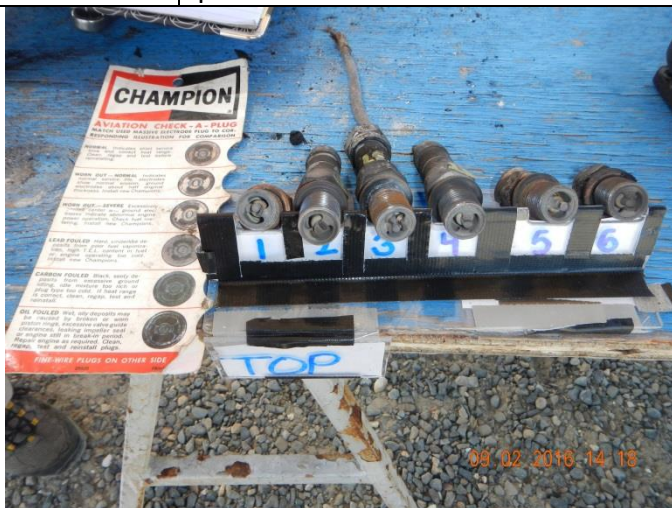
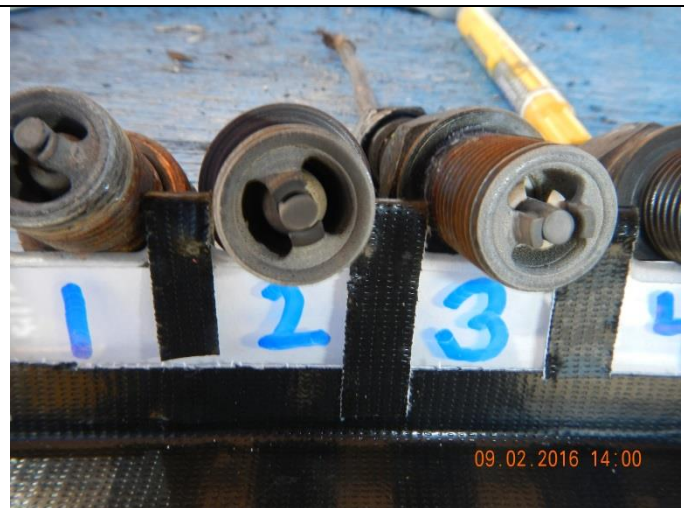
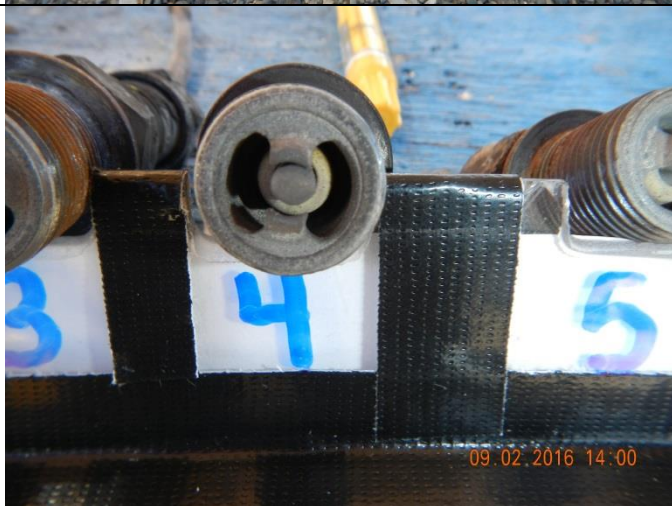
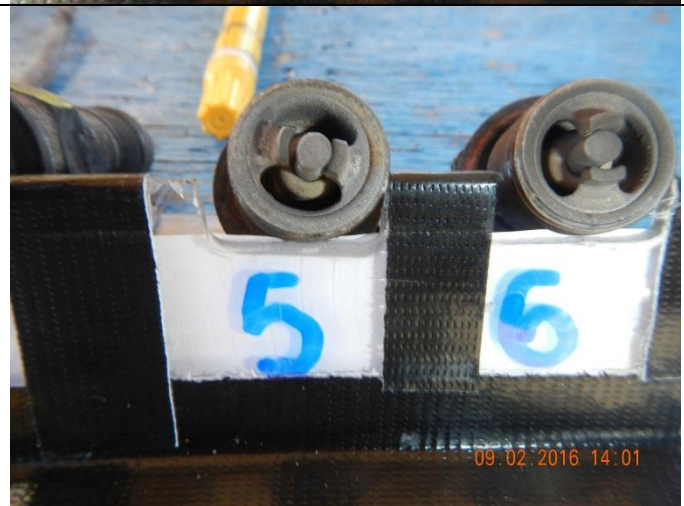
## SPARK PLUGS

All cylinders remained attached to their respective mounts but were impact damaged exhibiting damage to cooling fins. Each cylinder exhibited thermal distress and were heavily sooted. All rocker box covers remained intact with the exception of the number six cylinder. All top sparkplugs remained attached but the upper sparkplug bodies for cylinders 1, 5 and 6 were broken leaving only the base in each respective cylinder.

Top spark plugs were removed and inspected. When compared to a Champion Check-A-Plug chart, the spark plugs appeared to exhibit normal wear and coloration. However, spark plugs from cylinders one, five and six separated leaving only the lower portion inserted into its respective cylinder head. The #3 spark plug exhibited damage to the porcelain electrode insulator.

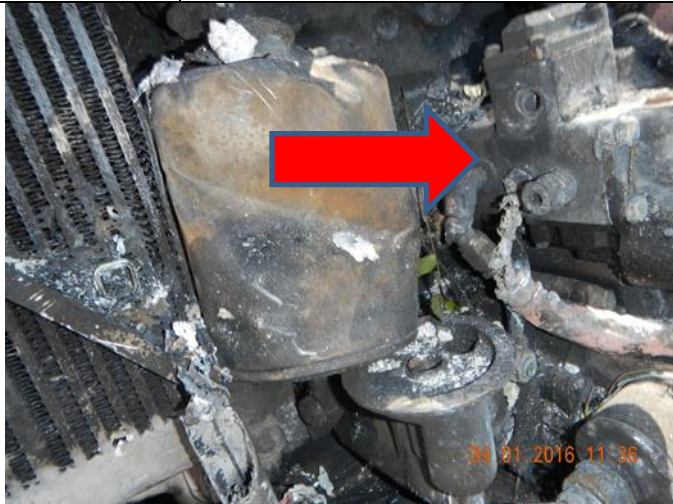
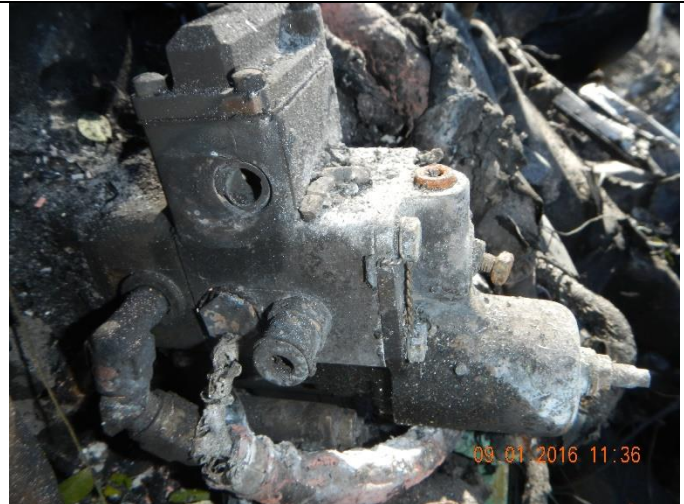
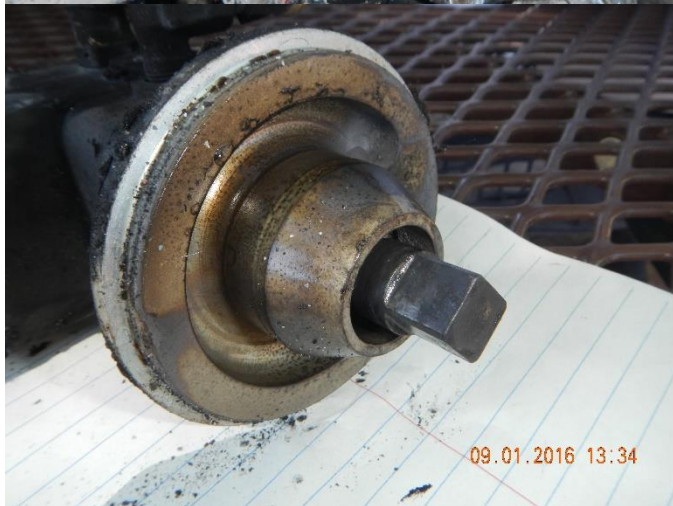
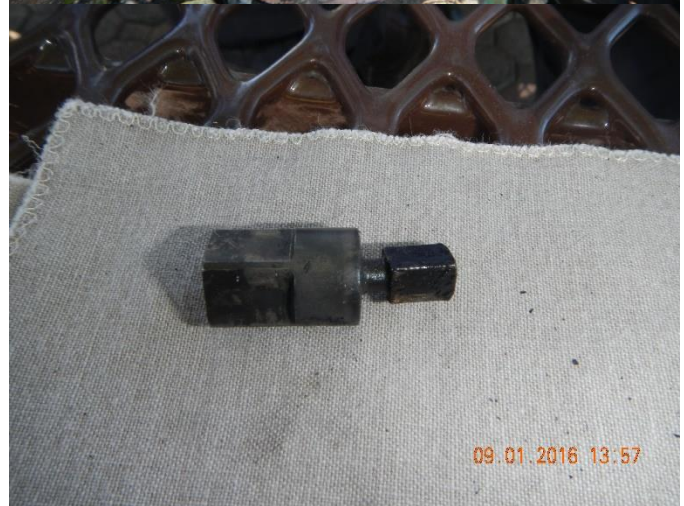
### FUEL PUMP

The engine driven fuel pump received heavy thermal damage. The fuel pump was removed and inspected. The pump could not be manually rotated. The fuel pump drive coupling was intact but slightly bent. The pump shaft exhibited heat signatures and the pump impeller blades were intact but heat damaged.

The fuel pump remained intact but was thermally damaged. The red arrow points to the fuel pump as found on the engine. The drive coupling was intact but slightly bent. The fuel pump could not be rotated manually due to thermal damage. The fuel pump was disassembled and inspected. Pump blades were found intact.

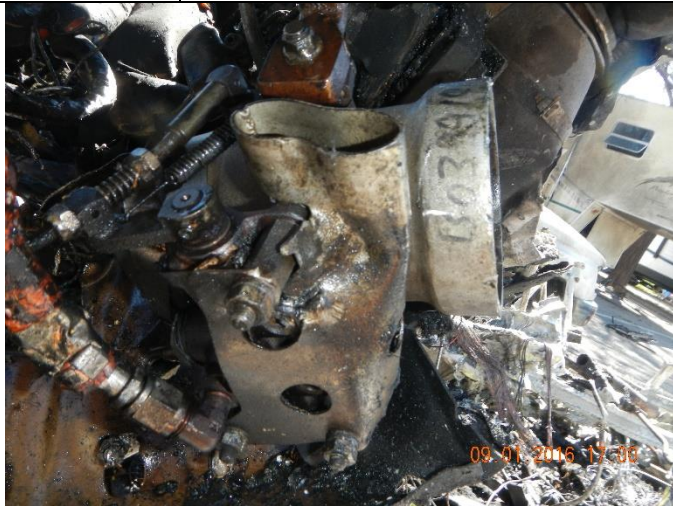
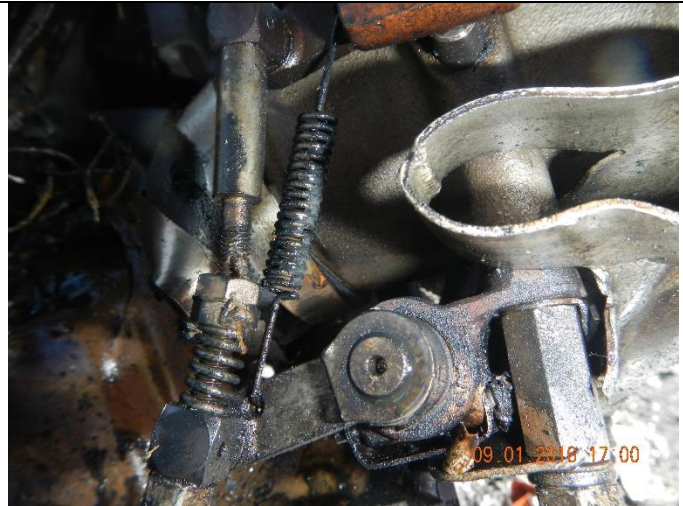
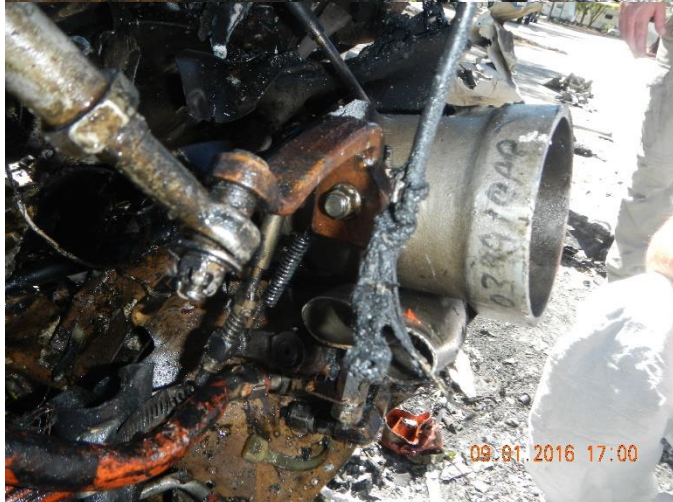
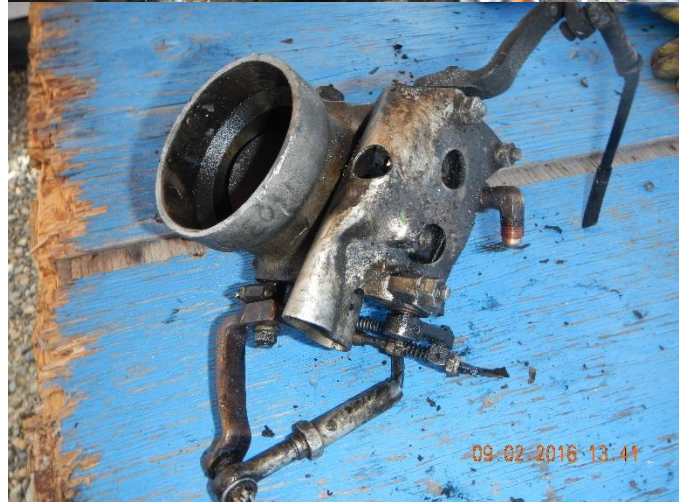
## THROTTLE BODY METERING UNIT

The fuel system throttle body-metering unit separated from its engine oil sump mount but was recovered. The control cables remained attached but were cut to facilitate removal of the throttle body-metering unit from the damaged engine. The individual throttle and mixture control arms remained attached and secured.

Control arms remained secured and attached to control cables. The unit received thermal and impact damage. The fuel screen was removed and inspected. No contaminations were noted.

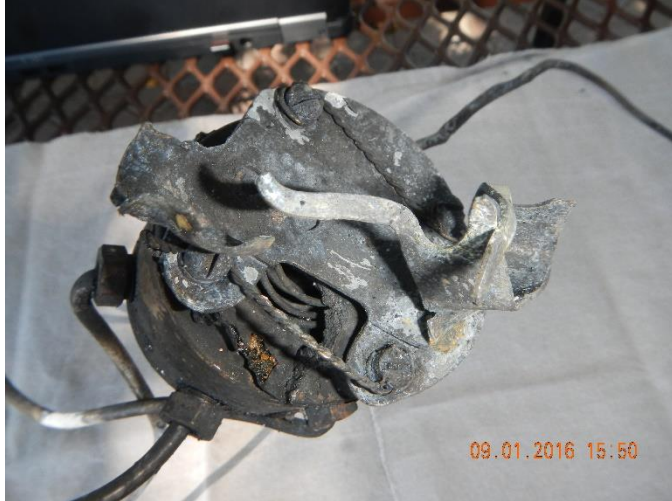
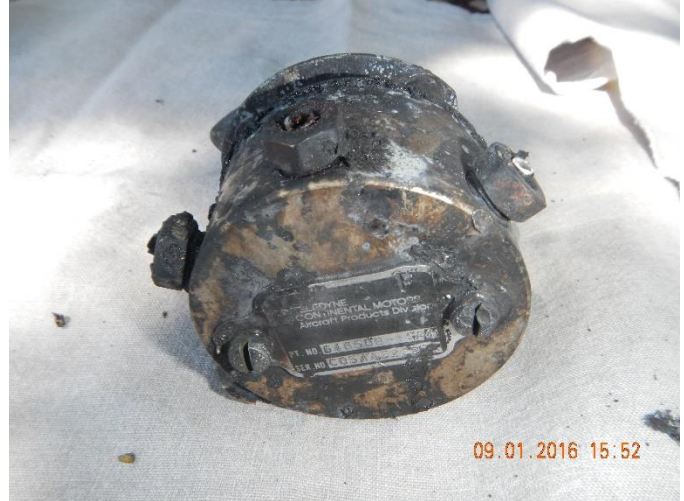
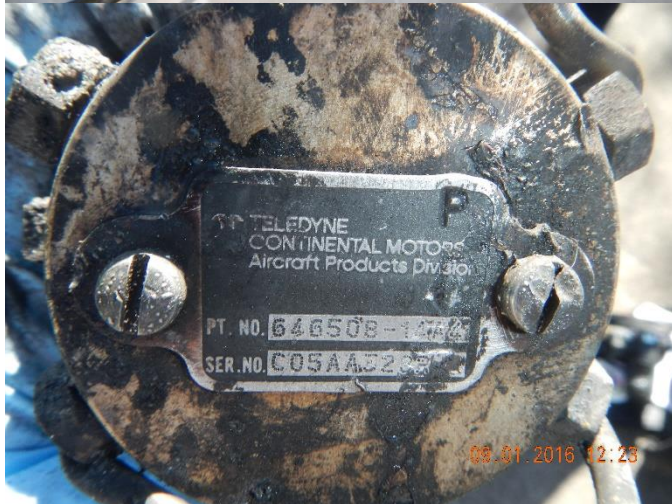
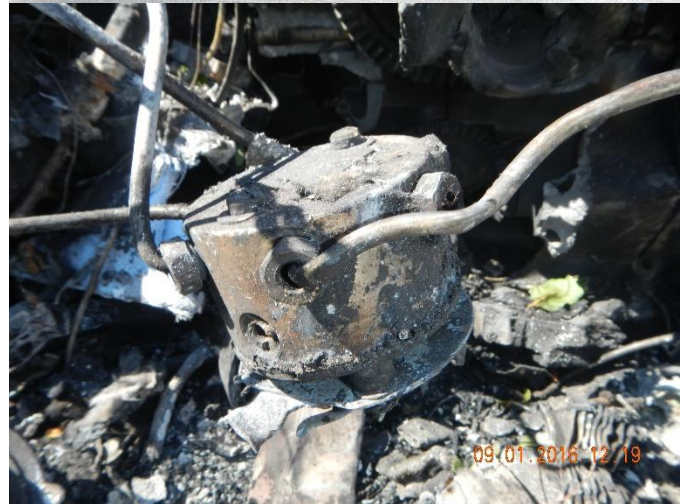
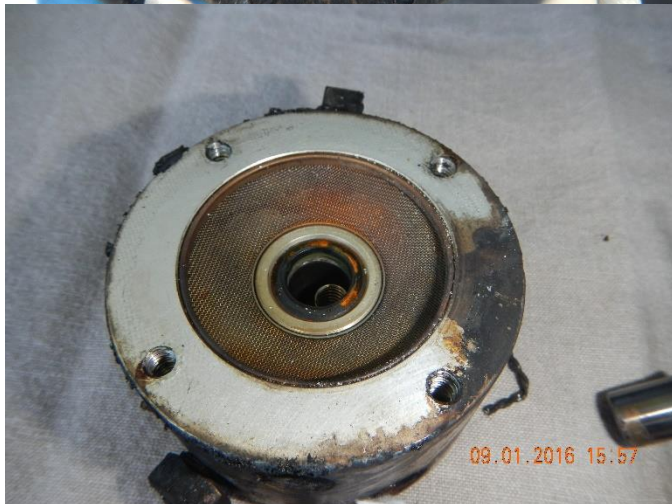
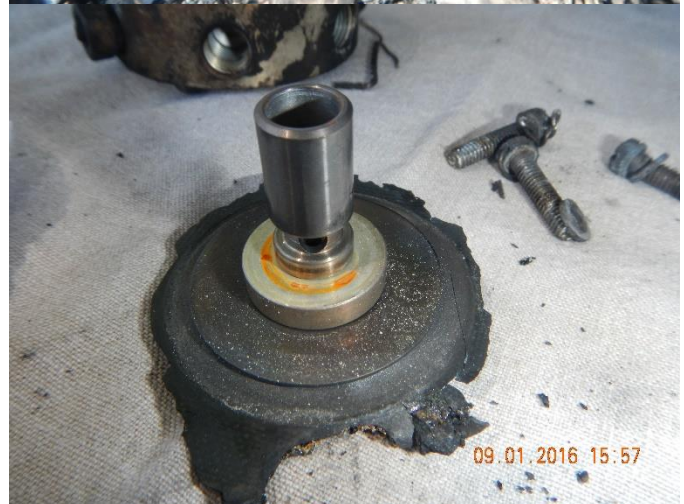
## FUEL MANIFOLD VALVE

The fuel manifold valve separated from the upper crankcase backbone but was discovered in the engine wreckage. The manifold valve was disassembled and inspected. The diaphragm was thermally destroyed. All other components of the manifold valve were intact but exhibited thermal distress. No fuel was discovered in the manifold valve.

The manifold valve was both impact and thermally damaged. The diaphragm was thermally destroyed but the fuel screen was clear. No fuel was present.

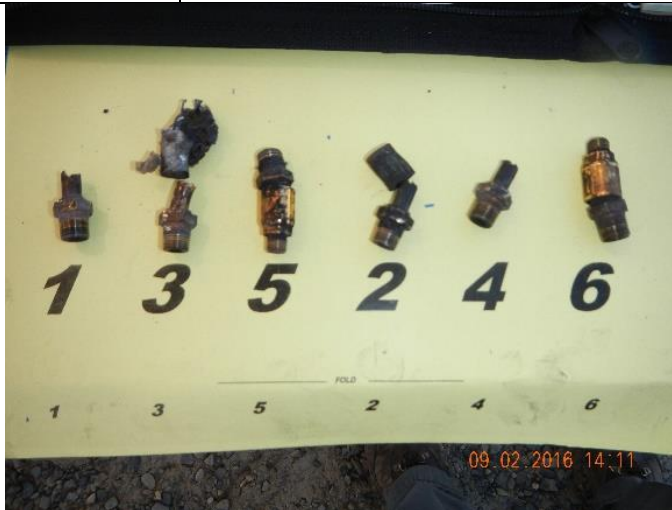
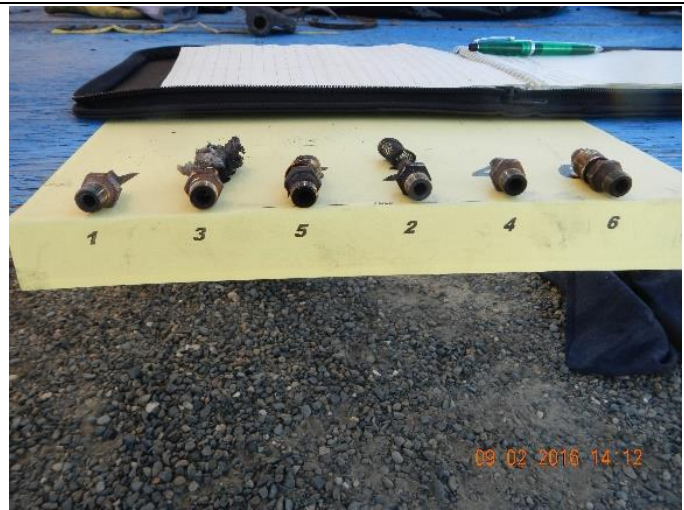
## FUEL NOZZLES AND LINES

| Position | #1 | #3 | #5 | #2 | #4 | #6 |
|---|---|---|---|---|---|---|
| Condition: | # 1, 2, 3 & 4 bodies were impact damaged. # 5 & 6 were intact but damaged. # 2 & 4 were open; all others were blocked with debris. | | | | | |

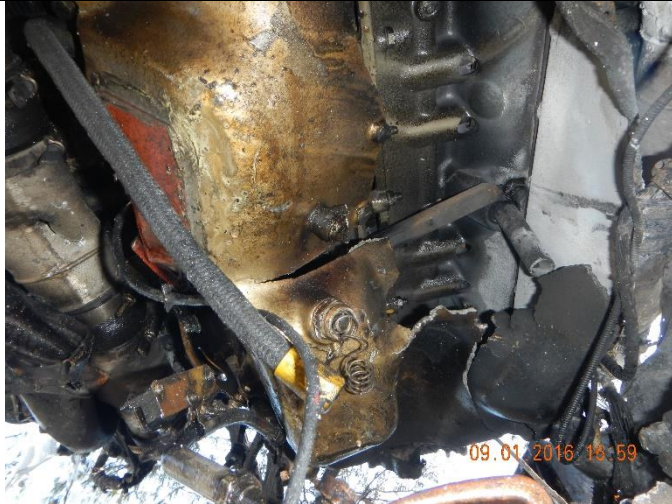
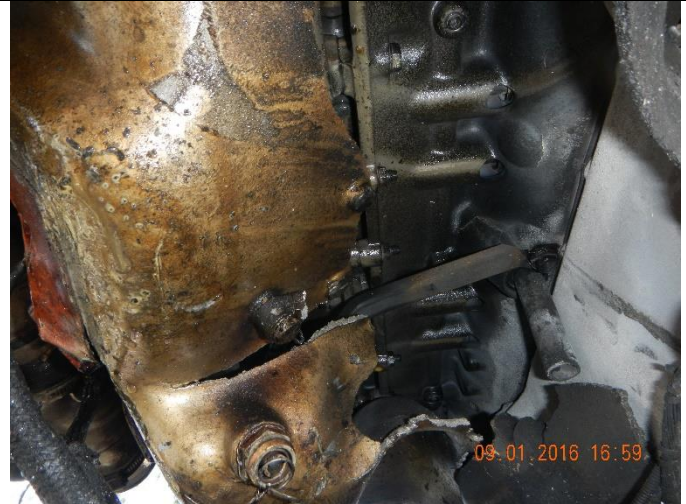
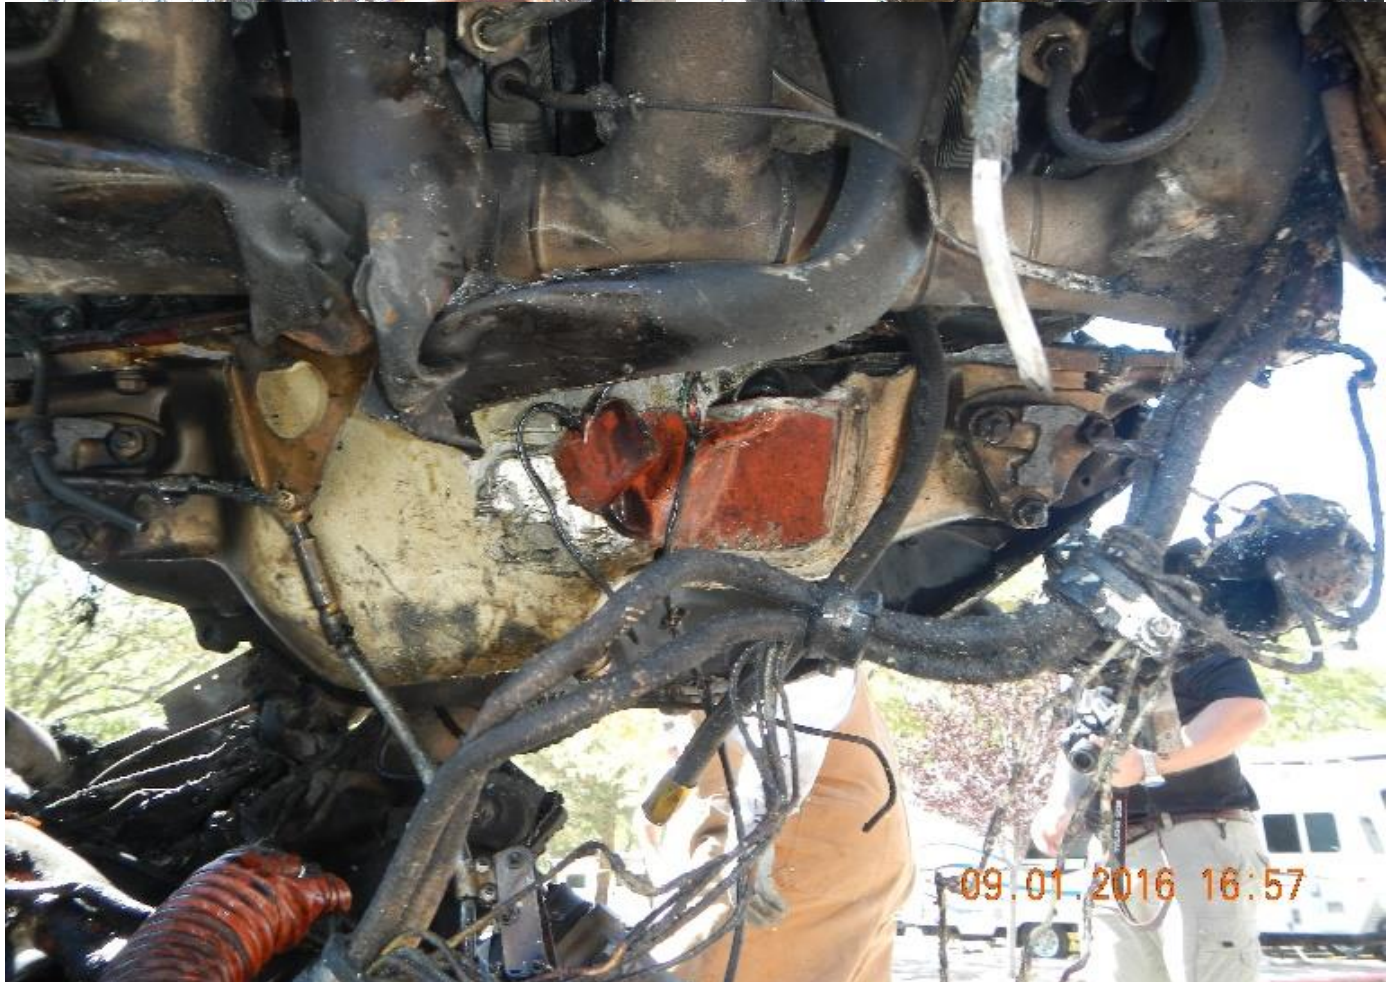
#### OIL SUMP

The engine oil sump was heavily impact damaged. Large portions of the oil sump separated and were discovered in the surrounding debris.

The sump was impact damaged with several pieces not recovered.

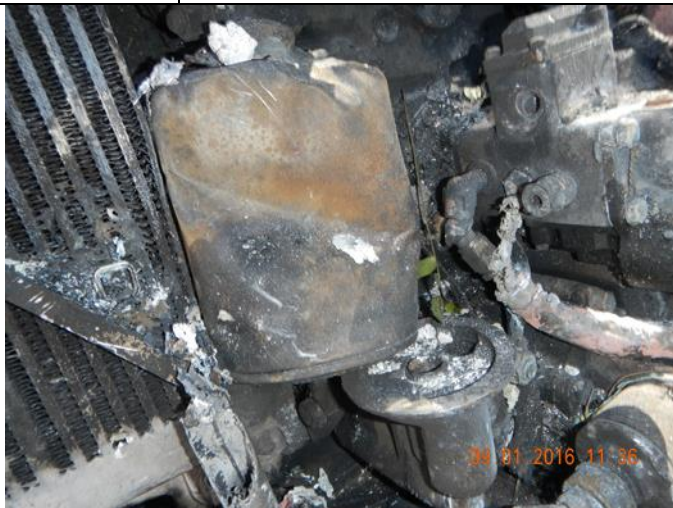
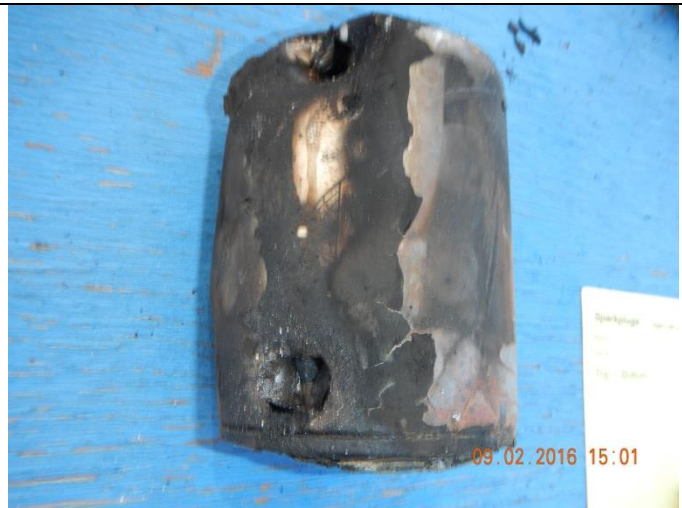
## OIL FILTER

The oil filter separated from the oil filter adapter flange and exhibited thermal damage.

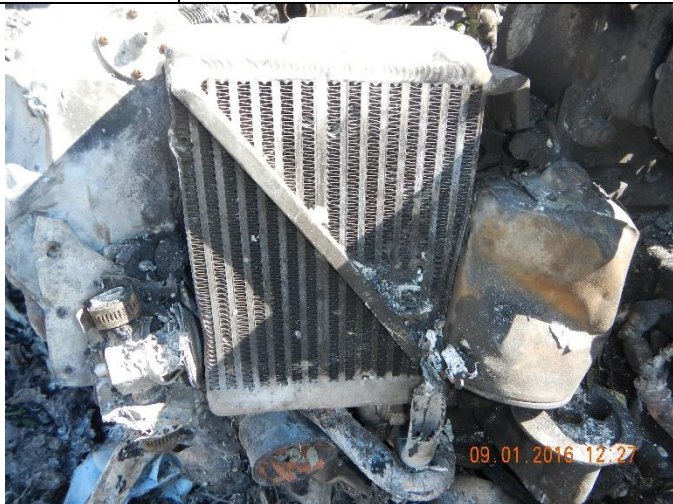
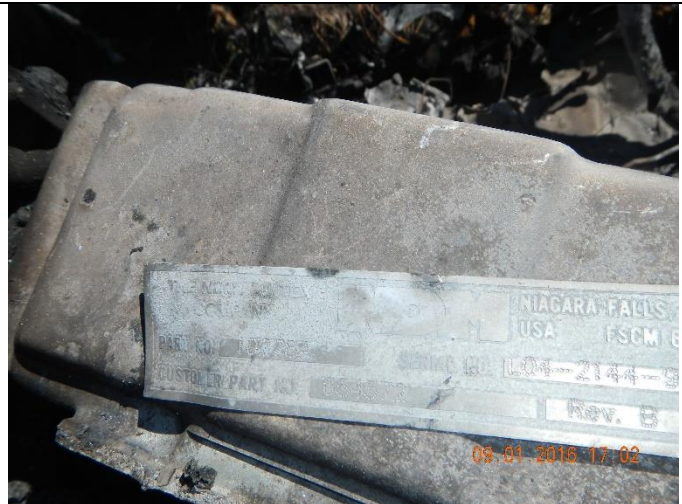
## OIL COOLER

The oil cooler remained attached but received thermal damage

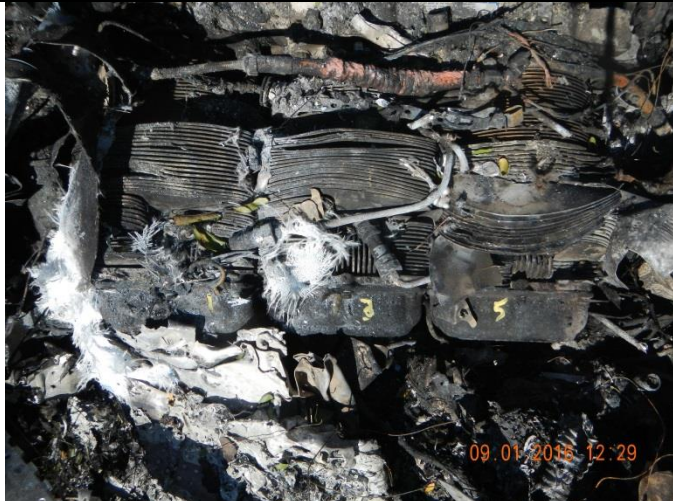
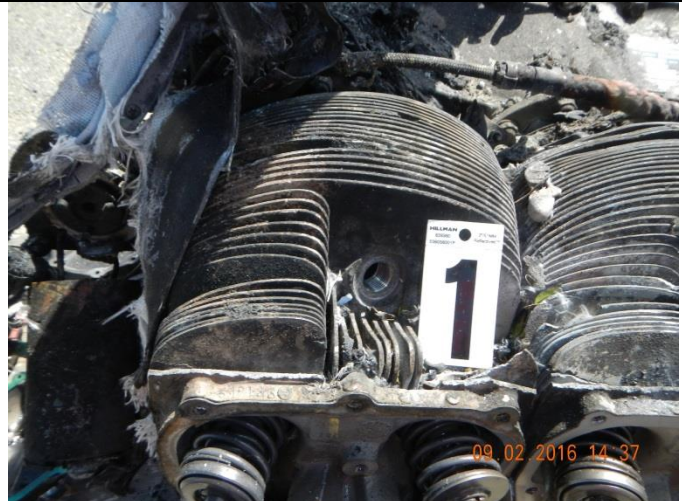
CYLINDER #1

Cooling fins were impact damaged and the cylinder exhibited thermal damage

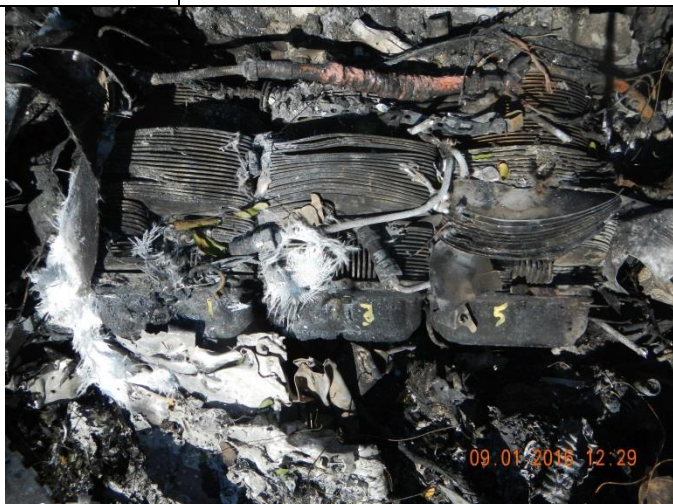
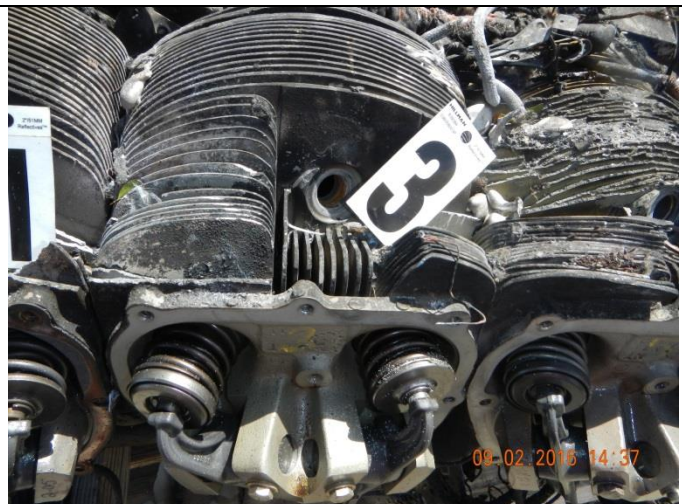
CYLINDER #3

The cylinder exhibited thermal damage

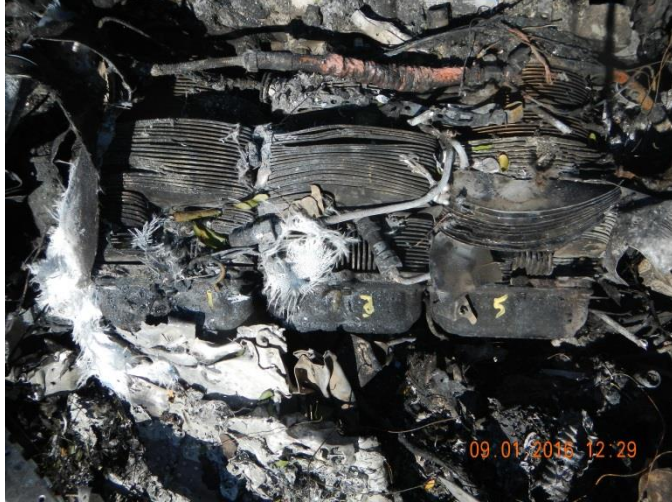
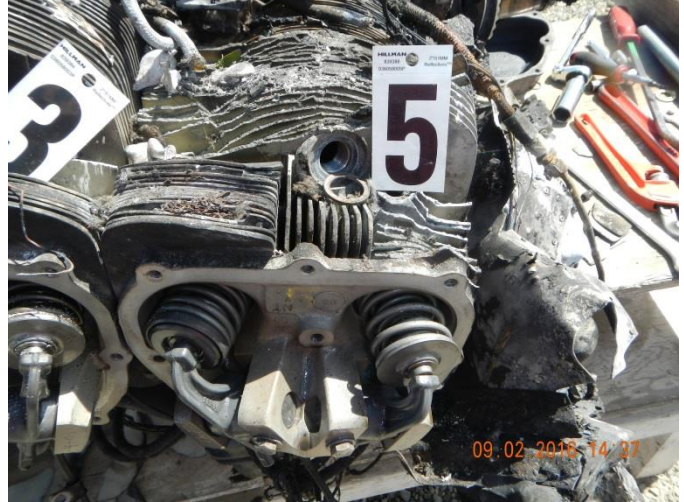
CYLINDER #5

Forward cooling fins were heavily damaged during impact and the cylinder exhibited thermal damage

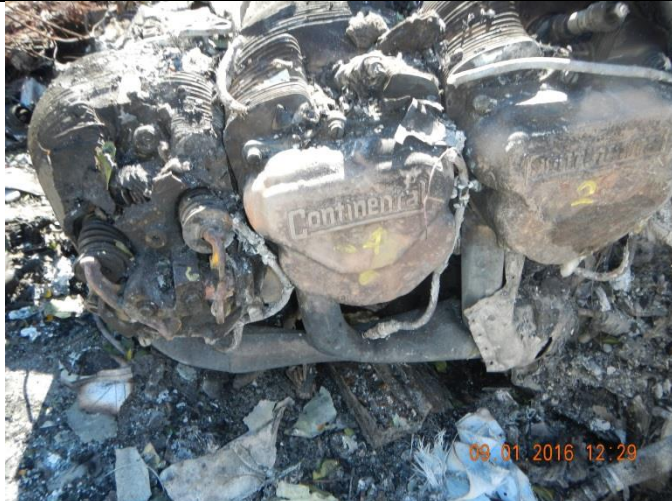
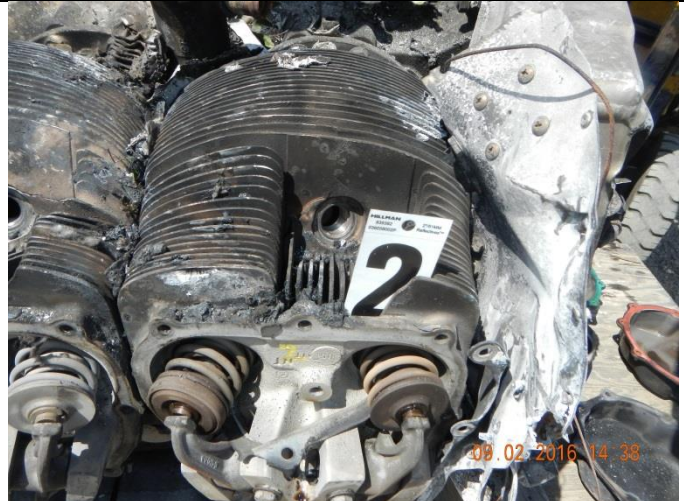
CYLINDER #2

The cylinder exhibited thermal damage.

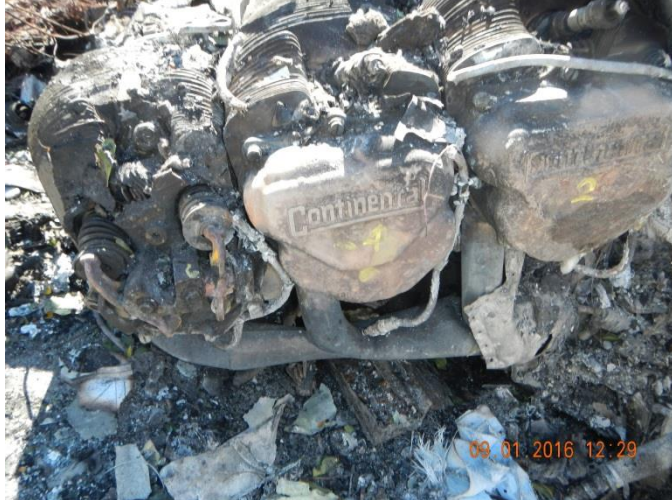
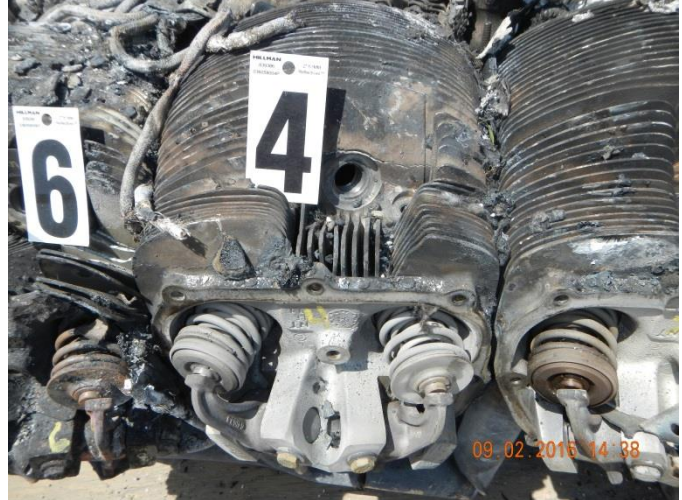
CYLINDER #4

The cylinder exhibited thermal damage.

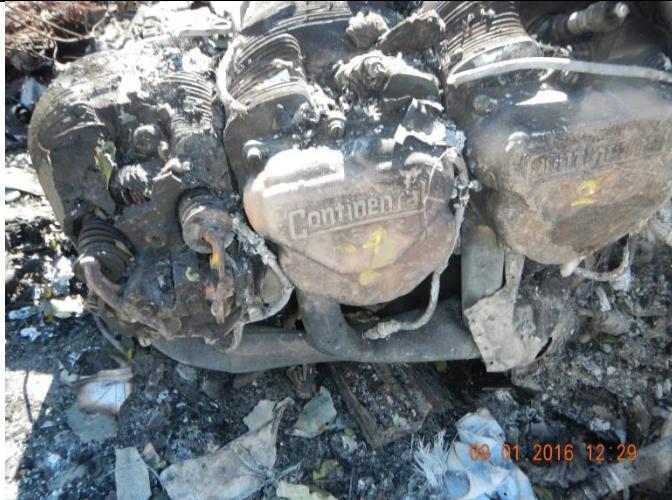
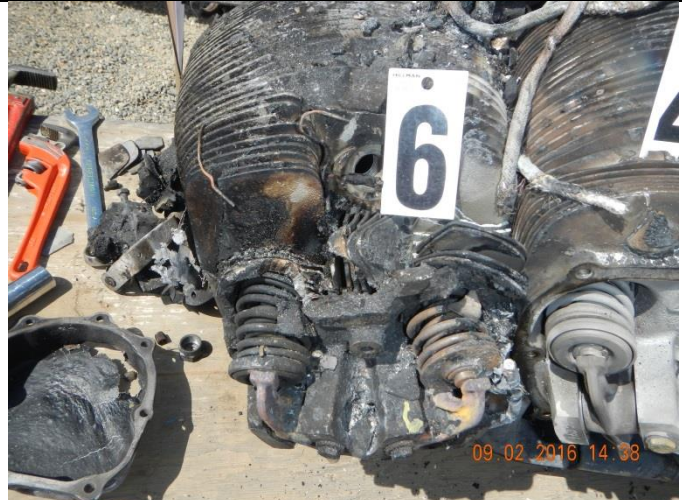
CYLINDER #6

The cylinder received impact damage to cooling fins and the rocker box cover separated. The cylinder also exhibited thermal damage.

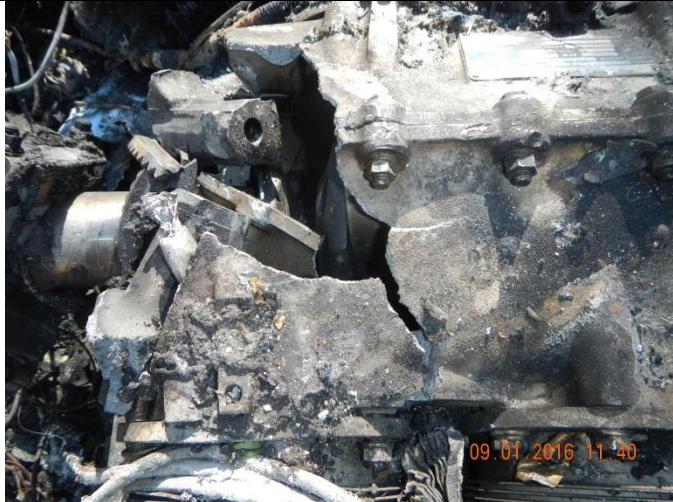
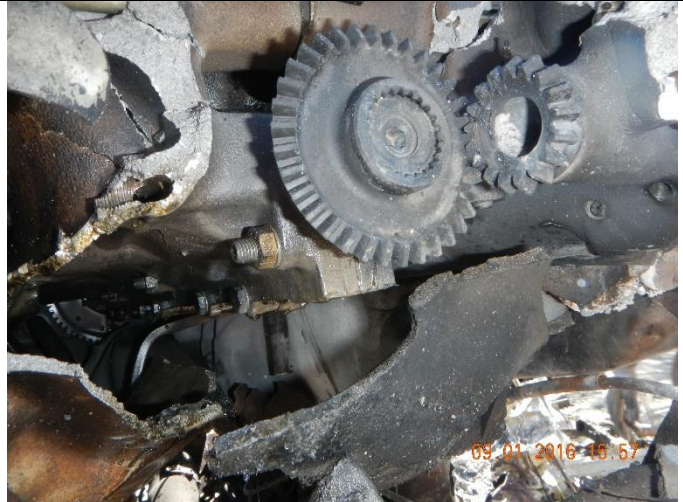
### CRANKCASE

The engine crankcase halves were intact with the exception of the lower forward portion, which separated exposing internal components. With the lower forward crankcase material missing, the # 6 connecting rod was exposed which exhibited a forward bending motion along the length of the connecting rod. This motion suggests that the crankshaft was forced rearward during the impact sequence. The crankshaft propeller flange separated and remained with the separated propeller. The forward portion of the damaged crankshaft exhibited an upward and left bending motion. The forward crankshaft main bearing saddle and bearings separated and were found outside of the crankcase forward of the engine. The face gear attached to the forward crankshaft was impact damaged.

The lower portion of the crankcase was heavily impact damaged exposing the internal components.

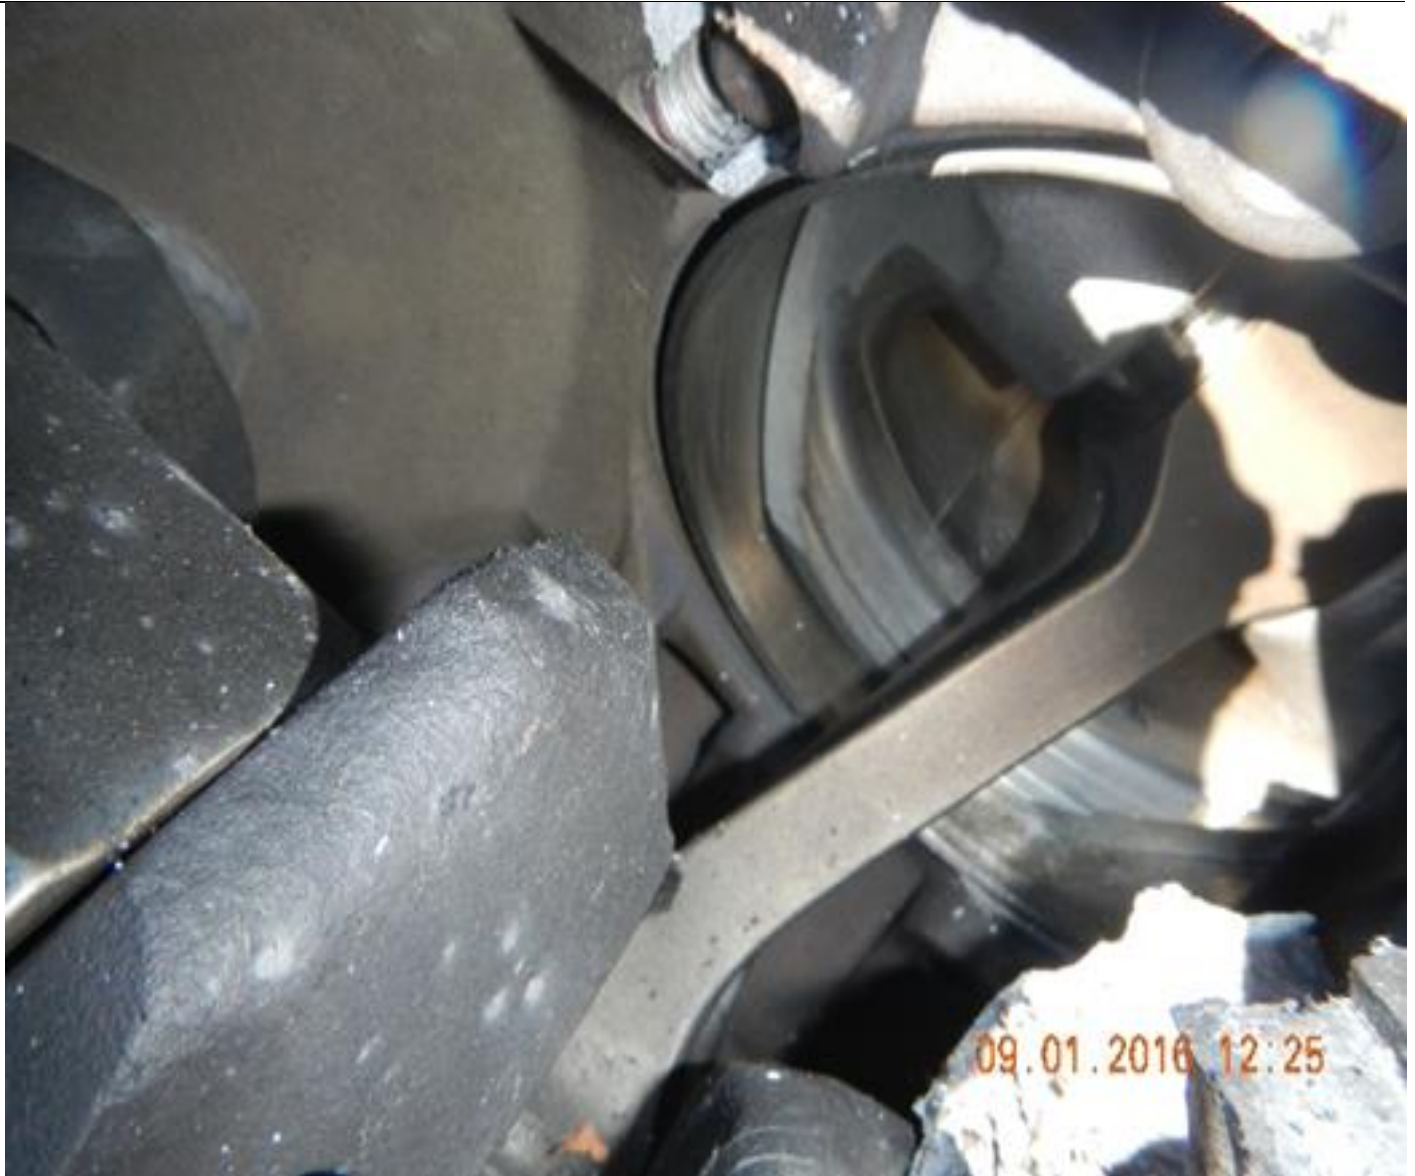
The connecting rod was visible through the breach in the forward crankcase. The # 6 connecting had a bending signature consistent with the crankshaft shifting rearward at impact.

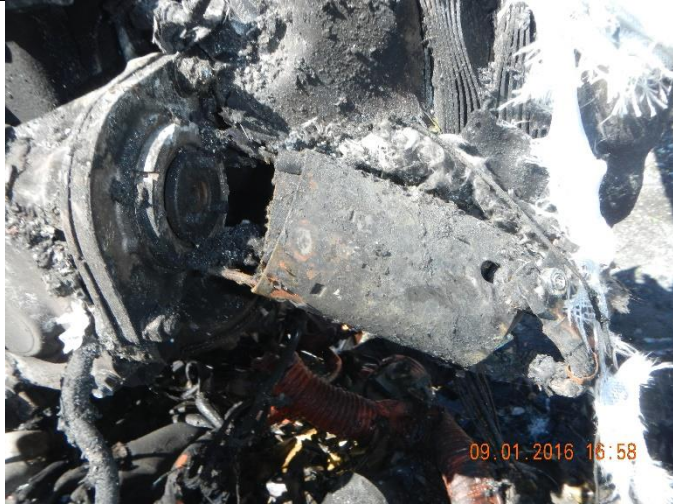
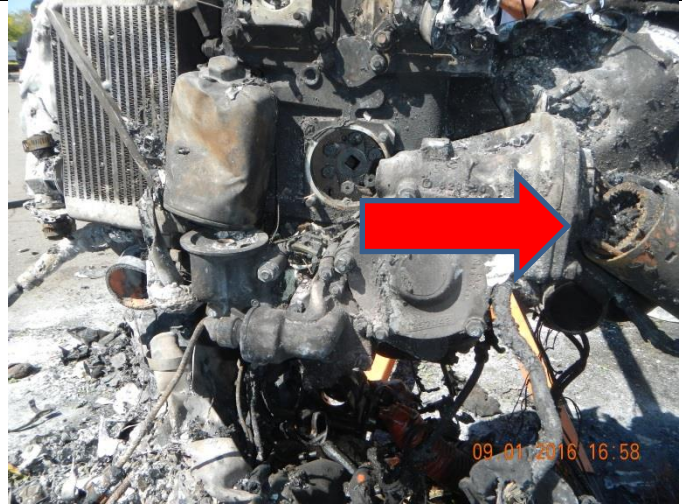
### STARTER

The starter partially separated and exhibited thermal damage. The red arrow points to the starter.

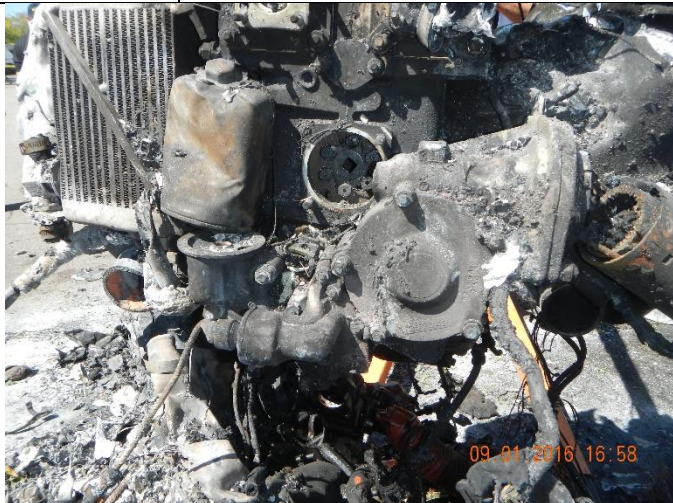
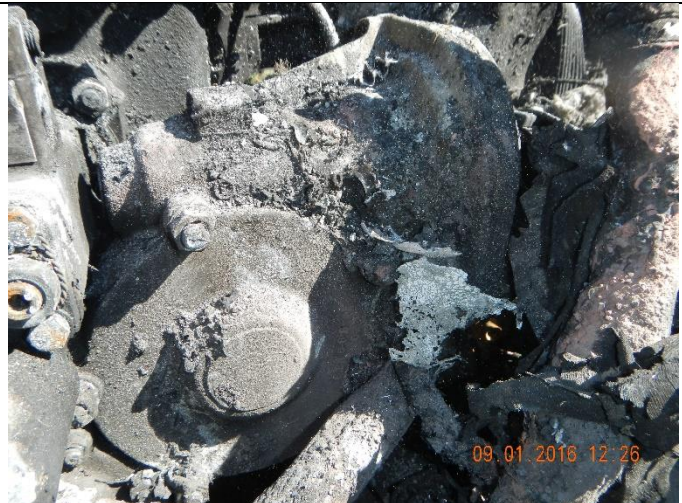
### STARTER ADAPTER

The starter adapter appeared to be intact but received thermal damage.

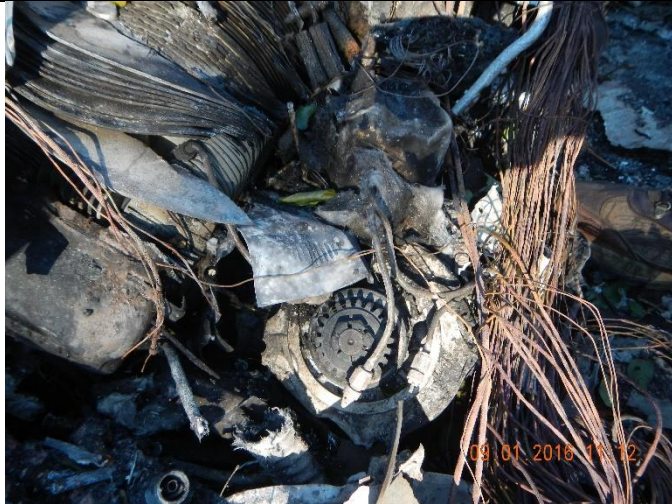
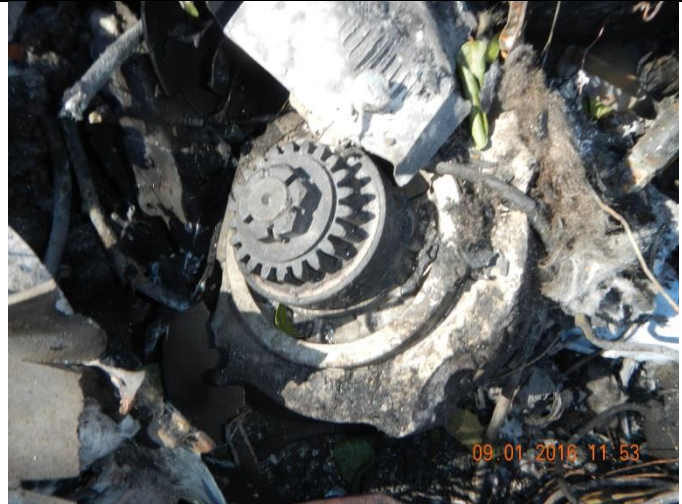
ALT #1

The alternator separated from its mount due to impact forces. Electrical cable remained attached.
