# Continental Motors

## ENGINE FIELD INSPECTION REPORT

| <b>ENGINE MODEL</b> | IO550C-6F converted to IO550B |
| <b>FILE NUMBER</b> | 16-143 |

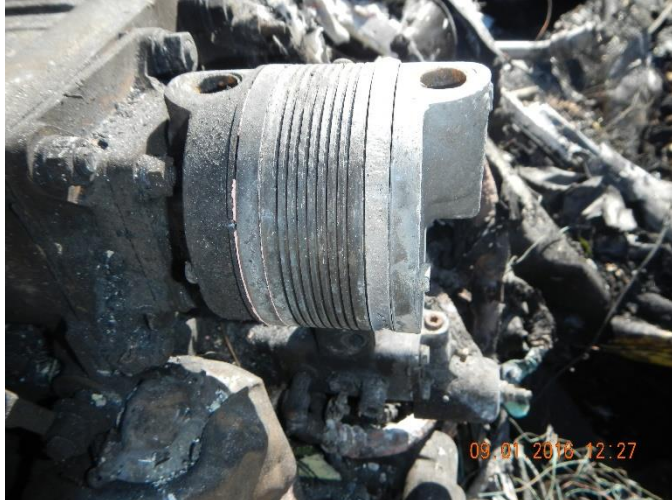
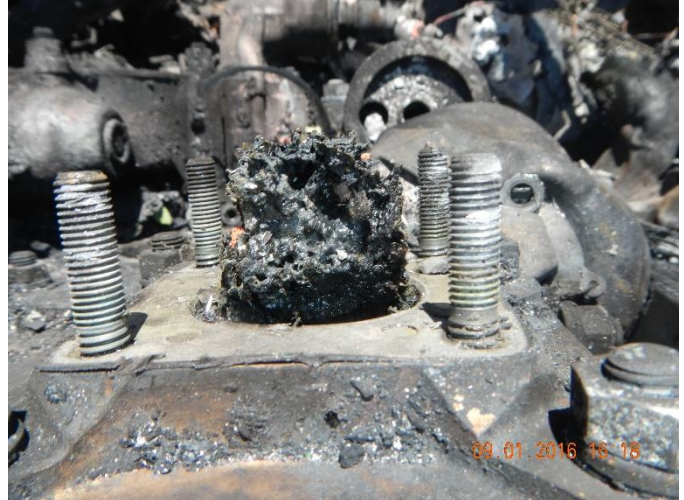
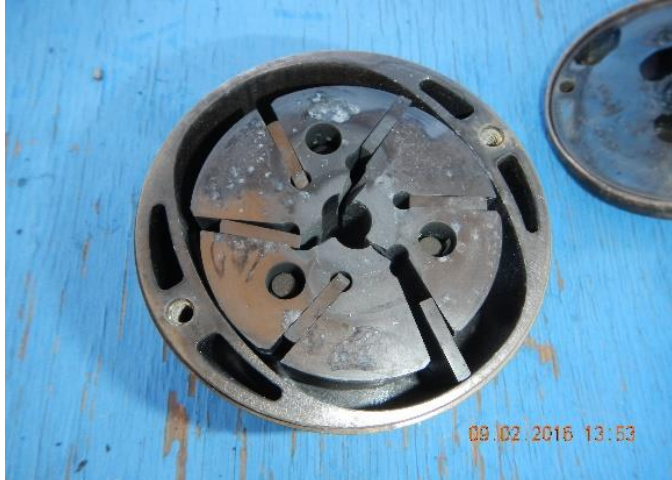
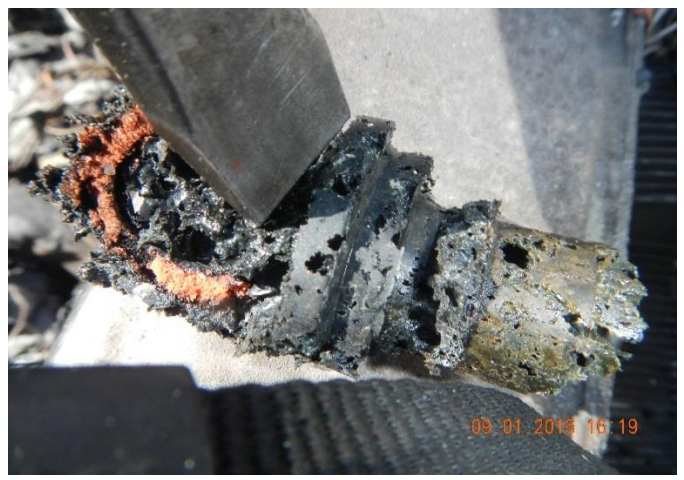
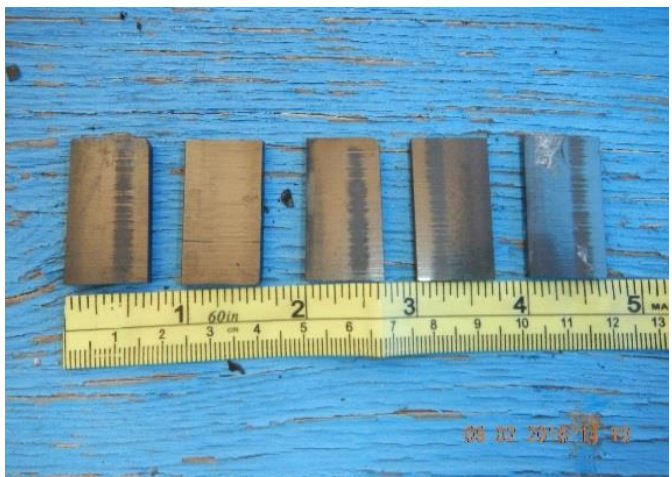
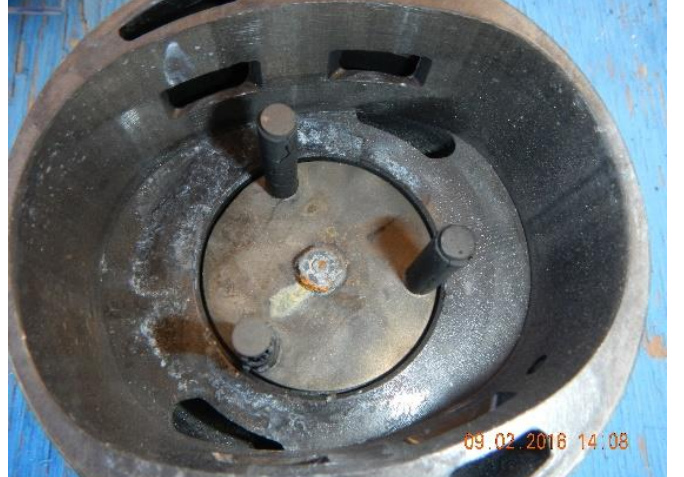
## VACUUM PUMP

The instrument air pump was removed to inspect the plastic drive gear. The drive gear was found to be thermally destroyed.

The instrument air pump was removed, disassembled and inspected. The plastic drive gear was thermally destroyed. The carbon rotor was broken but the individual blades were intact.

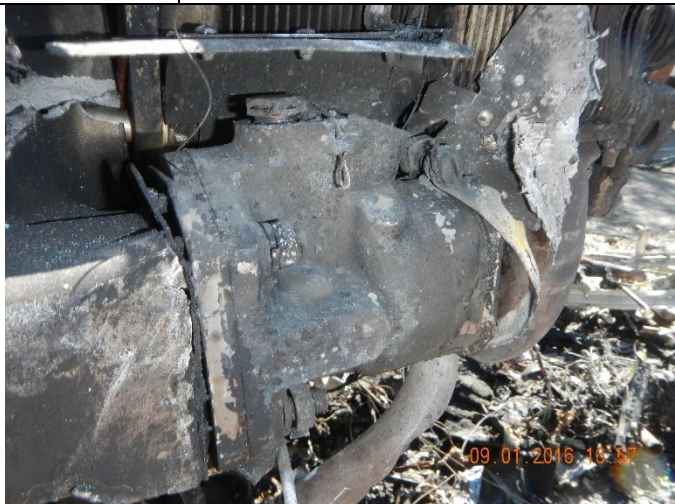
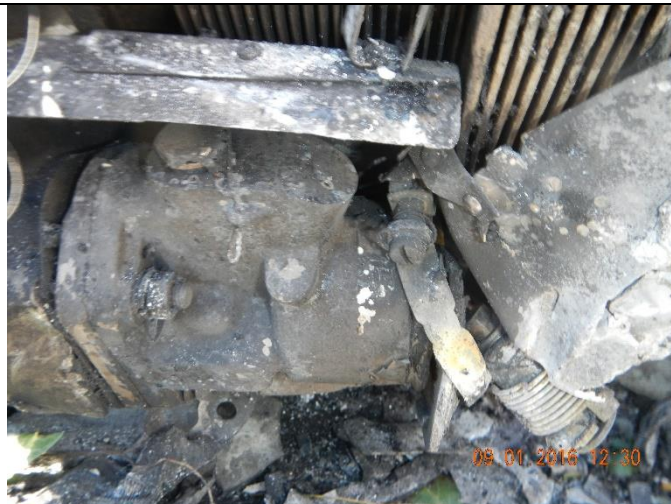
PROPELLER  
GOVERNOR

The propeller governor was impact damaged but remained attached to its mount. The control arm separated but remained attached to the control cable.

The governor was impact damage with the outboard section of the housing separated. The control cable remained attached and secured to the control arm. Thermal damage was also exhibited.
