# NATIONAL TRANSPORTATION SAFETY BOARD

## Sound Spectrum Study

**Specialist's Study Report  
by Christopher Babcock**

Location: Reno, Nevada  
Date: September 11, 2016  
Aircraft: Piper PA-28R-201T  
Registration: N821ET  
Operator: Private  
NTSB Number: WPR16FA178

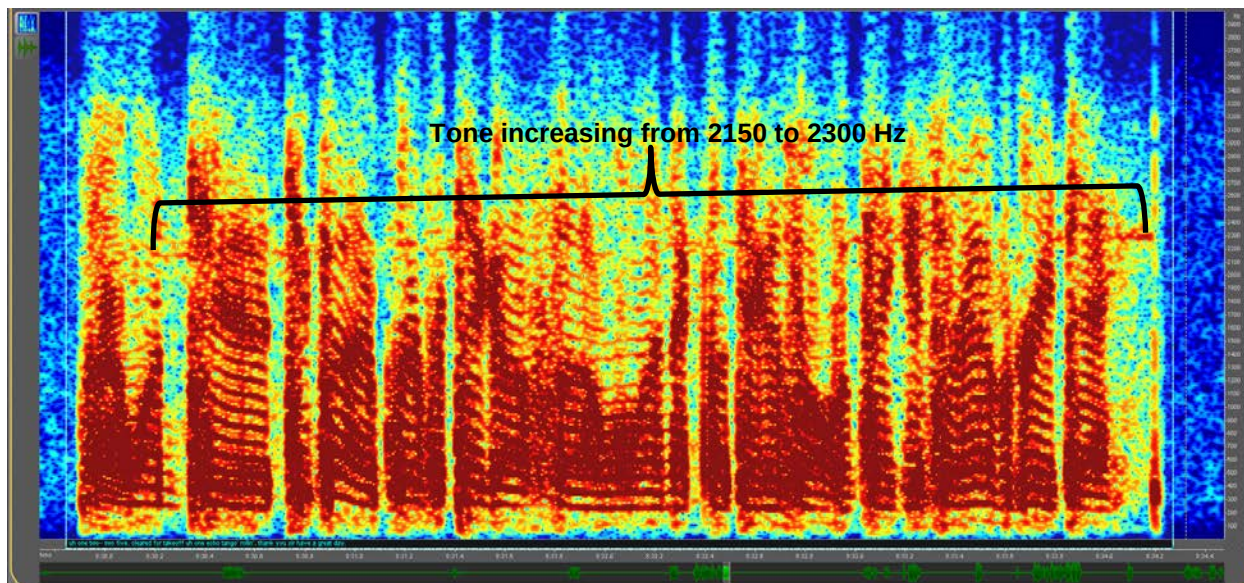
**Figure 1.** Spectrogram of takeoff clearance readback (color adjusted to emphasize increasing tone).

Figure 1 shows a faint tone increasing from about 2150 Hz to about 2300 Hz at the end of the transmission. This is a potential match for the turbocharger shaft second harmonic nearing takeoff power as the throttle was increased. This corresponds to turbocharger shaft speeds of 64500 rpm increasing to 69000 rpm. Sounds of the engine and propeller were not visible, likely because of the combination of audio processing effects between the microphone, radio system, and ATC recording system causing a rolloff below approximately 150 Hz.

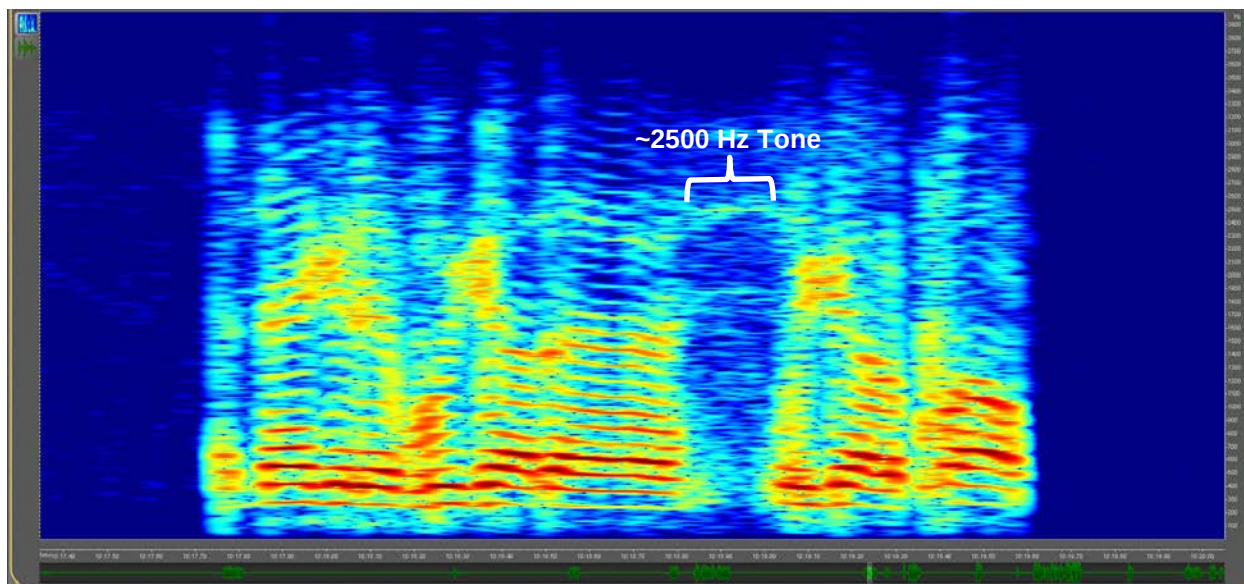
**Figure 2.** Spectrogram of pilot reporting a problem.

Figure 2 shows a tone at approximately 2500 Hz during a pause in the pilot's speech. This is also a potential match for the turbocharger shaft second harmonic corresponding to a shaft speed of 75000 rpm. Propeller and engine sounds were not visible. There are no tones consistent with a stall warning horn visible in the spectrogram. Figure 3 shows a spectrogram of an in-aircraft recording of an exemplar stall horn.

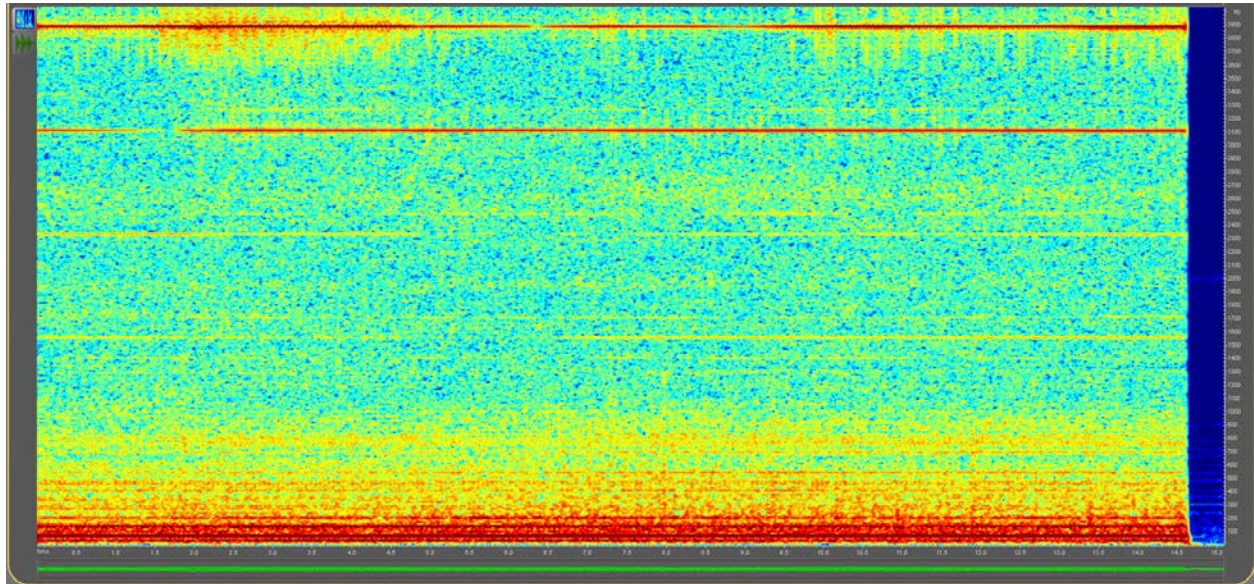
**Figure 3.** Exemplar in-aircraft recording of PA-28 stall horn
