Tail Number: 821ET

## RECORD OF CONVERSATION

**Date: September 11, 2016**  
**Person Contacted: Robert Stave**  
**NTSB Accident Number: WPR16FA178**

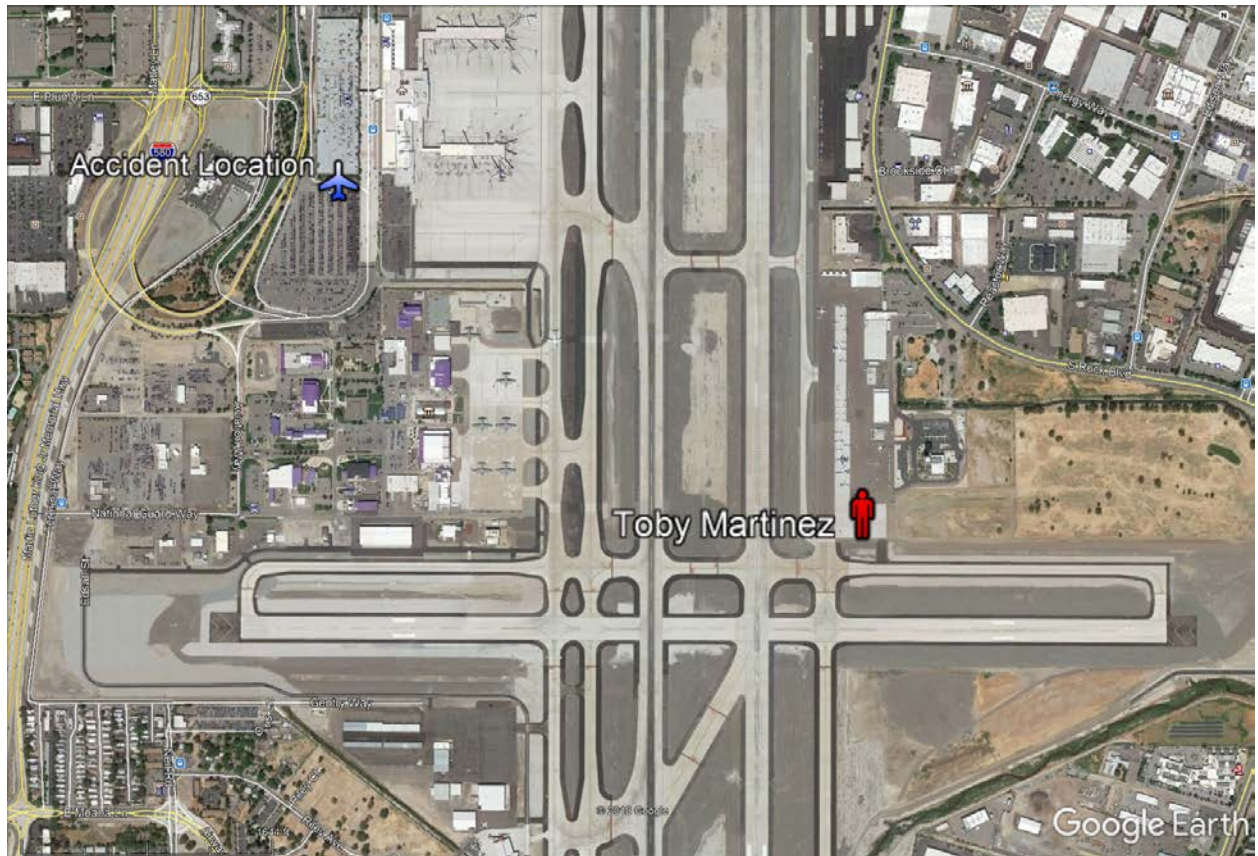
- He is a line technician at the KRNO Atlantic Aviation FBO.
- At the time of the accident, he was positioned at the south ramp, just north of Runway 25. (see attached image).
