## **NATIONAL TRANSPORTATION SAFETY BOARD**

### **AIRFRAME AND ENGINE EXAMINATION**

**WPR16FA178**

Location: Reno, Nevada  
Date: September 11, 2016  
Aircraft: Piper PA28R-201T, Registration Number: N821ET  
NTSB IIC: Elliott Simpson

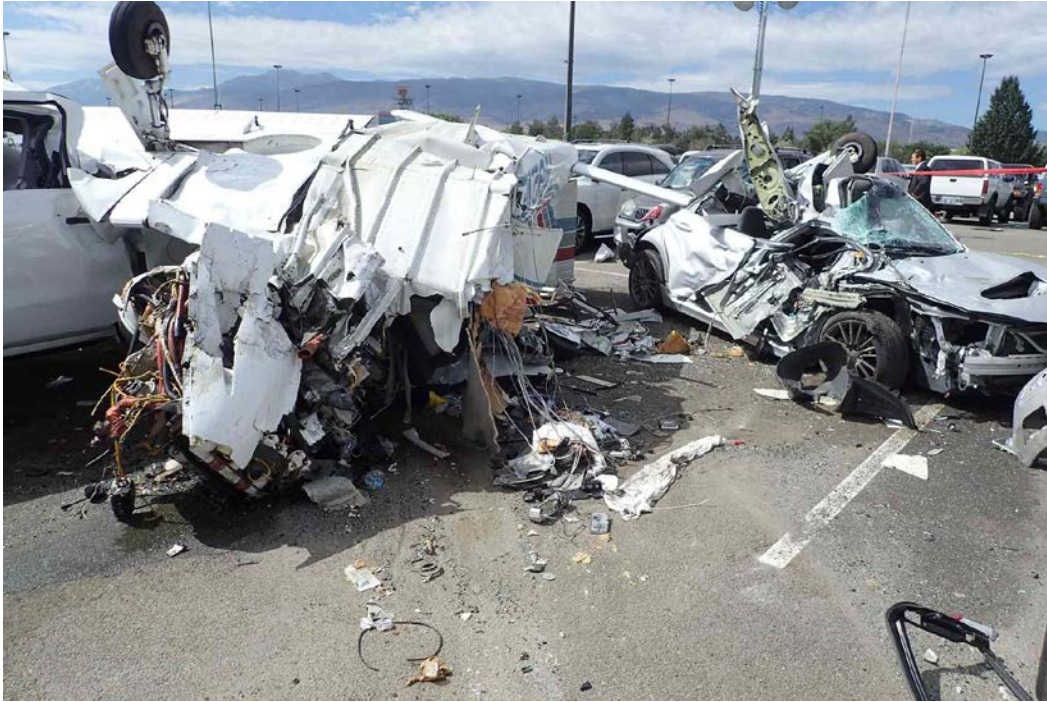
Photo 1 – Accident Site

The airframe sustained crush damage throughout, compressing the forward cabin through to the vertical stabilizer (Photo 1). The right wing was separated at the root. The engine remained partially attached to the firewall, which had detached from the forward cabin, and remained attached by control cables and engine supply hoses and electrical lines.

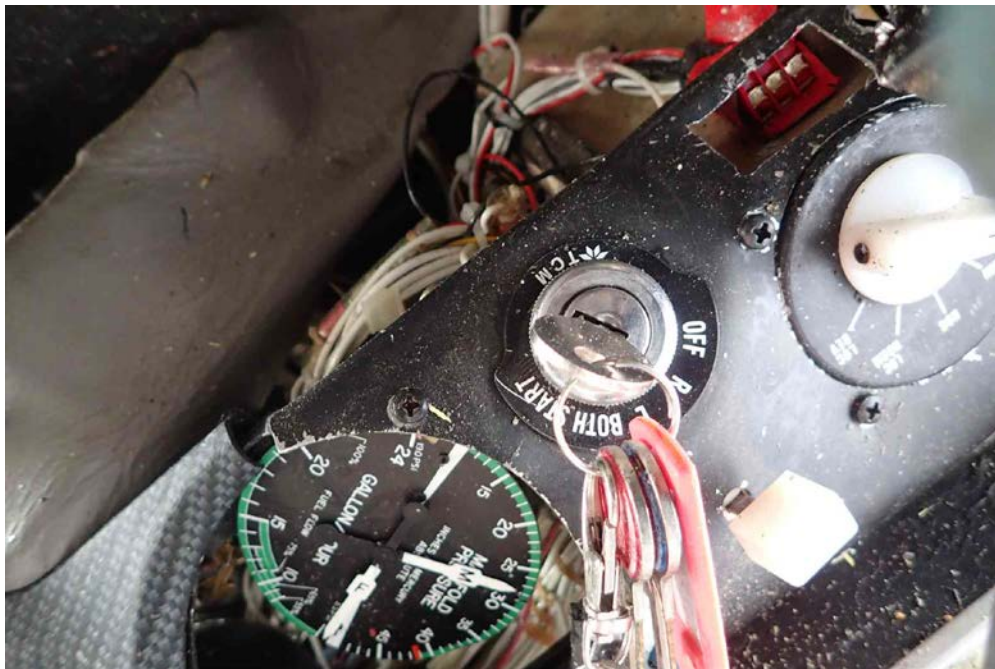
Photo – 2 Ignition Switch

Within the cabin, the instrument panel had sustained extensive fragmentation along with all flight controls. The ignition key at the accident site was in the ignition switch, appeared bent, and set in the right magneto position (Photo 2). The fuel boost pump was in the OFF position and had become impinged against its instrument panel cutout, and the battery switches were both in ON position (Photo 3). The autopilot controller face was crushed; the roll selector set to the right position. The fuel flow transducer was opened and appeared free of obstructions. The fuel selector was in the left tank detent (Photo 4). The gascolator had been crushed, exposing the inner surface of the bowl. The bowl was free of corrosion or blockage, and the screen was free of debris.

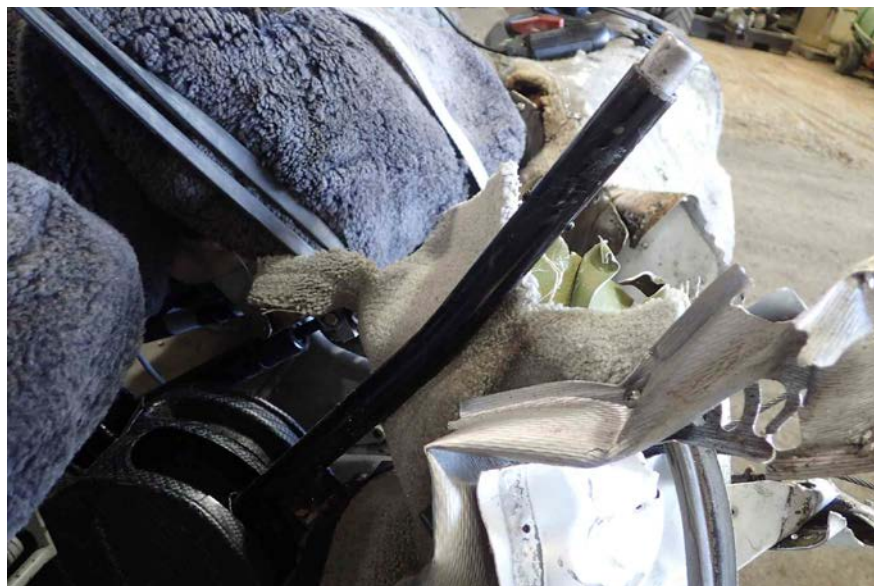
Photo 5 – Flap Control

The flap cabin control lever had become lodged against the buckled cabin floor, and was in the 10-degree flap position detent (Photo 5). The flap control torque tube remained attached to the drive sprocket, and the drive chain cables were continuous to the flap control lever assembly. The chain was close to its full travel position (Photo 6), extending the return spring; the Piper representative described the chain position as consistent with full flap deployment. The flap system design does not allow for movement of the lever down without pressing the lever button. As such, the discrepancy between the flap sprocket and flap lever most likely occurred during impact, with the most likely setting being either zero or 10 degrees flap.

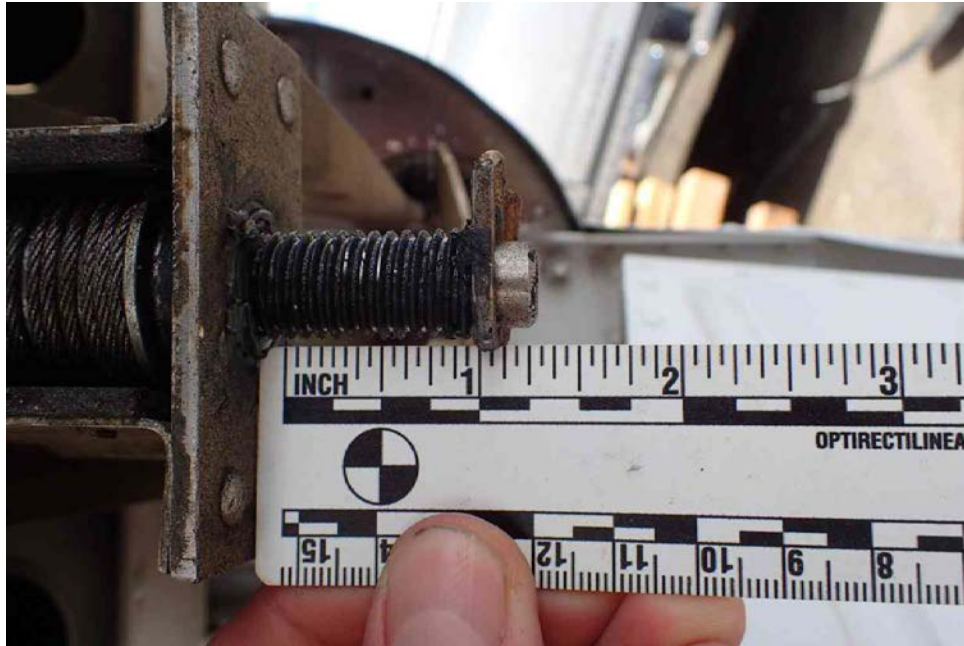
Photo 7 – Stabilator Trim Screw

The stabilator trim tab along with its associated trim screw and control arm assembly remained attached to the stabilator. The trim cables were continuous through to the trim wheel. The wheel assembly had become impinged against the cabin cover, and the indicator was in the full DOWN position. The trim jack screw in the aft cabin exhibited 12 exposed screw threads on the top side. (Photo 7). According to the Piper representative zero exposed threads indicated full nose down trim, 5 threads neutral, and 16 full nose up. The trim cable, passed through the autopilot stabilator trim servo assembly on its routing through to the control wheel. The servo capstan and tension wheels were intact and moved freely by hand, with no binding noted.

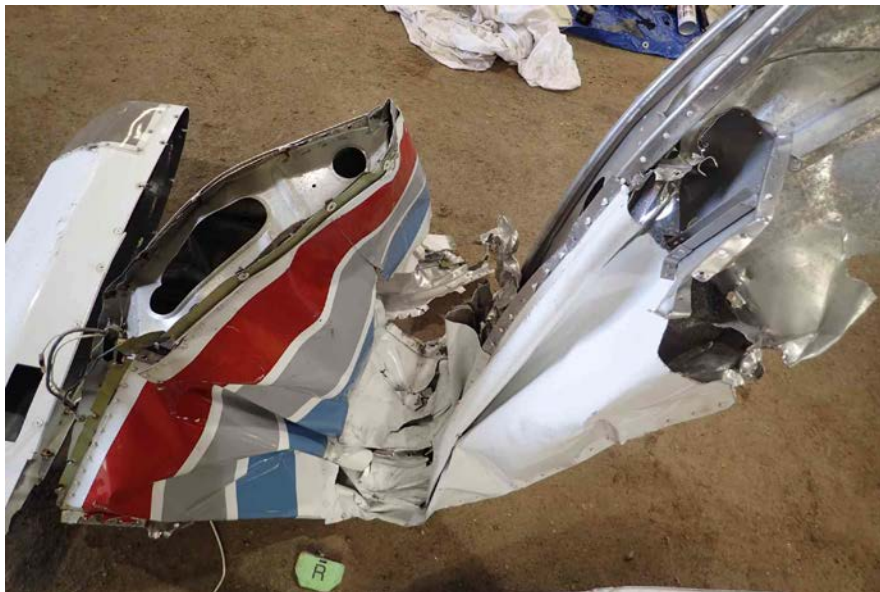
Photo 8 – Right Outboard Wing Section

The right wing separated from airframe at the root; the outboard wing tip had separated at aileron bellcrank, about 5 ft from the tip. The outboard section sustained a deep square indentation through to the aft spar about the same diameter as the damaged light pole in the airport parking lot (Photo 8). The aileron remained attached at inboard and center hinges. The outboard section of the aileron had separated and was found in debris field, torn away from outboard hinge which was still attached to the wing trailing. The bellcrank had separated from the airframe, and aileron push-pull tube. The fuel tank had been breached at the leading edge; the fuel filler cap was in place, and the fuel supply screen had broken away from its fitting. The flap remained attached at all three hinge points. The flap sustained limited damage beyond an upwards bend to the trailing edge about 3 ft from the root.

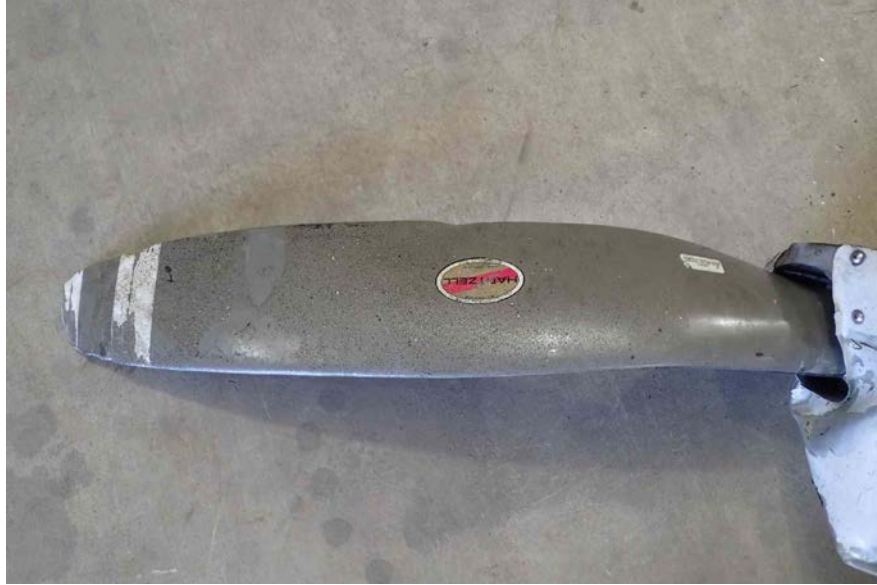
Photo 9 – Propeller Blade

Both propeller blades remained attached to the hub. One blade exhibited an aft 5-degrees curve at the root, and the leading edge at the tip had sustained multiple nicks and chordwise abrasions at the tip (Photo 9). The second blade exhibited an aft curvature, with the tip separated about midspan. The tip exhibited nicks, and material loss along its entire leading edge with chordwise abrasions (Photo 10). The tips separation surface was jagged in appearance (Photo 11). The hub remained attached to the crankcase flange, which had separated from the crankcase at the forward oil seal. The separation surface exhibited a 45-degree sheer lip around its entire circumference (Photo 12). The propeller governor remained attached to the crankcase, but had sustained crush damage. The control arm and cable remained attached.

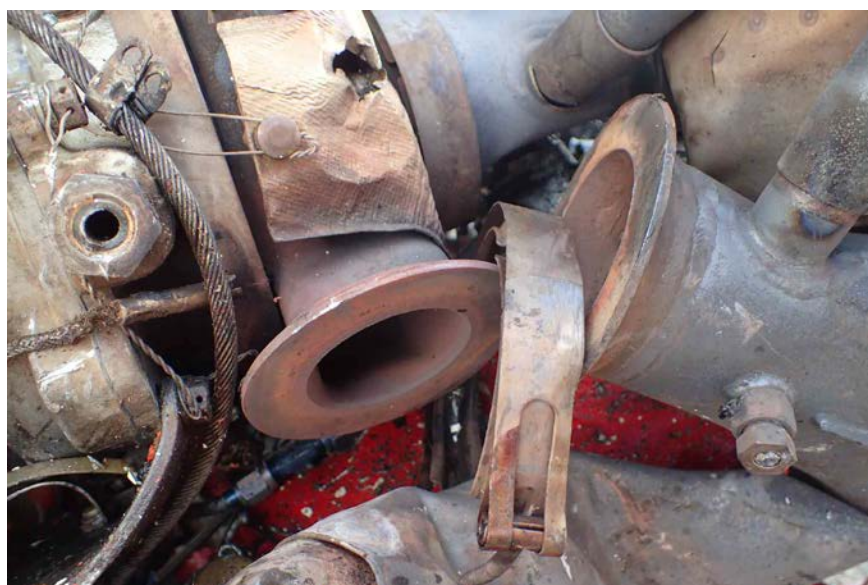
Photo 14 – Turbine Inlet

The turbocharger assembly had become partially detached from the engine, and all exhaust pipes were crushed. The turbo overboost valve had separated, and appeared intact, and the V-band clamp had broken away from the inlet side of the turbine shroud (Photo 14). The inlet manifold to the compressor had broken away at the shroud. The turbine and compressor wheel blades were intact, and the wheels could be rotated freely by hand (Photo 15).

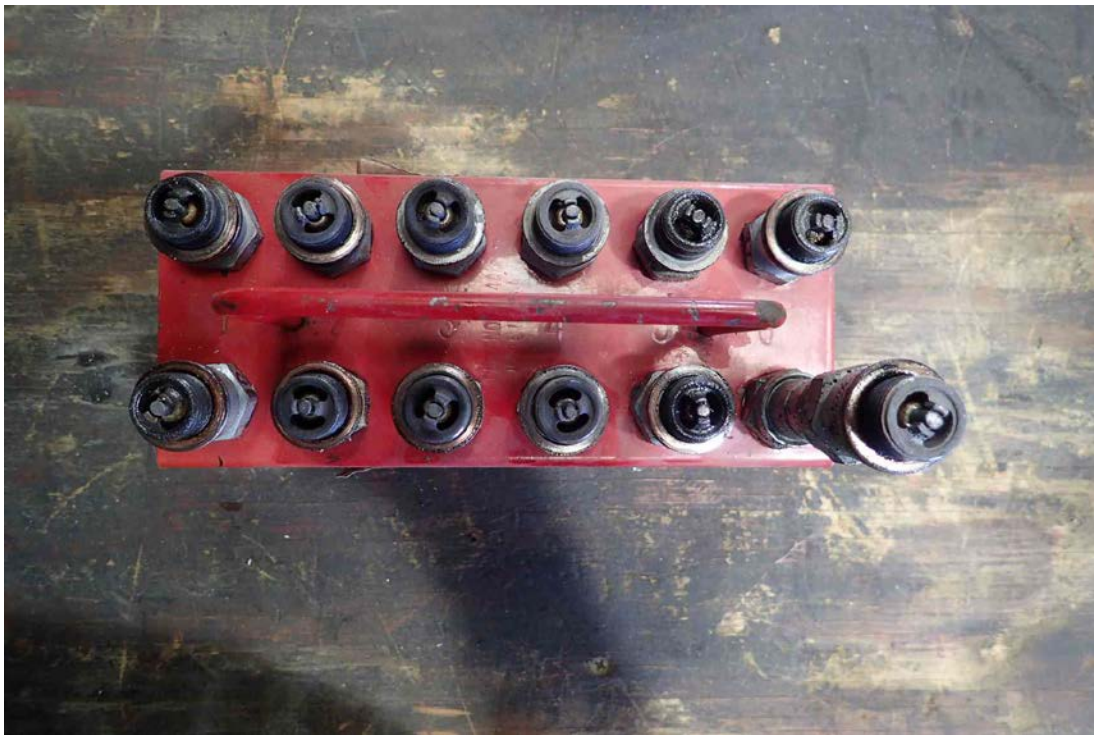
Photo 16 - Spark Plugs

Cylinders 4, 5, and 6 were silver in color, with all remaining cylinders red. Cylinder 6 exhibited forward crush damage, separating the intake and exhaust rockers. All pushrods appeared undamaged. The engine could be rotated smoothly via the vacuum pump accessory drive, all valves exhibited similar lift heights, and drive train continuity was confirmed through to the accessories. “Thumb” compression was observed on all cylinders except number 6. The upper and lower spark plugs for cylinders 2, 3, and 4 along with the lower spark plug for cylinder 6 exhibited grey deposits. The remaining plugs were coated in oil. All plugs exhibited worn out-normal signatures when compared to the Champion AV-27 Check-A-Plug chart. (Photo 16)
