## **NATIONAL TRANSPORTATION SAFETY BOARD**

# **TURBOCHARGER AND PROPELLER SYSTEM EXAMINATION REPORT**

**WPR16FA178**

Location: Reno, Nevada  
Date: September 11, 2016  
Aircraft: Piper PA28R-201T, Registration Number: N821ET, Serial #: 28P-7703147  
NTSB IIC: Elliott Simpson

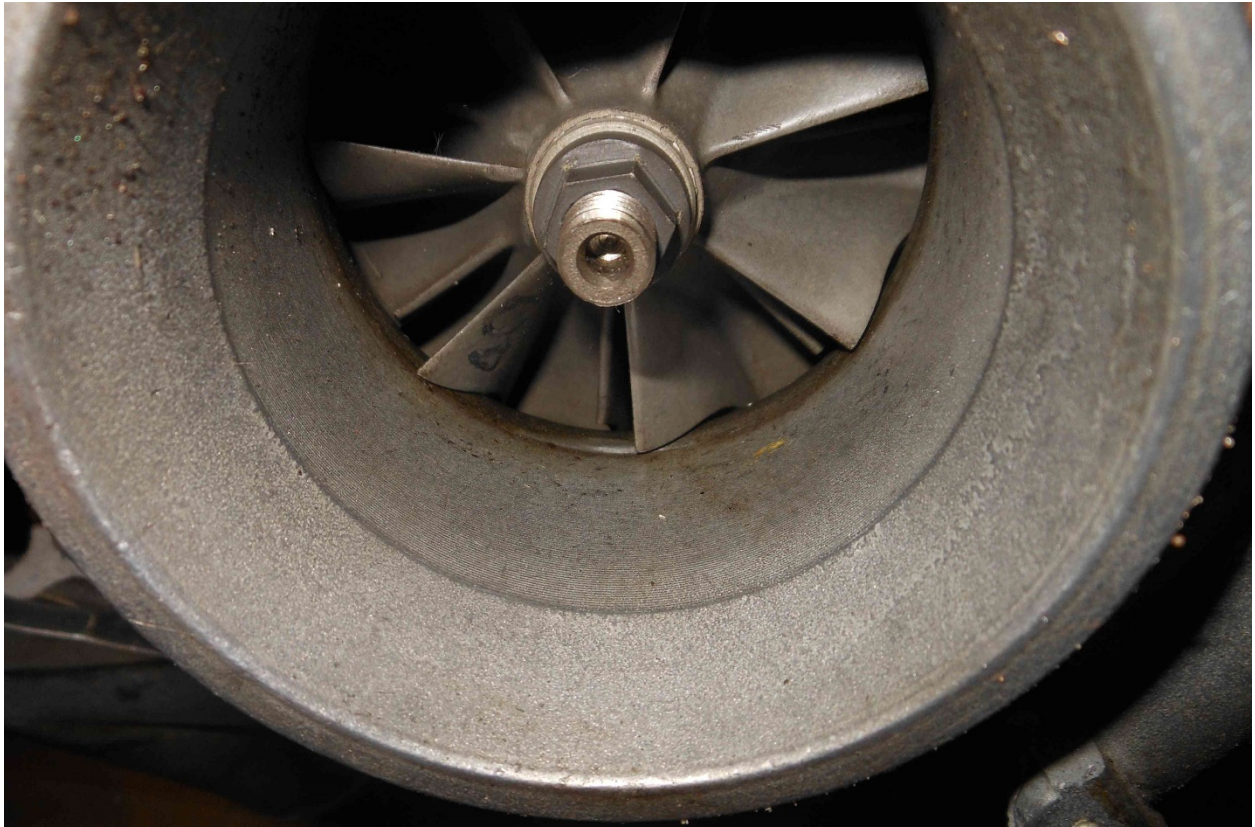
Photo 1 – Impeller Wheel

The turbocharger assembly was largely intact, except for the outlet to the compressor housing assembly, which had broken away. The exhaust pipe had been crushed and remained attached, along with the Merlyn upper deck pressure control unit, to the turbine housing via the exhaust band clamp. The impeller wheel could not be rotated, and a radial score mark was observed next to the impeller wheel in the area adjacent to the inlet. (Photo 1) (During the initial engine examination, dated September 14, 15, 2016 – the impeller wheel could be rotated by hand). The impeller wheel was intact, and no blades were missing or exhibited obvious signs of damage. The impeller nut was in place, and the Vee clamp was intact and safety wired.

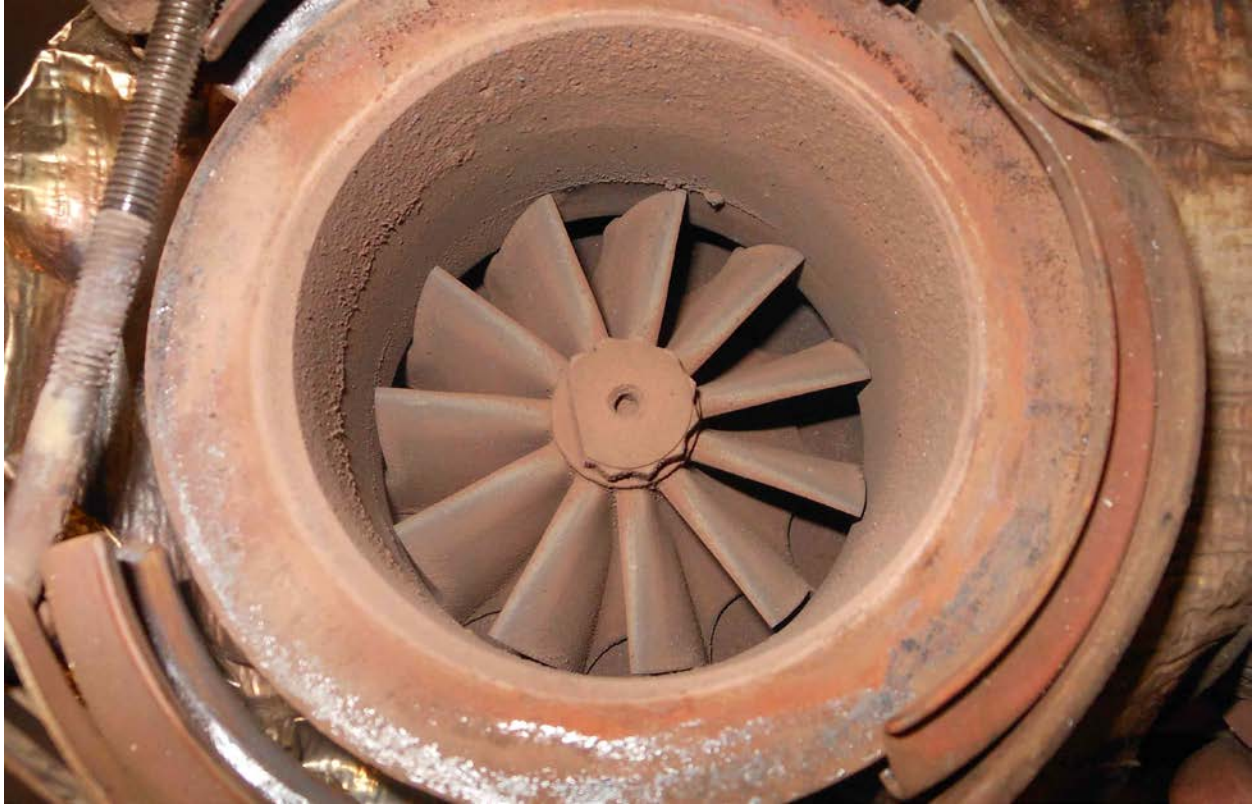
Photo 2 – Turbine Wheel

The exhaust pipe was removed, and a radial score mark was observed on the turbine housing next to the turbine wheel in the area adjacent to the inlet. (Photo 2). The housing was removed and score marks were observed to the outer blade surfaces of the outer turbine. All turbine wheel blades were intact and did not exhibit obvious indications of damage.

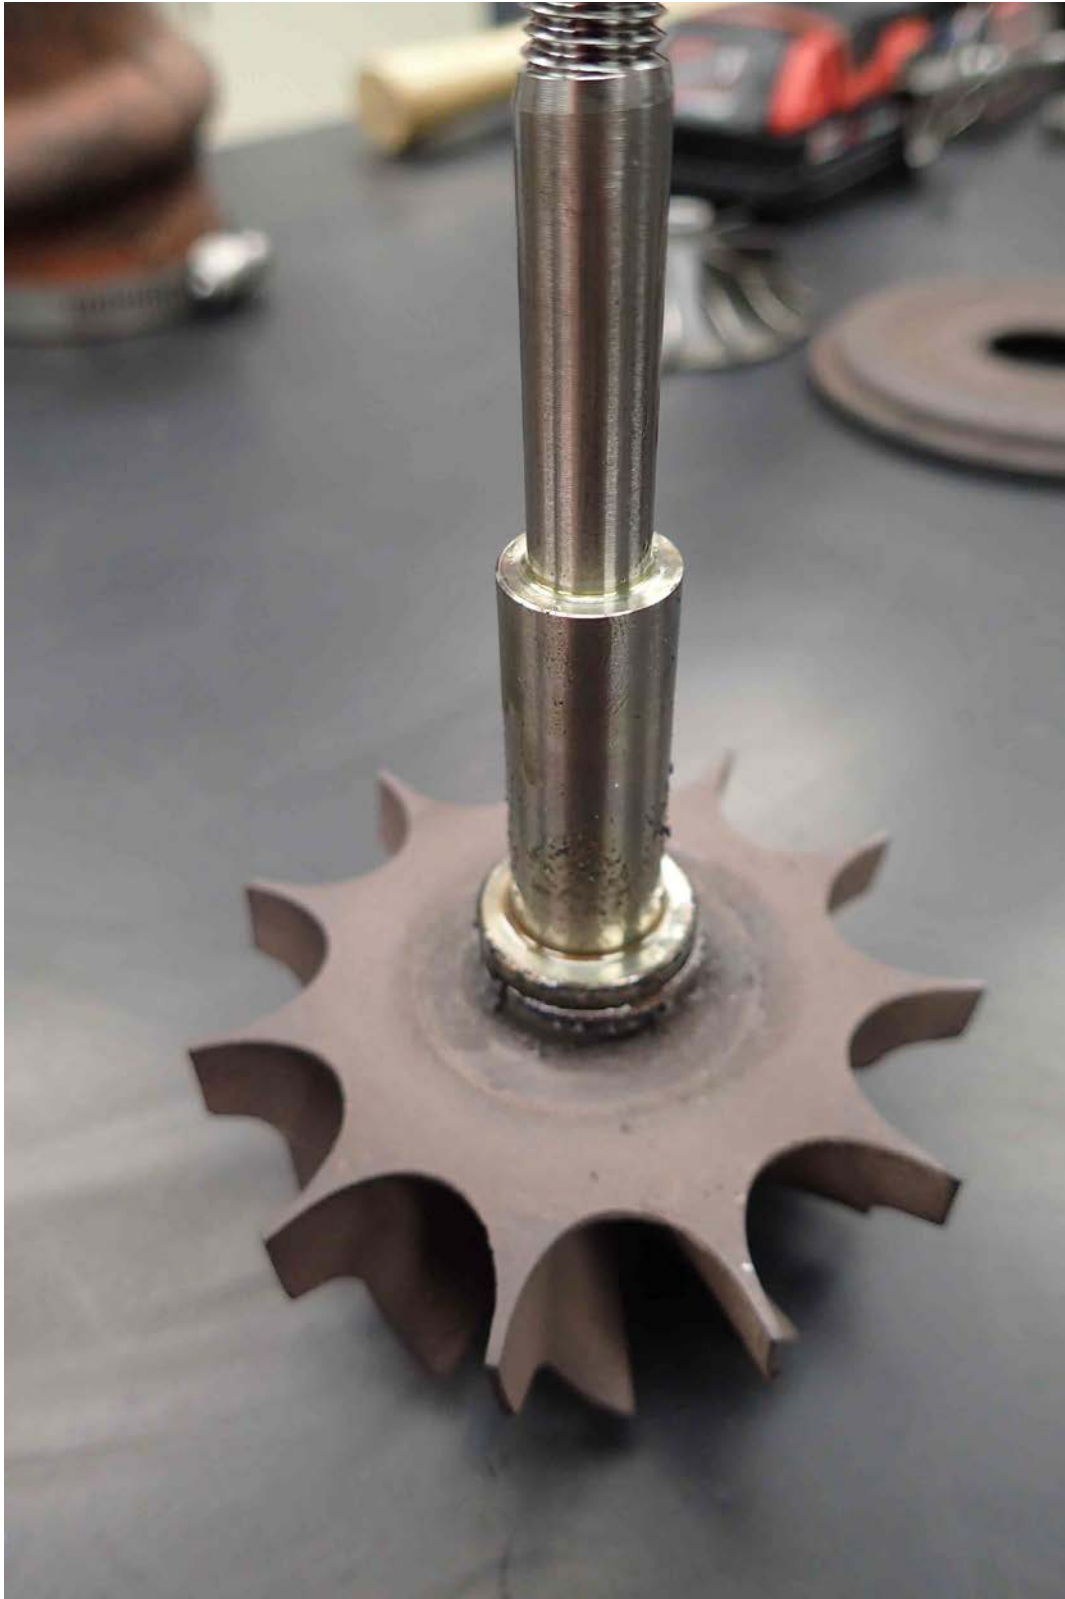
Photo 3 – Turbine Shaft

After the compressor wheel was removed, the turbine wheel could be rotated by hand. The turbine shaft was intact after the wheel was removed, and a light coating of oil was observed on the shaft bearing surface, which was free of scoring (Photo 3). Black coke deposits were observed on the center housing and spring ring, which according to the HET representative, was consistent with relatively low in-service life. The journal bearing was intact and wet with oil. The single feed bearing and bearing bore was coated in oil, and free of coke deposits (Photo 4). The oil feed and drain passages were clear.

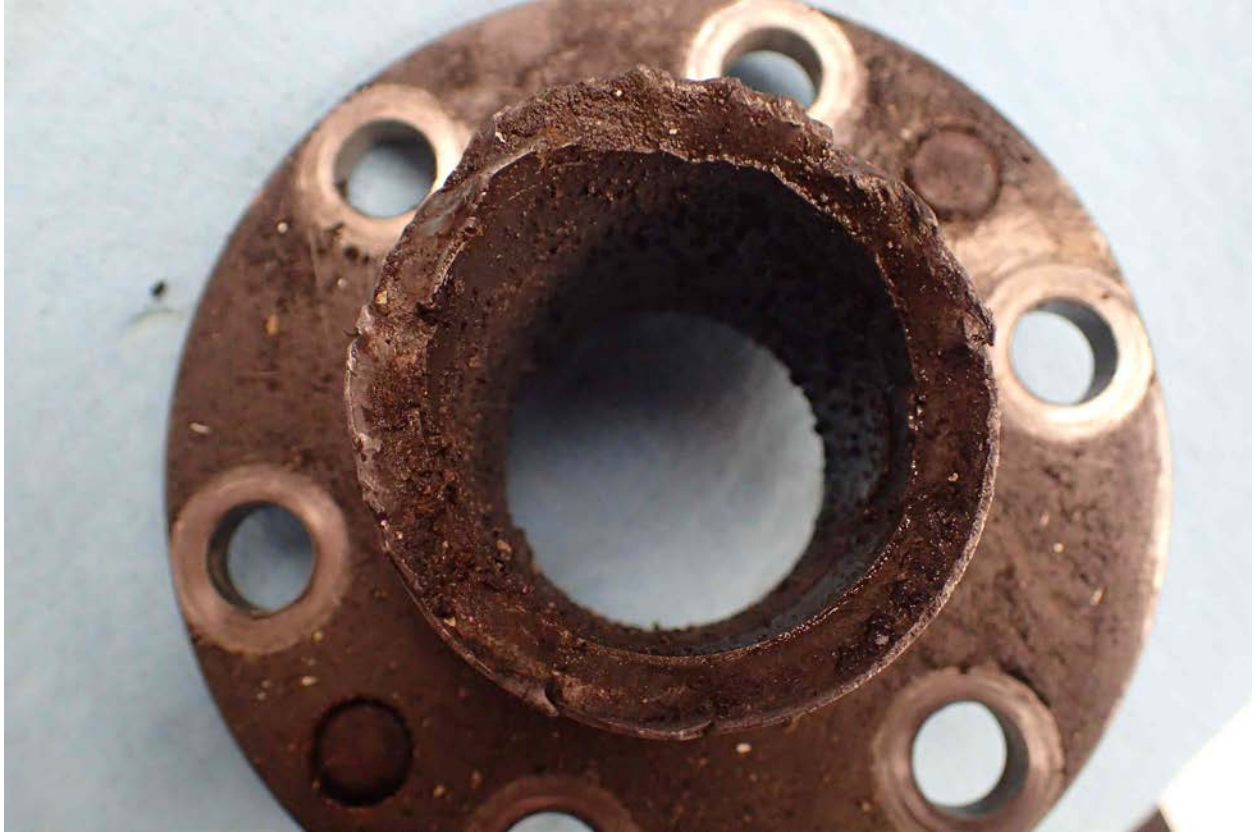
Photo 5 – Crank Flange

The spinner had crushed around the propeller hub and was removed to facilitate examination. The hub remained attached to the crank flange, which had separated from the crankshaft. The shaft exhibited a conical 45° shear lip around its entire circumference, with serrated, ratchet-like tear features around most of the crown (Photo 5). Circumferential crack marks were present on the radial surface of the shaft adjacent to the ratchet marks.

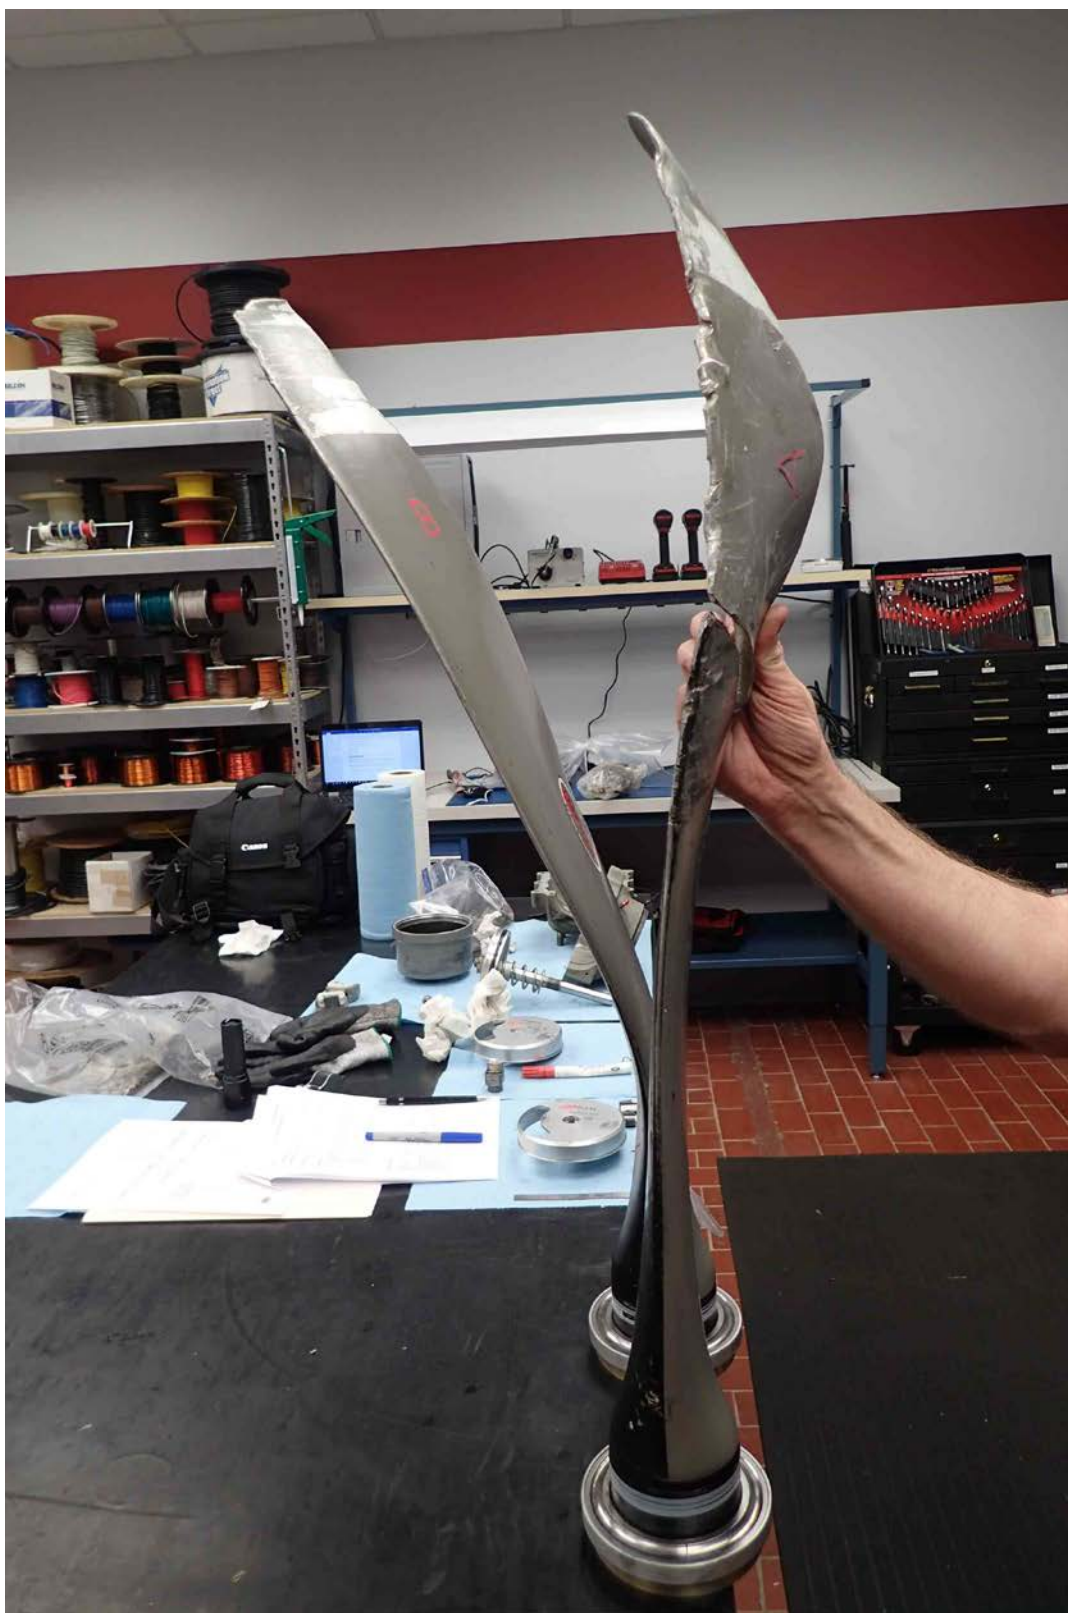
Photo 6 - Propellers

Blade A exhibited leading edge gouging, chordwise scratches to its front and aft surfaces (Photo 7, 8, 9), and an S-bend along its entire length (Photo 6). The blade angle was in the high pitch position at the root. The outboard approximately 16-inch long section of the tip, had separated leaving a jagged tear pattern (Photo 7, 8, 9).

Blade B was intact and appeared to be in a position beyond the high pitch stops. The blade exhibited chordwise scoring on its forward side, and was bent about 15 degrees aft, about 12 inches from the root (Photo 6). A 1-inch section of the tip appeared to have torn away and was

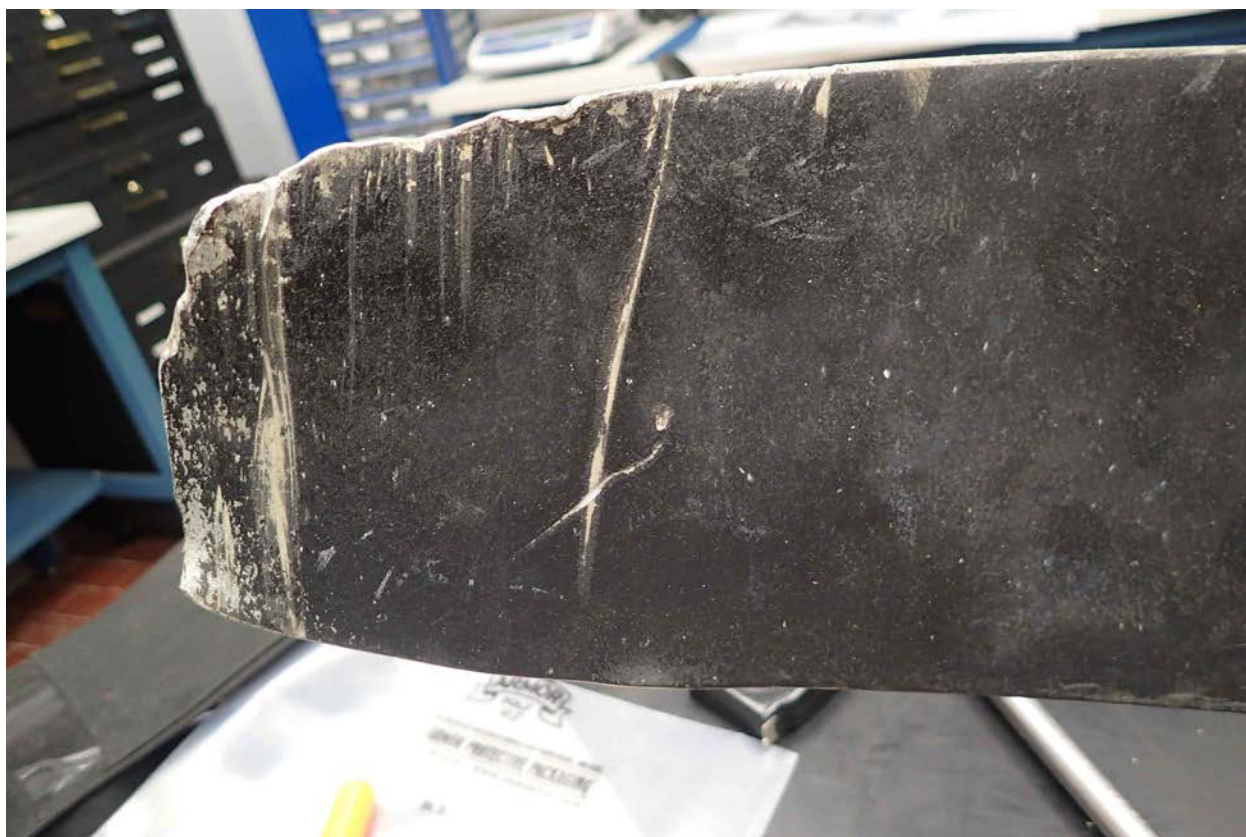
Photo 10 – Blade B Tip

not present for examination (Photo 10). The remaining tip section exhibited gouging and chordwise scoring at the area of separation.

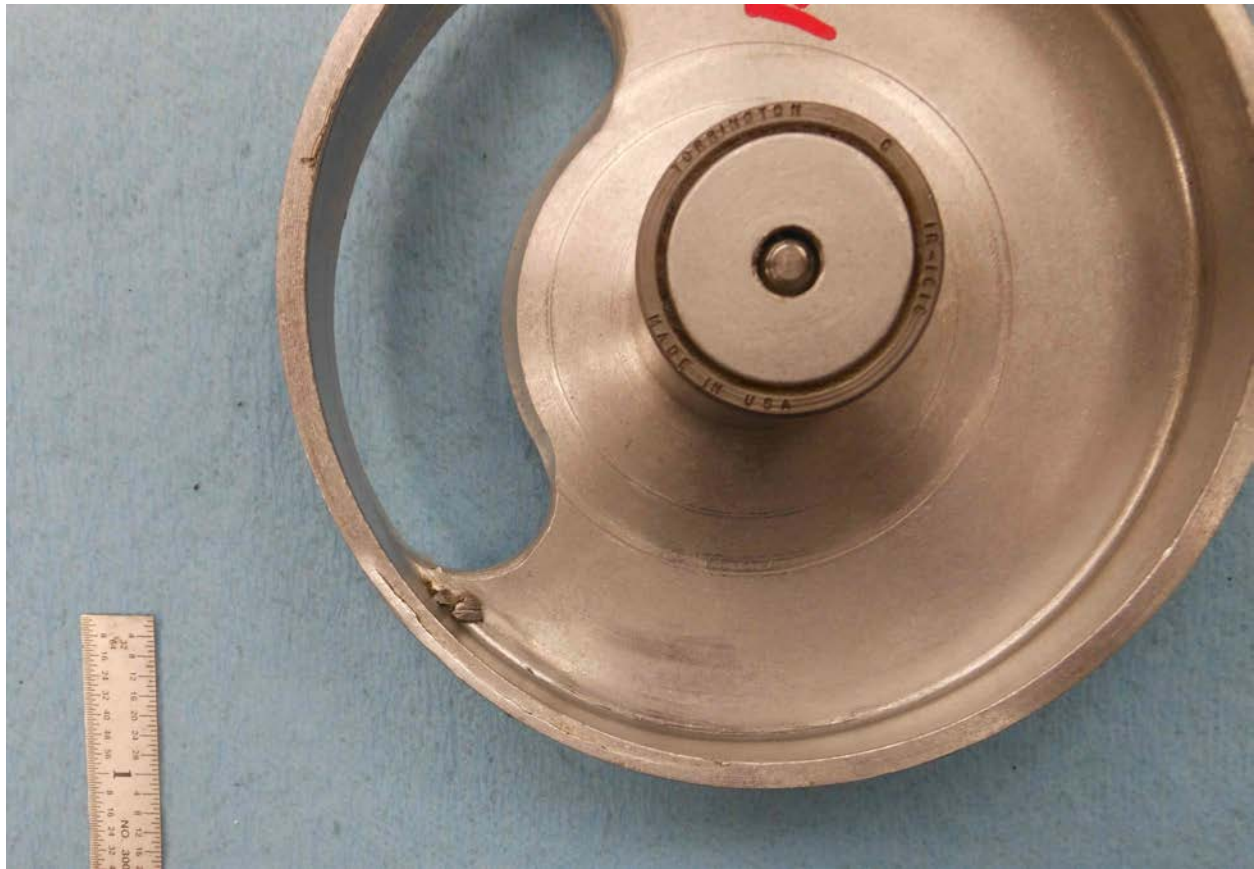
Photo 11 – Blade A Preload Plate

The preload plate for blade A exhibited damage on its inner side, close to the high pitch end of the slot with a steel-like bur embedded in the damage area (Photo 11). On the aft hub, a black smear was present on the aft trailing edge quadrant of the A blade aperture, with corresponding damage to the shelf of the blade root pocket (Photo 12). No significant damage was observed to the forward side of the hub, except for light damage to preload plate shelf for the blade B side.

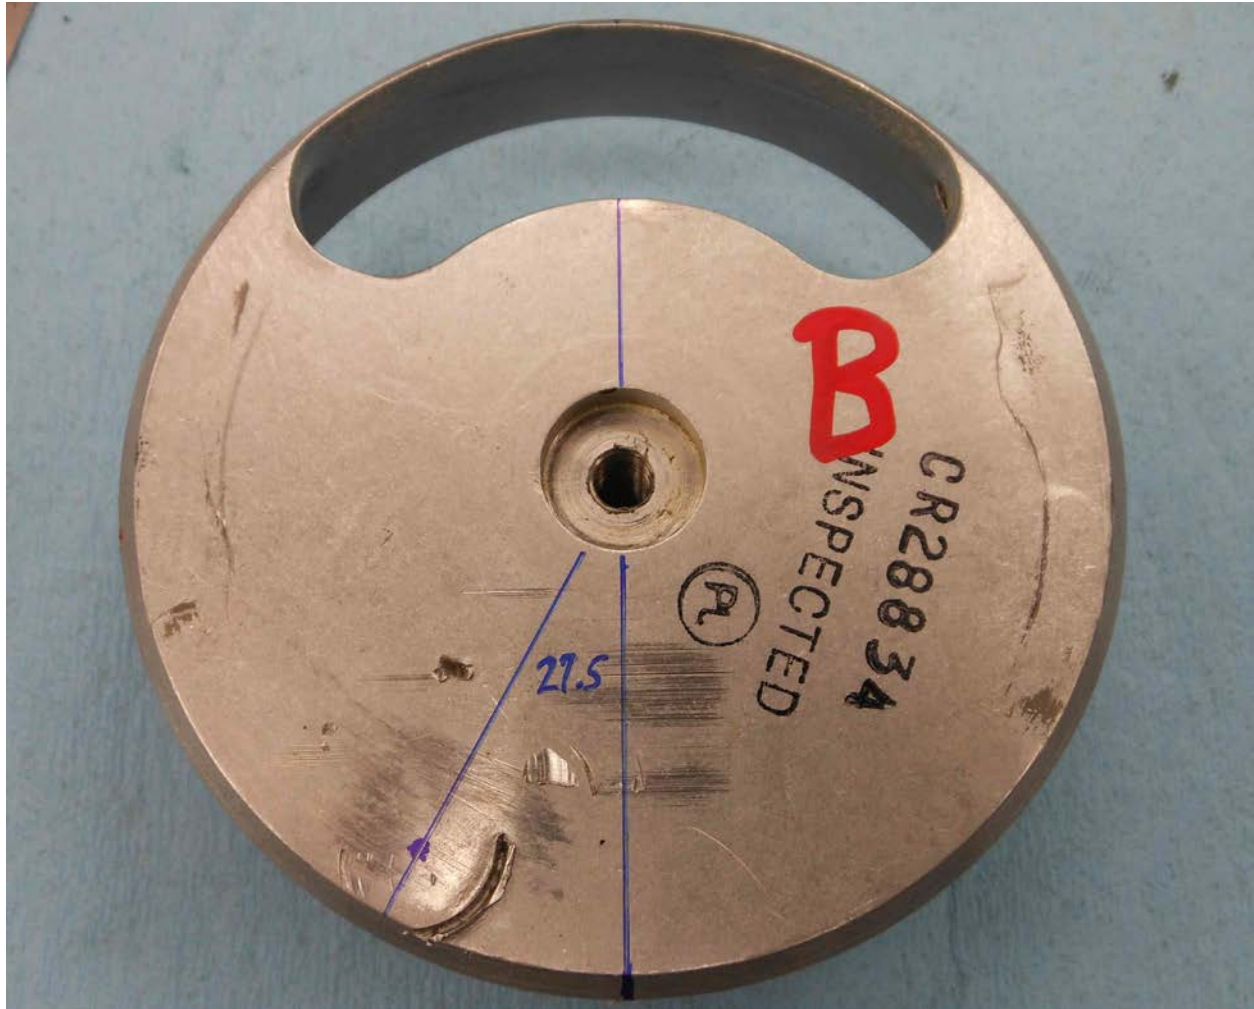
Photo 13 – Blade B Preload Plate

An imprint was present on the B preload plate, which corresponded to the bushing of the pitch change knob of blade A. The position of the imprint was at 27.5° forward of split line which corresponded to an A blade pitch angle of 17.5° (Photo 13). HET specifications call for a low pitch angle of 14.4 +/- 0.2°, and a high pitch angle of 29 +/- 1°. According to the HET representative, 17.5° pitch angle represents a position close to the maximum engine power at low airspeeds.

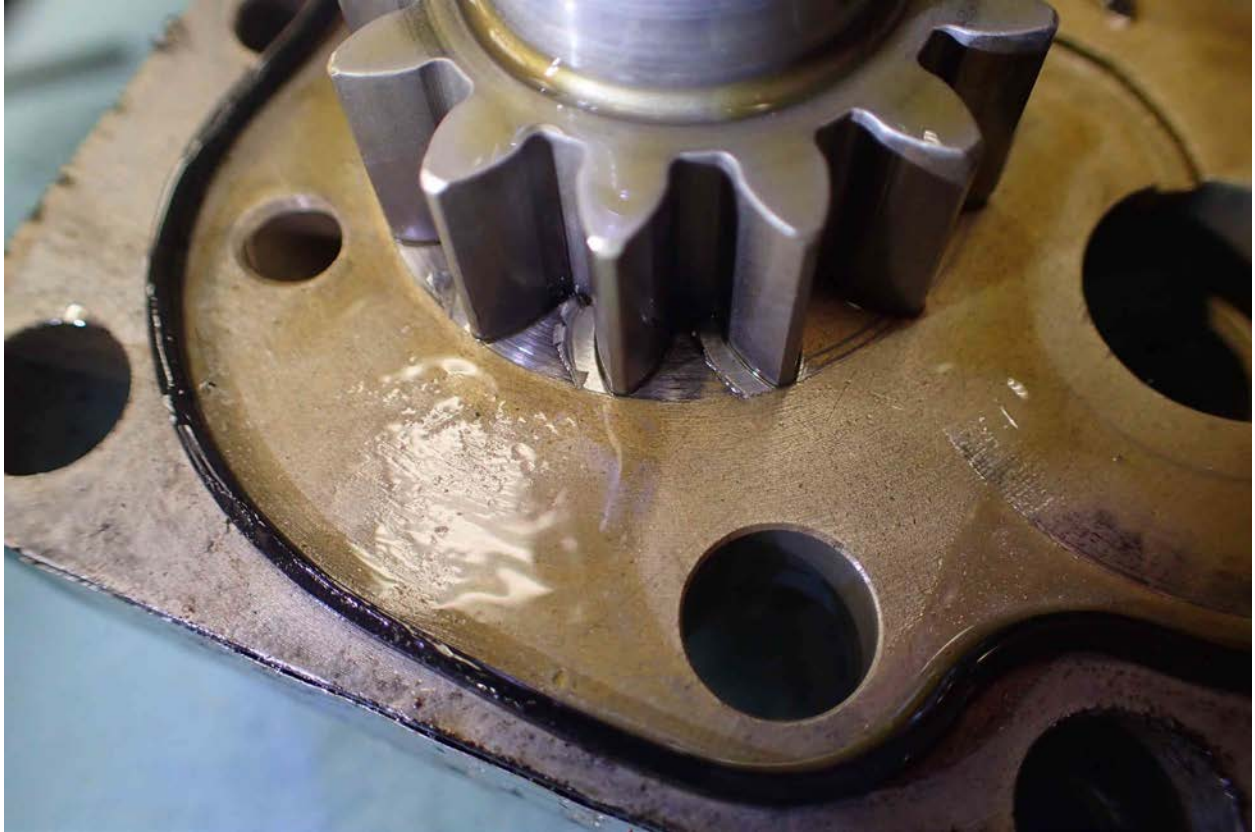
Photo 14 – Governor Pump Gears

The pump gears were intact and coated with oil, and all bores were clear. Scalloping of the case was present adjacent to the fourth teeth of both gears consistent with rotation during impact (Photo 14).
