**NATIONAL TRANSPORTATION SAFETY BOARD  
Western Pacific Regional Office  
Federal Way, Washington**

**On-Site Examination Report  
September 18, 2016  
Broadus, Montana**

NTSB Accident Number: **WPR16FA182**  
IIC: **T. Cornejo**  
Aircraft: **N413D – Beech 95-B55**

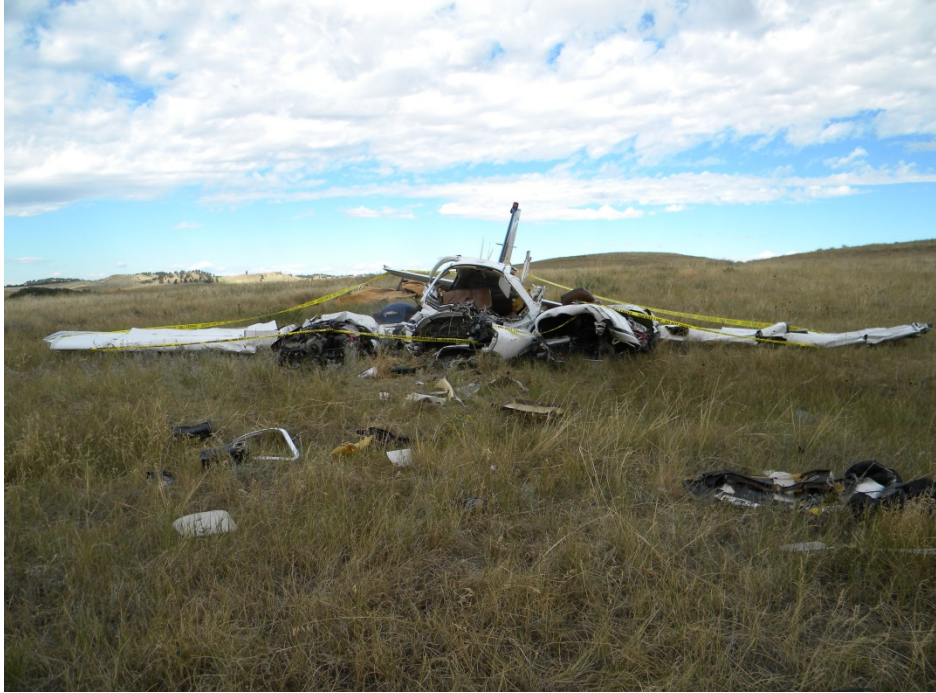
Photo 1 – Front View of Wreckage (NTSB)

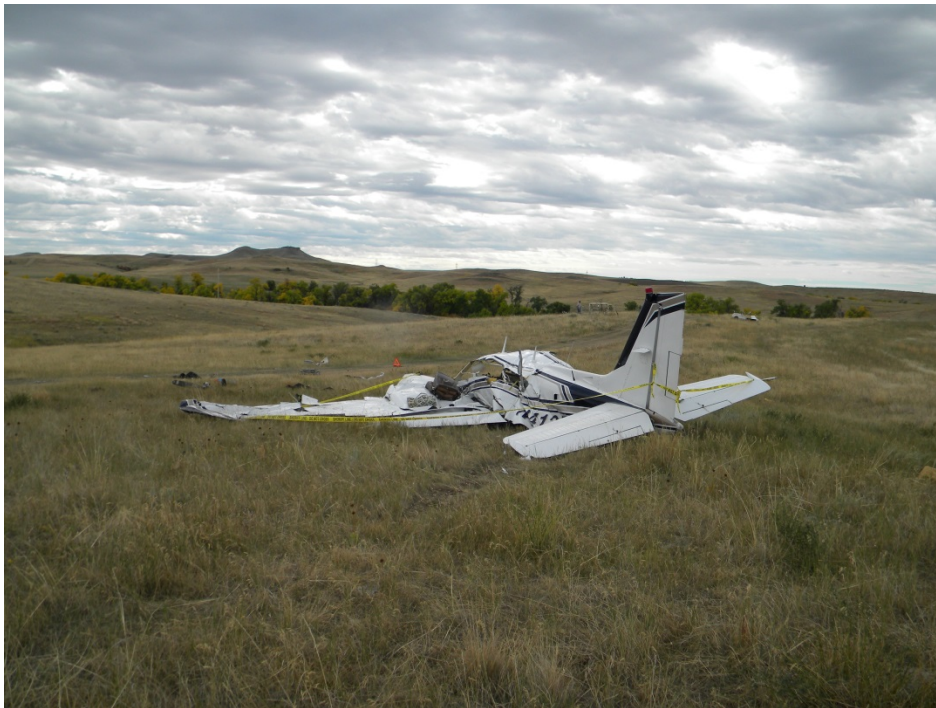
Photo 2 – Left Side View of Airplane (NTSB)

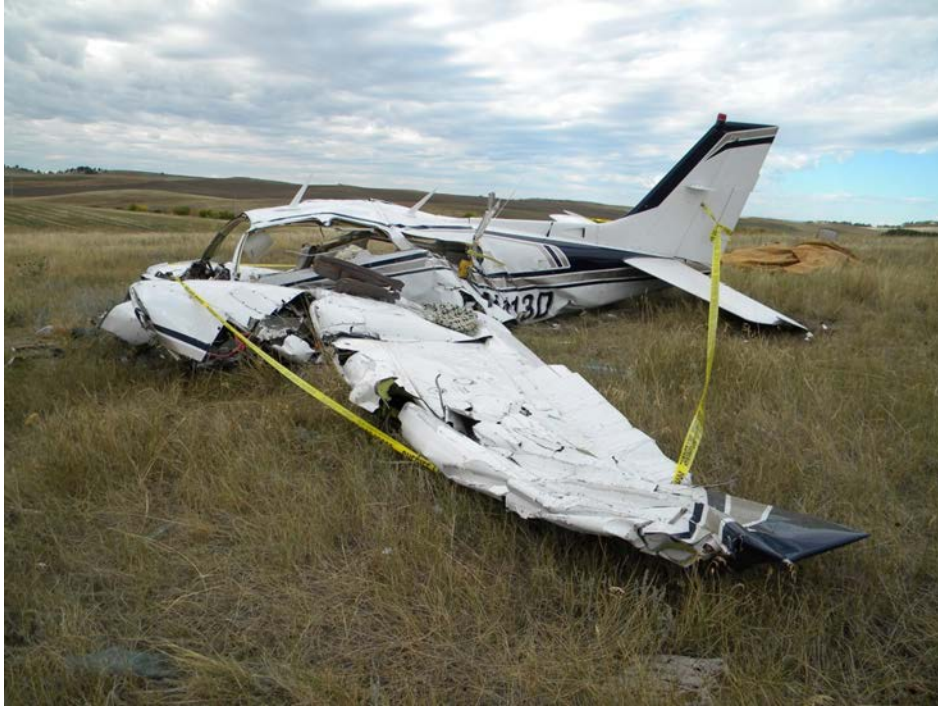
The left wing was canted forward and the upper aft wing attachment housing was separated but the attachment bolt was intact. The left-wing bladder fuel tank was breached, although the smell of 100LL fuel was evident. The left flap remained attached the wing and the left flap actuator was separated from the flap attachment point. The left aileron with attached trim tab remained attached to the left wing. The left-wing tip remained attached to the wing and from the tip inboard about 5 feet 4 inches, there was a 45-degree aft diagonal buckling. The left-wing fuel cap remained attached and the indicator showed 55 gallons. The fuel capacity was 68 gallons for the left tank. Outboard from the engine about 2 feet 6 inches the leading edge was flattened aft toward the wing front spar. The left engine was partially separated from the left wing. The left propeller separated from the left engine and was found about 10 to 15 feet forward of the left engine. The engine crankshaft propeller flange remained attached to the separated propeller. The right magneto separated from its attach point. The starter separated from its attachment. The inboard leading edge (between the fuselage and the left engine) showed aft impact and was canted aft.

Photo 3 - Close up View of the Left Side of the Airplane (NTSB)

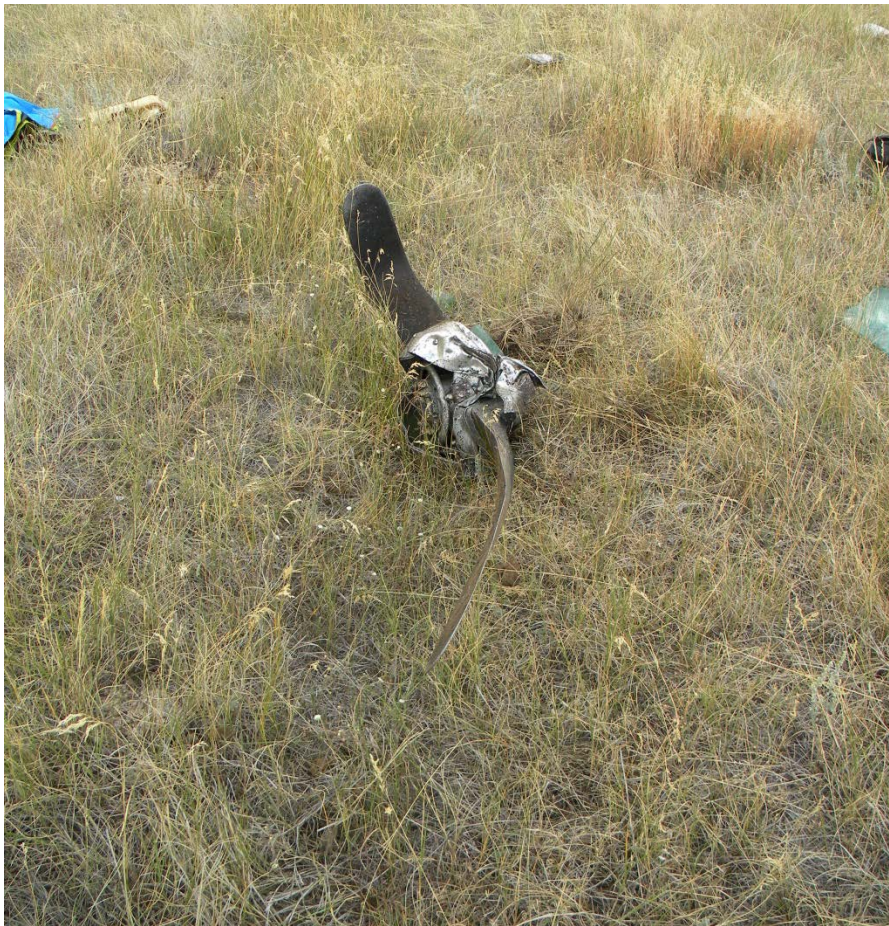
The left propeller had light chordwise scratches. Propeller blade designated as 1 was bent aft mid blade but attached at the hub. Propeller blade designated as 2 was loose in the hub and red mark on face of blade. The propeller spring was buried vertically in the ground just aft of left wing leading edge ground scar.

Photo 4 – Left Propeller (NTSB)

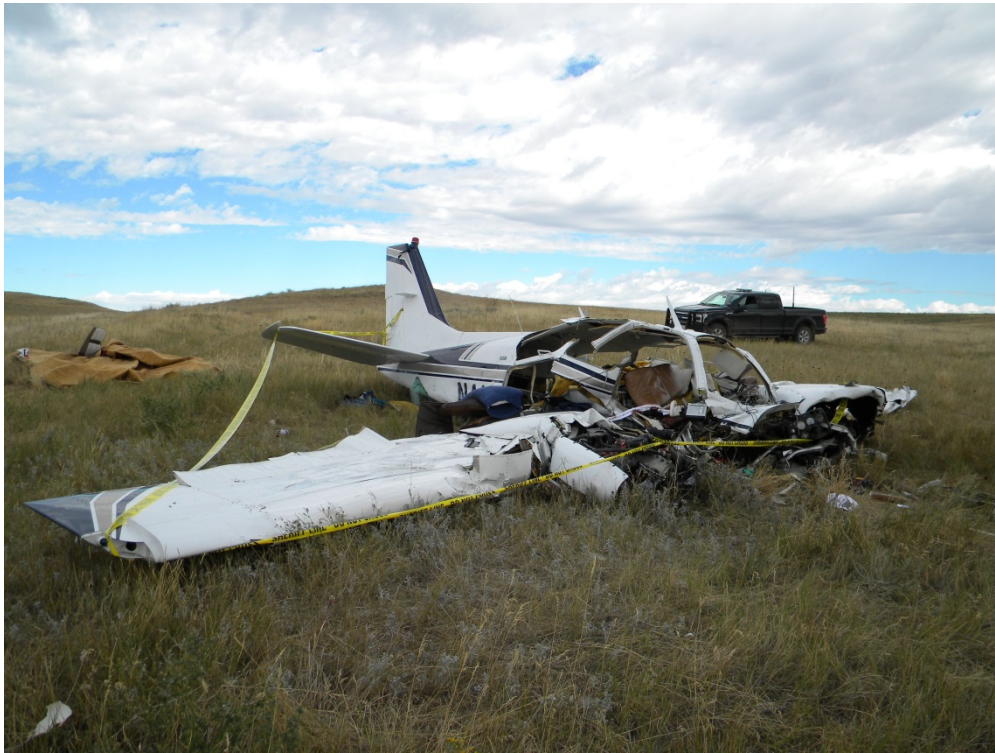
The right wing was breached of fuel and canted forward. The right engine was partially attached, and the case was cracked forward of cylinders 5 and 6. The magnetos and oil cooler separated. The back of the case was fractured. The fuel indicator need was separated. The right aileron and flap were attached. The cabin door entry was buckled upward. The aft baggage door was crushed upward and aft. The right propeller blades showed no chordwise striations. Blade 1 was bent aft at hub and slightly curved about 12 inches inboard. It was loose in the hub. Blade 2 had minimal damage and remained in the hub. The right flap actuator extension was 1 ¾ inches (approximately 0 degrees). The Continental IO-470-L engine, SN 454385 will be recovered for further examination.

Photo 5 – Right View of Airplane (NTSB)

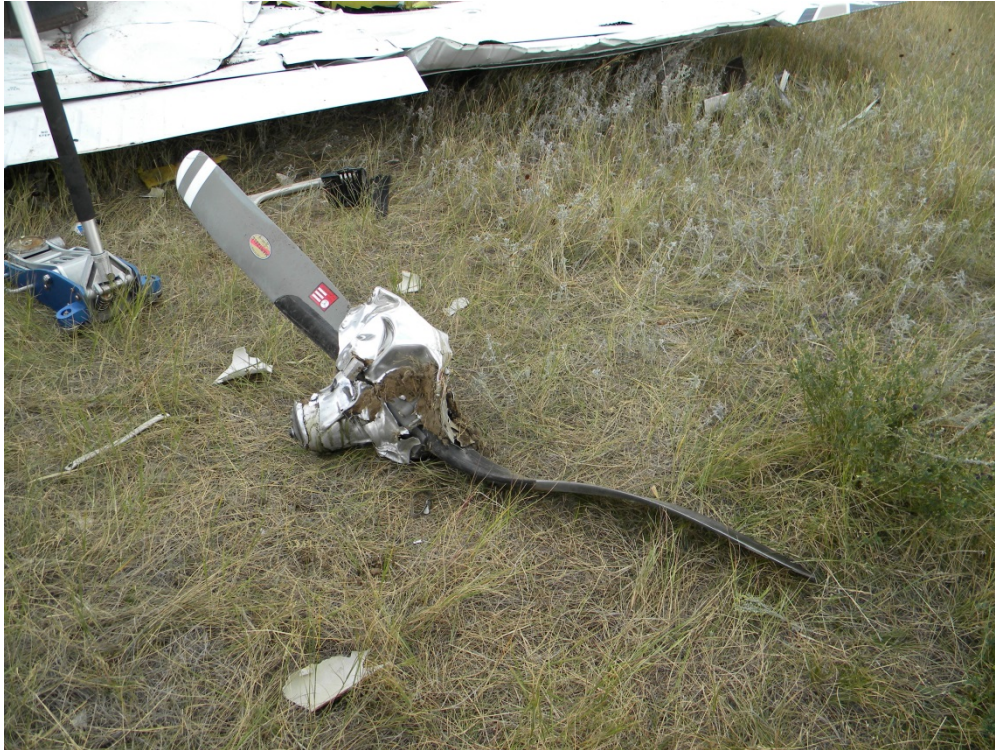
Photo 6 – Right Propeller (NTSB)
