Aircraft Accident/Incident report No.: 160917

**NTSB File No.:** WPR16FA182

**Aircraft:** Beechcraft 95-B55 (T42A)

**Registration No.:** N413D

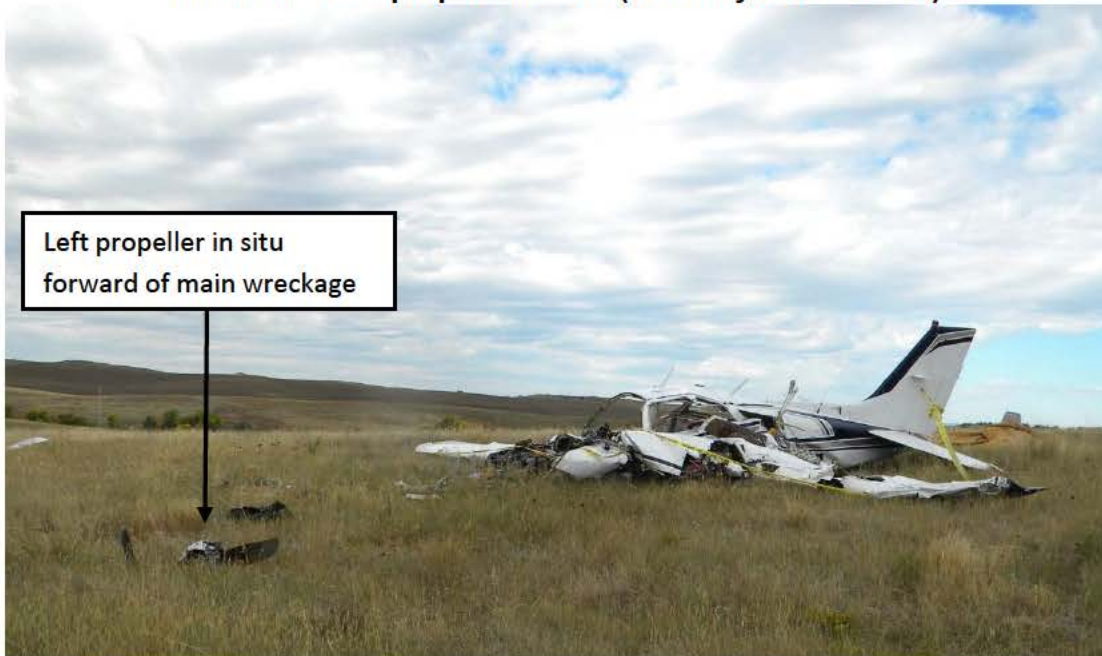
**In-situ Condition:** See Photos #1 through #4. The left propeller separated from the left engine and was found forward and to the left of the main wreckage. The engine crankshaft propeller flange remained attached to the separated propeller. The propeller hydraulic unit (cylinder, piston, feathering spring) was found embedded in the soil in a vertical orientation (front pointing down), forward of the left horizontal stabilizer, adjacent to a line formed by wing ground scars. Based on the wing ground scar, the aircraft continued rotation to the right and moved forward after the initial impact.

**Photo #1 – Left propeller in situ (courtesy of NTSB ASI)**

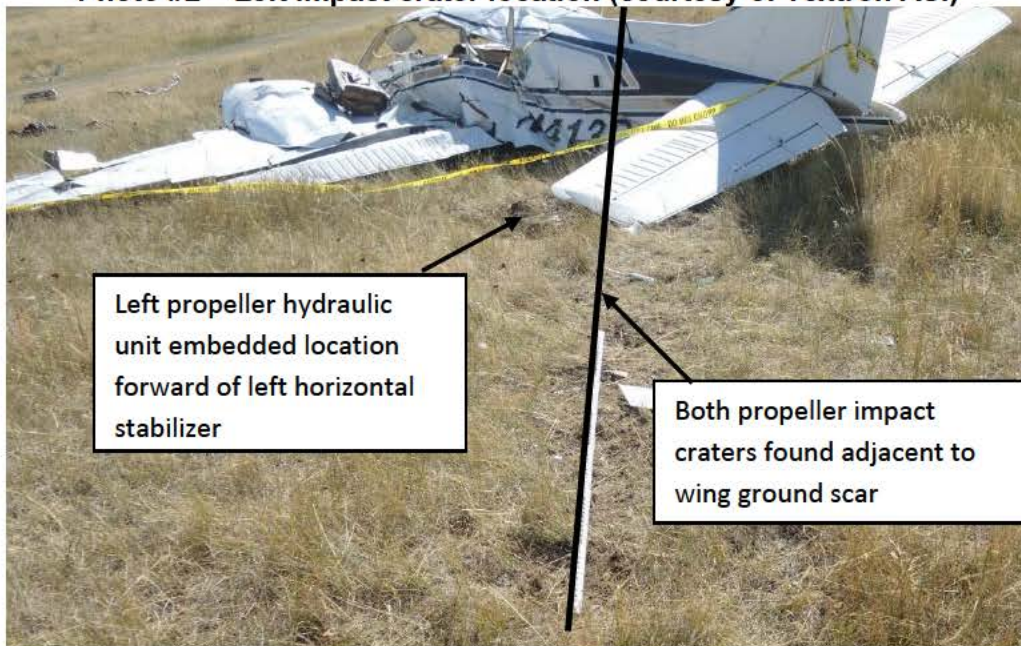
**Photo #2 – Left impact crater location (courtesy of Textron ASI)**

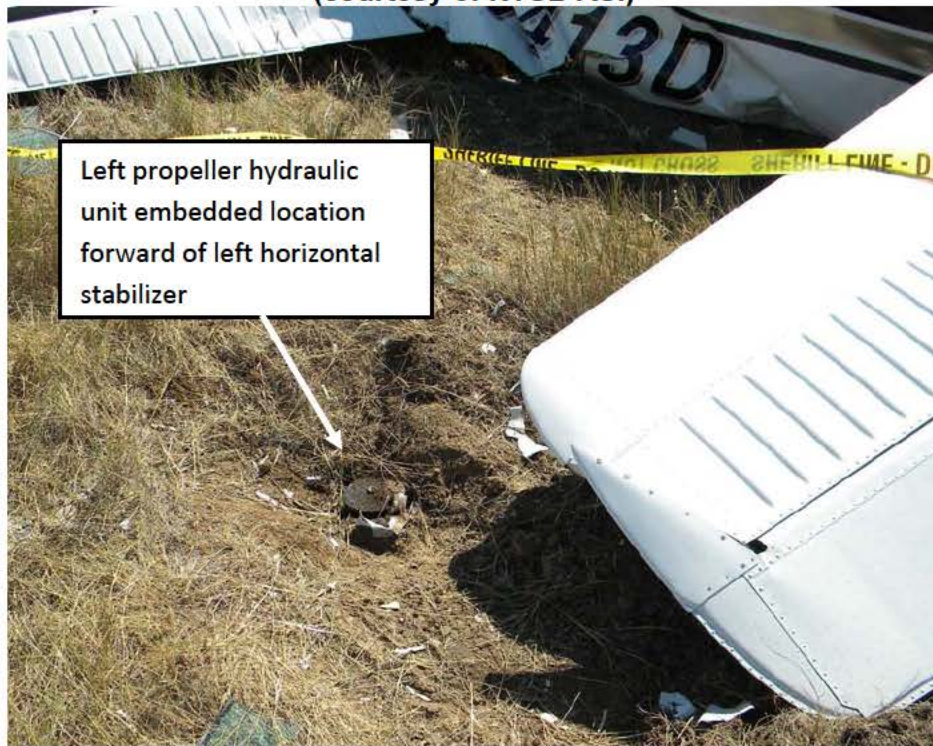
**Photo #3 – Left propeller impact crater location, hydraulic unit embedded  
(courtesy of NTSB ASI)**

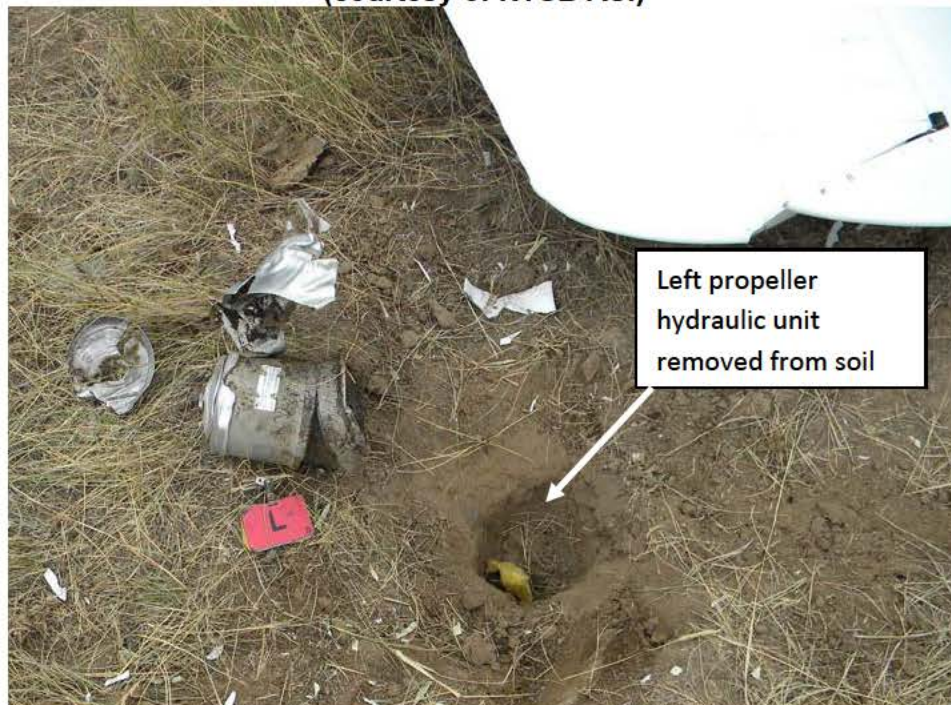
**Photo #4 – Left propeller impact crater location, hydraulic unit dug out  
(courtesy of NTSB ASI)**

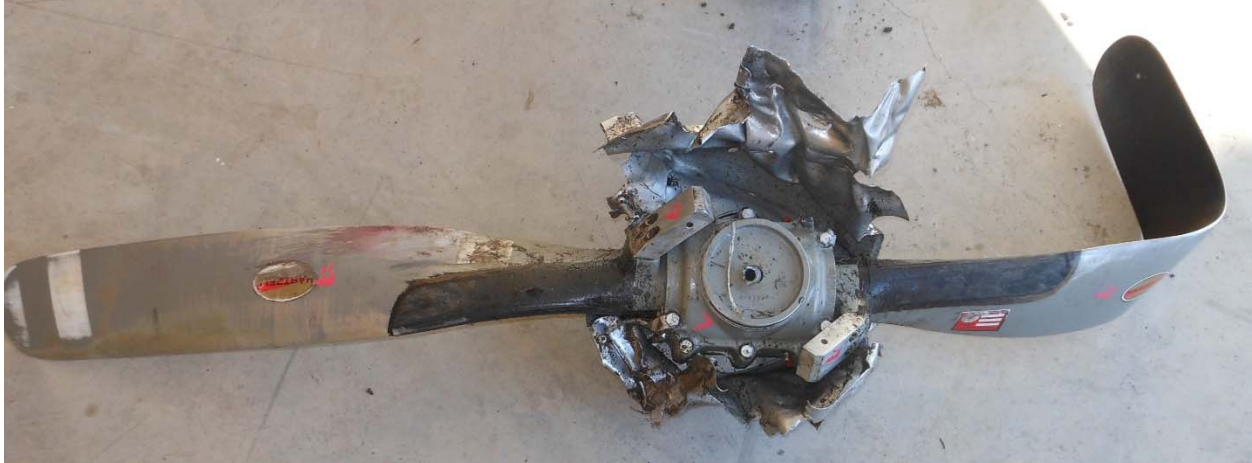
**As Received Condition:** The left propeller was recovered from the crash site and presented for examination in the condition shown in Photo #5. Both blades were bent aft in varying amounts and appeared to be in a normal operating range of blade angles; they were not in a feathered position. One blade exhibited chordwise/rotational abrasion. One blade (L2) could be rotated by hand, the other could not be rotated. The hydraulic unit fractured from the propeller hub. The pitch change rod had fractured aft of the piston and was bent toward one of the blades. The spinner dome was crushed and torn open. The assembly in and around the hub area was wet with oily dirt and grass.

**Photo #5 – Left propeller as-presented for examination**

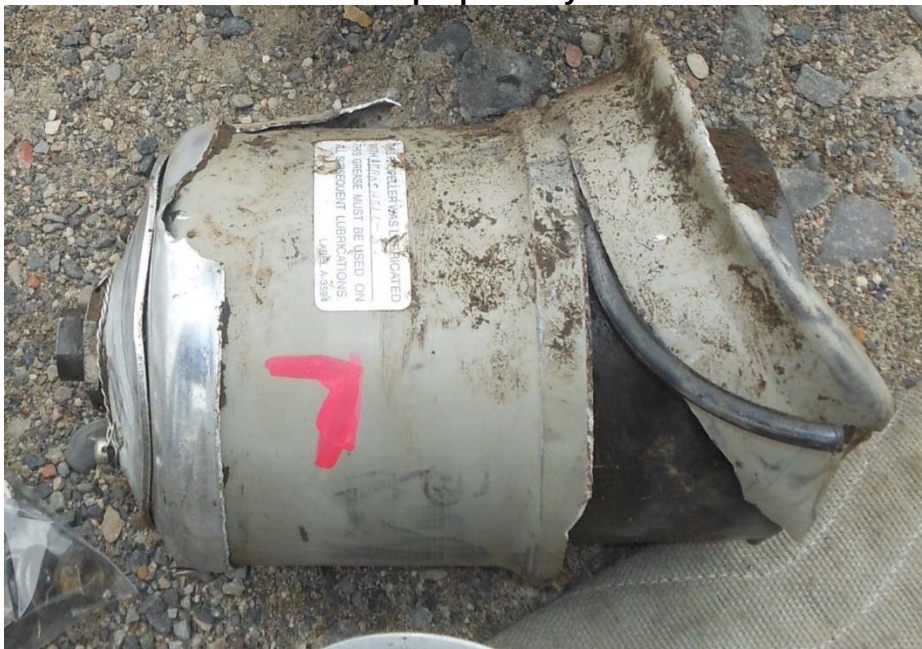
**Cylinder:** The cylinder fractured from the hub as part of the hydraulic unit. The cylinder fractured into several pieces aft of the piston O-ring groove and was exposing the majority of the piston (see Photo #6). The air valve had fractured off the low pitch stop assembly and was missing, presumed not recovered from the crash site.

**Photo #6 – Left propeller hydraulic unit**

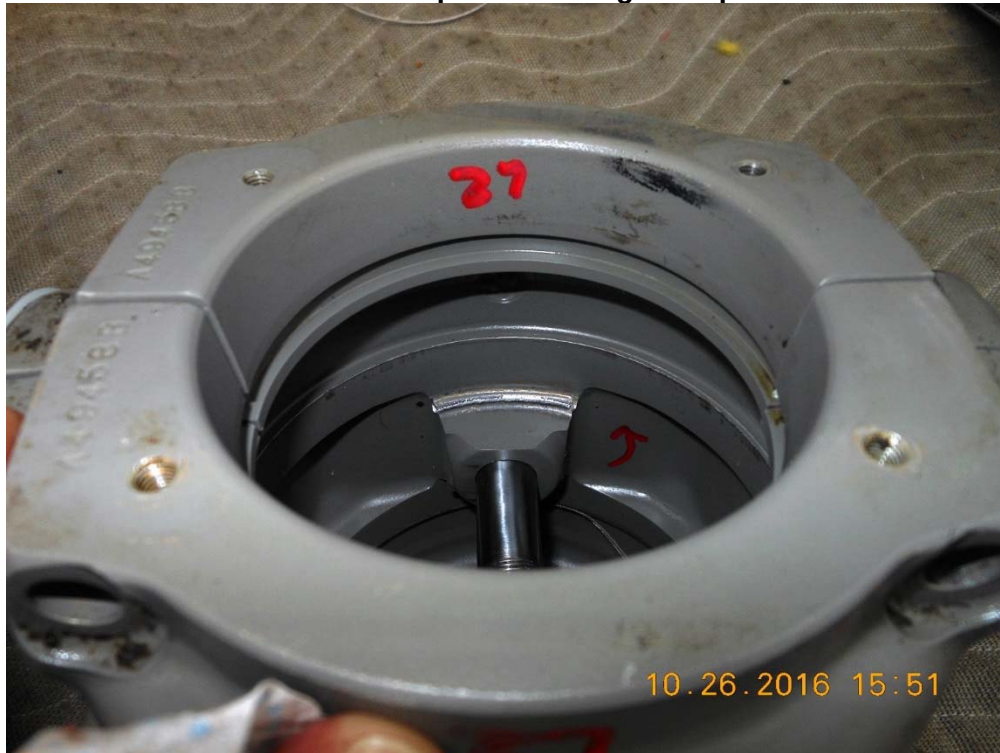
Photo #7 – Left hub L2 blade pocket damage and paint transfer mark

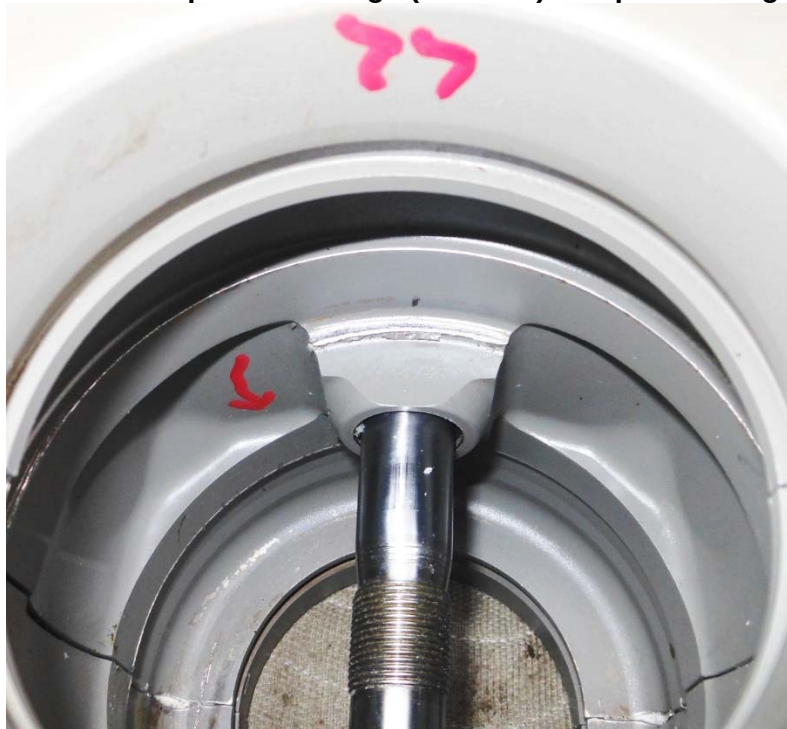
**Pitch Change Rod:** The pitch change rod bent and fractured just aft of the piston attachment. The bent portion remained in the forward hub half. There were scuff marks on the rod near the front end caused by rubbing in the fwd hub boss (see Photo #8); the rub marks represent a forward fork/low blade angle position.

Photo #8 – Left hub L2 blade pocket damage (fwd side) and pitch change rod scuff marks

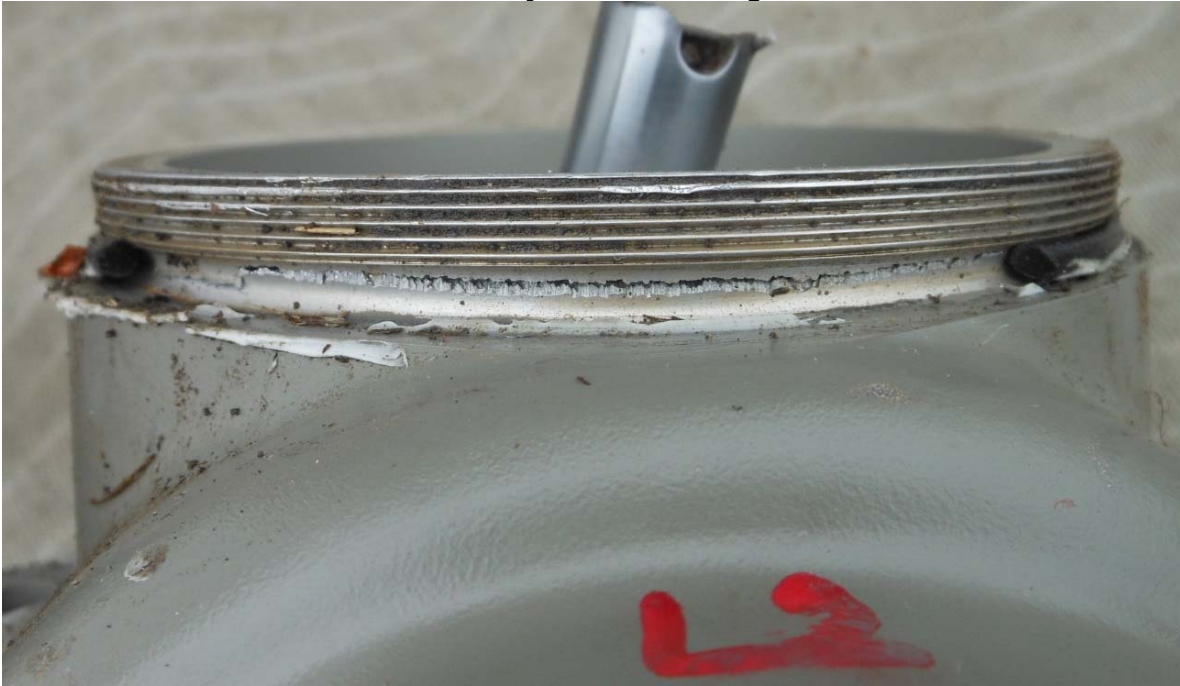
**Photo #9 – Left hub cylinder mounting boss fracture**

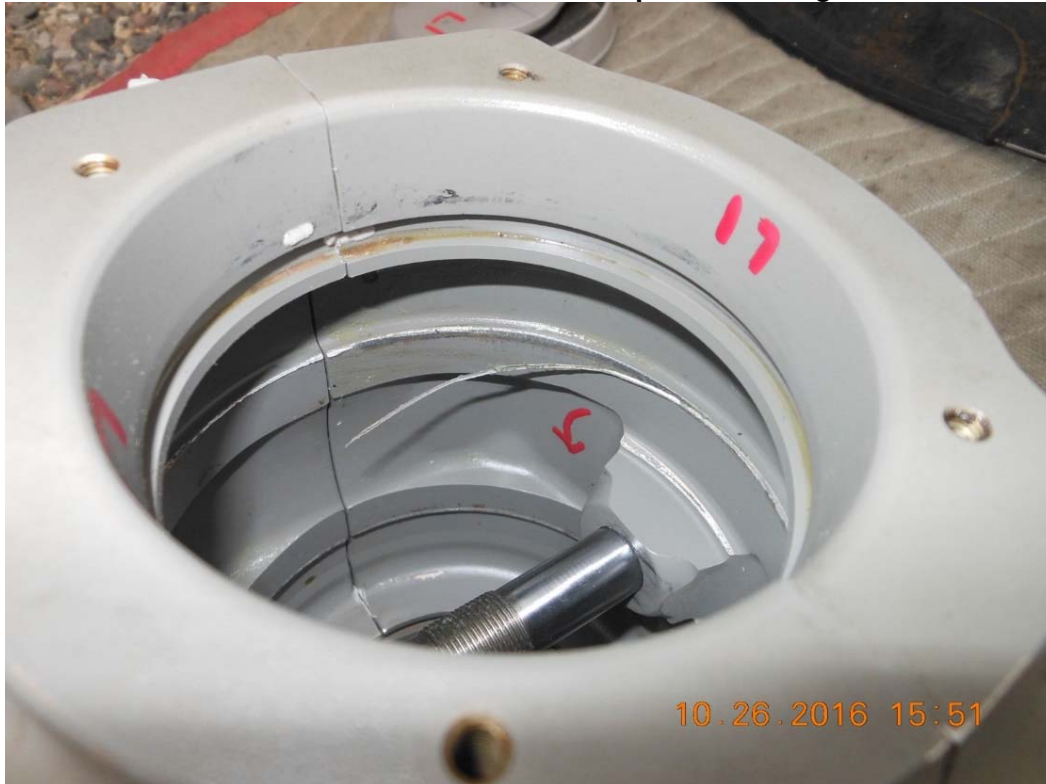
**Photo #10 – Left hub L1 blade pocket damage**

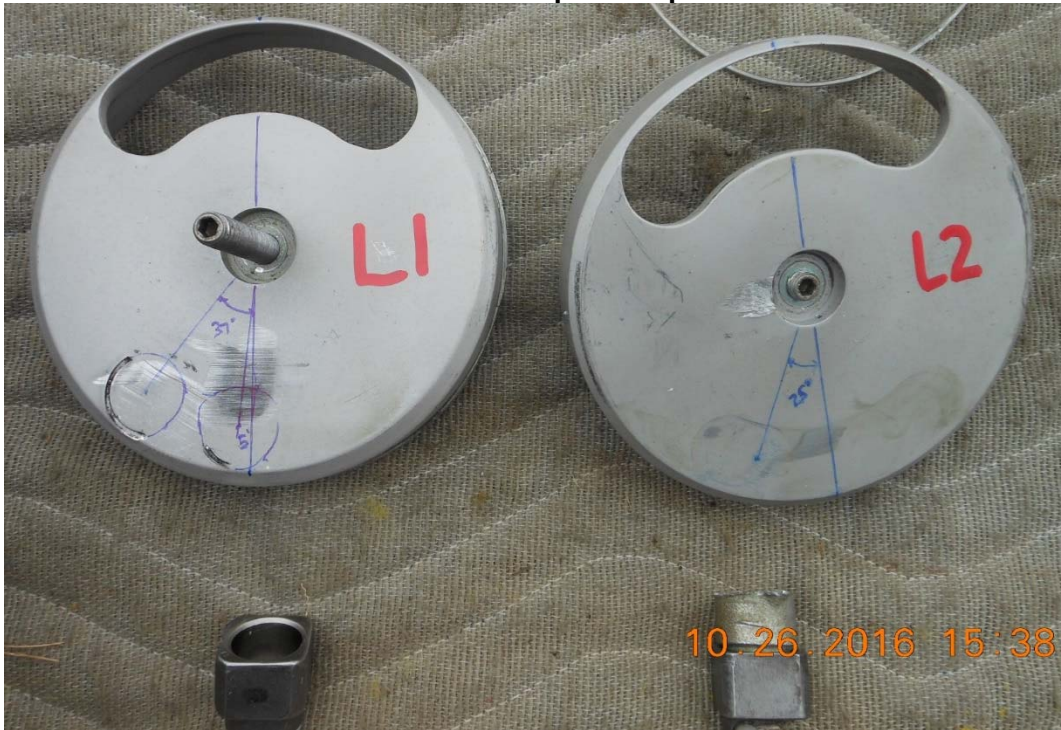
L1 preload plate had knob block impact marks at 5° and 37° forward of the hub parting line that suggest blade L1 was at approximately 45° and 13° respectively. There was lip deformation in both the lead/camber and face/trail quadrants.

L2 preload plate had the lip sheared off in one piece. There were hub impact marks on the lead and trail edge corners. There was a discernable knob block bumper swipe mark starting at approximately 25° forward of the hub parting line. There was also a gouge coming out of the preload screw counterbore in the forward direction.

Photo #11 – Left preload plates

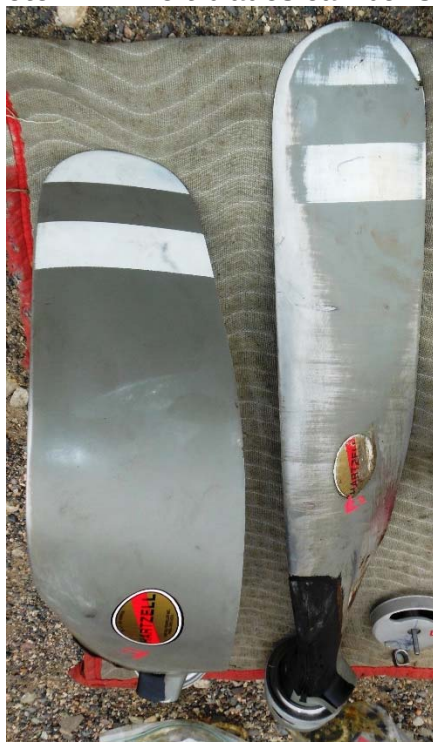
Photo #12 – Left blades camber side

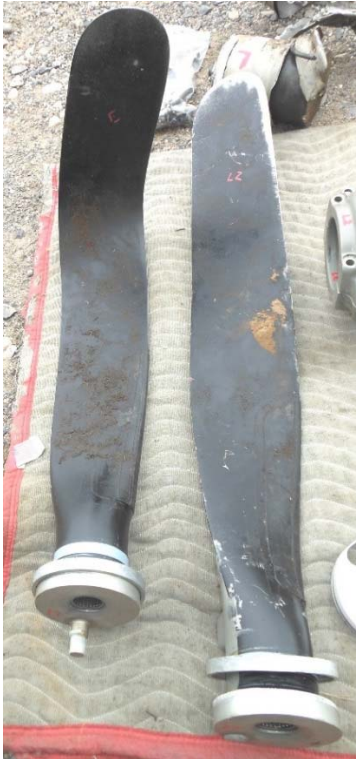
**Photo #13 – Left blades face side**

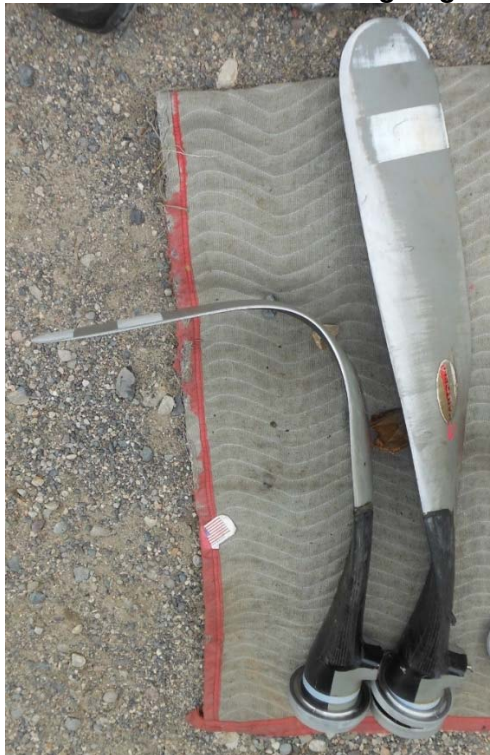
**Photo #14 – Left blades leading edge view**

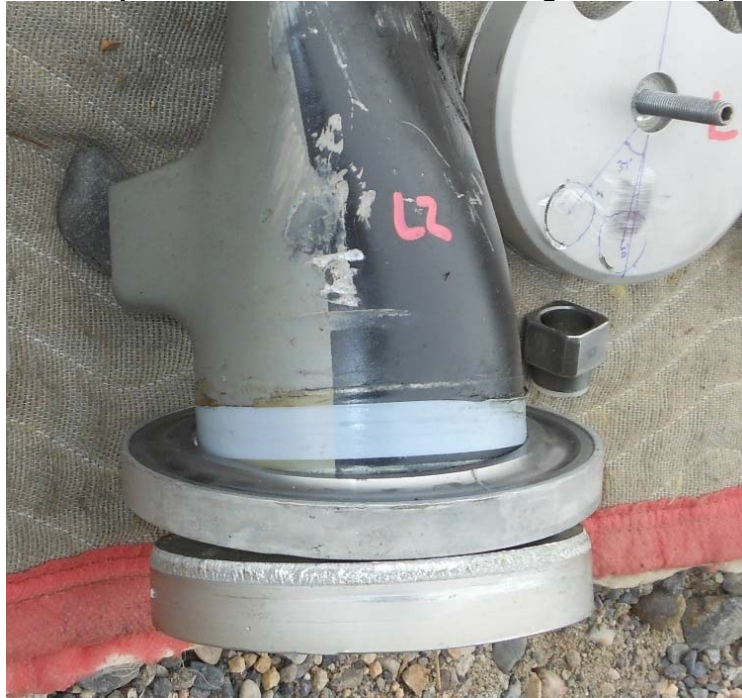
| Blade bearings | Intact but the bearing retention lip on the shank was fractured. The bearing retention ring was intact holding the bearing races and fractured portion of the retention lip. |
| Butt/shank impact marks | There was a paint transfer mark on the trail edge side above the Teflon O-ring rub strip (Photo #) |

**Photo #15 – L2 paint transfer mark and bearing retention lip fracture**

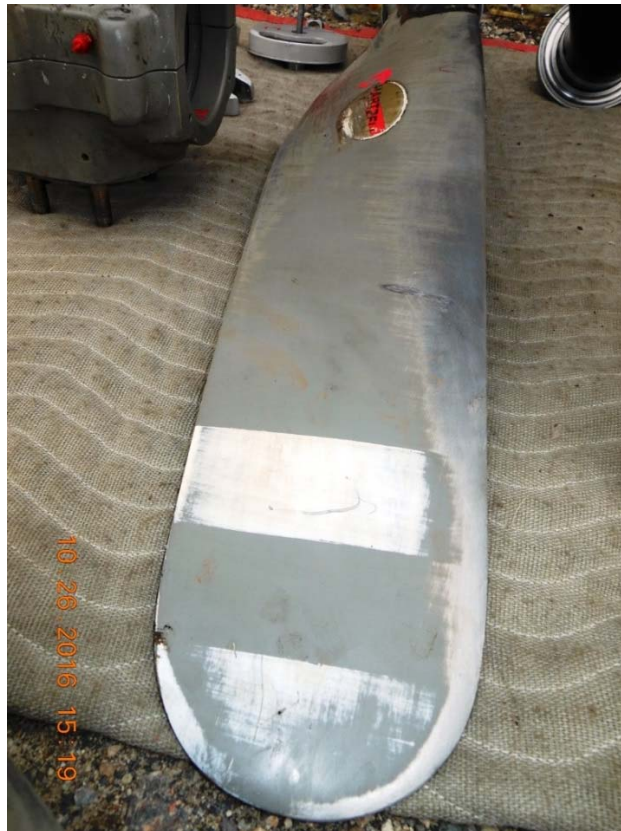
| Camber side | Chordwise/rotational abrasion back to approximately 50%c |

**Photo #16 – L2 camber side chordwise/rotational abrasion**

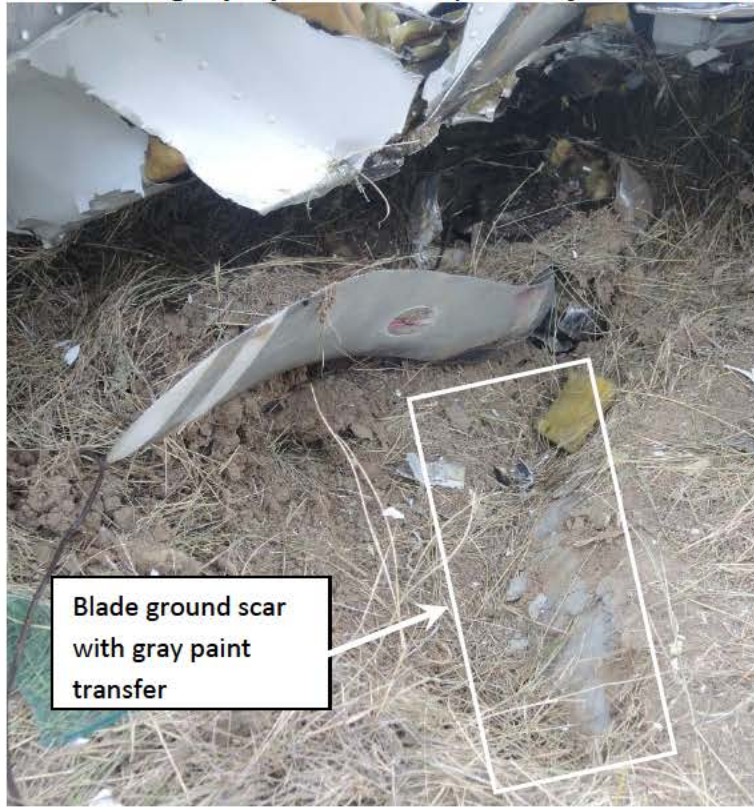
**In-situ Condition:** See Photo #16. The right propeller separated from the right engine and was found under the aircraft cabin floor, beneath the right aft seat area. The engine crankshaft propeller flange remained attached to the separated propeller. The propeller was found embedded in the soil in a vertical orientation, adjacent to a line formed by wing ground scars. The spinner was torn and crushed aft.

**Photo #17 – Right propeller in situ (courtesy of Textron ASI)**

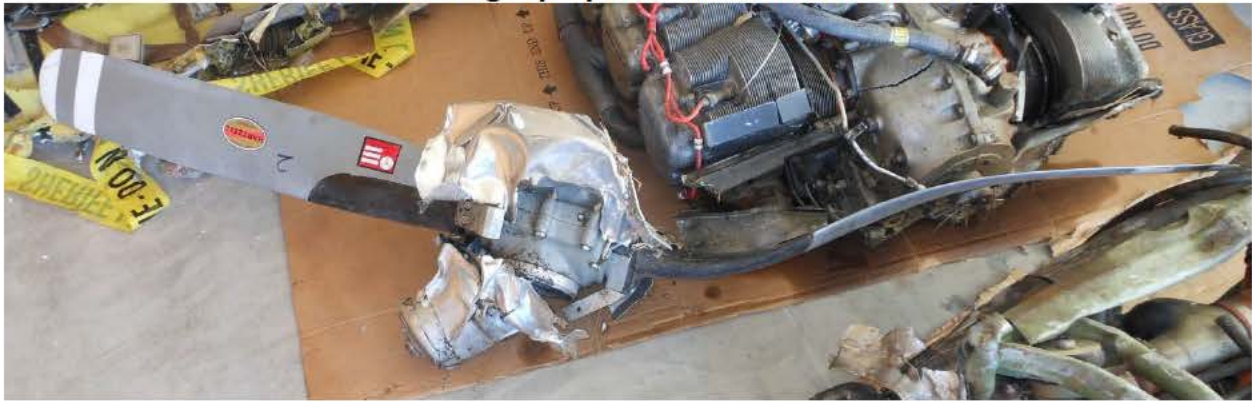
**As Received Condition:** The right propeller was recovered from the crash site and presented for examination in the condition shown in Photo #17. One blade (R1) exhibited S-bend characteristics and appeared to be in a normal operating blade angle range; this blade exhibited chordwise/rotational abrasion. The other blade (R2) was bent aft and appeared to be near a feathered position. R1 could be rotated by hand, R2 could not be rotated. The hydraulic unit fractured from the propeller hub but remained loosely attached to the assembly by fragments of the spinner dome that had hydro-formed around the cylinder. The pitch change rod had fractured aft of the piston and was bent toward one of the blades. The spinner dome was crushed and torn open. The assembly in and around the hub area was wet with oily dirt and grass.

**Photo #18 – Right propeller condition as-received**

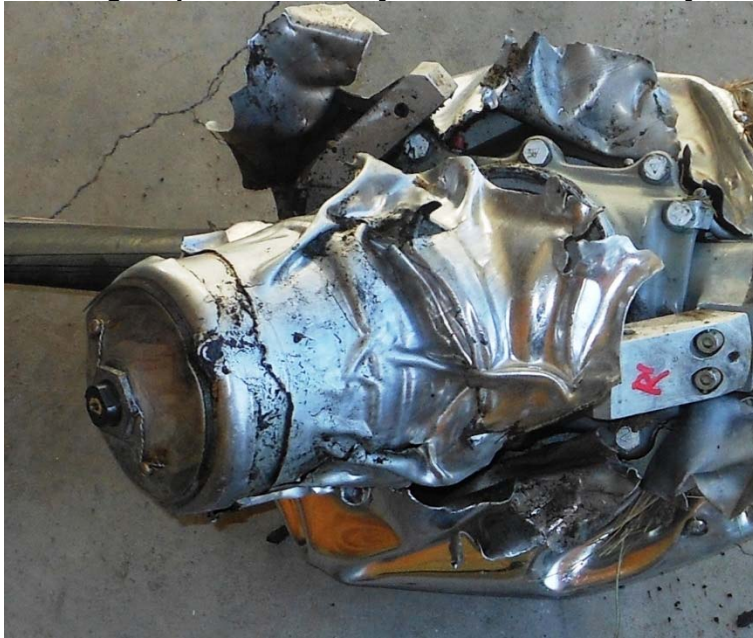
**Spinner Dome:** The spinner dome was crushed and torn but the majority was still attached to the spinner bulkhead flange via screws. A portion of the spinner dome was formed around the hydraulic unit (Photo #19). The dome was torn and crushed/compressed to either side of the propeller assembly, exposing the front sides of the propeller hub.

**Photo #19 – Right spinner dome hydro-formed around hydraulic unit**

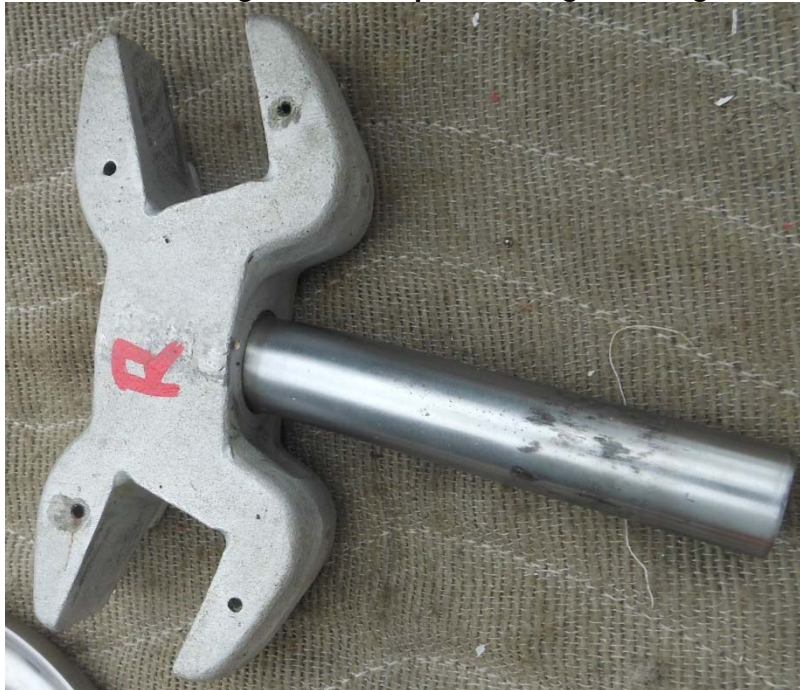
**Pitch Change Rod:** The pitch change rod bent and fractured just aft of the piston attachment. The bent portion remained in the forward hub half (Photo #23). The rod also fractured forward of the fork, near the threaded region. The remainder/aft segment of the pitch change rod remained threaded in the fork. There were rub marks on the rod near the aft end caused by rubbing in the aft hub boss (see Photo #20); the rub marks represent a forward fork/low blade angle position.

**Fork:** The fork was removed with the aft portion of the pitch change rod still attached. The fork appeared intact and undamaged (see Photo #20)

**Photo #20 – Right fork and pitch change rod segment**

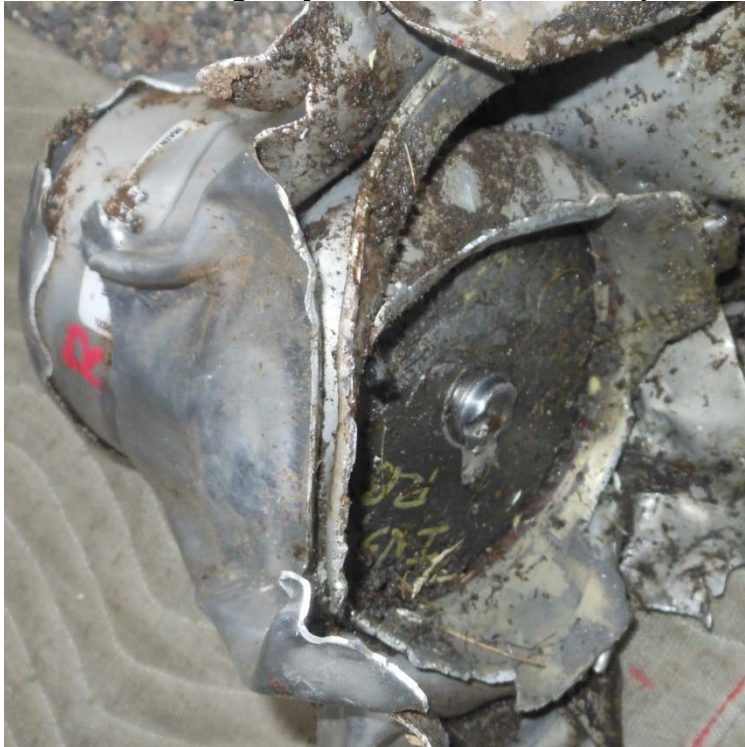
**Cylinder:** The hydraulic unit fractured from the hub (Photo #21). The cylinder fractured just forward of the mounting threads; the threaded portion remained on the hub boss (see Photo #22). The air valve had fractured off the low pitch stop assembly and was missing, presumed not recovered from the crash site.

Photo #21 – Right hydraulic unit, aft side of piston

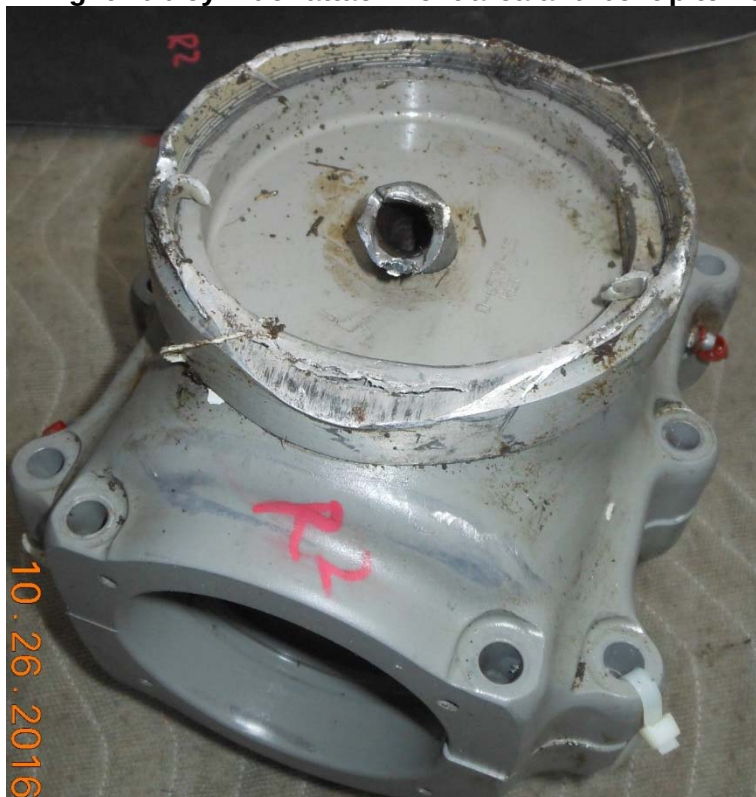
Photo #22 – Right hub cylinder attachment area and bent pitch change rod

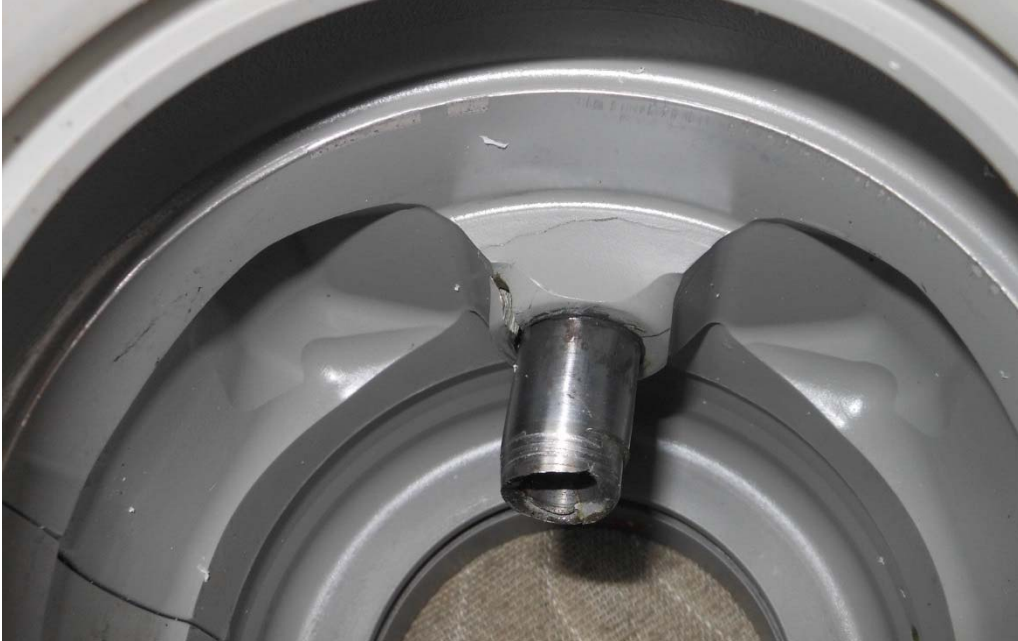
**Photo #23 – Right pitch change rod forward segment and fractured boss**

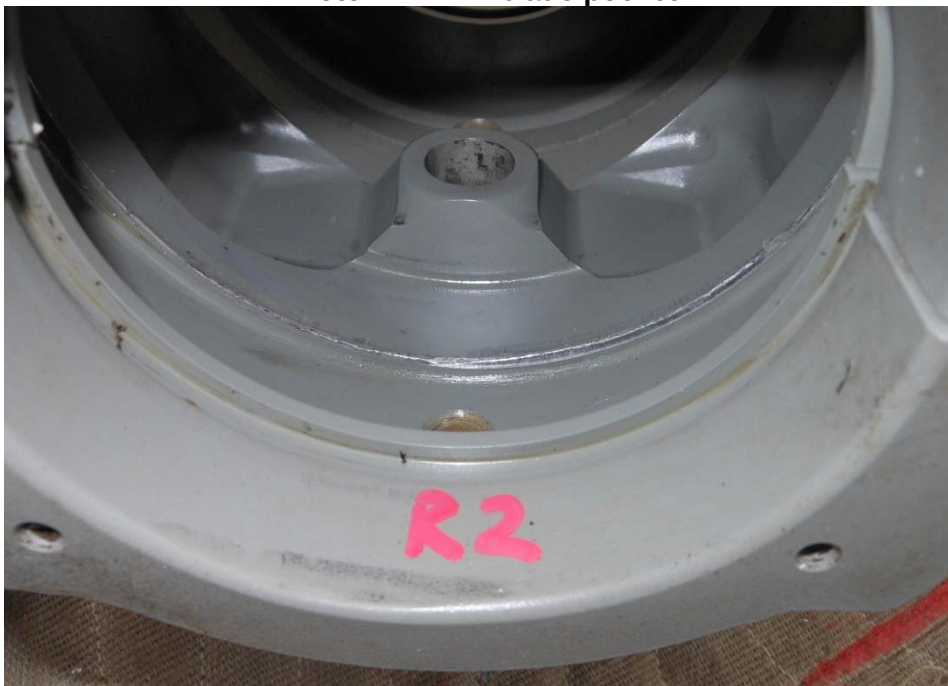
**Photo #24 – R2 blade pocket**

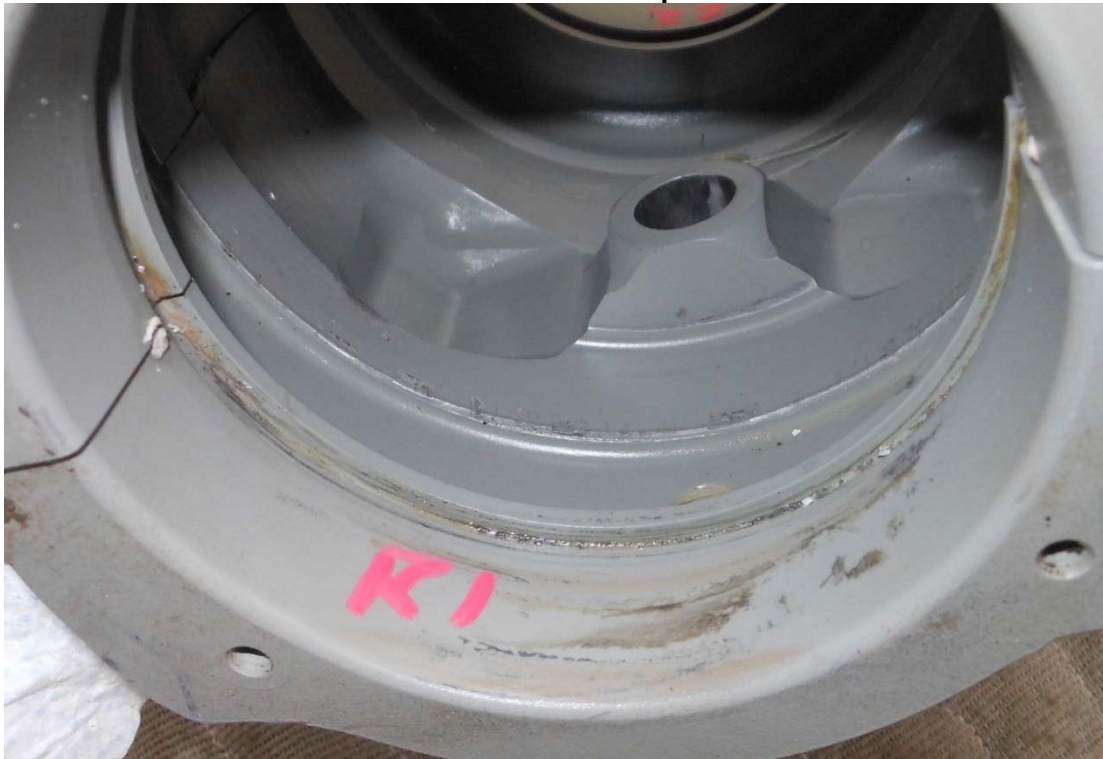
Photo #25 – R1 blade pocket

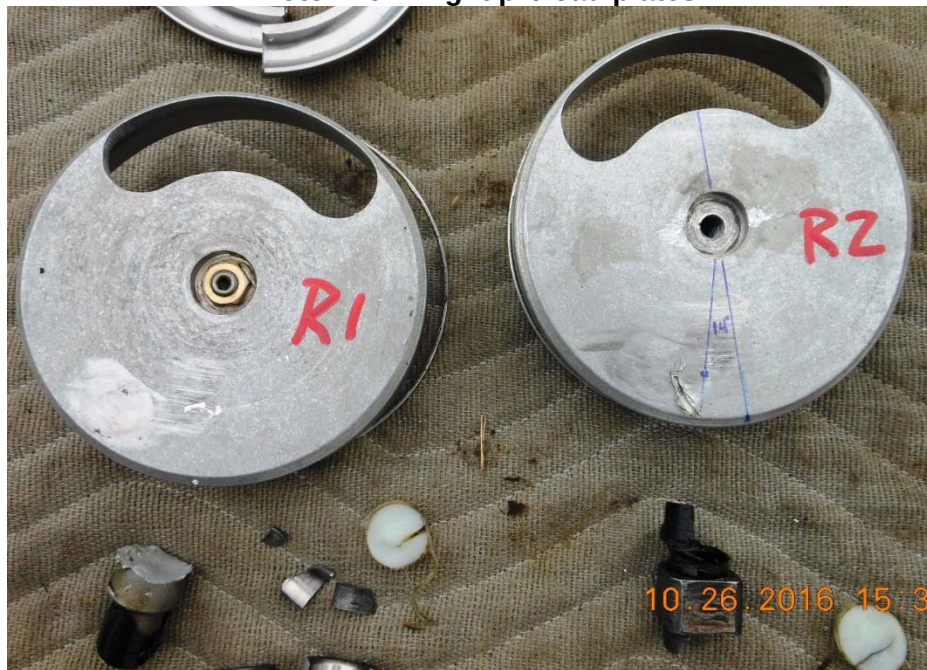
R1 preload plate had the lip sheared off approximately 90+% of the circumference. There were no discernable knob block impressions.

R2 preload plate had a knob block impact mark at 14° forward of the hub parting line that suggested blade R2 was at approximately 36°. The lip was sheared approximately 90+% of the circumference.

Photo #26 – Right preload plates

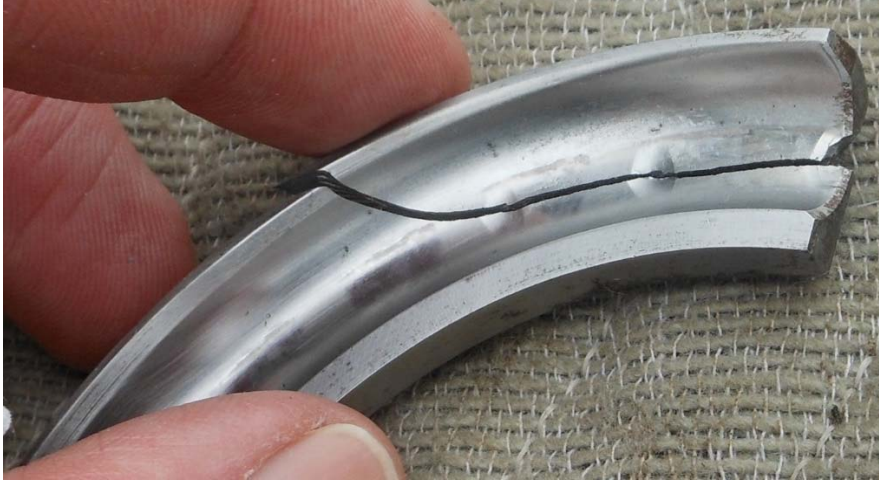
| Blade bearings | The hub side bearing races were fractured on either side of the leading edge split line (Photo #27) |

Photo #27 – R1 hub side bearing race fracture with ball impressions

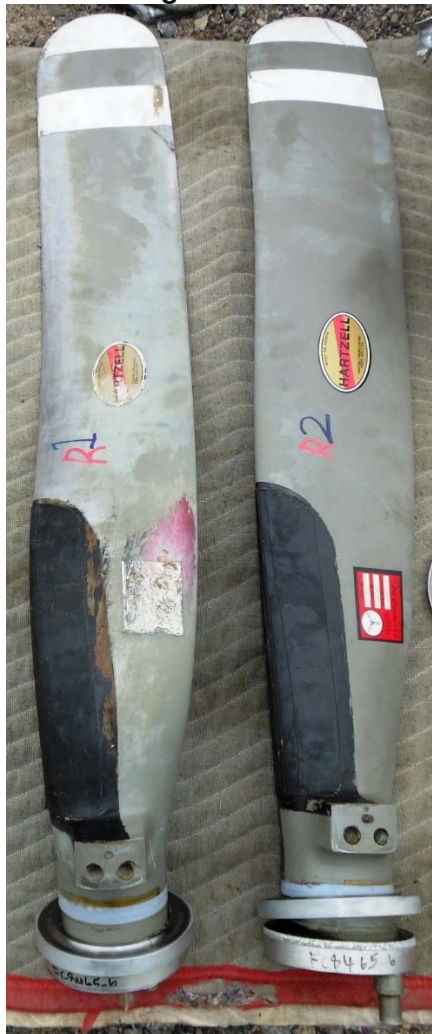
Photo #28 – Right blades camber side

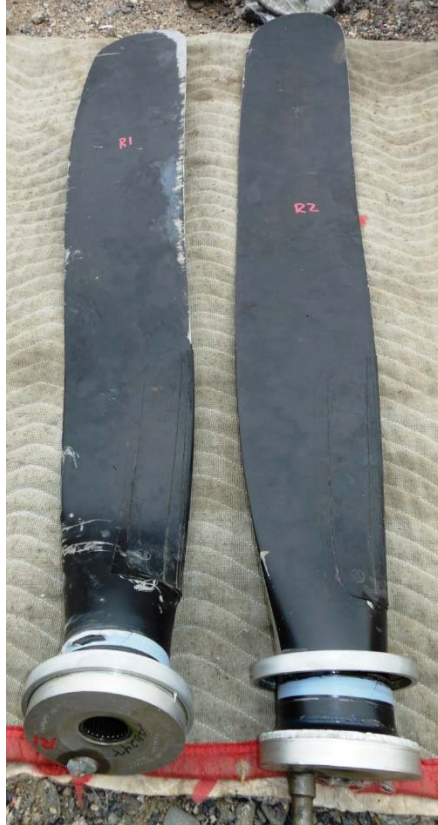
**Photo #29 – Right blades face side**

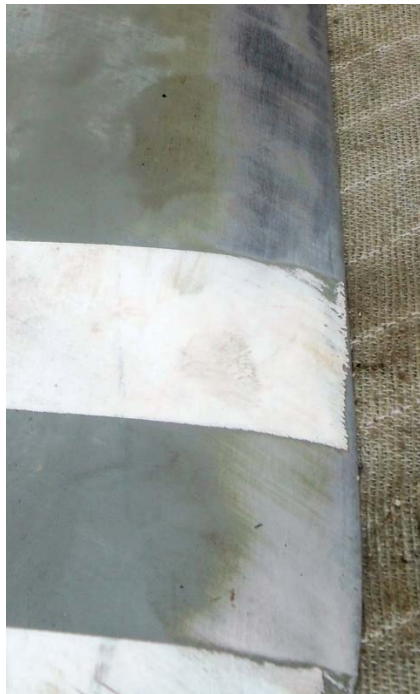
| Camber side | Chordwise/rotational abrasion back to approximately 30%c |

**Photo #30 – R1 camber side chordwise/rotational abrasion**

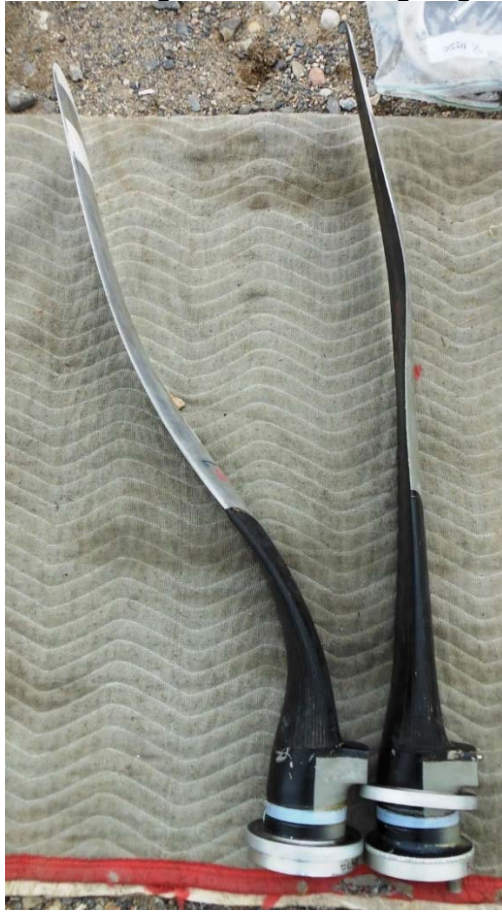
**Photo #31 – Right blades leading edge view**

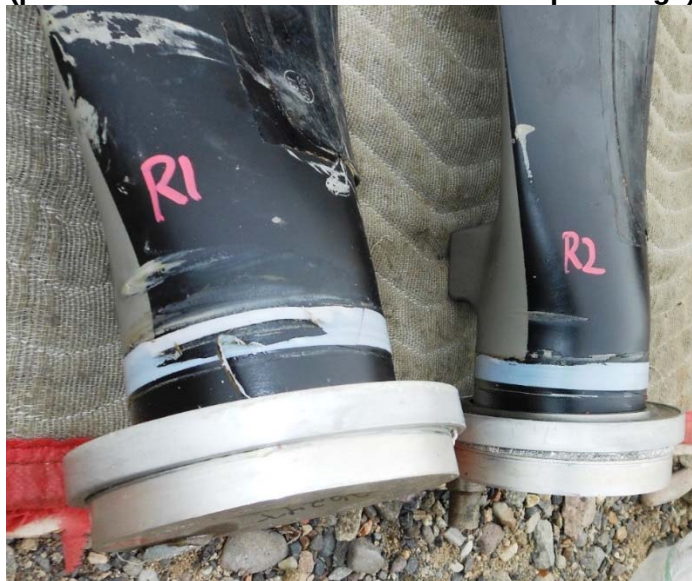
| Butt/shank impact marks | There was a paint transfer mark on the trail edge side above the Teflon O-ring rub strip (Photo #32) |

| Butt/shank impact marks | There was a paint transfer mark on the trail edge side above the Teflon O-ring rub strip (Photo #32) |

**Photo #32 – Right blades shank trailing edge view  
(paint transfer mark and Teflon rub strip damage)**
