# Continental Motors

## ENGINE FIELD INSPECTION REPORT

| ENGINE MODEL | IO-470-L21A |
| FILE NUMBER | 16-180 |

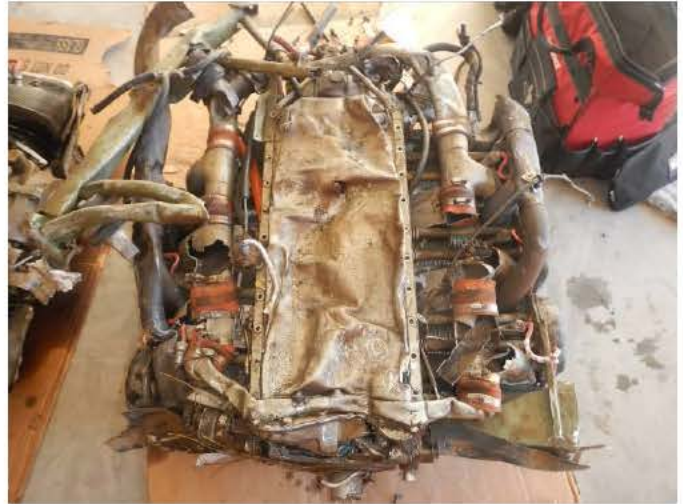
### INDUCTION SYSTEM

Condition: The intake filter and induction air box sustained deformation damage. The intake tubes were deformed and/or fractured. The balance tube was flattened against the oil pan. The throttle body remained attached to the backside of the engine and the throttle valve was found in a near full open position. The throttle lever remained attached to the throttle body and fuel metering unit. No pre-accident anomalies were noted with the induction system.

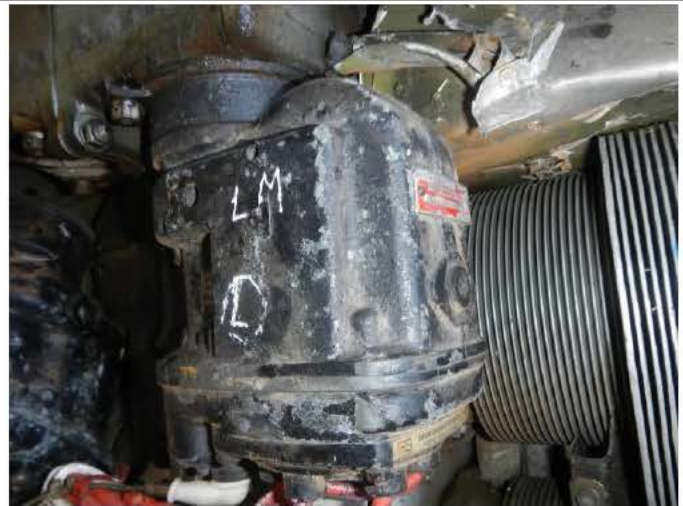
The left magneto remained secured to its mounting pad. Manual manipulation of the magneto did not result in any rotation or slipping. The ignition harness remained attached to the magneto. The magneto was removed and the top sparkplugs were inserted in the undamaged ignition terminals and the damaged terminal leads were cut to remove any impact-related shorts. The magneto's drive shaft was manually rotated and the impulse coupling made an audible snap with a corresponding spark from all of the sparkplugs or cut ignition leads. No pre-accident anomalies were noted with the magneto.

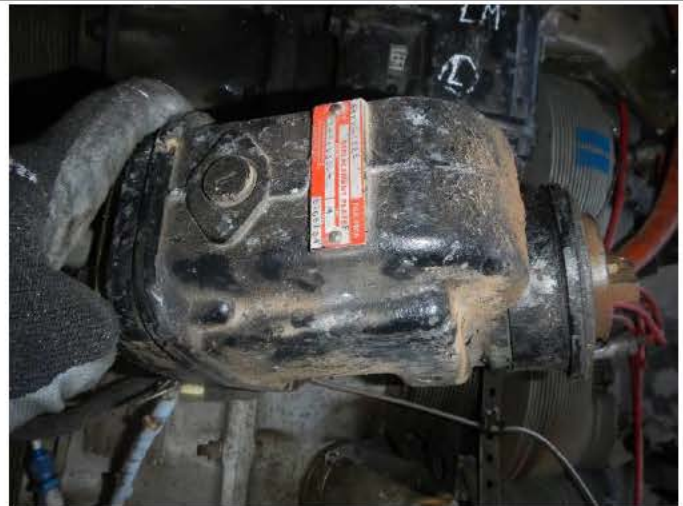
The right magneto was separated from its mounting pad and its flange was fractured in the area of the securing hardware. The ignition harness remained secured to the magneto. The top sparkplugs were inserted in the undamaged ignition terminals and the damaged terminal leads were cut to remove any impact-related shorts. The magneto's drive shaft was manually rotated and the impulse coupling made an audible snap with a corresponding spark from all of the sparkplugs or cut ignition leads. No pre-accident anomalies were noted with the magneto.

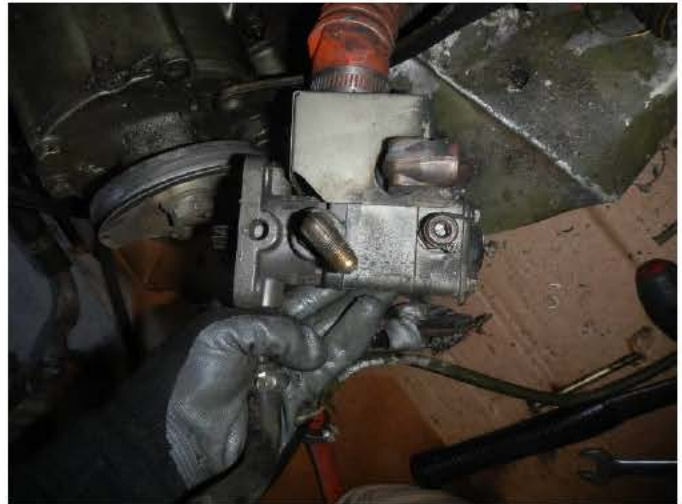
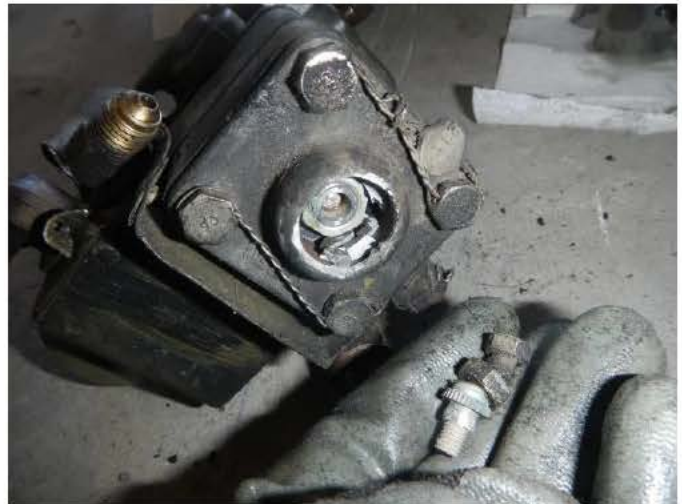
Condition: The engine-driven fuel pump remained attached to the backside of the engine and the fuel lines to and from the pump remained attached. The pump's low pressure relief valve adjusting screw was impinged by the left intake elbow. The low pressure relief valve cap was fractured. Manual rotation of the intact drive coupling resulted in a free and unbound rotation of the drive shaft. The fuel pump was disassembled and the low pressure relief valve diaphragm was torn. No obstructions or blockages were noted and the pump vanes were intact with no pre-accident anomalies noted.

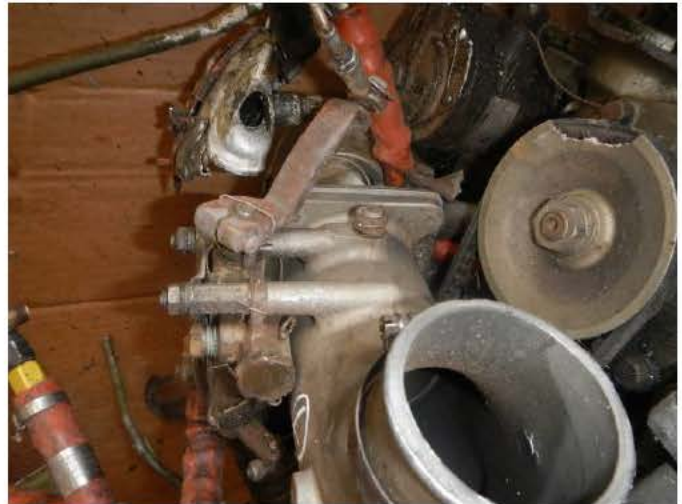
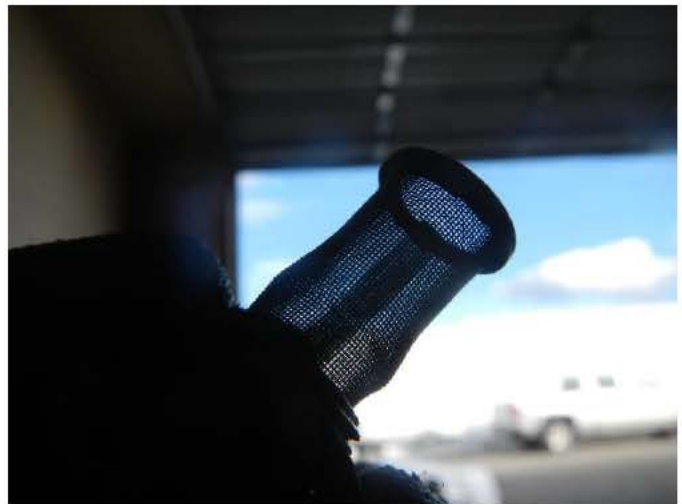
Condition: The throttle body remained attached to the backside of the engine and the fuel metering unit remained attached. The throttle and mixture control cables remained attached to the throttle and mixture control levers though the levers and cable rod ends were deformed. Rotation of the fuel metering unit's control levers resulted in a coinciding rotation of the shafts. The inlet fuel fitting was fractured. The inlet fuel screen was removed and no blockages or obstructions were noted. The fuel metering unit was disassembled and no pre-accident anomalies were noted with the internal components.

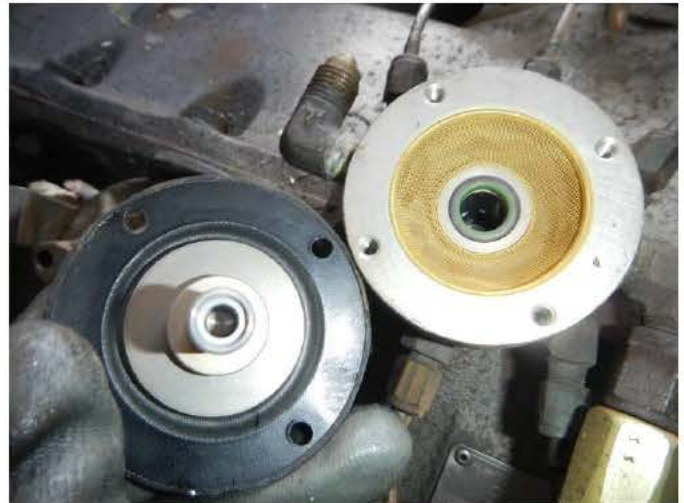
The fuel manifold valve remained attached to the topside of the engine and the fuel lines to and from the manifold valve remained attached. The manifold valve was disassembled and the plunger remained attached to the diaphragm and the screen was clean and unobstructed.

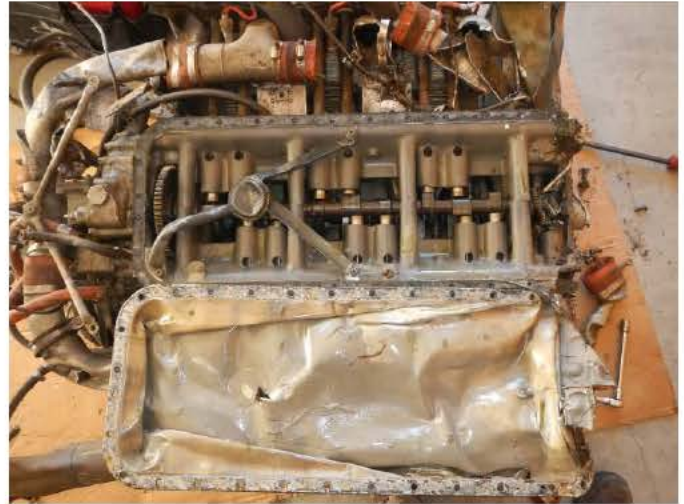
#### OIL SUMP

Condition: The oil sump remained attached to the bottom side of the engine. It was displaced upward and flattened and sustained puncture damage. The oil sump was removed and no pre-accident anomalies were noted.

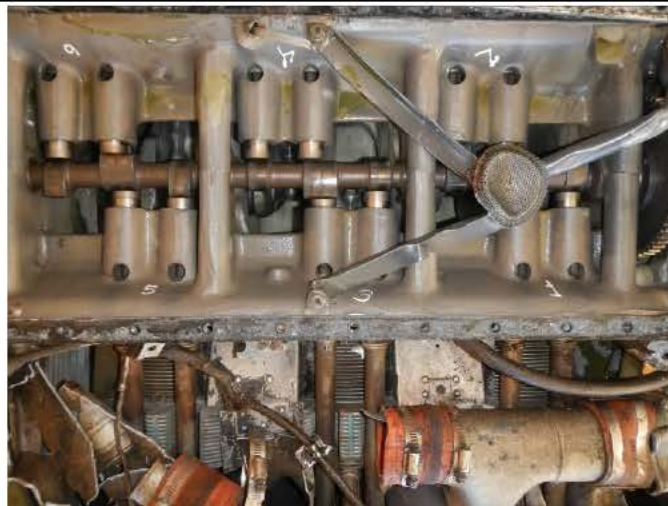
#### OIL PICKUP TUBE & SCREEN

Condition: The oil pickup tube and screen were intact but they sustained deformation damage. The screen was clear and unobstructed.

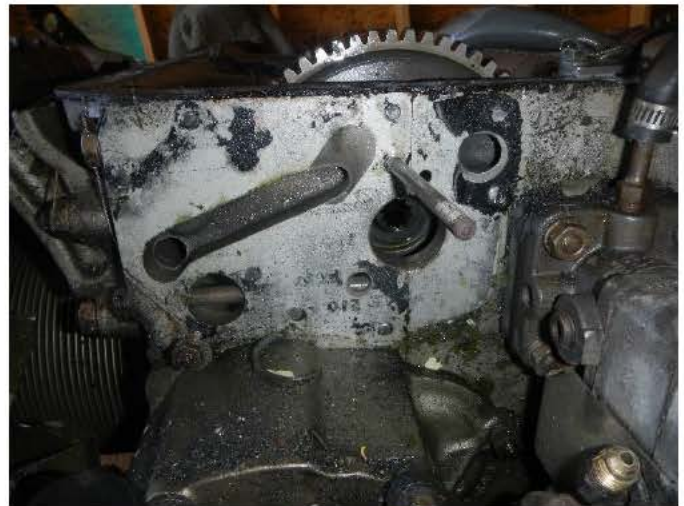
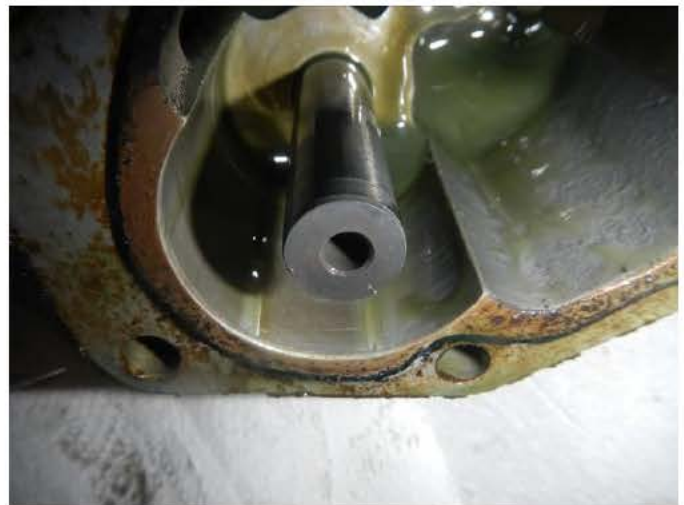
### OIL PUMP

Condition: The oil pump remained attached to the backside of the engine, though all but one of the mounting studs were sheered where the pump housing meets the crankcase. The pump was removed and examined. Oil coated all of the components. Surface corrosion was noted on the pump gears. Slivers of metal consistent with fresh shavings from the internal pump walls was observed on the gears. There were no signs of operational distress noted with the pump gears or housing.

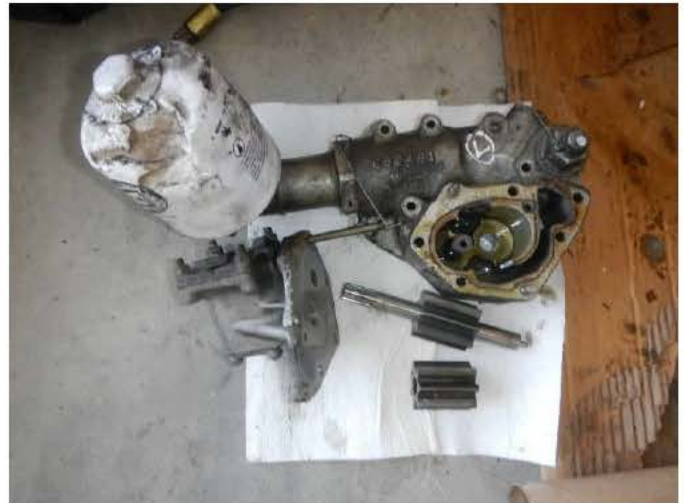
The oil filter remained attached to the oil filter adapter but it sustained deformation damage. The filter remained safety wired to the adapter. There was no sign of pre-existing leaks or anomalies.

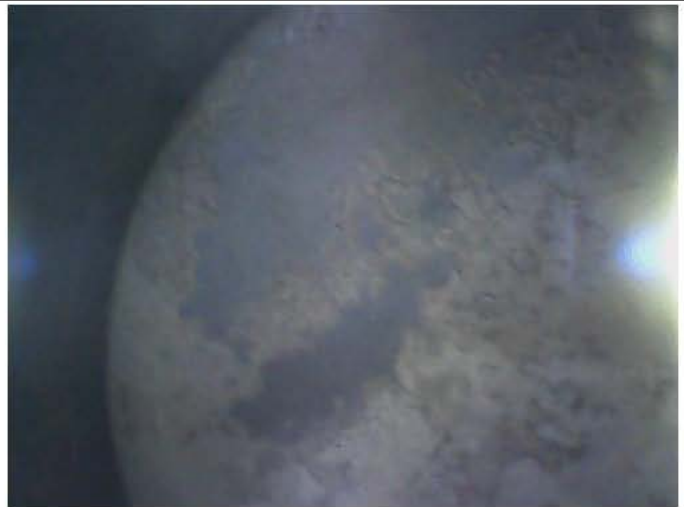
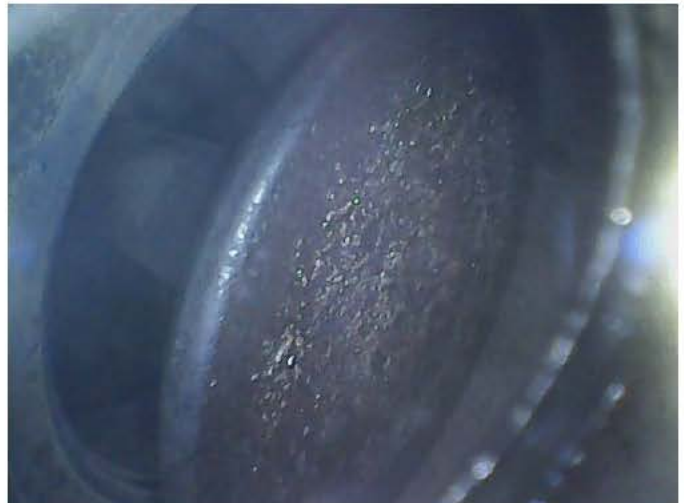
#### CYLINDER #1

Condition: The cylinder remained attached to the crankcase with no external signs of operational distress. The rocker cover was removed from the cylinder and the rockers were intact and well lubricated. The valve springs were intact and showed no signs of operational distress. The internal cylinder components were examined with a lighted borescope and no pre-accident anomalies or signs of operational distress were noted. Thumb compression was obtained during crankshaft rotation and valve operation was confirmed during the compression test.

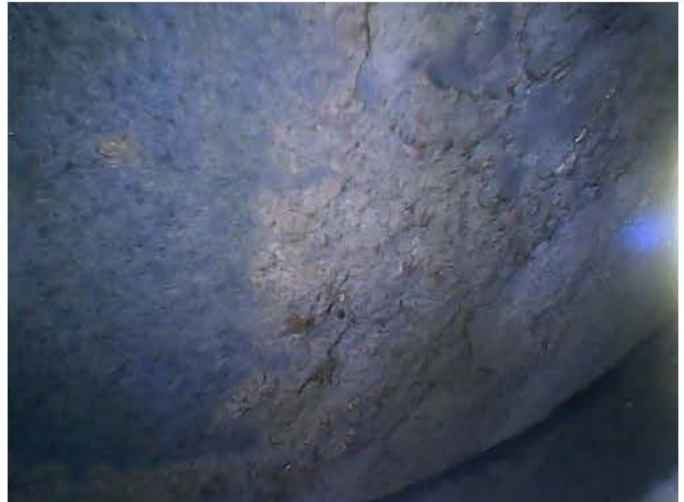
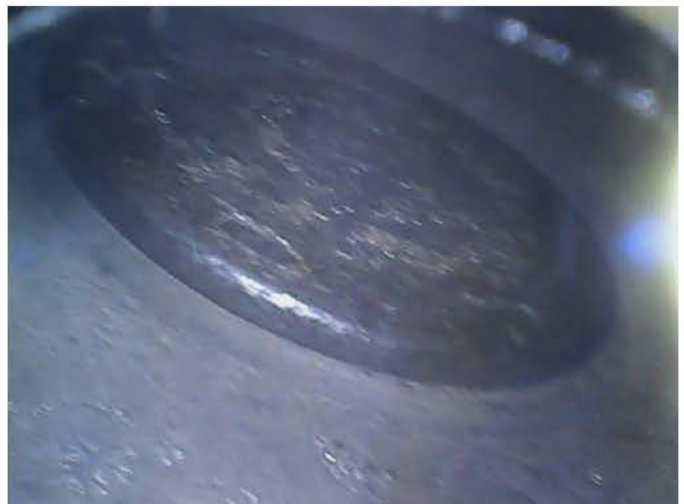
### CYLINDER #3

Condition: The cylinder remained attached to the crankcase with no external signs of operational distress. The rocker cover was removed from the cylinder and the rockers were intact and well lubricated. The valve springs were intact and showed no signs of operational distress. The internal cylinder components were examined with a lighted borescope and no pre-accident anomalies or signs of operational distress were noted. Thumb compression was obtained during crankshaft rotation and valve operation was confirmed during the compression test.

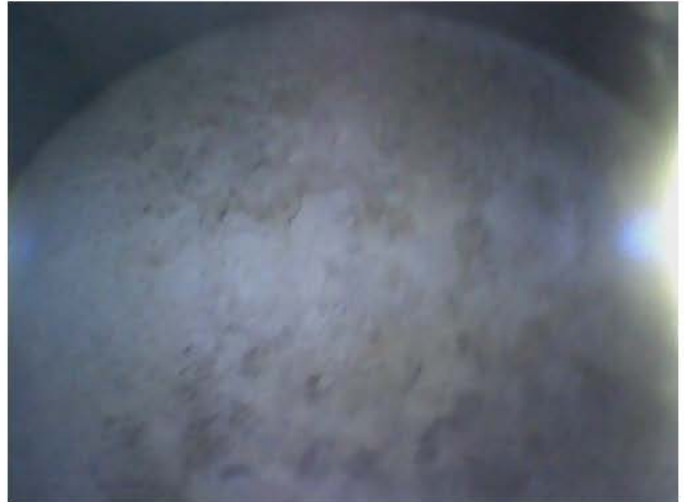
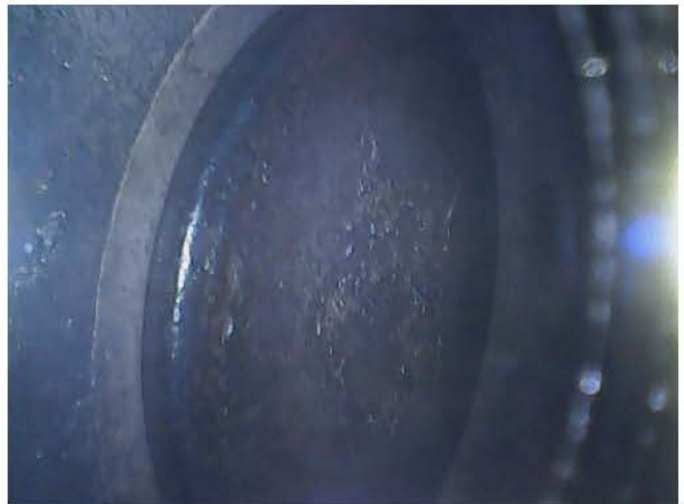
### CYLINDER #5

Condition: The cylinder remained attached to the crankcase with no external signs of operational distress. The rocker cover was removed from the cylinder and the rockers were intact and well lubricated. The valve springs were intact and showed no signs of operational distress. The internal cylinder components were examined with a lighted borescope and no pre-accident anomalies or signs of operational distress were noted. Thumb compression was obtained during crankshaft rotation and valve operation was confirmed during the compression test.

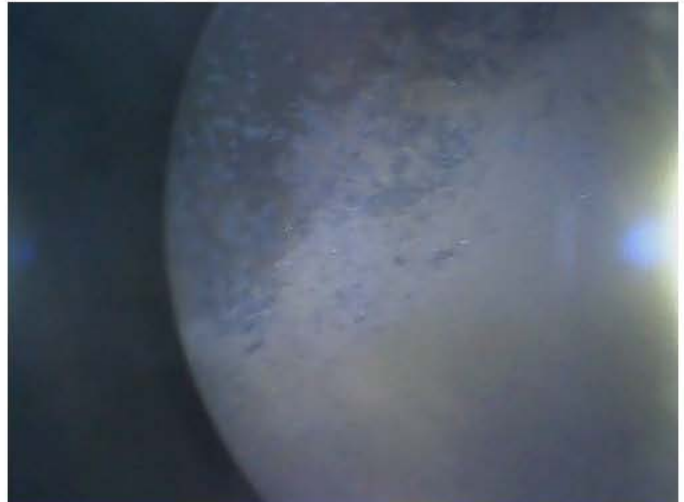
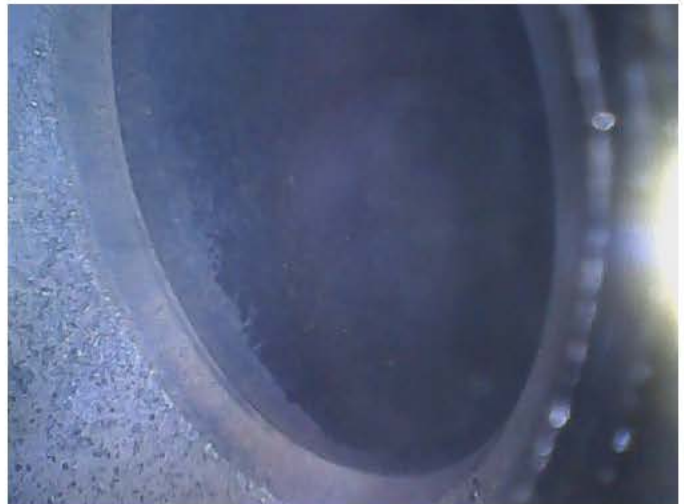
### CYLINDER #2

Condition: The cylinder remained attached to the crankcase with no external signs of operational distress. The rocker cover was removed from the cylinder and the rockers were intact and well lubricated. The valve springs were intact and showed no signs of operational distress. The internal cylinder components were examined with a lighted borescope and no pre-accident anomalies or signs of operational distress were noted. Thumb compression was obtained during crankshaft rotation and valve operation was confirmed during the compression test.

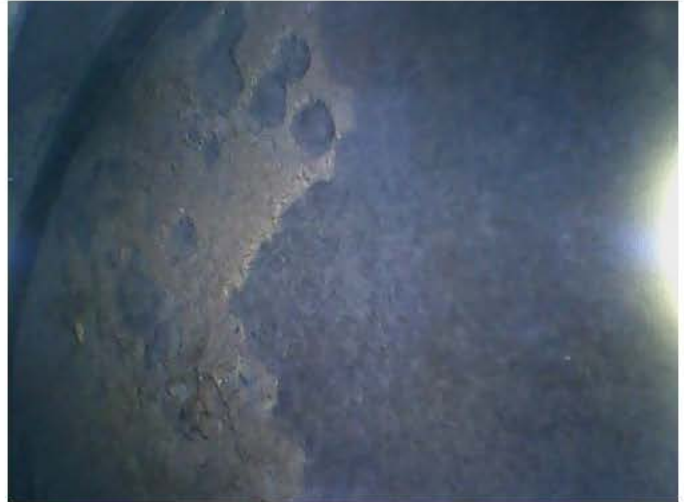
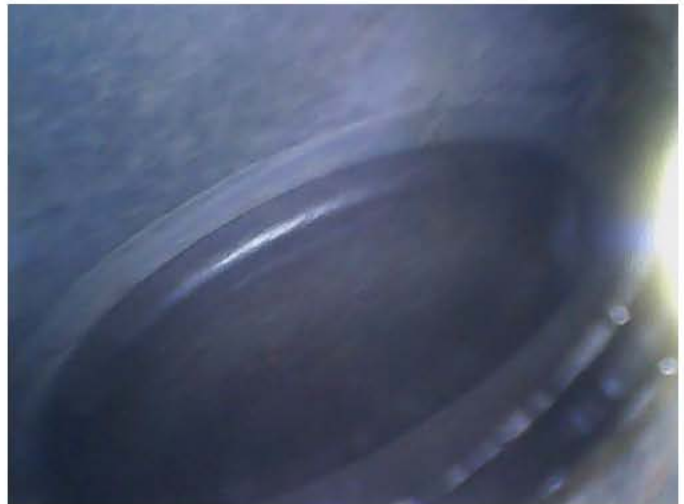
### CYLINDER #4

Condition: The cylinder remained attached to the crankcase with no external signs of operational distress. The rocker cover was removed from the cylinder and the rockers were intact and well lubricated. The valve springs were intact and showed no signs of operational distress. The internal cylinder components were examined with a lighted borescope and no pre-accident anomalies or signs of operational distress were noted. Thumb compression was obtained during crankshaft rotation and valve operation was confirmed during the compression test.

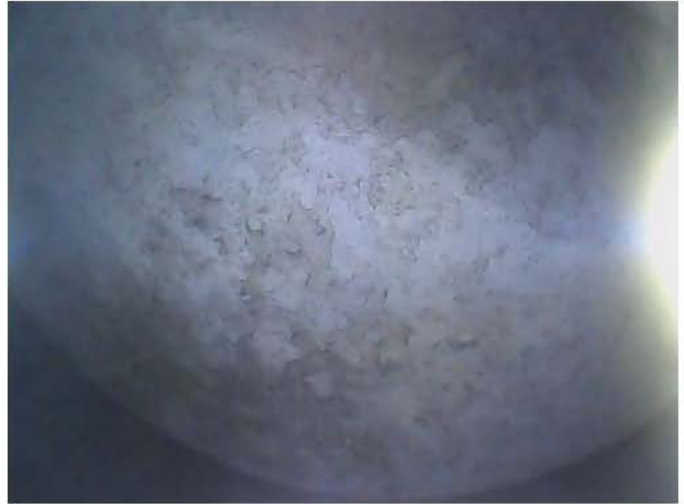
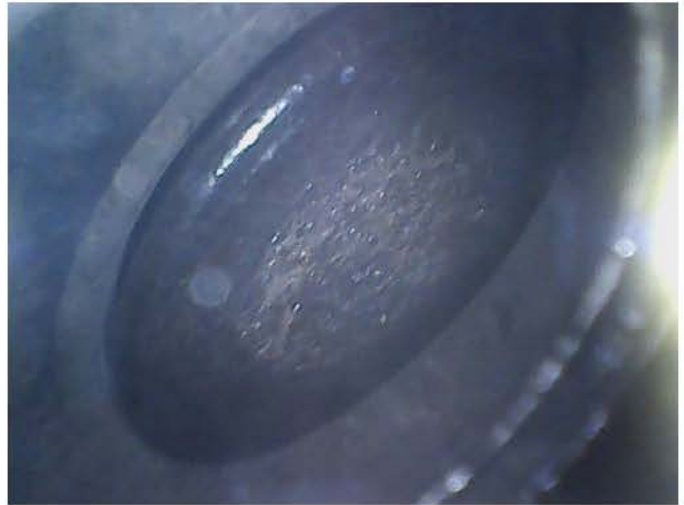
### CYLINDER #6

Condition: The cylinder remained attached to the crankcase with no external signs of operational distress. The rocker cover was fractured on the bottom side. It was removed from the cylinder and the rockers were intact and well lubricated. The valve springs were intact and showed no signs of operational distress. The internal cylinder components were examined with a lighted borescope and no pre-accident anomalies or signs of operational distress were noted. Thumb compression was obtained during crankshaft rotation and valve operation was confirmed during the compression test.

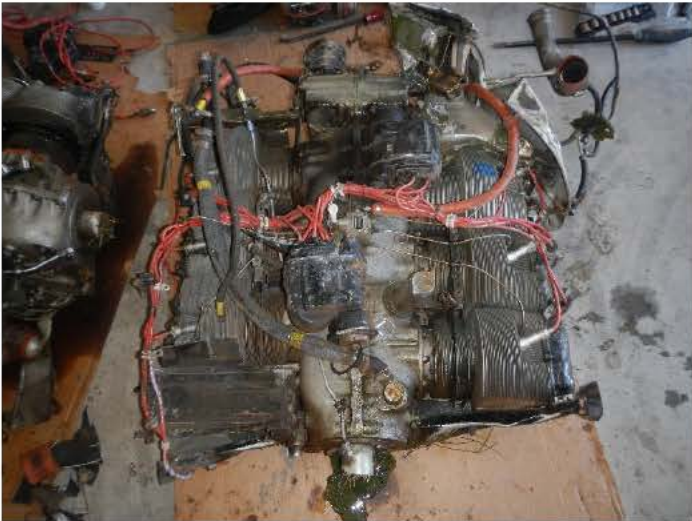
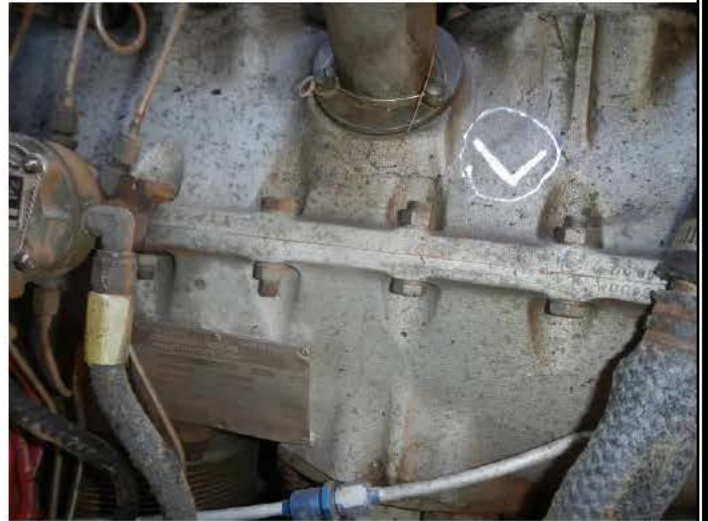
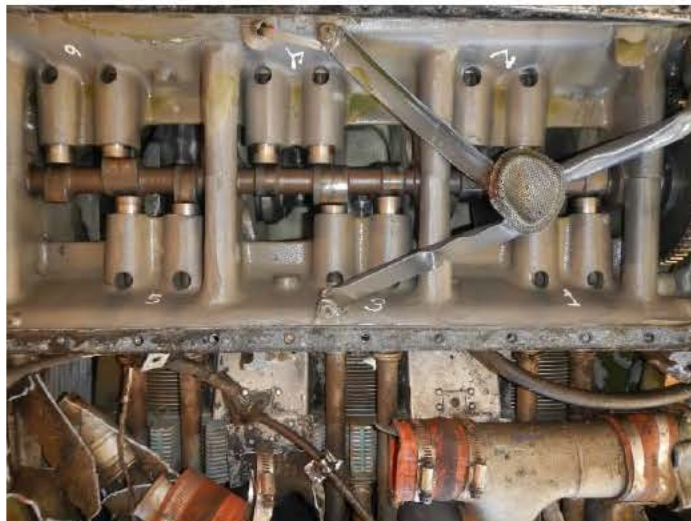
The crankcase halves remained attached but the bottom and front ends sustained impact-related fractures. Internal views of the crankcase with the oil sump removed revealed no signs of operational distress. During a crankshaft continuity check there was no binding noted with the main bearings or main bearing journals.

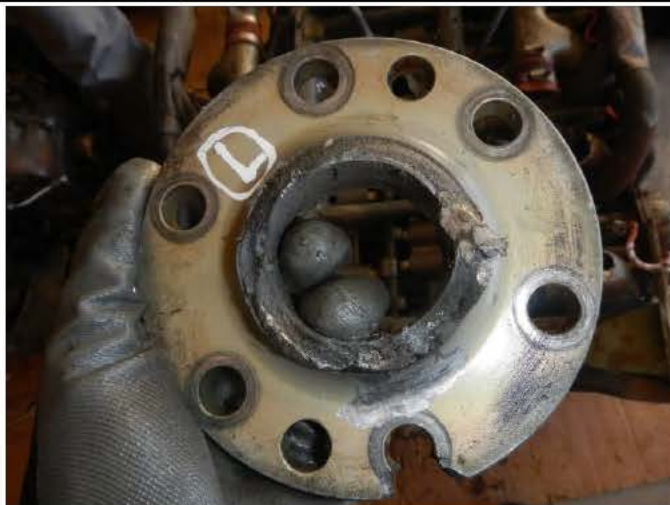
| CRANKSHAFT | Forging Number: Not Observed | S/N: B334 | Heat code: J18 |
|---|---|---|---|
| Condition: | The crankshaft's propeller flange was separated just aft of the flange. The fracture surface was jagged and irregular with small areas of thermal discoloration on the fracture features. One of the propeller bolt holes was torn open. The flange remained attached to the propeller hub. The rest of the crankshaft remained intact and crankshaft continuity was confirmed from the accessory end forward to the front fracture area and out to each connecting rod during a crankshaft continuity check. The crankshaft was manually rotated utilizing a tool that was inserted into the accessory gear. No binding or anomalies were noted. | | |

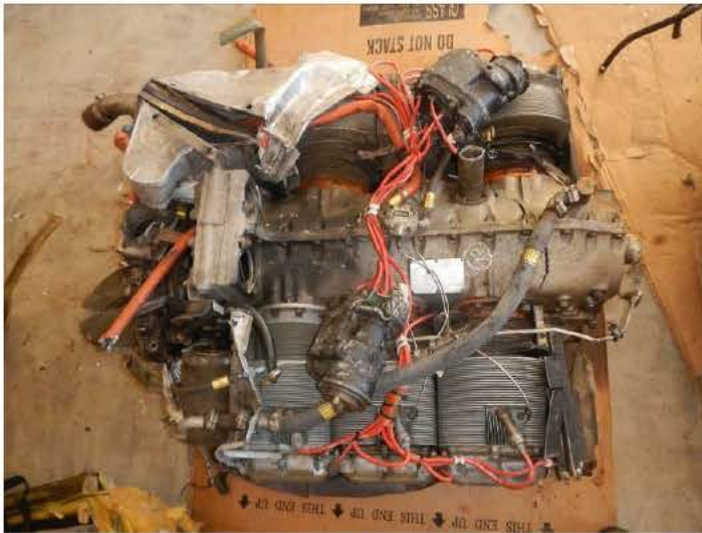
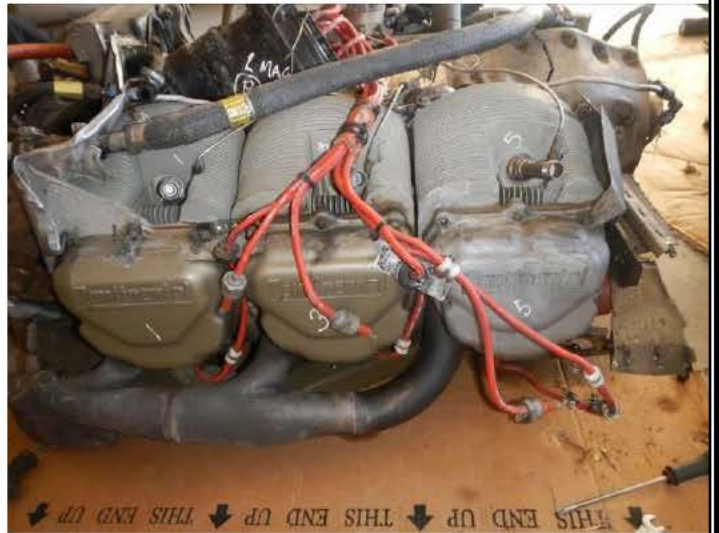
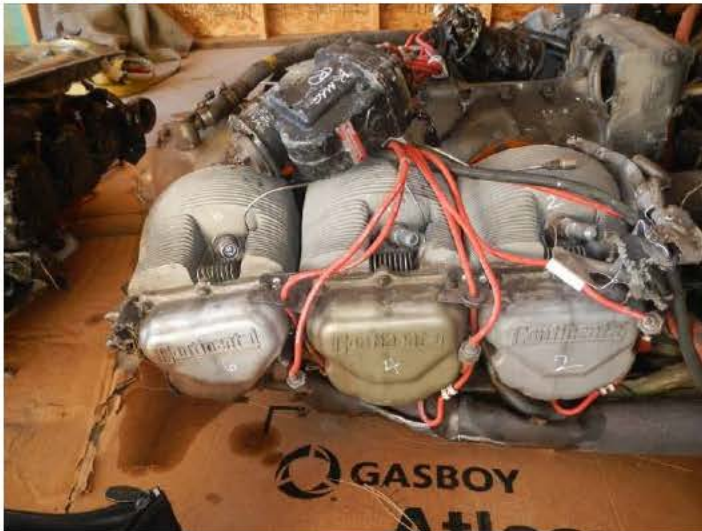
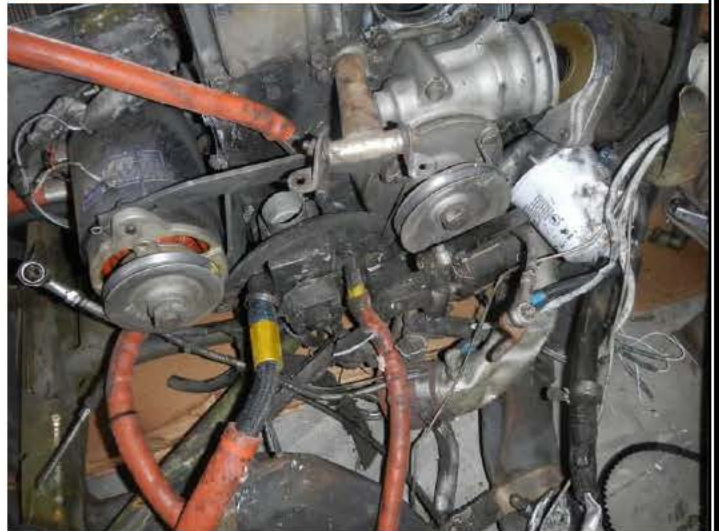
The right engine was separated from the aircraft and was lying on the storage facility floor. A large irregular and jagged fracture was observed in the front portion of the crankcase from the #5 cylinder's leading edge, over the topside of the crankcase, to the #6 cylinder's trailing edge. The two-bladed propeller was separated from the crankshaft aft of the propeller flange. The fracture surface was jagged and irregular in shape and displayed localized thermal discoloration at isolated areas of the fracture surface. The propeller flange remained attached to the propeller hub.

The engine was rolled over to facilitate oil pan removal. The oil pan was flattened and displaced into the bottom of the engine. The fracture noted on the top side of the crankcase continued to the bottom front portion of the crankcase. Numerous irregular fractures were noted in the bottom side of the crankcase halves with the predominance of damage being on the front right side. A portion of connecting rod cap was protruding through the oil pan but it was not discolored.

The oil pan was removed providing visual access to the engine's core components (camshaft, lifters, crankshaft, counterweights, connecting rods, and camshaft gears). All components appeared to be well lubricated. The #6 connecting rod bolt were fractured, the connecting rod cap was separated from the connecting rod, and the connecting rod was fractured near the piston pin. The #6 connecting rod bearing halves were found within the crankcase and they did not display any signs of thermal discoloration. The bearing halves sustained impact-related deformation damage. The #6 connecting

rod journal displayed normal operating signatures with no signs of operational distress or thermal discoloration. The camshaft was bent between the #6 exhaust cam lobe and the #5 and #6 intake cam lobes. The camshaft was fractured aft of the #5 exhaust cam lobe and the fracture was irregular in shape. The #5 and #6 hydraulic lifters were displaced from their normal positions and were found within the crankcase.

The engine was rolled over to an upright position. The upper crankcase remained intact and all six cylinders remained attached. The magnetos were separated from their mounting flange and remained attached to the engine via the ignition harness. The engine-driven fuel pump, throttle body/fuel metering unit, fuel manifold valve and fuel injection nozzles remained in place though they sustained varying degrees of impact-related damage.

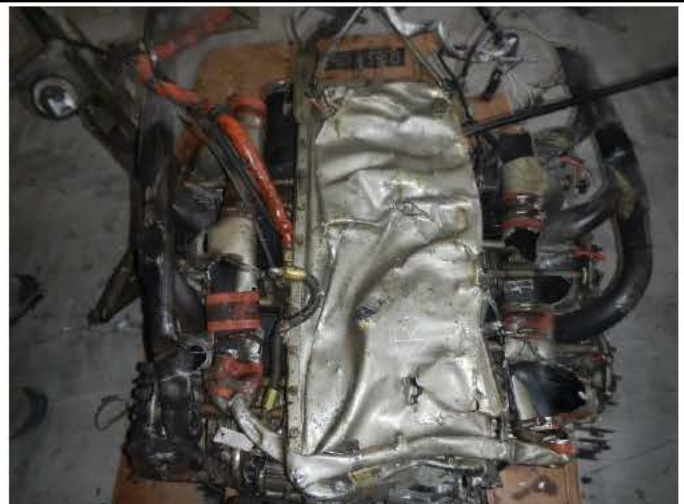
#### INDUCTION SYSTEM

Condition: The induction air box remained attached to the engine but it sustained deformation damage to it and the air filter. The air box was displaced from the throttle body and the throttle body was fractured as were many of the intake tubes and risers. The balance tube was flattened.

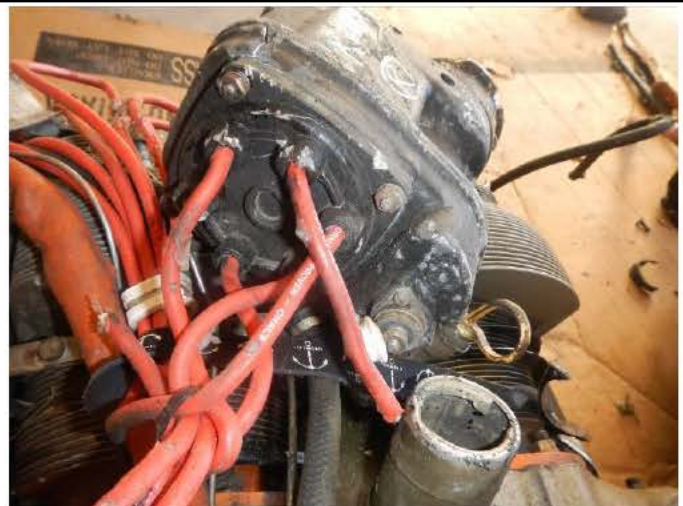
The left magneto was separated from its mounting pad and its flange was fractured in the area of the securing hardware. The ignition harness remained attached to the magneto but the harness cap sustained impact damage that deformed a few of the terminal towers. The top sparkplugs were inserted in the undamaged ignition terminals and the damaged terminal leads were cut to remove any impact-related shorts. The magneto's drive shaft was manually rotated and the impulse coupling made an audible snap with a corresponding spark from all of the sparkplugs or cut ignition leads, with exception of one that sustained the deformation damage. The ignition harness was removed and a piece of wire was inserted in the distributor tower and the drive shaft was again rotated. A spark was obtained from the damaged tower. No pre-accident anomalies were noted with the magneto.

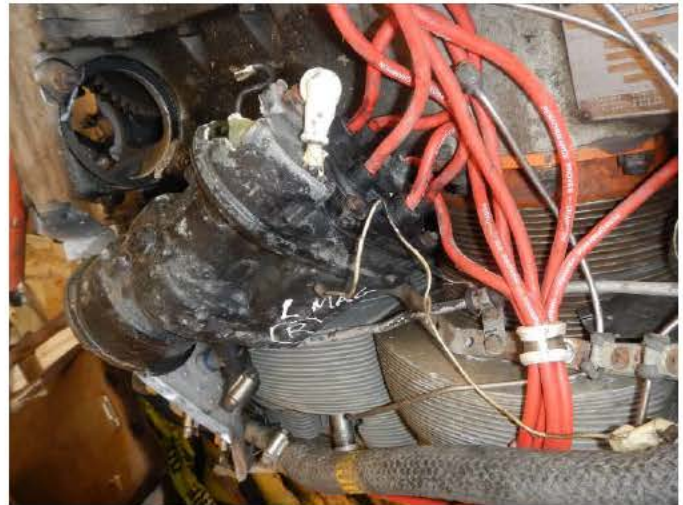
The right magneto was separated from its mounting pad and its flange was fractured in the area of the securing hardware. The housing also sustained fracture damage in the area of the contact points. The coil lead flag terminal was separated from the contact point tab. The ignition harness remained secured to the magneto. The top sparkplugs were inserted in the undamaged ignition terminals and the damaged terminal leads were cut to remove any impact-related shorts. The separated flag terminal was reinstalled on its tab. The magneto's drive shaft was manually rotated and the impulse coupling made an audible snap with a corresponding spark from all of the sparkplugs or cut ignition leads. No pre-accident anomalies were noted with the magneto.

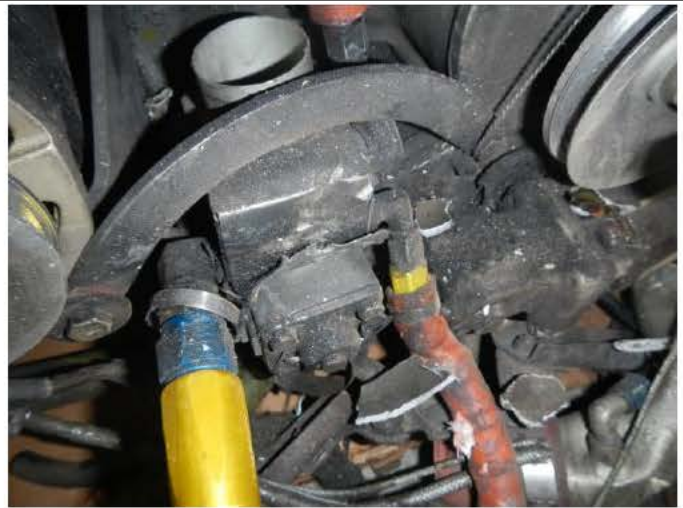
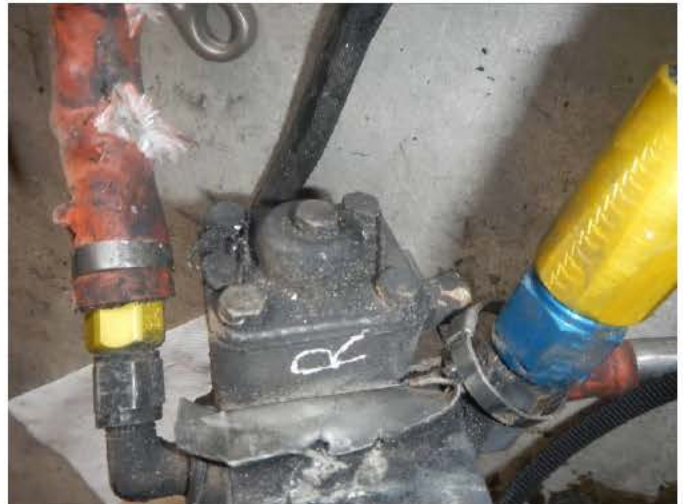
Condition: The engine-driven fuel pump remained attached to the backside of the engine and the fuel lines to and from the pump remained attached. The pump's low pressure release valve was slightly displaced. The adjustment screw was completely threaded into the cap. Manual rotation of the intact drive coupling resulted in a free and unbound rotation of the drive shaft. Manipulation of the fuel pump resulted in residual fuel pouring from the pump fittings. The fuel pump was disassembled and no obstructions or blockages were noted and the pump vanes were intact with no pre-accident anomalies noted.

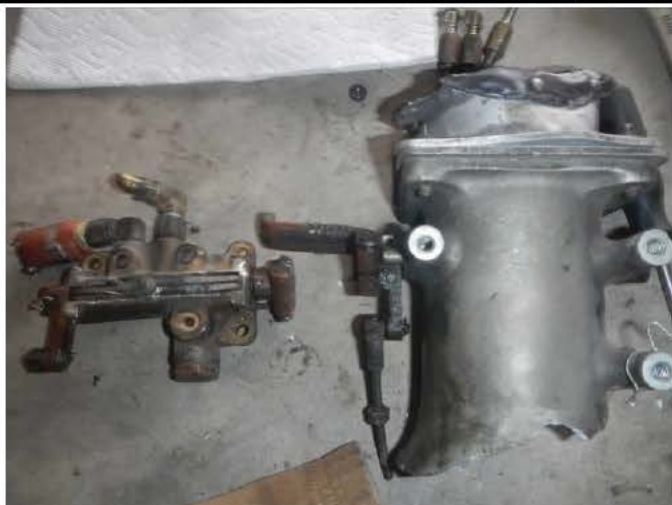
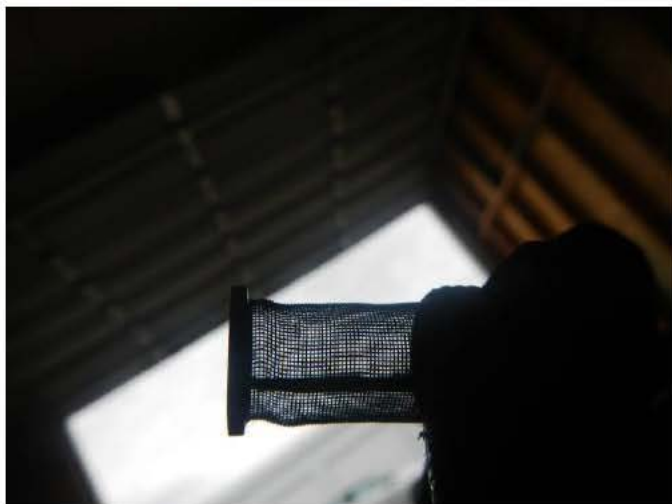
The throttle body remained attached to the backside of the engine, but the bottom wye was fractured. The mixture lever was cut by recovery personnel, but the portion that remained attached to the shaft was secured. The throttle cable and lever remained secured. The fuel metering unit's fuel inlet fitting was fractured. The inlet fuel screen was removed and no obstructions were noted. The fuel metering unit was disassembled with no pre-accident anomalies noted.

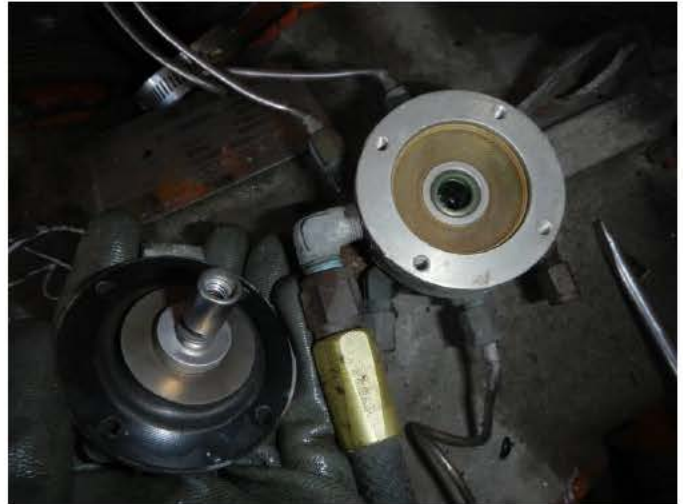
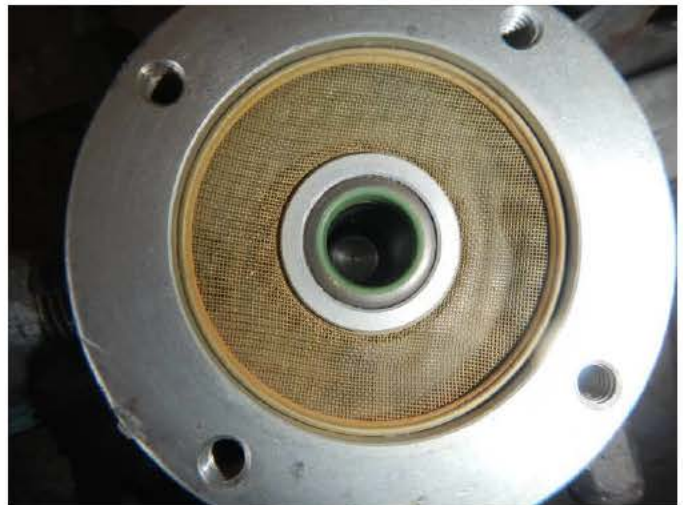
The fuel manifold valve remained attached to the engine. The #1 and #2 fuel injection line fittings and the fuel inlet fitting were fractured at the housing. The manifold valve was disassembled and the plunger remained attached to the diaphragm and the screen was clean and unobstructed.

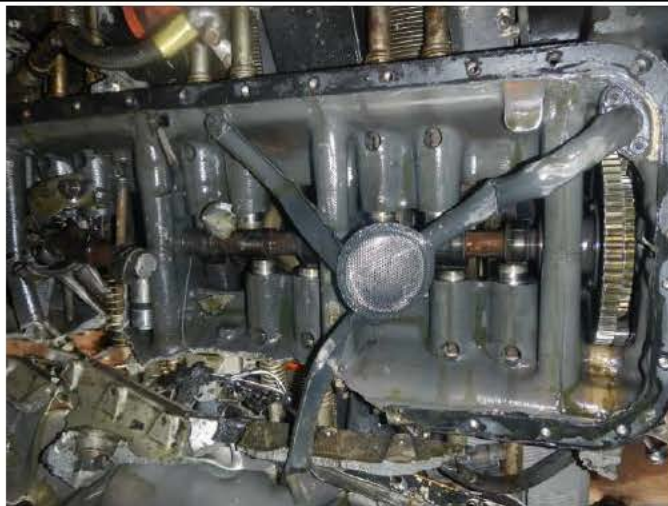
#### OIL PICKUP TUBE & SCREEN

Condition: The oil pickup tube and screen were intact but they sustained deformation damage. The screen was clear and unobstructed.

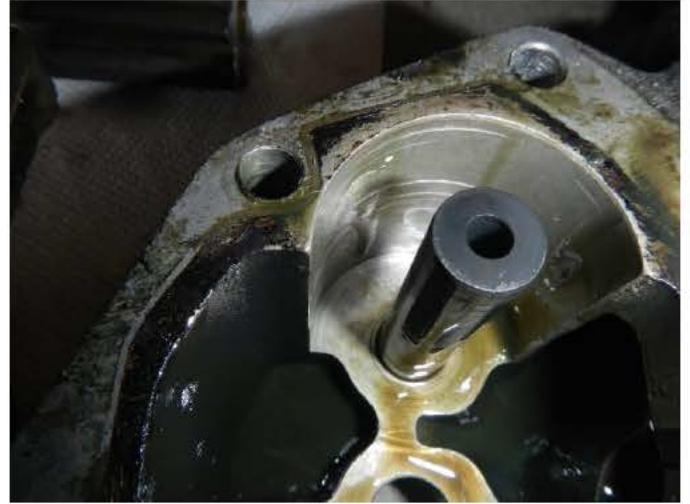
The oil pump remained attached to the backside of the engine. The pump was removed and examined. Oil coated all of the components. Surface corrosion was noted on the pump gears. Slivers of metal consistent with fresh shavings from the internal pump walls was observed on the gears. There were no signs of operational distress noted with the pump gears or housing.

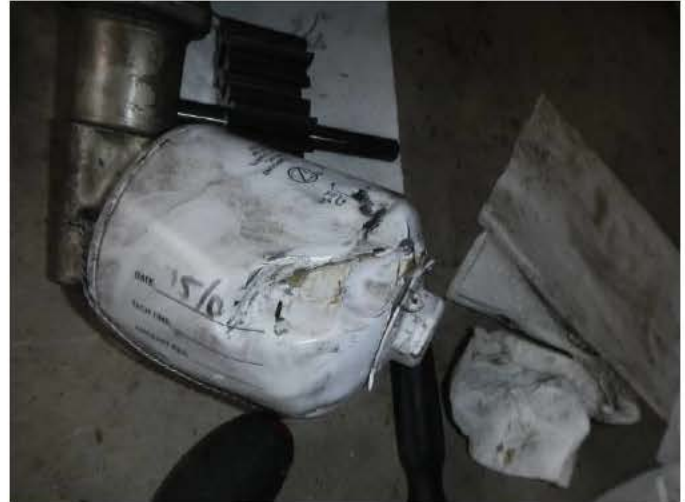
The oil filter remained attached to the oil filter adapter but it sustained deformation damage. The filter remained safety wired to the adapter. There was no sign of pre-existing leaks or anomalies.

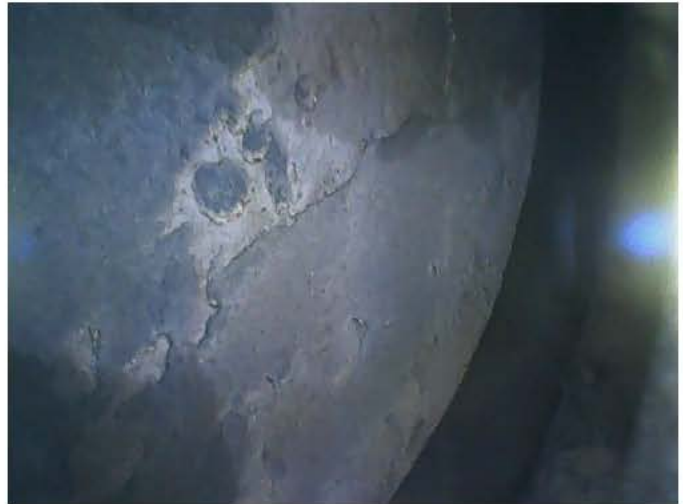
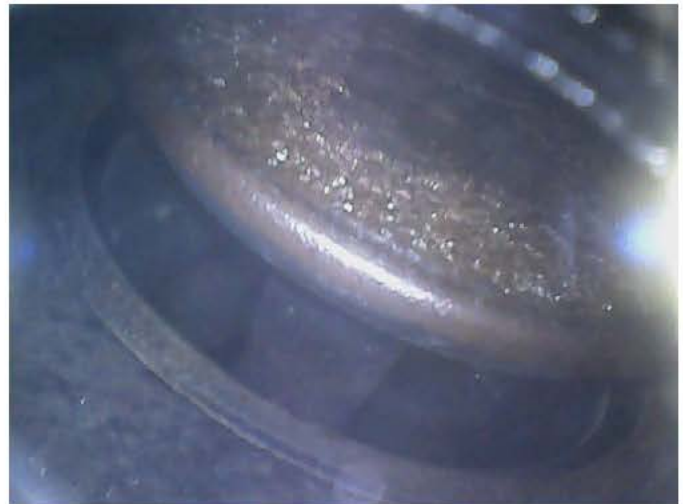
Condition: The cylinder remained attached to the crankcase with no external signs of operational distress. The crankcase was fractured just forward of the #5 cylinder. The rocker cover was removed from the cylinder and the rockers were intact and well lubricated. The valve springs were intact and showed no signs of operational distress. The internal cylinder components were examined with a lighted borescope and no pre-accident anomalies or signs of operational distress were noted.

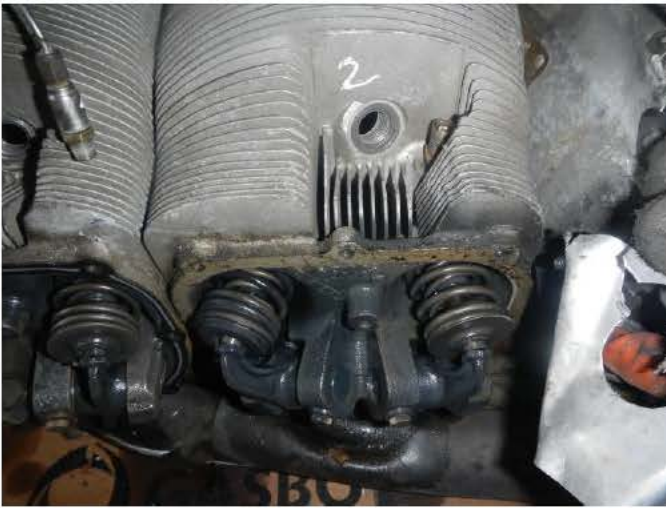
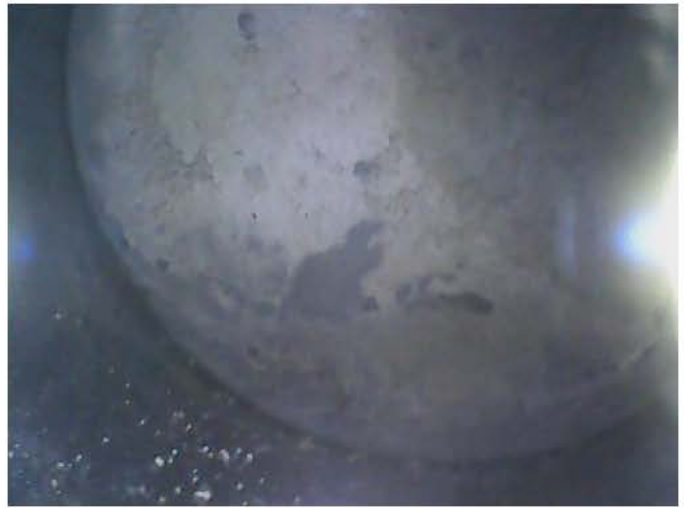
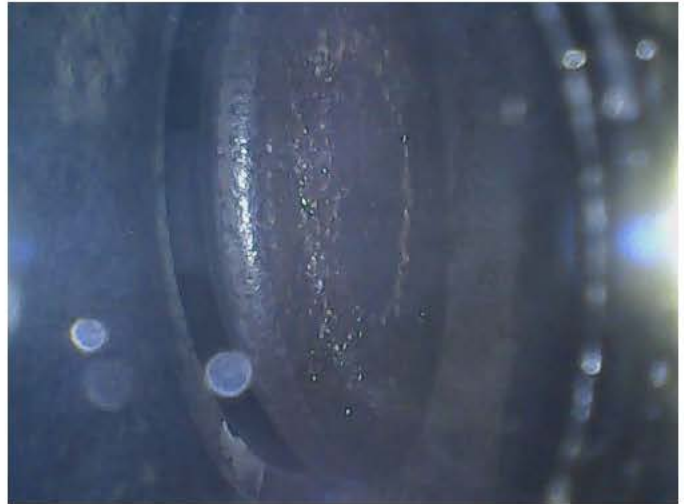
Condition: The cylinder remained attached to the crankcase with no external signs of operational distress. The rocker cover was removed from the cylinder and the rockers were intact and well lubricated. The valve springs were intact and showed no signs of operational distress. The internal cylinder components were examined with a lighted borescope and no pre-accident anomalies or signs of operational distress were noted.

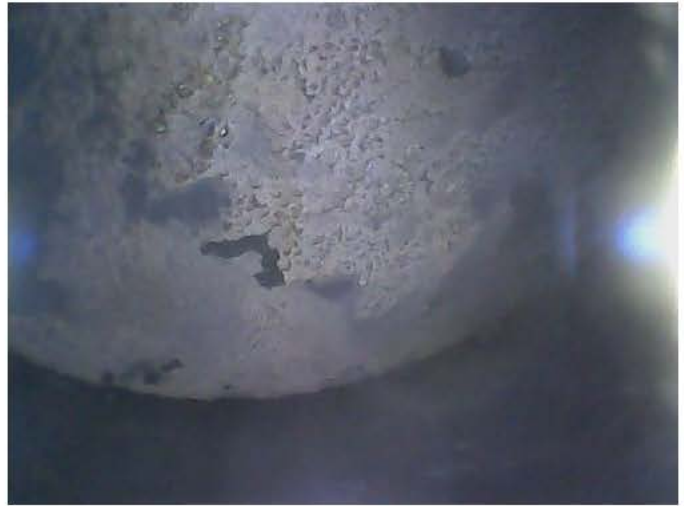
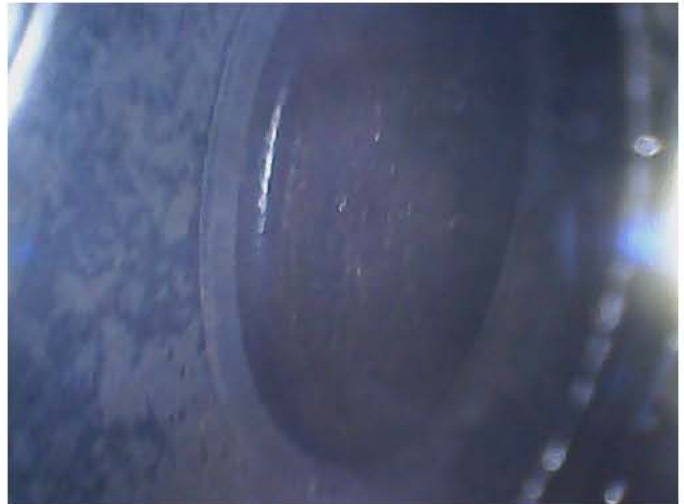
Condition: The cylinder remained attached to the crankcase with no external signs of operational distress. The rocker cover was removed from the cylinder and the rockers were intact and well lubricated. The valve springs were intact and showed no signs of operational distress. The internal cylinder components were examined with a lighted borescope and no pre-accident anomalies or signs of operational distress were noted.
