# Continental Motors

## ENGINE FIELD INSPECTION REPORT

| ENGINE MODEL | IO-470-L21A |
| FILE NUMBER | 16-180 |

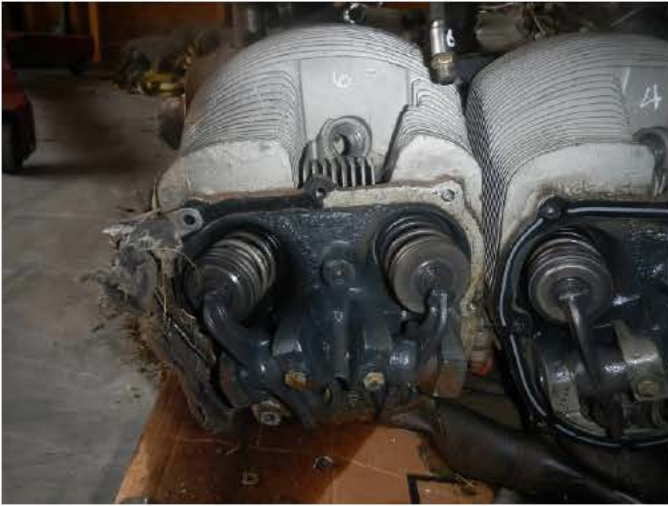
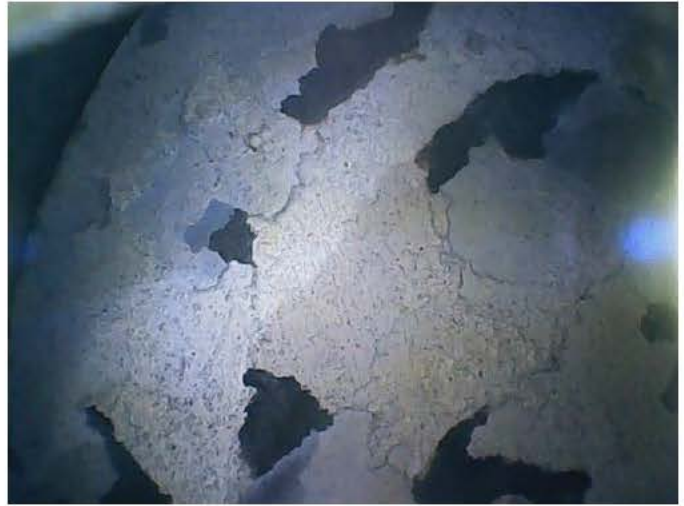
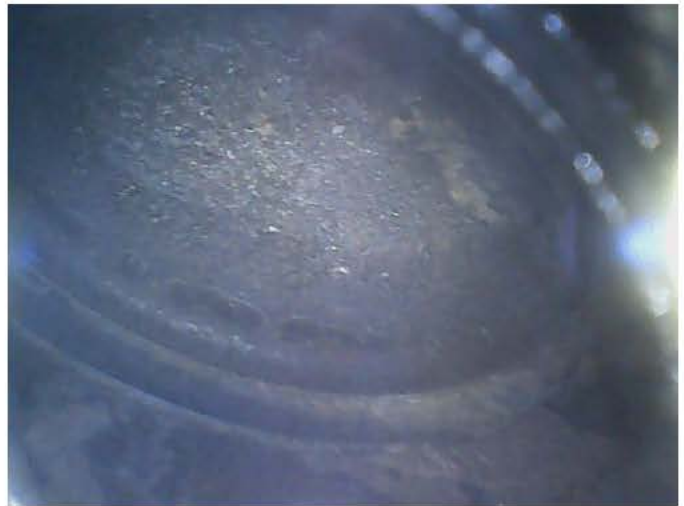
Condition: The cylinder remained attached to the crankcase with no external signs of operational distress. The crankcase was fractured aft of the cylinder. The rocker cover was removed from the cylinder and the rockers were intact and well lubricated. The valve springs were intact and showed no signs of operational distress. The internal cylinder components were examined with a lighted borescope and no pre-accident anomalies or signs of operational distress were noted.

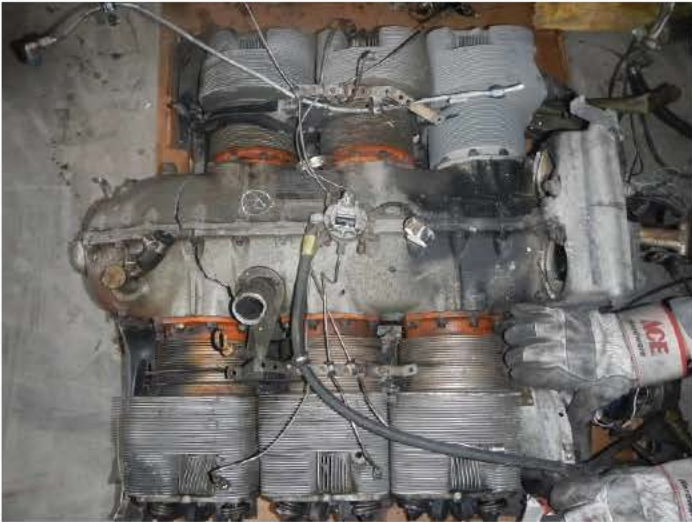
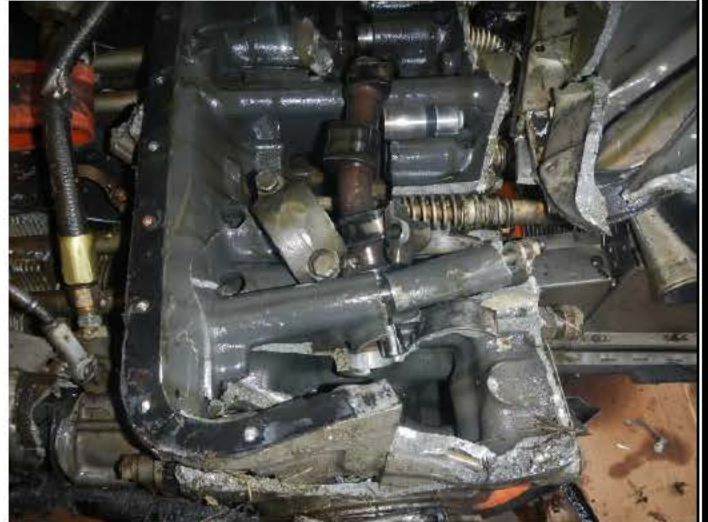
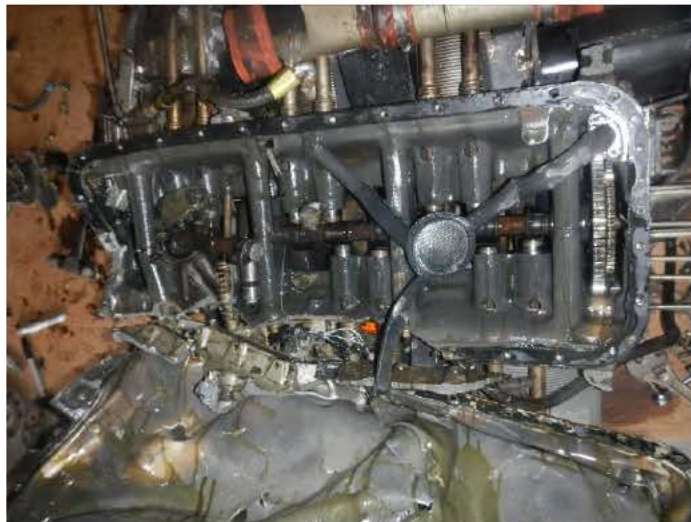
Condition: The crankcase halves remained attached. A large crack in the area of the #5 and #6 cylinders extended throughout the entirety of the crankcase circumference and fractured the #5 hydraulic lifter area. The bottom right oil sump mounting flange was also fractured. The fractures appeared to be irregular and jagged with no signs of pre-impact anomalies. The main bearings appeared to be intact with no signs of pre-impact anomalies.

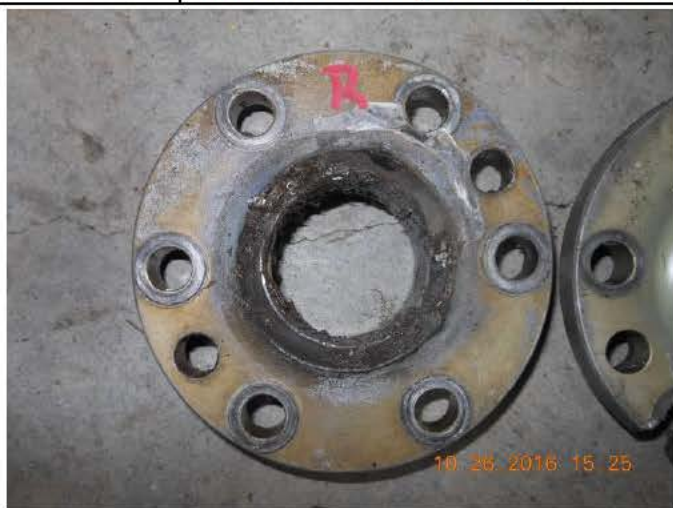
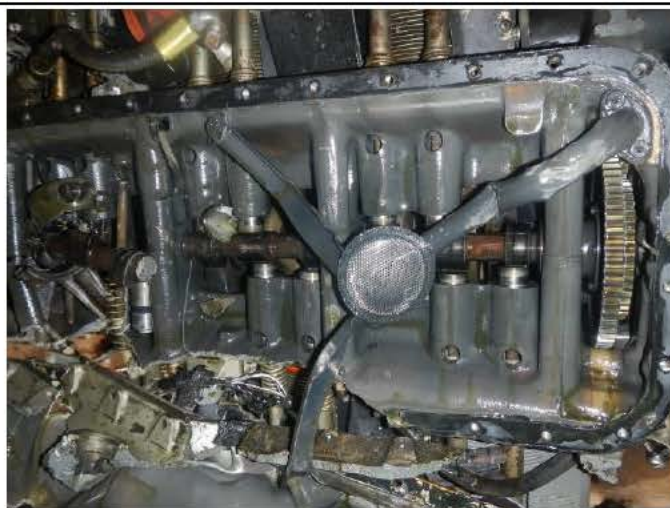
The crankshaft's propeller flange was separated just aft of the flange. The fracture surface was jagged and irregular with small areas of thermal discoloration on the fracture features. The flange remained attached to the propeller hub. The rest of the crankshaft remained intact and crankshaft continuity was visually confirmed from the accessory end forward to the front fracture area and out to each connecting rod, with the exception of the #6 connecting rod which was fractured into three pieces. The crankshaft's #6 connecting rod journal did not display any signs of pre-accident anomalies or signs of operational distress.

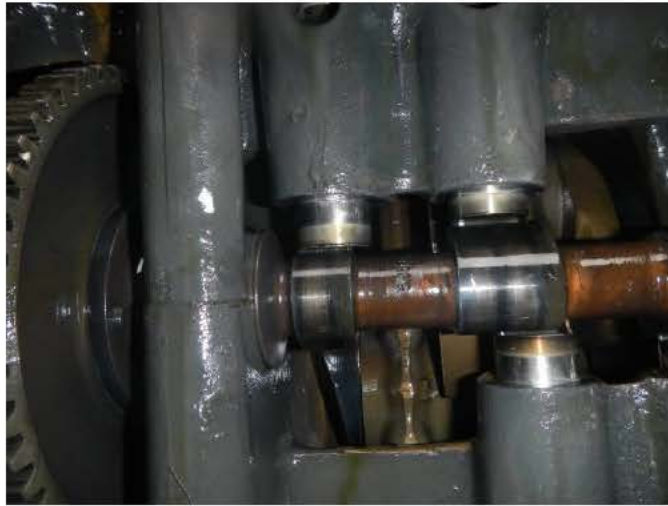
Condition: The connecting rod was viewed when the oil pan was removed from the engine crankcase. The connecting rod remained attached to both the crankshaft and piston pin with no signs of operational distress noted.

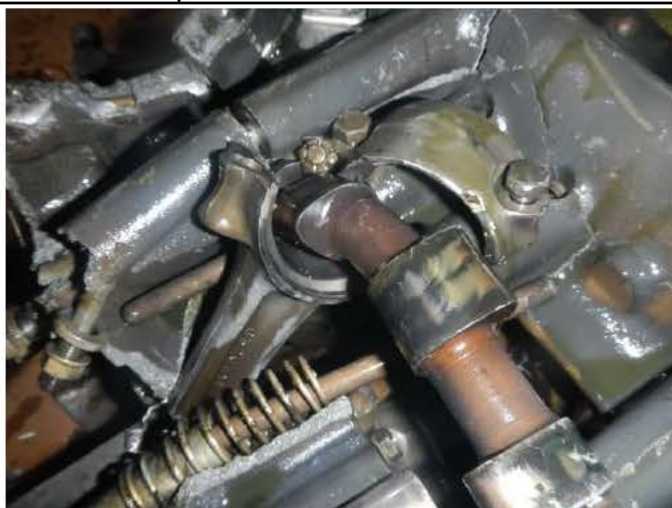
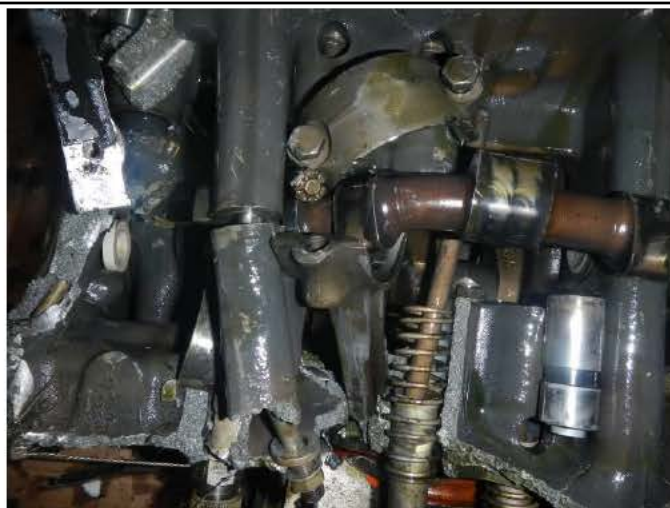
The #6 connecting rod was fractured into three pieces. The rod cap was displaced through the bottom of the engine and punctured the oil sump. The rod cap bolts were fractured with the bolts displaying notable necking deformation and irregular fracture surfaces. The bolt nuts remained threaded on the bolts with the cotter pin installed in each. The connecting rod i-beam was fractured approximately 2 inches from the piston pin. The fracture surfaces at the i-beam were smeared with stud a thread imprint noted on one of the fracture ends. The connecting rod was not discolored. The connecting rod bearings were found in the engine crankcase and they displayed deformation damage with no signs of pre-impact anomalies.

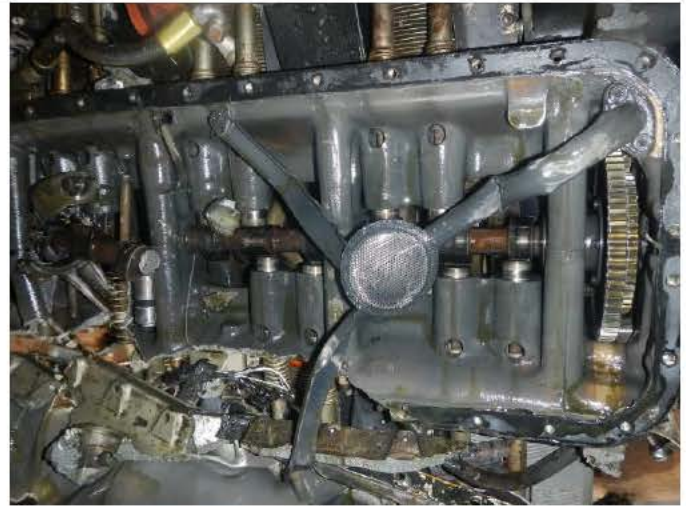
**Condition:** The camshaft was bent between the #6 exhaust cam lobe and the #5 and #6 intake cam lobes. The camshaft was fractured aft of the #5 exhaust cam lobe and the fracture was irregular in shape. The #5 and #6 lifters were displaced from their normal positions and were found within the crankcase. There were no signs of pre-impact anomalies with the lifters or camshaft. The camshaft's governor drive gear was displaced from the end of the camshaft and was found in the crankcase.

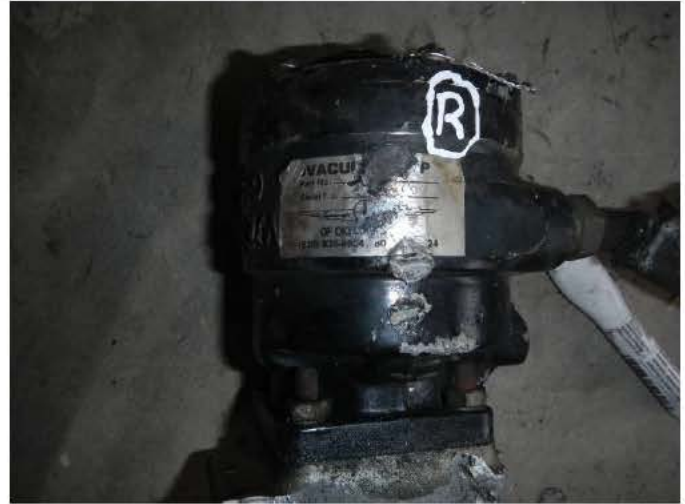
The vacuum pump remained attached to the mounting pad, but the pad was fractured. The drive gear remained attached to the vacuum pump with no anomalies noted with the gear or gear teeth. Manual manipulation of the drive gear did not result in rotation of the drive shaft. The pump was not disassembled.
