## Air Safety Investigations Aircraft Incident/Accident Technical Report

| Aircraft Incident/<br>Accident Information | Year: 1974 | Make: Beechcraft | Model: 95-B55 |
| Location: Broadus, MT | | Date: 09-17-16 | Time: ~1200 MDT |
| Air Safety Investigator: Ernest C. Hall | | Report #: ASI-16-CV-T | Report date: 03-17-17 |

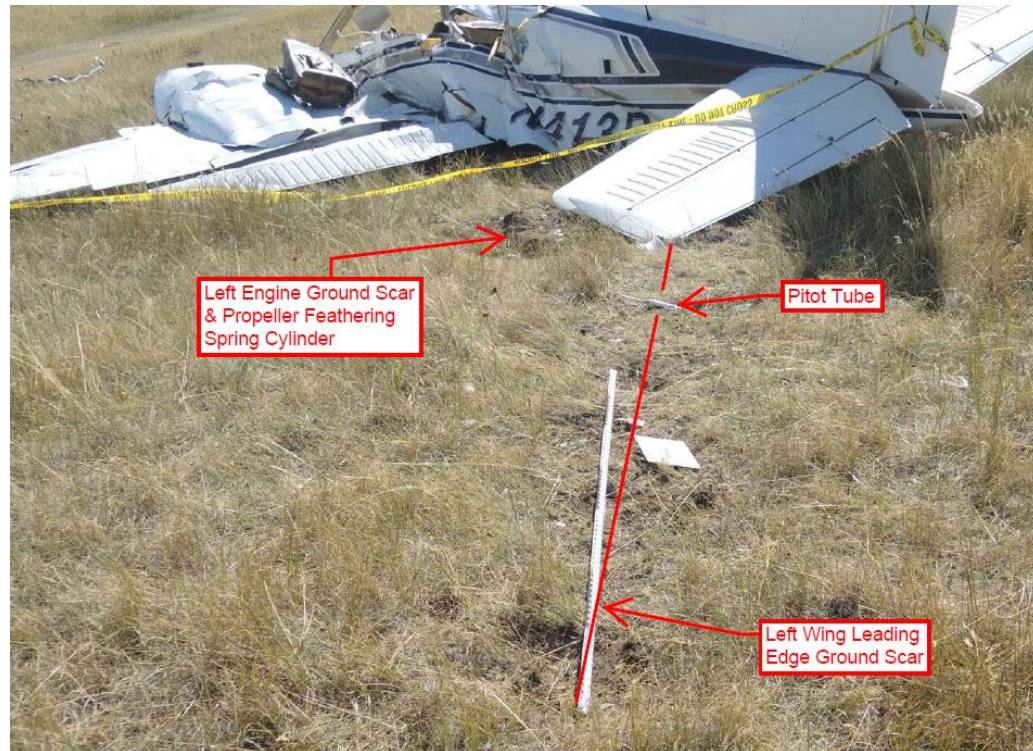
There were ground scars consistent with the width and length of the left wing leading edge, left engine, and right engine. Buried in the left engine ground scar was the left propeller feathering spring cylinder in a vertical position. The ground scars indicated an impact of a magnetic heading of about 120°. The airplane came to rest upright about 2' forward of the ground scars on a magnetic heading of about 143°. Both engines were canted down and partially separated from the airframe. Both Hartzell 2-blade propeller assemblies separated from their respective engine. The left propeller came to rest about 10' to 15' forward of the left engine. The right propeller came to rest under the right wing root and the fuselage. The front and rear carry thru spars were canted forward. The rear carry thru spar had about 5 45° diagonal buckles. The landing gear was retracted and the nose landing gear was pushed aft to the front carry thru spar. There was a 45° aft and downward diagonal buckle from the left rear cabin window to bottom of the airplane. The nose fuselage was fragmented. The cockpit floor was buckled upward. The cockpit roof and side structures were compressed downward.

Ground Scars

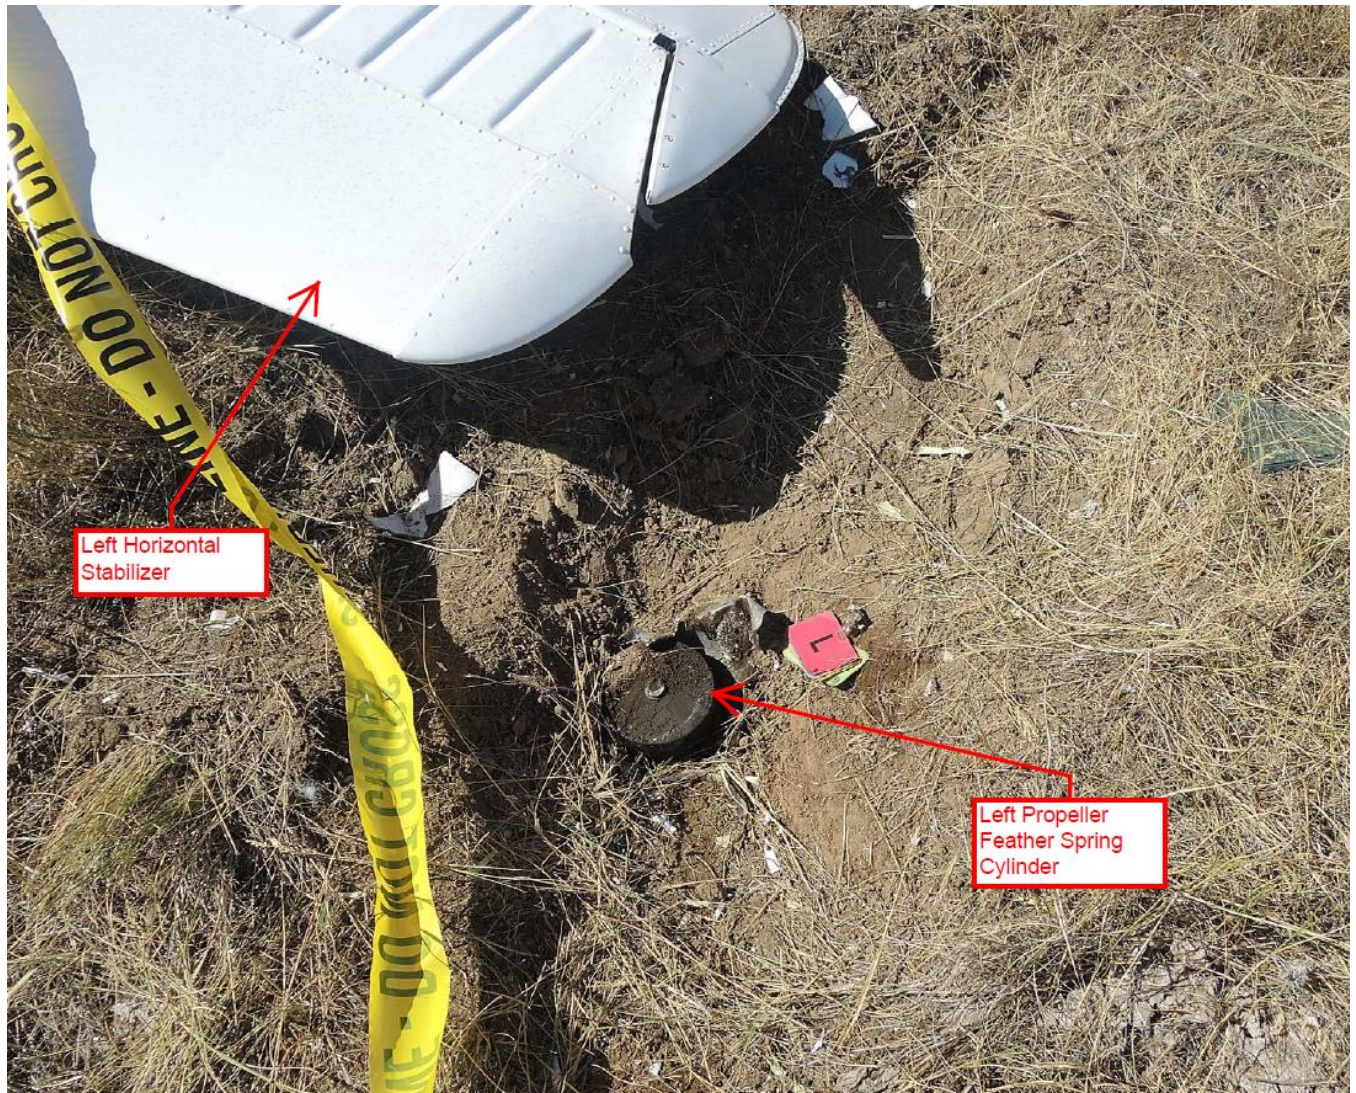
Left Engine Ground Scar and Left Propeller Feathering Spring Cylinder

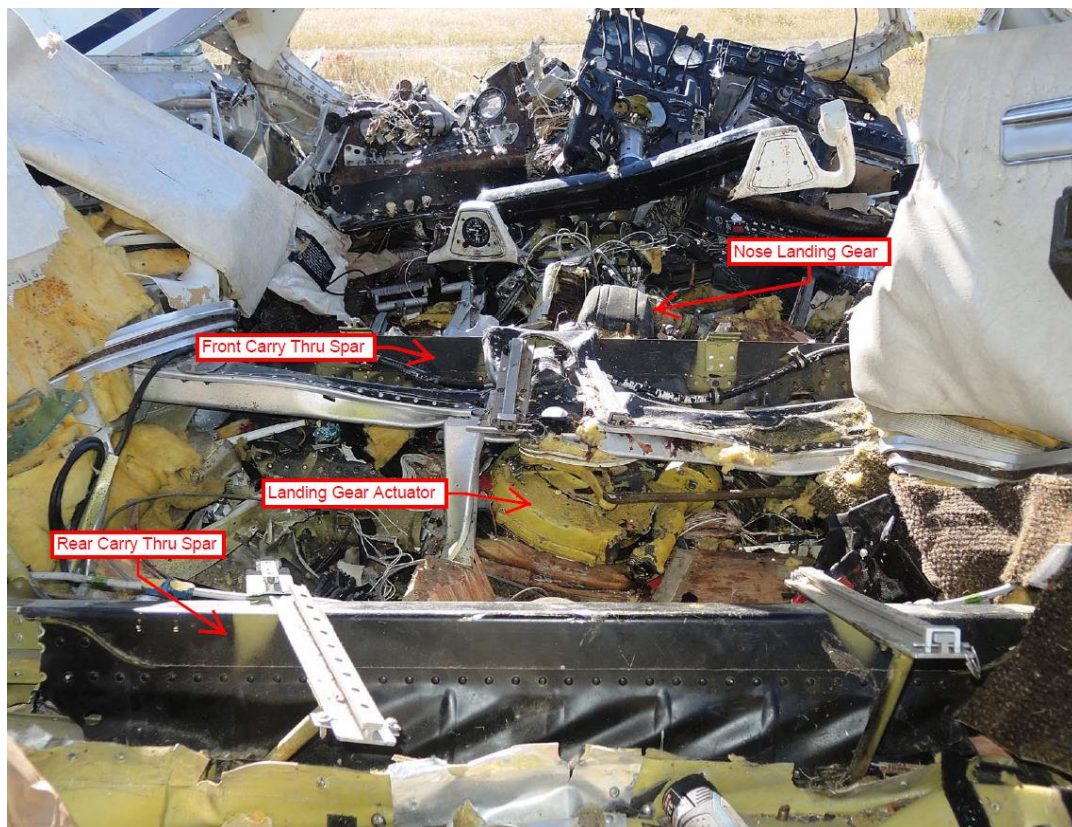
Front and Rear Carry Thru Spars and Nose Landing Gear

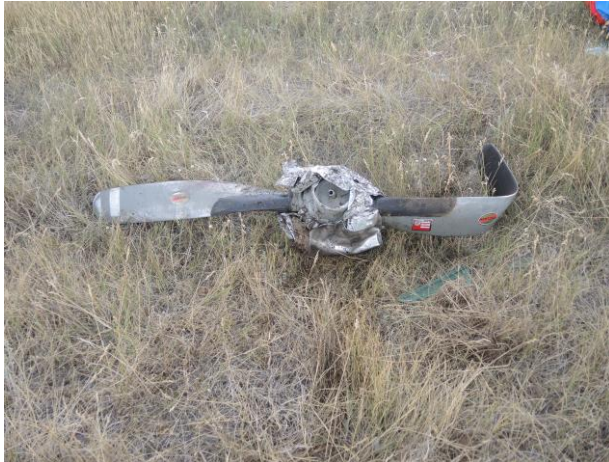
One left propeller blade exhibited leading edge polishing, chordwise scratches, and a span wise twisting toward the non-camber side. The other blade was bent aft toward the non-camber side about mid span.

Left Propeller

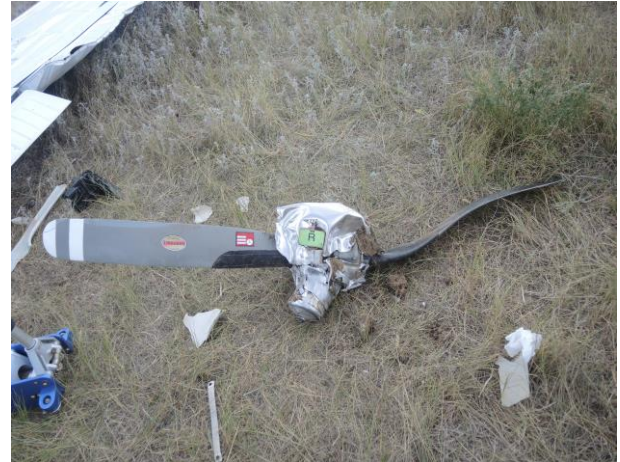
The right propeller blades exhibited no leading edge polishing, chordwise striations, or significant blade twisting. One blade was bent aft toward the non-camber side at hub and was loose in the hub. The other blade had minimal damage and remained in the hub.

Right Propeller
