# NATIONAL TRANSPORTATION SAFETY BOARD

## MATERIALS LABORATORY FACTUAL REPORT

Report No. 17-035

Place : Gilbert, AZ  
Date : 9/17/2016  
Vehicle : Cessna 182P, N20844  
NTSB No. : WPR16FA183  
Investigator : Albert Nixon

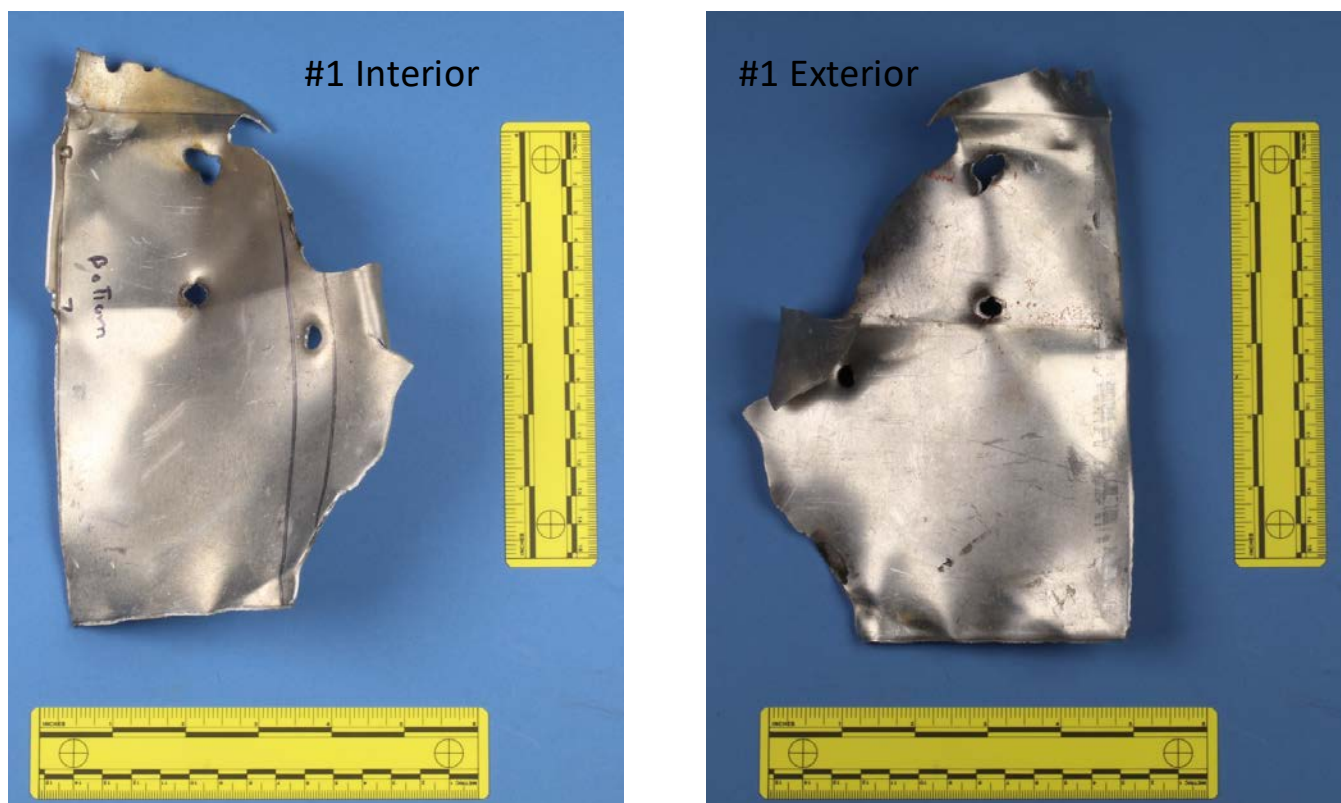
Figure 4: Portion #1 (both sides shown).

Portions #1, #3 and #5 originated from the bottom of the pyrotechnics box. Portions #1 and #3 share a fracture surface and contain the holes used to mount the pyrotechnics box to the step on the landing gear arm. Portions #1 and #3 had overstress fractures around their periphery. Some of these fractures followed the fold lines.

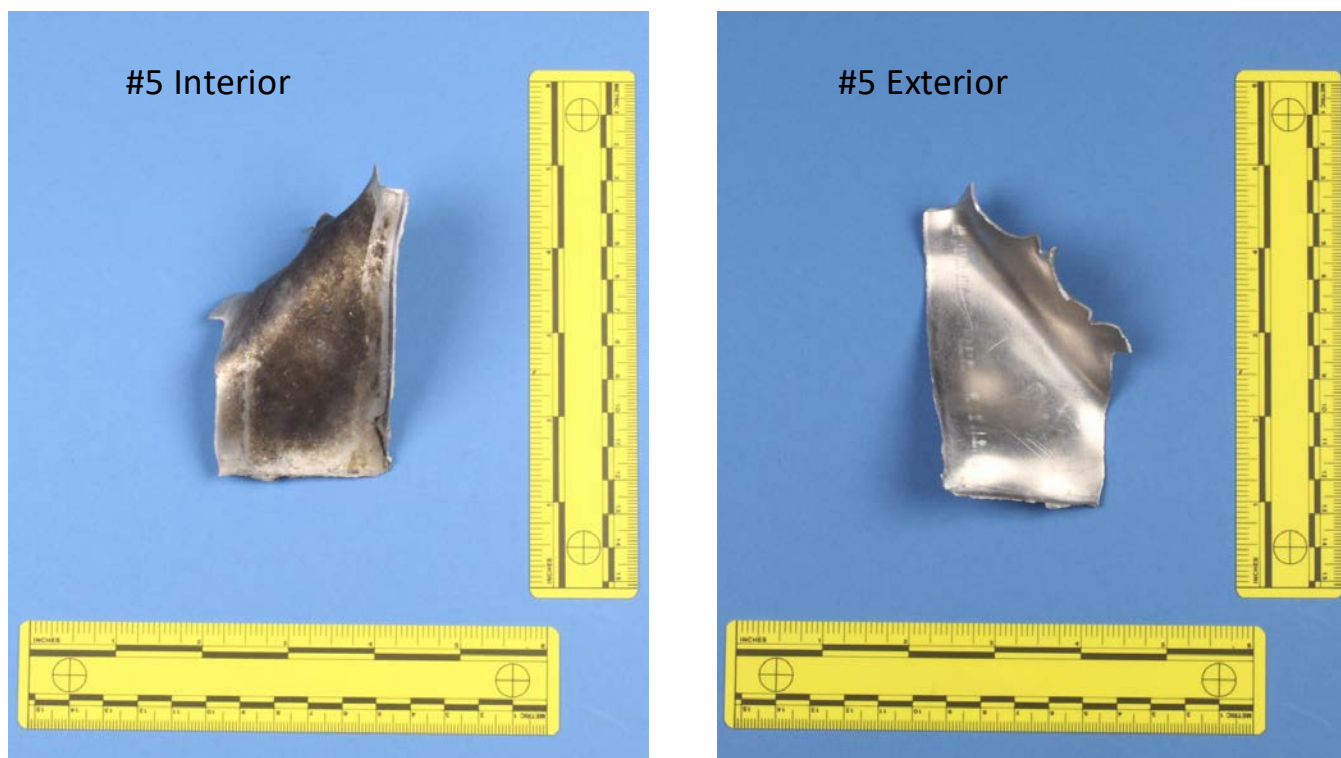
Figure 8: Portion #5 (both sides shown).

Portion #5 was from the aft outboard corner of the pyrotechnics box. Portion #5 had a blackened-sooted appearance. Portion #5 exhibited overstress fractures around its periphery. The fractures around the outboard edges of this portion occurred at the fold lines.

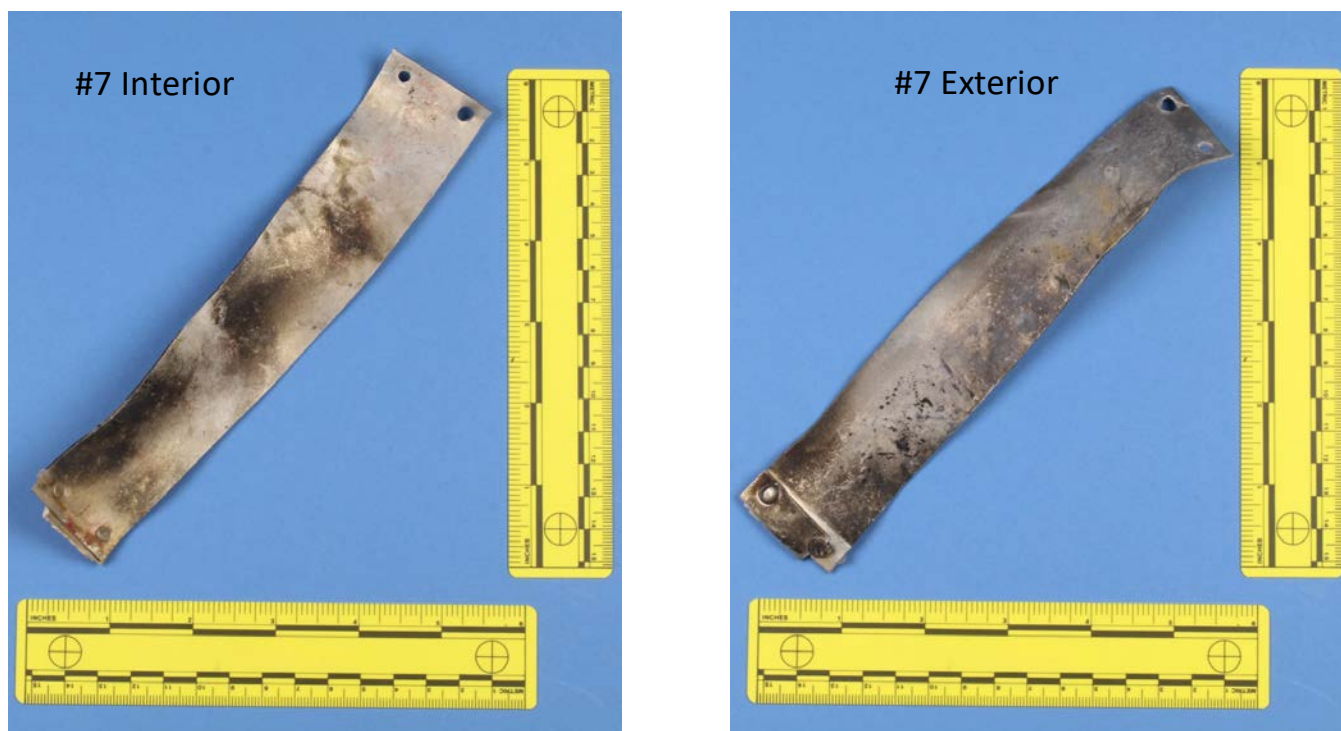
Figure 10: Portion #7 (both sides shown).

Portion #7 originated from the aft part of the pyrotechnics box (Figures 10, 3). This portion exhibited blackened-sooted regions on both the interior and exterior surfaces. The deformation and rivet pullouts are consistent with a force originating from inside the box.

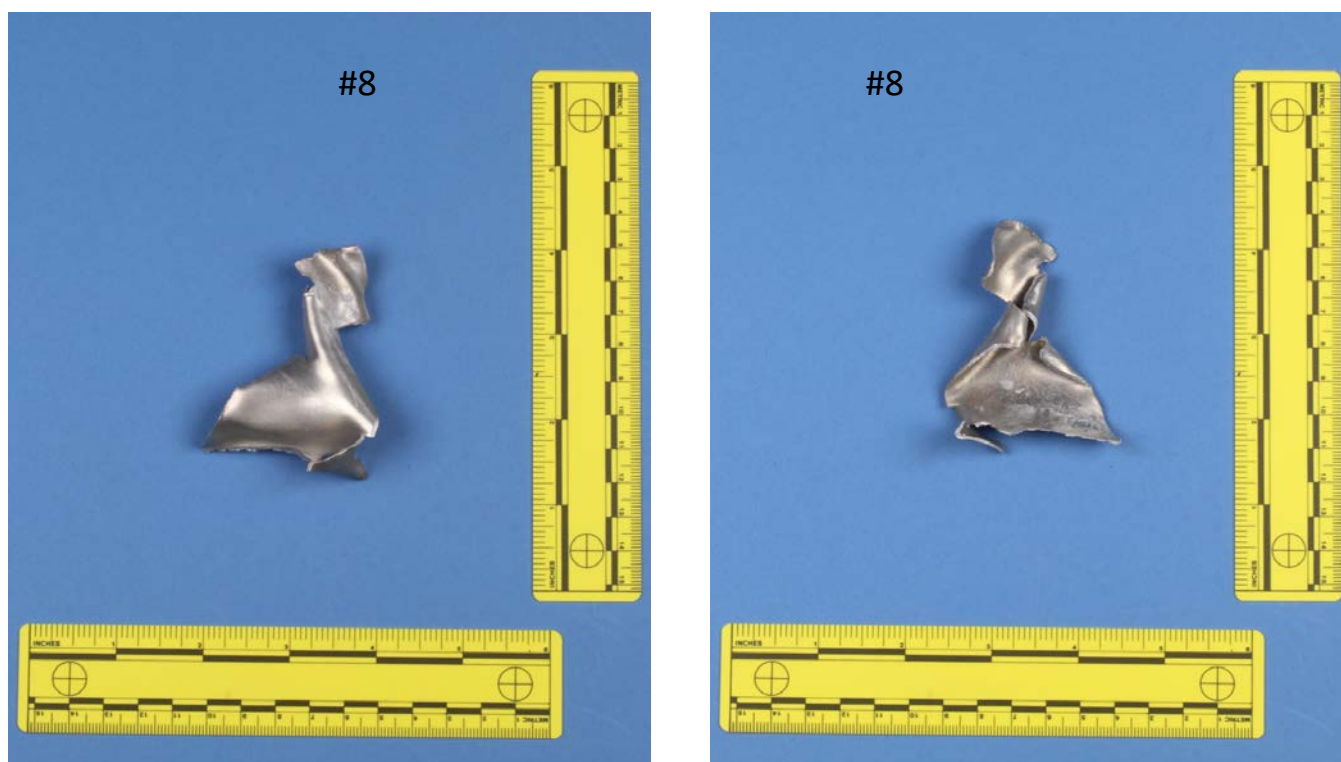
Figure 11: Portion #8 (both sides shown).

The origin of portion #8 could not be established based on any features contained within the part (figure 11). Portion #8 exhibited multiple fracture surfaces and torn edges that had curled over consistent with explosive damage.

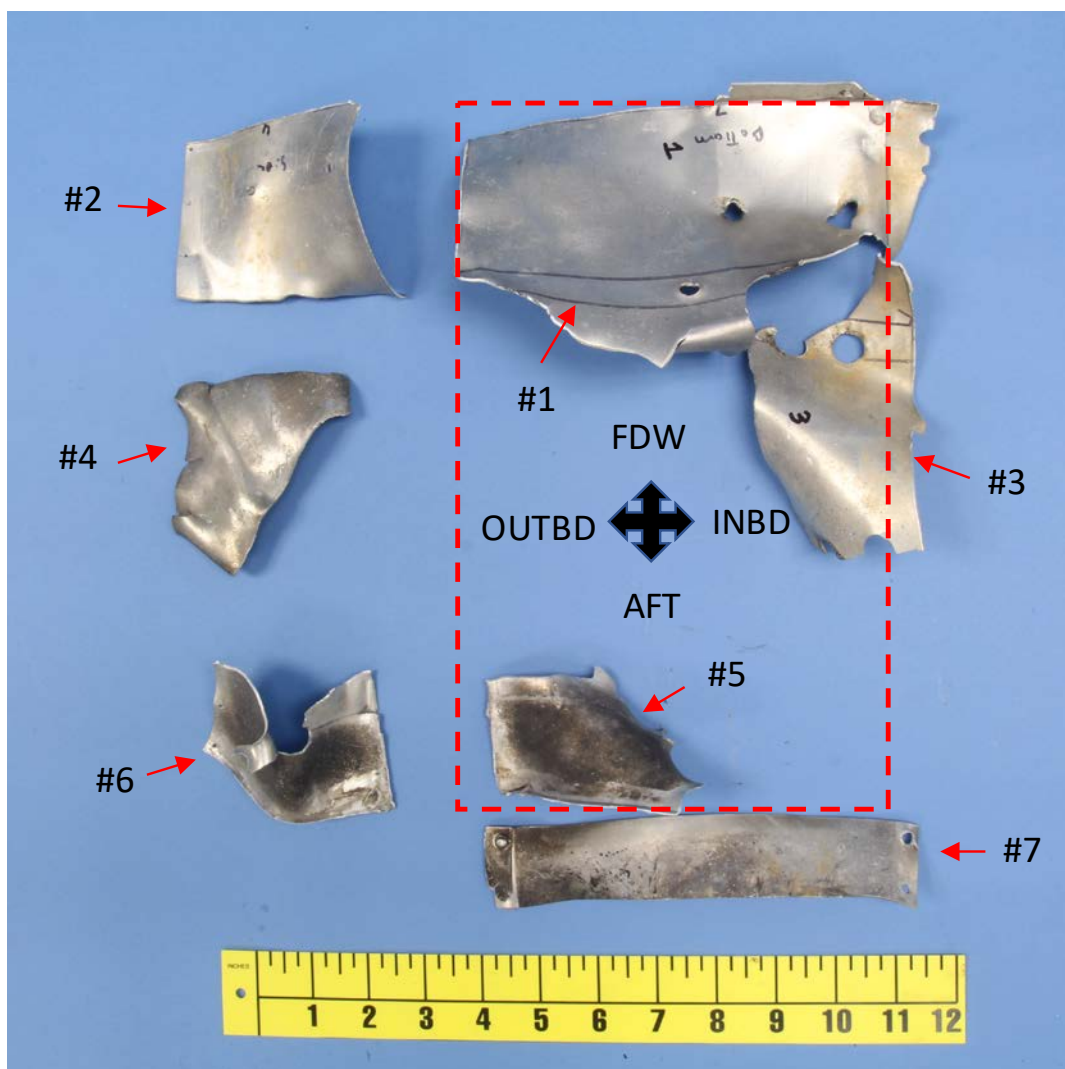
After examination of the recovered portions of the pyrotechnics box, and comparison with the photo in figure 3, their relative position with respect to each other is shown in figure 12. The red dotted line in figure 12 represents the bottom footprint of the pyrotechnics box. Portion #8 did not have any features from which to establish its position with respect to the other portions.

Figure 12: Relative positions of pyrotechnics box portions with respect to each other. The dashed line rectangle denotes the footprint of the pyrotechnics box. This view shows the interior surface of the portions.

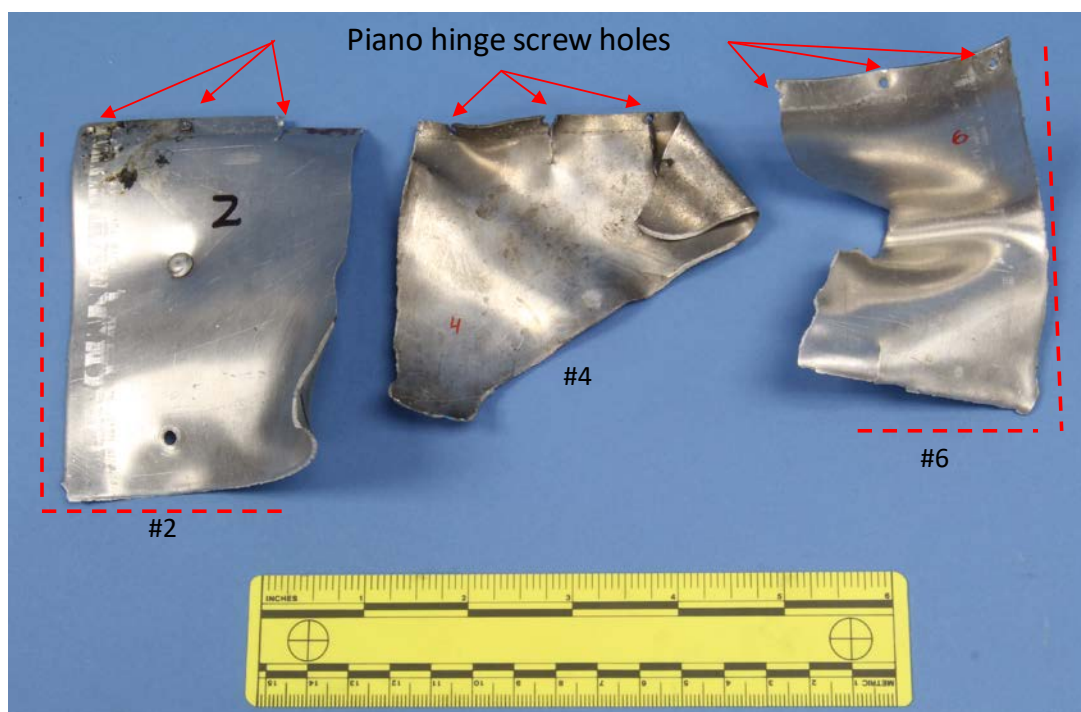
Portions #2, #4, #6 originated from the outboard side of the pyrotechnics box (Figure 13). The screw holes for the piano hinge are distributed along the top edge of these portions. Portion #2 had fractures on the sides along the fold lines of the box as well as a fracture separating it from portion #4 (the fractures in between portions #2 and #4 are not mating). The fractured edges between portions #2 and #4 are deformed in a direction suggesting the applied force originated from the inside of the box. Portion #4 exhibited a folded over edge resembling a folded leaf petal. This folded over edge feature is consistent with explosive damage. The screw holes on portion #4 were torn. Portion #6 exhibited fractures along the box fold lines. Portion #6 exhibited deformation consistent with the applied force originating on the inside of the box.

Figure 13: Portions from the outboard side (see figures 12 & 3 for orientation) of the pyrotechnics box. The dashed lines show the fold lines of the box. This view shows the exterior surfaces of the portions.

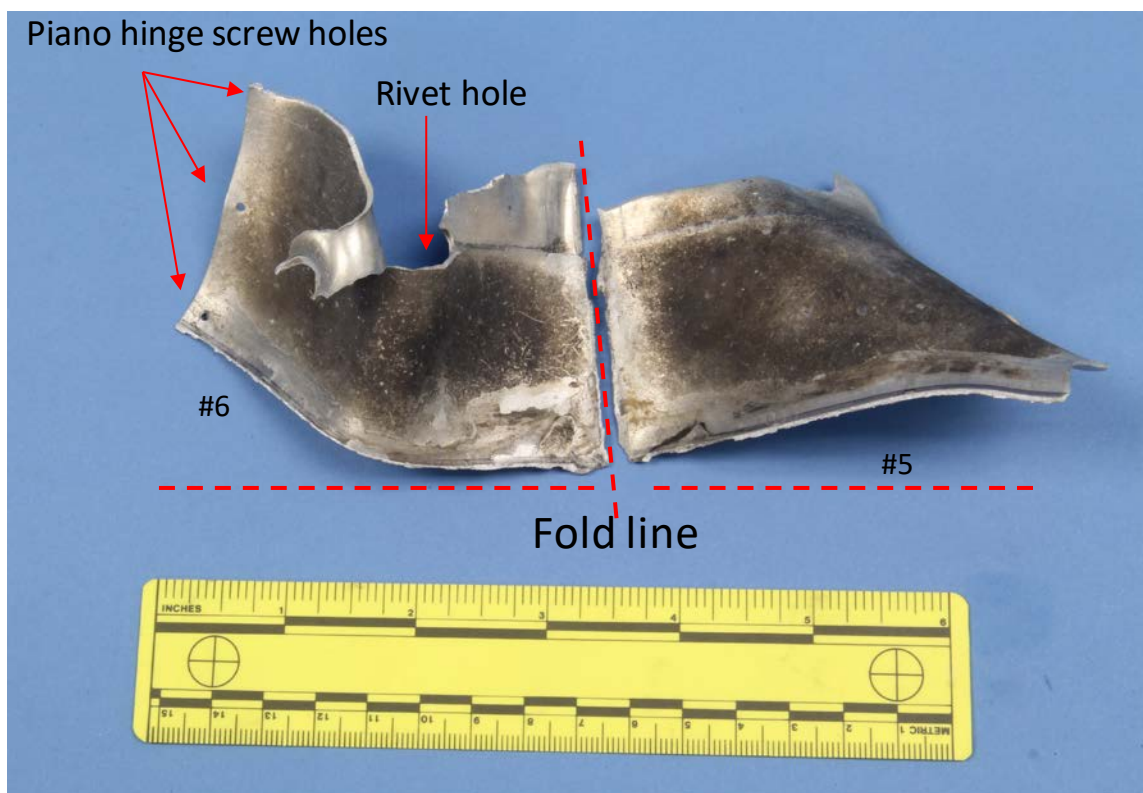
Portions #5 and #6 originated from the aft outboard corner of the pyrotechnics box (Figure 14). Both portions exhibited a blackened-sooted appearance on their inward facing surfaces. These two portions separated from each other along the fold line. Both of these portions also exhibited fractures along the aft fold lines of the box. There was a rivet hole in portion #6 that fractured and was deformed inward with the rest of portion #6 being deformed outward.

Figure 14: portions from the aft outboard corner of the pyrotechnics box (see figures 12 & 3 for orientation). The dashed lines show the fold lines of the box. This view shows the interior surfaces of the portions.

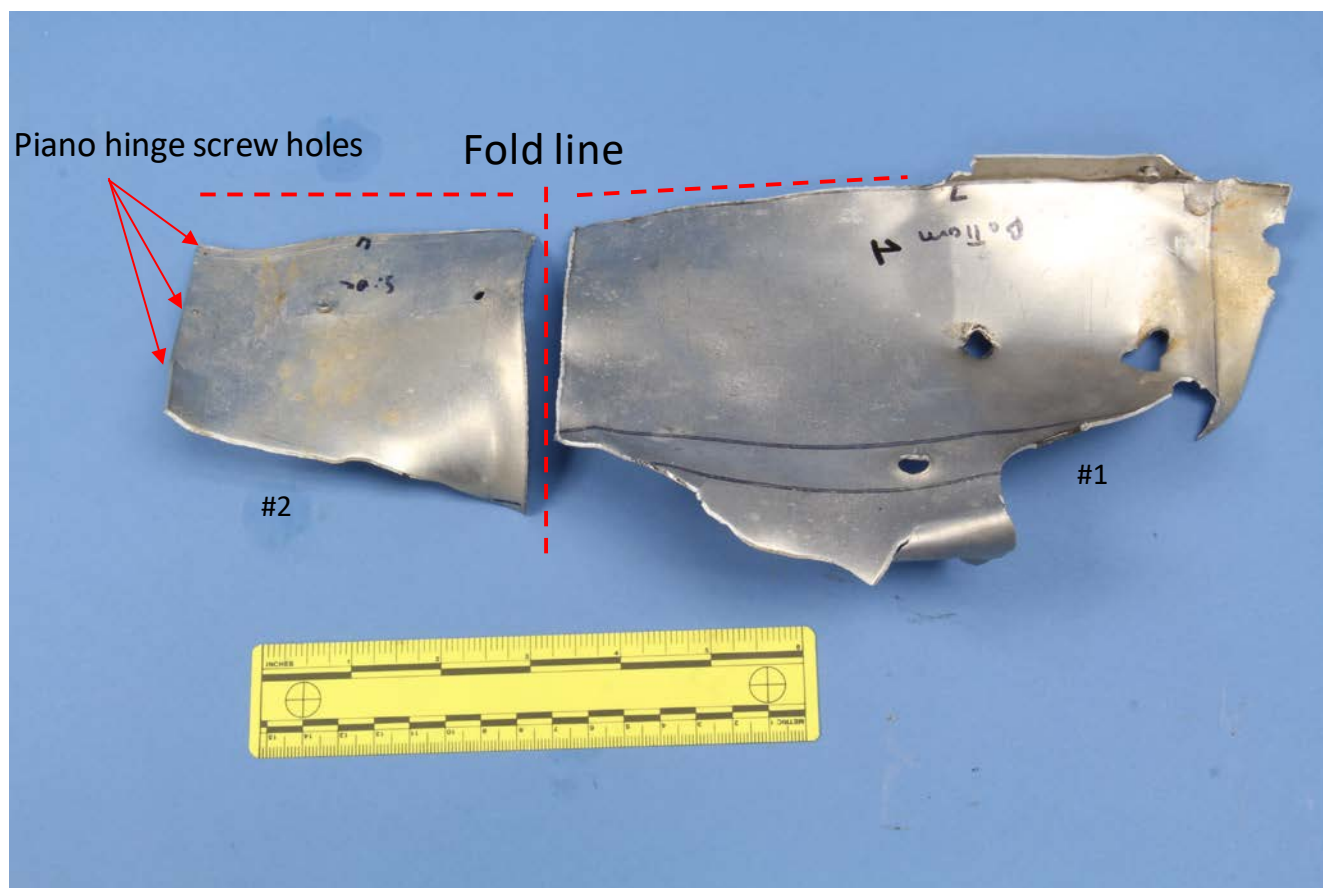
Portions #2 and #1 originated from the forward outboard corner of the pyrotechnics box (figure 15). These two portions separated from each other along the fold line. Both of these portions also exhibited fractures along the forward fold lines of the box.

Figure 15: Portions from the forward outboard corner of the pyrotechnics box (see figures 12 & 3 for orientation). The dashed lines show the fold lines of the box. This view shows the interior surfaces of the portions.

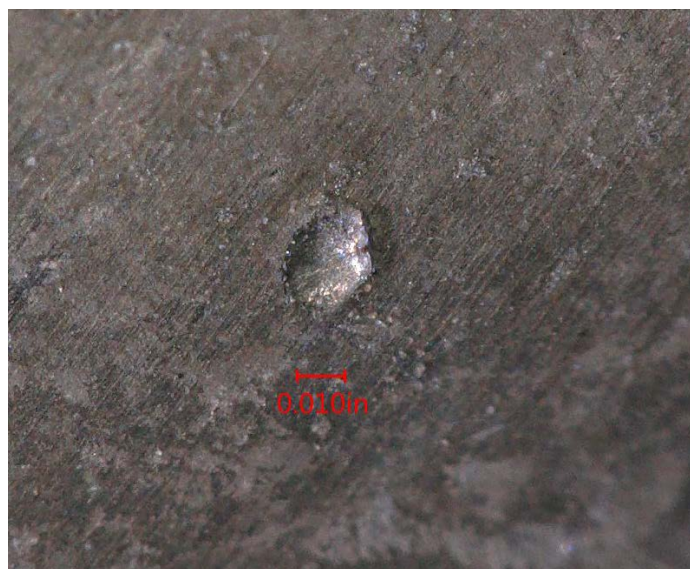
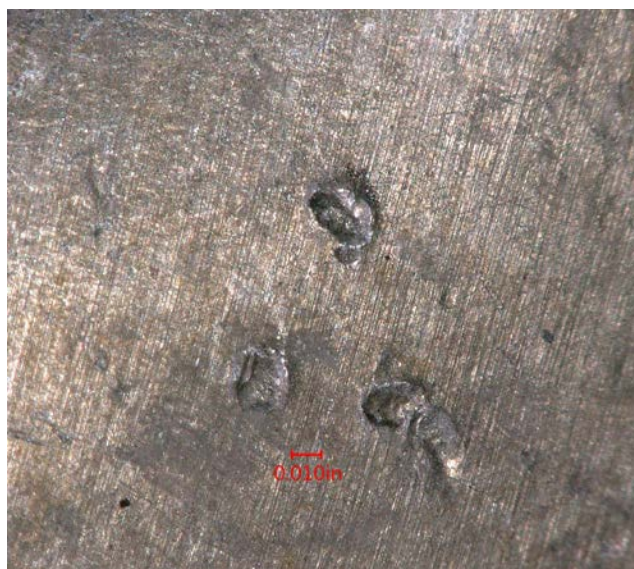
Portions #6, #5 and #7 all exhibited a blackened-sooty interior surface. Portion #4 did not exhibit this same level of staining but did exhibit a peppering of little craters on the surface of the interior side (figure 16). This evidence of cratering is consistent with high velocity particle impact associated with an explosion originating in the interior of the box. Similar cratering was observed on the interior sides of portions #5 and #6.

Figure 16: Particle impact craters on interior surface of portion #4.
