## **NATIONAL TRANSPORTATION SAFETY BOARD**

# **ACCIDENT SITE SUMMARY**

**WPR16FA183**

Location: Gilbert, Arizona  
Date: September 17, 2016  
Aircraft: Cessna 182P, N20844, Serial #: 182261251  
NTSB IIC: Albert Nixon

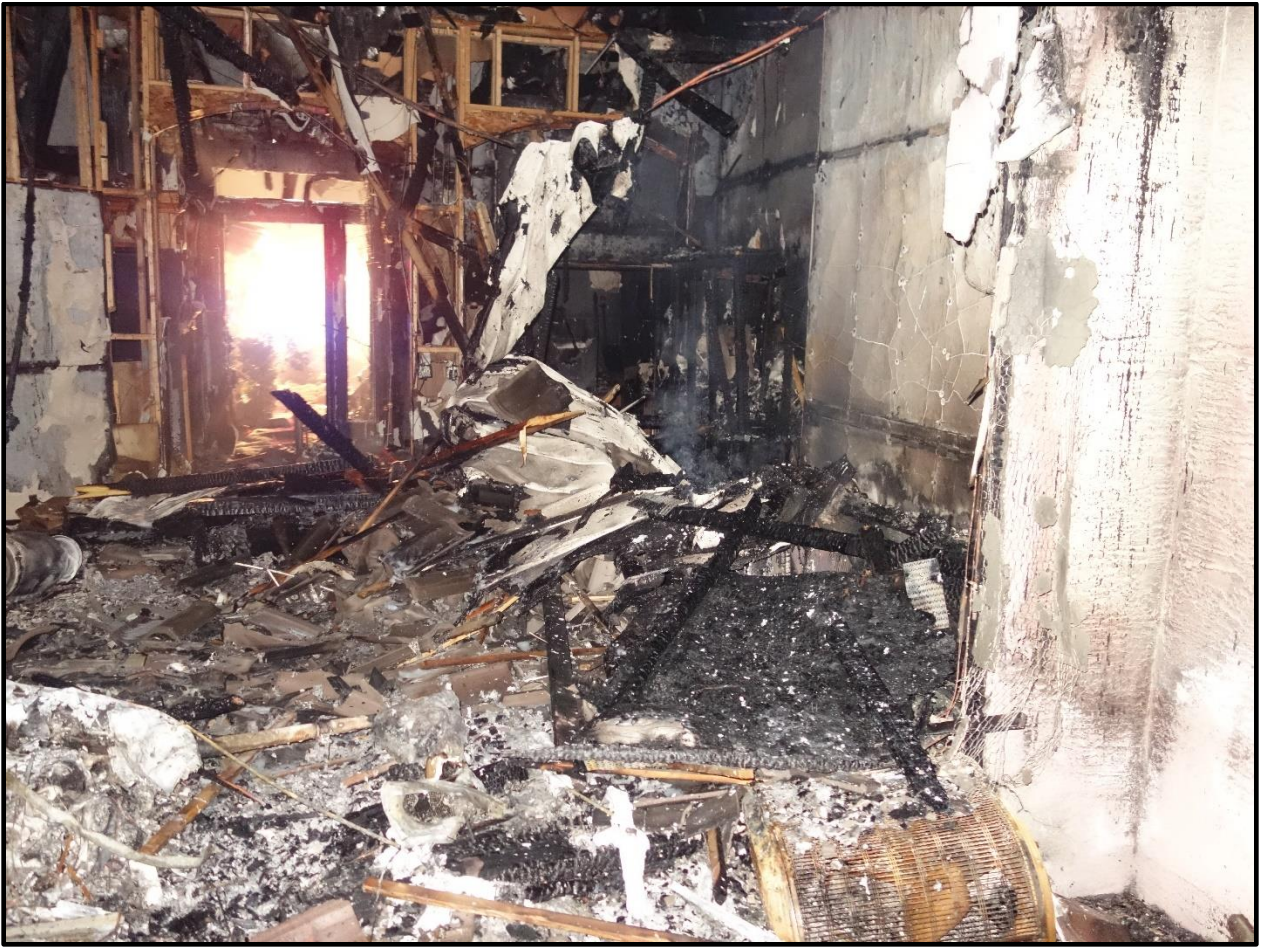
Examination of the accident site by the NTSB investigator-in-charge revealed that the airplane penetrated through the roof of a single-story residential house about in the middle of the back half of the house. A postimpact fire ensued, which consumed most of the airplane and interior of the house. The airplane impacted the residence at a steep nose down angle. All major components of the airplane were contained within the wreckage site. Most of the wreckage debris was scattered in the back half of the house and backyard. Behind the backyard fence there was an open field.

**Figure 1:** Interior of house where airplane impacted.

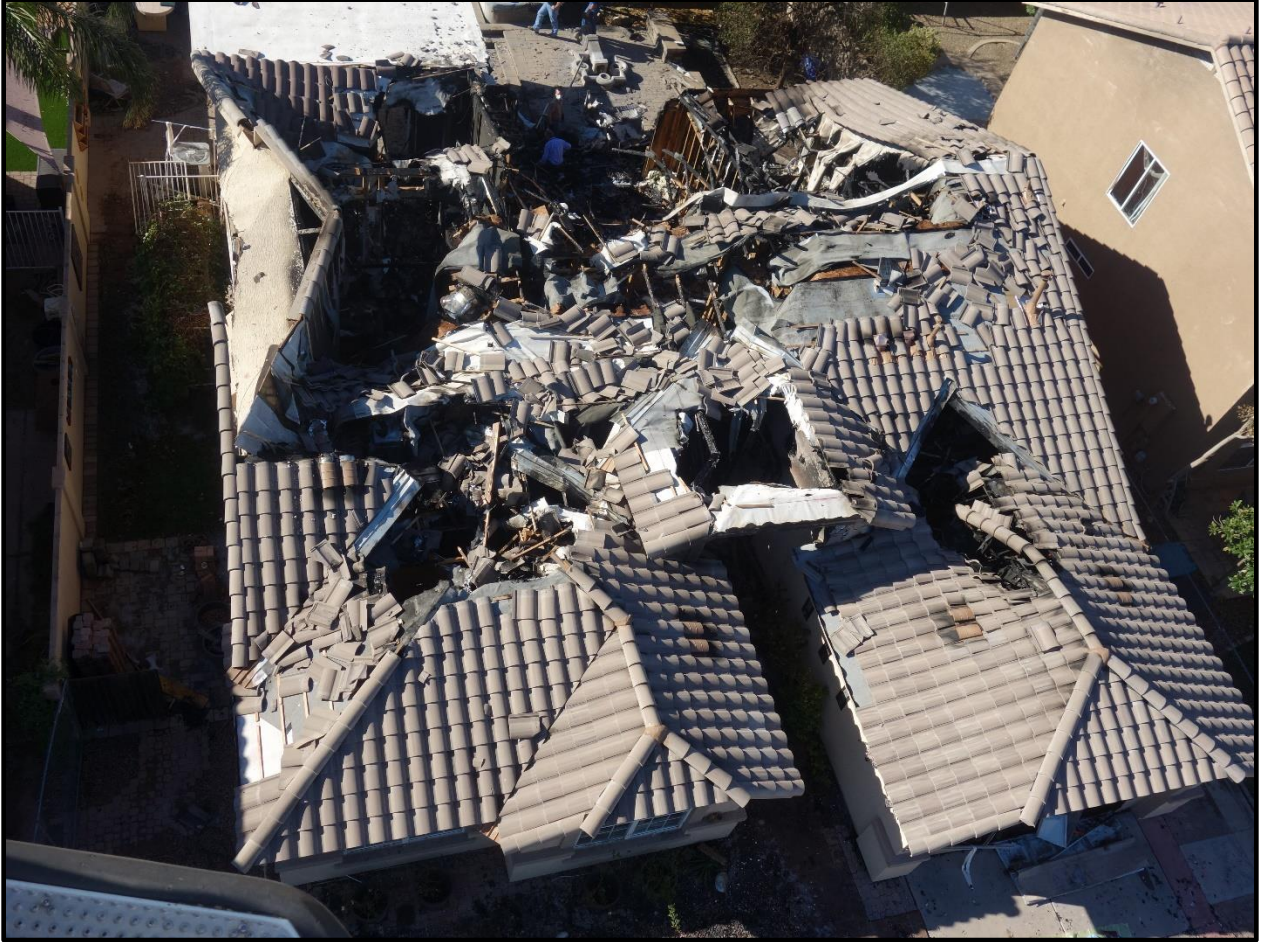
**Figure 2:** Top view of house damage.

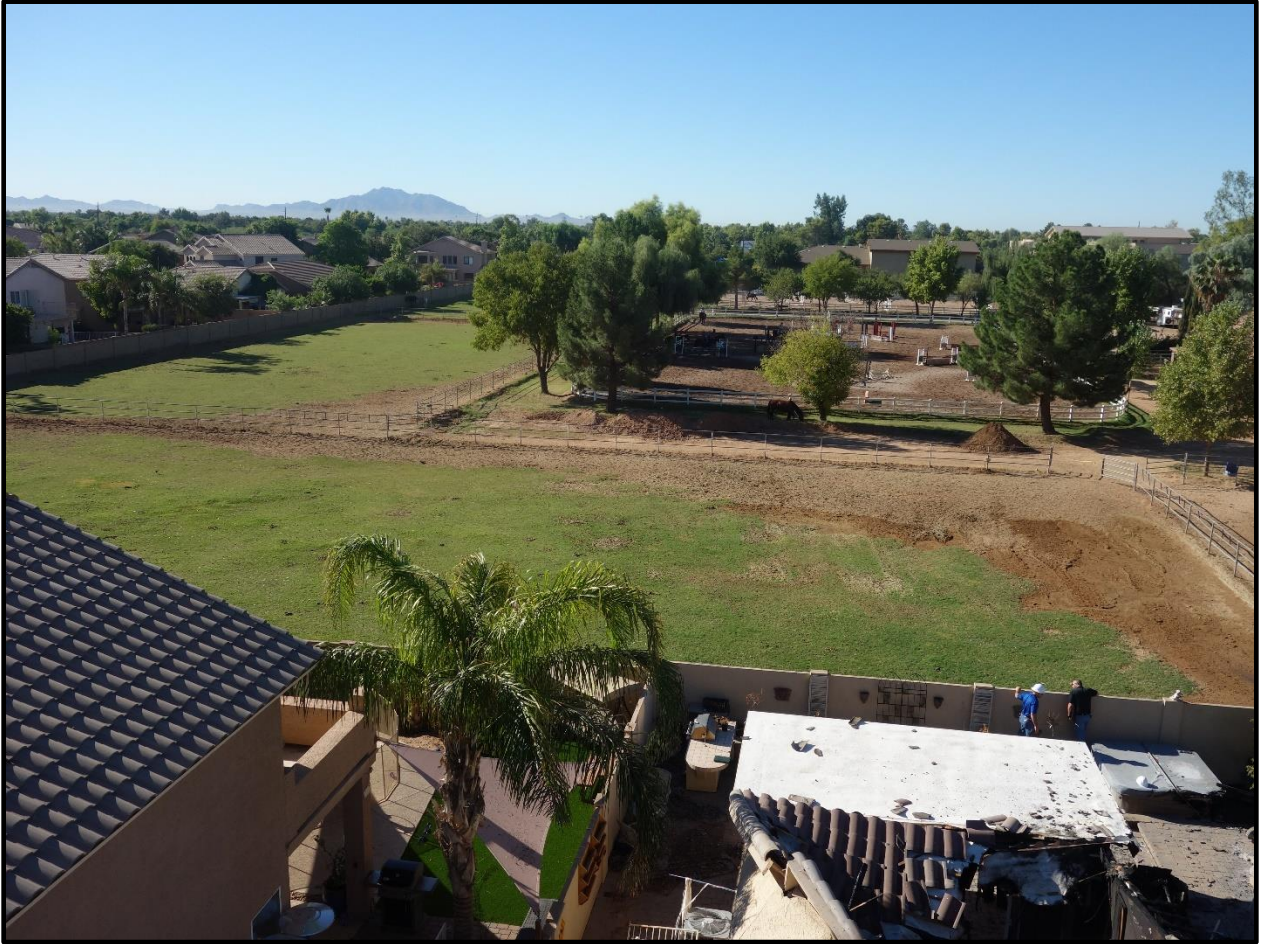
**Figure 3:** Grass field beyond the backyard fence.
